# **Laser Road Surface Sensor Camera Evaluation Project**

**Aurora Project 2004-02**

**Final Report  
August 2008**

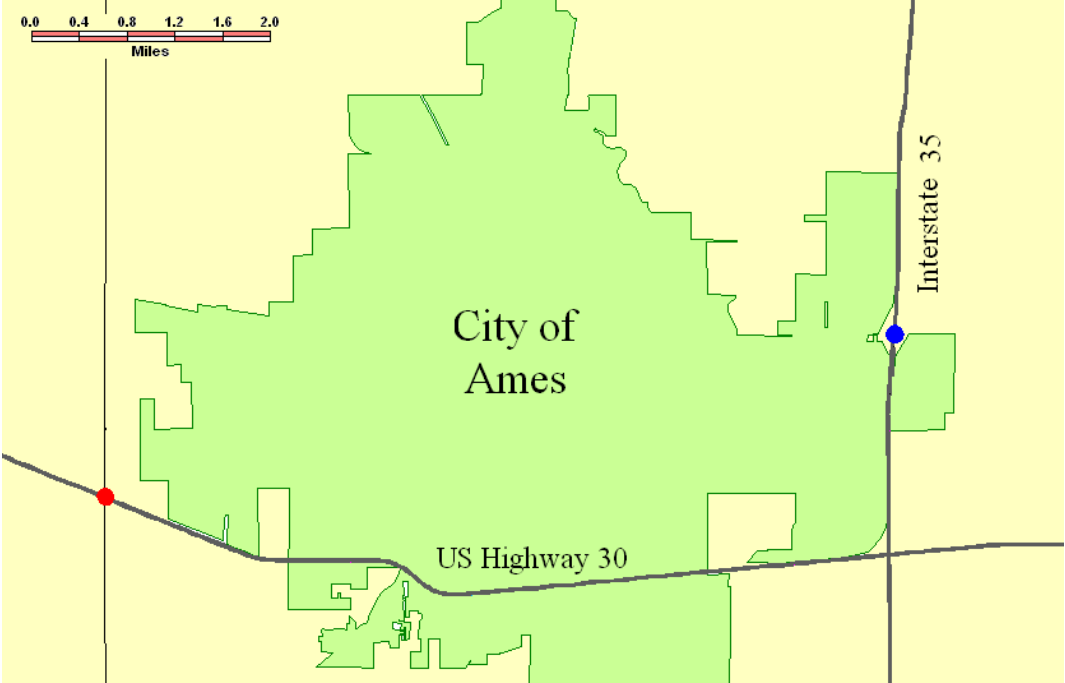
**Figure 1. Map of LRSS test locations**

During the test period, one version of the LRSS was installed in two different locations (Figure 1). The red dot in Figure 1 identifies the first location, a rural bridge crossing US Highway 30. The blue dot in Figure 1 represents the second test location, a bridge on northbound Interstate 35.

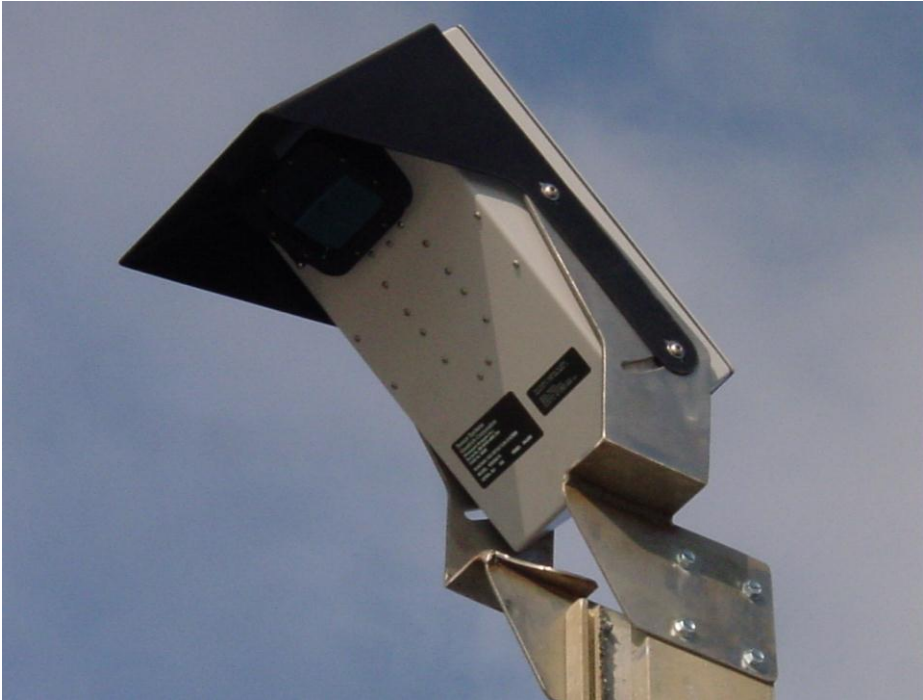
**Figure 2. LRSS sensor module and mounting bracket**

The camera was installed at the top of the pole to a slotted bracket that allowed adjustment of the sensor module (see Figure 2). The electronics module was attached to the side of the pole (Figure 3). The camera was positioned to view an area in the middle of the bridge.

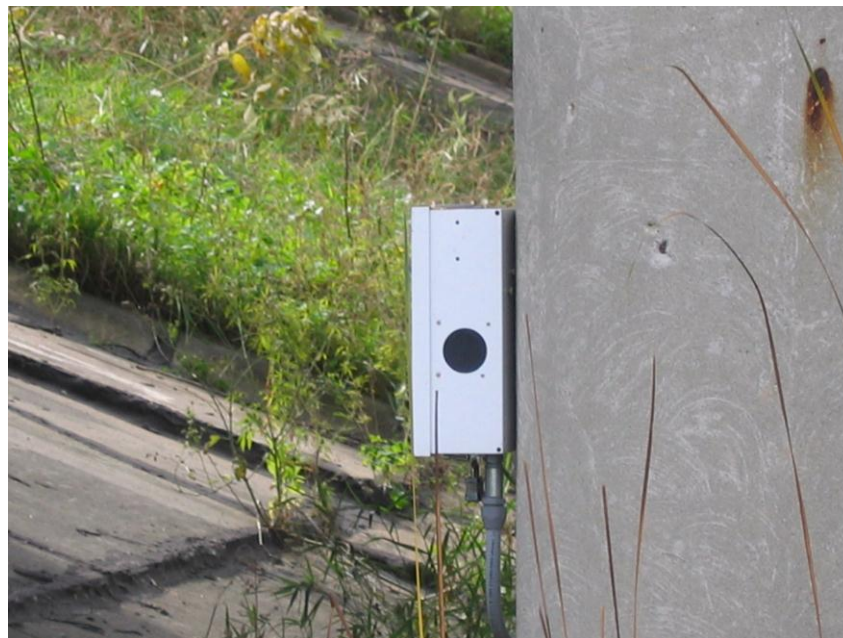
**Figure 5. Lockable box with 12 V power supply located under the bridge**

A lockable box supplied with 12 V DC power was installed on one of the bridge pillars below the bridge. The box was also provided with a 120 V AC receptacle, used to supply voltage to the power supply. Locks were installed on the pole mount and the cover of the power supply box. The download cables were secured to the side of the bridge and terminated in the power supply box below the bridge. This location provided a much safer place to complete downloads than the bridge above (Figure 5).

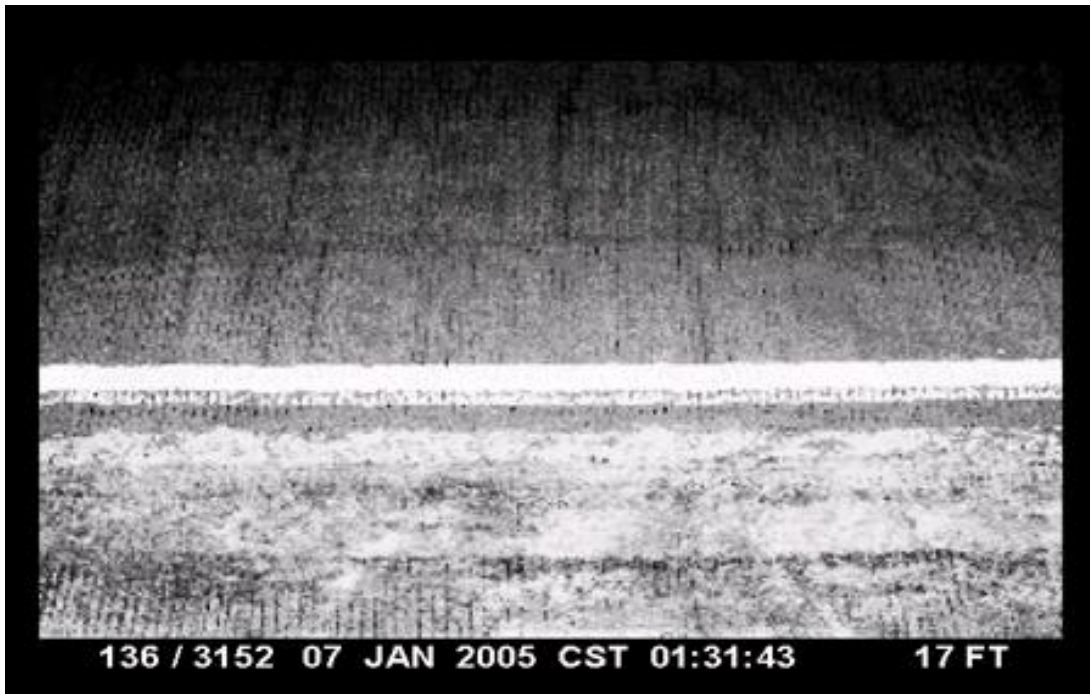
**Figure 7. LRSS images of snow collecting on the apron of the bridge**

Figures 7 through 9 show examples of some pavement conditions observed during the test period. In these figures, the upper portion of the image is the northbound driving lane of Interstate 35. The driving lane is separated from the bridge apron (bottom portion of the image) by a white line. Surface conditions in the color-enhanced images are differentiated by color. Red indicates ice, dark blue indicates snow, and light blue indicates water. Darker variations of those colors denote thicker accumulation.
