Holding Strategies for Low-Volume State Routes – Phase I

**Final Report
December 2020**

Sponsored by
Federal Highway Administration
Iowa Department of Transportation
(InTrans Project 13-459)

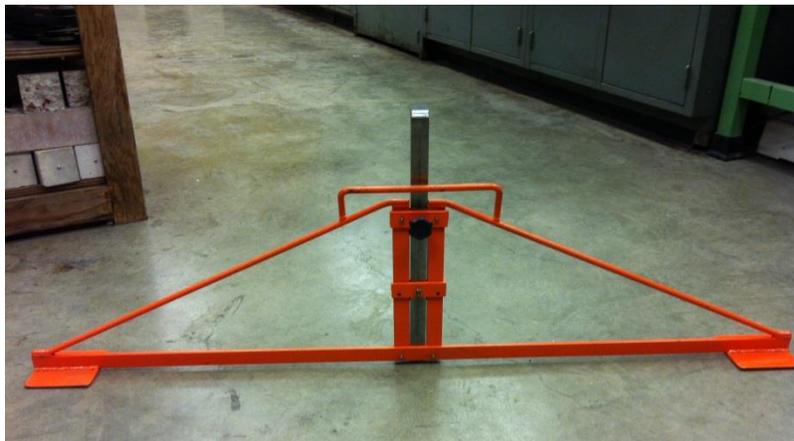
Pavement condition surveys were performed by following the Federal Highway Administration (FHWA) pavement distress identification manual (Miller and Bellinger 2003). Surficial distresses, such as transverse and longitudinal cracking, fatigue cracking, raveling, and rutting, were evaluated. The majority of the evaluations involved visual inspection. The severity level of the cracks was determined using a caliper. Rutting was measured in the wheelpaths using a deflectometer equipped with a 4 ft straight edge and a vertical ruler (Figure 1).

Figure 1. Deflectometer for measuring rutting

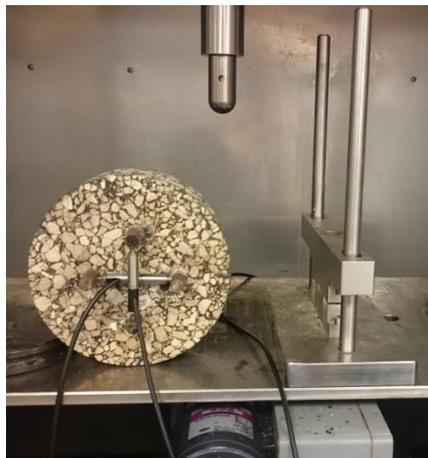
The E* tests were performed on specimens prepared from field core samples. The E* tests used an indirect tensile strength (IDT) test setup with strain measurement devices (linear variable differential transformers [LVDTs]) mounted in the vertical and horizontal directions (Figure 2).

Figure 2. IDT dynamic modulus testing setup

The testing principles and procedure details were provided by Kim et al. (2004). The existing pavement layers before construction of the holding strategies and the FDR layers were too thick for this type of testing setup. Therefore, the core samples of these layers were shaped to make 4 in. diameter cylinder specimens and were tested by following the standard procedures specified in ASTM D3497. The E^* values were measured at 0.4°C, 17.1°C, and 33.8°C for each specimen. The sample cores procured from Section 5 and the CIR layer of Section 7 were destroyed during coring due to their low strengths. Three replications were conducted for each pavement layer in the other sections.

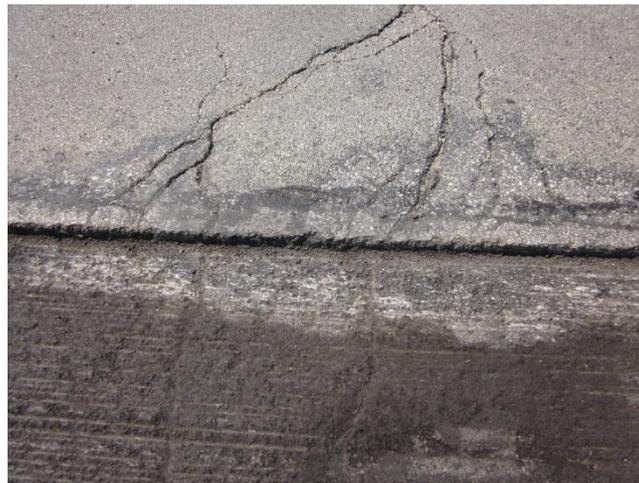
Water was sprayed on the milling drum in order to control dust and cool down the drum. A water tank truck accompanied the profiler to provide a continuous source of water. Before it was opened to traffic, the scarified surface was cleaned with a rotary broom, as specified by Article 2214.03.B5 of the Iowa DOT Standard Specifications (Iowa DOT 2012). Field observations indicated that the milling process eliminated most of the cracks in the existing pavement surface. Some cracks, mostly transverse cracks, were found to have propagated deeper than the milling depth and remained evident in the scarified surface (Figure 8).

Figure 8. Cracks that had propagated deeper than milling depth

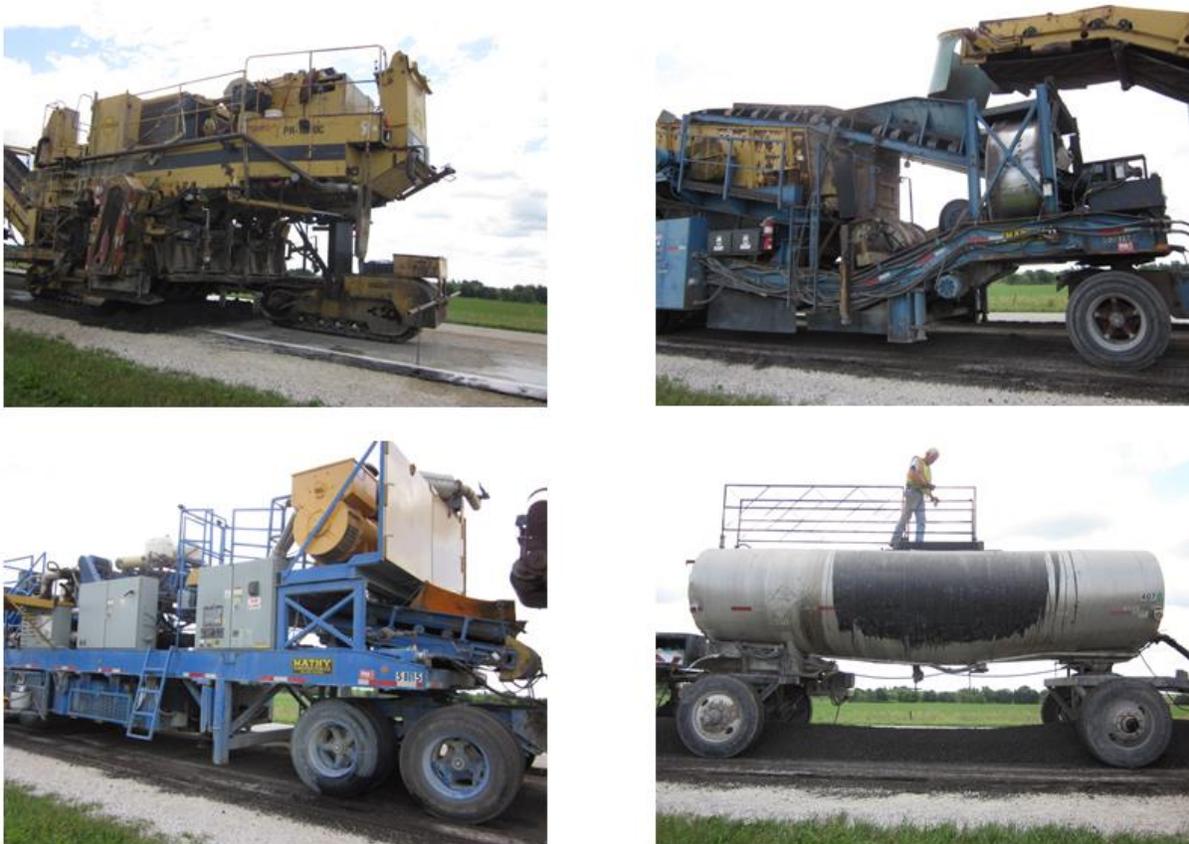
Cold in-place recycling operations commenced on July 23 and were completed on July 26 in 2013. The operation was performed with a CIR train, which included a milling machine, a crushing and screening unit, a pug mill, and an oil tank trailer (Figure 9).

Figure 9. Cold in-place recycling train with milling machine (top left), crushing and screening unit (top right), pug mill (bottom left), and oil tank trailer (bottom right)

The milling machine milled the existing pavement to a 2.5 in. depth, and the RAP was conveyed to the crushing and screening unit. This unit further crushed large chunks of RAP into smaller particles to meet the specification requirements for RAP gradation. Section 2318 of the Iowa DOT Standard Specifications requires 98% to 100% of RAP particles to pass the 1.5 in. sieve and 90% to 100% of RAP particles to pass the 1 in. sieve (Iowa DOT 2012).

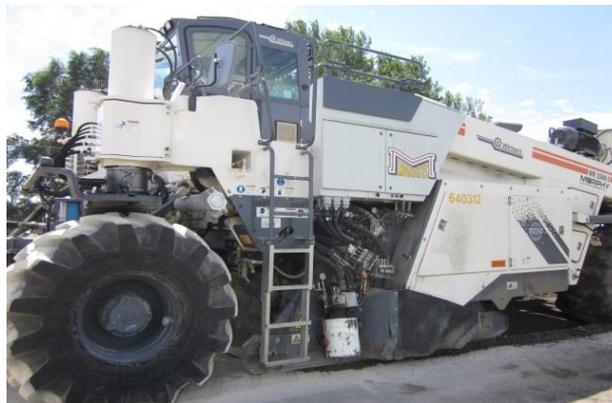
FDR operations were performed in two phases. Phase I construction included a pulverizing machine (Figure 10) that pulverized the full depth of the existing pavement.

Figure 10. Pulverizing machine for FDR

The required gradation for the pulverized pavement is the same as that for CIR material. A sheepfoot compactor was used to compact the pulverized material until the required compaction was achieved. The initial sizing pulverization passes commenced on July 31 and ended on August 1, 2013.

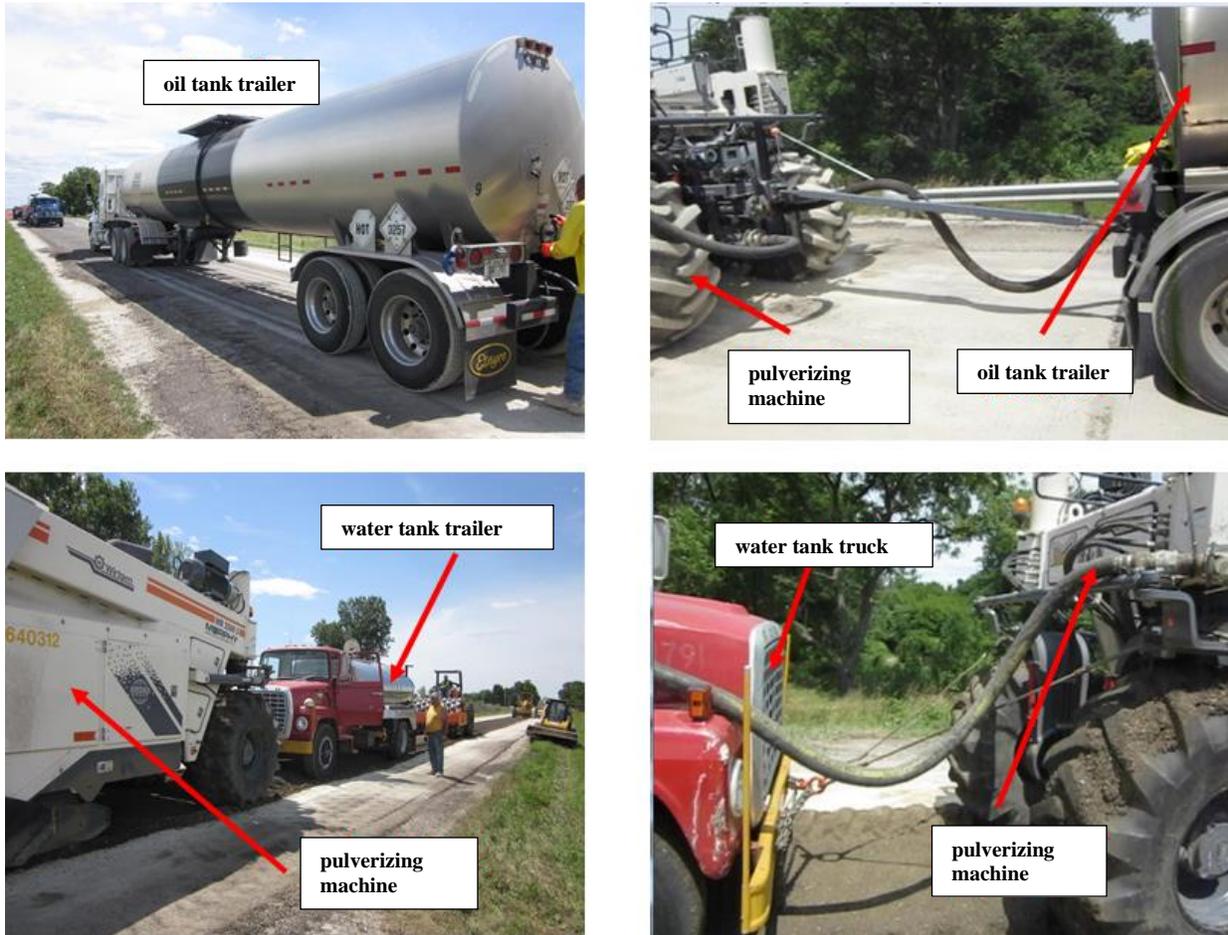
Phase II operations included incorporating fly ash and foamed asphalt into the pulverized RAP, followed by compaction and finished grading. A truck loaded with fly ash was used to place fly ash at a rate of 2.4 tons per station. Fly ash and sized RAP were mixed with foamed asphalt using the same pulverizing machine that was utilized for the initial sizing. An oil tank trailer and a water tank trailer were attached to the pulverizing machine to supply asphalt binder and water for foaming (Figure 11).

Figure 11. FDR train

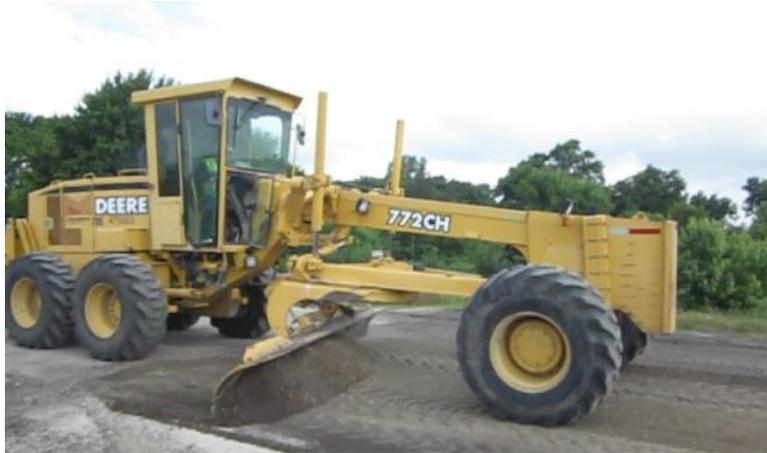
Initial rolling was performed with a sheepsfoot compactor immediately after the mixing process. A motor grader (Figure 12) was operated to eliminate the sheepsfoot roller marks and to perform rough grading of the compacted surface.

Figure 12. Motor grader used for finishing FDR

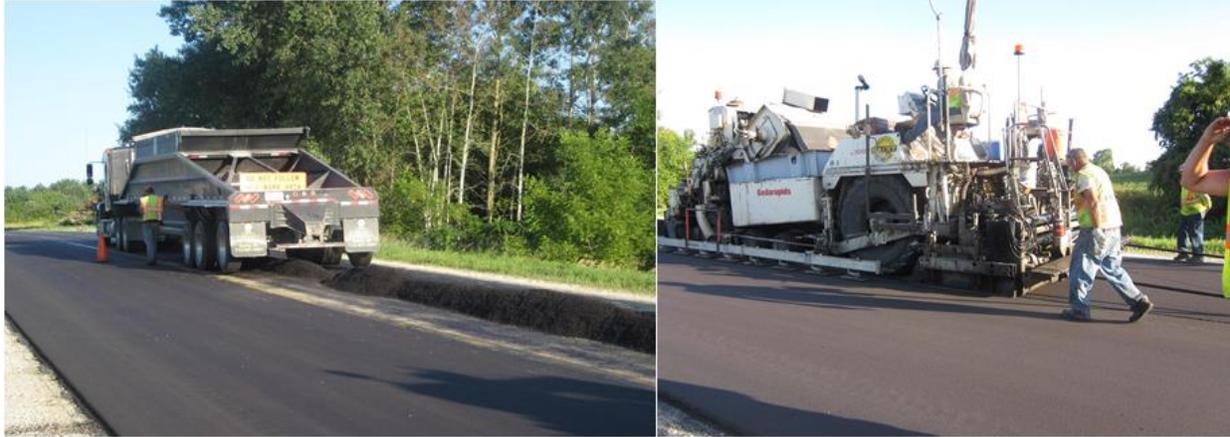
of X Avenue and IA 93. Bottom dump trucks were used to haul the HMA materials to the construction area and place them in a windrow. A windrow pickup unit was used to transfer the materials from the windrow to the paver, which formed the materials to the design thicknesses (Figure 13).

Figure 13. Bottom dump truck and paver

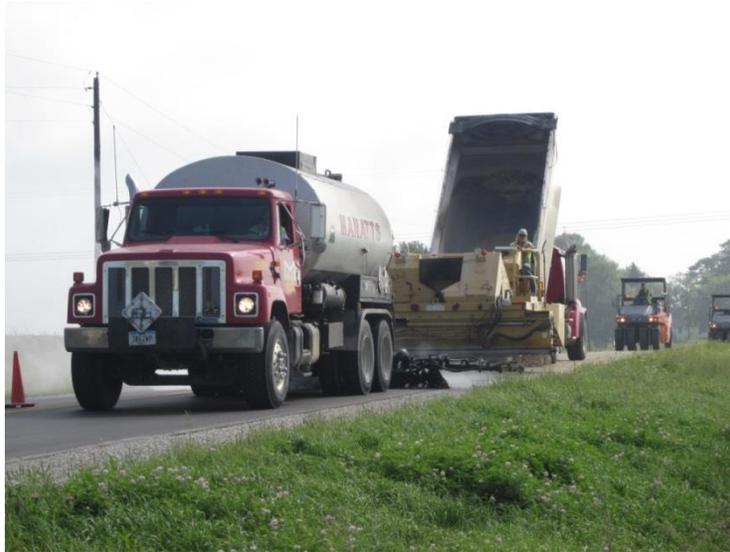
Before the bituminous seal coat was applied, the road surface was cleaned with a rotary broom. An oil distributor then sprayed emulsified asphalt at a temperature between 150°F and 185°F onto the road surface. A chip spreader followed the oil distributor and placed the cover aggregate. The aggregate cover was compacted by two pneumatic rollers to embed the aggregate into the bituminous film. An overview of the seal coat treatment operation is shown in Figure 14.

Figure 14. Construction of seal coat

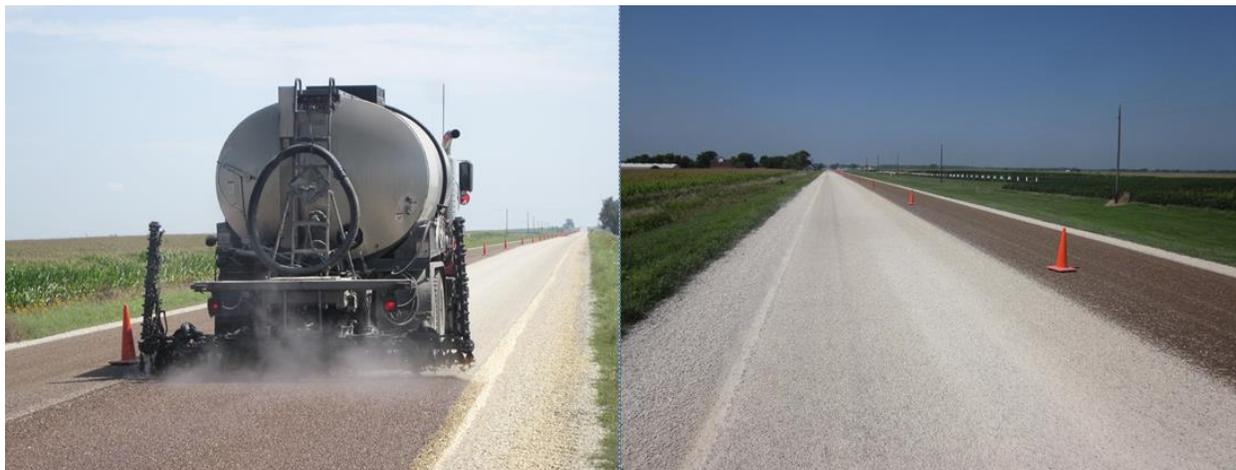
After two hours of curing, the aggregate was sufficiently adhered to the asphalt and the road was opened to traffic. Before opening to traffic, the rotary broom was used to sweep away loose aggregate. Diluted emulsified asphalt was then sprayed onto the road surface to control dust (Figure 15).

Figure 15. Dust control for seal coat

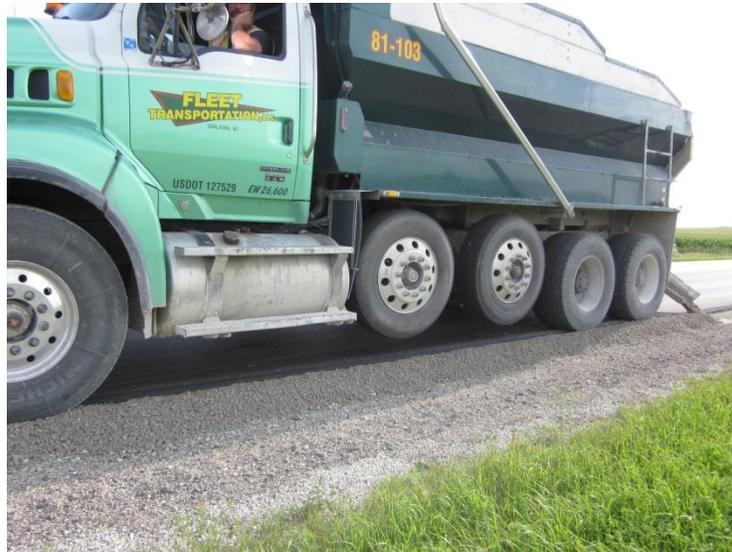
A Type B granular shoulder treatment, as specified in Section 2121 of the Iowa DOT Standard Specifications (Iowa DOT 2012) was applied to the pavement edge for this project. Damp aggregate was placed on the road shoulder with a laydown vehicle as shown in Figure 16.

Figure 16. Shoulder aggregate placement vehicle

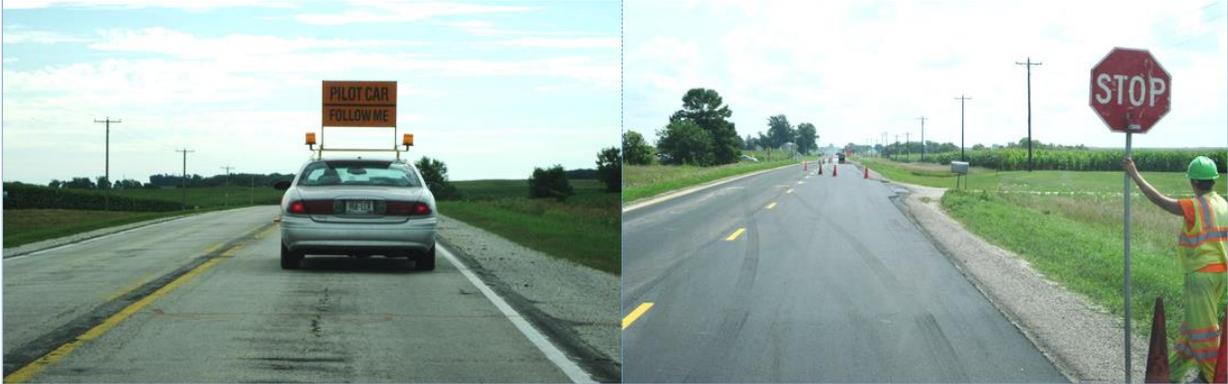
Traffic control operations were conducted according to Article 1107.08 of the Iowa DOT Standard Specifications, “Public Convenience and Safety” (Iowa DOT 2012). The roadway was completely closed in both lanes during FDR operations. A detour was established over adjacent roads. For other operations, single-lane traffic control and a pilot car and flaggers were used to lead traffic through the work zone safely (Figure 17).

Figure 17. Single-lane pilot car traffic control

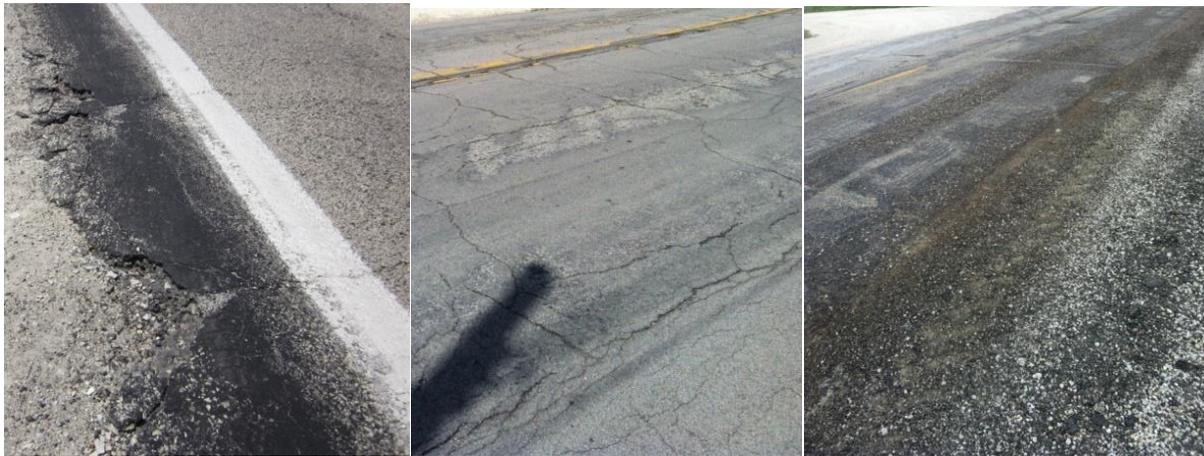
The pre-construction survey showed that the existing pavement was suffering from severe thermal cracking, raveling, edge breaks, and a rough surface (see Figure 19).

Figure 19. Existing pavement surface condition

However, no signs of severe load-related failures, such as considerable longitudinal cracking in the wheelpaths, bottom-up cracking, or severe fatigue cracking, were found. The first post-construction survey showed that the construction was successful. The later post-construction

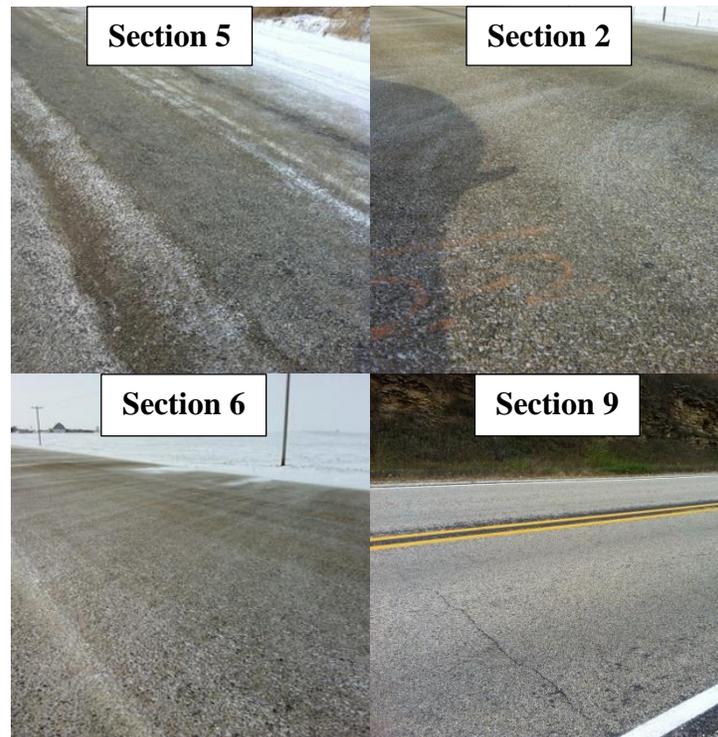
A severe loss of chip seal cover aggregate was found in the wheel paths of Section 5. In some areas, the aggregate loss had led to small potholes. This was especially evident at a bridge approach where compaction of the FDR materials might have been difficult. Loss of aggregate did not occur in the other chip seal surfaces. A comparison of the chip seal surface appearances is shown in Figure 23.

Figure 23. Appearance of four chip seal surfaces

Snow plowing operations are believed to be the primary cause for the aggregate loss problem. The relatively low bond strength between the chip seal aggregate and the full-depth reclaimed layer may have resulted in the performance difference between the chip seal in Section 5 and the chip seals in other test sections.

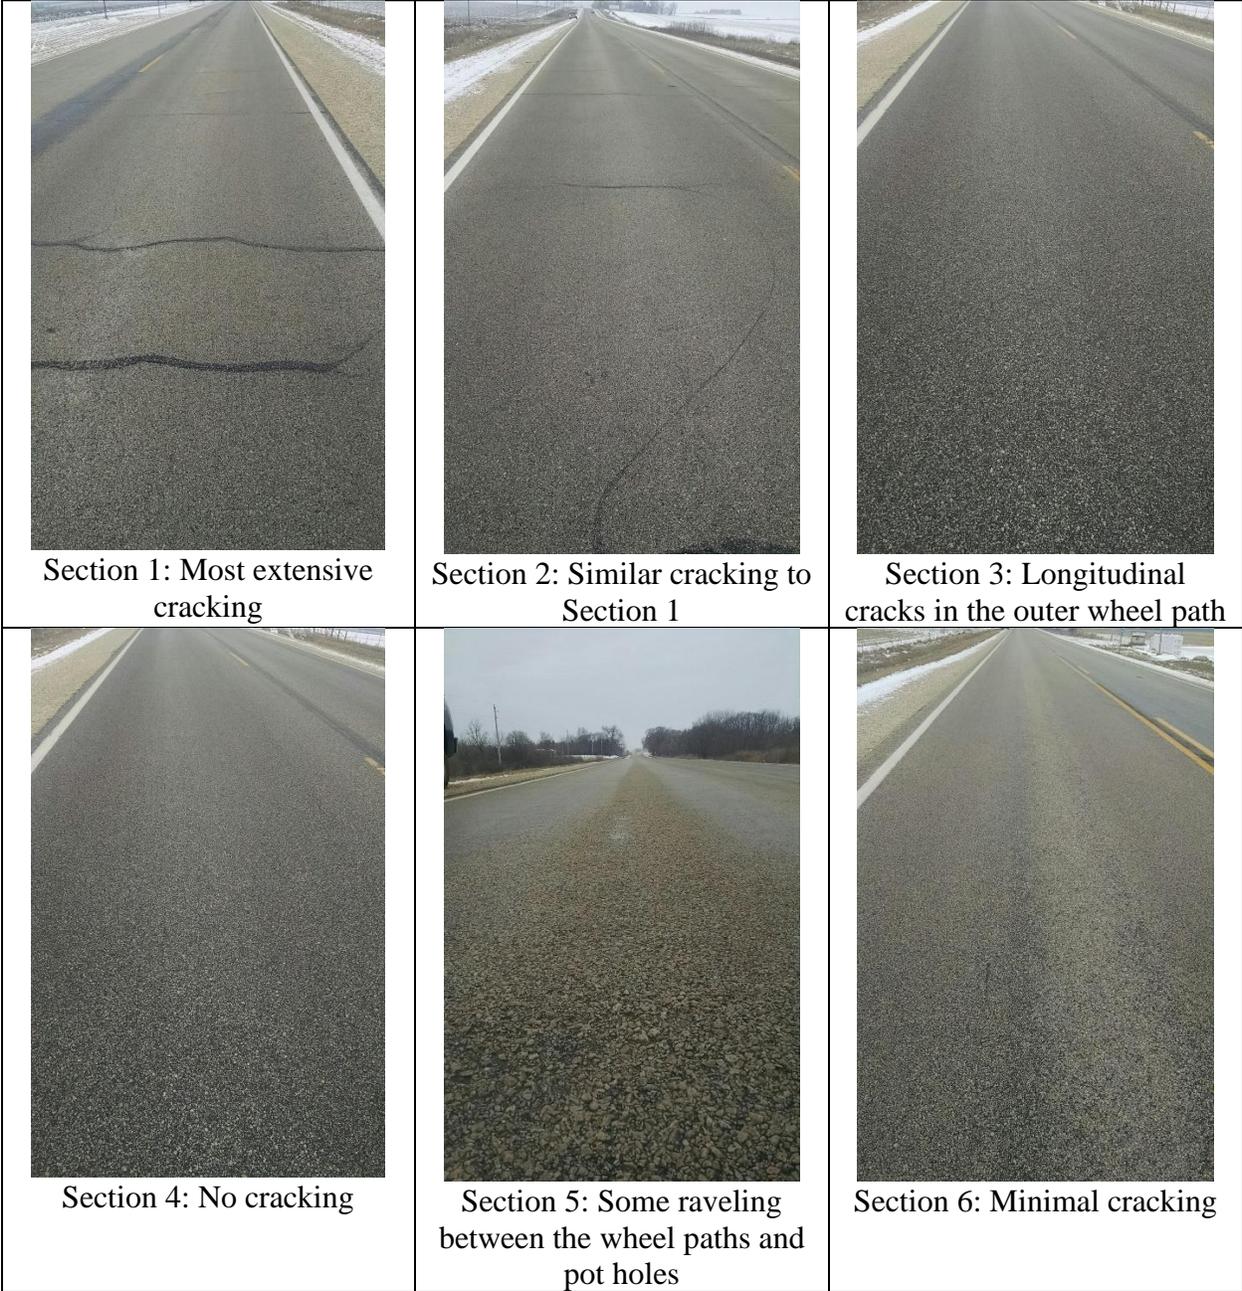
Figure 24 summarizes post-construction conditions as of December 2018; only minor changes occurred between this time and the last survey that was conducted in October 2019.

Figure 24. Post- construction conditions of treatment sections
