Holding Strategies for Low-Volume State Routes – Phase II

Final Report
November 2020

Sponsored by
Iowa Highway Research Board
(IHRB Project TR-735)
Iowa Department of Transportation
(InTrans Project 17-634)

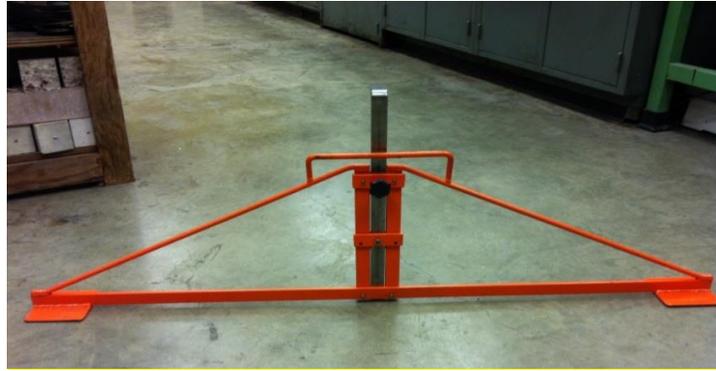
Figure 1. Deflectometer for measuring rutting

Pavement condition surveys were performed according to the Federal Highway Administration (FHWA) pavement distress identification manual (Miller and Bellinger 2014). The severity level of the cracks was determined using a caliper. Figure 1 shows a deflectometer equipped with a 4 ft straight edge and a vertical ruler used to measure the rutting in the wheel paths.

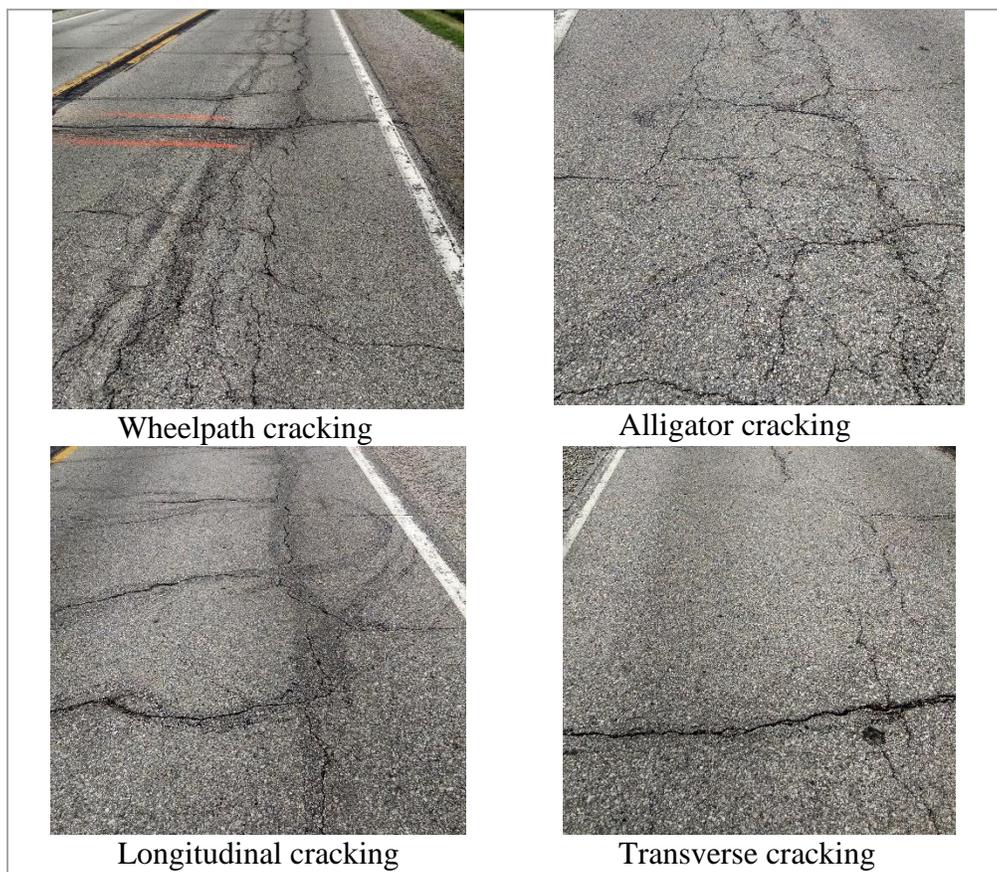
Figure 2. Surface distresses from pre-construction visual inspection

Cracking, fatigue cracking, raveling, and rutting were evaluated. The majority of the evaluation used was visual inspection as presented in Figure 2.

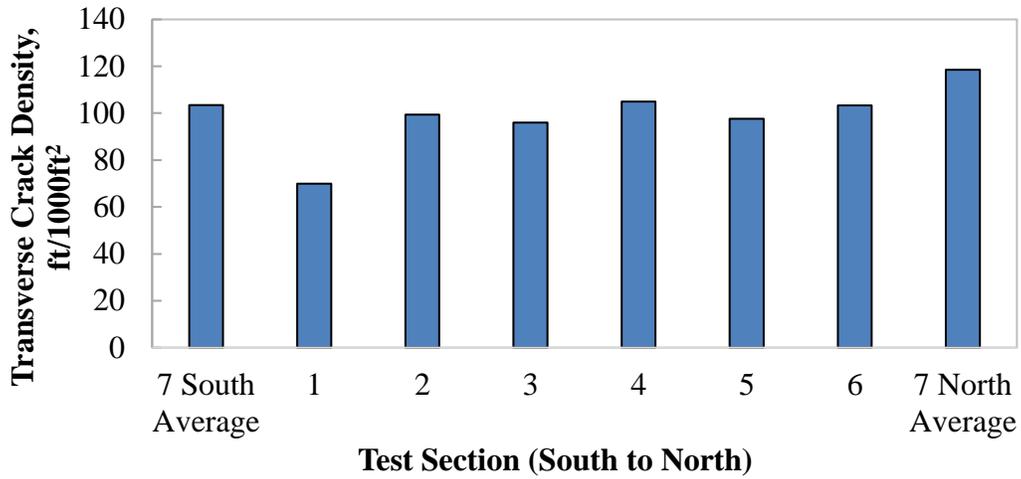
Figure 3. Pre-construction transverse cracking density per test section

geometry of the road. The results from the pre-construction survey for transverse and longitudinal cracking and rutting are shown in Figures 3 through 5.

A higher crack density (longitudinal and transverse) and rutting was found in all sections, making this stretch of pavement an ideal candidate for various treatments.

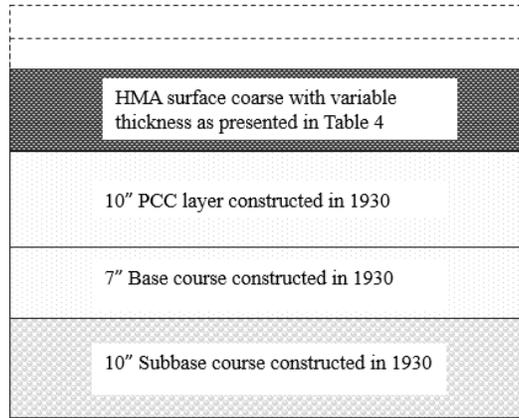
Figure 8. Structure of existing pavement

A general sketch of the structure of the existing pavement is presented in Figure 8.

Pre-construction field coring yielded cores for all eight test sections. The field core samples showed high pavement thickness variation. Multiple distress types were observed including bleeding, potholes, raveling, surface cracking, and edge cracking. The Iowa DOT records indicated the roadway rutting index was 47 and 51 for Story and Hardin counties, respectively. The project applied various holding strategy treatments to the eight test sections as previously presented in Table 1.

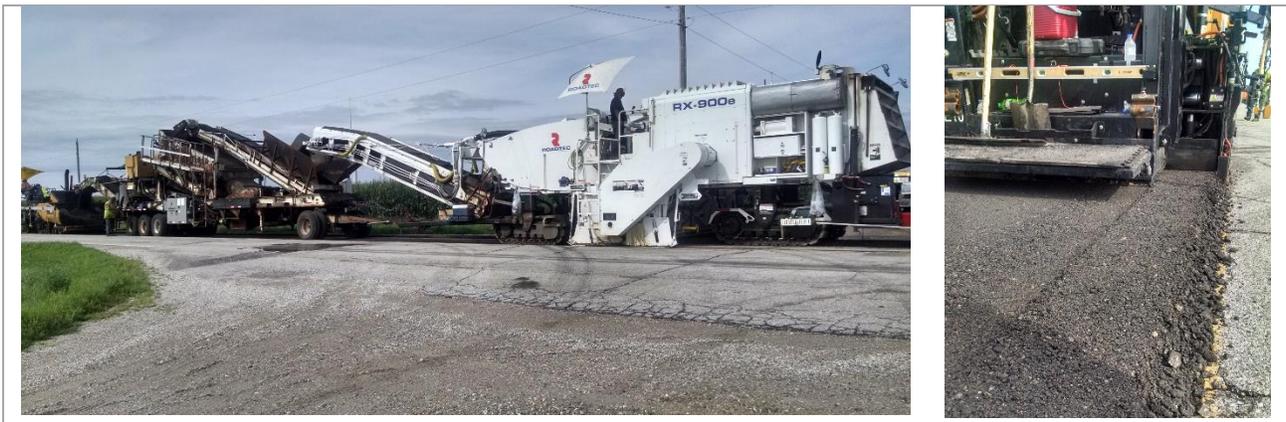
Figure 9. CIR operations: train, left, and pavement placement, right

Cold in-place recycling operations were conducted by a CIR train including a milling machine, a crushing and screening unit, a pug mill, and an oil tank trailer (Figure 9).

The milling machine milled the existing pavement to 4 in. depth and the RAP was conveyed to the crushing and screening unit. This unit further crushed large chunks of RAP into smaller particles that met the specification requirements for RAP gradation. The processed RAP was then conveyed to the pug mill, where it was blended with foamed asphalt. The asphalt binder was supplied by the oil tank trailer that was attached behind the pug mill. The blended mixture was placed in a windrow for the paver. Iowa specifications require the density of the CIR layer to be 94% or above the laboratory density.

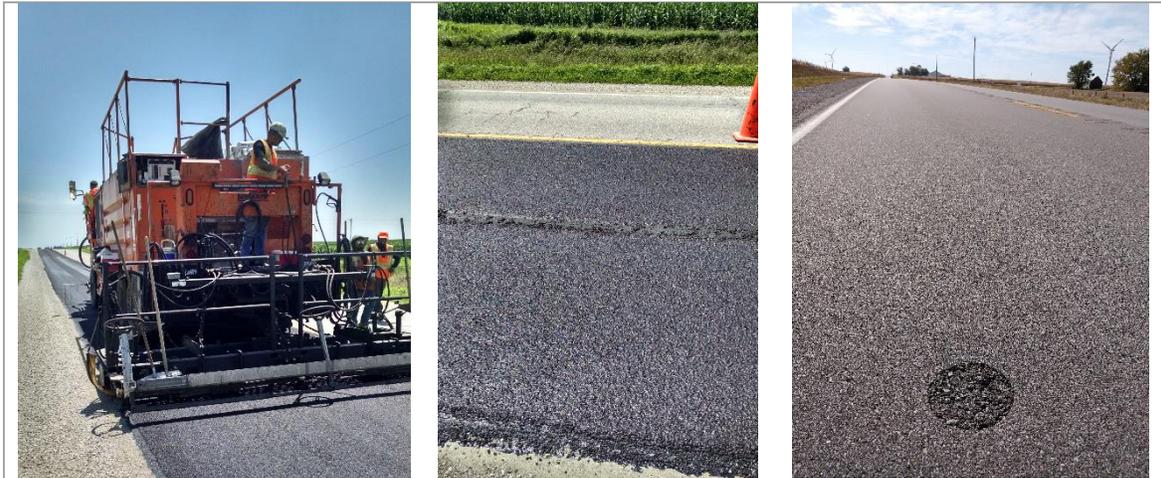
Figure 10. Microsurfacing and paving operations

HMA materials for surface, interlayer, and leveling and strengthening courses were placed following Iowa DOT specifications (Figure 10).

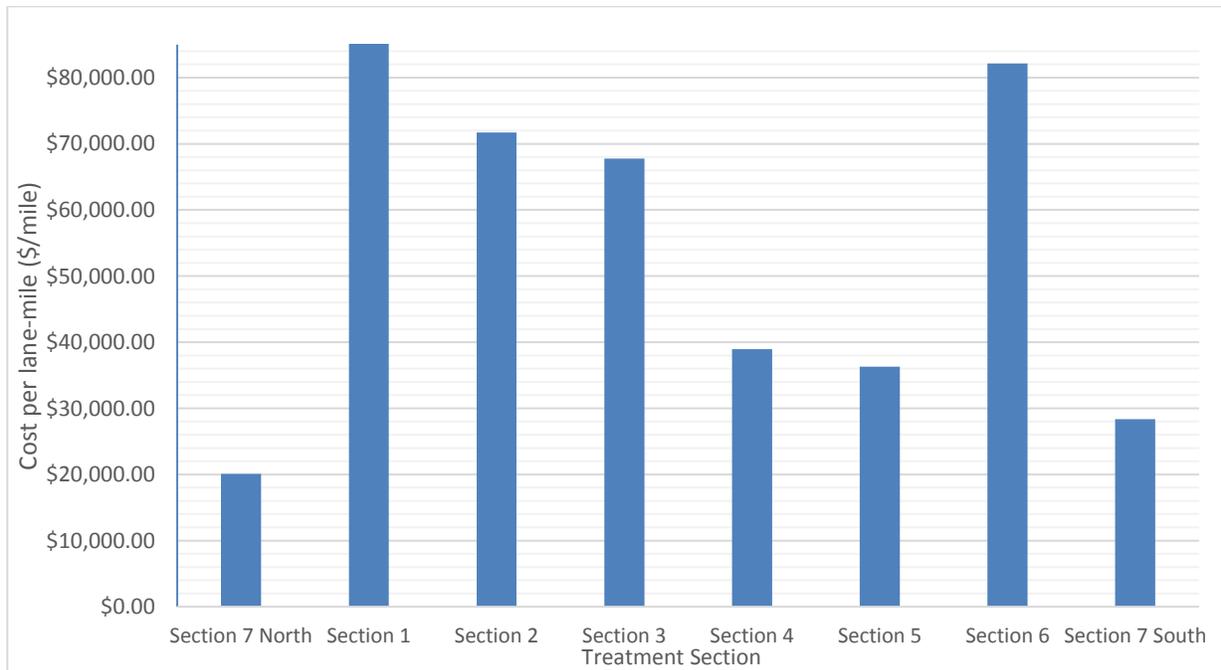
Figure 11. Comparison costs per test sections, dollars per lane-mile

A comparison between the costs for the various test sections is shown in Figure 11.

The cost per lane-mile was most related to the HMA thickness of the constructed pavement. The treatment thicknesses ranged from 1 in. in the ultra-thin overlay section to 6 in. of CIR and HMA surface in Section 1.

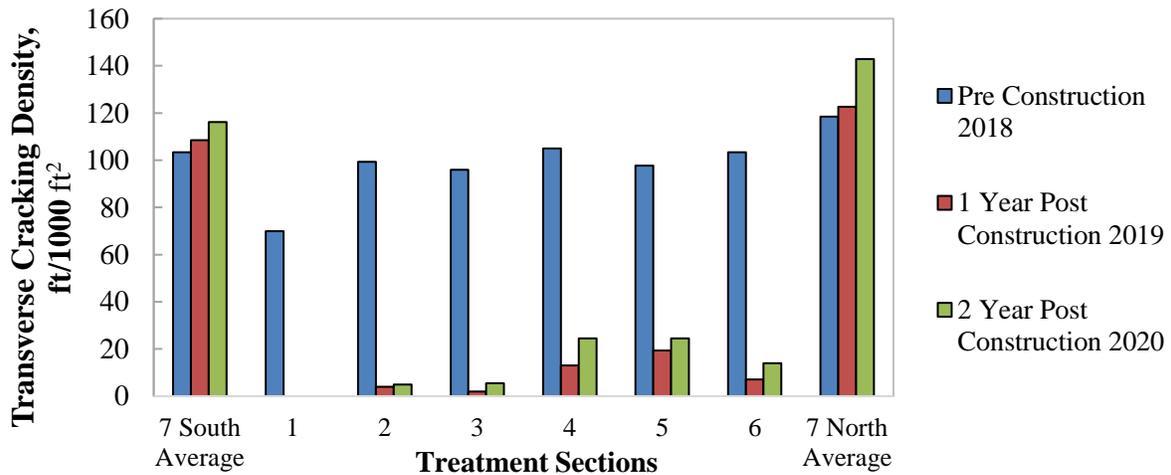
Figure 12. Transverse cracking densities for each treatment section

Pavement condition surveys were conducted before and after the construction. A comparison of the pavement conditions from before and after the construction is presented in Figures 12 and 13 for transverse and longitudinal cracking. The rut depth from the post-construction surveys for each section was 0 in. so were excluded from the following comparisons.

From Figures 12 and 13, it is apparent that the microsurfacing had little effect on the transverse cracking mitigation while reducing some of the longitudinal cracks present. Sections 1 through 6 showed major improvement in both longitudinal and transverse cracking. Additional pavement condition surveys over the life span of these treatments are required to evaluate the long-term cracking performance of these treatments over the holding period. The rule of thumb with regard to crack progression is 1 inch per year, which would imply a significant increase in the reflective cracking of these treatments in the 3- to 5-year post-construction time frame based on their thickness. The estimated holding life of these treatments can be extrapolated, but accurate holding lives will take several more years of crack propagation to determine accurately.

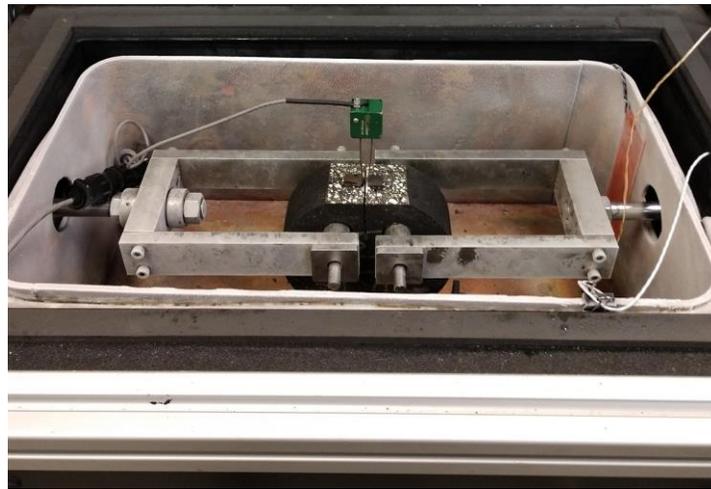
Figure 14. DCT testing apparatus Table 12. DCT fracture energy results

ASTM D7313 disk-shaped compact tension (DCT) testing (shown in Figure 14) was done to compare the fracture energy of field cores pre- and post-construction (Table 12).

Due to the fabrication standards of DCT specimens, only to a depth of 2 in. (~50 mm) from the pavement surface was tested. All pre-construction sections tested within a range of 157 J/m² to 245 J/m². Post-construction Sections 3, 4, and 5 performed the best, likely due to the high elastic recovery in the overlays.

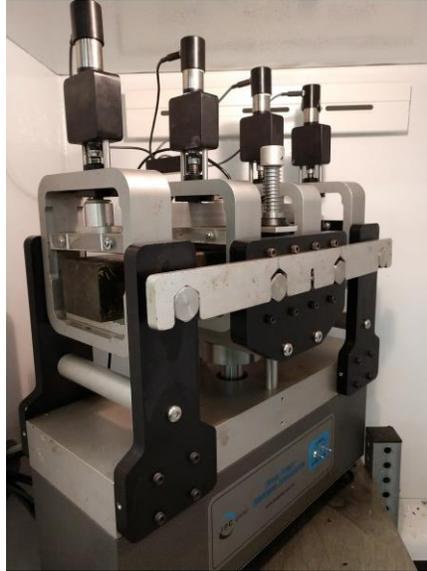
Figure 15. Four-point bending test apparatus

Sections 3, 4, 5, and 6 contained highly elastic modified binders and were tested using the AASHTO T 321 four-point bending test to evaluate their fatigue performance (Figure 15).

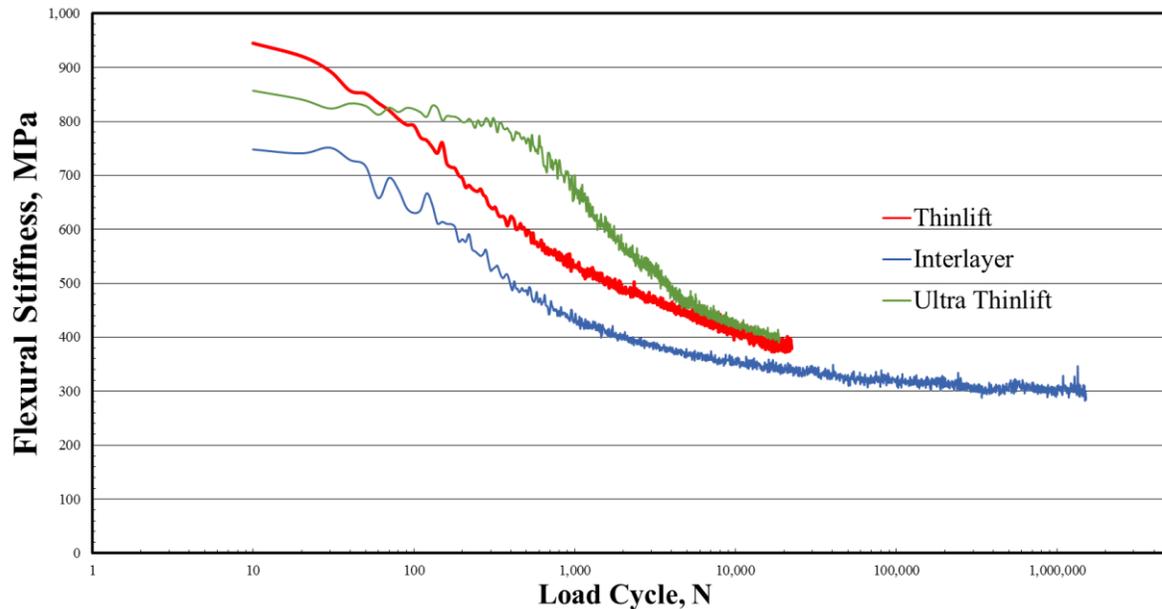
Figure 16. Four-point bending fatigue testing results

Sections 3 and 4 contained thin lifts, Section 5 was constructed with an ultra-thin lift, and Section 6 was an interlayer. The performance of the mixes is displayed in Figure 16.

The interlayer reached 50% of its initial stiffness, which is designated as the failure point for interlayers by the Iowa DOT, at 1,508,170 cycles. The ultra-thin lift and the thin lift reached failure at 22,350 and 75,220 load cycles, respectively.

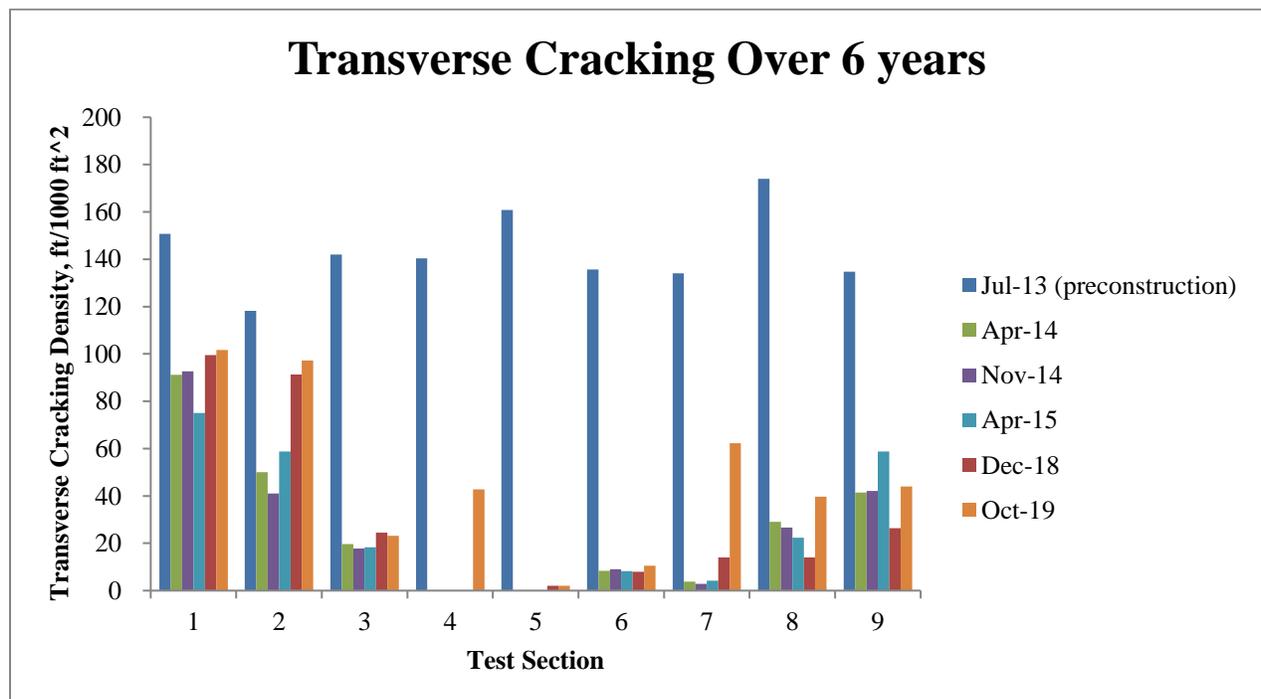
Figure 17. Transverse cracking density for Phase I test sections

From six years of pavement survey conditions, Figure 17 and Figure 18 were developed showing the trends for both transverse and longitudinal cracking density.

The findings support the 2015 report’s conclusion that the recycling technologies, including CIR and FDR, seemed to be the most effective treatments for mitigating reflective cracking.

The CIR and FDR sections also showed the lowest amount of transverse and longitudinal cracking after five years, with a reduction of more than 92% in transverse cracking and more than 97% in longitudinal cracking compared to the pre-construction survey. The CIR and FDR sections also had among the lowest equivalent annual costs.
