Improving Joint Durability in Concrete Pavements

A Summary of Current Knowledge

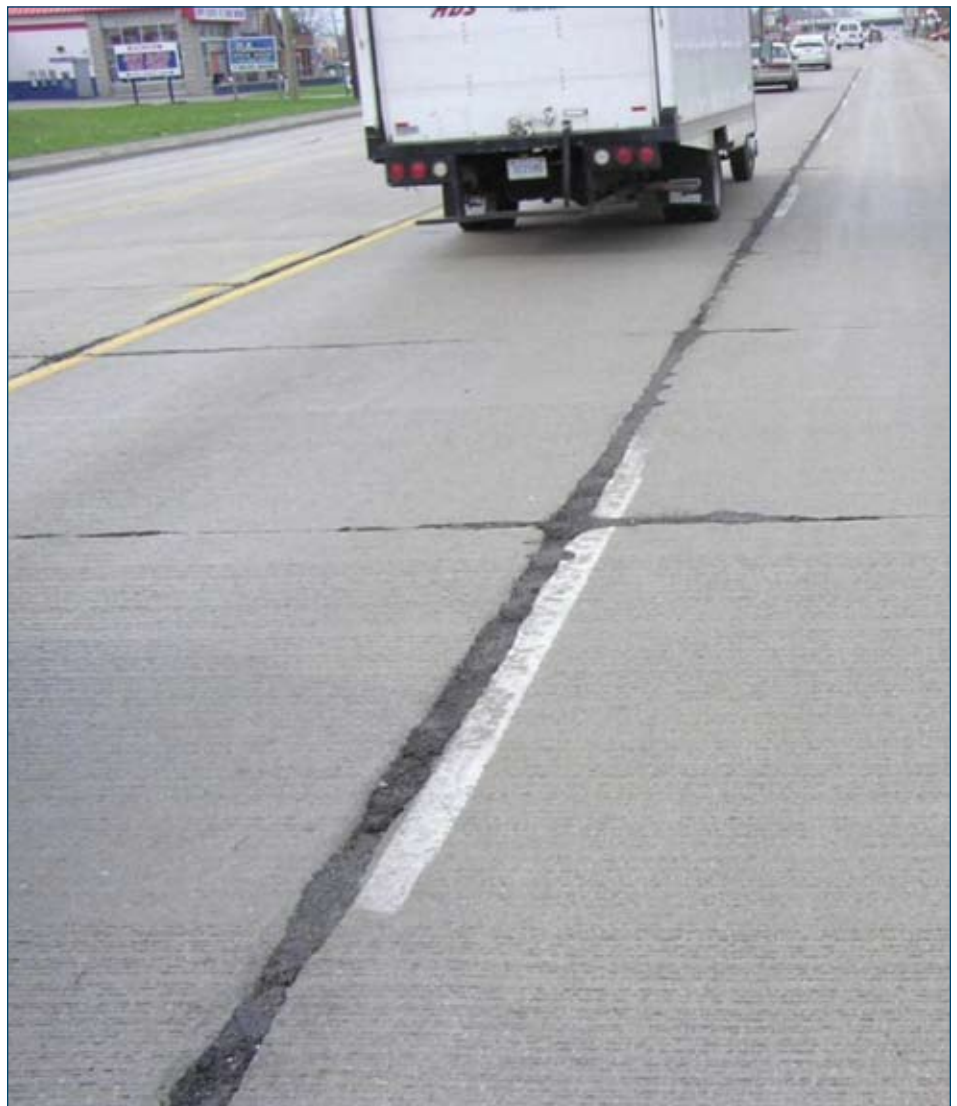
Distress in a longitudinal joint on a city street

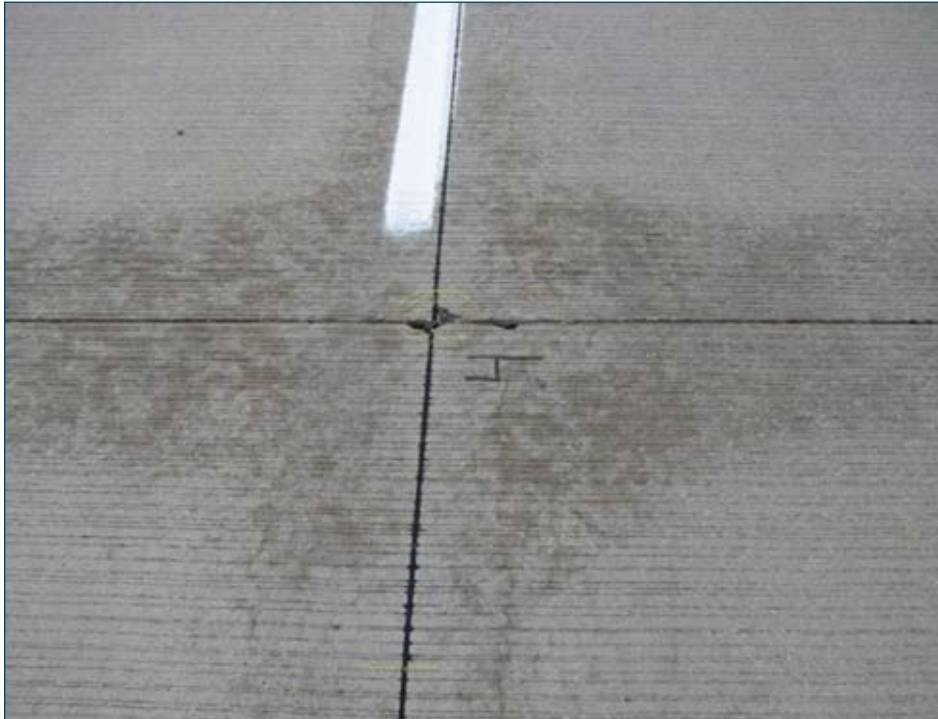
Typical shadowing

Typically, joint deterioration is initially observed in longitudinal joints, followed by transverse joints, and is most common in pavements ranging from 5 to 15 years old. The distress is first observed as

shadowing, as microcracking near the joints traps water, and is later exhibited as significant loss of material (see photos below).

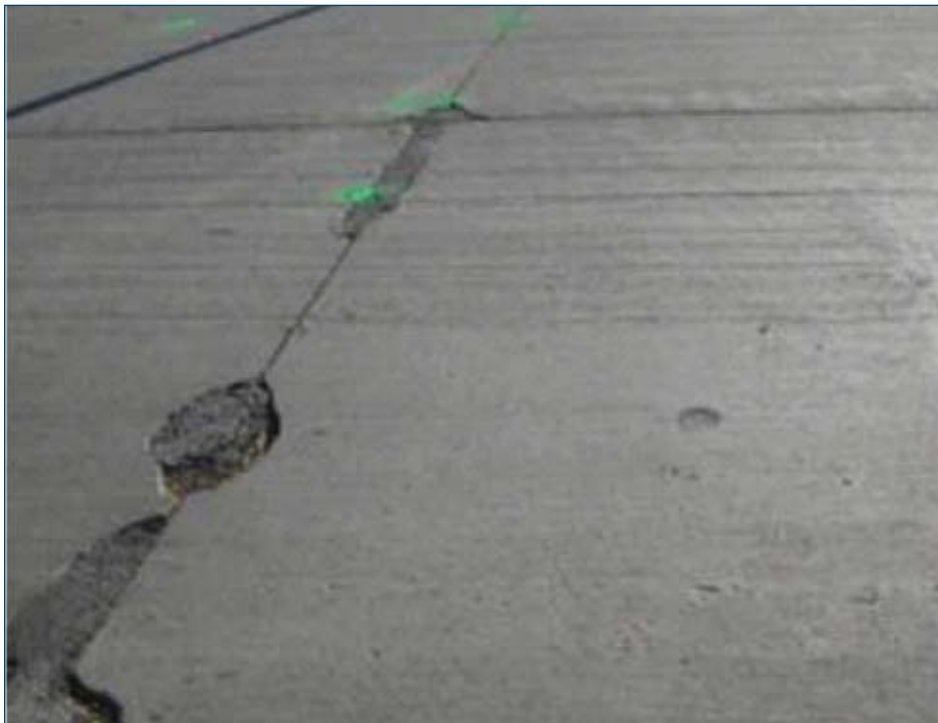
Loss of material

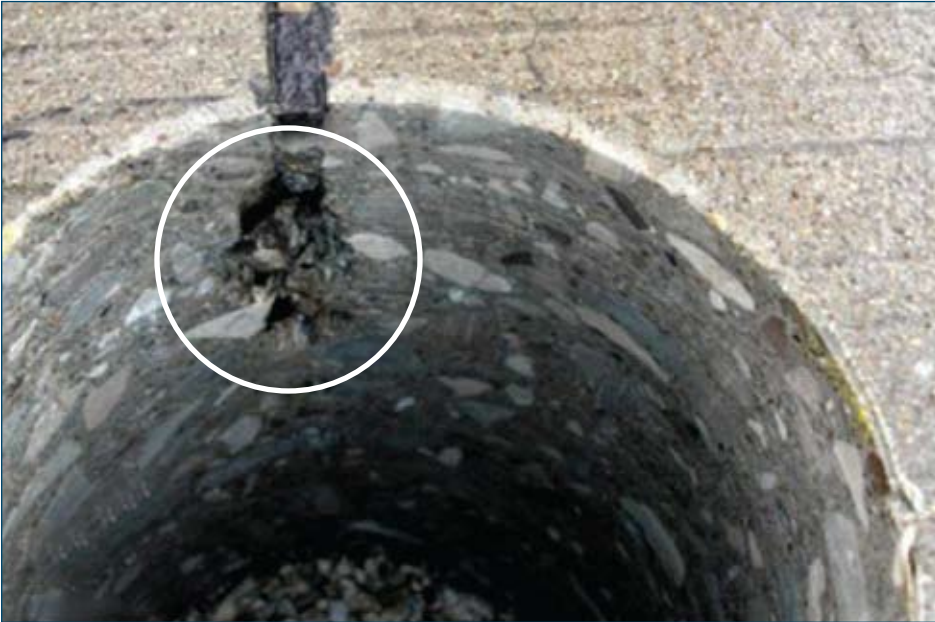
An example of damage occurring below the backer rod

Finally, it has also been reported that some mixtures may have eroded during early-entry sawing, leaving voids below the backer rod.

- Make provisions to allow water to leave the hardened concrete.
 - It has been reported that water is being trapped below backer rods (see photo below). Consider limiting joint sawing to 1/16 to 1/8 in. wide and not installing sealants or backer rods.

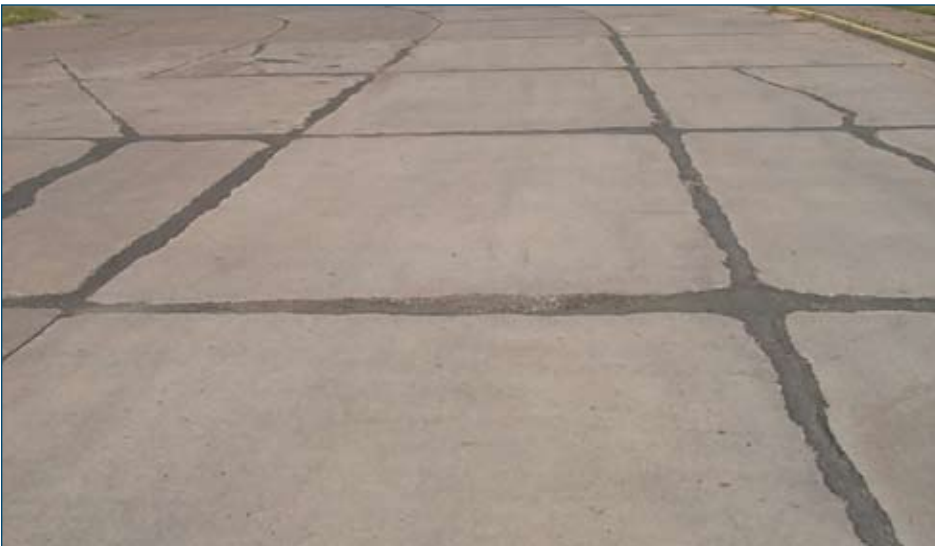
Distress in longitudinal and transverse joints

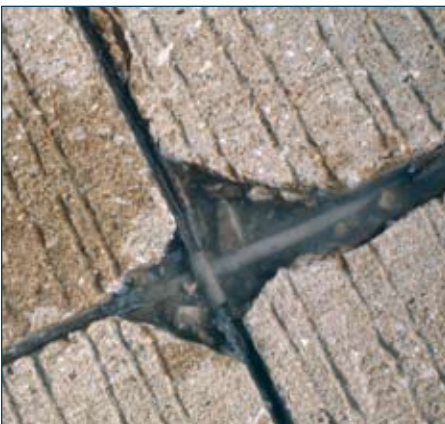
Water ponding at joints

Experts agree that water is the common factor in most deterioration mechanisms. Water that is trapped behind a failed seal or above a non-cracked joint will result in longer periods of saturation and lead to greater risk of freezing-related damage.

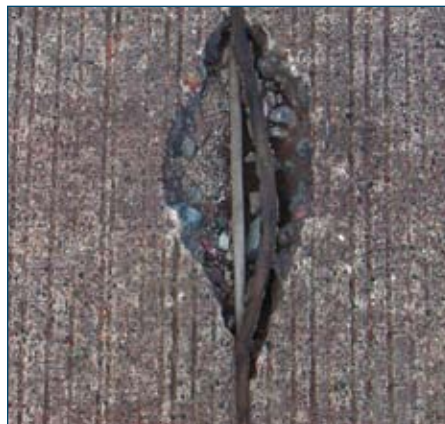
Localized damage on each side of a joint
