Evaluation of Galvanized and Painted Galvanized Steel Piling

tech transfer summary

September 2022

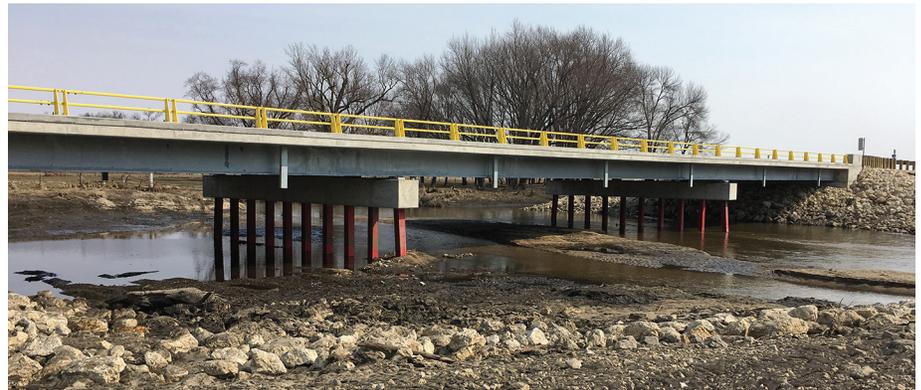
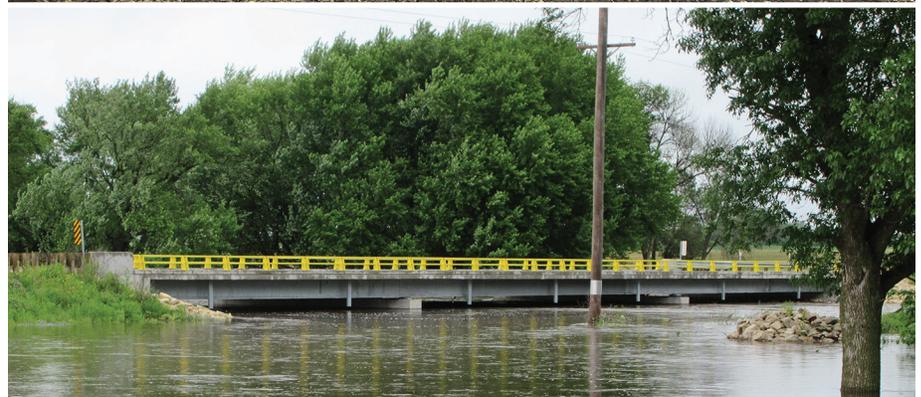
Bucanan County Buffalo Creek Bridge with water levels low and high

A unique opportunity emerged with the Buffalo Creek Bridge in Buchanan County to monitor the performance of a galvanized pile system on a local bridge structure in Iowa.

The Buffalo Creek Bridge is a 200 ft by 40 ft three-span bridge that was under construction at the initiation of this project and available for in-service data acquisition. The performance of the galvanized piles could be evaluated based on the thickness change of the coatings.

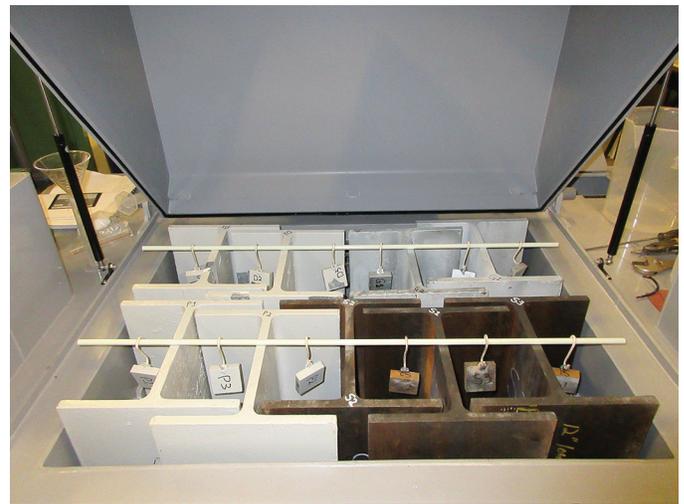
Pile specimens and coupon samples inside the cyclic corrosion chamber

In the laboratory, five variations of coupon samples—bare steel, galvanized, painted galvanized, painted galvanized with simulated paint layer damage, and galvanized with the galvanizing layer damaged—and four variations of one-foot pile specimens—bare steel, galvanized, painted galvanized, and painted galvanized with simulated paint layer damage—were tested using an accelerated corrosion testing protocol. This testing provided side-by-side performance data as well as valuable inputs for a life-cycle cost analysis.

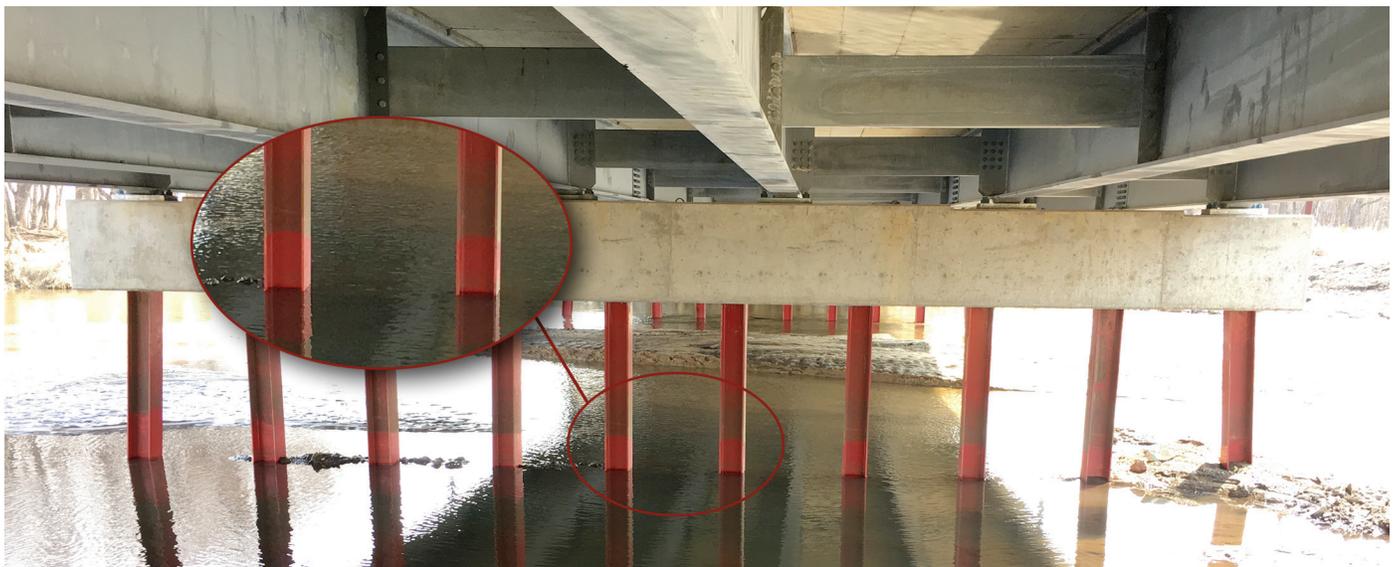
Buffalo Creek Bridge galvanized and painted piles

- Damaged galvanized layers offer better protection to smaller scratches (self-healing).
- The initial three-year period of service life of the Buffalo Creek Bridge in Buchanan County showed the paint and galvanized coating of the piles to perform well with no damage or corrosion observed.
