Investigation of the Causes of Transverse Bridge Deck Cracking

tech transfer summary

September 2022

Iowa Department of Transportation
(InTrans Project 14-503)
Federal Highway Administration

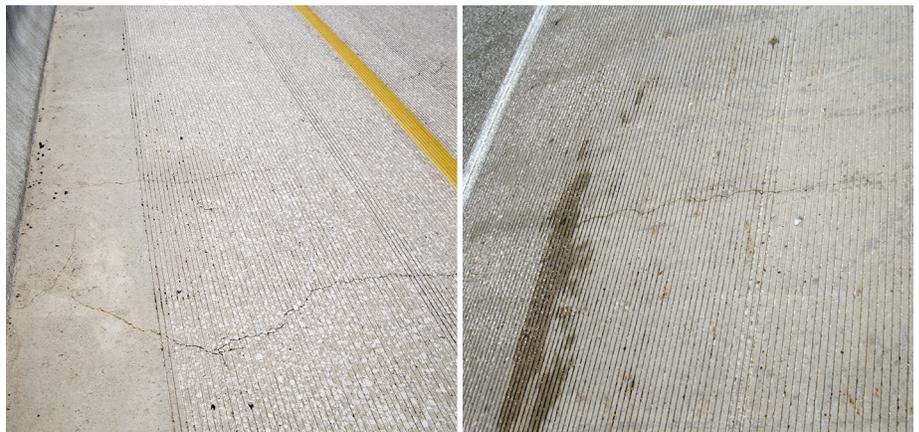
Early-age transverse deck cracks on two Iowa bridges

Iowa Department of Transportation (DOT) bridge staff have noticed multiple recent occurrences of transverse deck cracks developing shortly after bridge construction. This situation is very problematic because the cracks can provide a direct pathway for the intrusion of water and chlorides. In the worst case, these early-age cracks can speed up corrosion of the reinforcing steel, deteriorate the deck concrete, and eventually lead to increased maintenance costs and a reduced bridge deck service life.

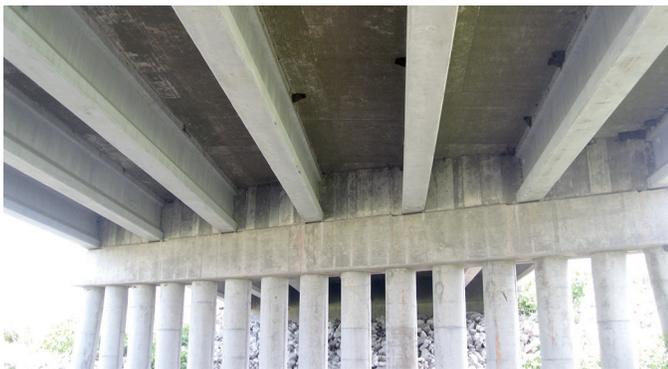
Underside bridge deck image similar to those in DOT inspection reports near the pier and above the pile cap from a field visit

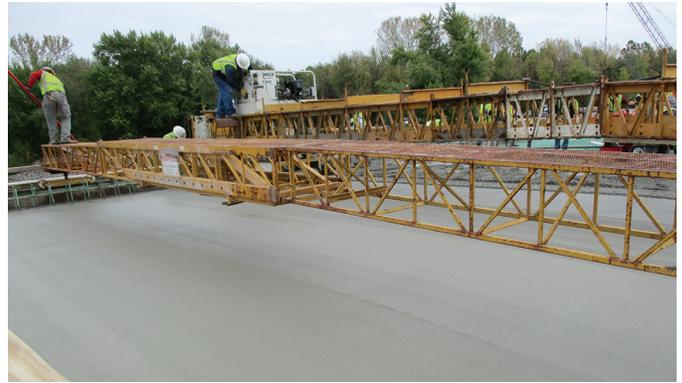
Concrete deck placement in Iowa like that observed and studied for construction factors as part of this study

The third stage of the investigation was carried out based on data collected starting with deck concrete placement from six field visits. The parameters investigated in this stage included evaporation rate (lb/ft²/h), air temperature (°F), concrete temperature (°F), relative humidity (%), and wind speed (mph).

During each field trip, a form was used to record the basic bridge information and the on-site construction data. The crack rate for each bridge was later calculated utilizing the Bridge Engineering Center’s crack rate formula and used to characterize the relationship to each studied factor.
