# Investigation of the Causes of Transverse Bridge Deck Cracking

Final Report  
September 2022

**Sponsored by**  
Iowa Department of Transportation  
(InTrans Project 14-503)  
Federal Highway Administration

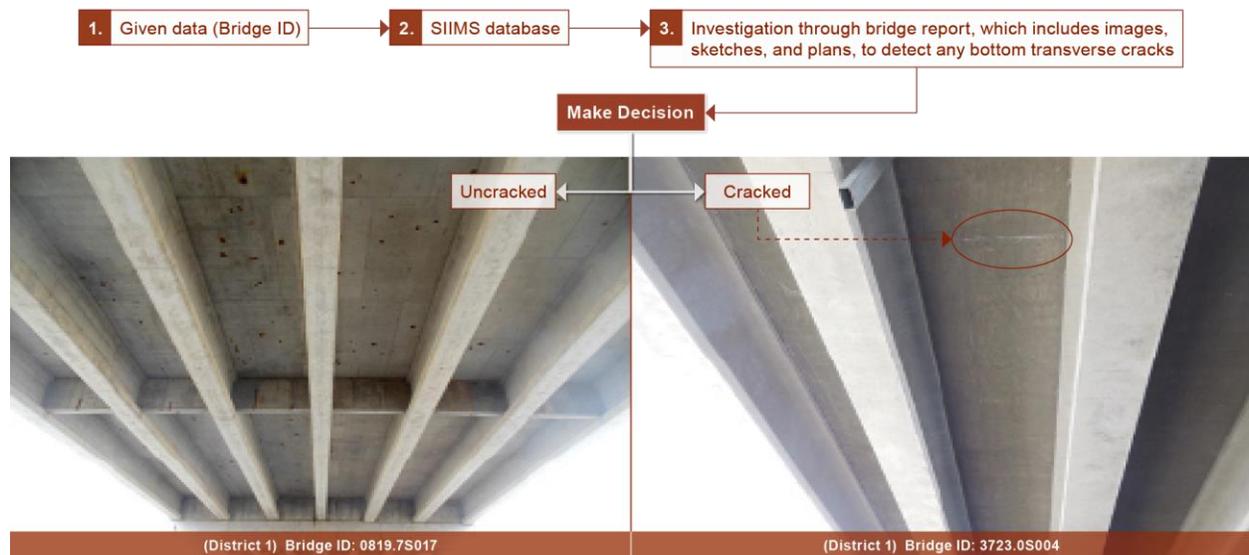
The bridge deck crack information used in this stage was obtained primarily from the Iowa DOT Structure Inventory and Inspection Management System (SIIMS) database. A unique ID for each bridge was used to search available sketches, images, and notes in the database. Figure 1 shows a flowchart of the investigation process.

**Figure 1. Investigation process used to identify bridges with cracked decks**

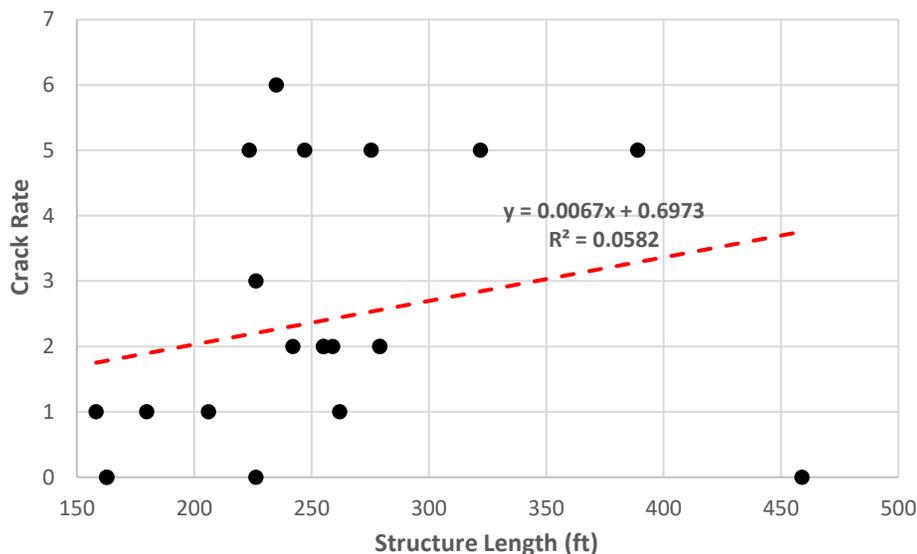
**Figure 3. Relationship between crack rate and bridge length (Stage 2 results)**

The results showed a positive correlation between the crack rate and structure length, which indicates that increasing the structure length increases the crack rate. However, the R-squared value was 0.0582.

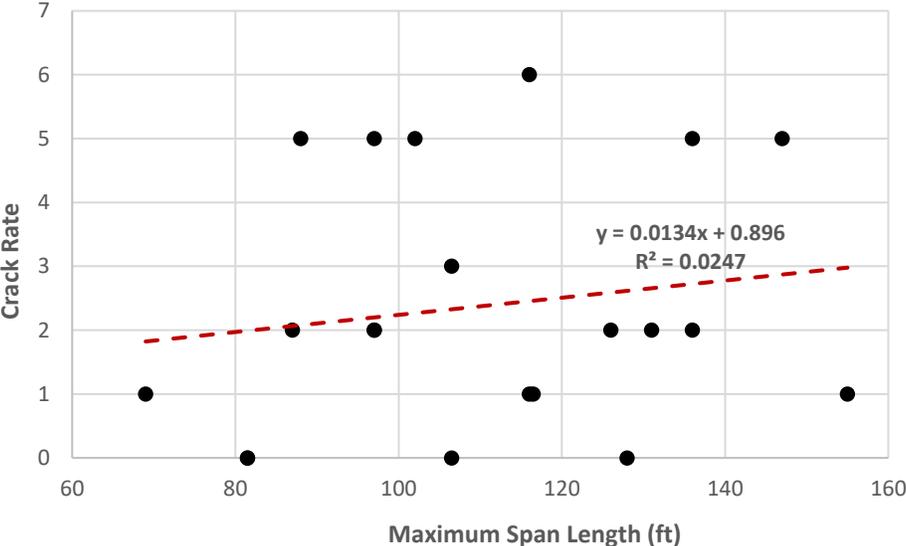
**Figure 4. Relationship between crack rate and maximum span length (Stage 2 results)**

While the correlation between the crack rate and maximum span length was positive, the R-squared value was 0.0247.

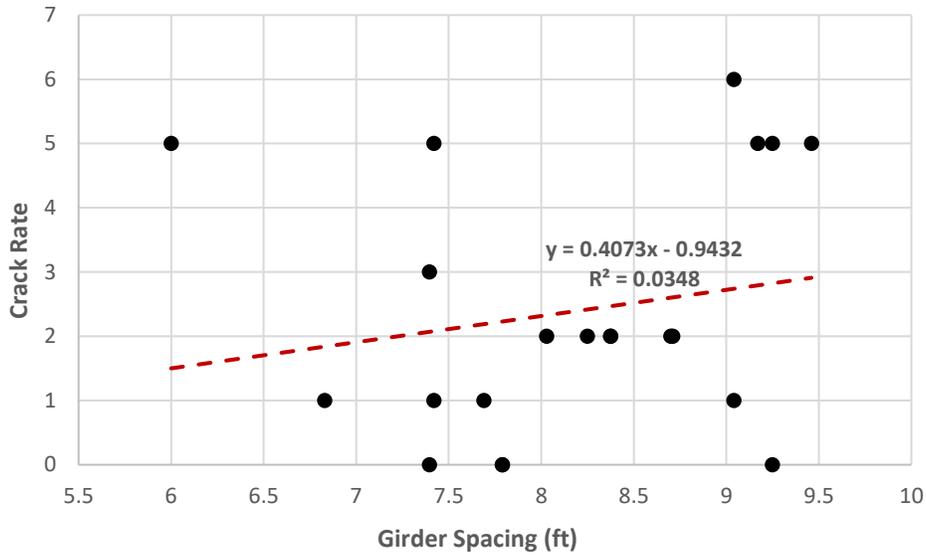
**Figure 5. Relationship between crack rate and girder spacing (Stage 2 results)**

Even though the correlation between the crack rate and girder spacing was positive, the value of R-squared was 0.0348.

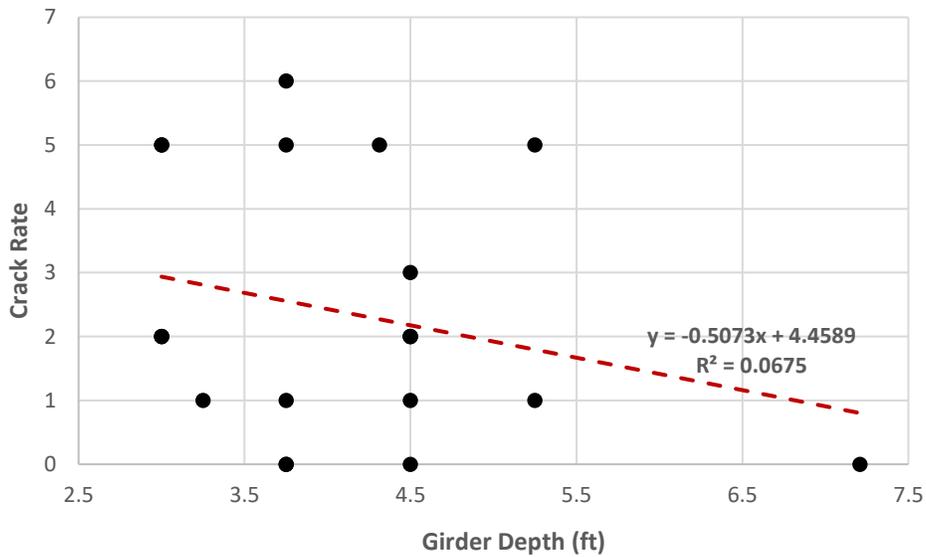
**Figure 6. Relationship between crack rate and girder depth (Stage 2 results)**

The correlation between the crack rate and girder depth was negative, which means increasing the girder depth decreased the crack rate, while the value of R-squared was 0.0675.

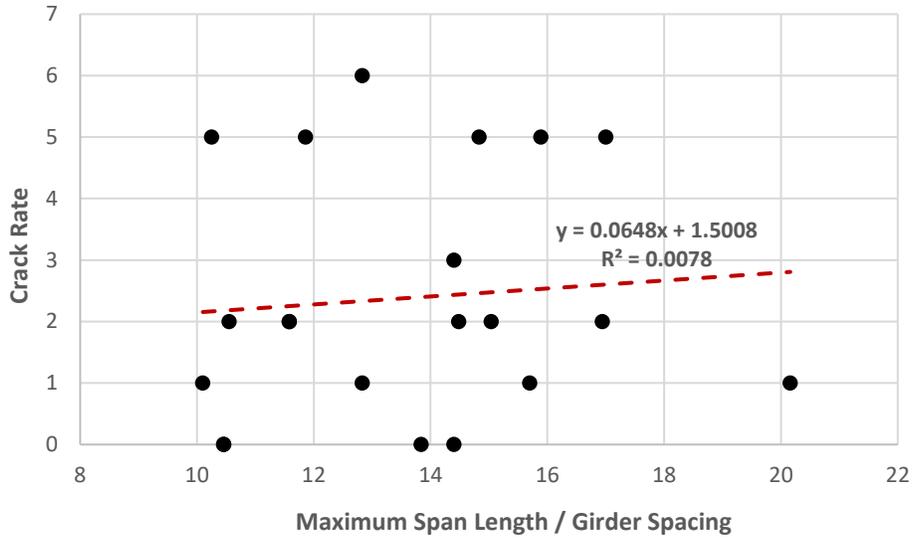
**Figure 7. Relationship between crack rate and maximum span length-to-girder spacing ratio (Stage 2 results)**

Although, the correlation between the crack rate and the span length-to-girder spacing ratio was positive, the value of R-squared was 0.0078.

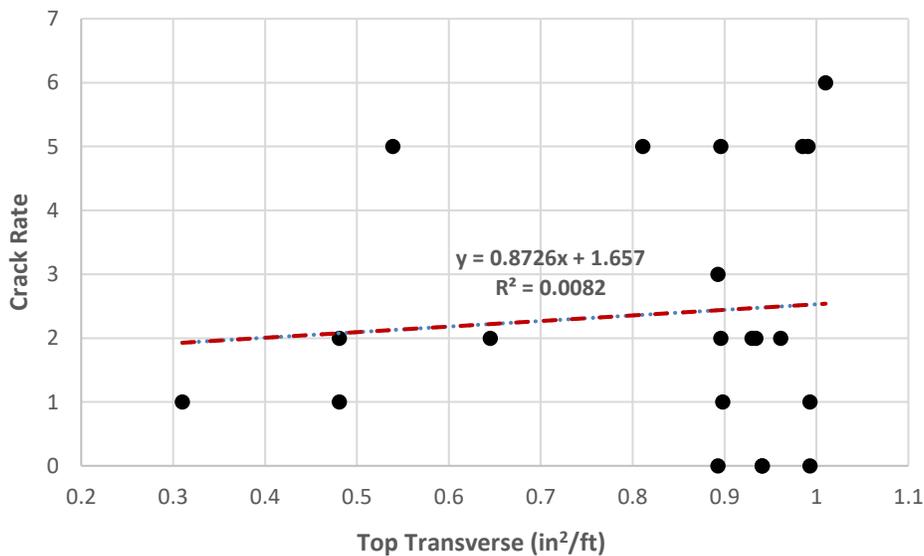
**Figure 8. Relationship between crack rate with top transverse reinforcement area (Stage 2 results)**

The correlation between the crack rate and top transverse reinforcement area was positive, although the R-squared value was 0.0082.

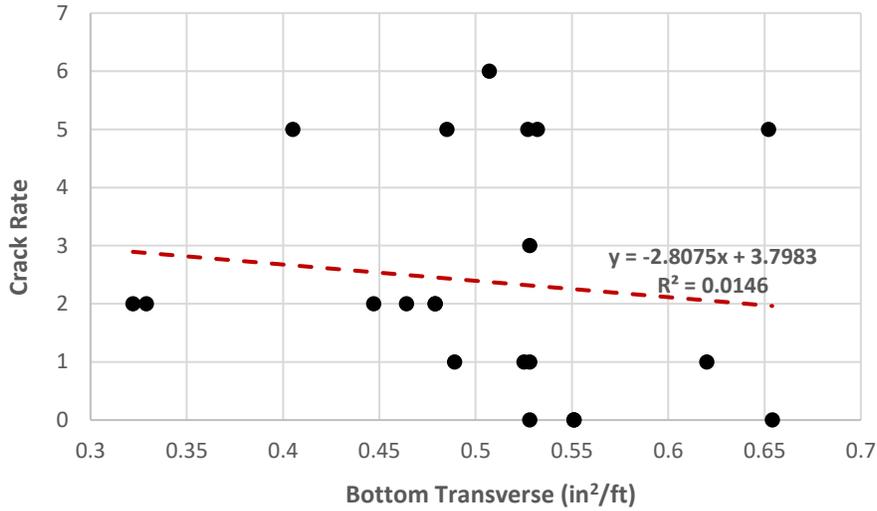
**Figure 9. Relationship between crack rate and bottom transverse reinforcement area (Stage 2 results)**

Although, the correlation between the crack rate and bottom transverse reinforcement area was negative, the R-squared value was 0.0146.

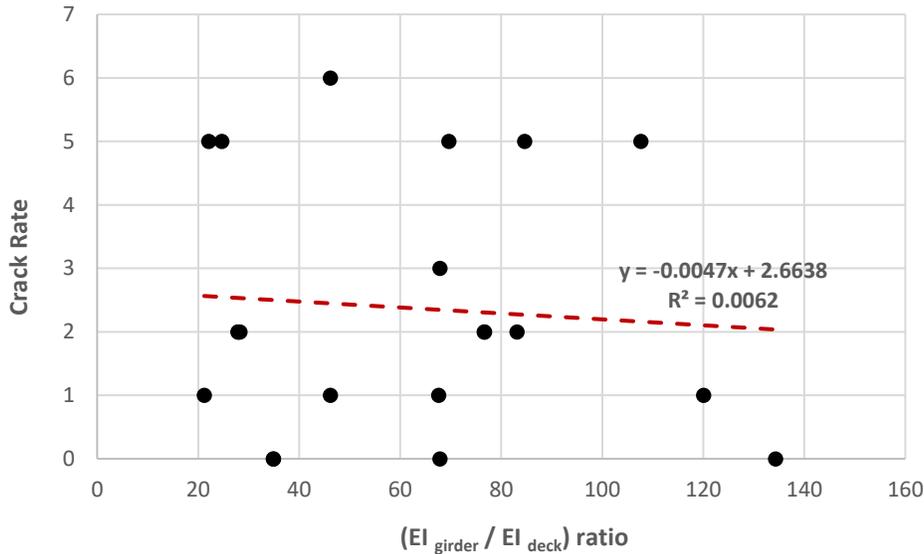
**Figure 10. Relationship between crack rate and bridge stiffness (Stage 2 results)**

While the correlation between the crack rate and bridge stiffness was negative, the value of R-squared was 0.0062.

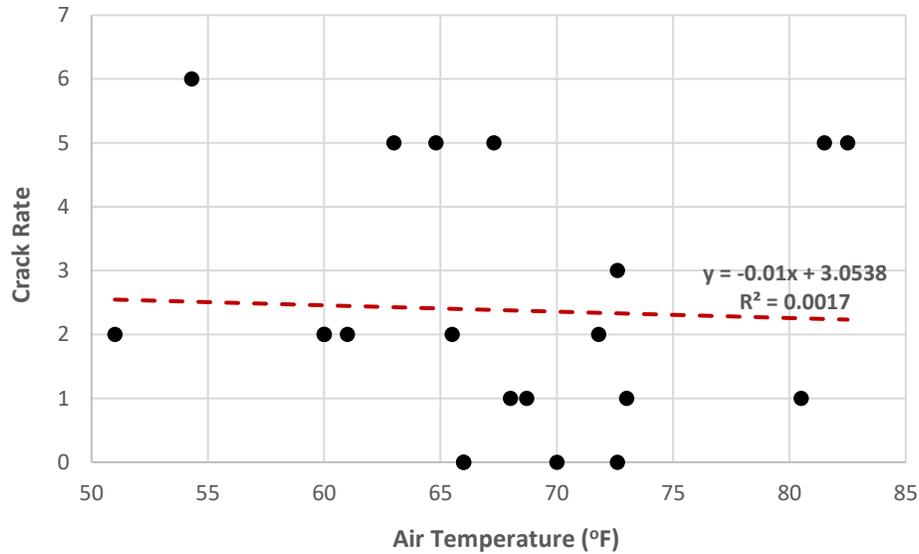
**Figure 11. Relationship between crack rate and air temperature (Stage 2 results)**

Although the correlation between the crack rate and air temperature was negative, the value of R-squared was 0.0017.

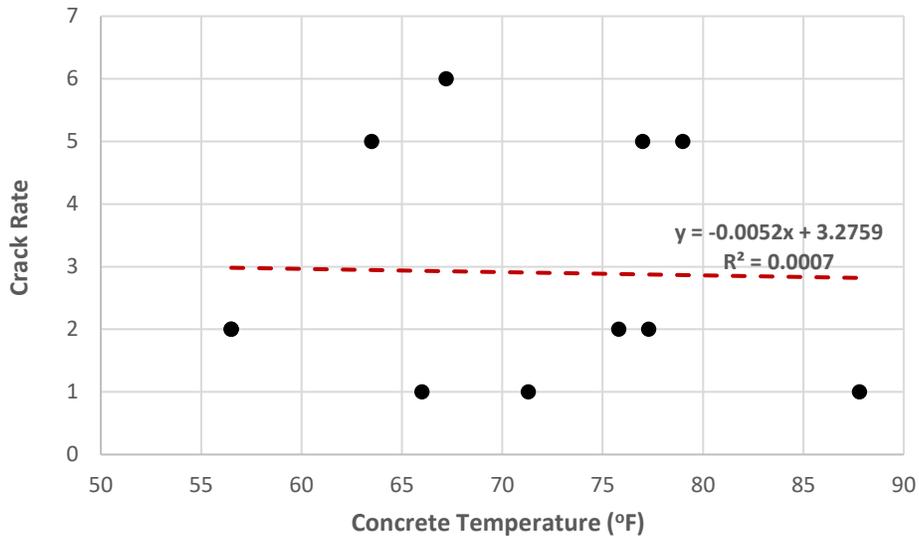
**Figure 12. Relationship between crack rate and concrete temperature (Stage 2 results)**

Although the correlation between the crack rate and concrete temperature was negative, the value of R-squared was 0.0007.

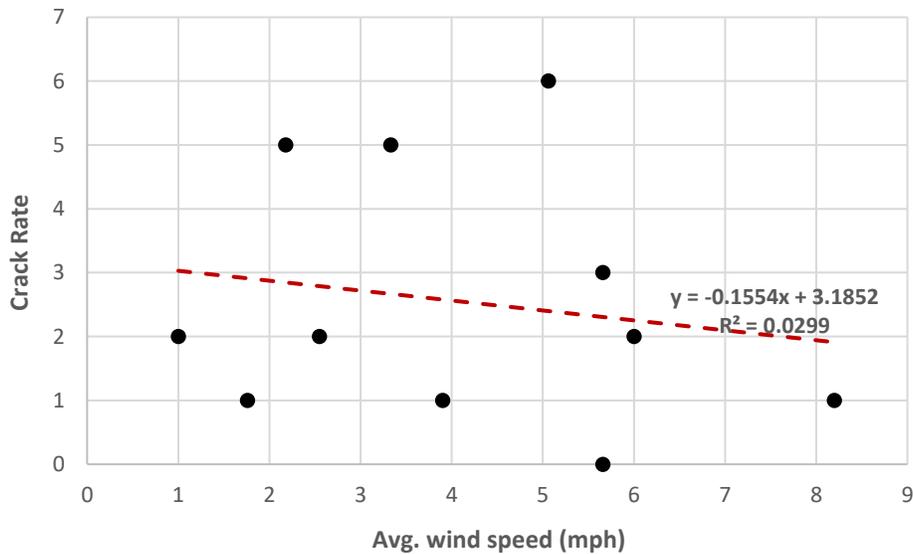
**Figure 13. Relationship between crack rate and average wind speed (Stage 2 results)**

Even though the correlation between the crack rate and average wind speed was negative, the value of R-squared was 0.0299.

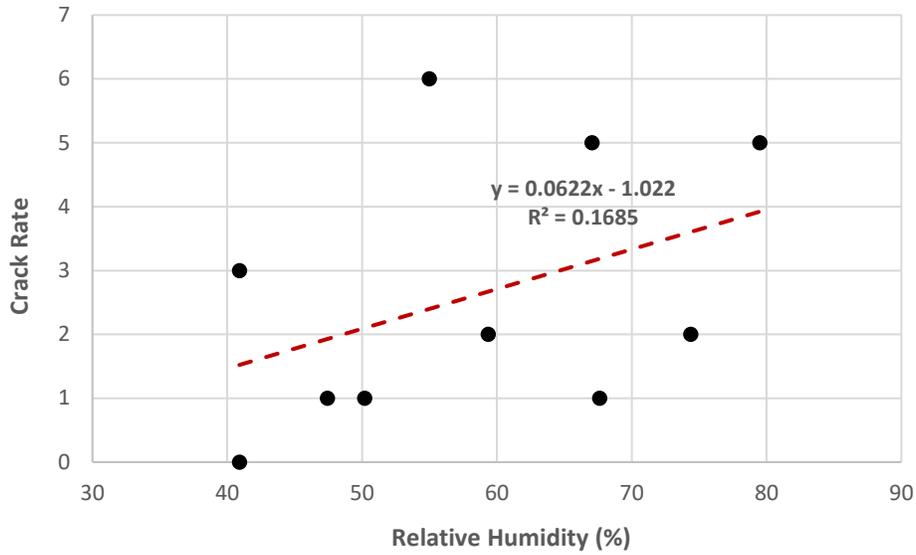
**Figure 14. Relationship between crack rate and relative humidity (Stage 2 results)**

Despite the positive correlation between the crack rate and relative humidity, the value of R-squared was 0.1685.

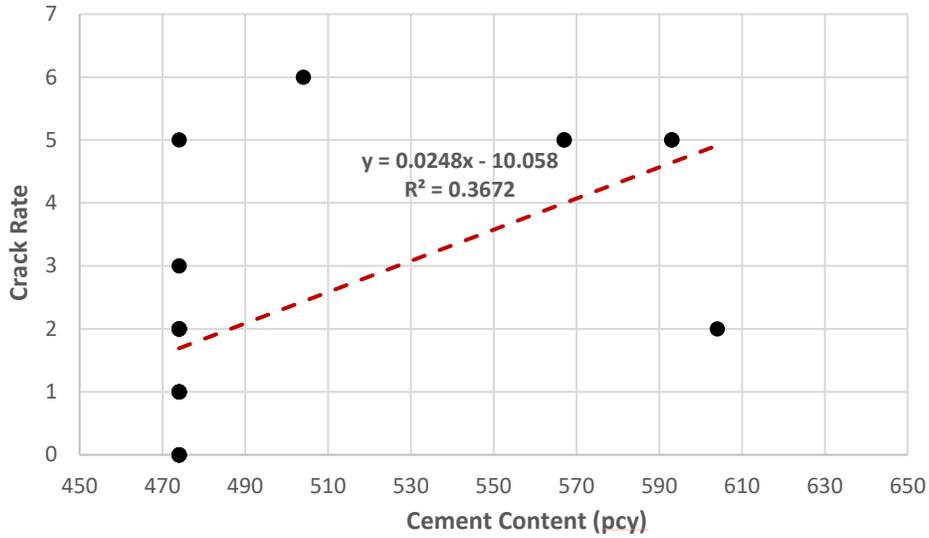
**Figure 15. Relationship between crack rate and cement content (Stage 2 results)**

Regarding the cement content and its effects on the crack rate, the correlation between the crack rate and cement content positive, and the value of R-squared was 0.3672.

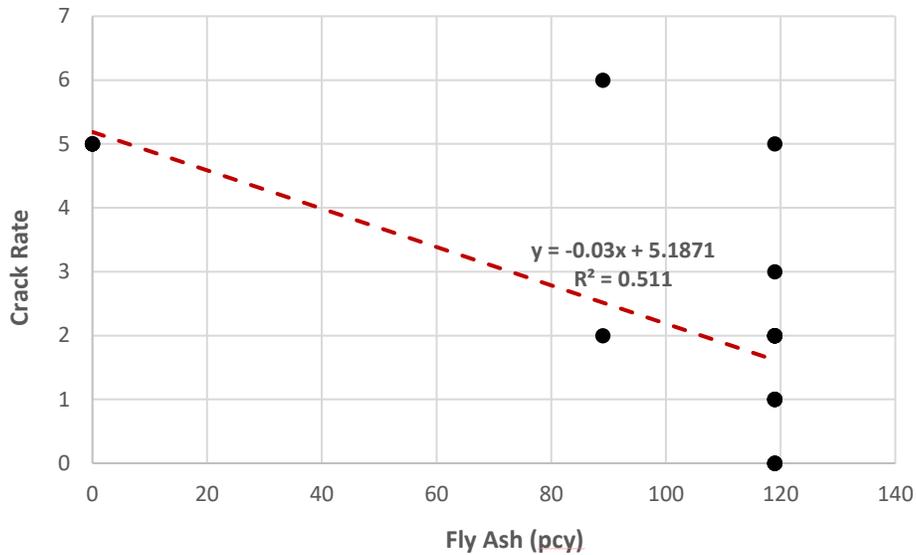
**Figure 16. Relationship between crack rate and fly ash content (Stage 2 results)**

The results indicated a negative correlation between the crack rate and fly ash content, and the value of R-squared was 0.511.

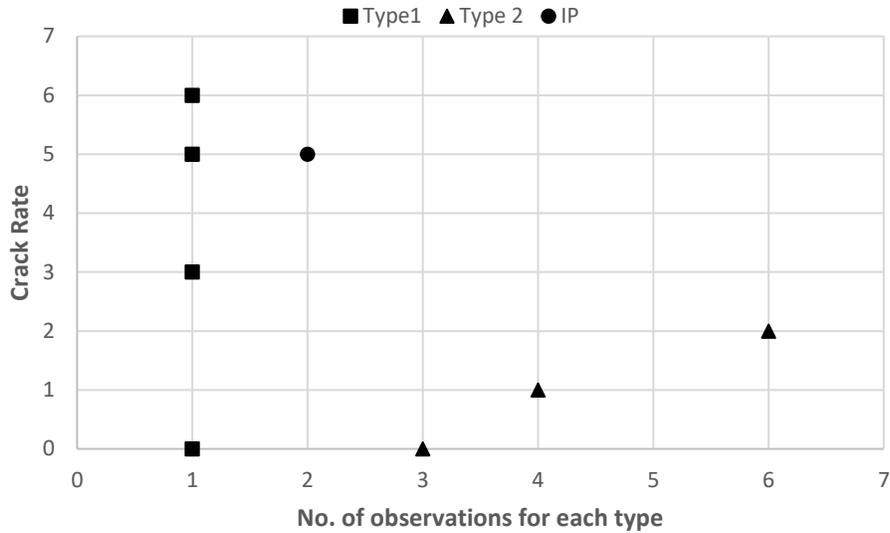
**Figure 17. Relationship between crack rate and cement type (Stage 2 results)**

In general, the results indicated that a high crack rate (6 and 5) exists when Type 1 and IP cement were used compared to a low crack rate when Type 2 cement was used.

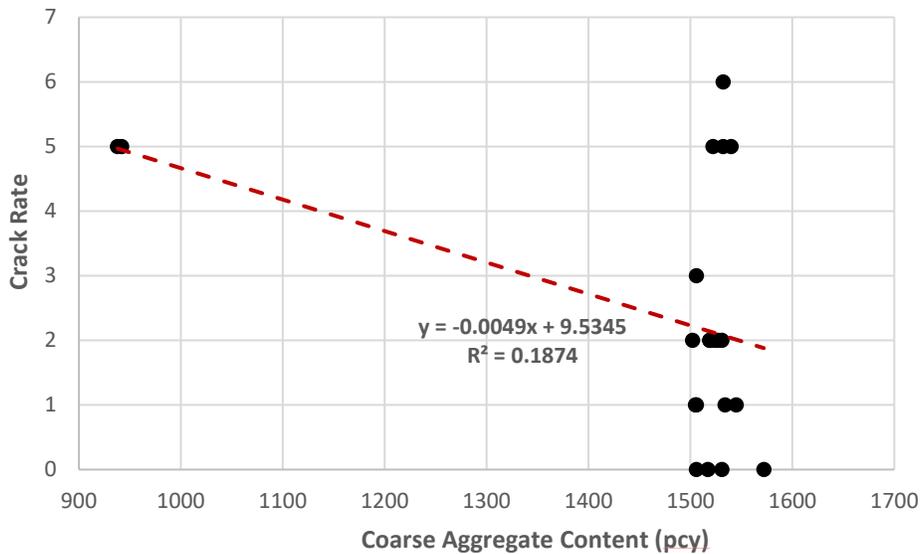
**Figure 18. Relationship between crack rate and coarse aggregate content (Stage 2 results)**

The correlation between the crack rate and coarse aggregate content was negative, and the value of R-squared was 0.1874.

Due to a lack of a good statistical distribution for both coarse and fine aggregate content data in Figure 18 and Figure 19, the results achieved from these graphs were not used for the further investigation in Chapter 6.

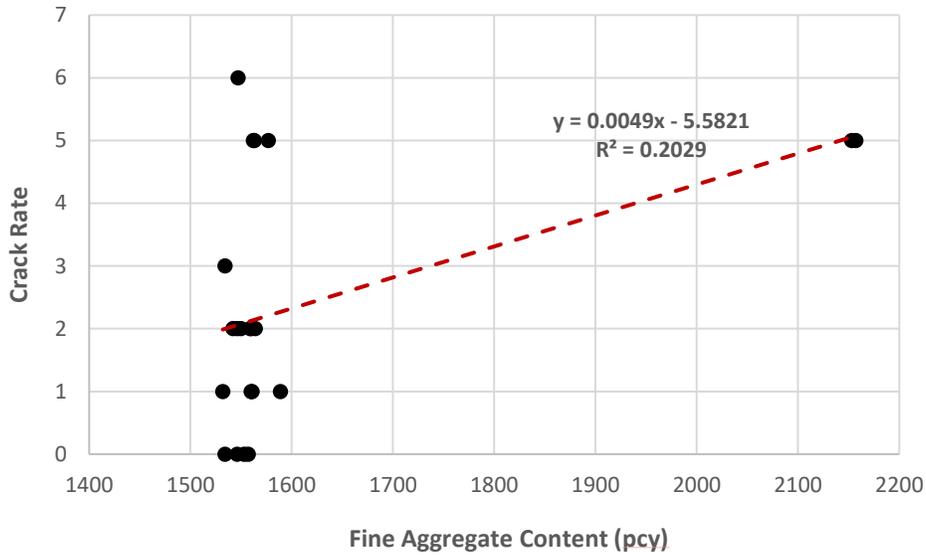
**Figure 19. Relationship between crack rate and fine aggregate content (Stage 2 results)**

Despite the positive correlation between the crack rate and fine aggregate content, the value of R-squared was 0.2029.

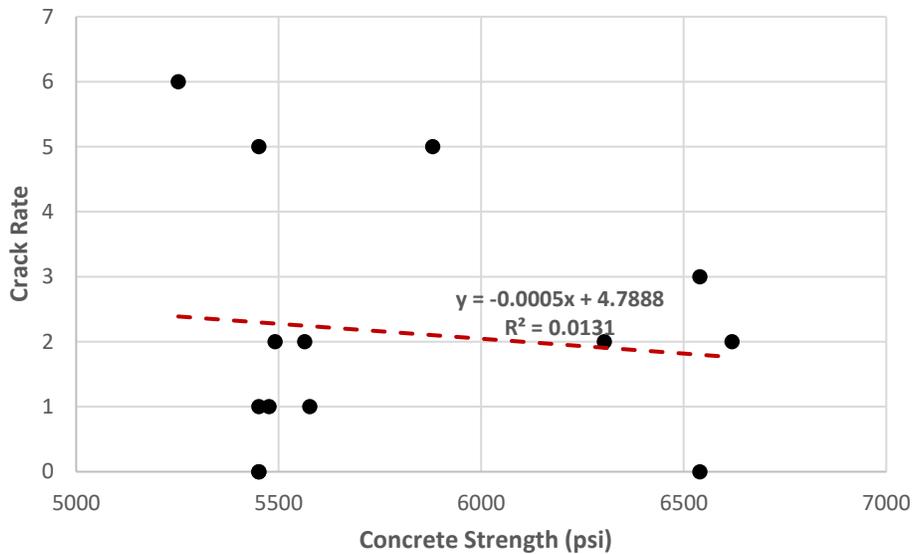
**Figure 20. Relationship between crack rate and concrete strength (Stage 2 results)**

The correlation between the crack rate and concrete strength negative with a low R-squared value of 0.0131, which indicated that this relation is not significant.

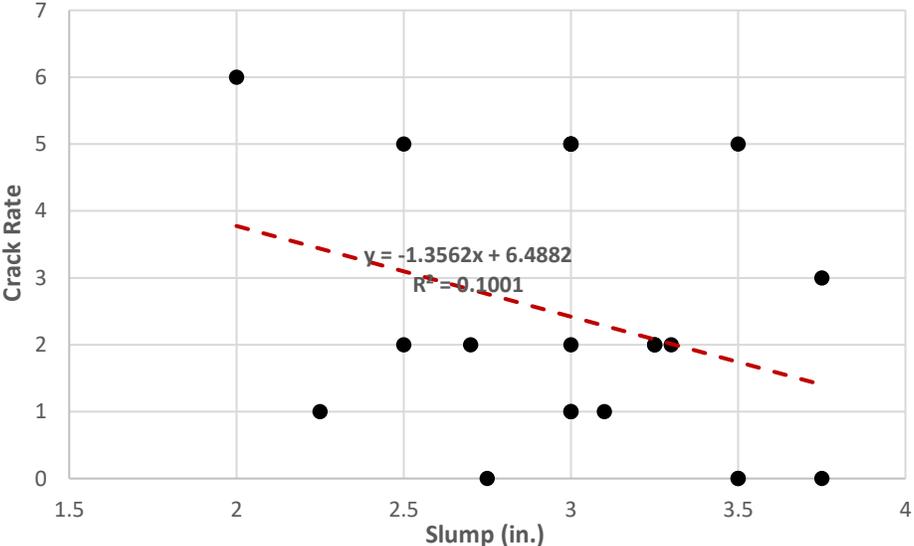
**Figure 21. Relationship between crack rate and concrete slump (Stage 2 results)**

The results indicated that the value of R-squared was small at 0.1001, which meant the correlation was slight.

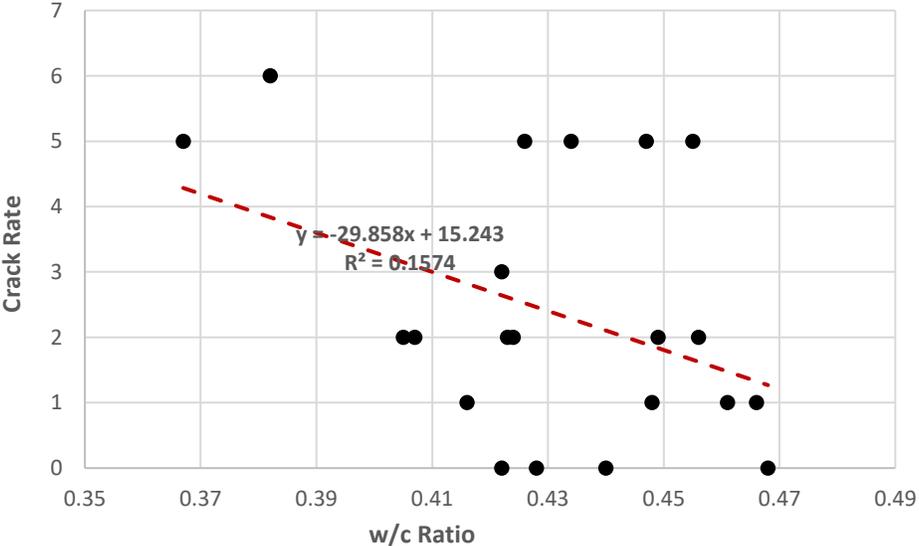
**Figure 22. Relationship between crack rate and w/c ratio (Stage 2 results)**

The correlation between the crack rate and w/c ratio was negative, and the value of R-squared was 0.1574, which is considered a slight correlation.

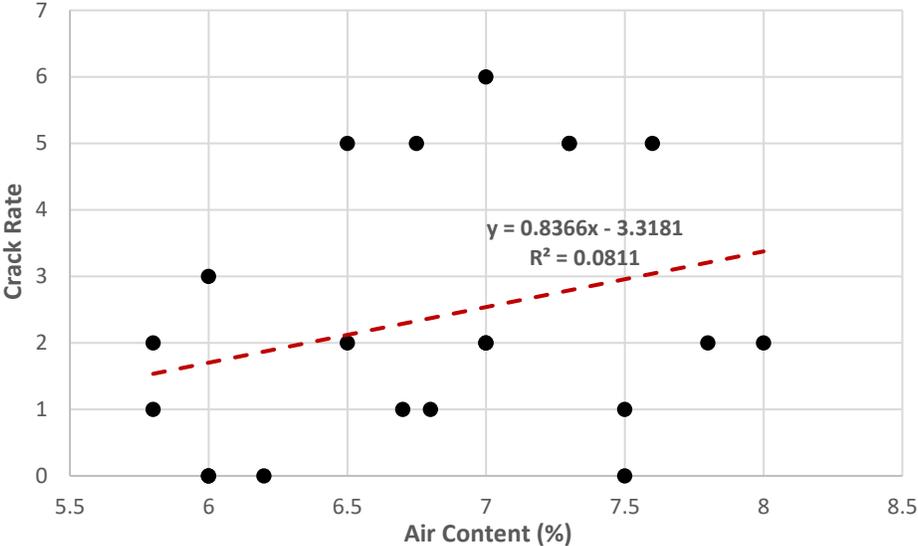
**Figure 23. Relationship between crack rate and air content (Stage 2 results)**

The correlation between the crack rate and air content was positive with the R-squared value of 0.0811, which is considered a slight correlation.

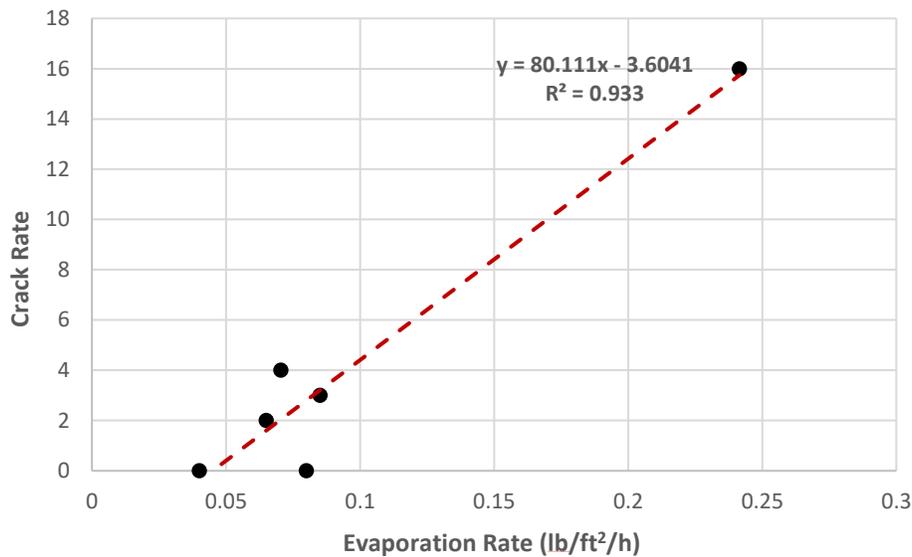
**Figure 26. Relationship between crack rate and evaporation rate (Stage 3 results)**

The results indicated a positive correlation between the crack rate and evaporation rate. Moreover, the R-squared value was 0.933 This indicated a significant correlation between crack rate and evaporation rate.

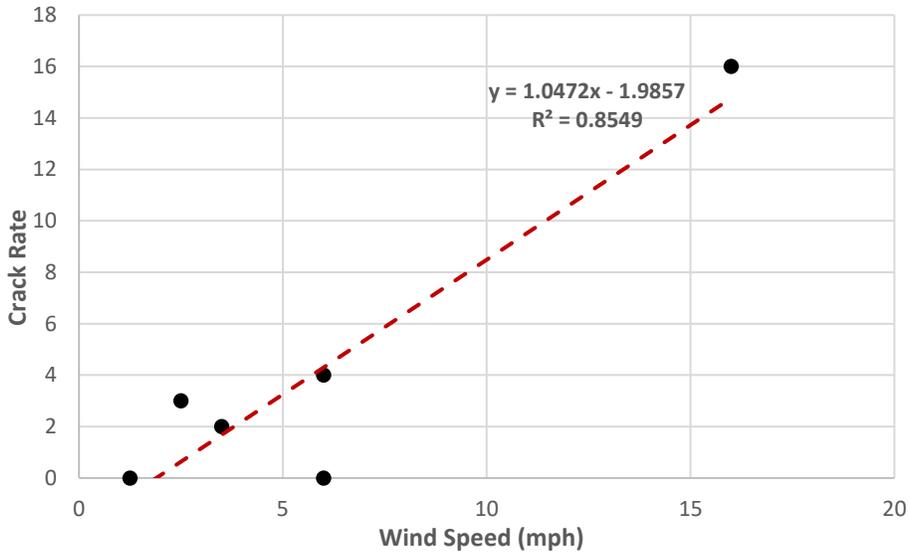
**Figure 27. Relationship between crack rate and wind speed (Stage 3 results)**

The results indicated a positive correlation between the crack rate and wind speed. Furthermore, the R-squared value was 0.8549. This indicated a significant correlation between the crack rate and wind speed.

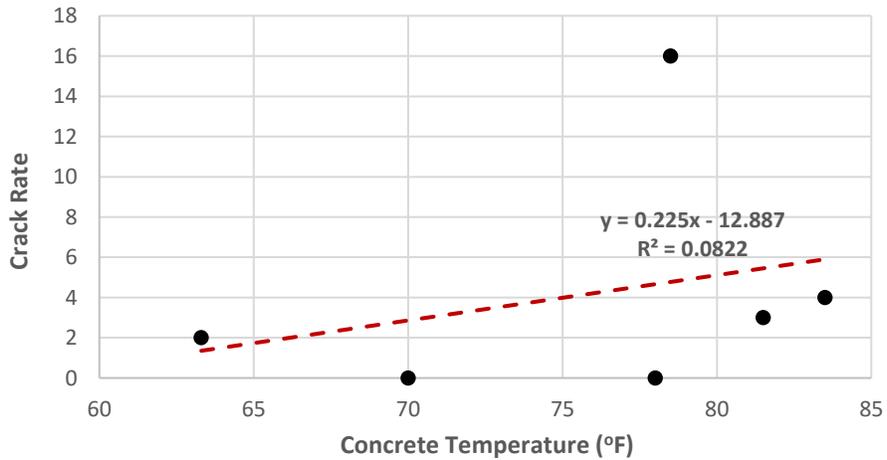
**Figure 28. Relationship between crack rate and concrete temperature (Stage 3 results)**

The results indicated a positive correlation between the crack rate and concrete temperature. However, the R-squared value was 0.0822. This indicated a slight correlation between the crack rate and concrete temperature.

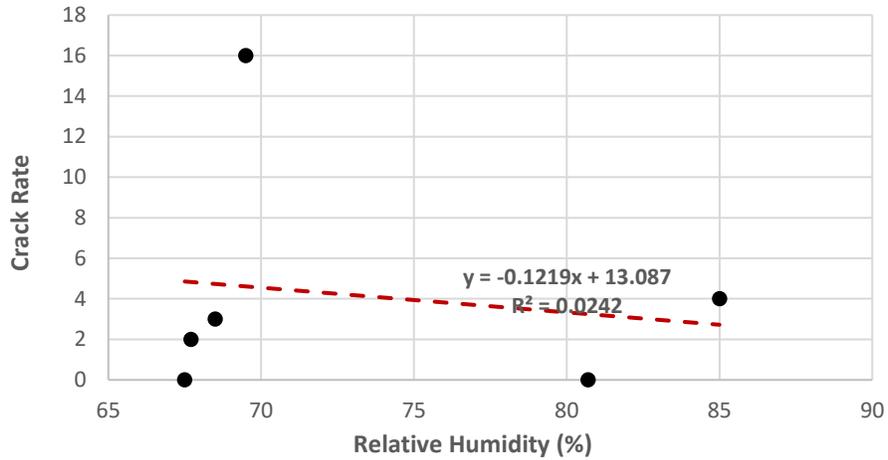
**Figure 29. Relationship between crack rate and relative humidity (Stage 3 results)**

The correlation between the crack rate and relative humidity was negative with an R-squared value of 0.0242. This indicated a slight correlation between the crack rate and relative humidity.

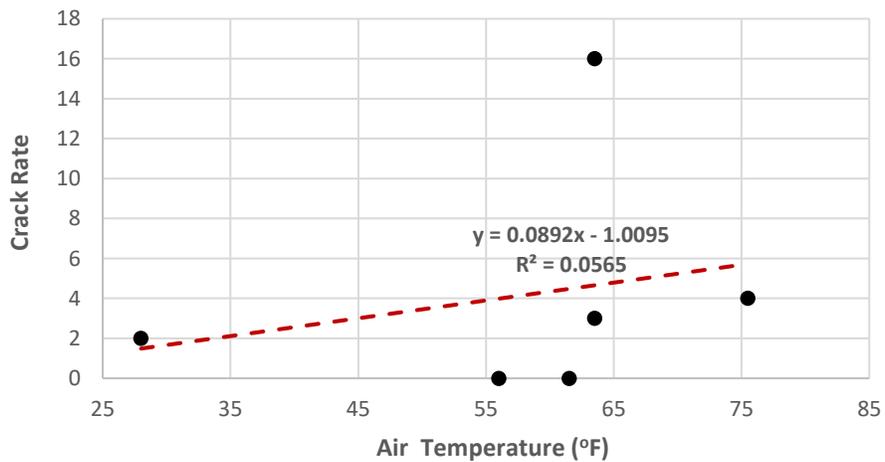
**Figure 30. Relationship between crack rate and air temperature (Stage 3 results)**

The results indicated a positive correlation between the crack rate and air temperature with an R-squared value of 0.0565. This indicated a slight correlation between the crack rate and air temperature.
