Concrete Pavement Buckling

Dan King, P.E.
Research Engineer, CP Tech Center

National Concrete Pavement
Technology Center

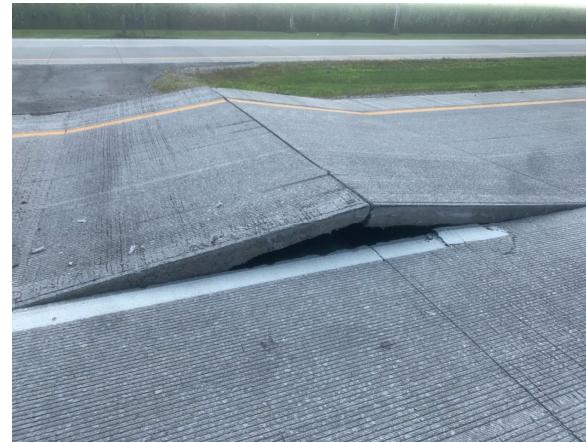
- Localized upward movement or shattering of a slab along a transverse joint or crack
- Results from volumetric expansion that becomes restricted at the joint/crack, buildup of stresses, and release of pressure

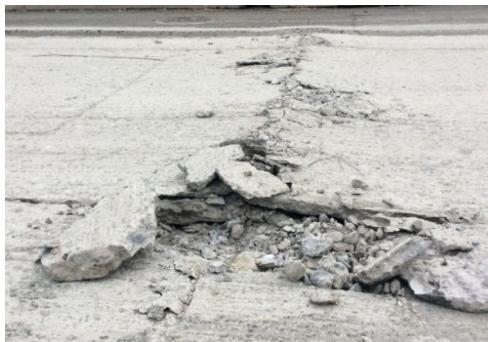
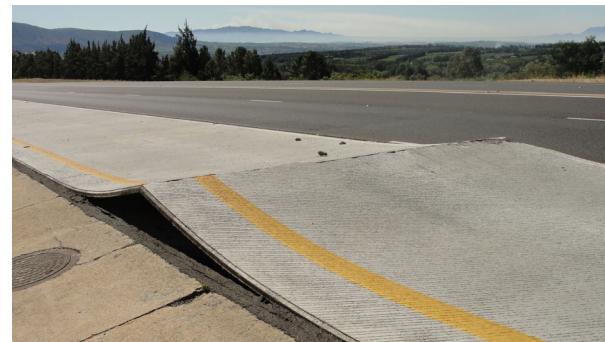
- Buckling is relatively uncommon and failures are not always catastrophic, but they often require immediate attention and result in closures due to the safety hazard and need for repair

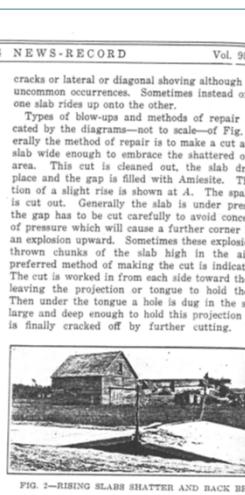
FIG. 2—RISING SLABS SHATTER AND BACK BREAK

Types of blow-ups and methods of repair are indicated by the diagrams—not to scale—of Fig. 3. Generally the method of repair is to make a cut across the slab wide enough to embrace the shattered or spalled area. This cut is cleaned out, the slab drops into place and the gap is filled with concrete. The condition of a slight rise is shown at A. The spalled area is cut out. Generally the slab is under pressure so the gap has to be cut carefully to avoid concentration of pressure which will cause a further corner break or an explosion upward. Sometimes these explosions have thrown chunks of the slab high in the air. The preferred method of making the cut is indicated at C. The cut is worked in from each end toward the middle leaving the projection or tongue to hold the slab above. Then under the tongue a hole is dug in the subgrade so large and deep enough to hold this projection when it is finally cracked off by further cutting. Without

- 1—Original Position
- 2—Spalled on Line of Dowel Bars
- 3—One Slab Shoves and Mounts the Other, Telescoping joint

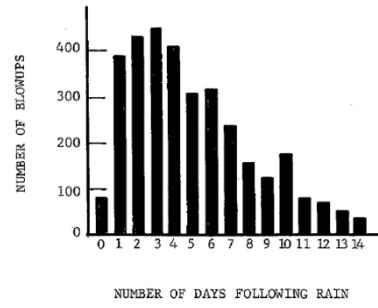
- Two of the first comprehensive studies were published by Purdue University (1946) and the Illinois Division of Highways (1957)
 - Strong correlation with coarse aggregate source (IN)
 - Strong correlation with temperatures $> 90^{\circ}\text{F}$ and rain events (IL)

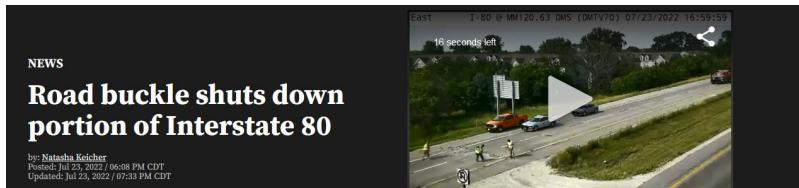
WEST DES MOINES, Iowa — A road buckle shut down a portion of Interstate 80 in West Des Moines on Saturday.

The road buckle occurred westbound on I-80 near the Jordan Creek Parkway entrance ramp. The westbound lanes were shut down for several hours while law enforcement and Iowa DOT repaired the road.

No accidents or injuries have been reported during this incident. The cause of the road buckle was due to extreme heat.

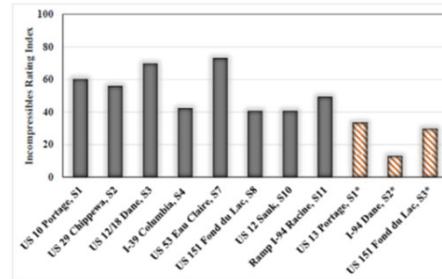
- In Wisconsin, joints are generally left unsealed or unfilled
- The 2022 ARA study found more incompressible materials at sites experiencing buckling than at control sites
- Unsealed joints can also be more prone to intrusion of water and chemicals
- Likely a contributing factor to why buckling is more frequent in WI than in nearby states

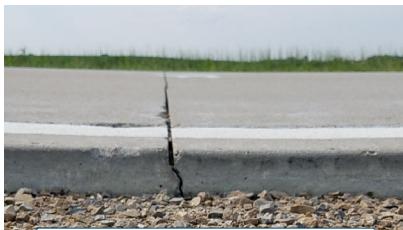
- Cracks don't always form beneath saw cut joints on these types of concrete overlays
- Some joints may never activate, while others may become dominant joints that exhibit more movement and opening
 - The working joint spacing could be significantly greater than designed
- 5 inch COA-B with 5.5 ft x 5.5 ft slabs, Worth County, IA:

Activated – wide working joint

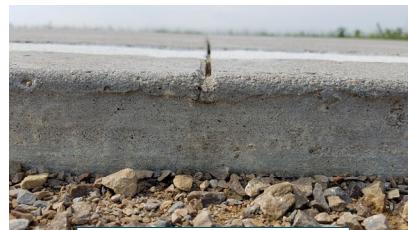
Activated – very narrow

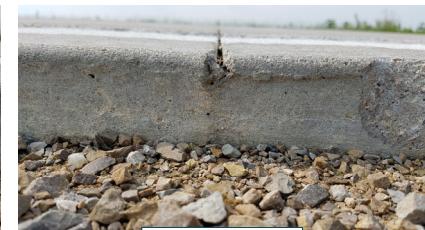
Not activated

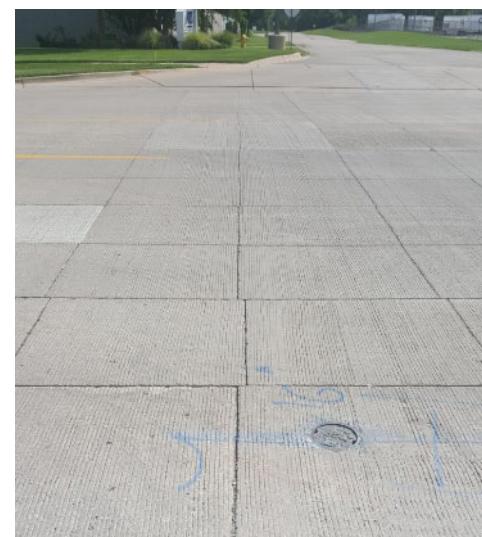
- Connected or correlated phenomenon of slab migration
 - More prevalent in thinner overlays with short joint spacing
 - Overlays \leq 5 in. may not have tie bars at longitudinal joints

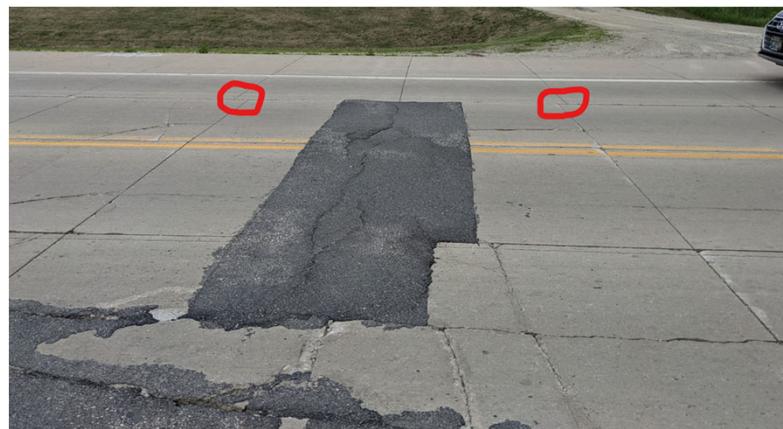
- Panel movement often precedes and accompanies buckling in concrete overlays

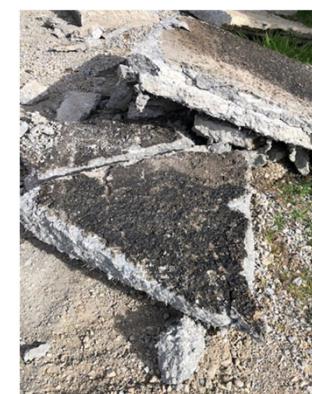
- Stripping in the underlying asphalt pavement (COA) or the asphalt interlayer (COC-U) has also been found at buckled concrete overlay sections
- Potential source of incompressibles at the joint
- Does rutting in existing asphalt contribute to drainage issues?
- How well do we understand the role that moisture plays in this process in general?

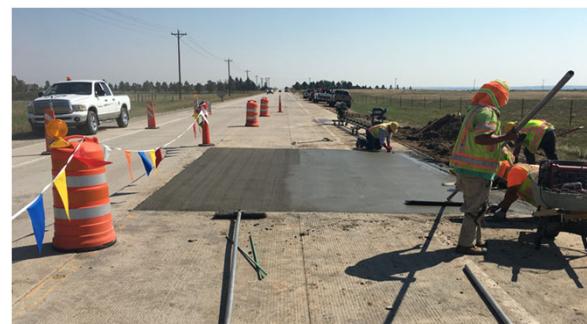
- When failure occurs, full-depth concrete patches are best
 - Asphalt can be used for a temporary patch, but not for long-term repairs – pavements that experience buckling usually aren't finished
- Given the potential for recurrence, is there preventative maintenance that can be done on a susceptible pavement?

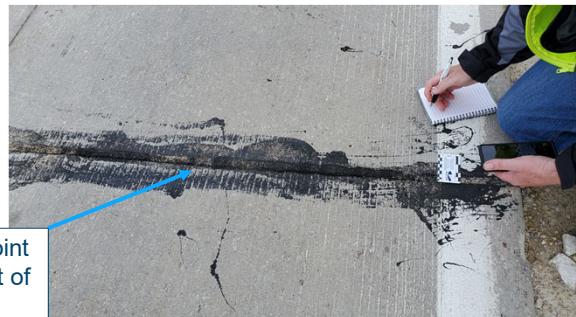
- This is probably not the way to go...
- Historically not a consistently successful method
- They can end up closing very quickly, and have not successfully mitigated buckling on concrete overlays in Iowa

Sealant squeezed out of joint just weeks after placement of expansion joints

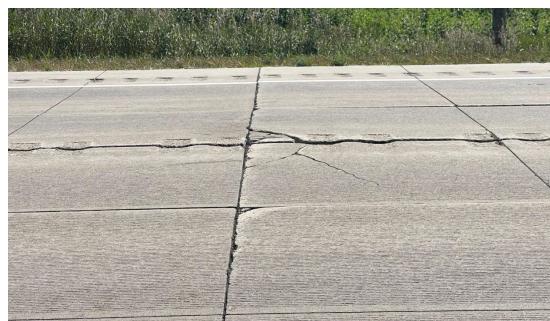
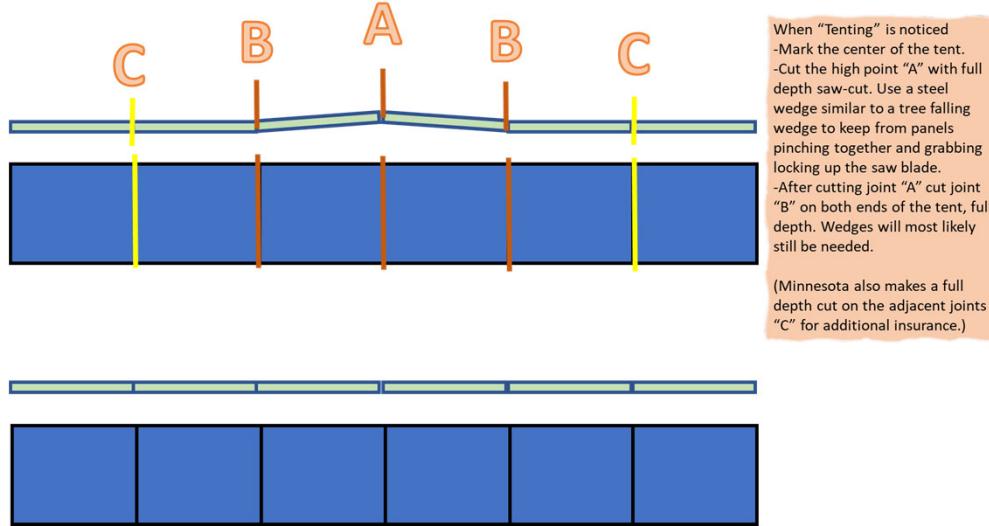
- If you see panels just beginning to tent up, or other signs of spalling or compression at the joint, relief cuts could help mitigate stresses and prevent a blowup
 - This technique has been used recently in IA & MN with promising results so far

- The relief cut method requires ability to monitor pavement sections and prior knowledge of susceptibility
 - Future need: ability to predict what types of pavements might be most susceptible buckling
- Joint sealing/filling
 - If a pavement has had buckling and the joints are not sealed, it's not too late to clean out and seal the joints
