MnROAD Concrete Pavement Research – A 2023 Tour

Tom Burnham, P.E. | Senior Road Research Engineer, Minnesota Department of Transportation

NCC Spring Meeting, Savannah, GA

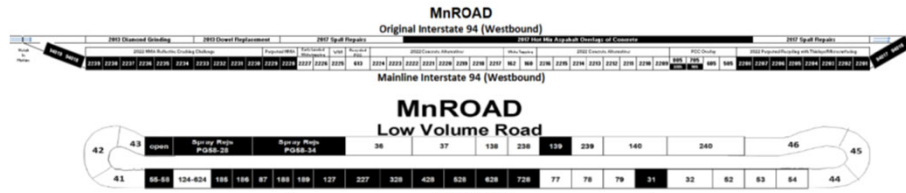
- **Active Concrete Pavement Test Sections**

- 26 - Mainline
- 24 - Low Volume Road
- 47 – Old WB I-94 (Repairs to 1973 JRCP)

- Jointed plain concrete pavement on gravel base
- Concrete overlay on asphalt
- Concrete overlay on concrete

- **Test sections from all 3 phases (1994-2022)**

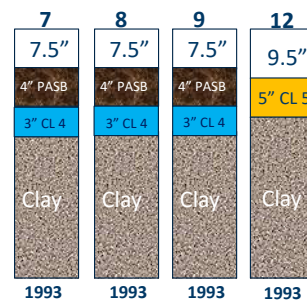
- Jointed plain concrete (early 1990's mix specs)
- Panel length/width
 - Cell 7 = 20 ft / 14 ft
 - Cell 8 = 15 ft / 14 ft
 - Cell 9 = 15 ft / 14 ft
 - Cell 12 = 15 ft / 12 ft
- Skewed transverse joints (silicone seals)
- Base layer = Permeable Asphalt Stabilized Base (PASB) or Class 5 gravel
- Dowel bars (epoxy coated steel) = 1"/1.25" dia., 15" long

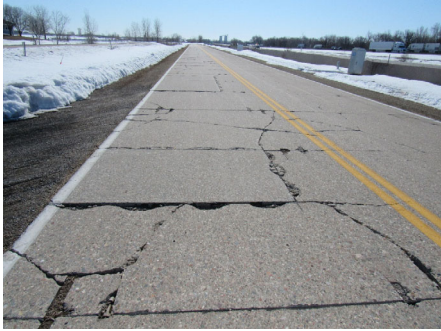
Age = 22 yrs

- **Loadings**
 - 166,000+ passes of 80,000 lb. 5-axle tractor-trailer
- **Distress**
 - Much pumping early in life
 - Significant number of cracked panels
 - Failed experimental repairs (installed 2013)
 - Short plate dowels
 - Retrofit dowel bars and long plate dowels
- **Several performance reports available**

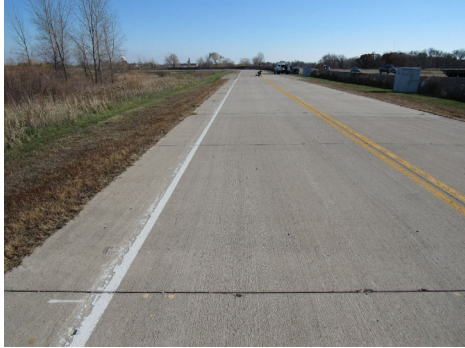
Photo taken @ age = 19 yrs

- **Loadings**
 - 166,000+ passes of 80,000 lb. 5-axle tractor-trailer
- **Distress**
 - No cracked panels
 - Minimal joint faulting
- **Performance**
 - Excellent performance
 - LTE for FRP dowels variable and slightly lower than epoxy coated steel dowel bars

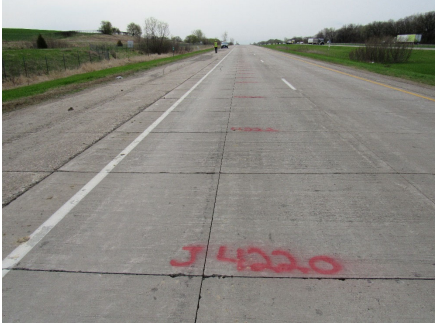
Photo taken @ age = 11 yrs

- **Loadings**
 - 11+ million CESALs (8+ million trucks)
- **Distress (2011-2022)**
 - Widespread transverse joint spalling
 - Low number of cracked panels
 - Significant joint faulting
- **Performance (2011-2022)**
 - Good performance until faulting developed
 - Faulting not expected (maybe warp & curl?)

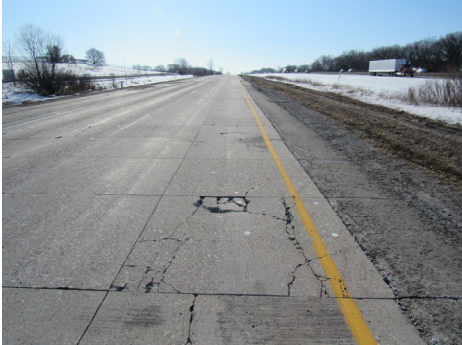
Photo taken @ age = 9 months

- **Distress (2023)**
 - All replacement panels in 505 cracked
 - Possible causes
 - Poor support from broken joints below
 - Restraint from tie-bars around perimeter of repairs

Tie bars around perimeter of repairs

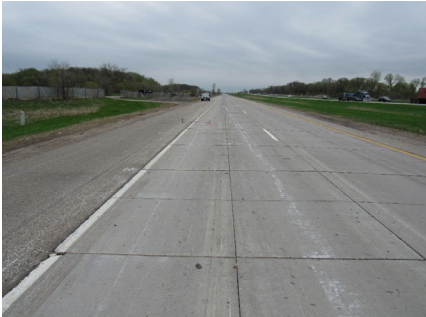
Photo taken @ age = 9 yrs

- **Loadings**
 - 9.3+ million CESALs (6.8 million trucks)
- **Distress (2013-2022)**
 - Low number of cracked panels
 - Significant joint faulting
- **Performance (2013-2022)**
 - Good performance until faulting developed
 - Fibers contained tight cracks, but not larger ones
 - The fibers type and dosages did not have a significant impact on the mitigation of joint faulting
 - Several publications available

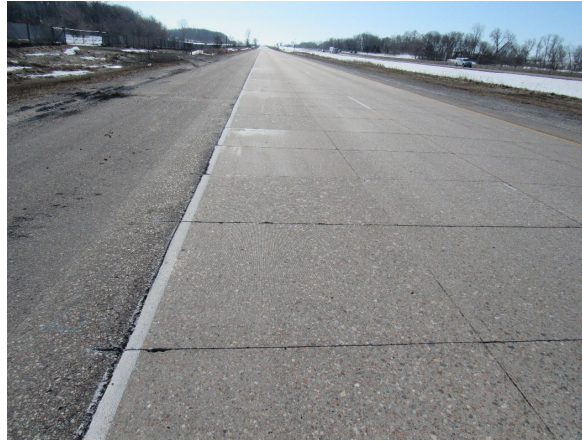
- **Distress (2023)**

- Moderate faulting has returned to many joints

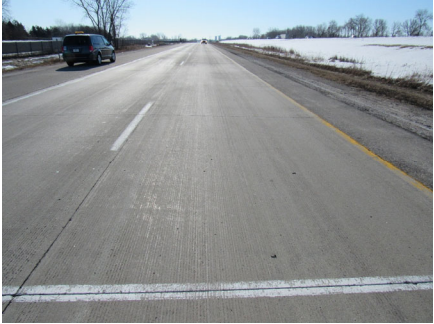
Photo taken @ age = 10 yrs

- **Loadings**
 - 9.3+ million CESALs (6.8 million trucks)
- **Distress (2013-2022)**
 - Low number of cracked panels
 - Some wide transverse joints
- **Performance (2013-2022)**
 - Good performance (little surface distress)
 - MnDOT report underway

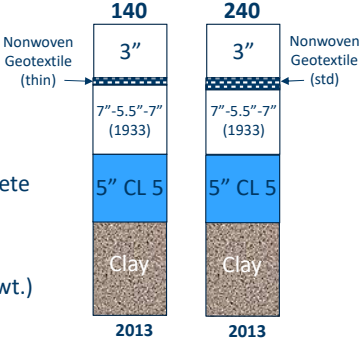
- **Phase 2**
 - Cells 140 and 240 – Low Volume Road
 - First traffic = 2013
- **Design details:**
 - Ultra-thin unbonded concrete overlay on concrete
 - Fiber-reinforced concrete (20% RSR - C1609)
 - Panel length/width = 6 ft L / 6 ft W
 - Geotextile fabric Interlayer (thin and standard wt.)

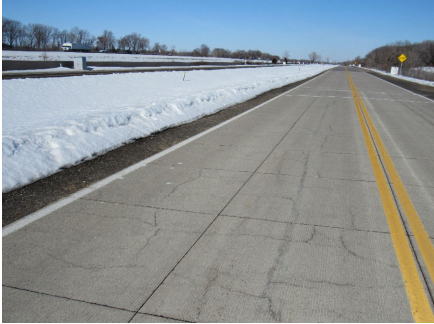
Photo taken @ age = 10 yrs

- **Loadings**
 - 82,300+ passes of 80,000 lb. 5-axle tractor-trailer
- **Distress (2013-2022)**
 - Many cracked panels
 - Very little joint faulting
- **Performance (2013-2022)**
 - Very good performance
 - Fibers appear to be keeping cracks tight
 - Noise issue in cooler condition for panels on standard weight fabric

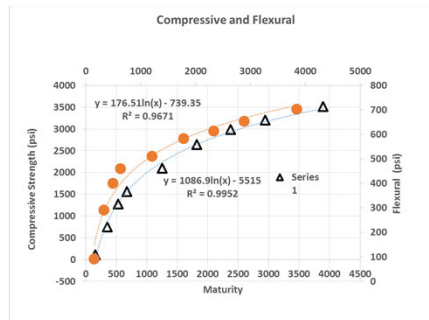
Early loading of Cells 124-424

Cell x24 Early Loading Sequence		
Maturity (Deg-Hr)	Flexural (psi)	Loads applied to lanes
100	73	1st Load on Cell 124 (forward and back) 3 hrs
200	196	1st Load on Cell 224, 2nd load on Cell 124
300	267	1st Load on Cell 324, 2nd load on Cell 224, 3rd load on Cell 124
400	318	1st Load on Cell 424, 2nd load on Cell 324, 3rd load on Cell 224, 4th load on Cell 124

Starting Day 2, 5 passes per day for first week

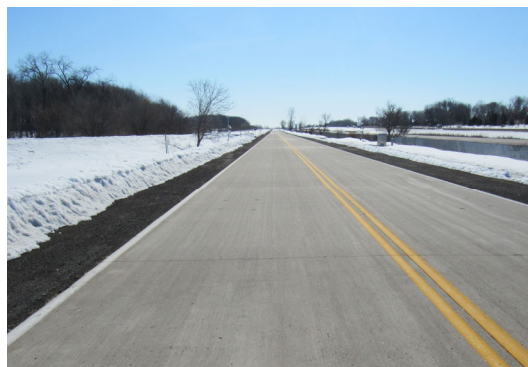
Photo taken @ age = 5.5 yrs

- **Loadings**
 - 47,300+ passes of 80,000 lb. 5-axle tractor-trailer
- **Distress (2013-2022)**
 - No cracking or surface distress
 - Some wide joints
- **Performance (2013-2022)**
 - Very good performance
 - LTE lower in some joints

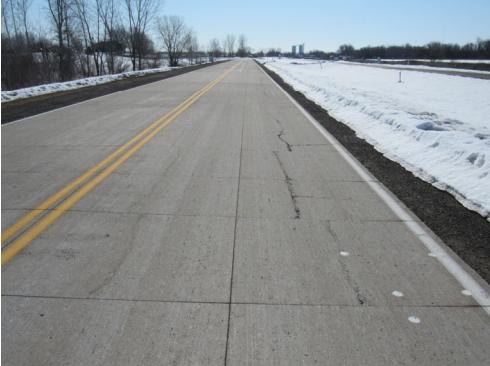
Cell 239 @ age = 5 year

- **Loadings**
 - 47300+ passes of 80,000 lb. 5-axle tractor-trailer
- **Distress**
 - Major cracking of panels
- **Performance (2017-2023)**
 - Fibers holding cracks together
 - 4" thick panels performing substantially better than 3" panels
 - Starting to develop joint faulting
