NCHRP Project 1-61 Evaluation of Bonded Concrete Overlays on Asphalt (BCOA)

National Concrete Consortium

Savannah, GA
April 11, 2023

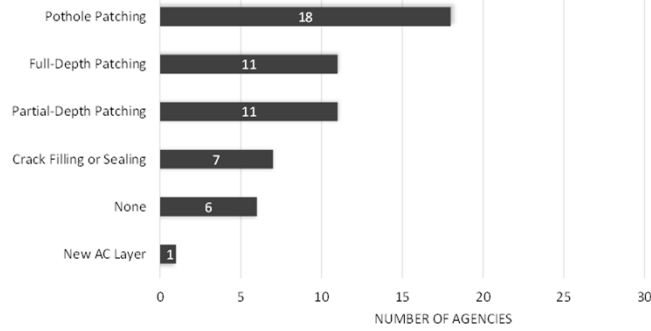
Pre-overlay repairs

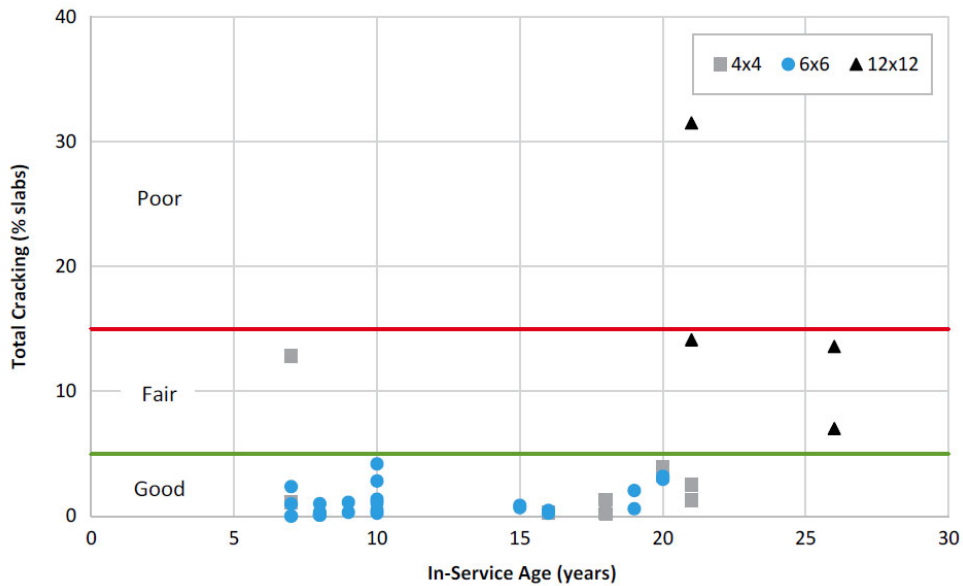
Performance by Slab Size – Automated Cracking

Condition	Slab (ftxft)	Age (years)	No. Projects	Average	Std Dev
IRI (in/mi)	4x4	7 to 21	5	181	63
	6x6	7 to 21	13	104	26
	12x12	21 to 26	2	116	18
Faulting (inch)	4x4	7 to 21	5	0.05	0.03
	6x6	7 to 21	13	0.03	0.01
	12x12	21 to 26	2	0.05	0.01
Total cracking (% slabs)	4x4	7 to 21	5	3.0	3.9
	6x6	7 to 21	13	1.1	1.2
	12x12	21 to 26	2	16.6	10.5

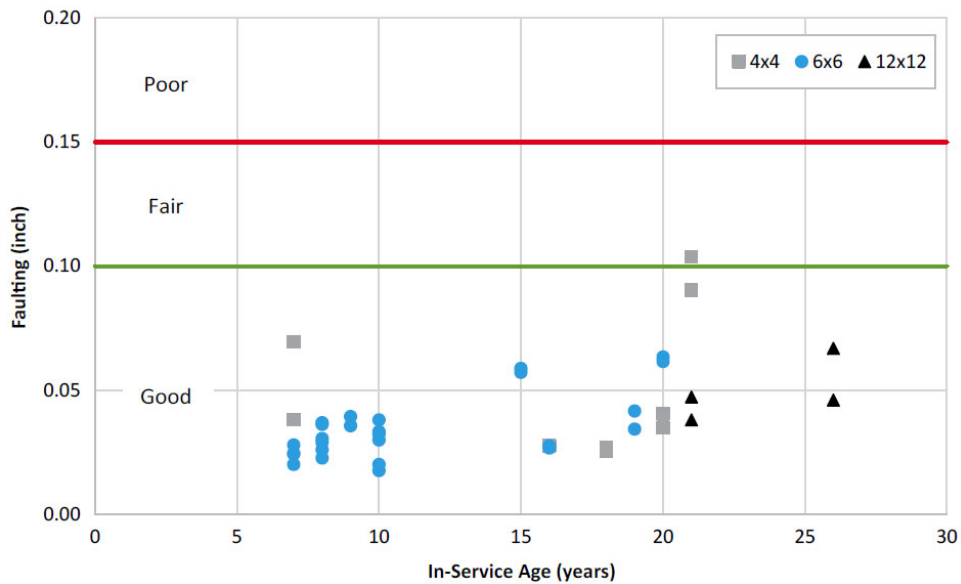
Performance by Slab Size – Automated Faulting
