Revisiting Concrete Scaling

SUMMER 2023

Peter Taylor, National Concrete Pavement
Technology Center

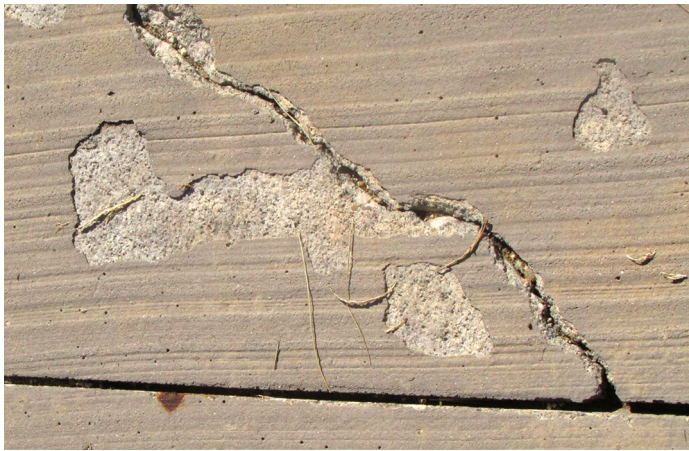
Figure 2. Surface flaking

Flaking is normally a surface effect, with sound concrete below the flakes (Figures 2 and 3). The key clue to identifying this distress is that thin flakes can be removed from the concrete surface by tapping it with a hammer. Note that the aggregate in Figure 3 is debonded from the paste, indicating that the damage occurred very early in the life of the concrete.

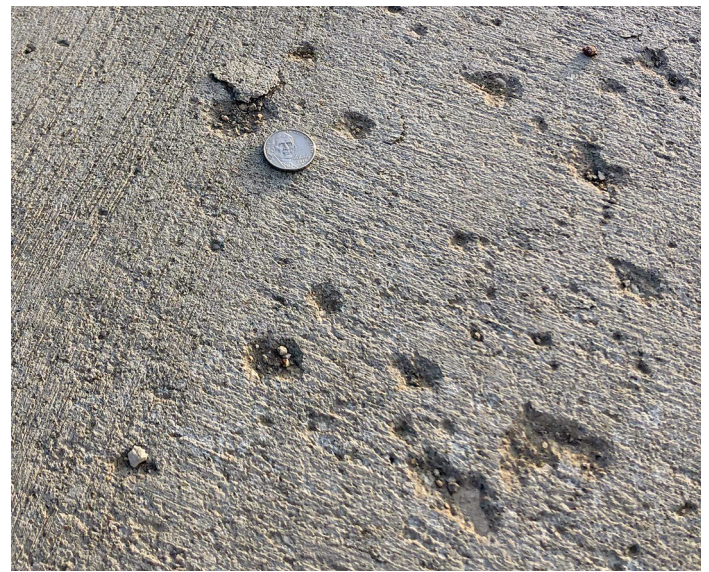
Figure 4. Popouts

Popouts (Figure 4) are typically observed as cone-shaped holes with broken aggregate particles at the bottom, with the other portion of the aggregate still attached to the loose cone.

This distress is due to porous aggregates, such as chert, that absorb water and expand under freezing. The damage is often progressive as water gets to the deeper particles, particularly at joints.

Popouts are prevented by avoiding the use of such aggregates. There is no way to mitigate popouts, although surface sealants may slow the rate of water penetration.

Cause	Effects	Photo
Highly porous aggregates, such as chert	Popouts	Figure 4
Aggregates with smooth surfaces	Mortar flaking due to reduced bond with paste	—
High dosage of supplementary cementitious materials	Increased risk of distress. The exact mechanisms are still debated. Risks include slower hydration, early finishing due to delayed setting, and chemical effects.	—
Portland limestone cement	Possible variation in finishing timing and bleed rates	—
Cement with high C ₃ A or high alkali content	Increased risk of distress. The exact mechanisms are still unknown.	—
High w/cm ratio (exceeding maximum w/cm ratio of 0.45 due to poor mix design), retempering, bleeding, and adding surface water during finishing	Freeze-thaw damage caused by rapid saturation due to high permeability	—
Early finishing	Flaking due to bleed water trapped under the sealed surface Increased w/cm ratio at the surface as bleed water is reworked into the surface. See “High w/cm ratio” above. These effects can be avoided by using observations rather than rules of thumb to decide when to start finishing.	Figure 6

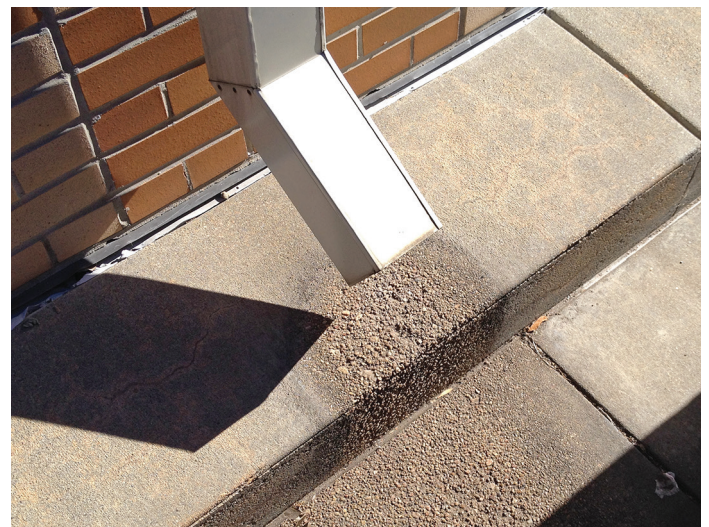
Figure 5. Freeze-thaw damage

Loss of surface material is likely due to a combination of permeable, saturated concrete subjected to an aggressive environment, such as one with numerous freezing and thawing cycles (Figure 5), and salt-related distress.

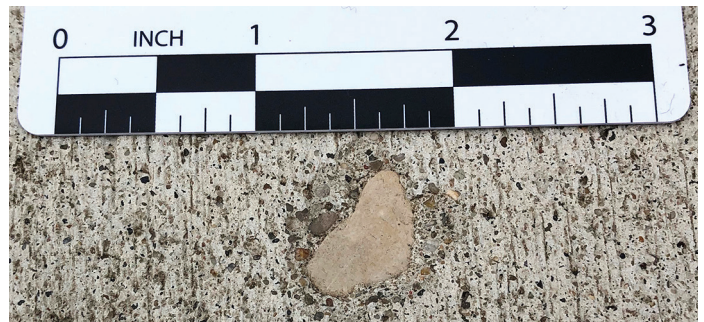
Figure 7. Mortar flaking

Overworking a stiff mixture	Mortar flaking as partially hydrated paste flakes are debonded from the tops of aggregate particles. A key clue to identifying mortar flaking is that damage is localized to just above sand, smooth, aggregate particles. Increased surface w/cm ratio and risk of saturation as excess water in the paste is worked up to the surface	Figure 7
Insufficient air during proportioning and batching	Continuous loss of surface under freeze-thaw action	—
Insufficient hydration and poor curing caused by hot, dry weather or placement late in the season	Soft concrete. This leads to progressive abrasion and rapid saturation, accelerating freeze-thaw damage over the whole surface. Mortar flaking may also be a symptom.	—
Salts	Loss of paste due to expansion or dissolution of surface paste. This is exacerbated by the application of salt to immature (porous) concrete. Dissolution of the surface paste depends on cementitious chemistry and salt type (CaCl ₂ and MgCl ₂ are more aggressive) and is distinctive due to the clean aggregate particles left behind. Because salts are used for deicing, these effects are most often seen in cold weather regions, but they can be seen in warm weather industrial applications where salts precipitate.	Figure 8
