Troubleshooting Inadequately Cured Concrete or Why Did my Concrete Scale?

Iowa Better Concrete Conference

Gerard Moulzolf, PG

American Engineering Testing, Inc.

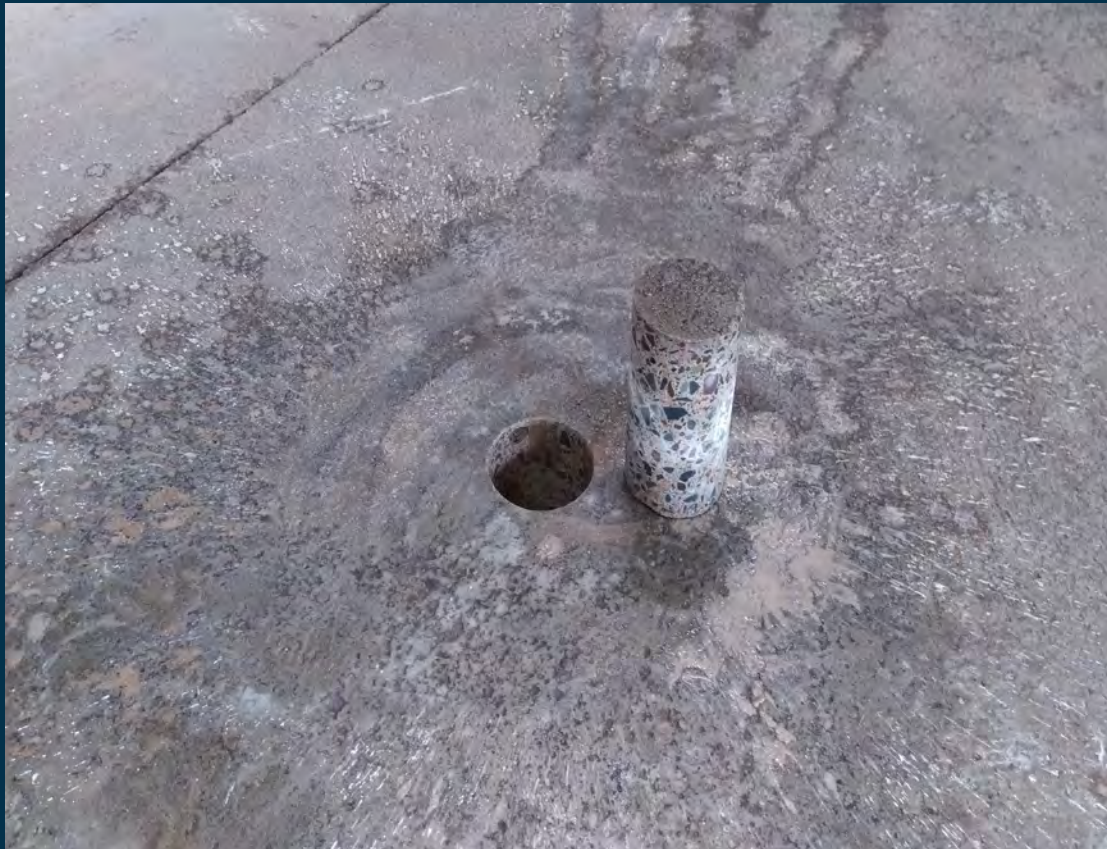
2. Poor finishing practices

- a. Over-finishing
- b. Working water into the surface
- c. Retempering/excessive w/cm
- d. Inadequate curing
 - Late
 - Incomplete

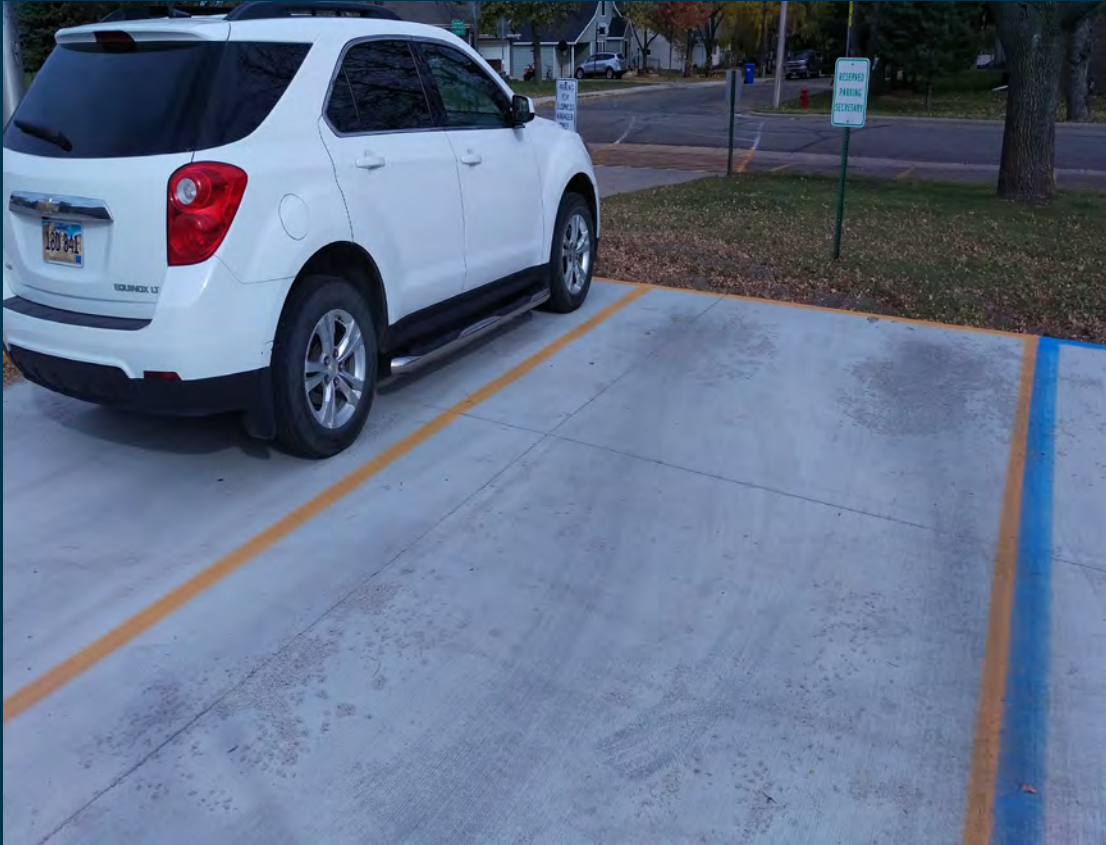
3. Late season placements (premature service) – lack of durability strength
4. Exposure to Salt hastens distress
 - a. Lowers freezing temp of water
 - b. Critical saturation due to osmosis
 - c. Produces a specific environmental condition
 - d. Who's fault?
 - e.concrete was already compromised

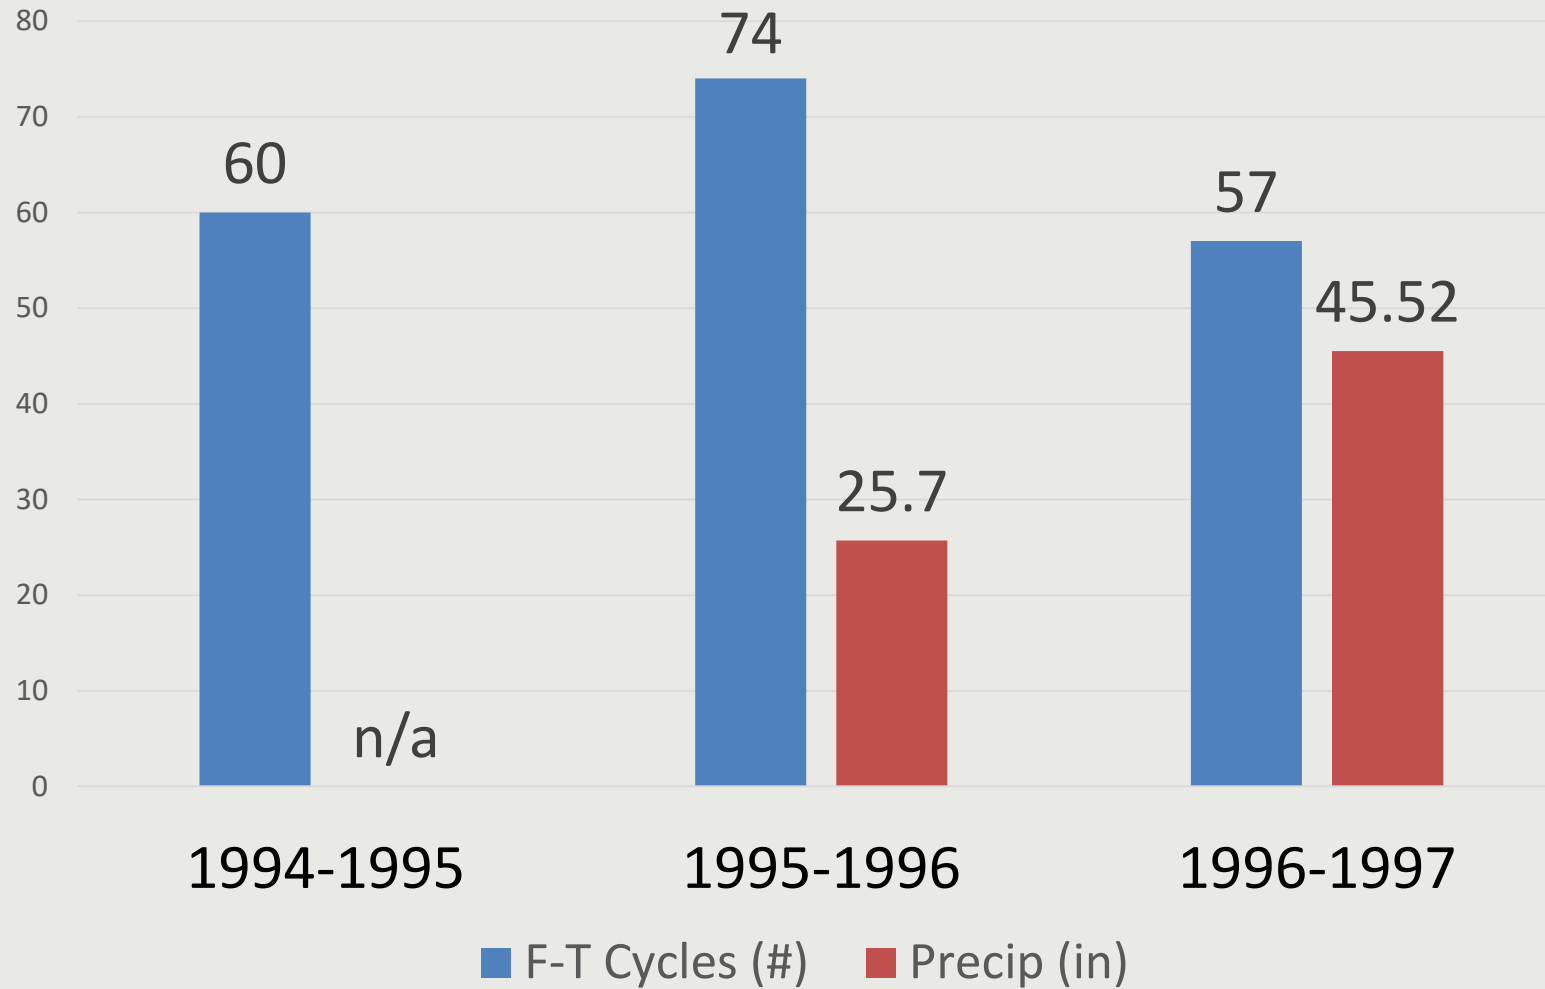
1994-1997 Freeze-Thaw Cycles & Precipitation

Cycle Low temp ≤ 28
Precip. only Oct Nov Dec

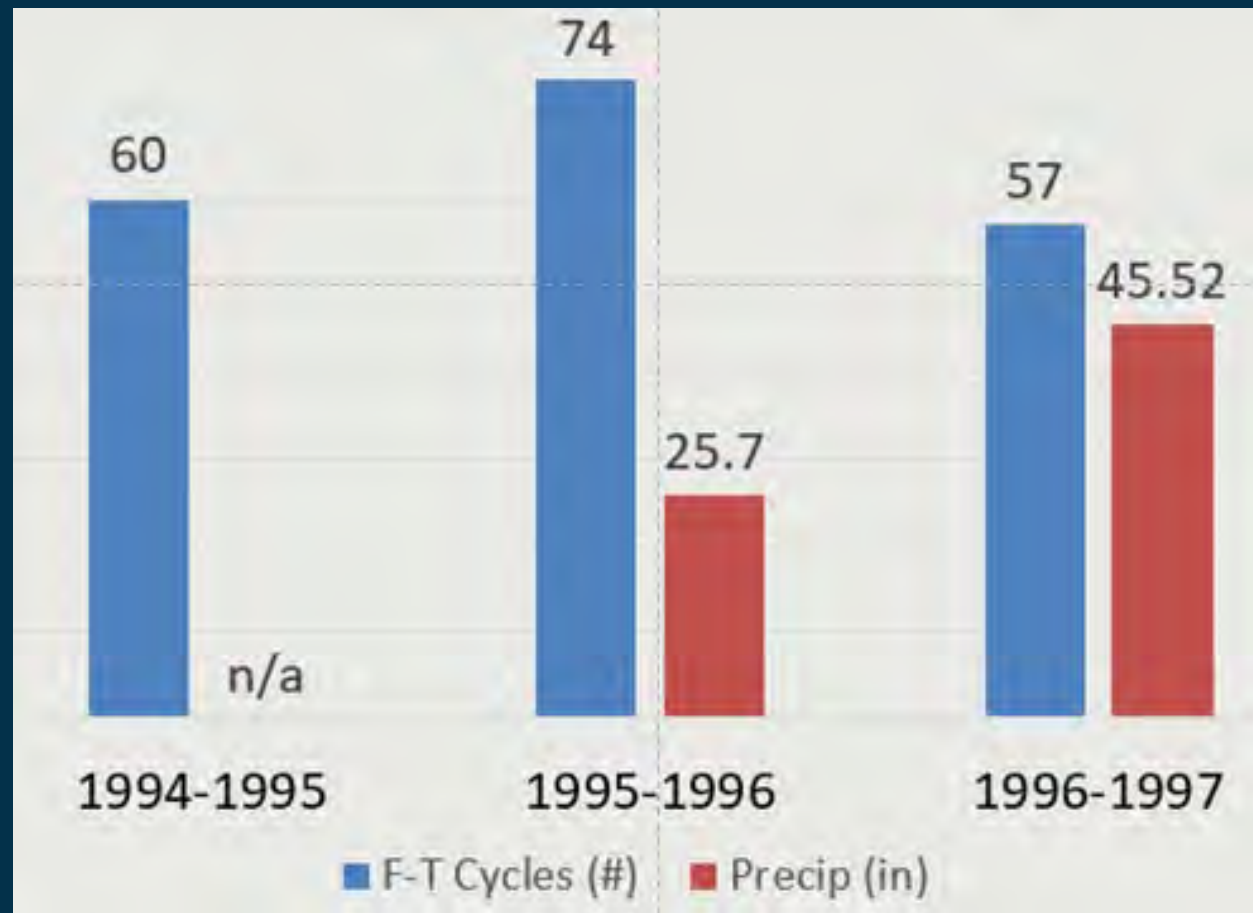
1994-1997 Freeze-Thaw Cycles & Precipitation

1998 ARMMN Study After 96-97

33 Core Samples

Air Problems	21% total
Low air	15%
No air	6%
Over-finishing	48%
Inadequate Curing	61%
Long Haul Time (>45min)	42%
High w/cm (>0.45)	39%
Late Season Placement	15%

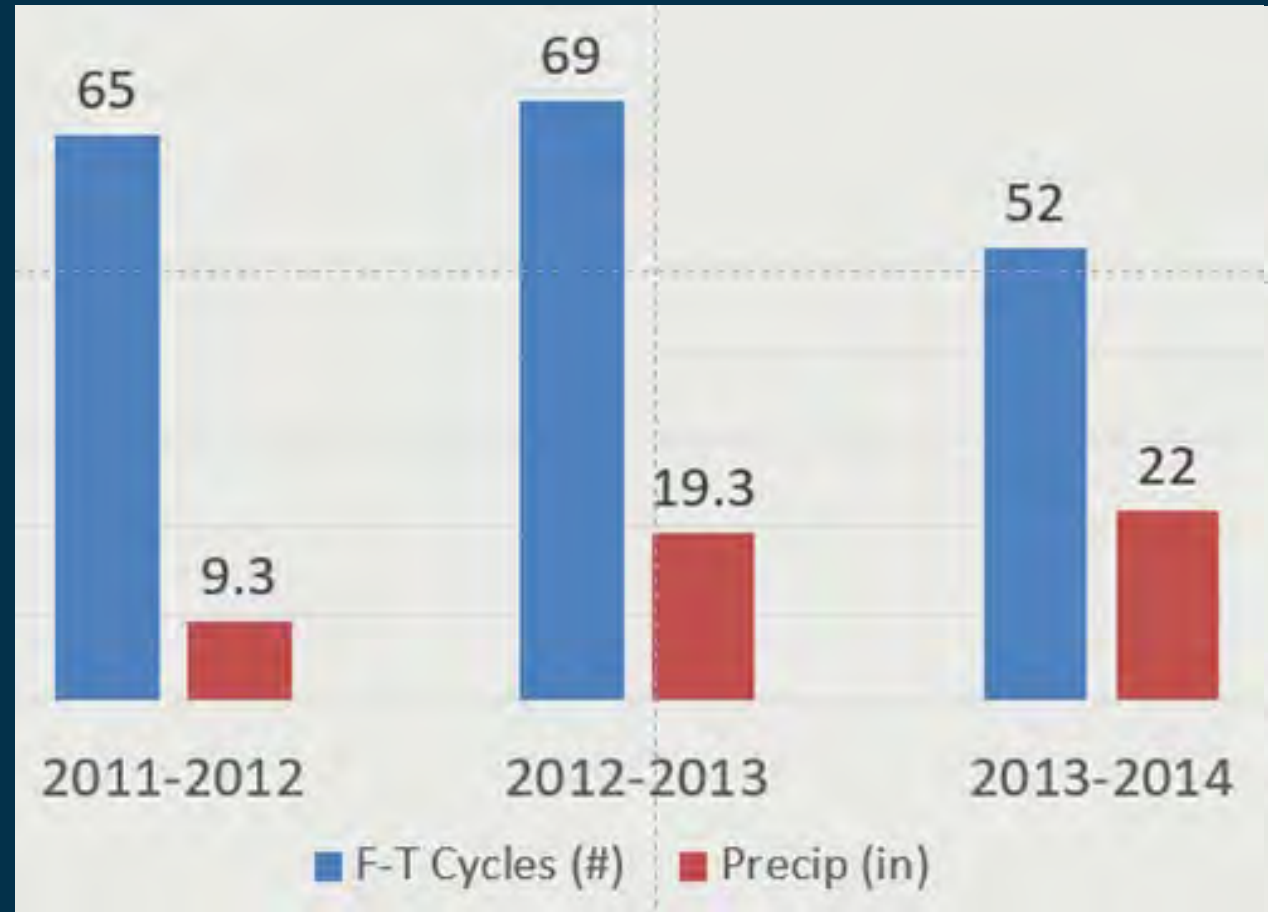
2011-2014 Freeze-Thaw Cycles & Precipitation

2015 ARM Study After 13-14

16 Core Samples

Low air	13%
Over-finishing	13%
Inadequate Curing	44%
w/cm <0.45	100%
Late Season Placement	31%

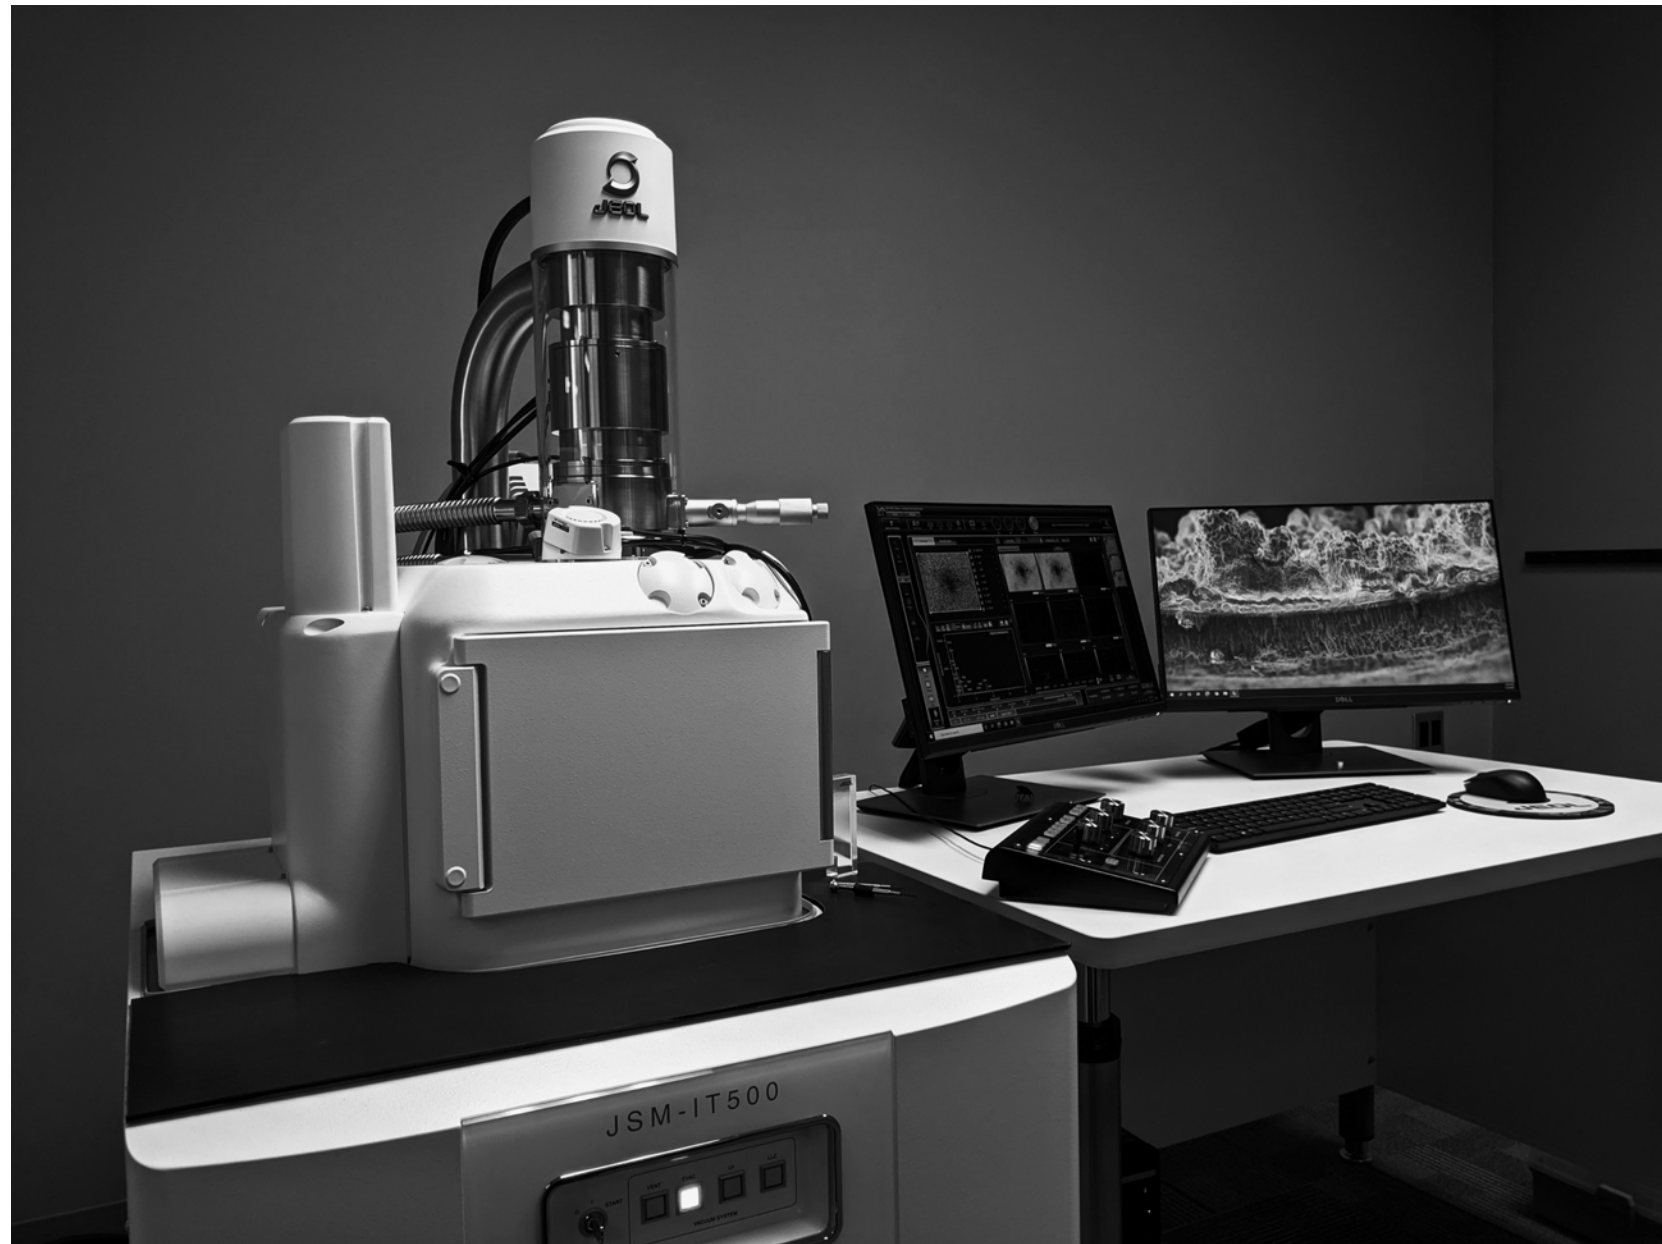
PETROGRAPHY

Microscopical
analysis of concrete
and aggregates

ASTM's

C856

C457

C1723

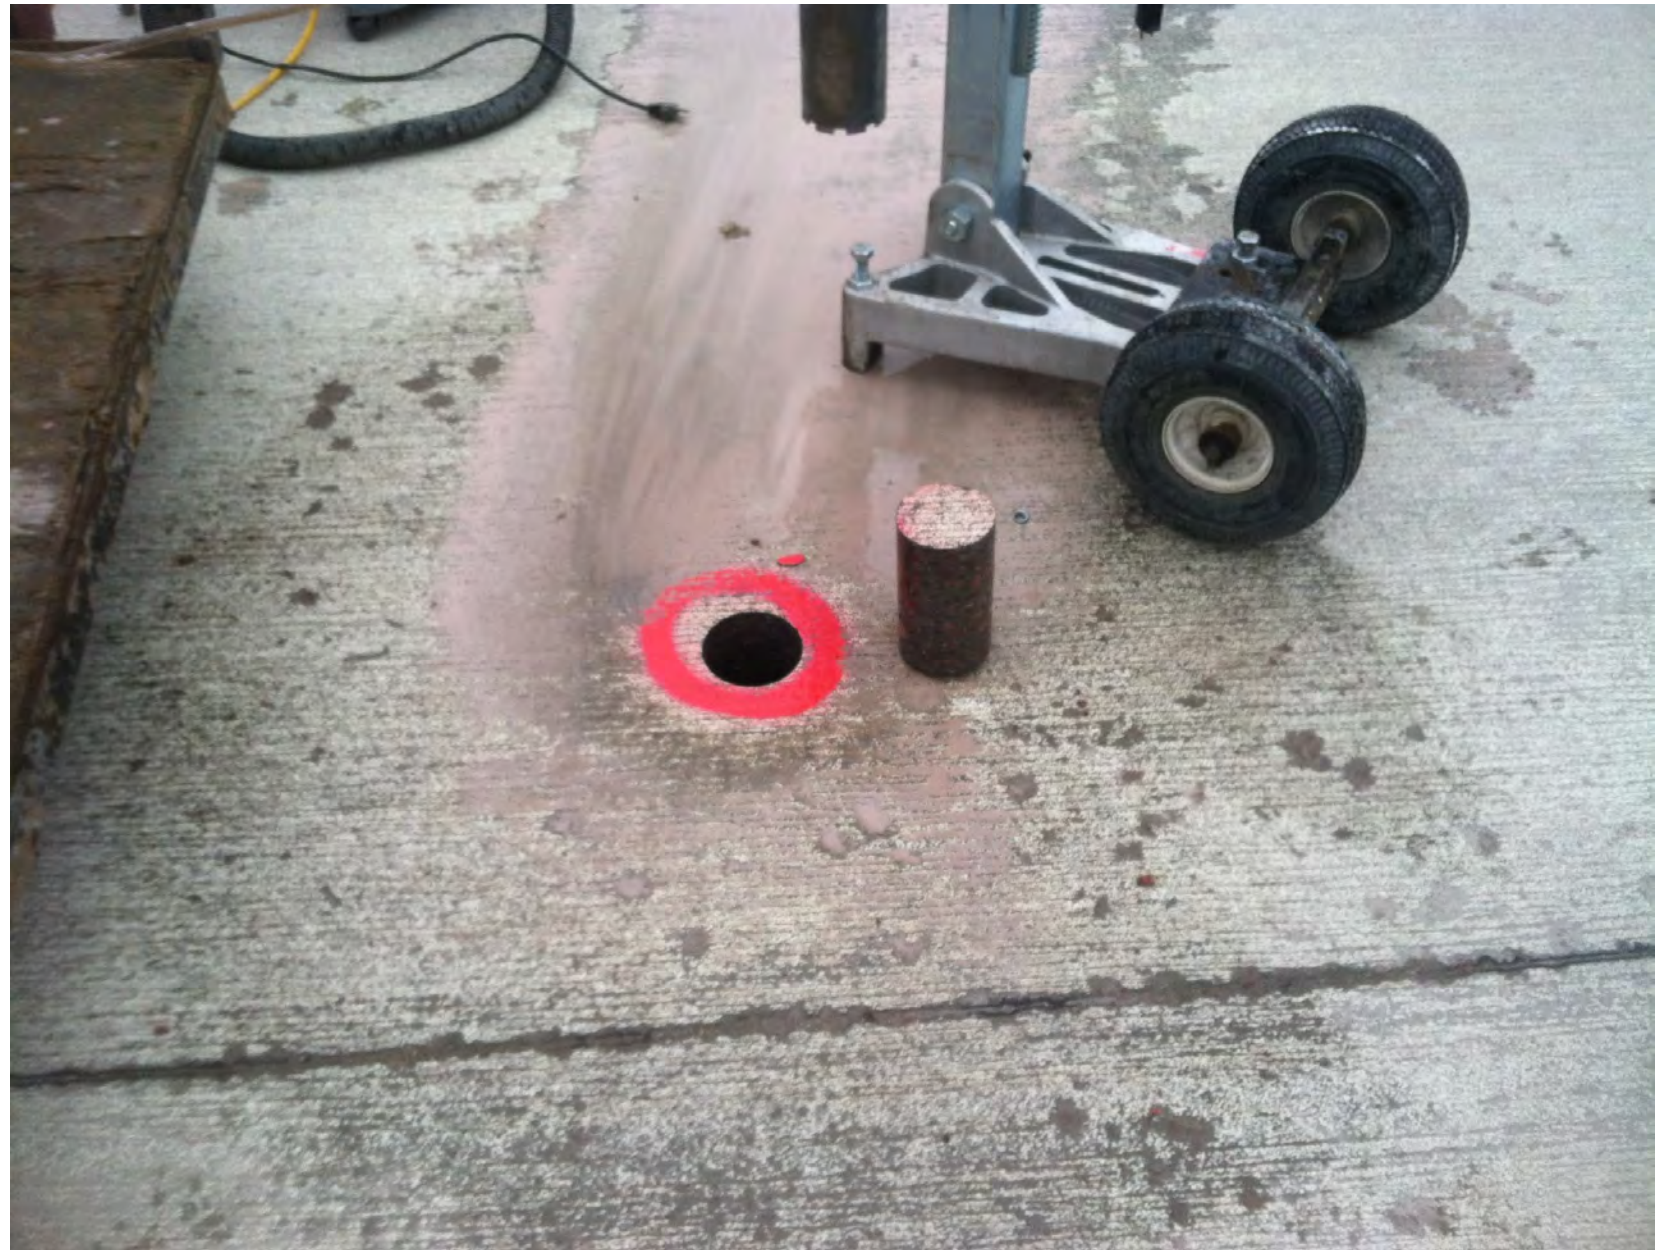
PETROGRAPHY

Core Sampling

Preparation of lapped
and thin sections

Various microscopes

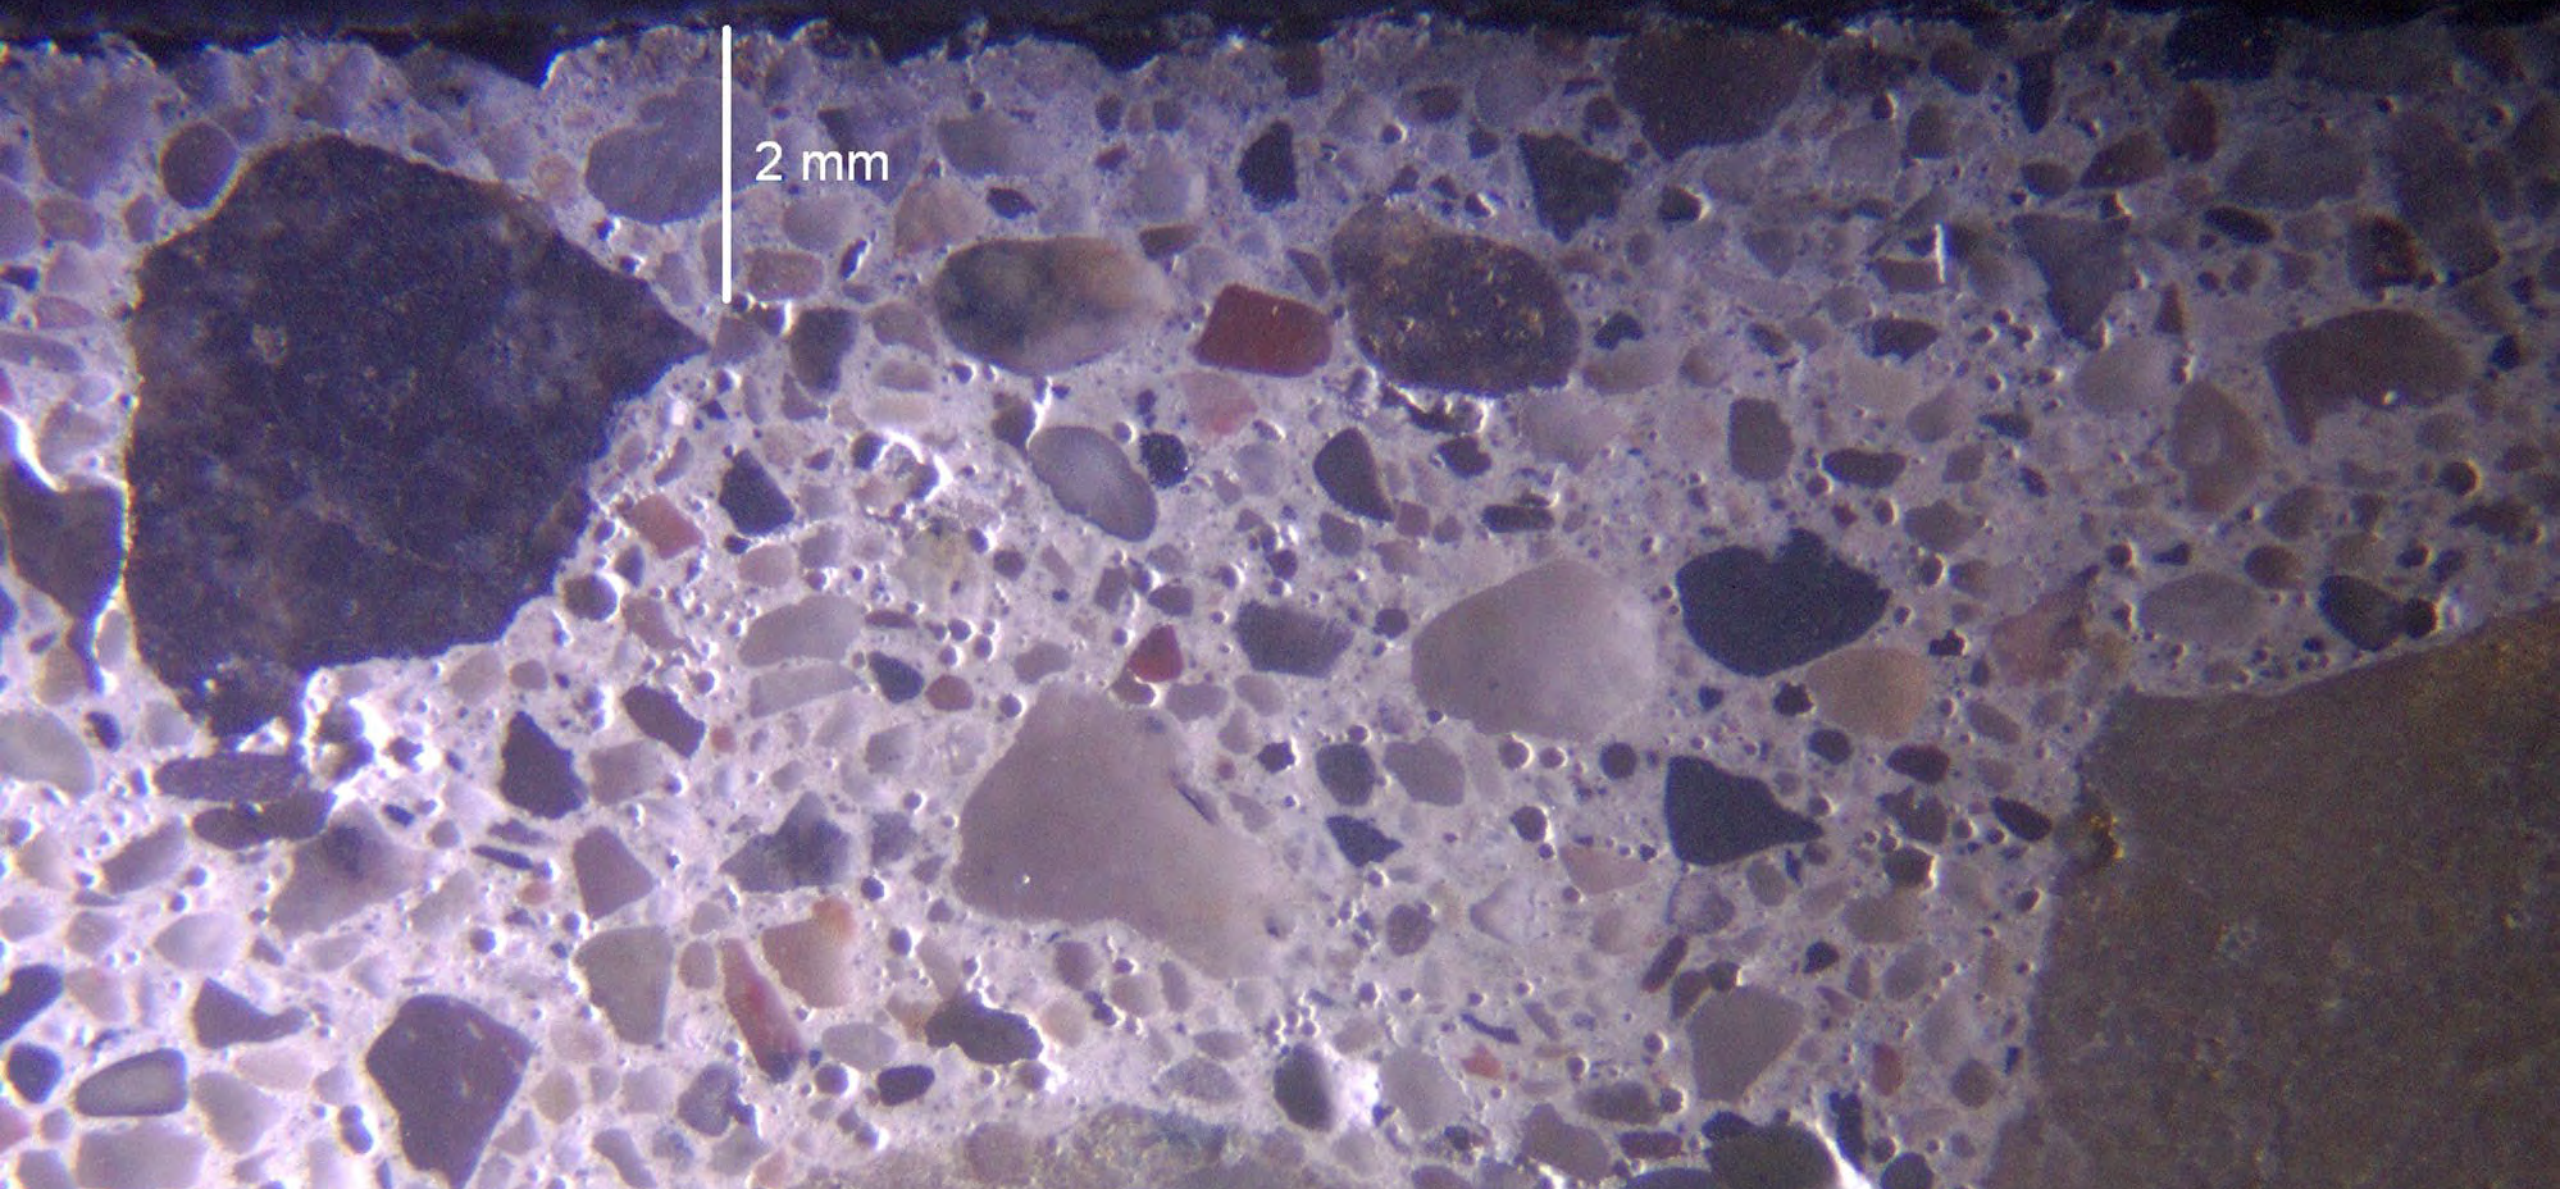
Over-finishing

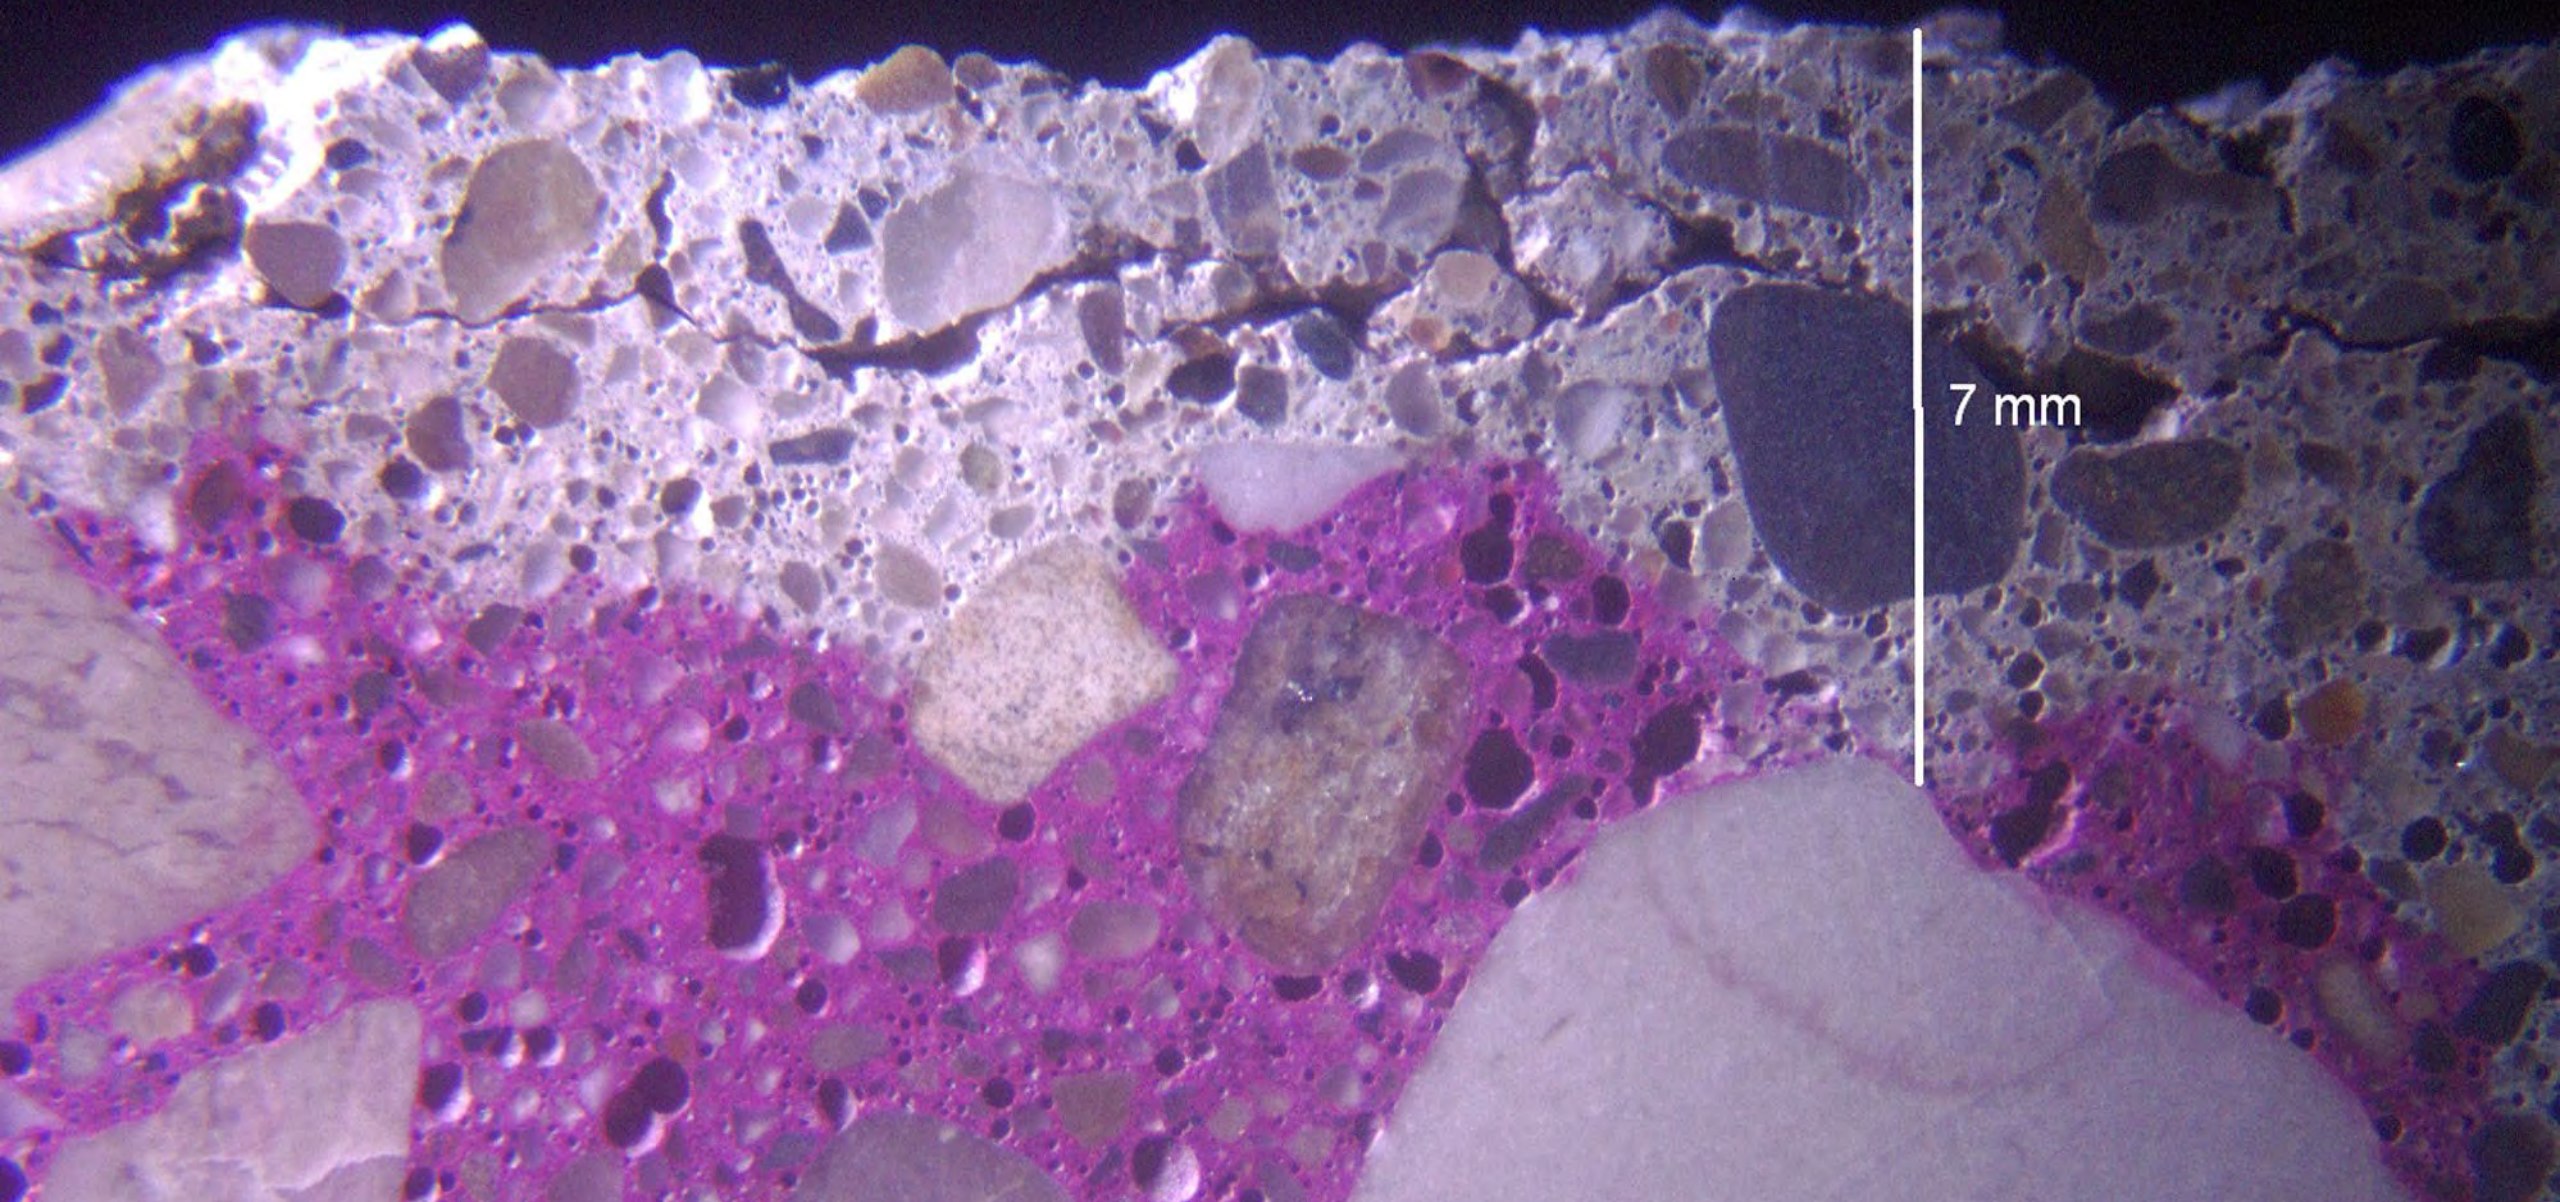
Carbonation and Scaling

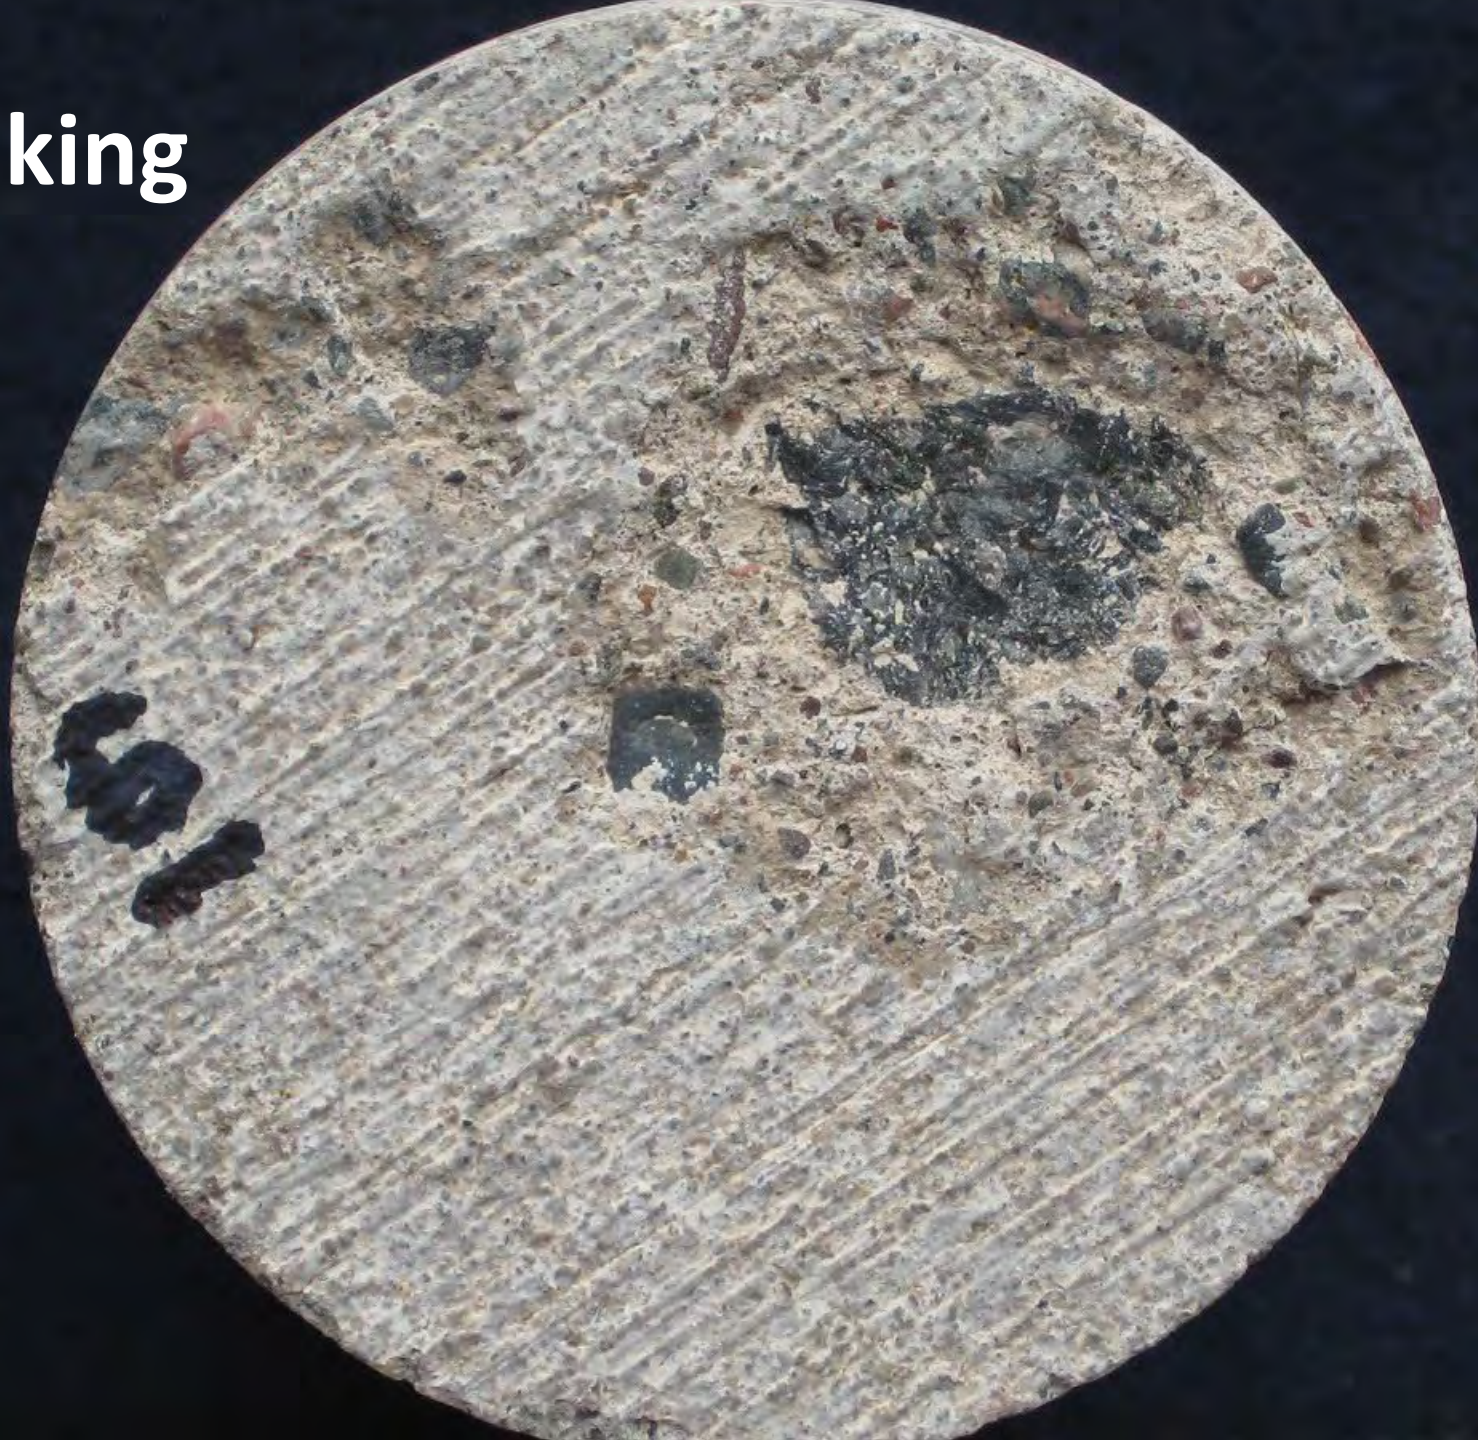
Mortar Flaking

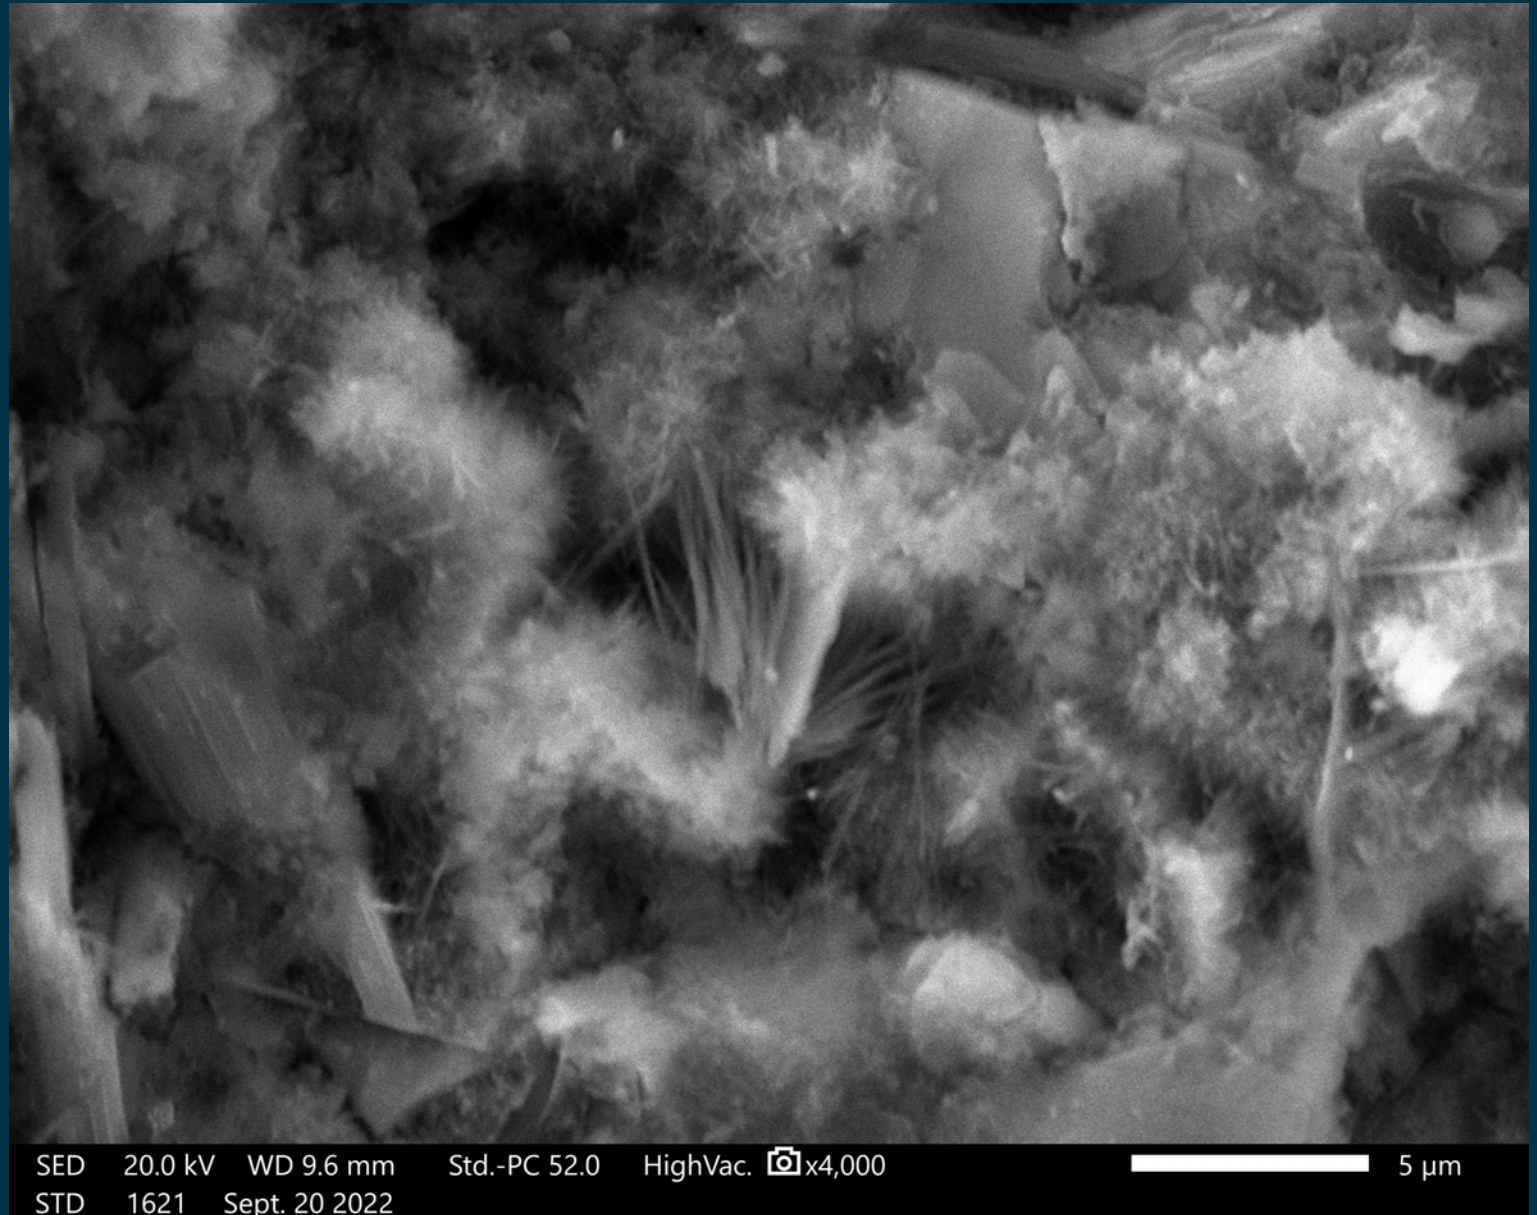
SEM ANALYSIS

OPC Paste

CSH (fuzzy)

Ettringite (needly)

Ca(OH)₂ (tabular crystals)

Pore solutions > pH11

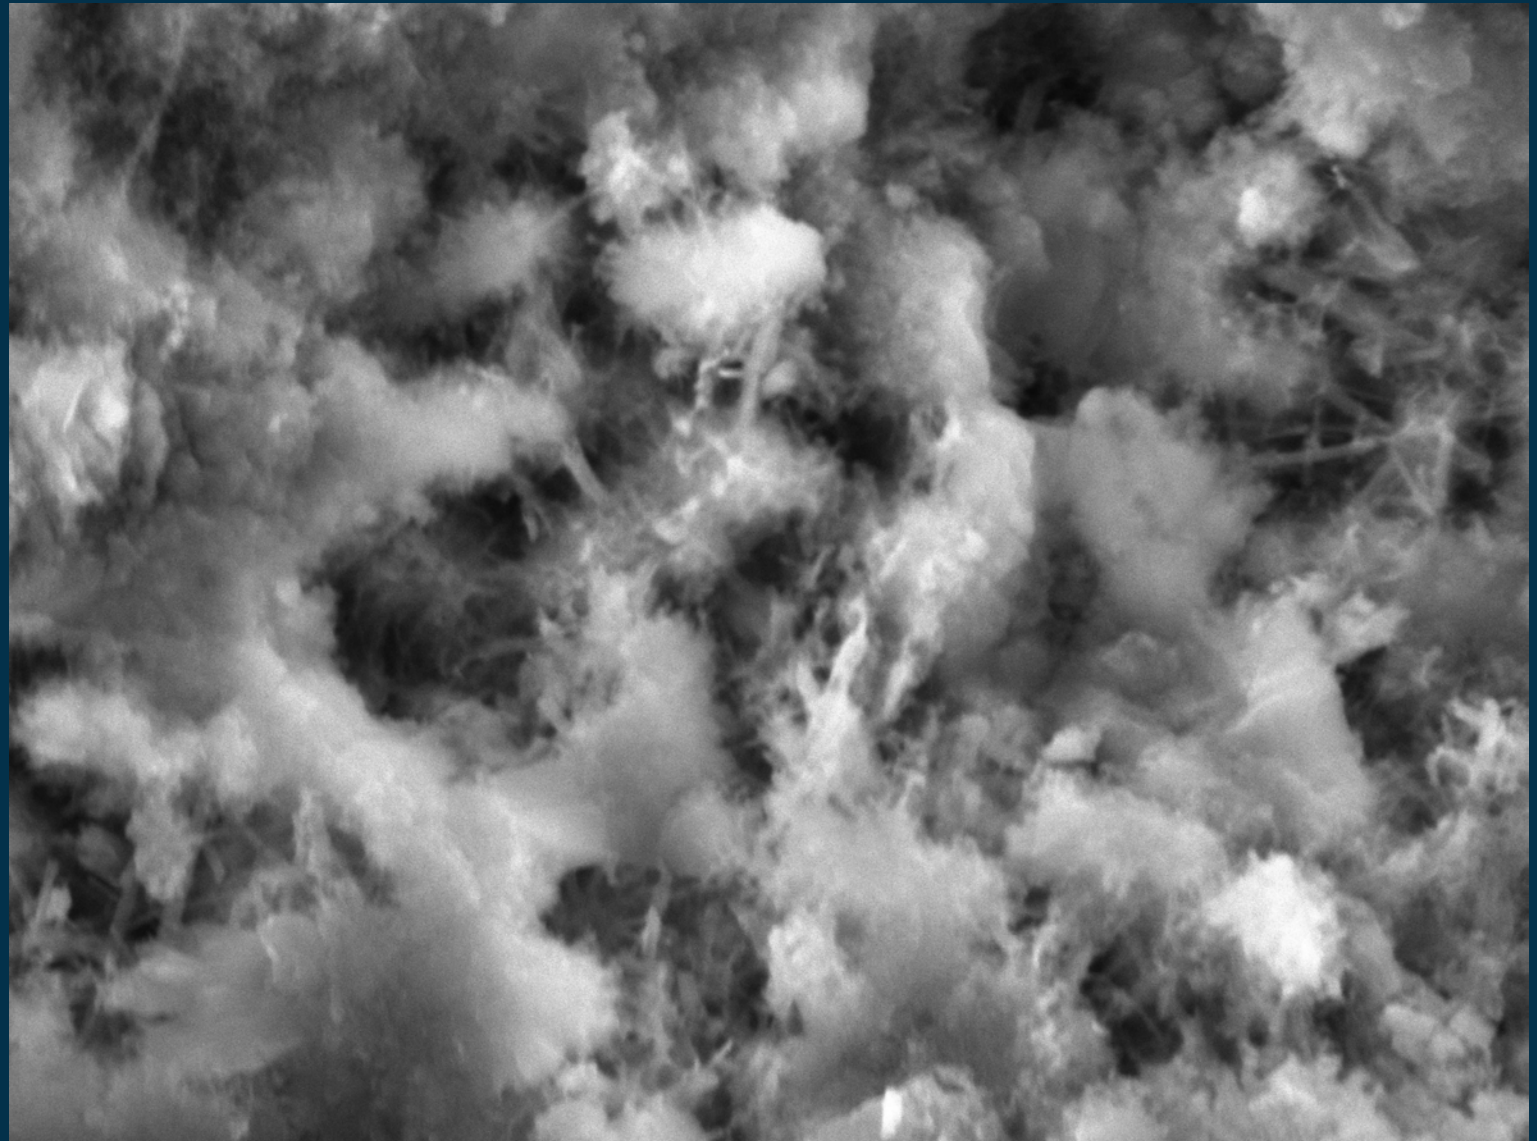
SEM ANALYSIS

Carbonated Paste

Completely different microstructure

CaCO₃ like material

..with residual Si, Al, Fe

Very little ettringite

Pore solutions close to neutral pH 7
