Troubleshooting Inadequately Cured Concrete or Why Did my Concrete Scale?

Iowa Better Concrete Conference

Gerard Moulzolf, PG

American Engineering Testing, Inc.

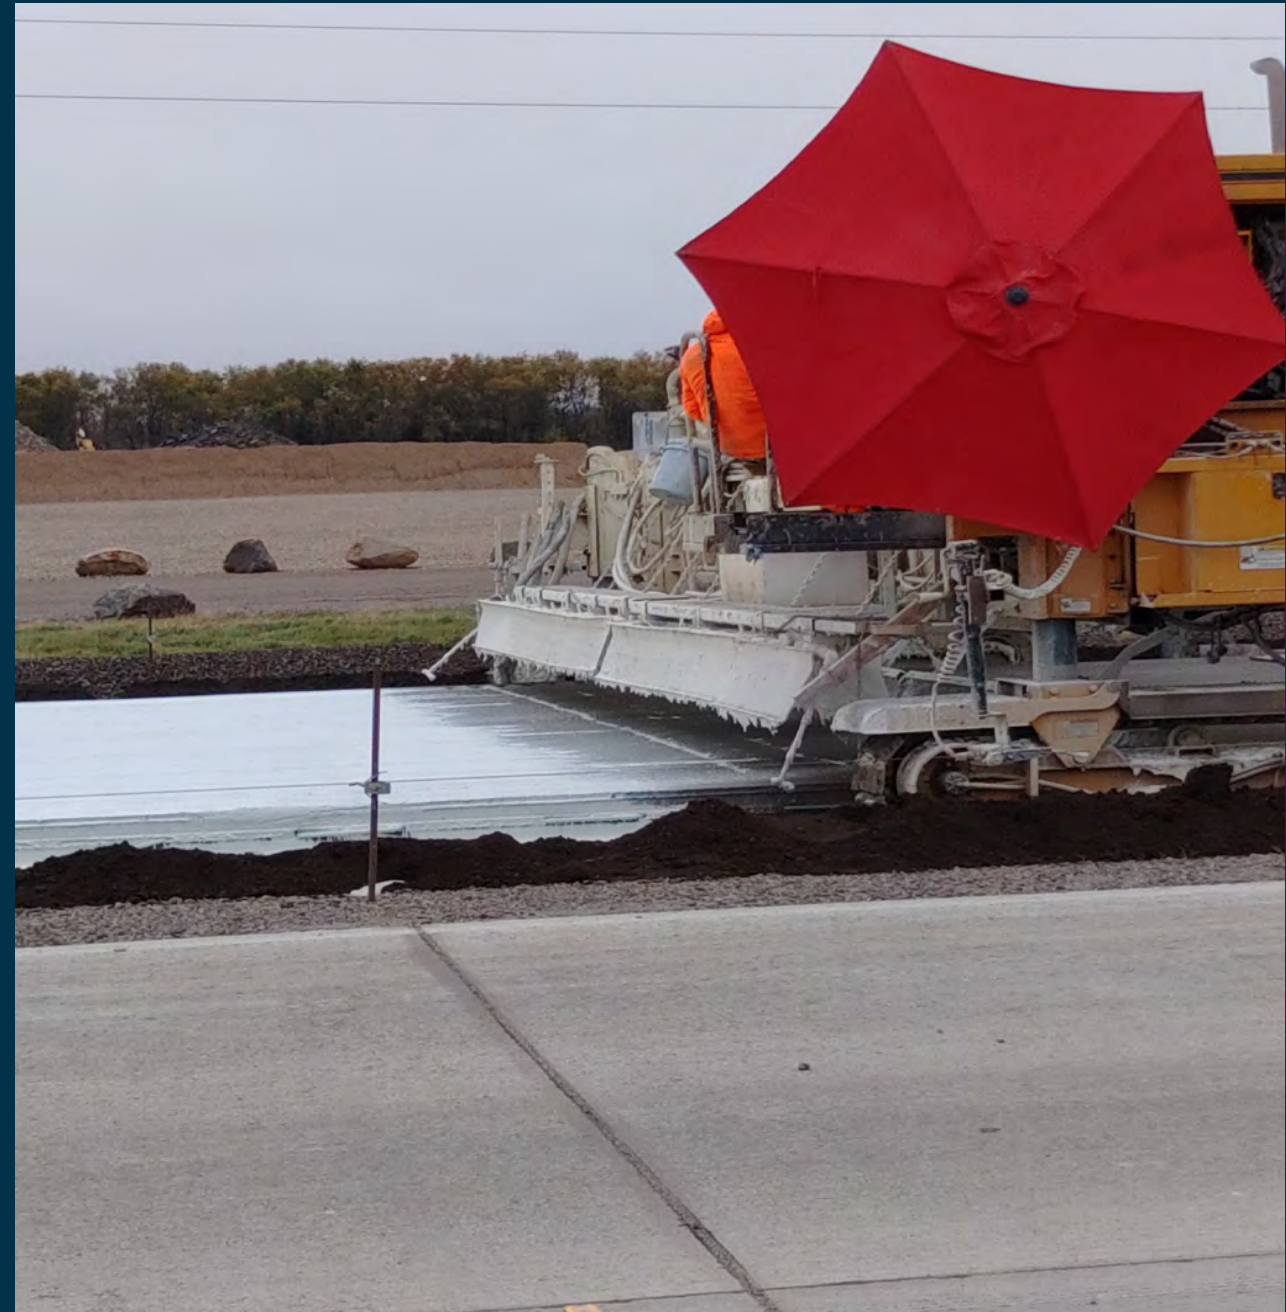
Heavy Civil Paving

Lower w/cm

Comprehensively enforced

Timely

Curing method

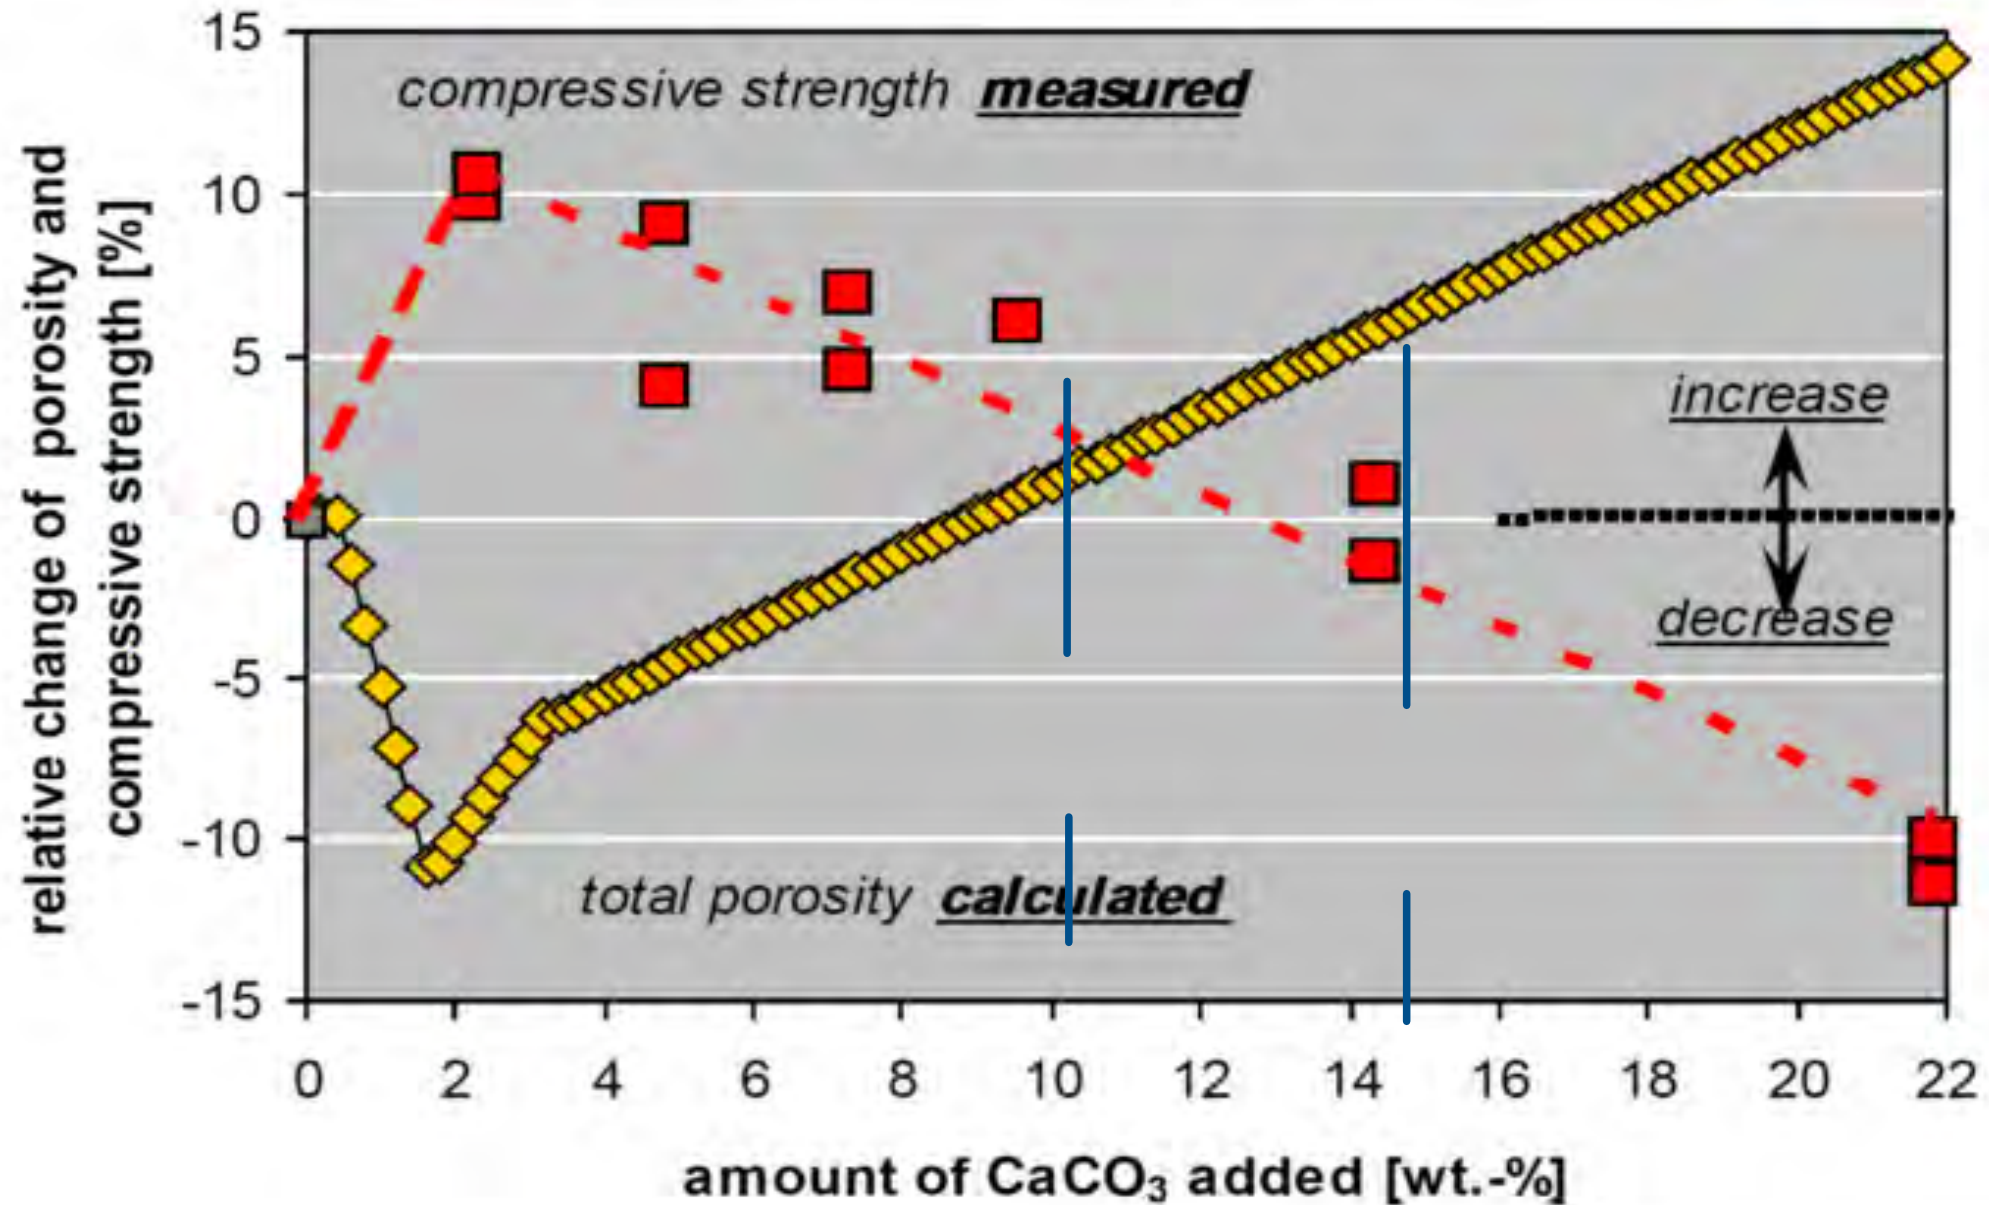
Correlation: Porosity – Compressive Strength (exp. Data by D. Herfort, Aalborg cement)
