DEER CROSSING SIGNS AND TECHNOLOGIES

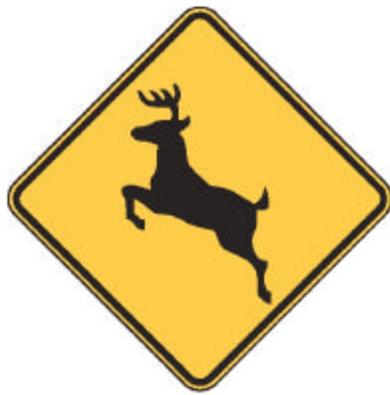
W11-3

One of the most widely used measures to reduce deer-vehicle crashes (DVCs) is the deer crossing warning sign (See Figure 1). The design of this sign is controlled by the *Manual on Uniform Traffic Control Devices* (MUTCD), and consists of a diamond-shaped panel with a black “Deer Crossing” legend or deer symbol and a yellow background (See Figure 1) (1).

FIGURE 1 Typical deer symbol crossing warning sign (1).

No research literature was found that specifically considered or quantified the DVC reduction and/or vehicle speed reduction impacts of typical deer crossing signs (See Figure 1). The deer crossing sign studies that were reviewed appear to be based on the general assumption that a typical deer crossing warning sign does not generally reduce vehicle speeds (one measure of warning sign effectiveness), and that the effectiveness of these signs needs to be improved in some manner.

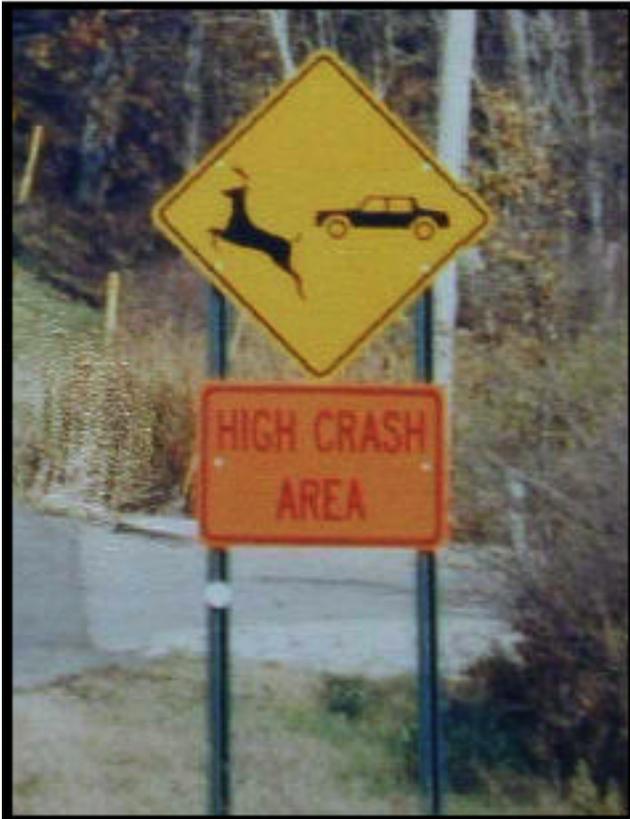
FIGURE 5 Michigan temporary deer crossing sign design (6).

The researchers in Michigan collected and compared DVC and vehicle speed data to evaluate the impact of the seven specially signed roadway segments (6). A comparison of two years of DVC data, however, showed no reduction in this type of crash after the signs were installed within either the entire township or along the roadway segments with

The seasonal use of specially designed deer crossing signs was also considered in two states (See Figures 4 and 5). Researchers in Utah installed signs during the mule deer migratory season, and observed reductions in vehicle speed and DVCs. However, researchers in Michigan investigated the impact of a different deer crossing sign design that was installed during the fall months (a “high” DVC and white-tailed deer movement time period), and generally found no significant reduction in DVCs or vehicle speed. The differences in these two studies include sign design, animal species, and apparently the general ability of drivers to appropriately assess the risk of a collision at a particular time and location. In Utah the familiarity of the drivers with the distinct migratory seasons and locations of the mule deer were believed to have had an impact on the sign effectiveness. It is proposed that more consistent and incremental studies may be needed to support or refute the speed- and DVC-reduction impacts of properly installed (i.e., at “high” DVC locations) deer crossing signs for both the existing and any proposed designs. An incremental approach (e.g., first add an additional text message, then reflectorized flags, and then amber flashing lights) may be necessary to determine what changes to deer crossing signs are the most effective. The appropriate use of temporary signs is clearly less expensive than some of other potential DVC countermeasures discussed in this toolbox.

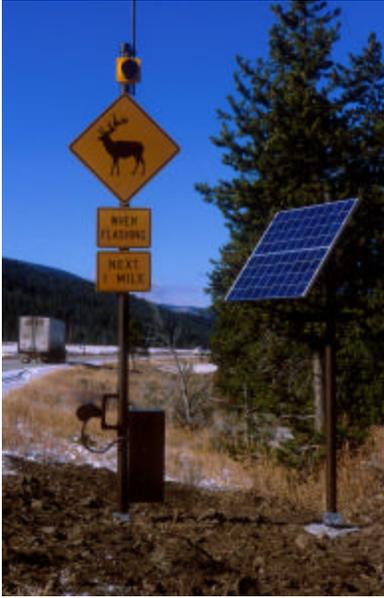
FIGURE 6 Dynamic elk sign and sensor system example (*Photo courtesy of the Western Transportation Institute*).

The research described previously investigated the impacts of enhanced deer crossing sign designs. If used, these enhanced signs are either constantly active or must be turned away from traffic. More recently, a number of dynamic sign and sensor systems have been proposed and/or installed. These systems typically alert the driver, through flashing lights for example, when an animal has been detected near the roadway. An example of some of the equipment used by one dynamic sign and sensor system is shown in Figures 6 and 7.

- In Minnesota, a dynamic sign and system has been installed at one location, and is planned for two other sites (8). The choice of locations was based on deer population and DVC data. The system uses an infrared light beam on both sides of the roadway to detect animal movement, and when these sensors are activated a battery-powered transmitter turns on amber warning lights on top of a series of traditional deer crossing signs (8).
- In Montana, the Western Transportation Institute has also installed and is testing a dynamic sign and sensor system that operates with radar beam sensor equipment connected to amber lights on traditional elk crossing and “When Flashing” sign installations (9). This is the system shown in Figures 6 and 7.

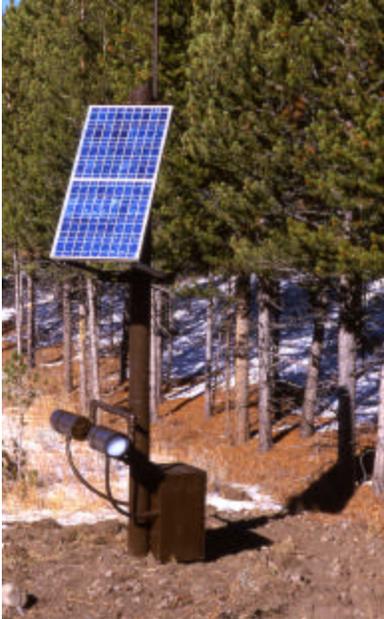
FIGURE 7 Solar powered animal sensors (*Photo courtesy of the Western Transportation Institute*).
