***ISU Spring Transportation Seminar Series
April 1, 2016***

**IMPLEMENTING SEISMICALLY ROBUST ACCELERATED BRIDGE
CONSTRUCTION in CALIFORNIA**

Mark Mahan, PhD, P.E.
Ron Bromenschenkel, P.E.

California Department of Transportation

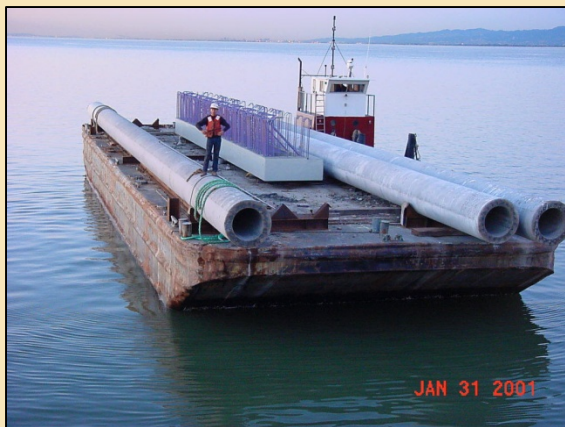
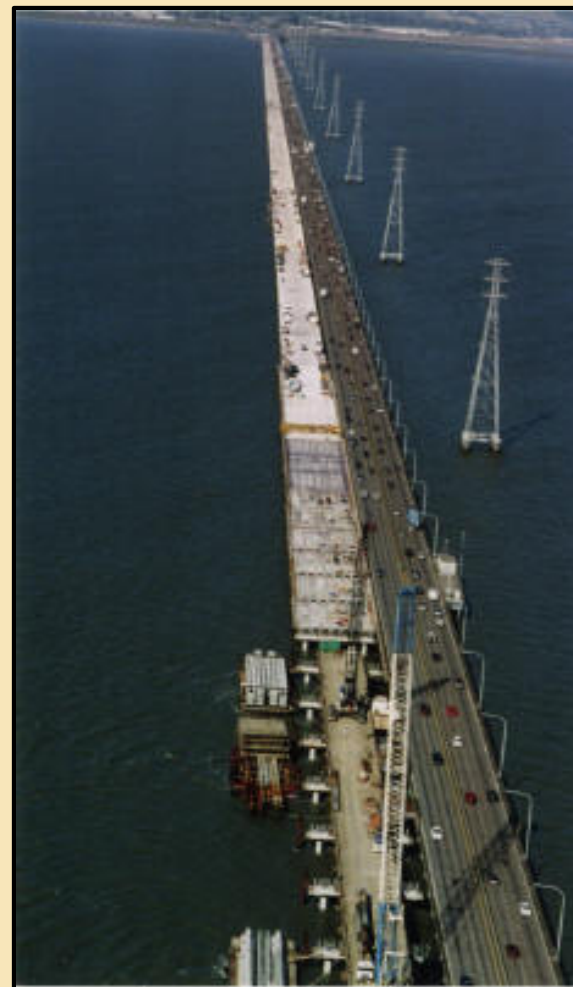
San Mateo-Hayward Bridge Widening (2002)

- Up to 270 feet of structure completed per week
- 5.15 mile long portion of south bay crossing
- PC Hollow Piles
- PC Cap Tubs
- PC Girders
- PC Deck Forms

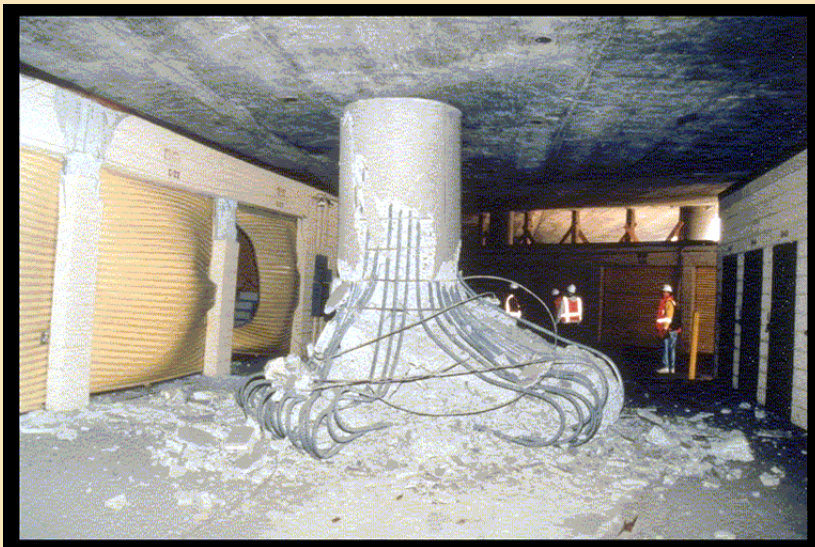
1971 San Fernando EQ: Collapse of multiple structures including Route I-5/I-405 Separation Structure resulted in a drastic increase in “**Confinement**” reinforcement in columns.

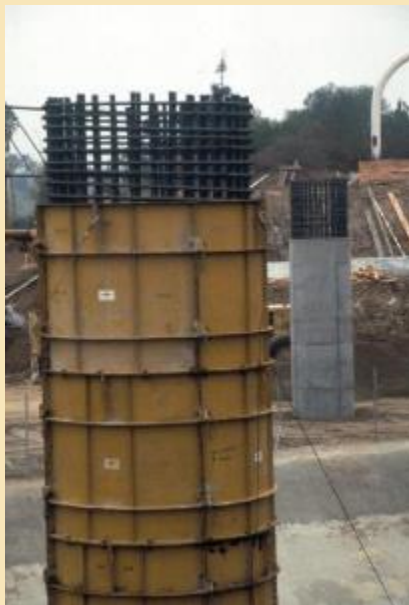
Caltrans' pre- 1971 columns,
1994 damage.

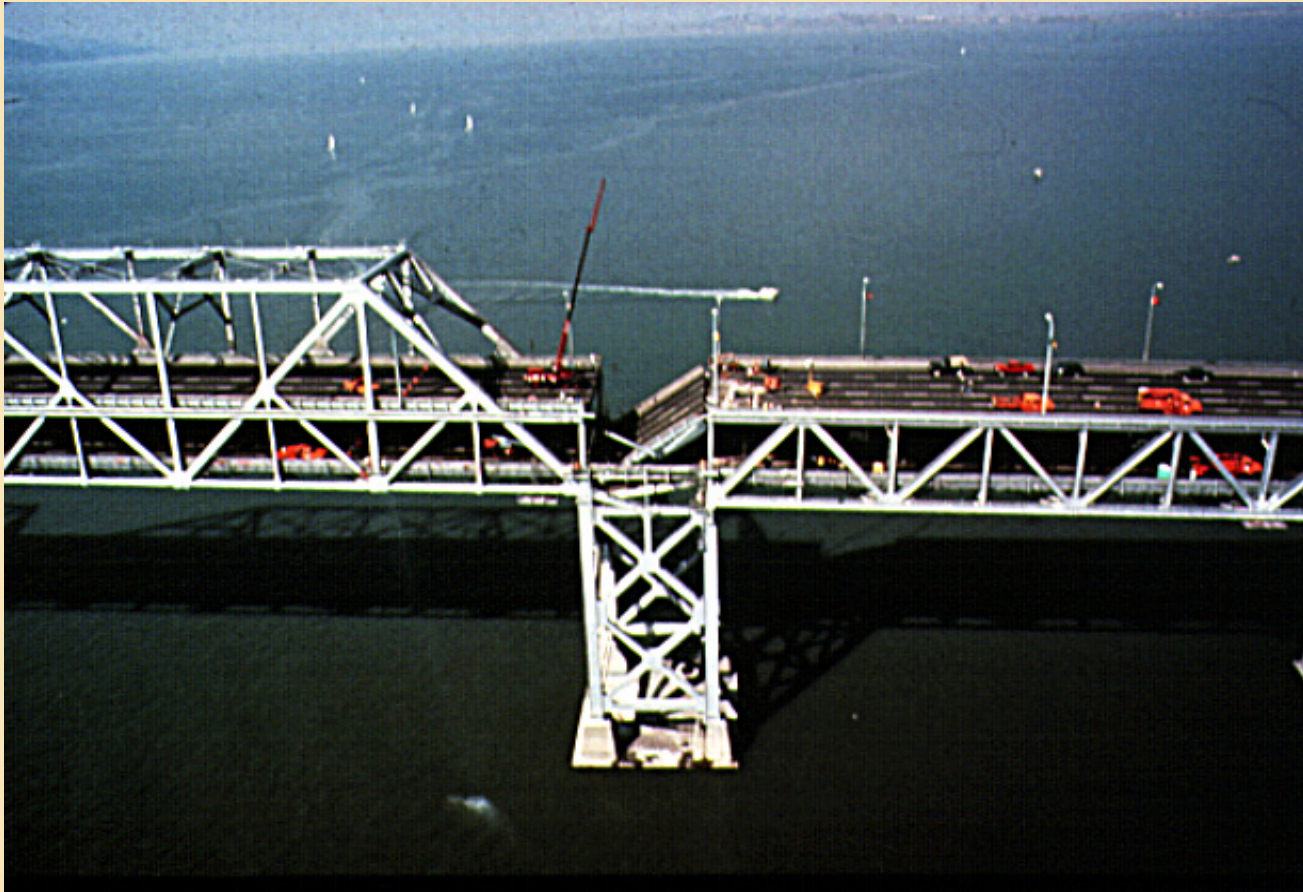
1989 Loma Prieta Earthquake: The San Francisco-Oakland Bay Bridge lost a deck segment due to insufficient hinge seat.

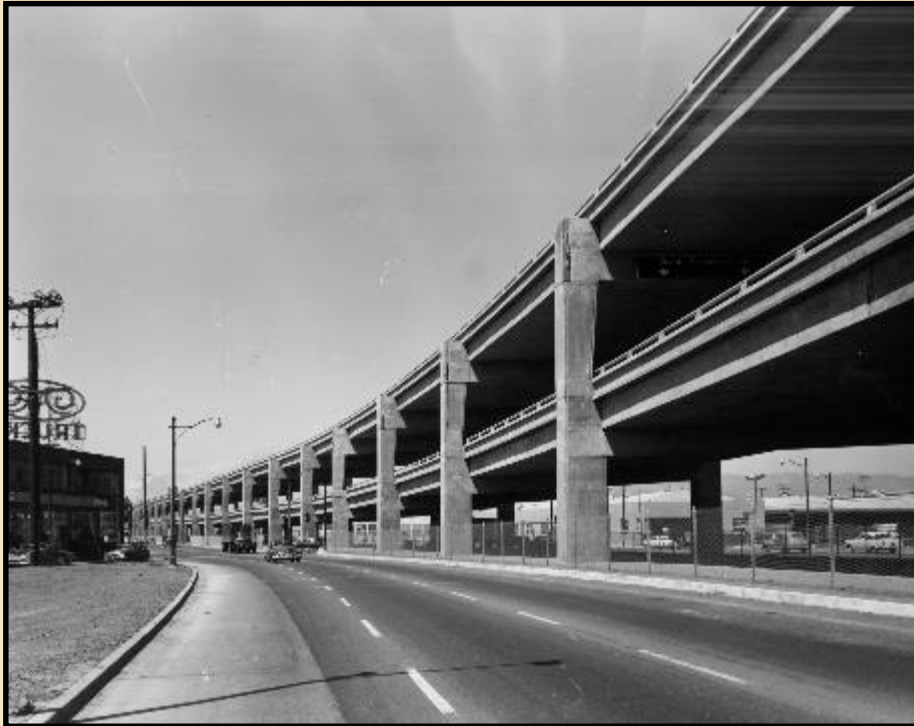
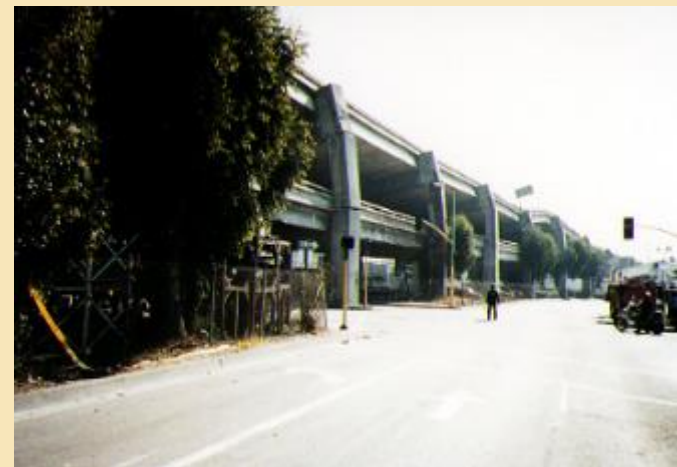
1989 Loma Prieta Earthquake: The Cypress Viaduct collapsed partly due to excessive joints in the structure

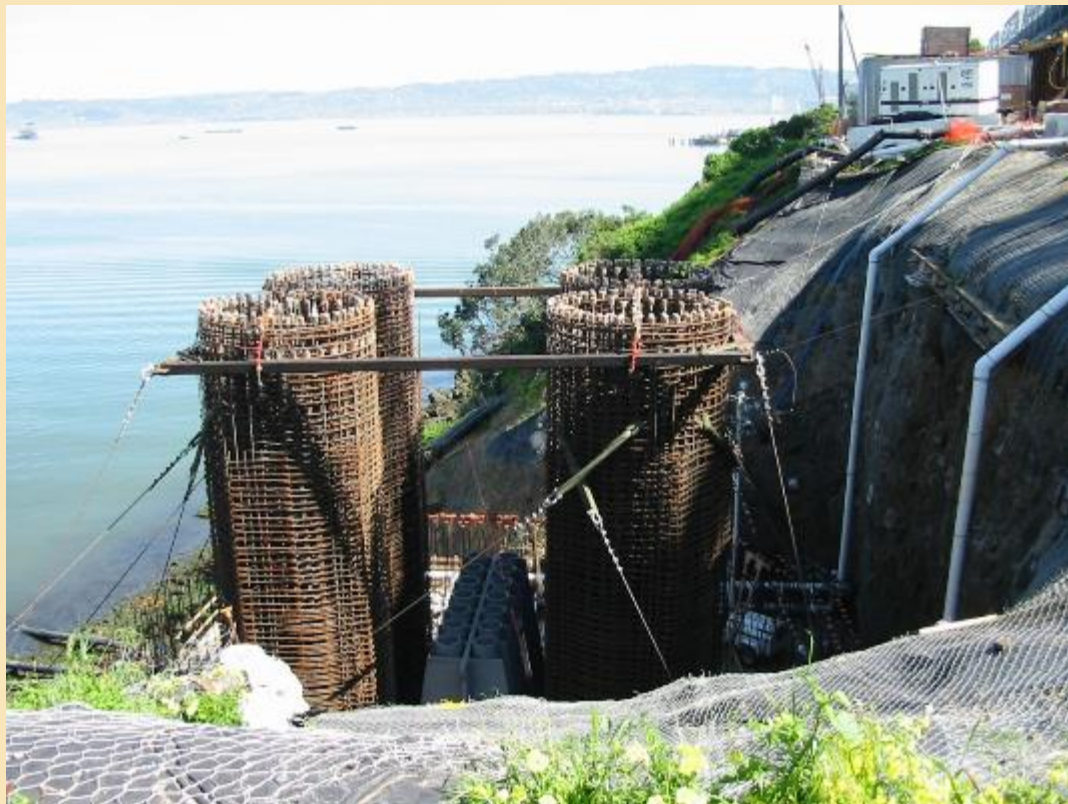
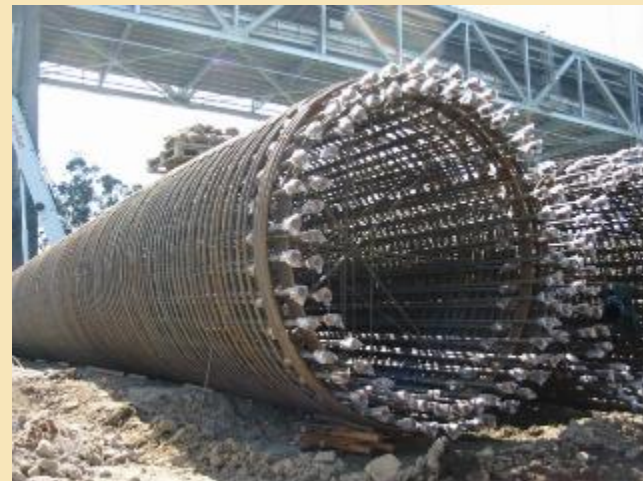
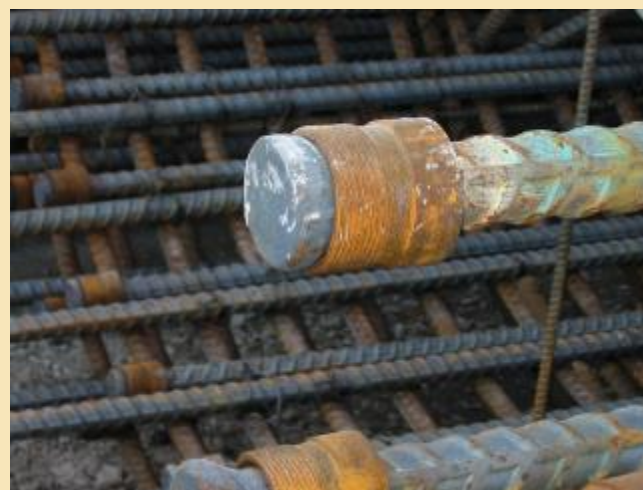
Caltrans' columns and shafts, new construction

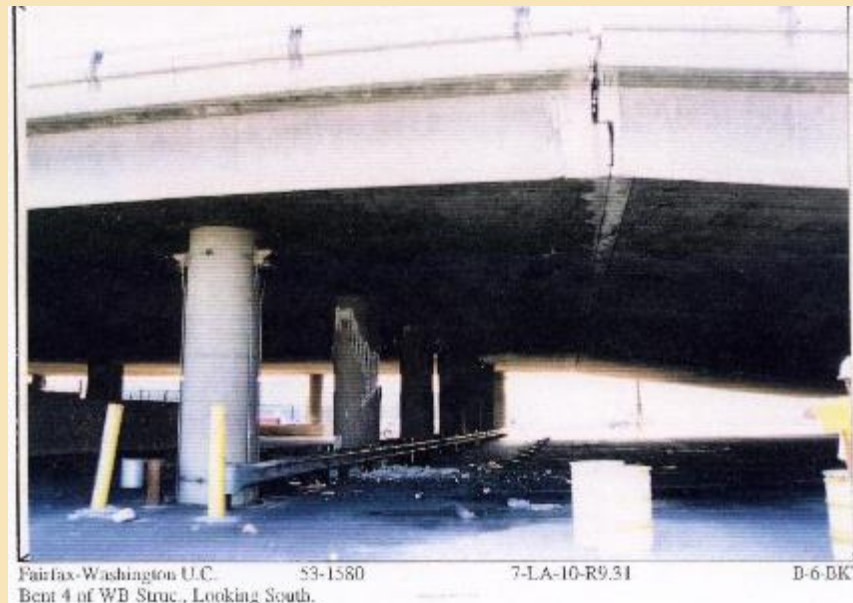
Caltrans' hinge seat, before 1971

- Caltrans' SDC 7.2.5.4 and 7.8.3
Equation 7.5, *minimum 24"* seat width for in-span hinges and Equation 7.46, *minimum 30" at abutments*.
- Caltrans' Cast-In-Place, post-tensioned box girder bridges have excellent continuity and framing. They meet the SDC requirements.
- Do Pre-Cast bridges meet the continuity requirements?

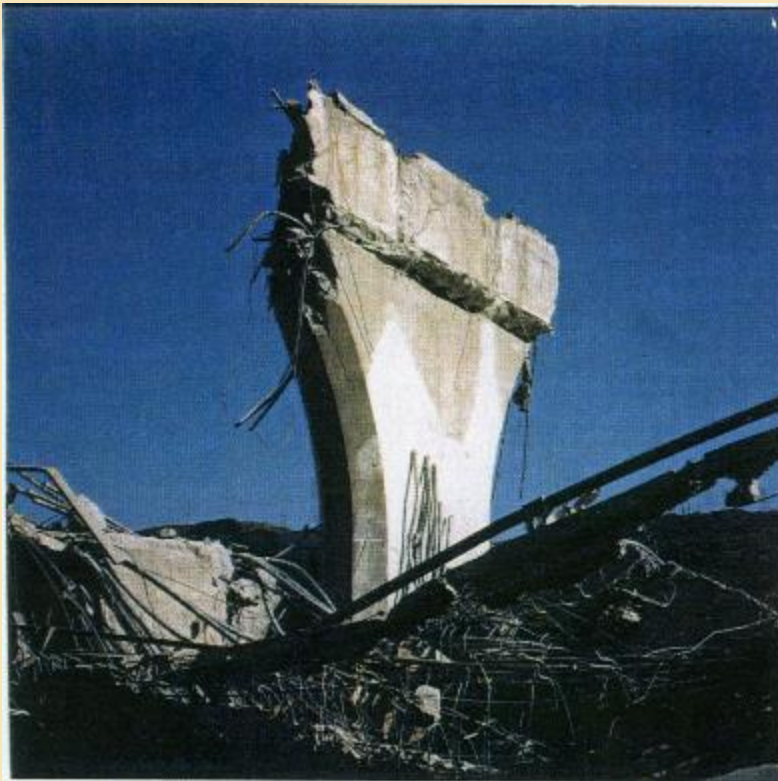
Route 14/Interstate 5 Interchange
Collapsed Connectors 53-1964F & 53-1960F

1994 Northridge Earthquake: I-5/SR-14 collapse, lack of stiffness and mass “*Balance*” from bent to bent.

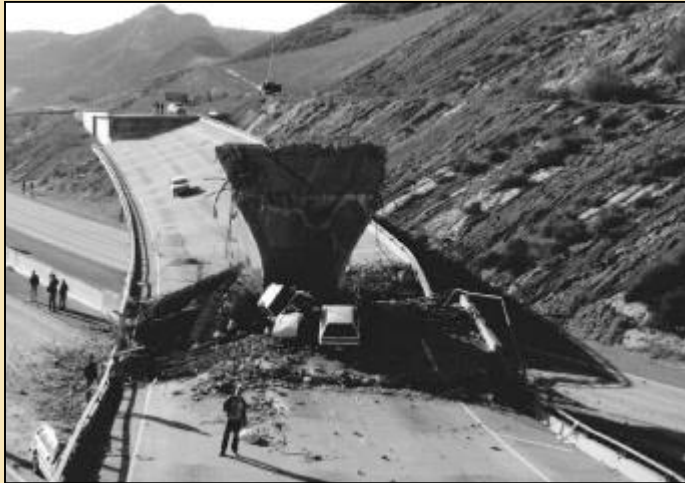
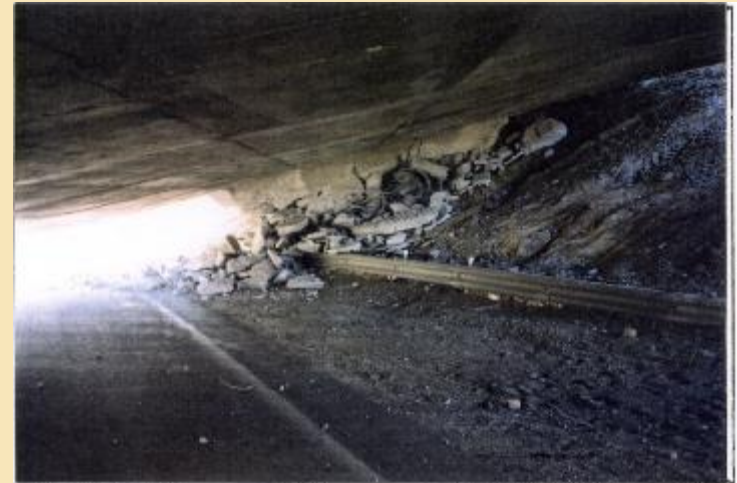
1994 Northridge Earthquake: I-5/SR-14 collapse.

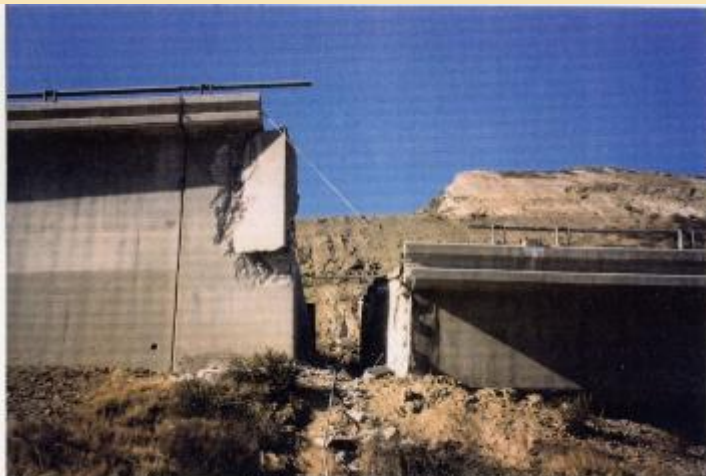
14/5 Conn. Sep. & OH 53-1960F 7-LA-14/5-R14.73/R45.62 4-23-RLM
Pier 2.

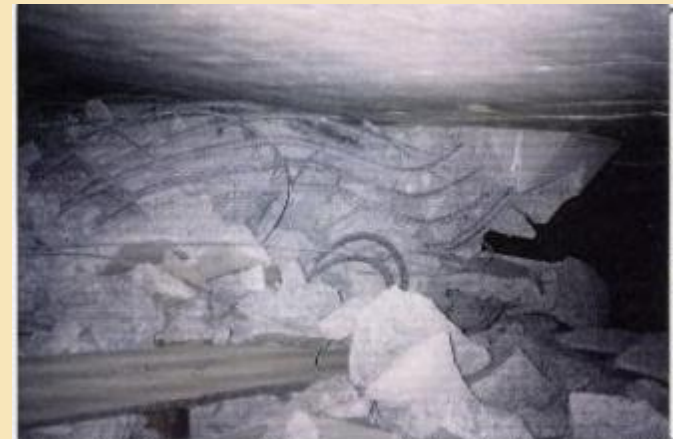
14/5 Conn. Sep. & OH 53-1960F 7-LA-14/5-R14.73/R45.62 3-26-JSM
Abutment #1.

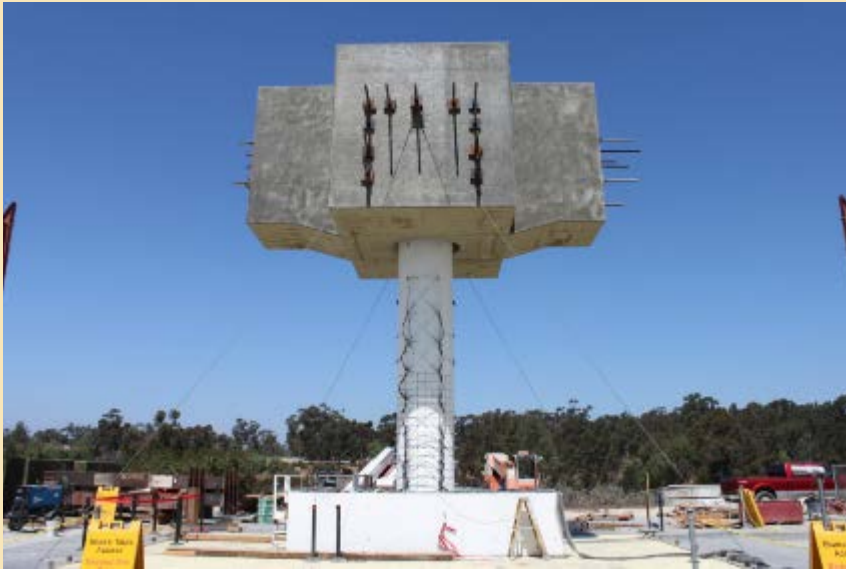
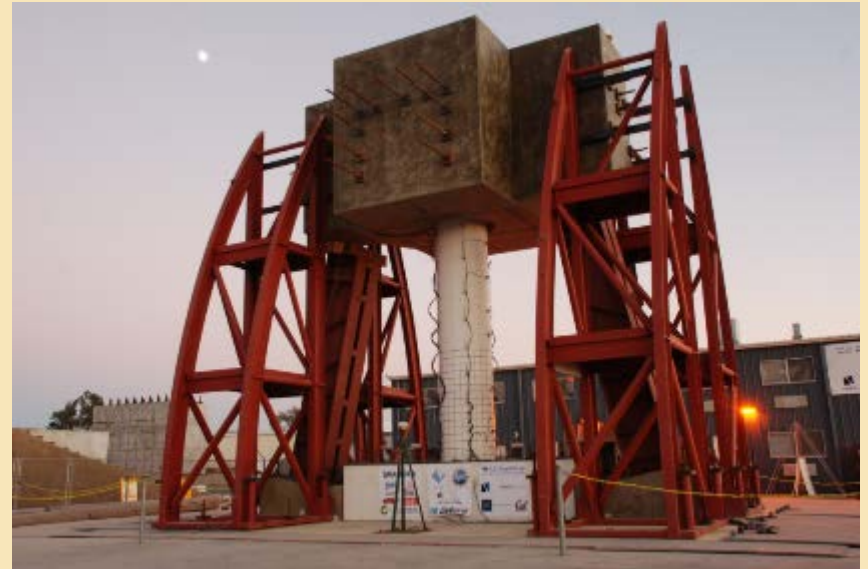
UCSD 4-foot Diameter Column Test

Test ID EQ	Record	Magnitude	Scale	Table PGA	Target Ductility
2	Loma Prieta 1	6.9	1.0	0.409	2
3	Loma Prieta 2	6.9	1.0	0.526	4
5	Kobe-Takatori	6.9	-0.8	-0.533	8
7	Kobe-Takatori	6.9	1.0	0.646	?
8	Kobe-Takatori	6.9	-1.2	-0.829	?
9	Kobe-Takatori	6.9	1.2	0.819	?
10	Kobe-Takatori	6.9	1.2	0.851	?

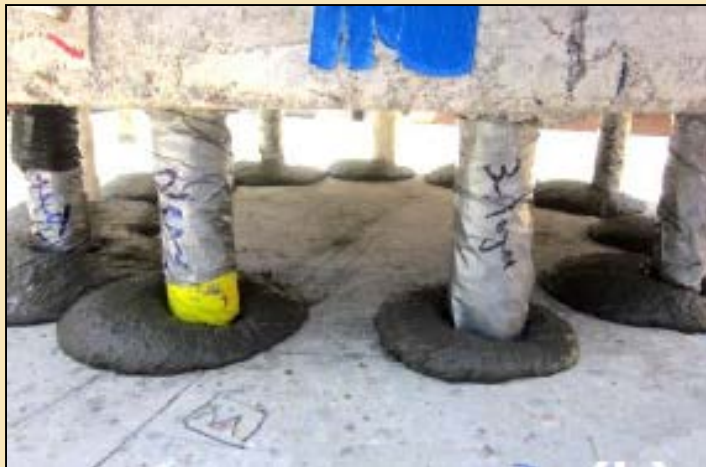
ABC Column Connection Research

PC Column with partially debonded bars plunged into UHPC filled voids

Testing at University of Nevada, Reno

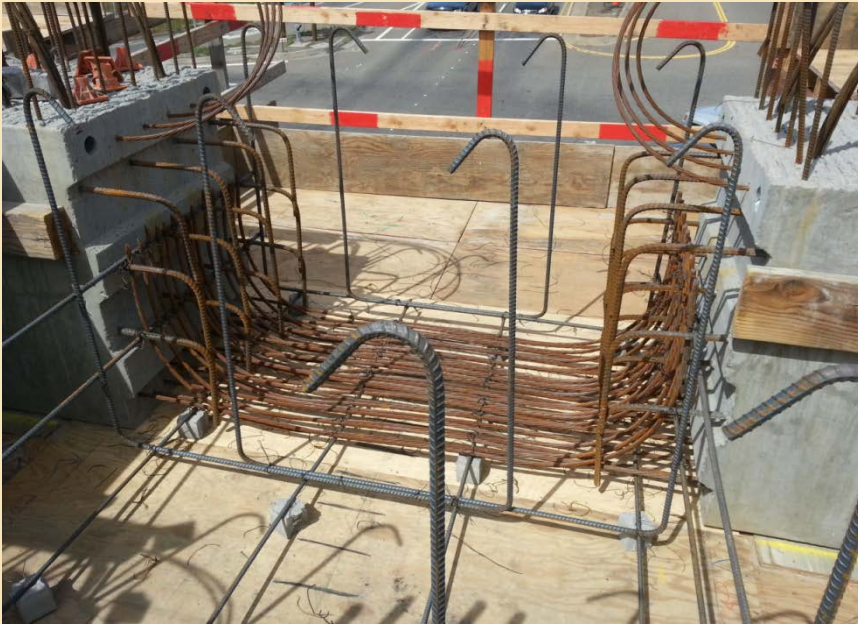
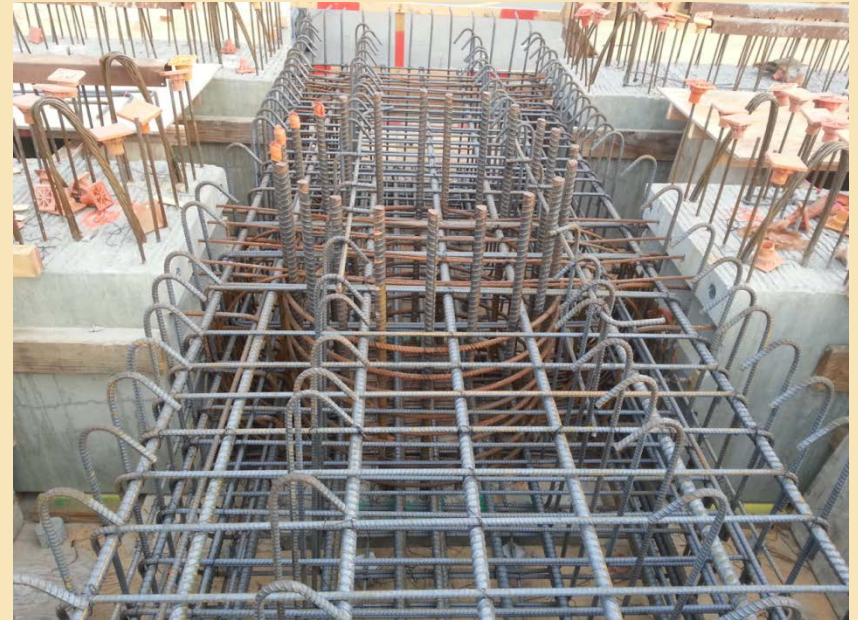
PC Girder Continuity Hwy 50, El Dorado Hills, CA (2013)

Strand tails lapped and hooked, then tied into place for longitudinal continuity
