History of Structure Inspection Program Development in the U.S. and the World

By Terry Browne, P.E. Collins Engineers, Inc. January 16, 2004 Columbia, Missouri Midwest Transportation Consortium

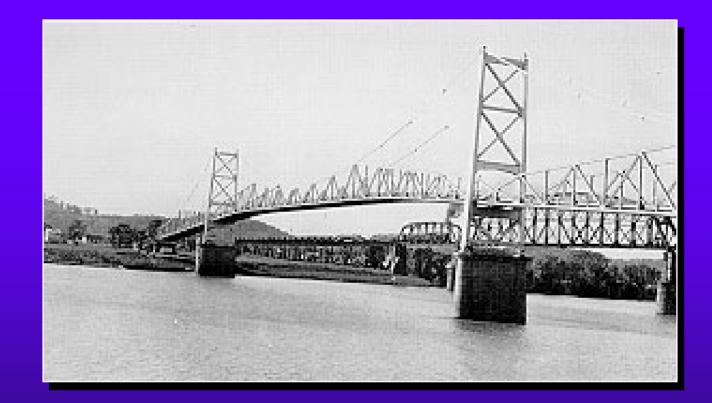
December 15, 1967

Silver Bridge Collapsed
Ohio River at Point Pleasant, West Virginia
46 people killed

This Catastrophic Failure Focused National Attention on Bridge Safety December 15, 1967

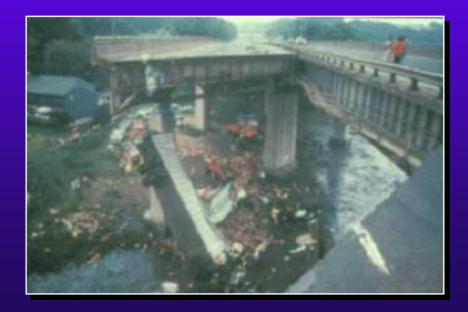
Mianus River Bridge Collapse

- Pin and hanger failure
- Collapse of main span carrying I-95 in Connecticut
- Several fatalities
- Disruption of traffic for months

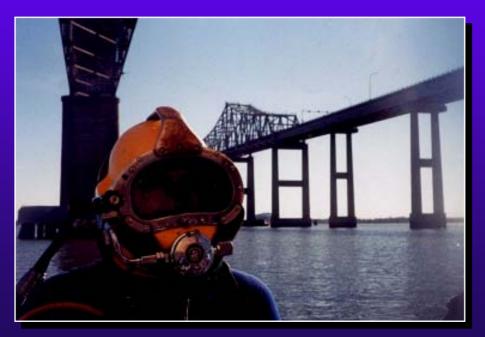
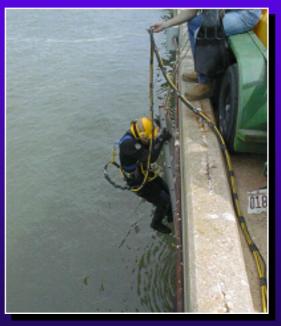
Collapse of the U.S. Route 43 Bridge

- Occurred in April of 1985
- Over Chickasawbogue Creek Mobile, Alabama
- Lead to FHWA issuance of memo stressing
 - The importance of Underwater Inspections
 - Ordering steps to ensure each state has a wellfounded underwater inspection program

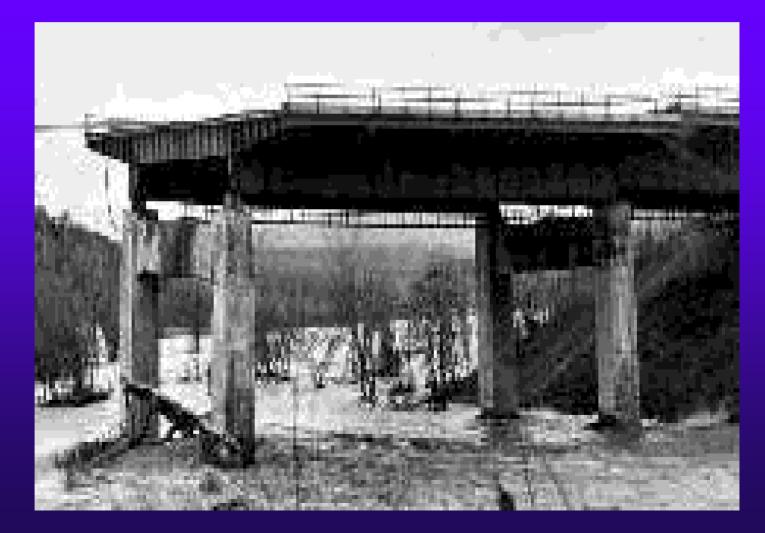
New York's Schoharie Creek Bridge Collapse April 1987

Schoharie Creek Bridge Collapse

- Center Pier Scour Failure
- Collapse of Main Span Carrying I-90 in New York
- 10 Fatalities and Significant Disruption of Traffic
- "Inspection 1 Week Earlier Did Not Detect Scour Due to Silt Infilling."

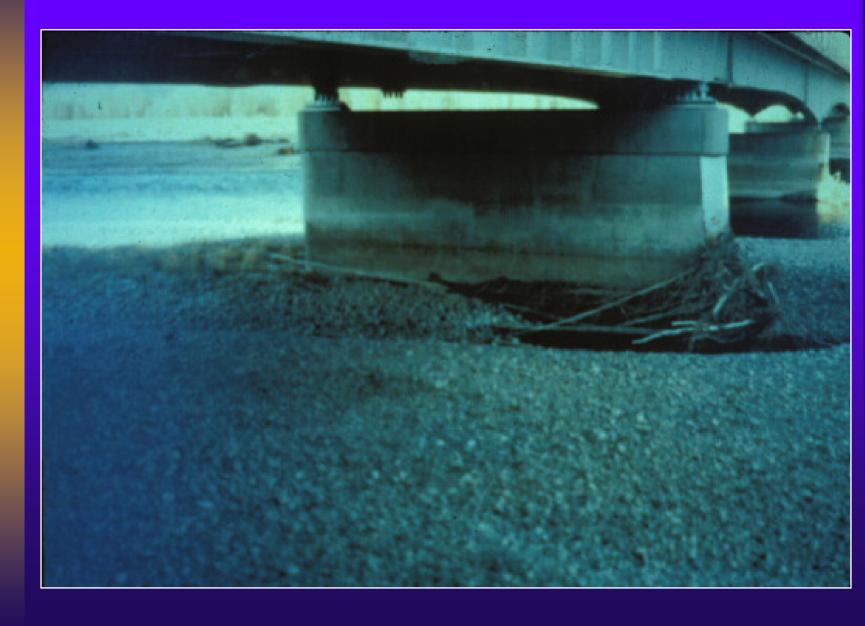
Scour (Cont'd.)

Excavating and Carrying Away Material From the Bed and Banks of Streams and Rivers.

The Result of Erosive Action of Running Water,

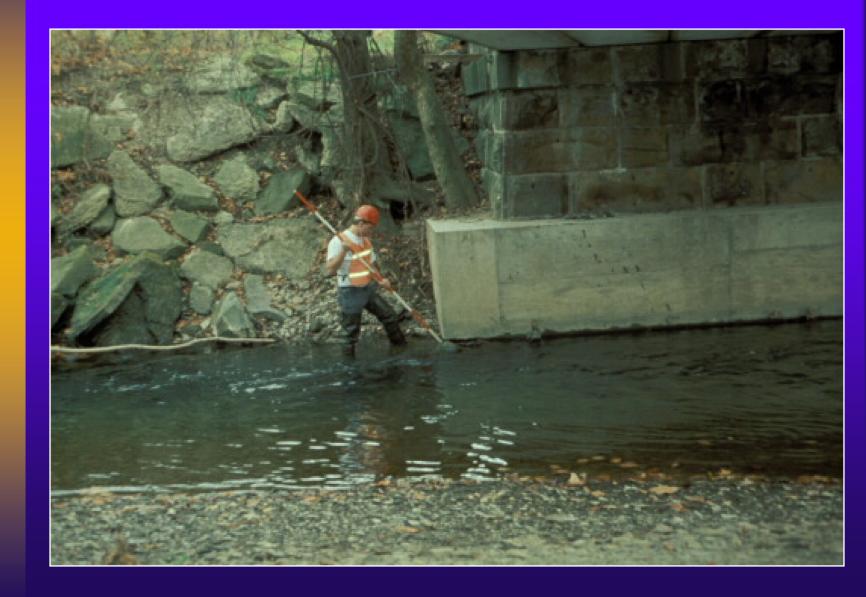
Lead Lines and Sounding Poles

Disadvantages of Simpler, Traditional Methods

- Extensive Note Taking
- Current Problems
- Depth Limitations
- May be Misleading

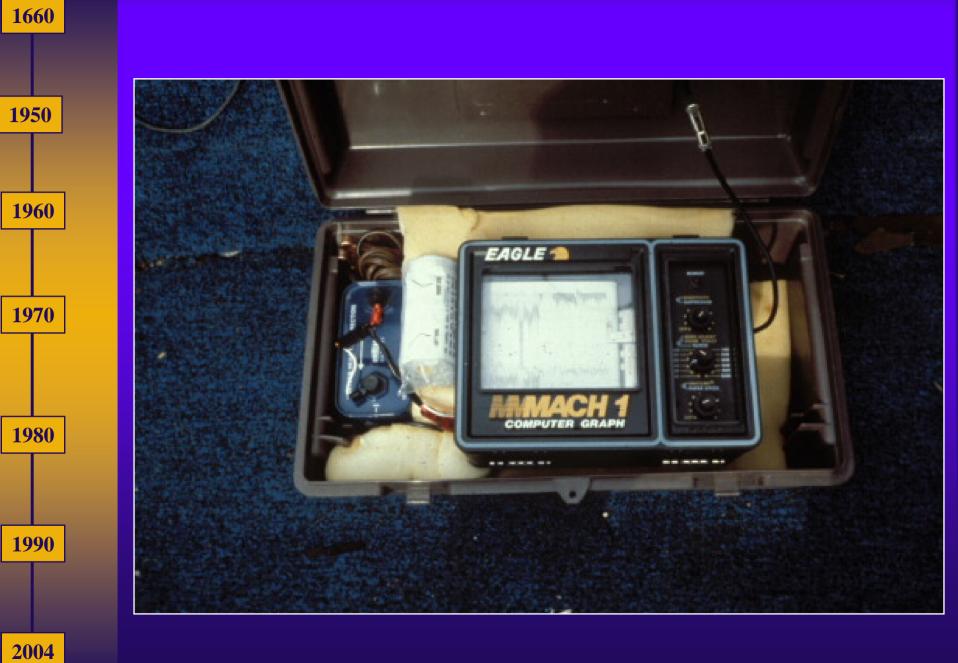
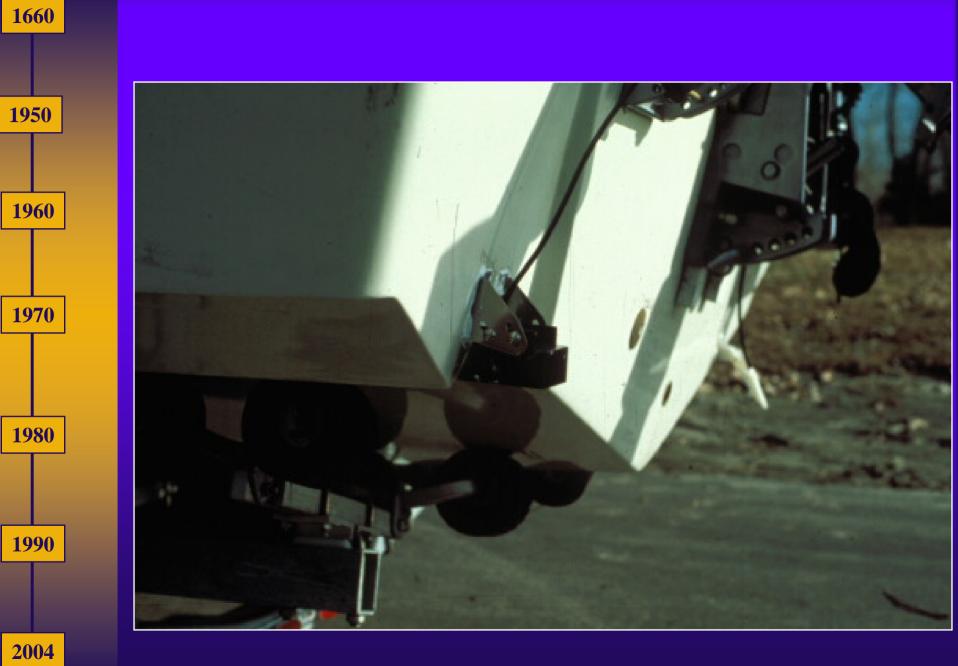
Depth Sounders

- Sonar (50KHZ & 200KHZ)
- Black & White Chart Recorder
- Various Transducer Angles
- Simple to Elaborate Equipment (\$500 - \$15,000 +)

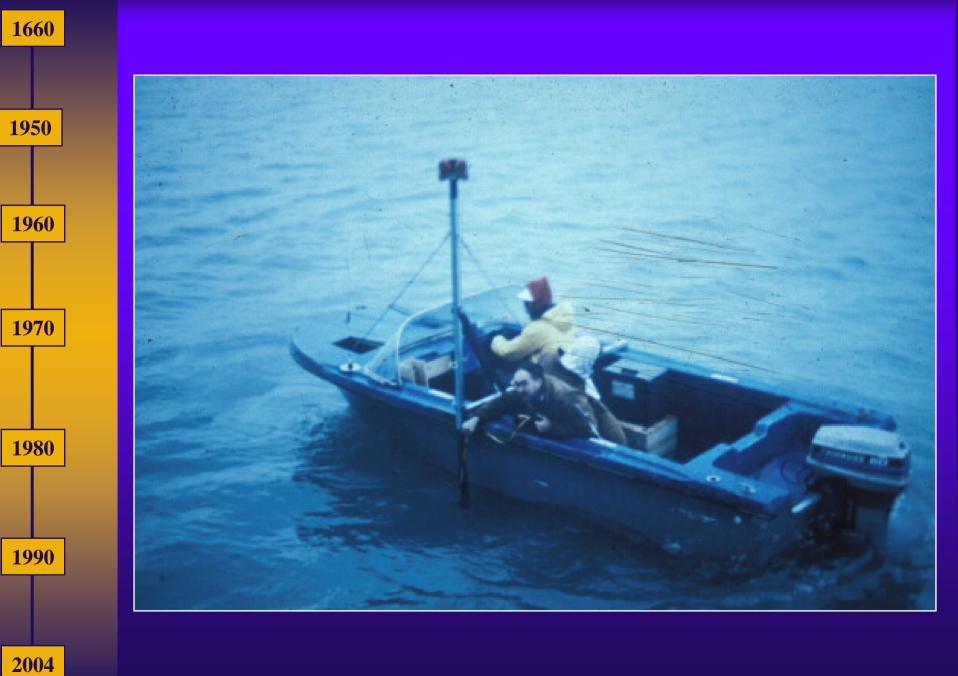
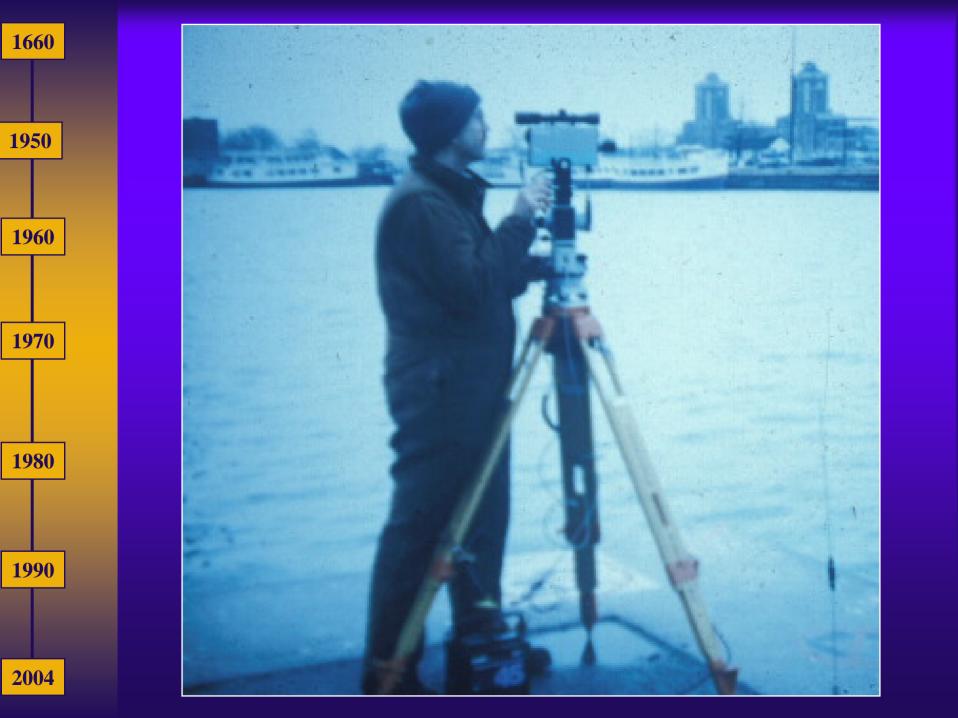
Soundings

- Plot Plan
- Plot Cross Sections

+ Channel Bottom
 + Foundations
- Plot Historical Record

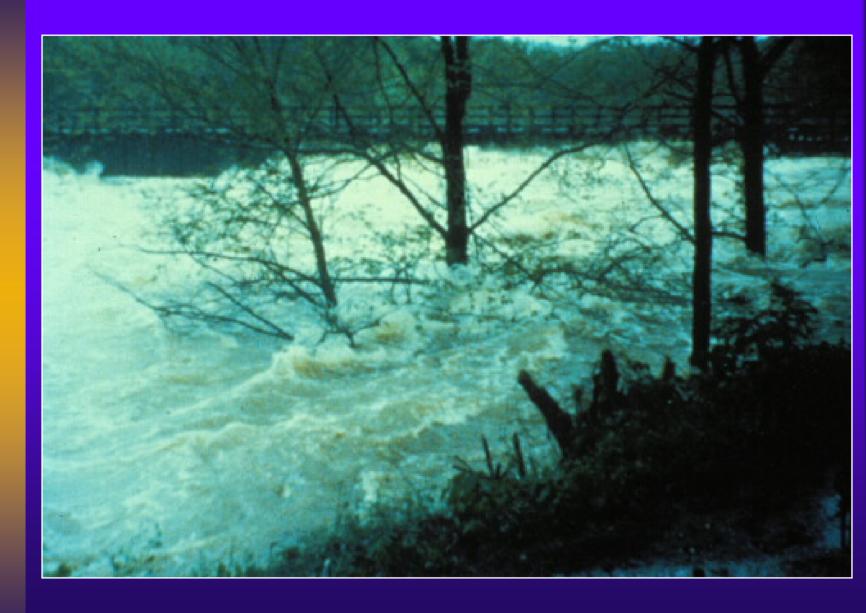
Scour Can Only be Measured With Certainty During High Flood Events; Infilling may Occur During Lower Flows

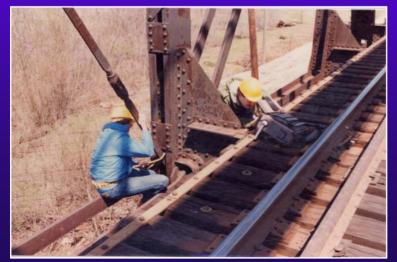
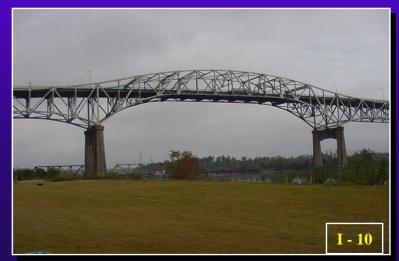
Hatchie River Bridge Collapse

- April 1989 Covington, Tennessee
- 8 fatalities
- Disruption of traffic

- Illustrated critical importance for Underwater Bridge Inspections
- Focused attention on taking appropriate corrective action when deficiencies are discovered

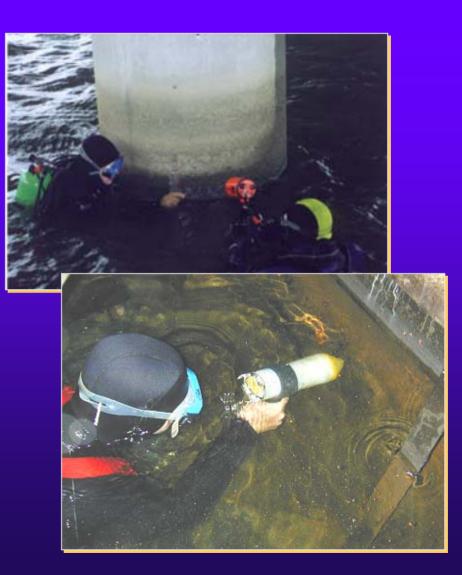
Underwater Structural Deterioration

- Level I
 Visual; Minimal Cleaning
- Level II
 Limited Cleaning & Measurement
 - Level III High Detailed; NDT
