Instrumentation and Monitoring of Precast Prestressed Concrete Pavement

Vellore S. Gopalaratnam

University of Missouri-Columbia

Transportation Seminar

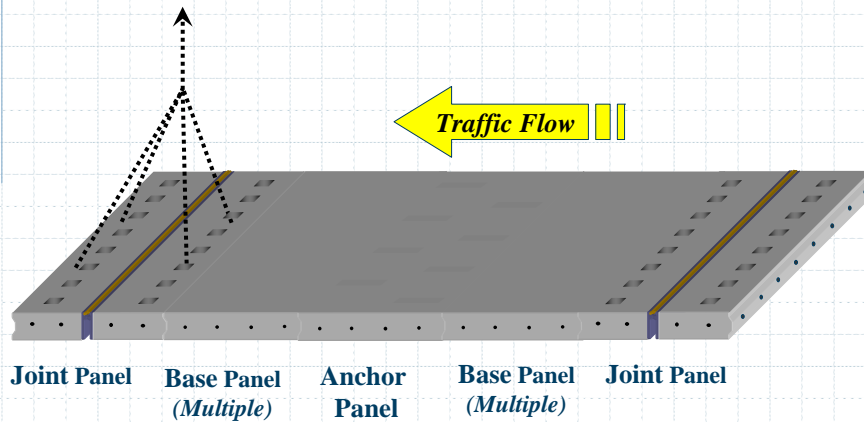
Pavement Design

- Comprises three panel types: joint, base, and anchor panels

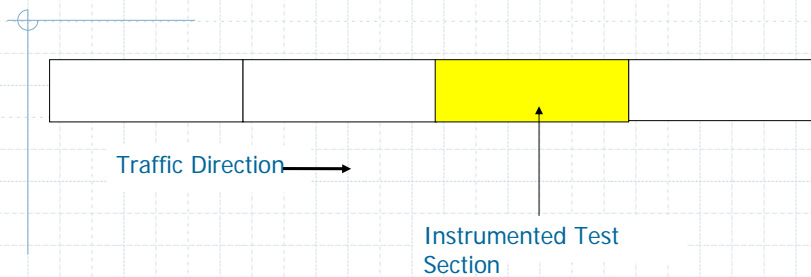
Precast Sections

- Divided into four – 250' sections
- Each 250' section was post-tensioned together

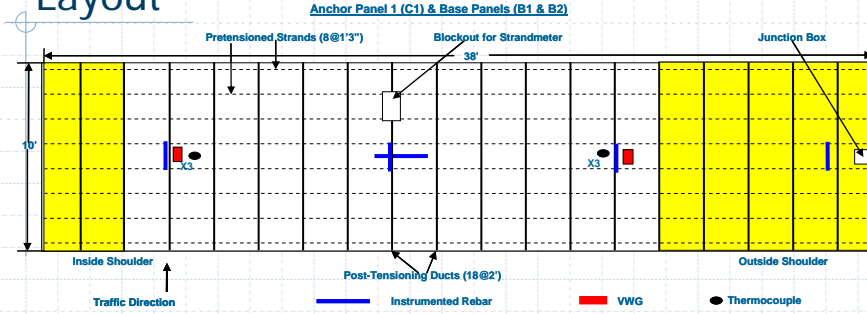
Typical Panel Design & Instrumentation Layout

- Precast Panels are 10' by 38'
- Pre-tensioned in the transverse direction and post-tensioned longitudinally after installation

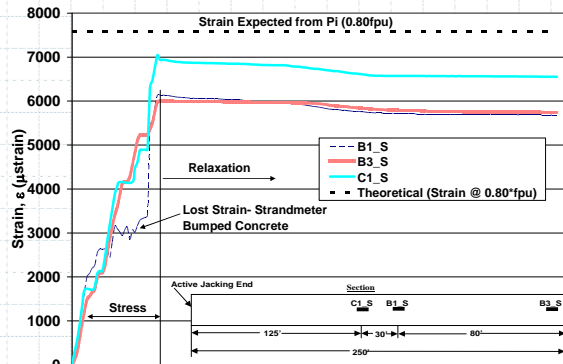
Strandmeter During Post-tensioning

- Prestressing force lost in PT ducts = 61.8 lb/ft/duct

Post-Tension Strands

- 0.6" Diameter
- 7-wire Low Relaxation Strands
- Uncoated
- Stressed to 80% of ultimate ($U_c = 270$ ksi)

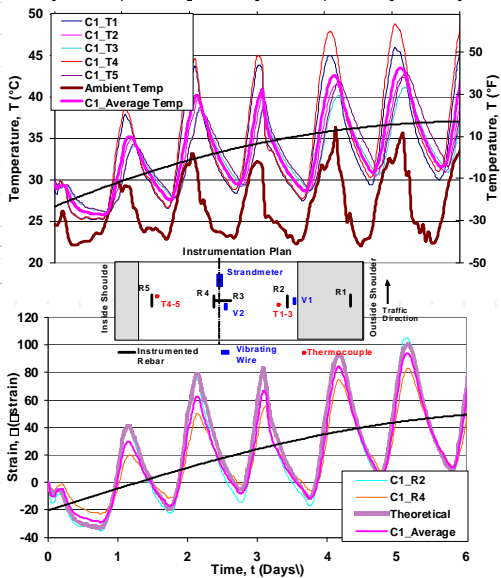
Service Performance for Week Long Period

Trends

Increase in relative temp.
= 11 C

Increase in relative strain
= 68 mstrain

$$68 / 11 = 6.2$$

(Close to CTEconcrete as assumed of 6.0)

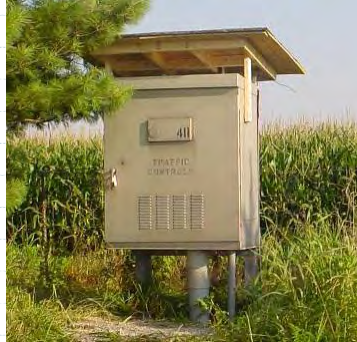
Weather Related Issues

- Summer heat waves were problematic for sensitive circuitry.
 - Addition of a shade roof
 - Larger heat sinks, with strategically placed fans
 - Military grade parts since exceeding Max. Junction Temp.
