Carney Mill Road Bridge

2nd International Conference on Timber Bridges

Murray M. Johnson, P.Eng., PE
Buckland & Taylor Ltd.

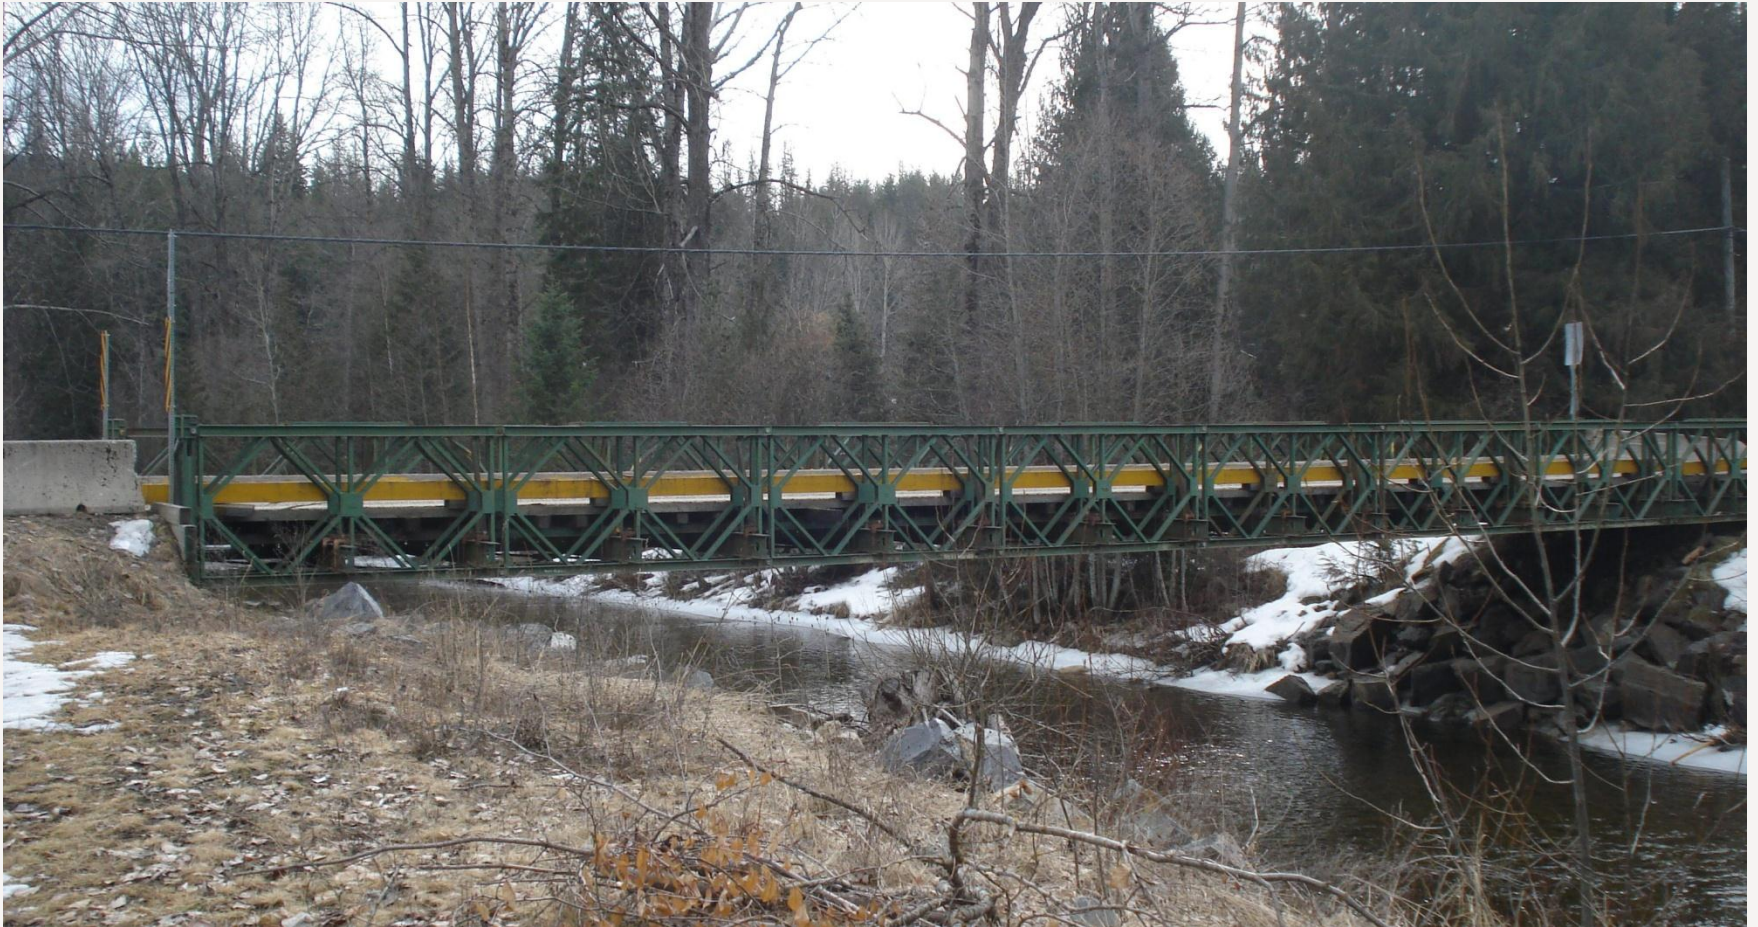
Existing Bridge: 15 t Load Limit, Narrow for Pedestrians

- **25 m Span "Bailey" Bridge**
 - **"Temporary" several decades earlier**
 - **Load limited to 15 tonnes (approx. 20% of legal highway load)**
 - **Steel deteriorating**
 - **Poor abutments**
 - **Pedestrians sharing narrow roadway with traffic**
 - **Greater flood clearance desired**
-
- **Could be removed and not replaced, existing highway bridge nearby**
 - **Replacement not in Owner's current budget, until timber bridge incentive program provided**

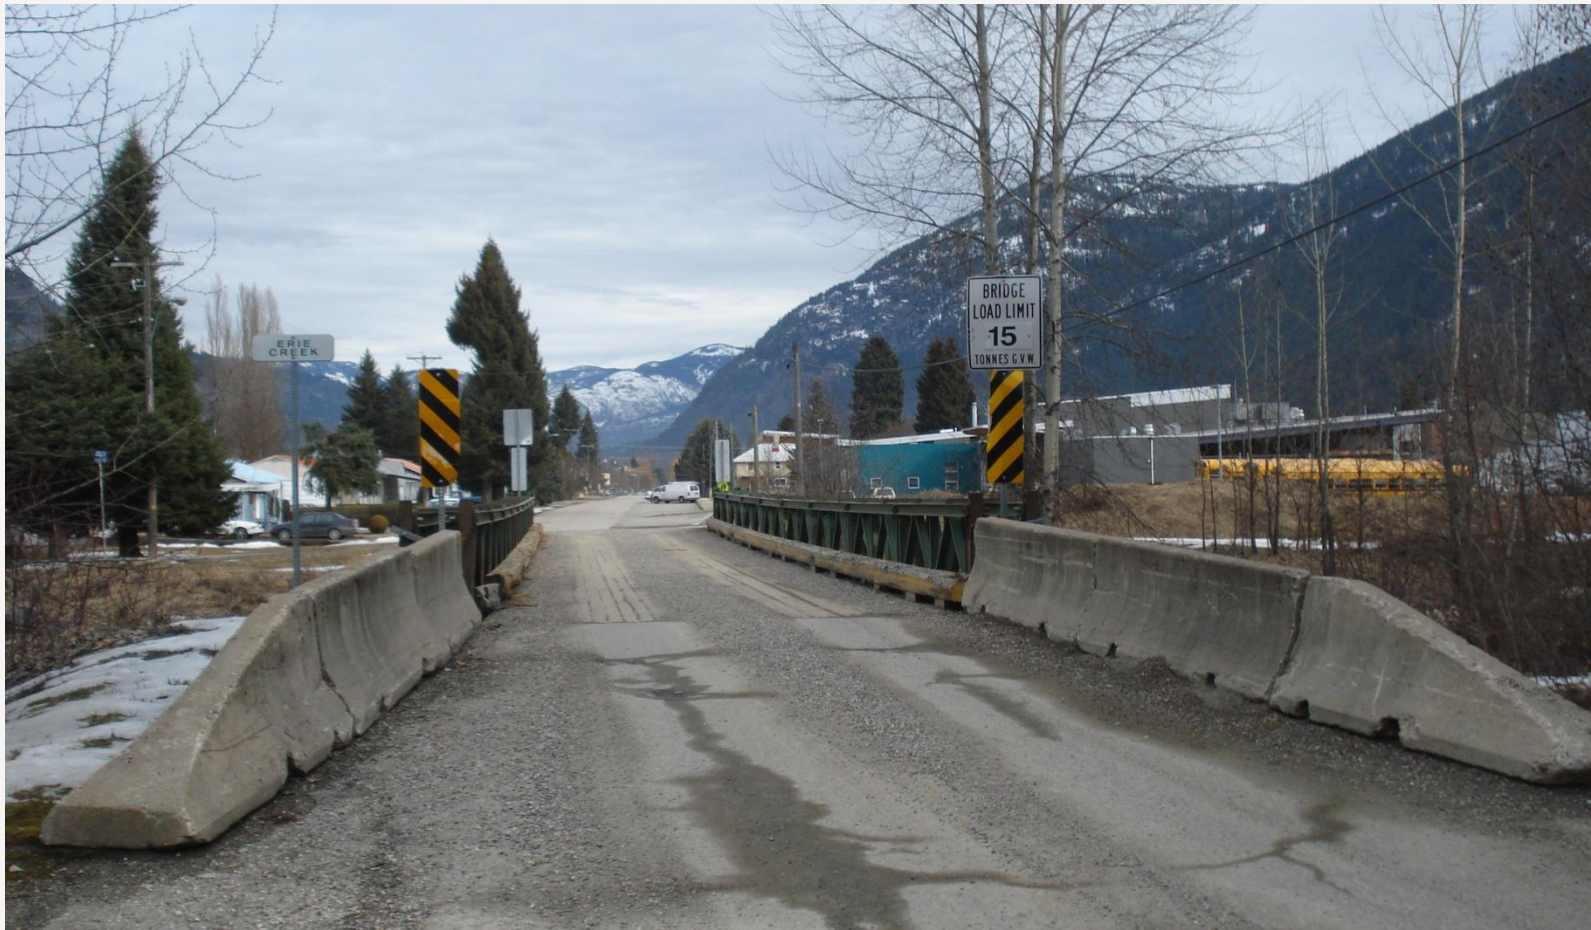
Existing Bridge: Stream Banks OK, Abutments Poor!

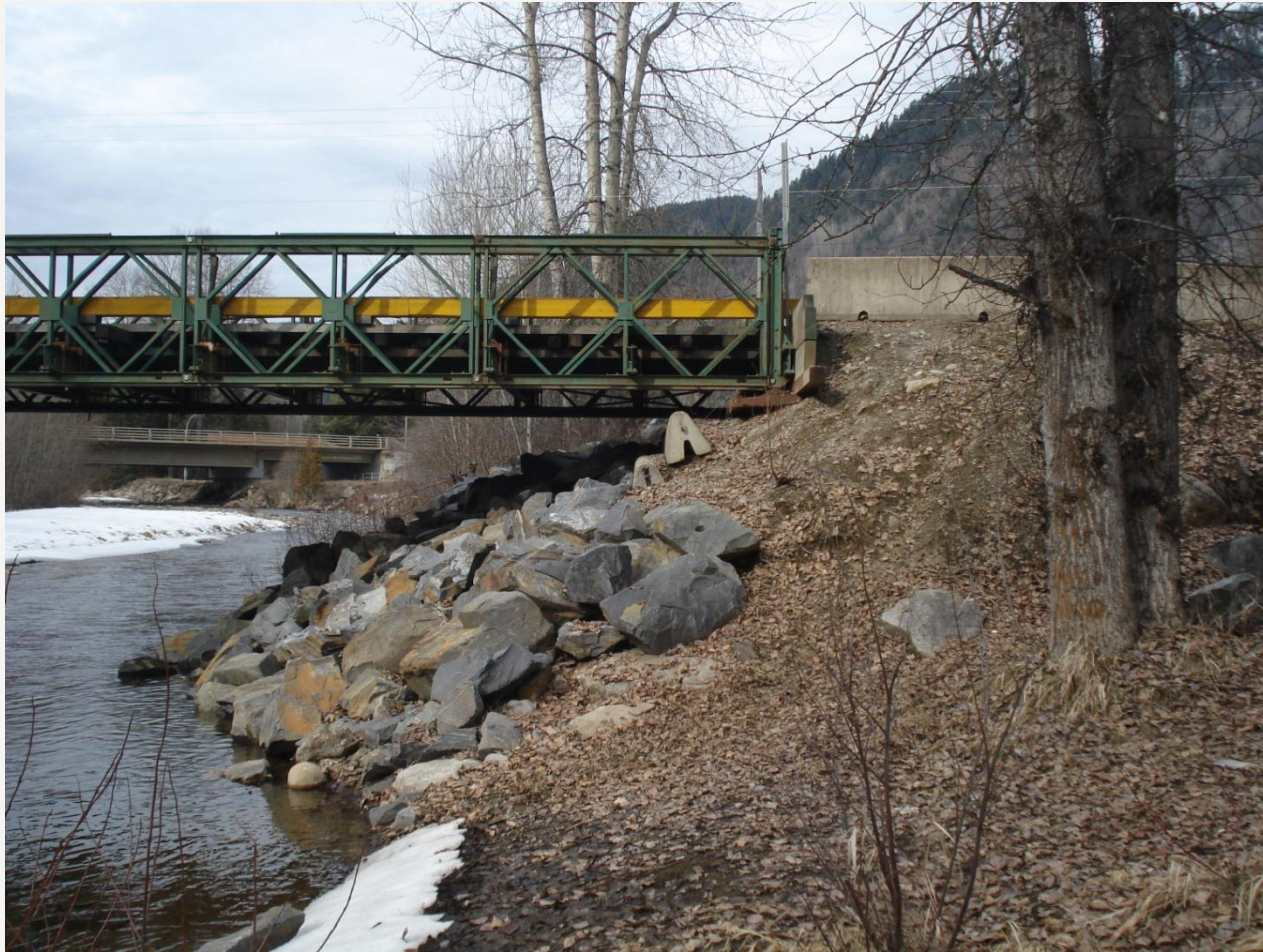
Existing Abutment

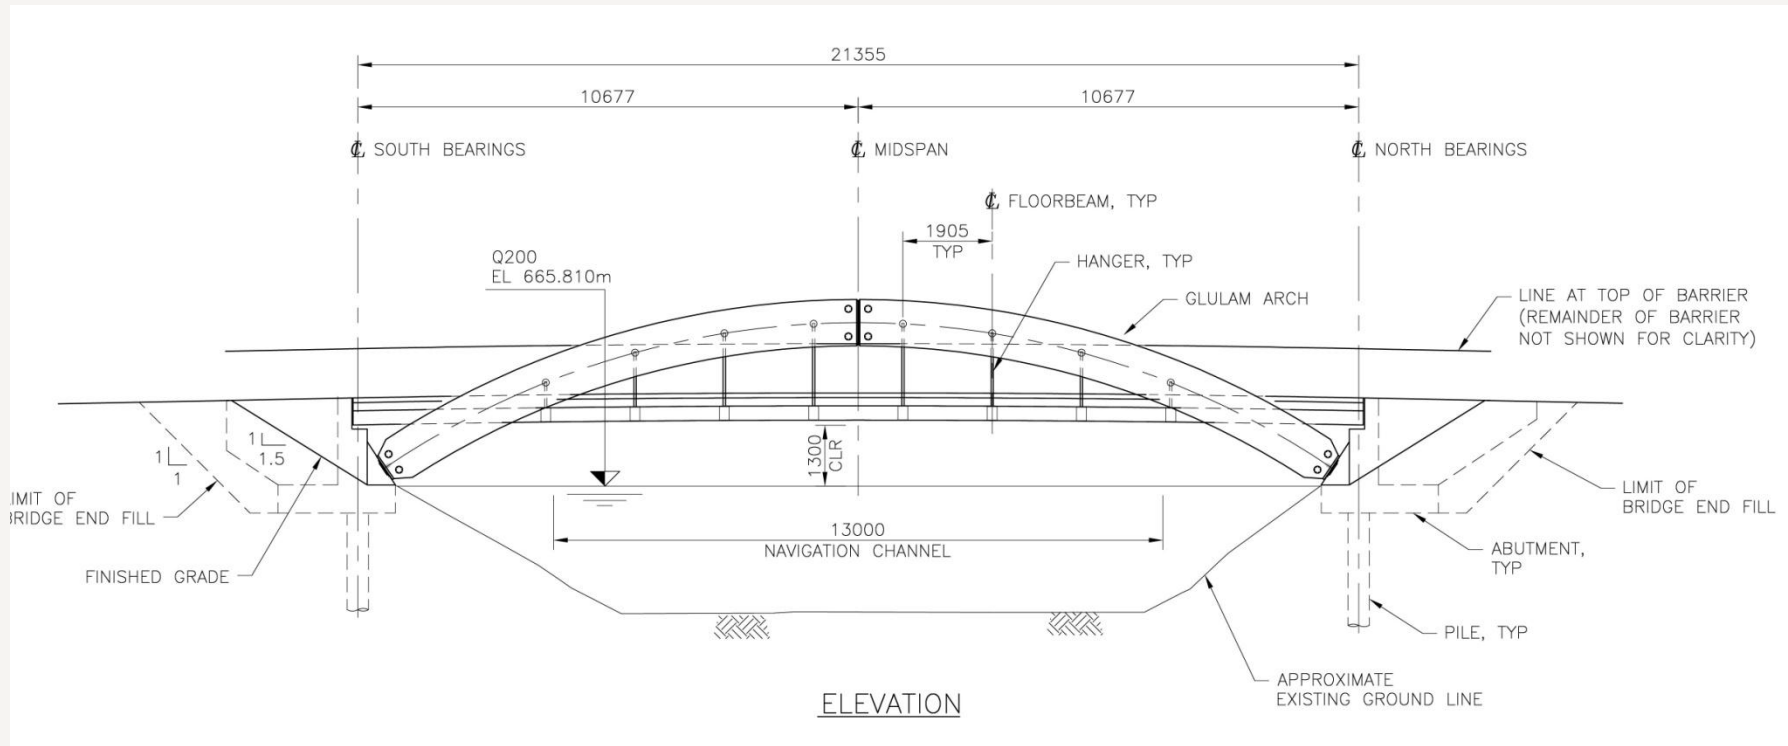
Deck Cross Section

- **Approx 20m minimum span required**
 - **Permanent bridge**
 - **No load limit (63,700 kg design vehicle)**
 - **Timber structure desired**
 - **One traffic lane, but wider to share with pedestrians**
 - **Improved flood clearance to be provided**
 - **Roadway not to be raised: existing streets and driveways**
 - **Available depth for structure 0.6m**
 - **Minimize disruption to stream**
-
- **Solution: glulam timber arch with shallow deck structure**

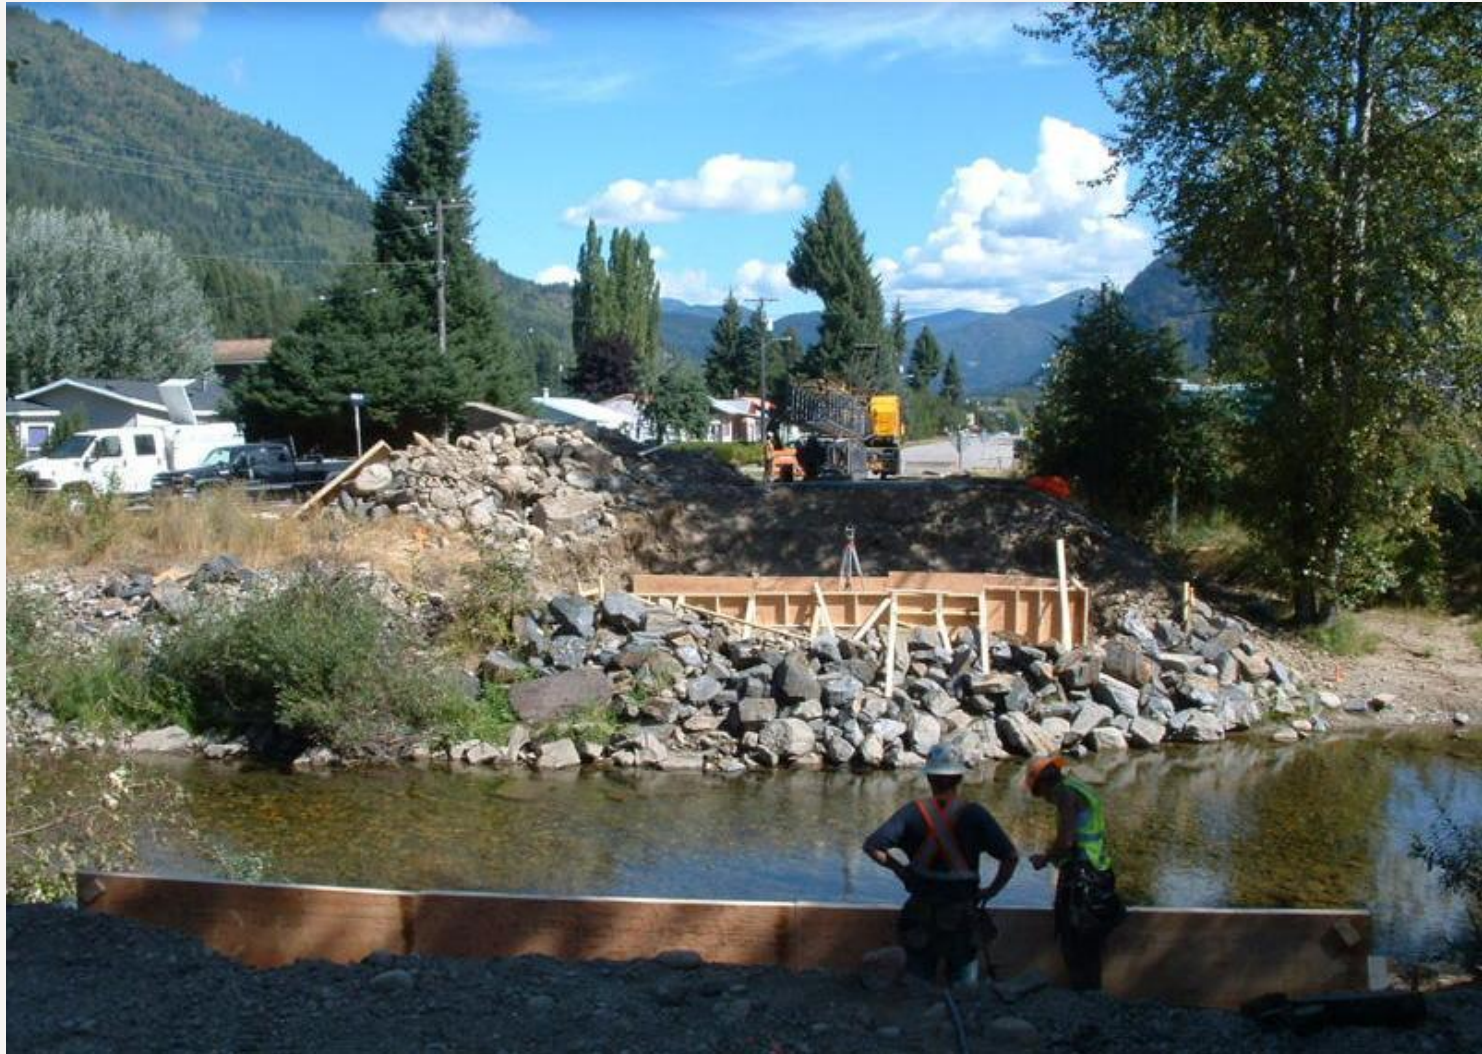
Abutments

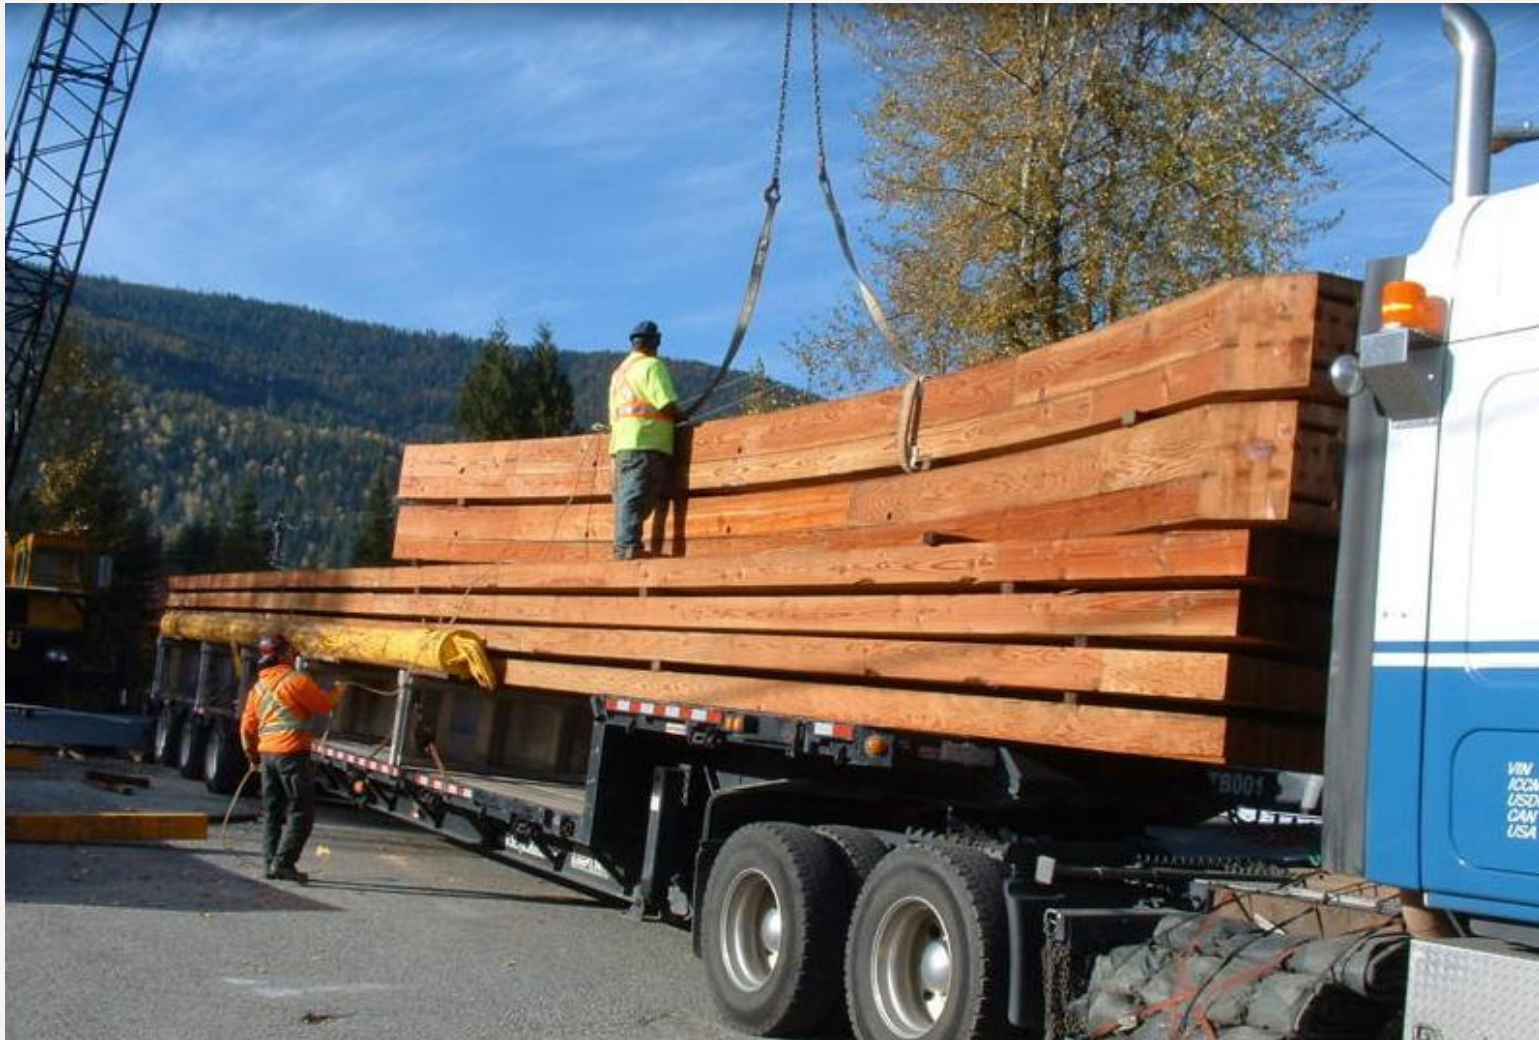
Galvanized Steel Deck Grid

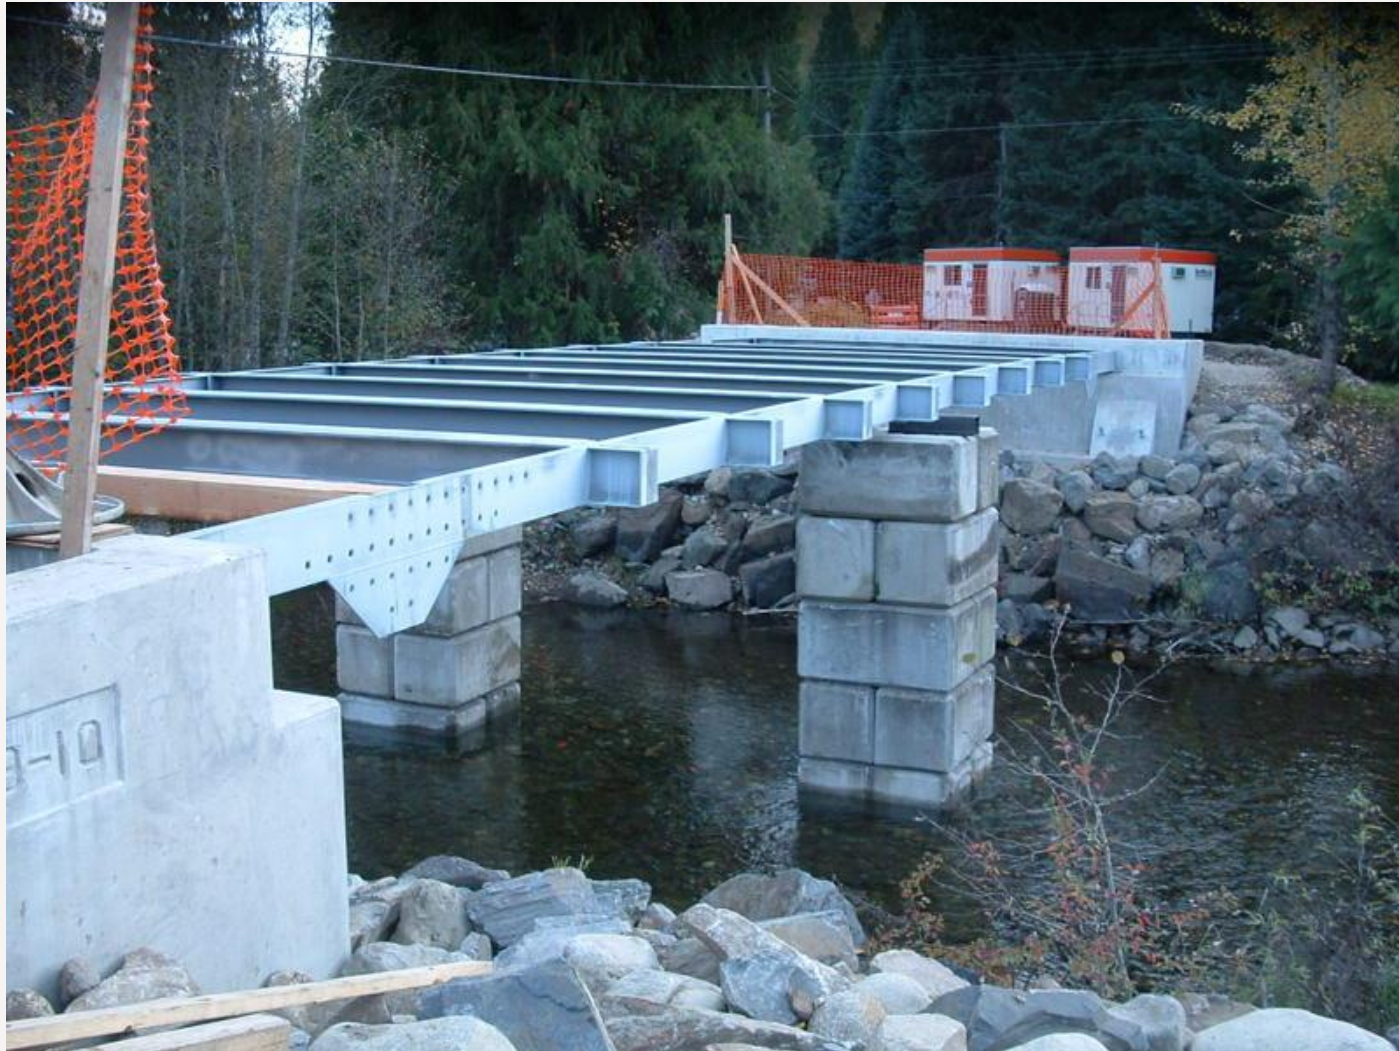
Arch & Tie Beam

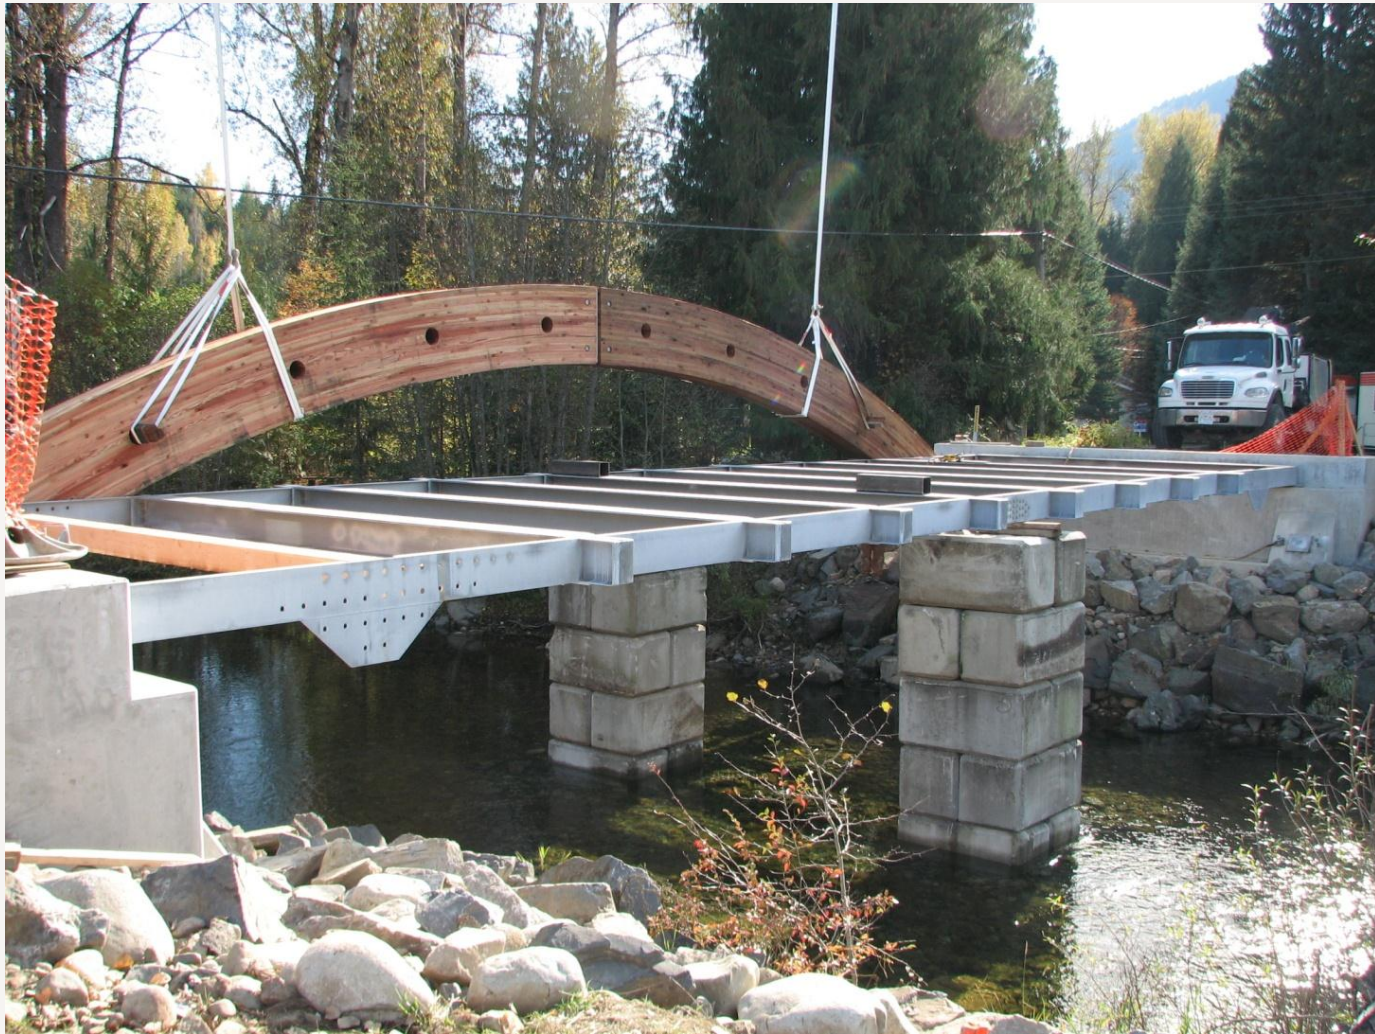
Arch Erection

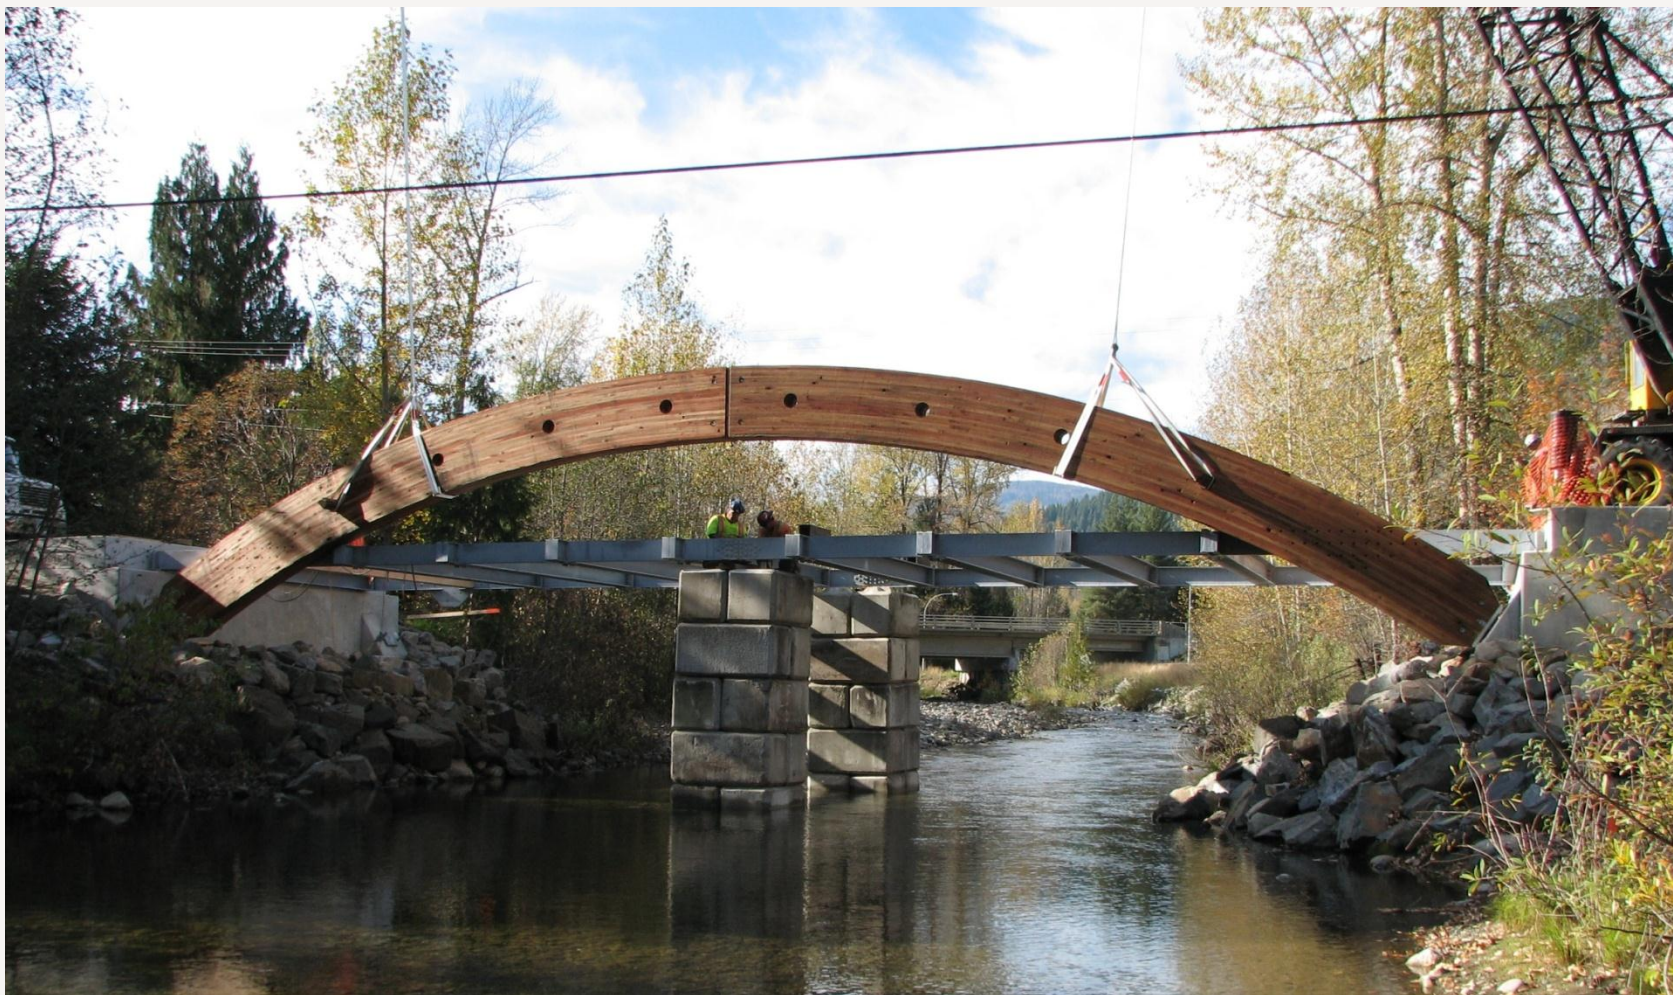
Arch End Details

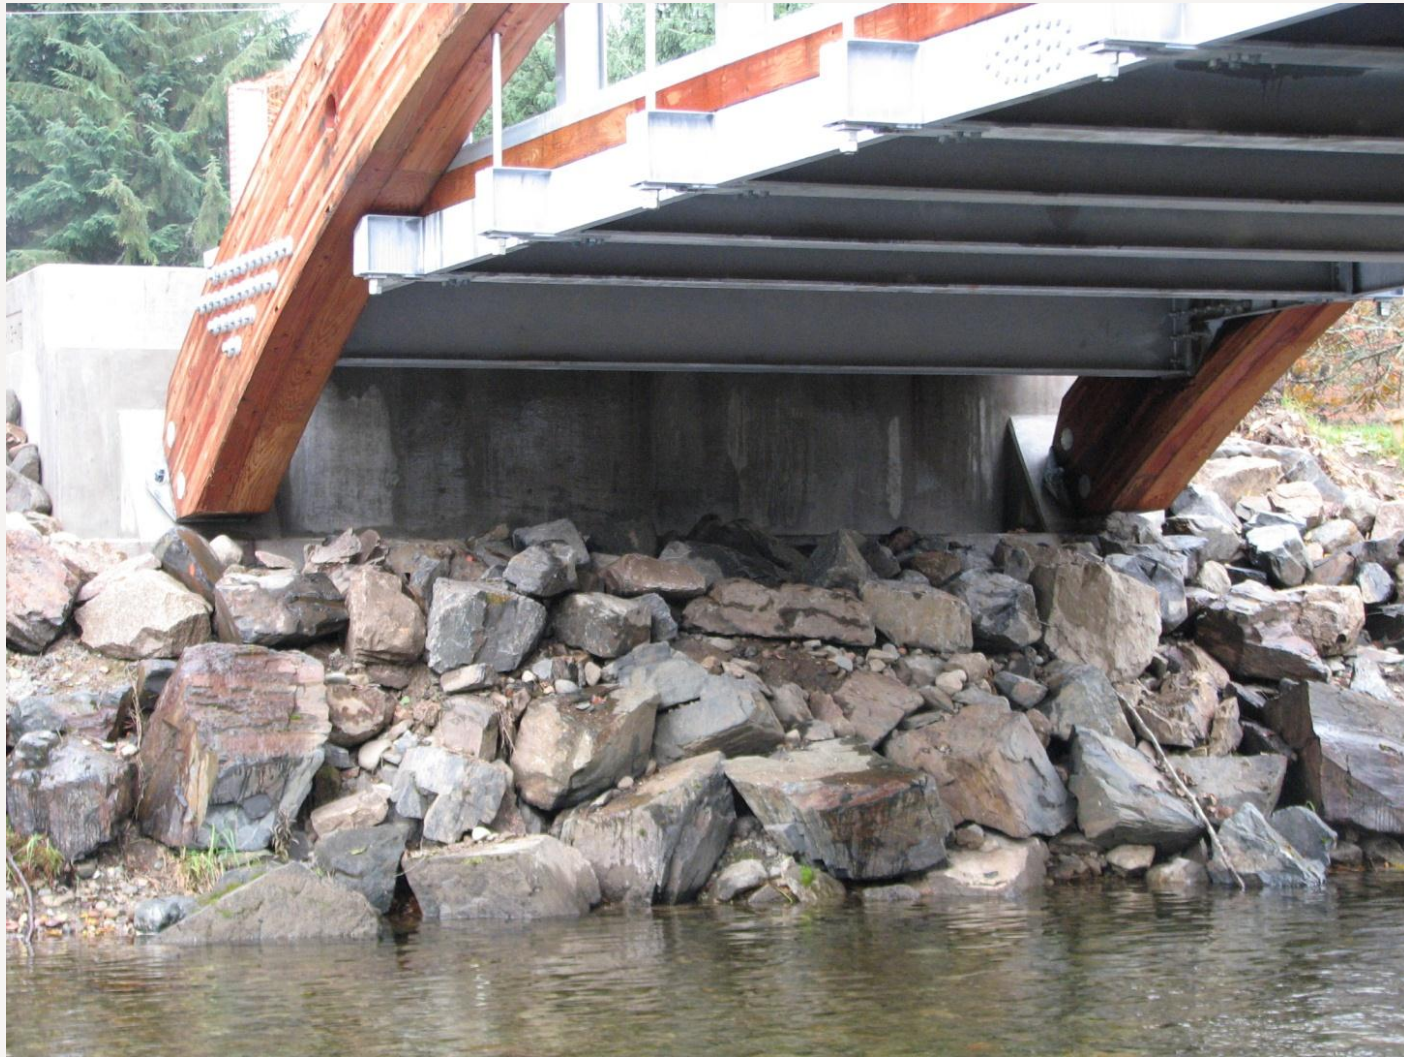
Hanger / Tie Beam / Deck Detail

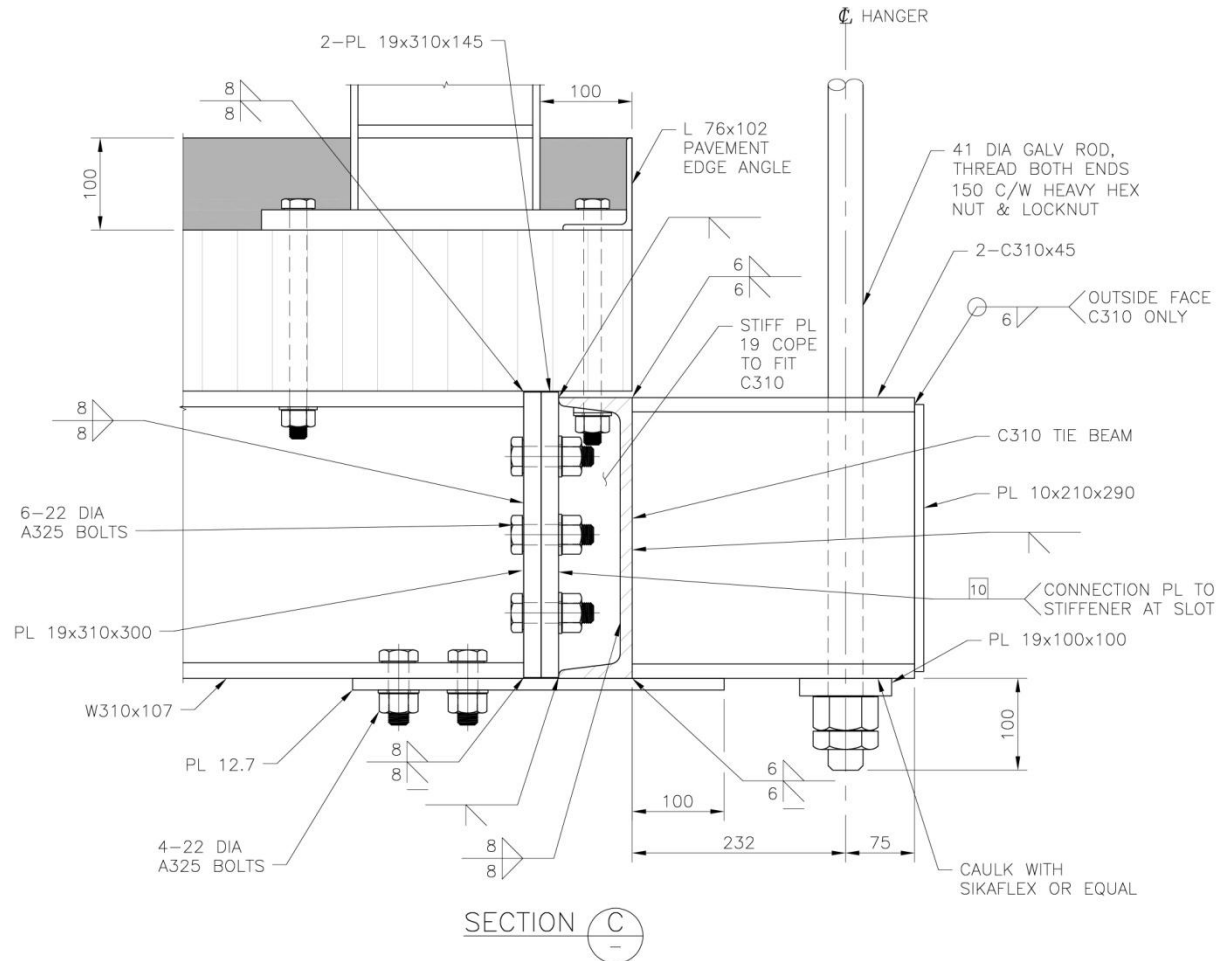
Deck Panels

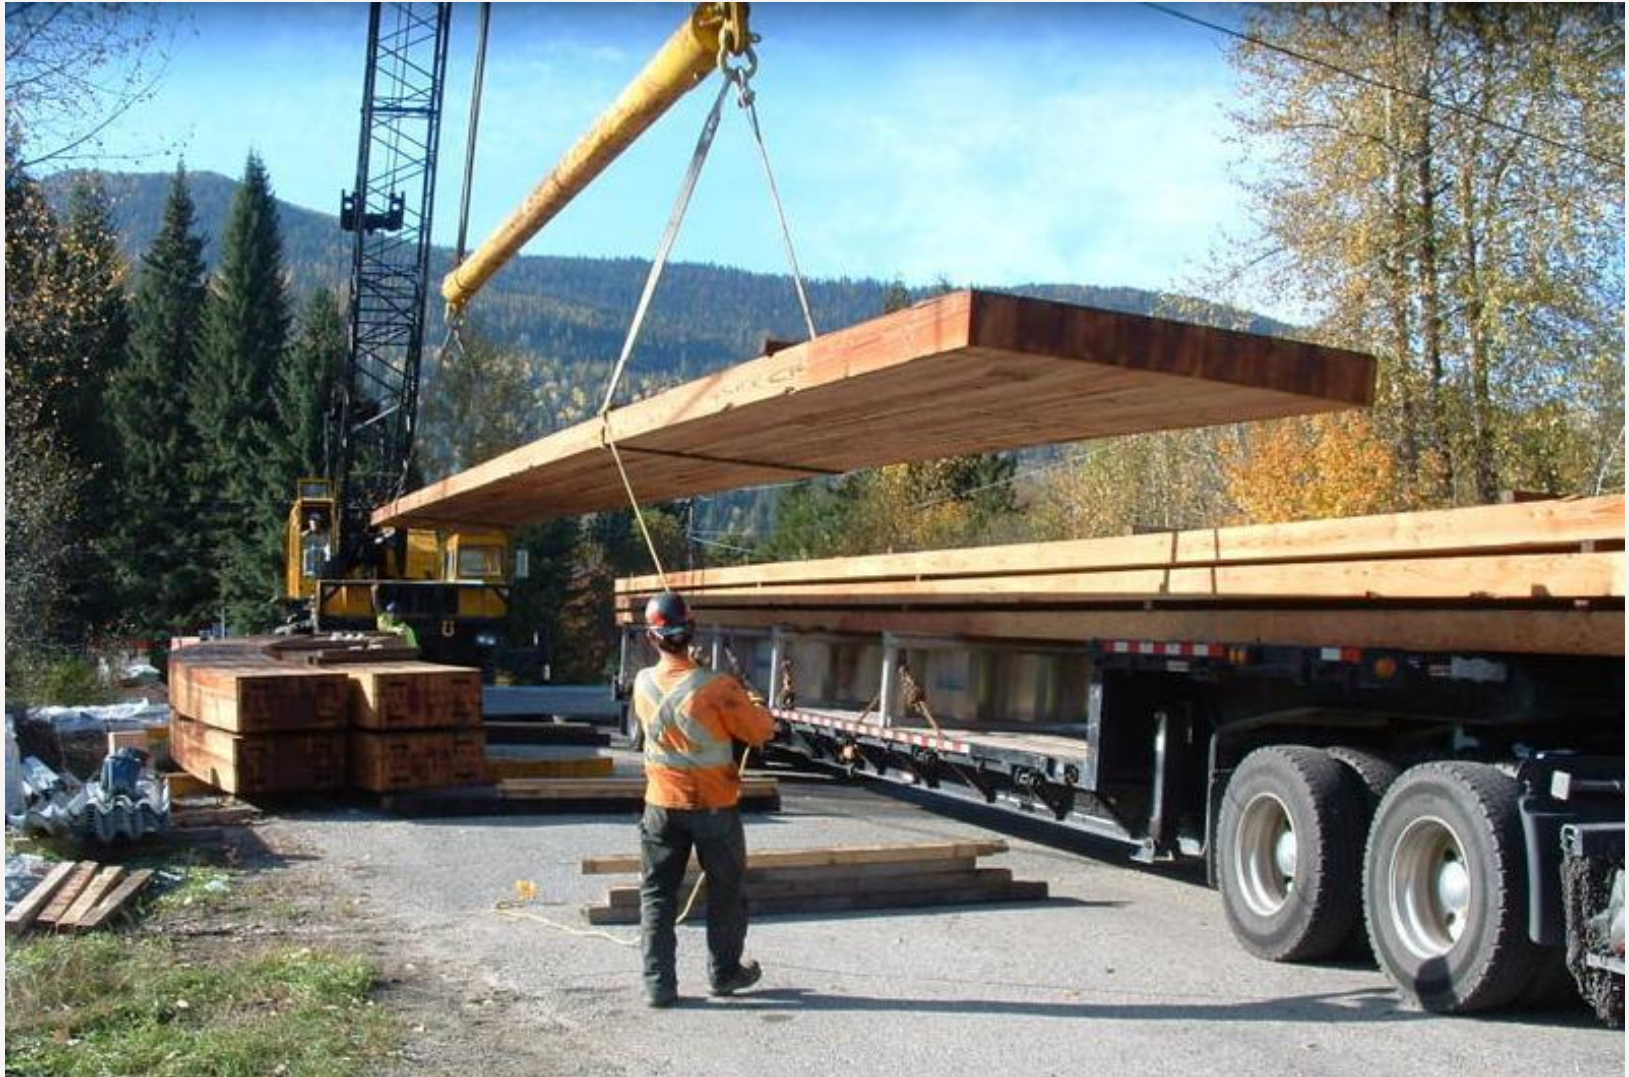
Crash-Tested Barrier Design

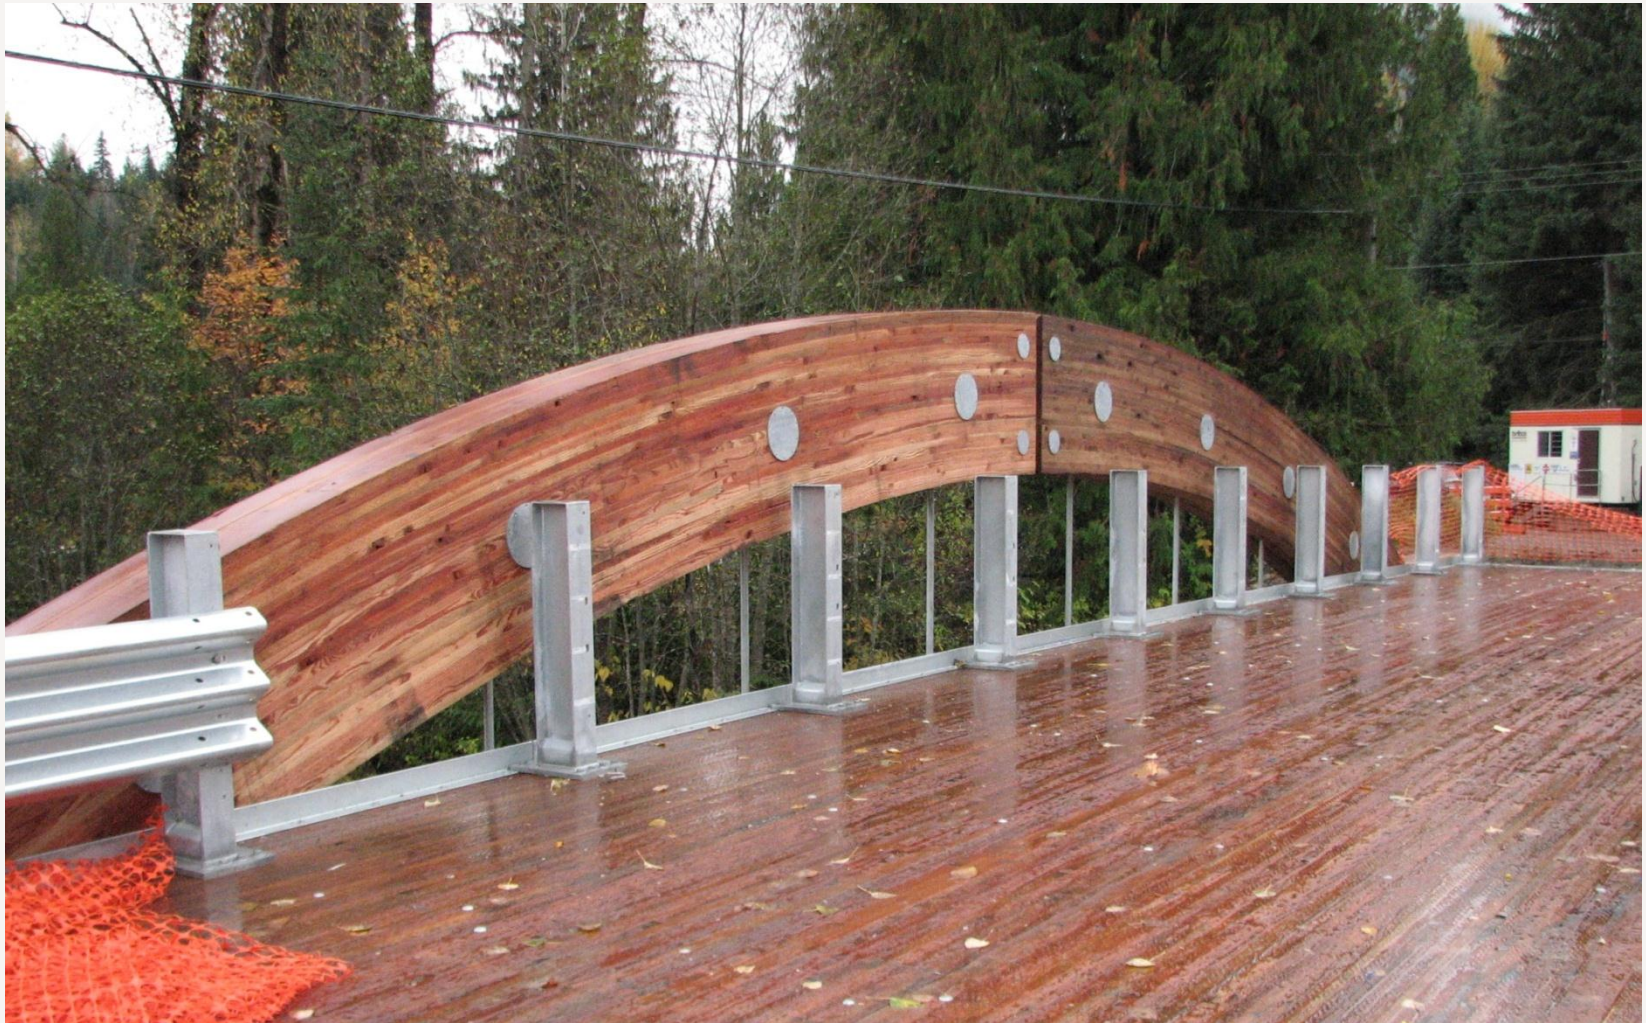
Barrier Detail

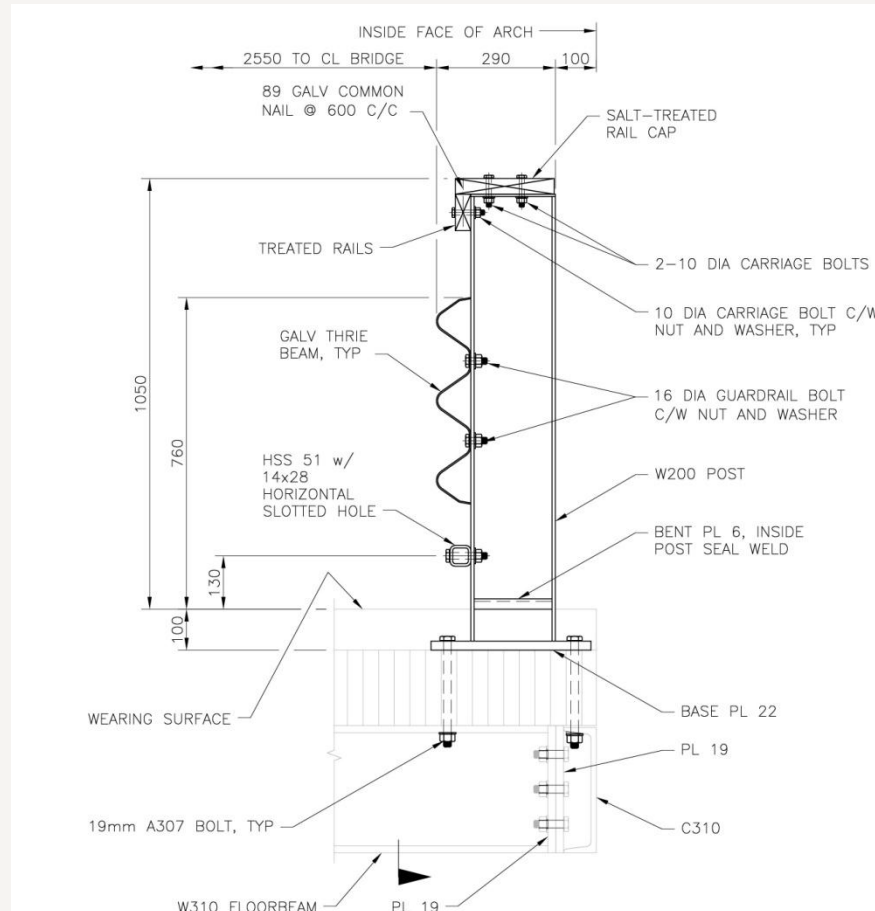
Barrier Post

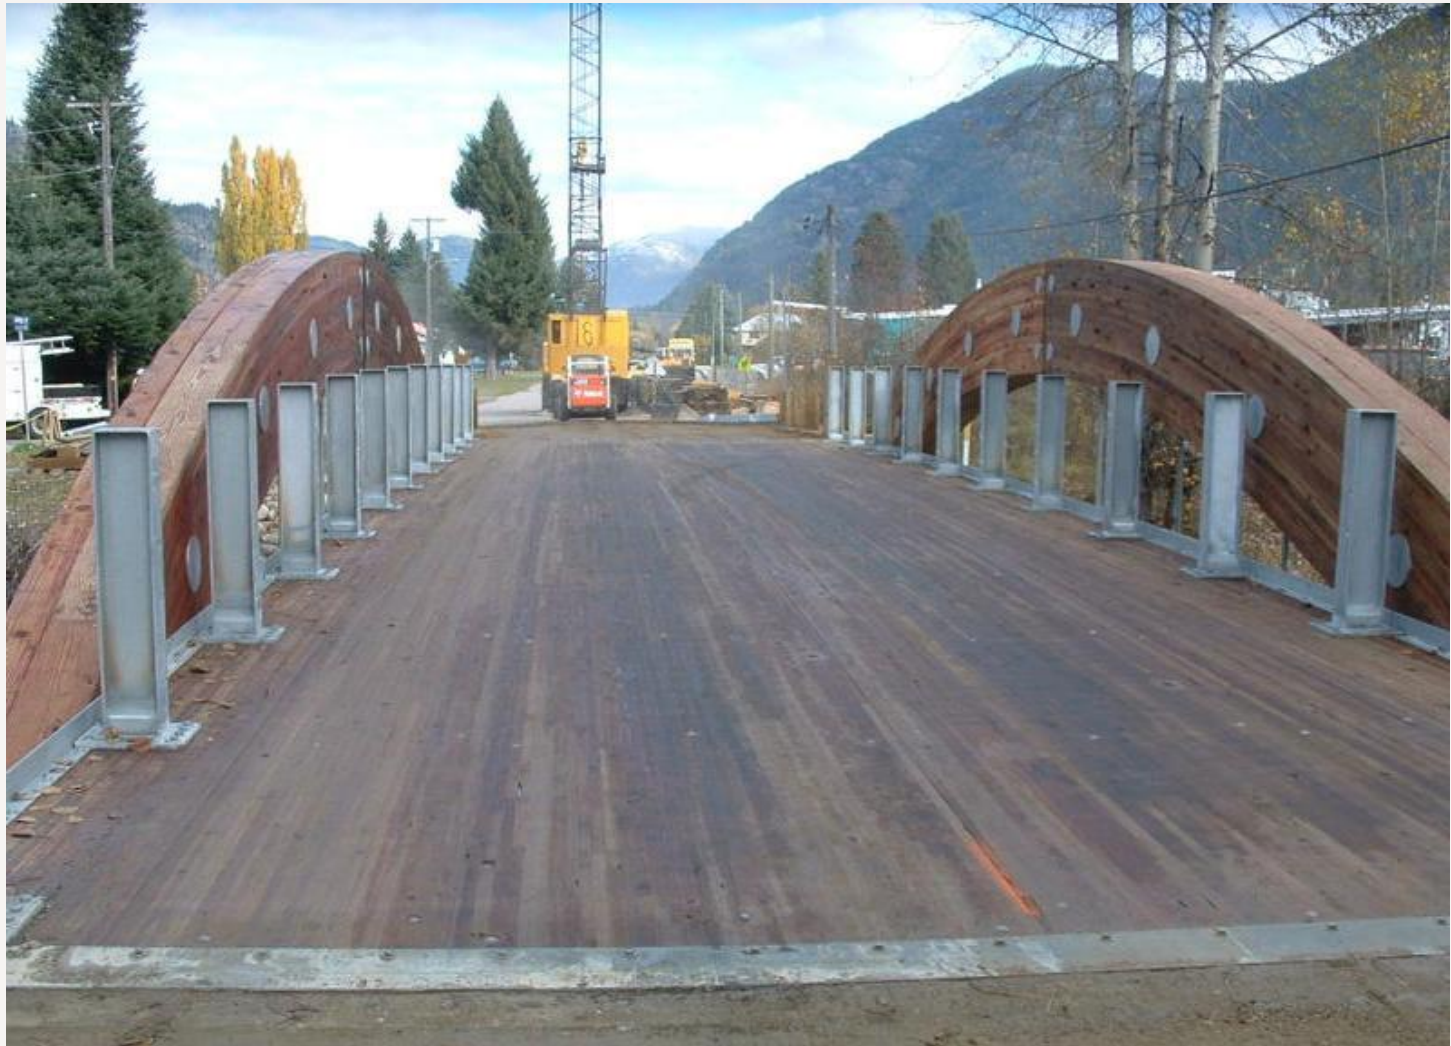
Paving
