Carney Mill Road Bridge

2nd International Conference on Timber Bridges

Murray M. Johnson, P.Eng., PE
Buckland & Taylor Ltd.

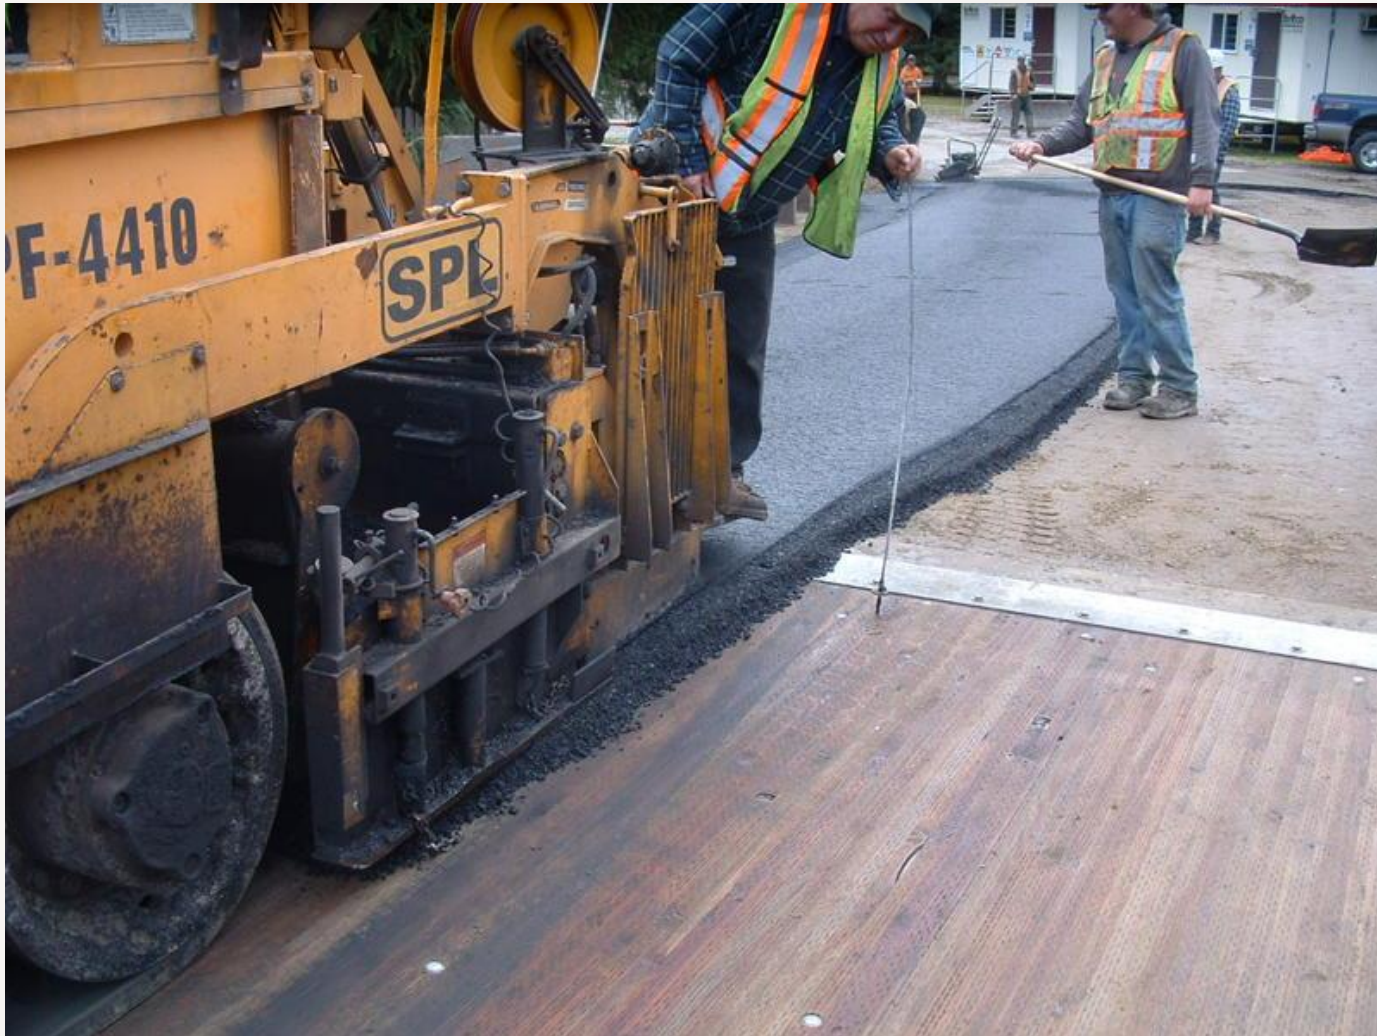
End Joint Sawcutting
