Rehabilitation of St. Marys Wycliffe Bridge in British Columbia, Canada

2nd International Conference on Timber Bridges

Murray M. Johnson, P.Eng., PE
Buckland & Taylor Ltd.

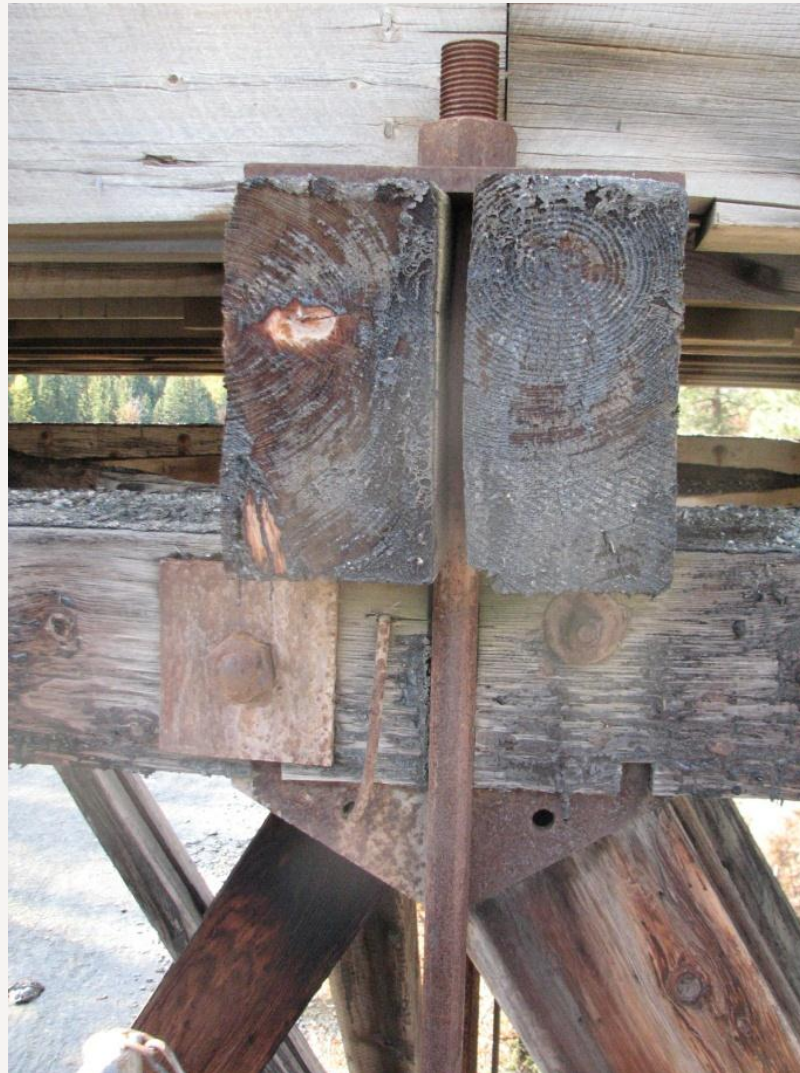
Howe Truss Detail

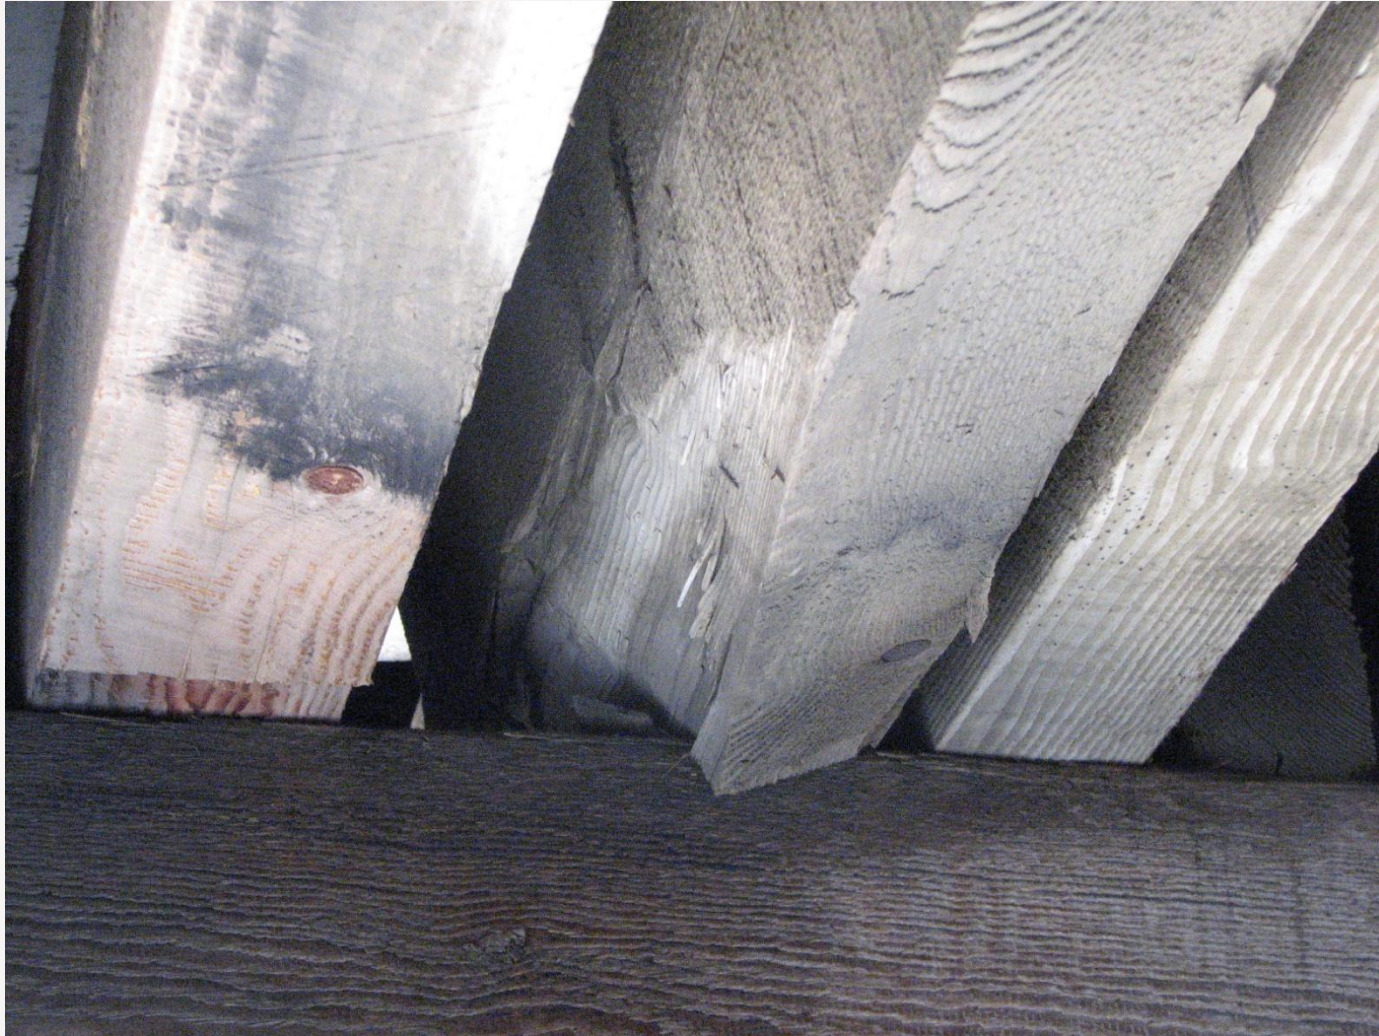
Inspection: Deck Level Deterioration

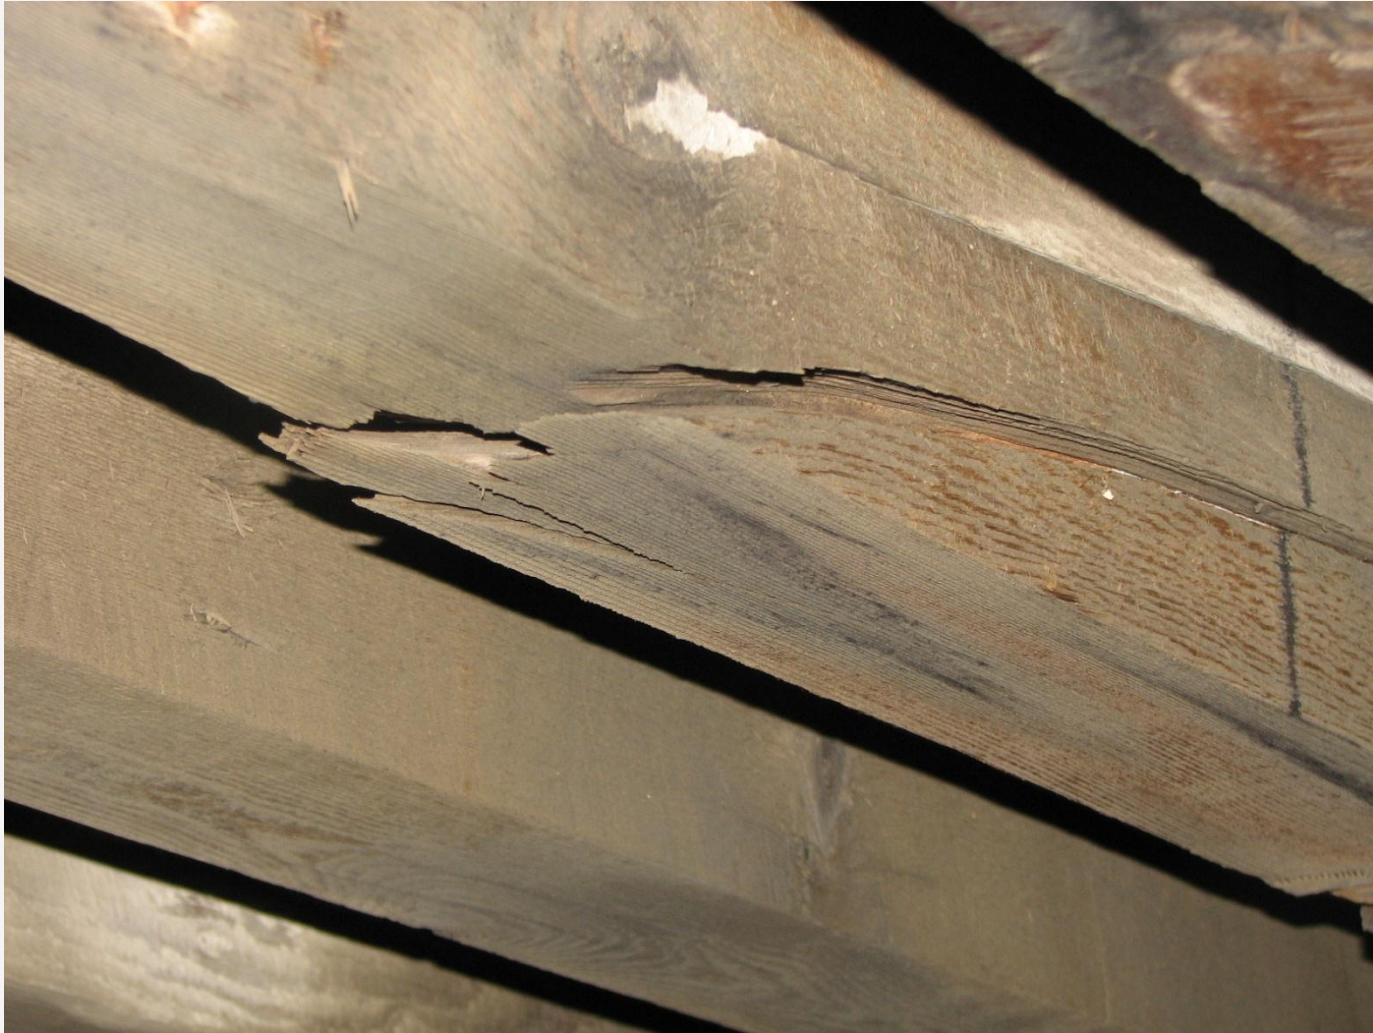
Inspection: Deck Level Deterioration

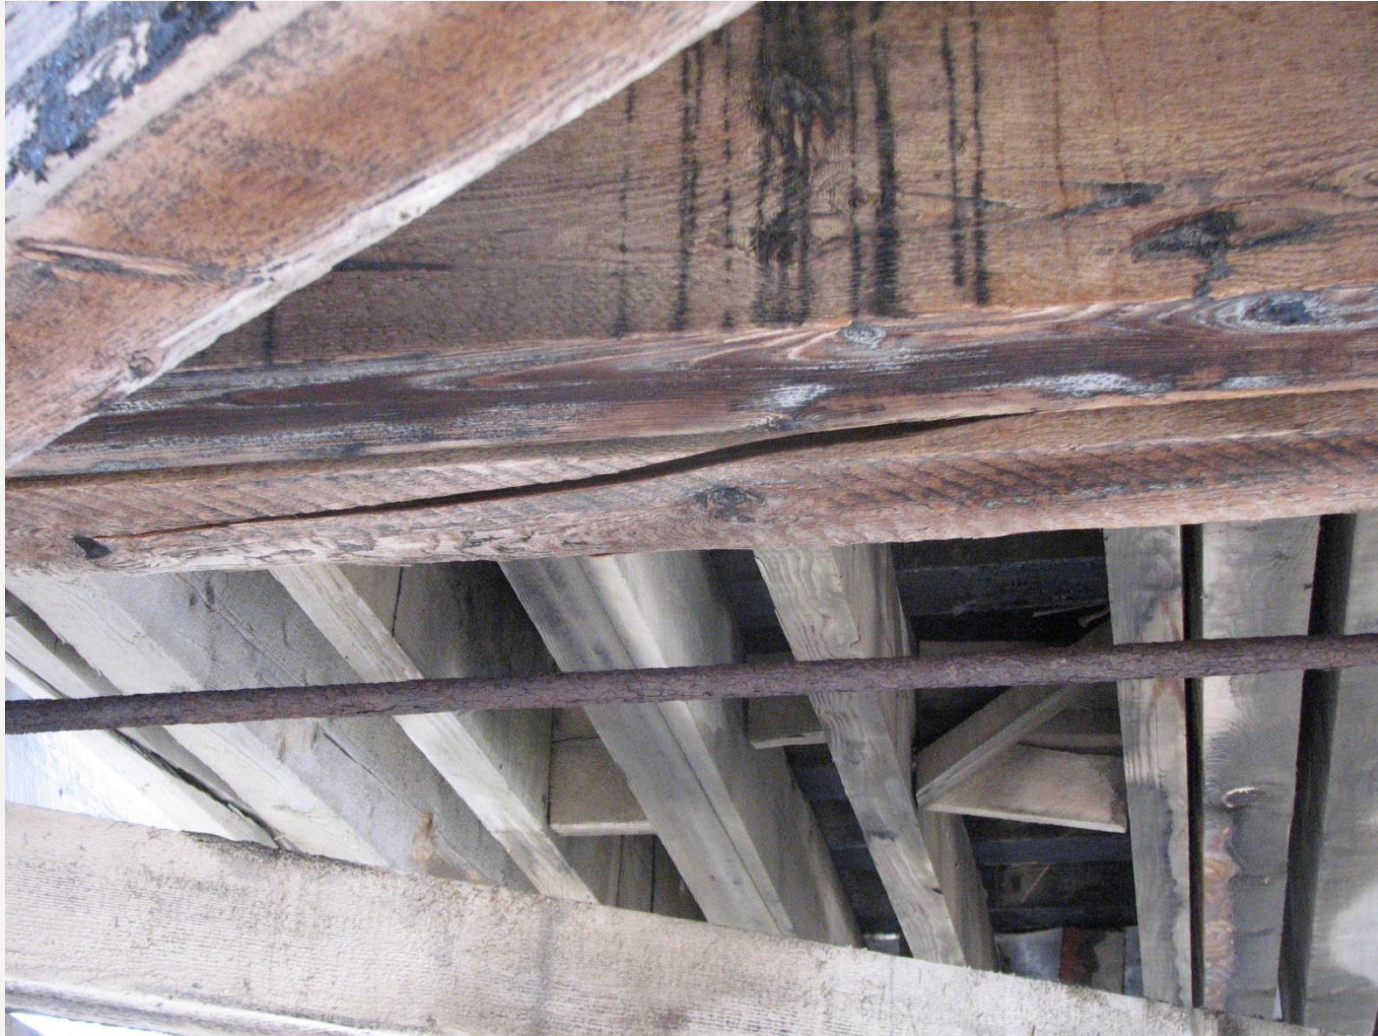
Inspection: Deck Level Deterioration

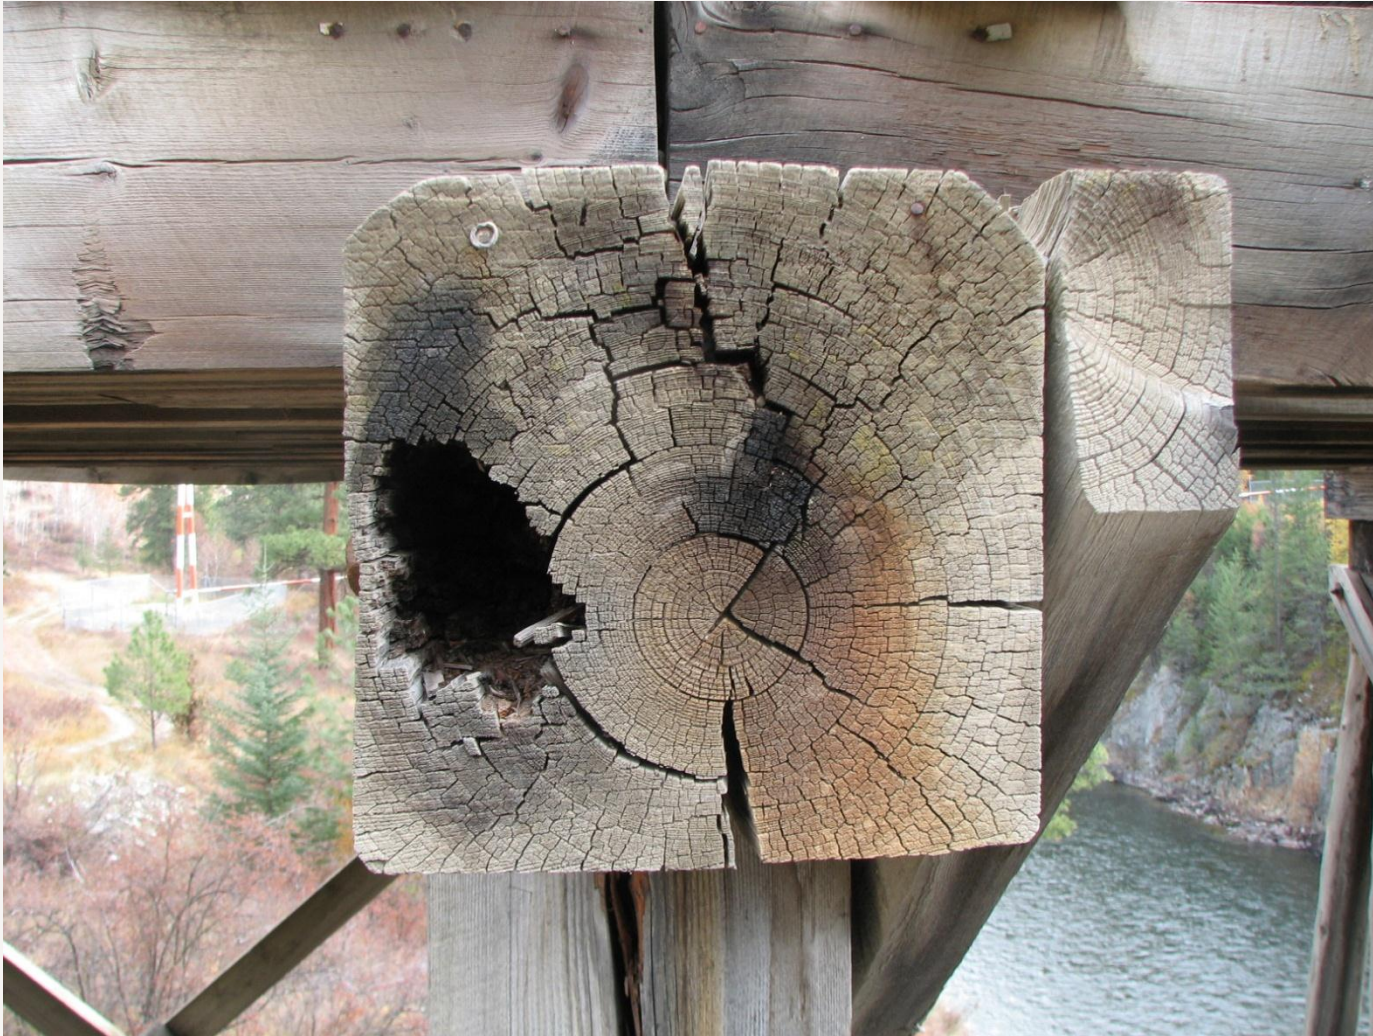
Inspection: Deck Level Deterioration

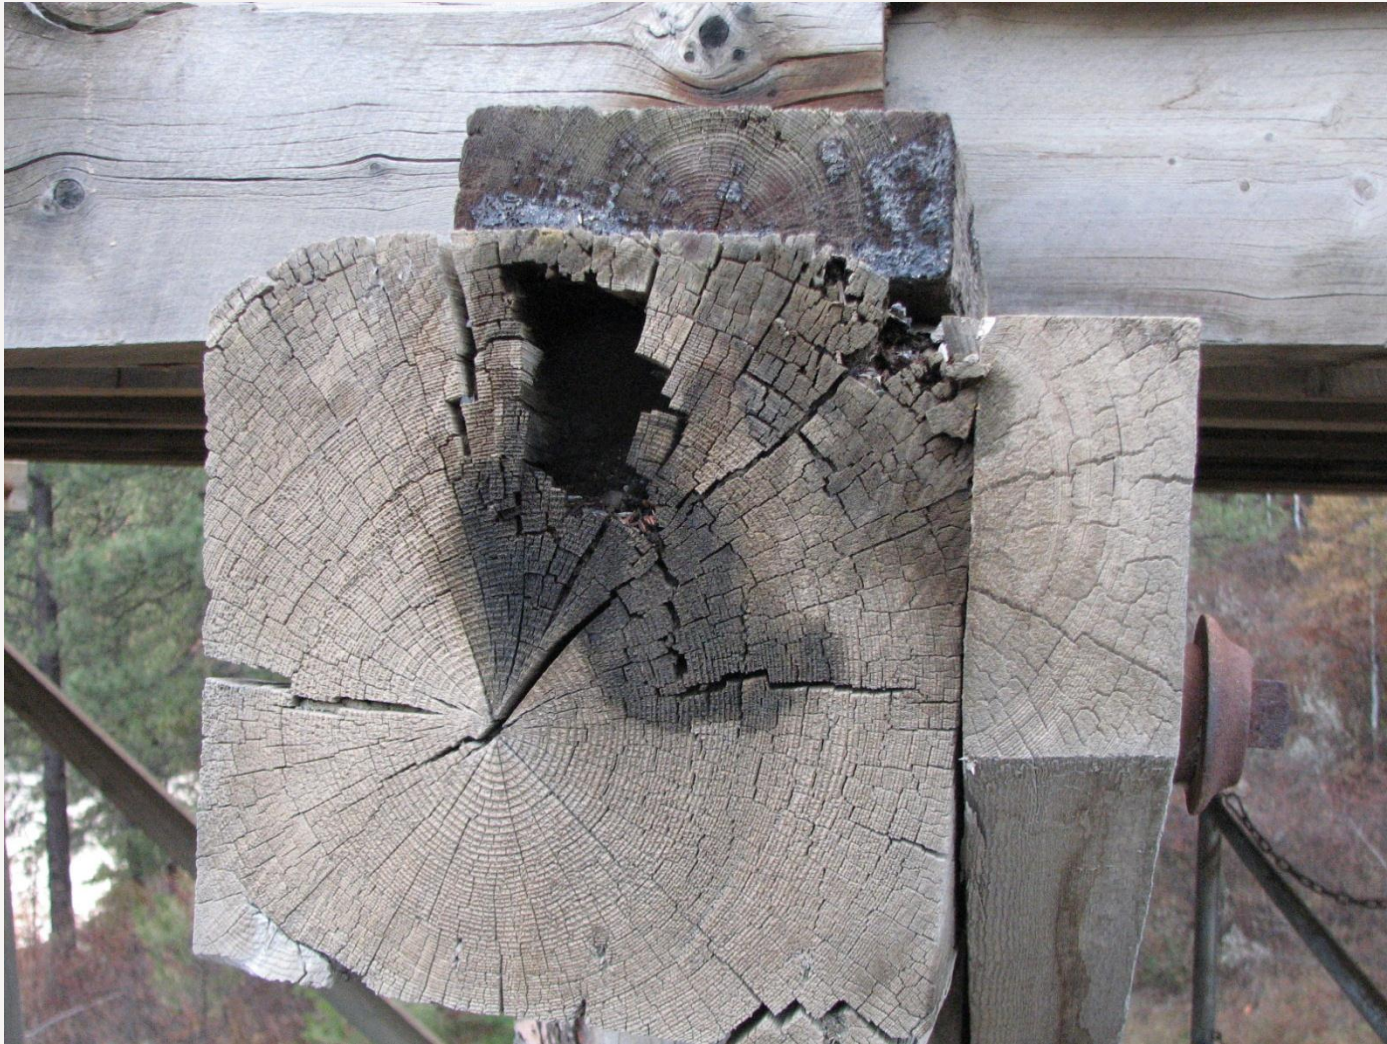
Inspection: Deck Level Deterioration

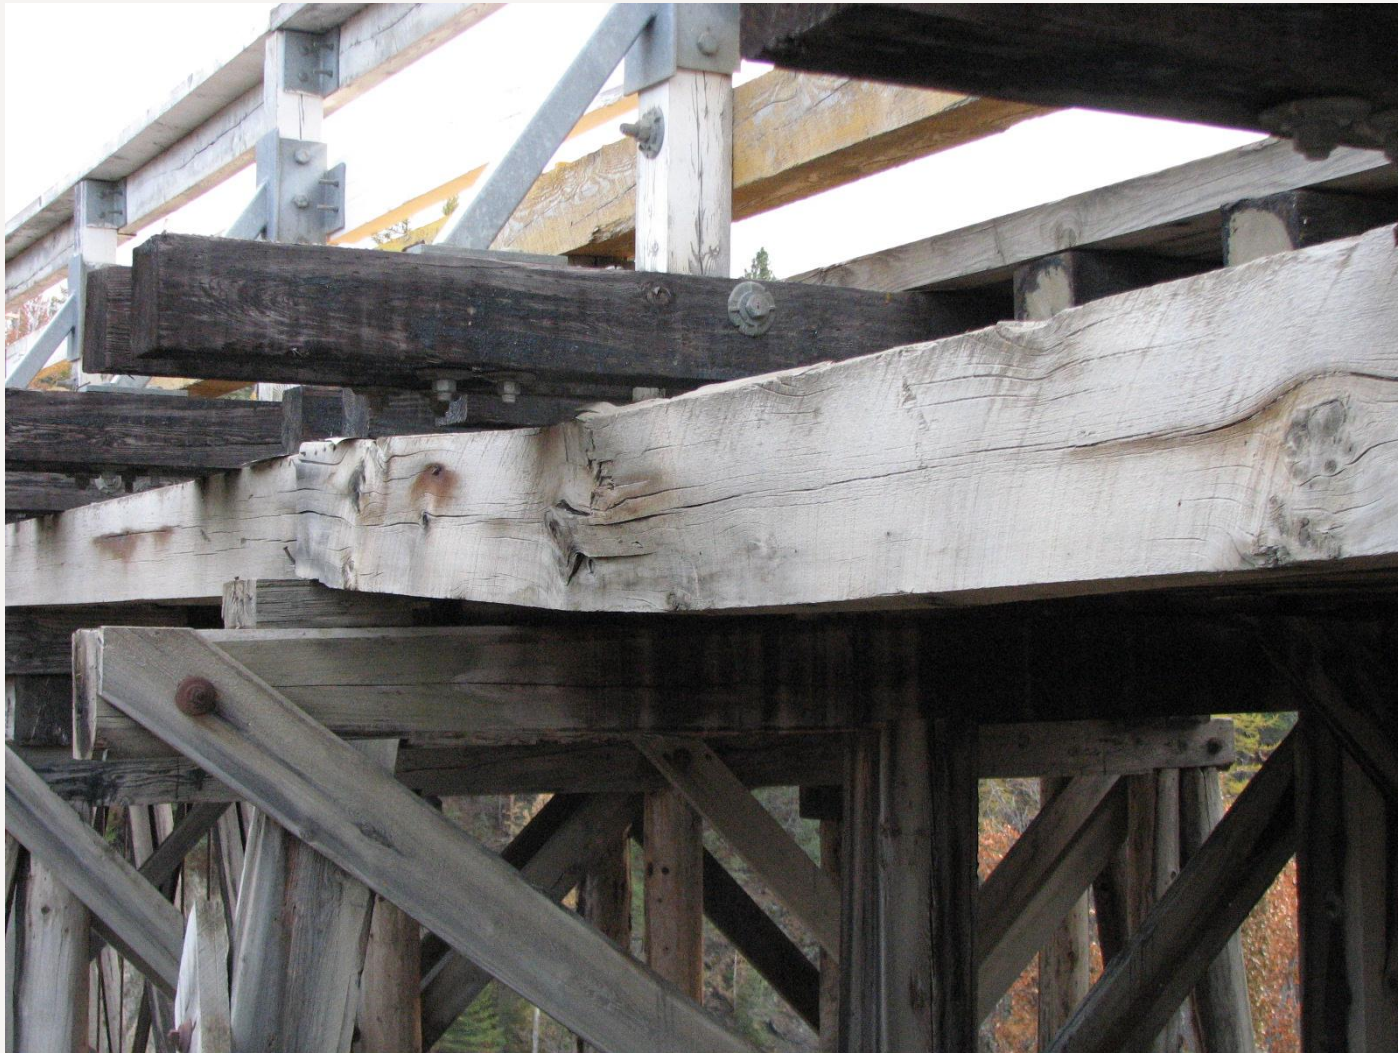
Inspection: Deck Level Deterioration

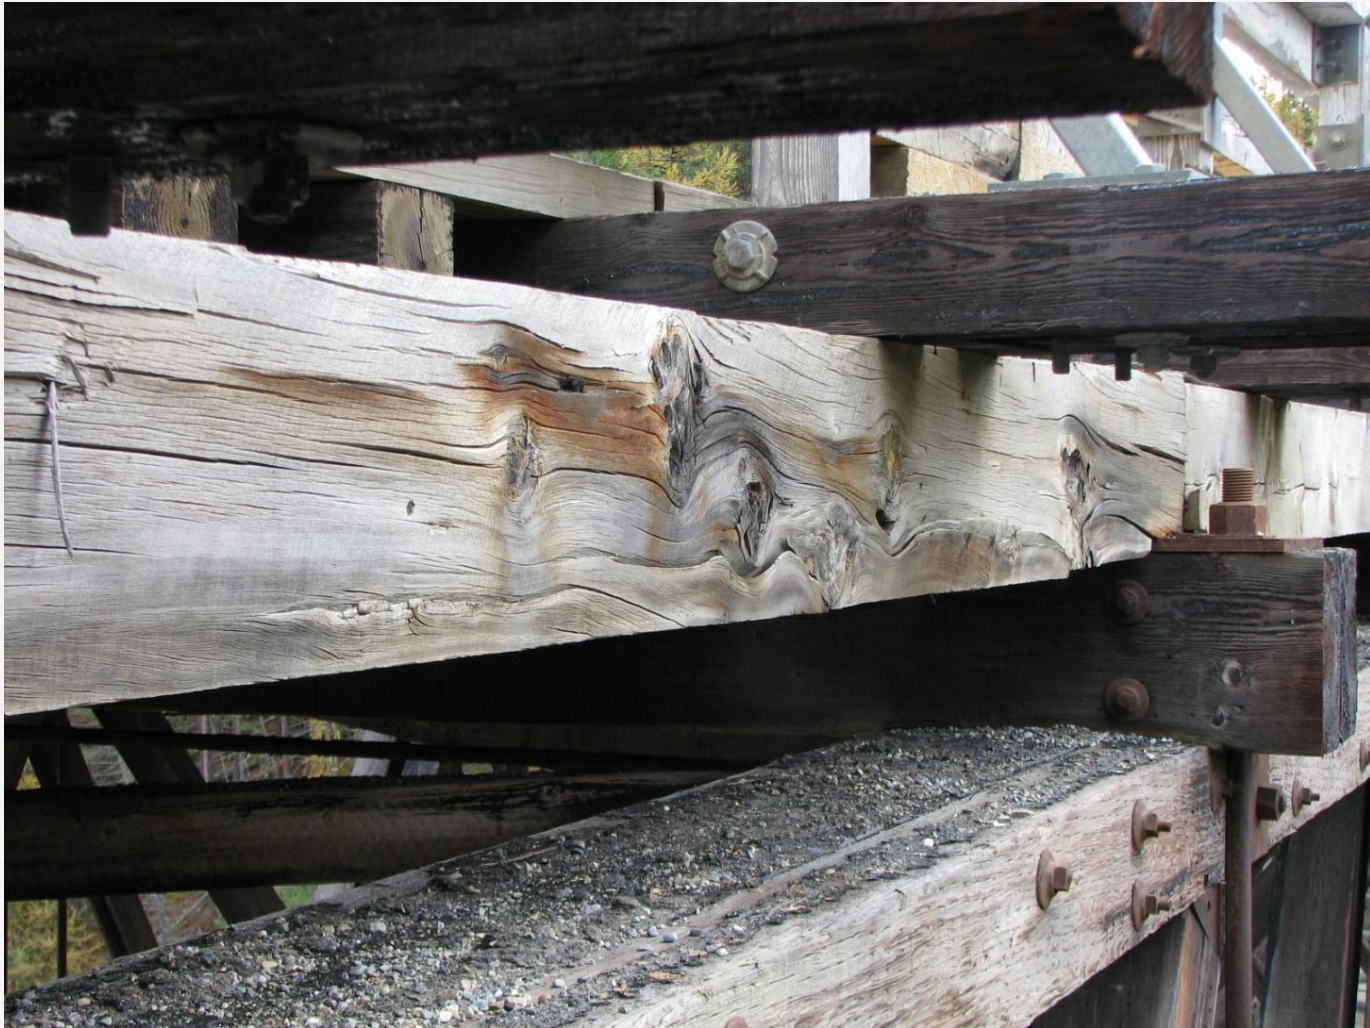
Inspection: Deck Level Deterioration

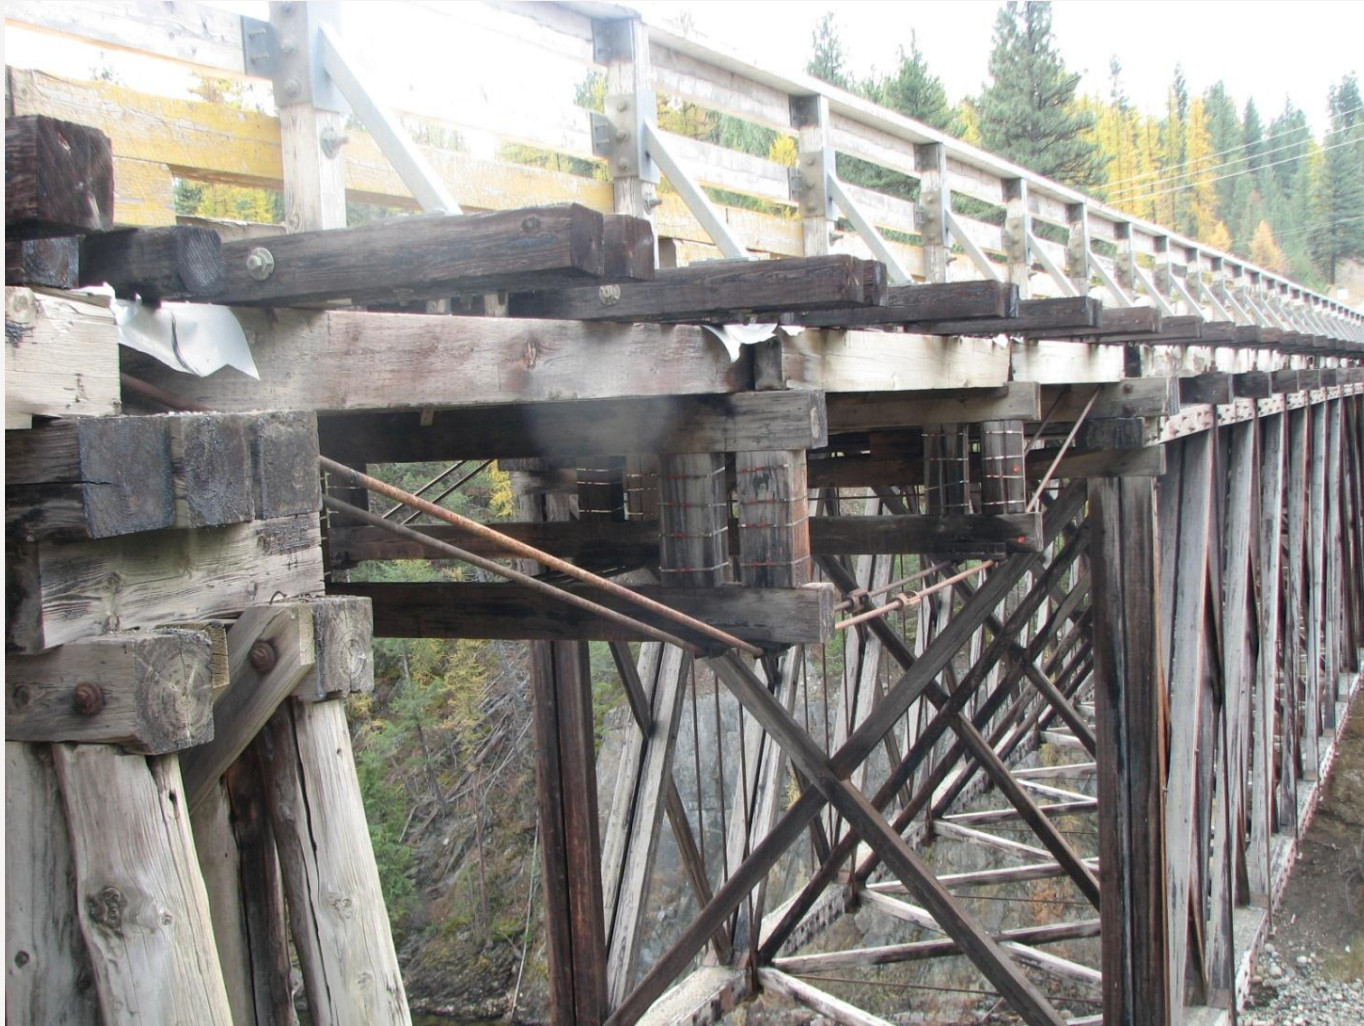
Inspection: Queenpost Truss Deterioration

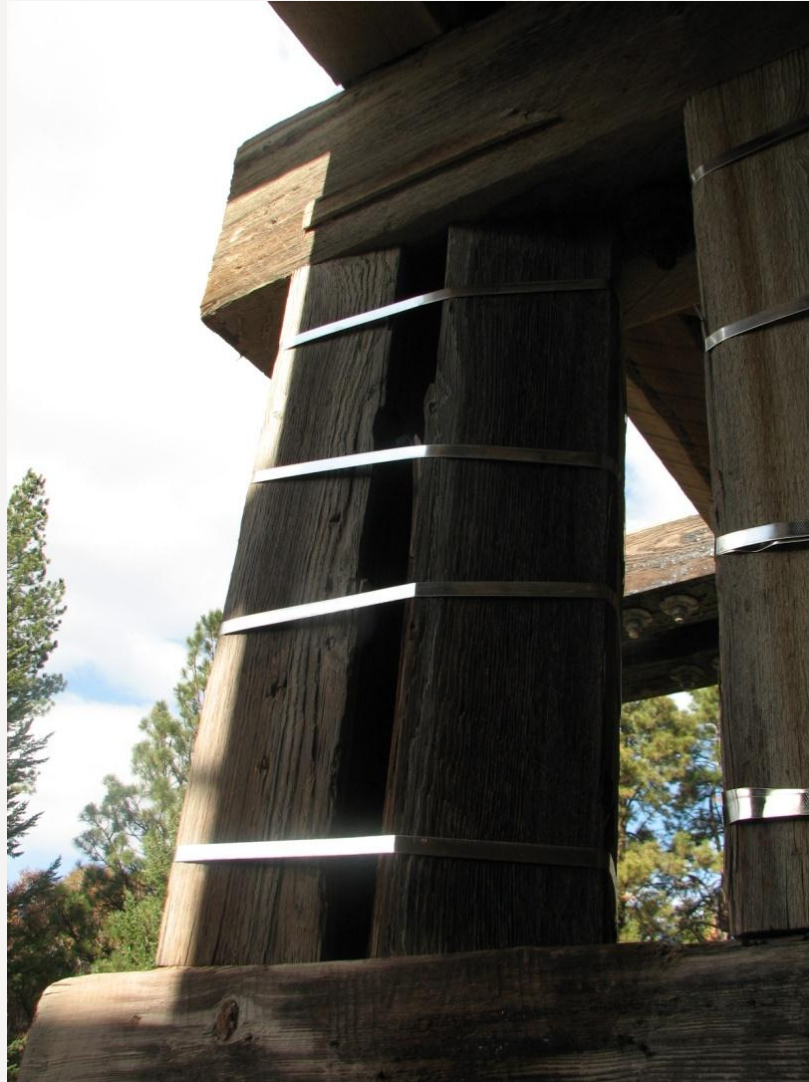
Inspection: Queenpost Truss Deterioration

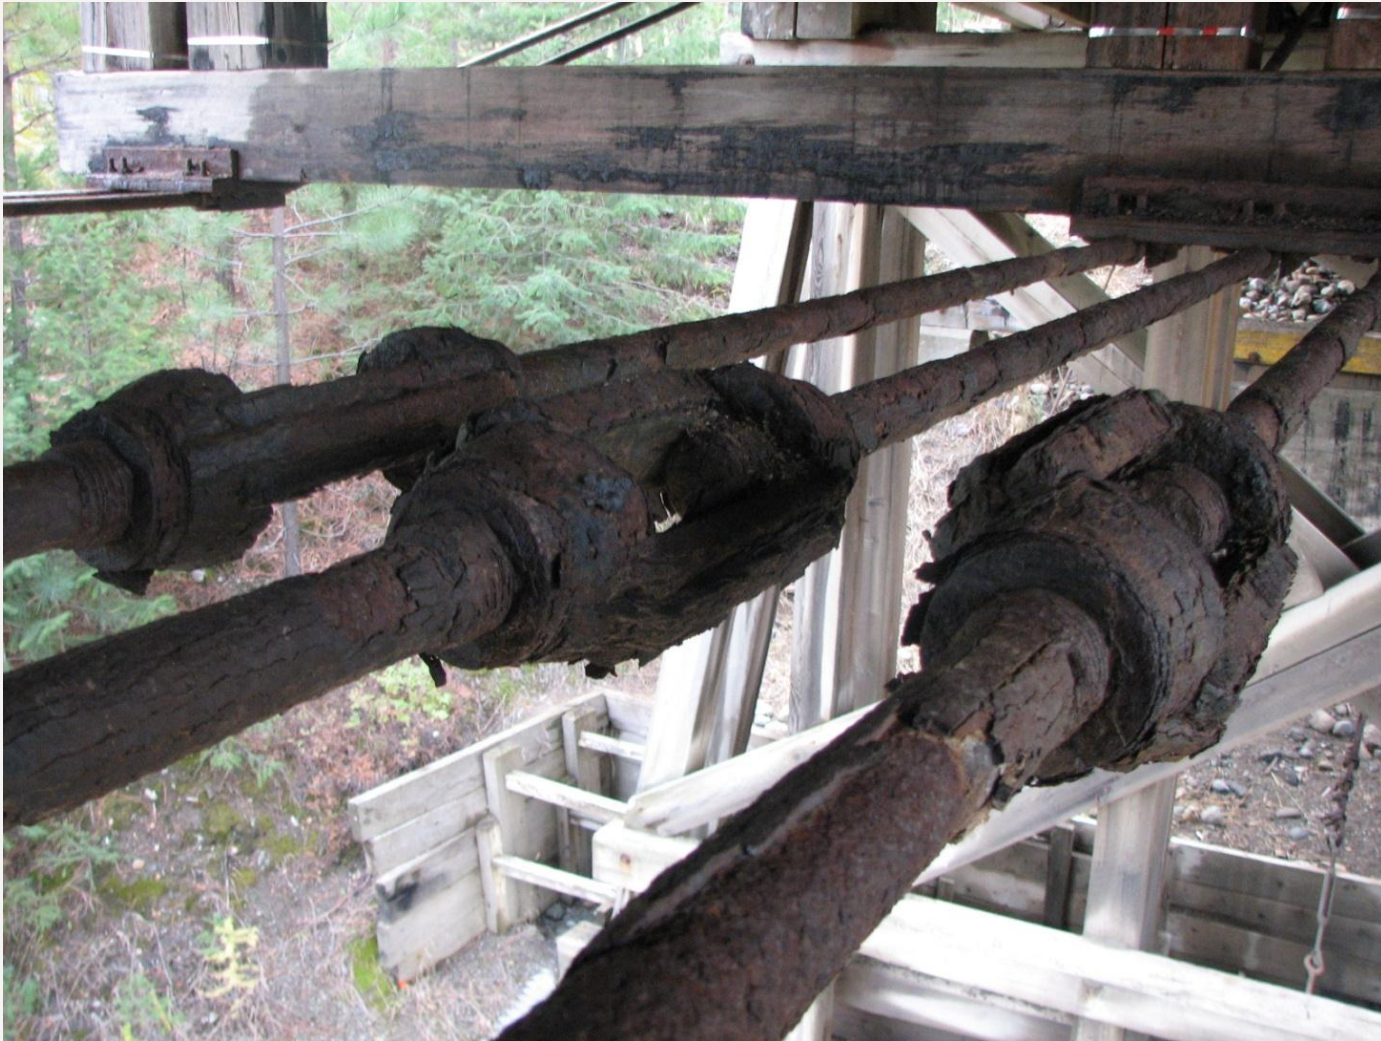
Inspection: Queenpost Truss Deterioration

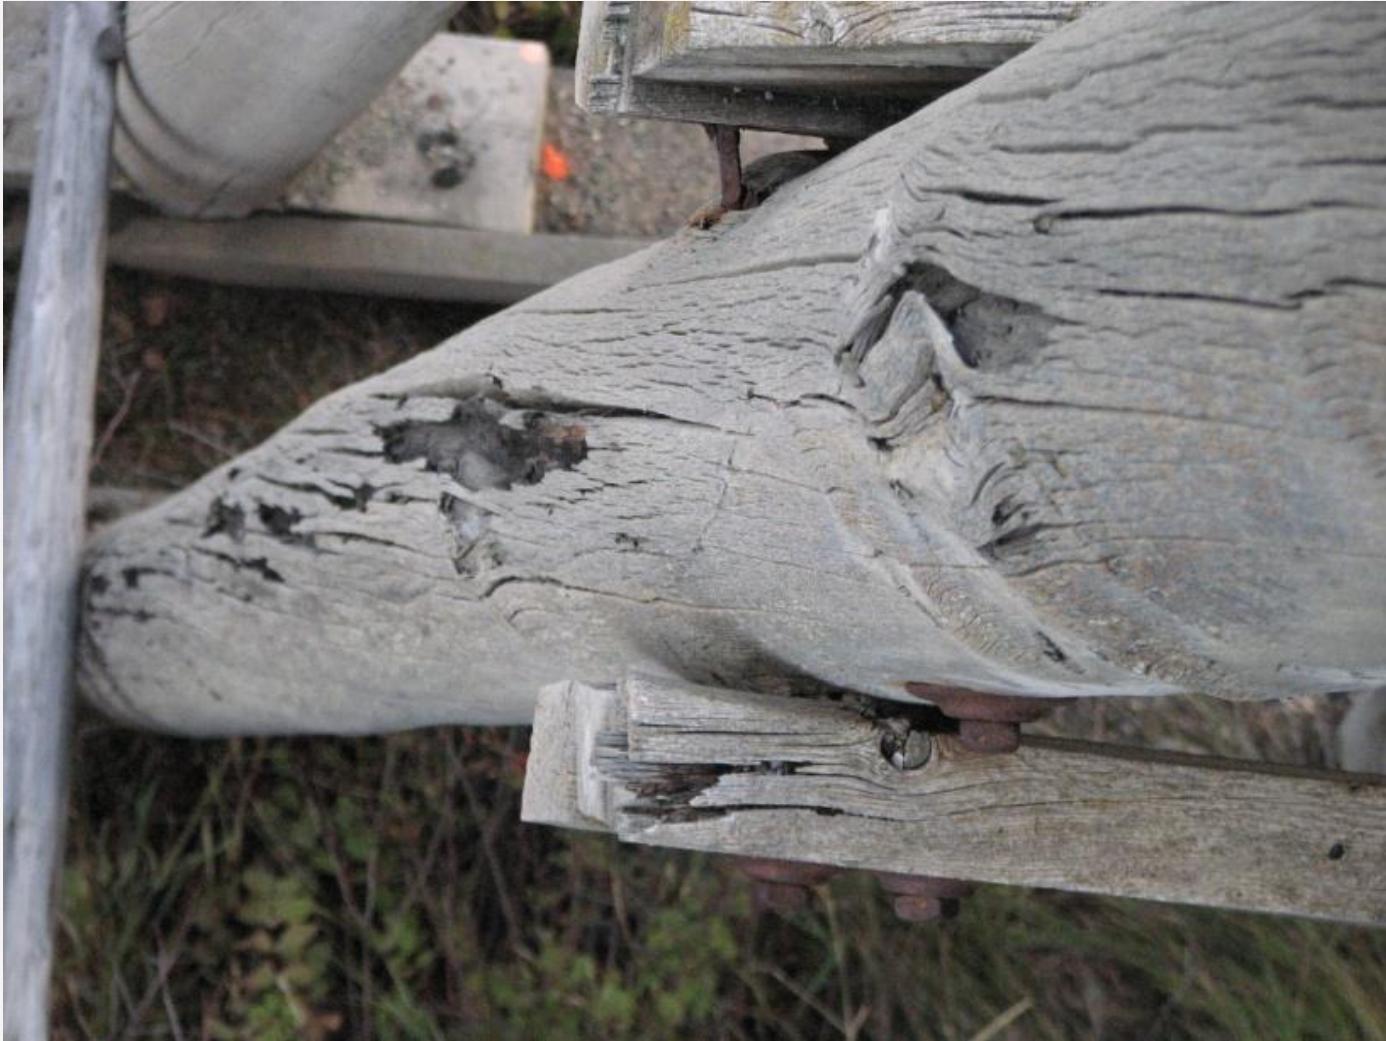
Inspection: Substructure Deterioration

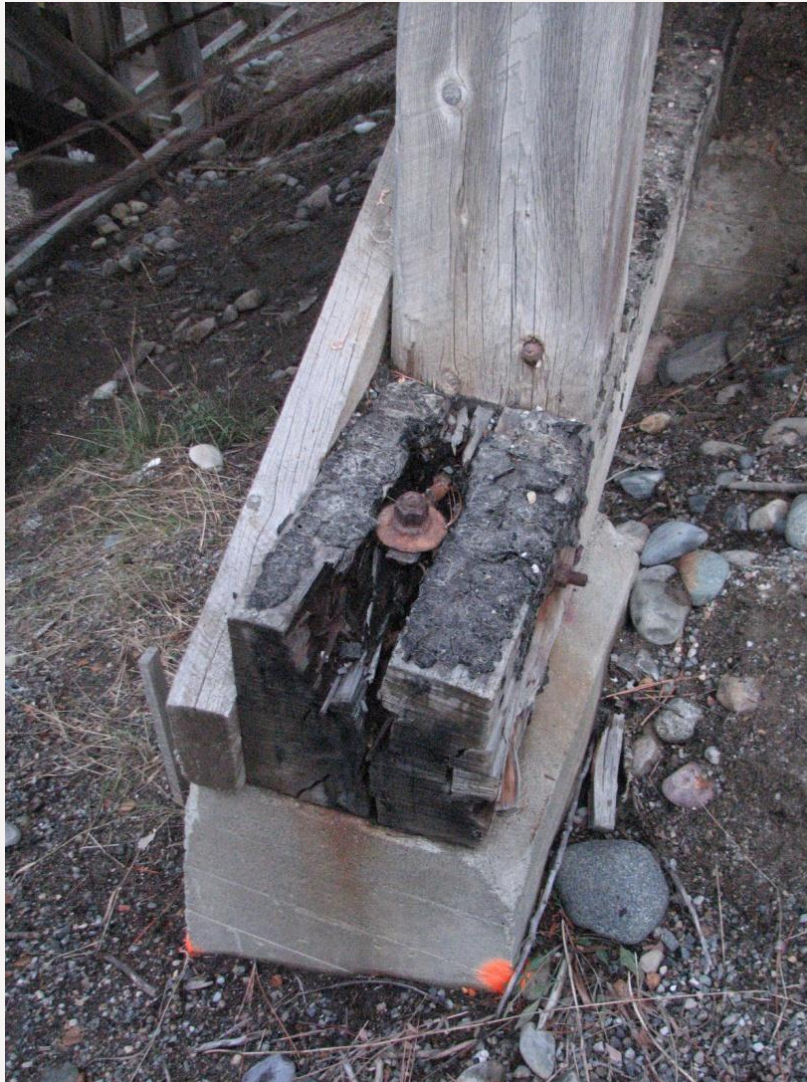
Inspection: Substructure Deterioration

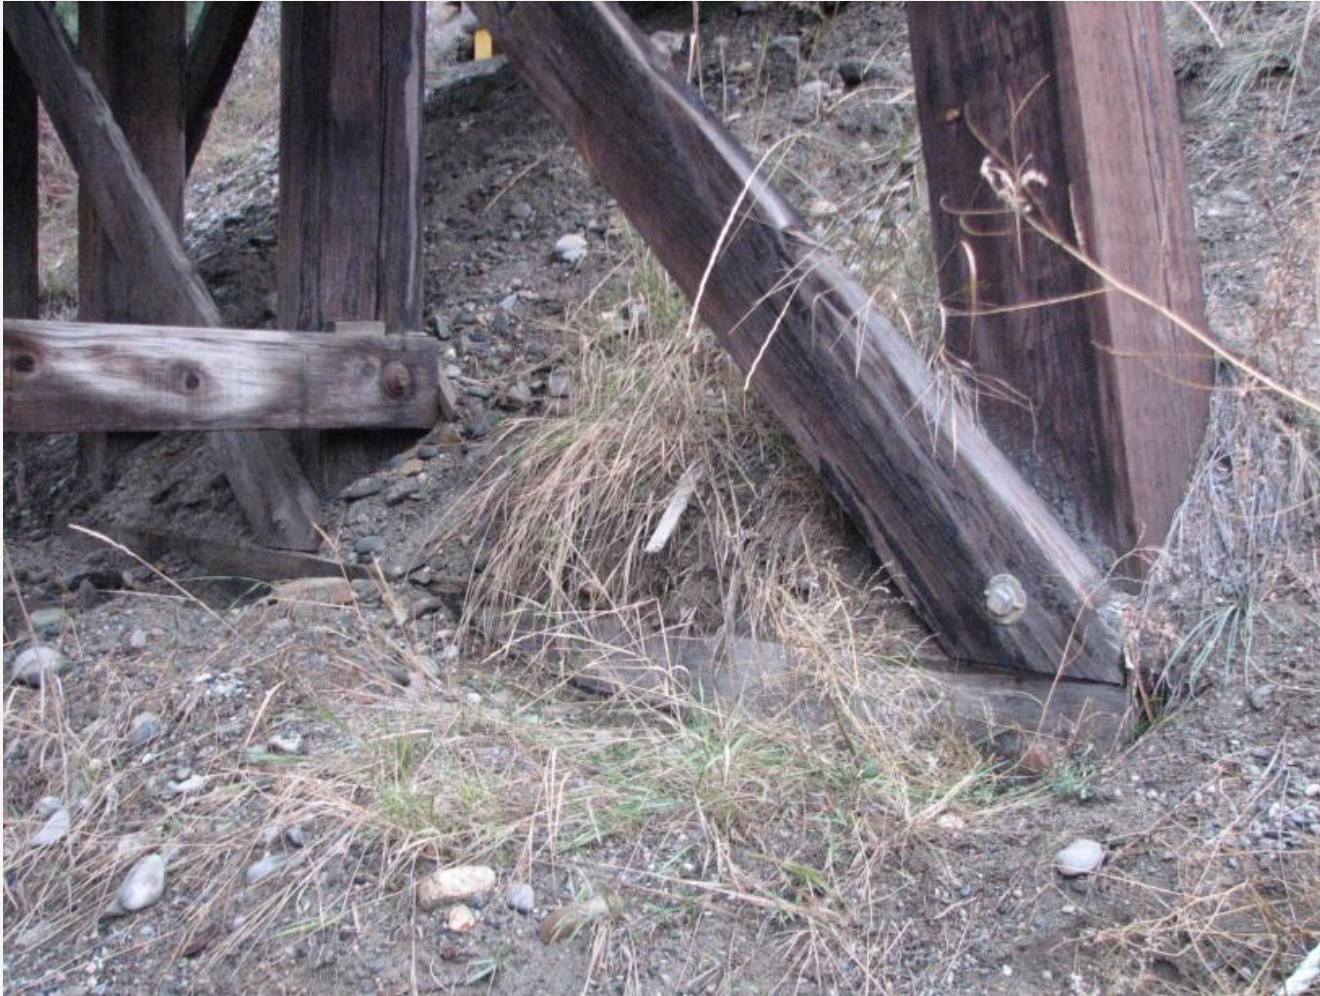
Inspection: Substructure Deterioration

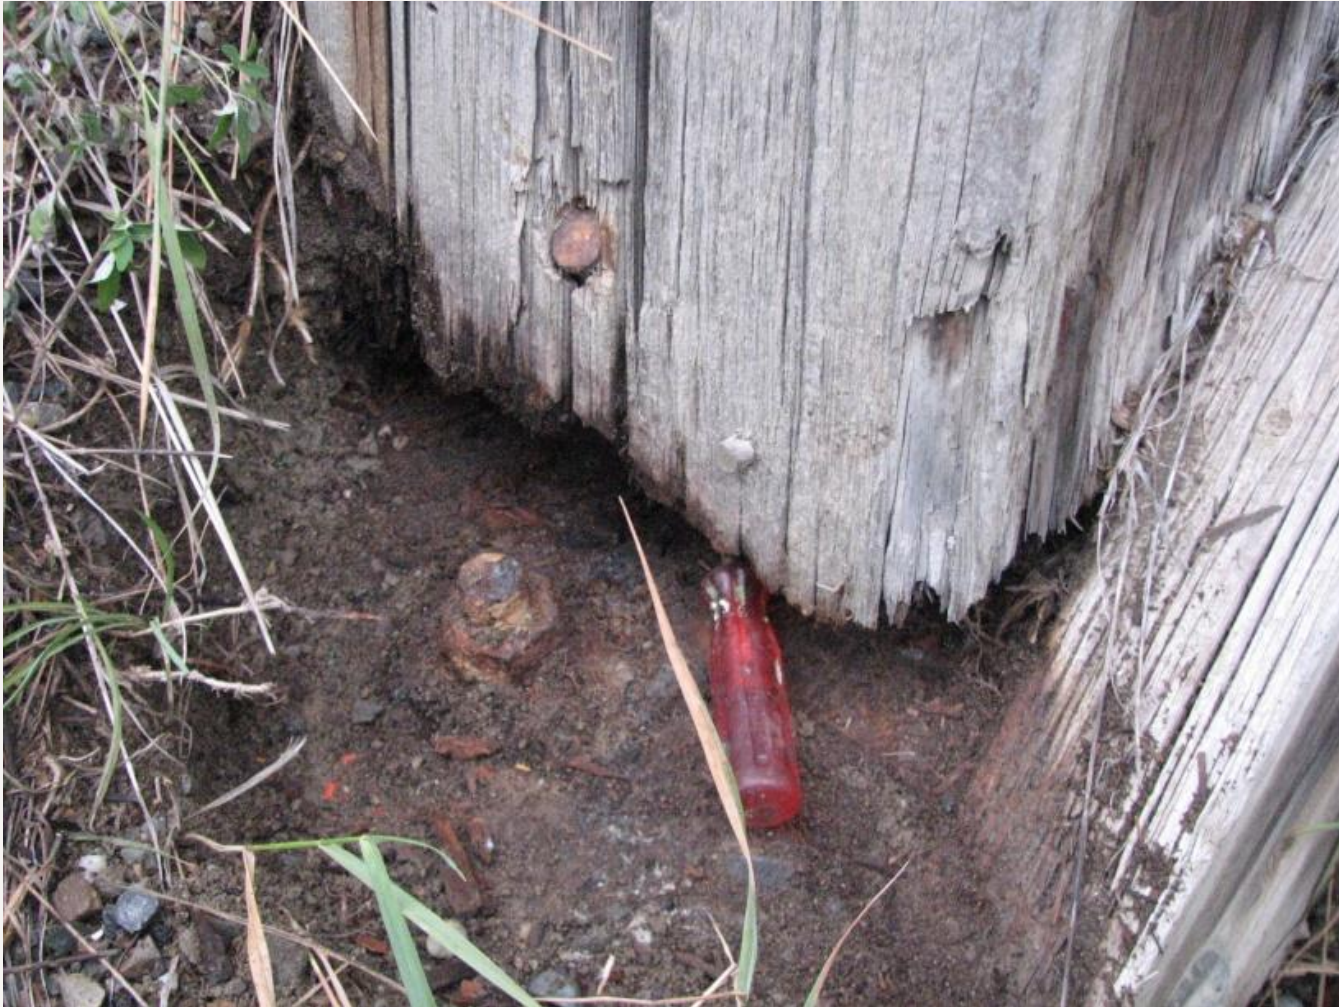
Inspection: Substructure Deterioration

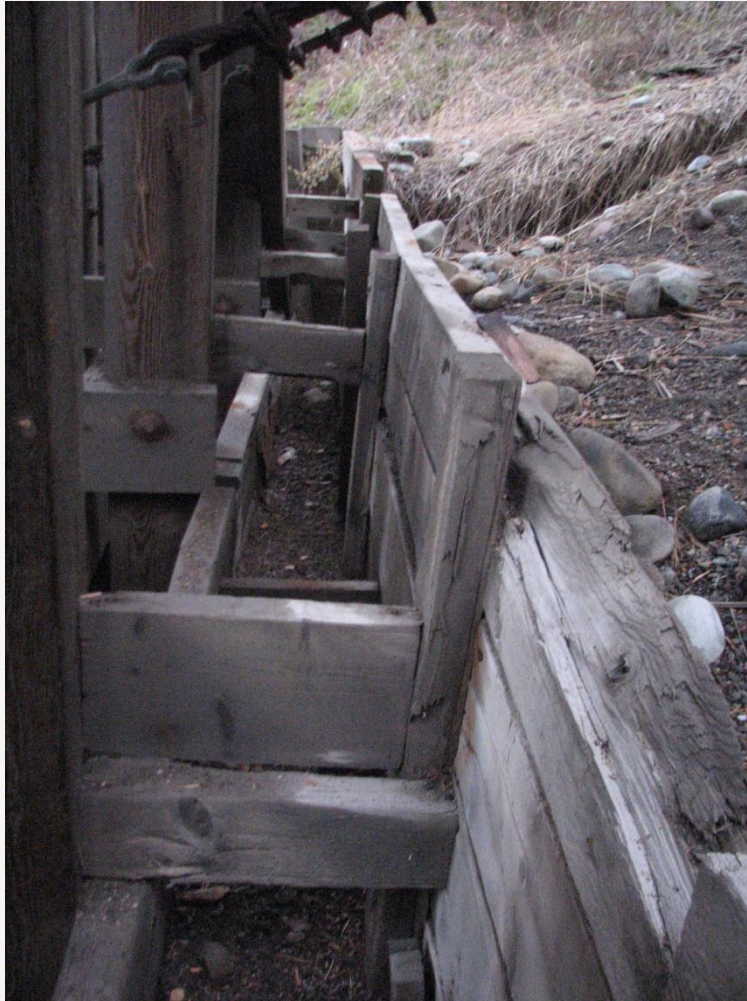
Inspection: South Slope Movement

- **Double load limit to 36 tonnes**
- **Pedestrians and cyclists to share roadway**
- **Drastically reduce maintenance requirements**
- **Mitigate south slope movement problem**

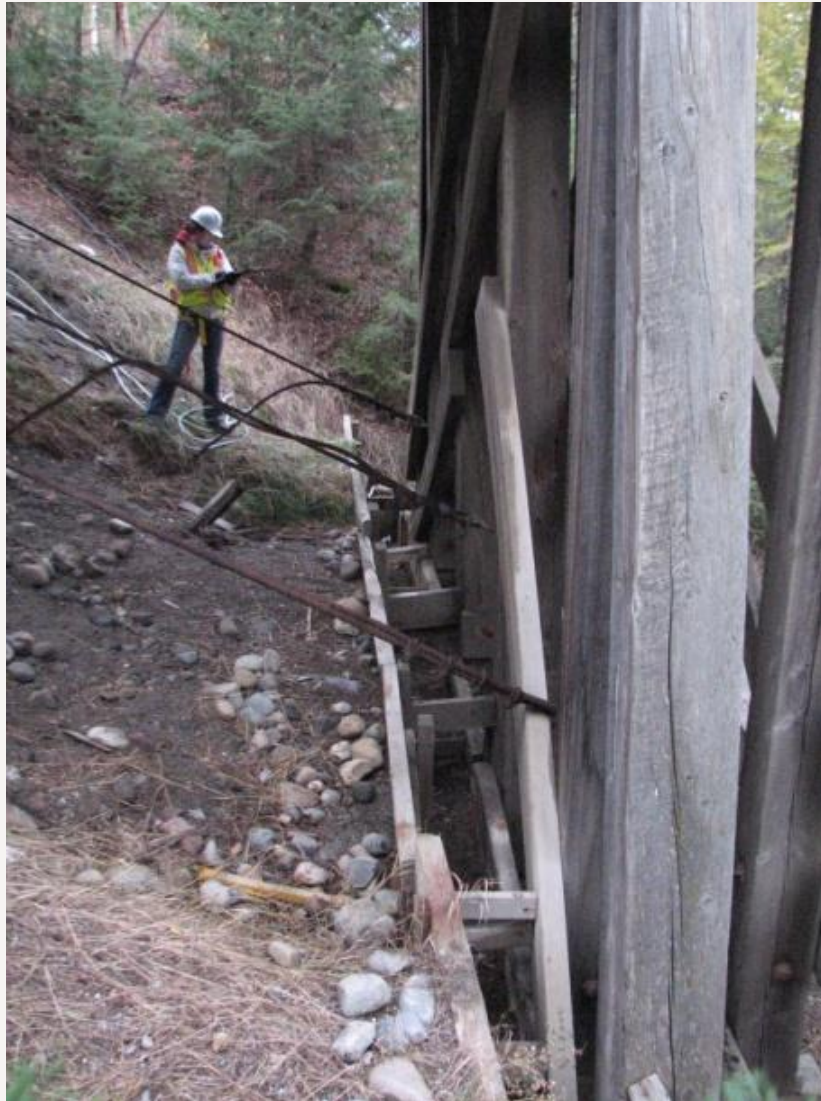
Inspection: South Slope Movement

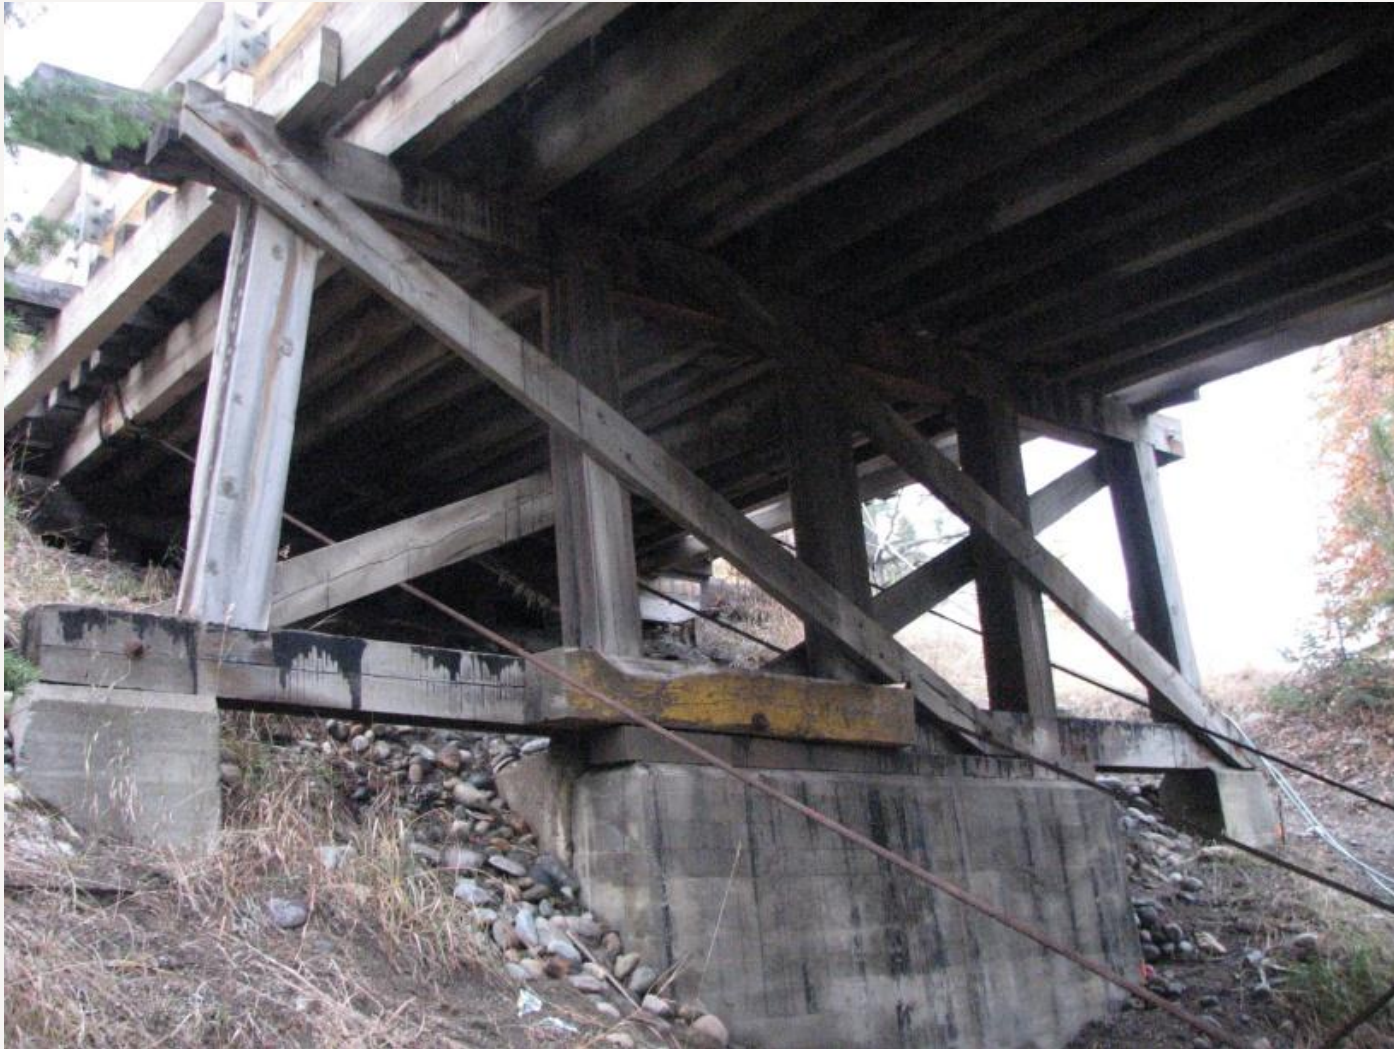
Inspection: South Slope Movement
