Rehabilitation of St. Marys Wycliffe Bridge in British Columbia, Canada

2nd International Conference on Timber Bridges

Murray M. Johnson, P.Eng., PE
Buckland & Taylor Ltd.

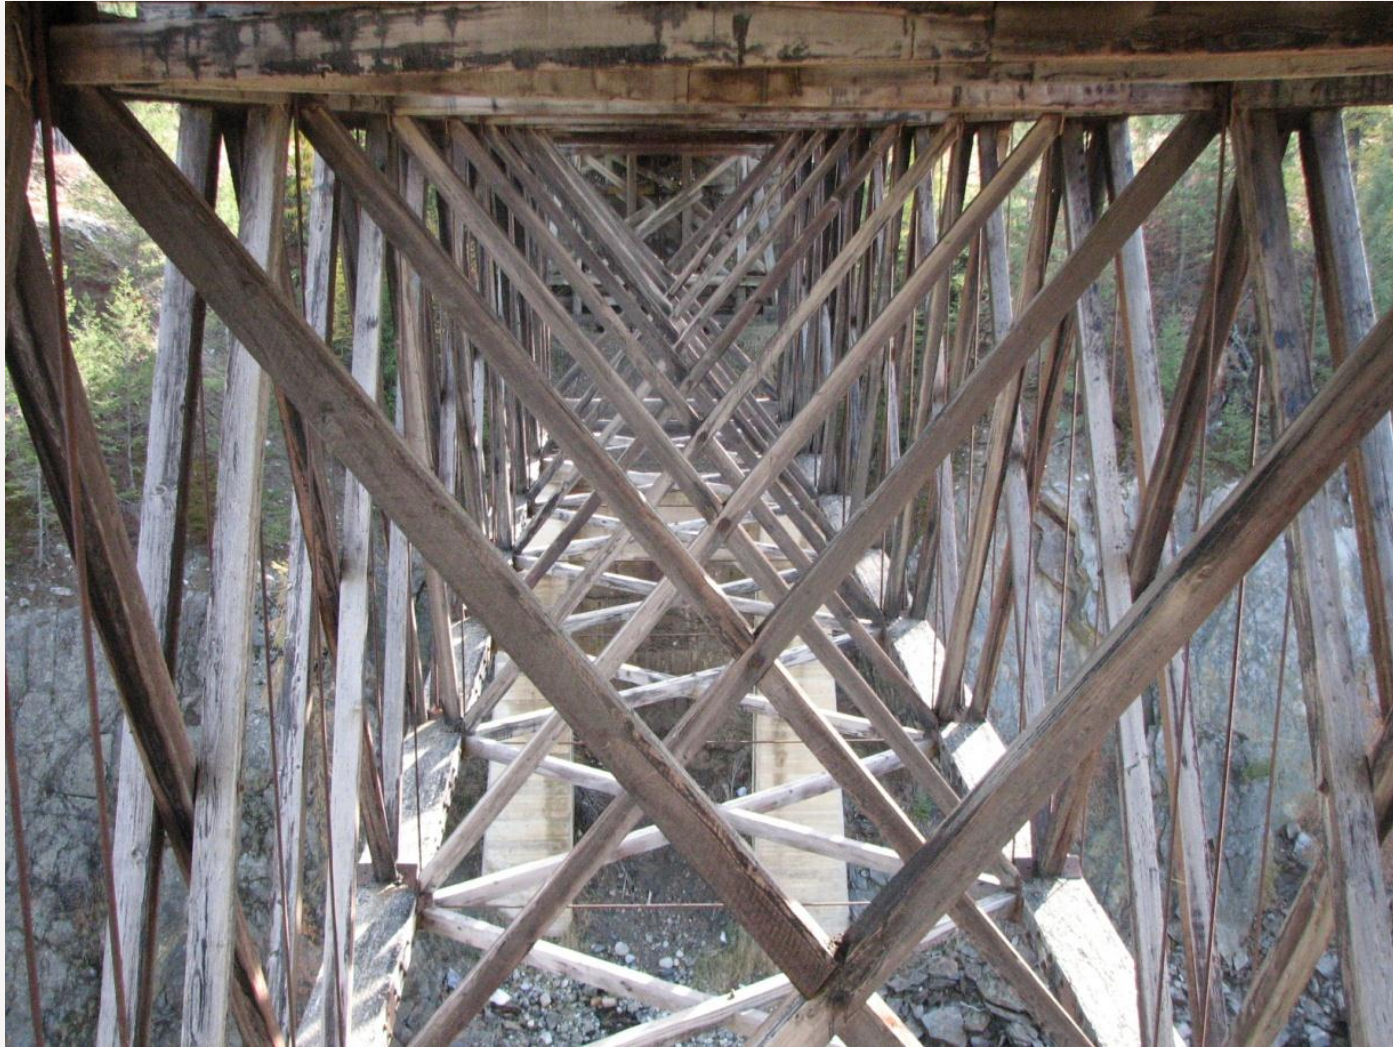
Inspection: Howe Truss

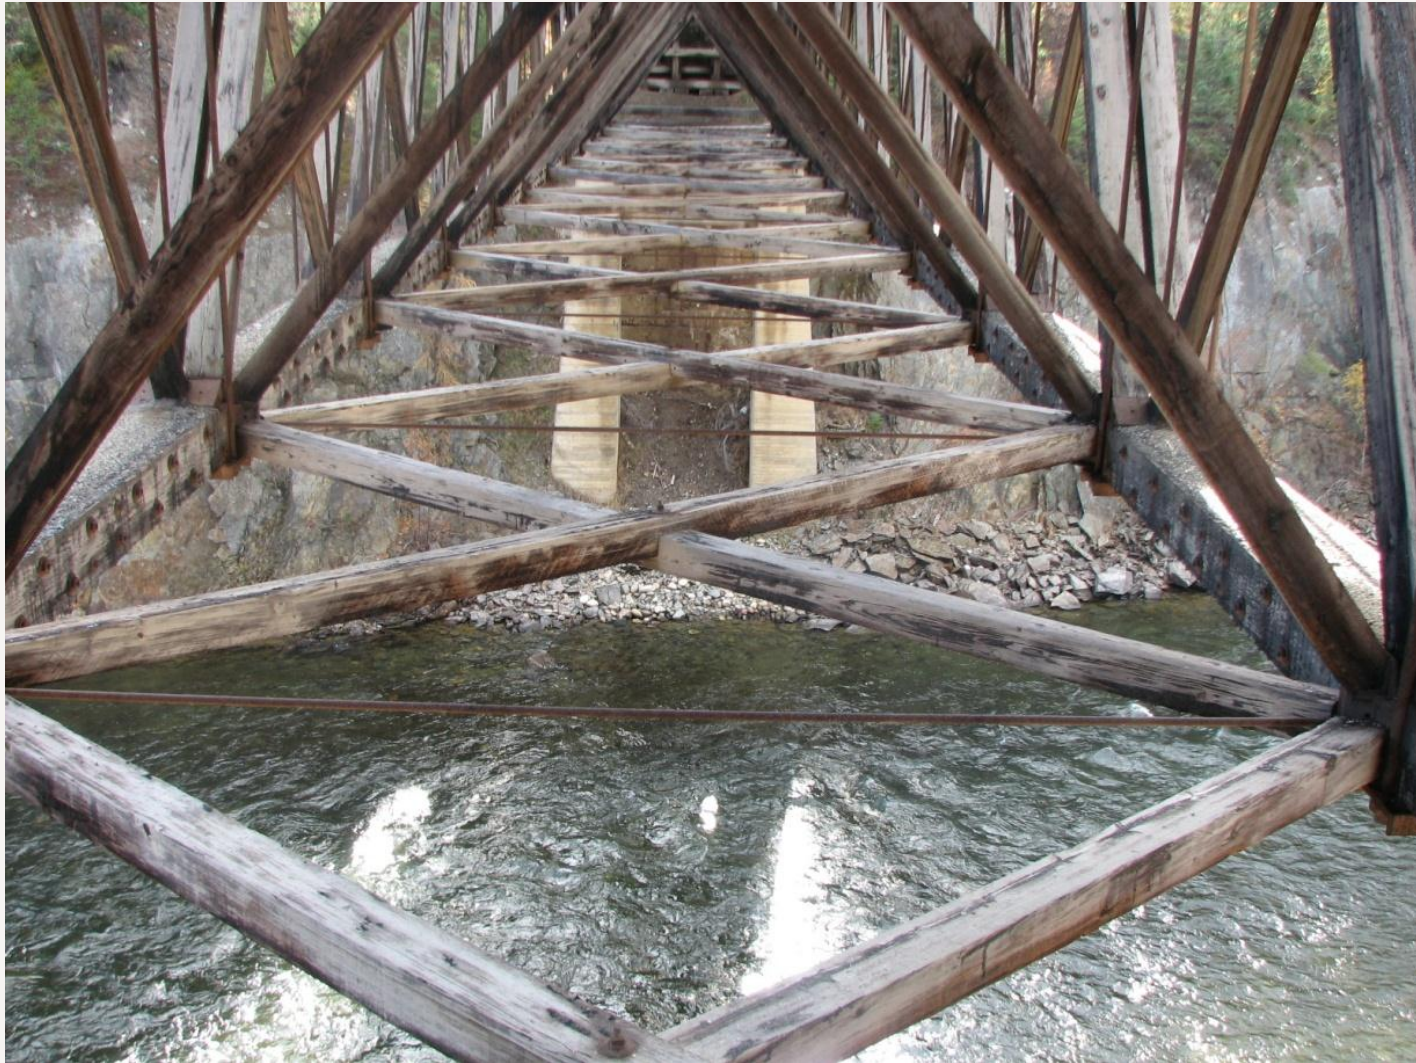
Inspection: Howe Truss

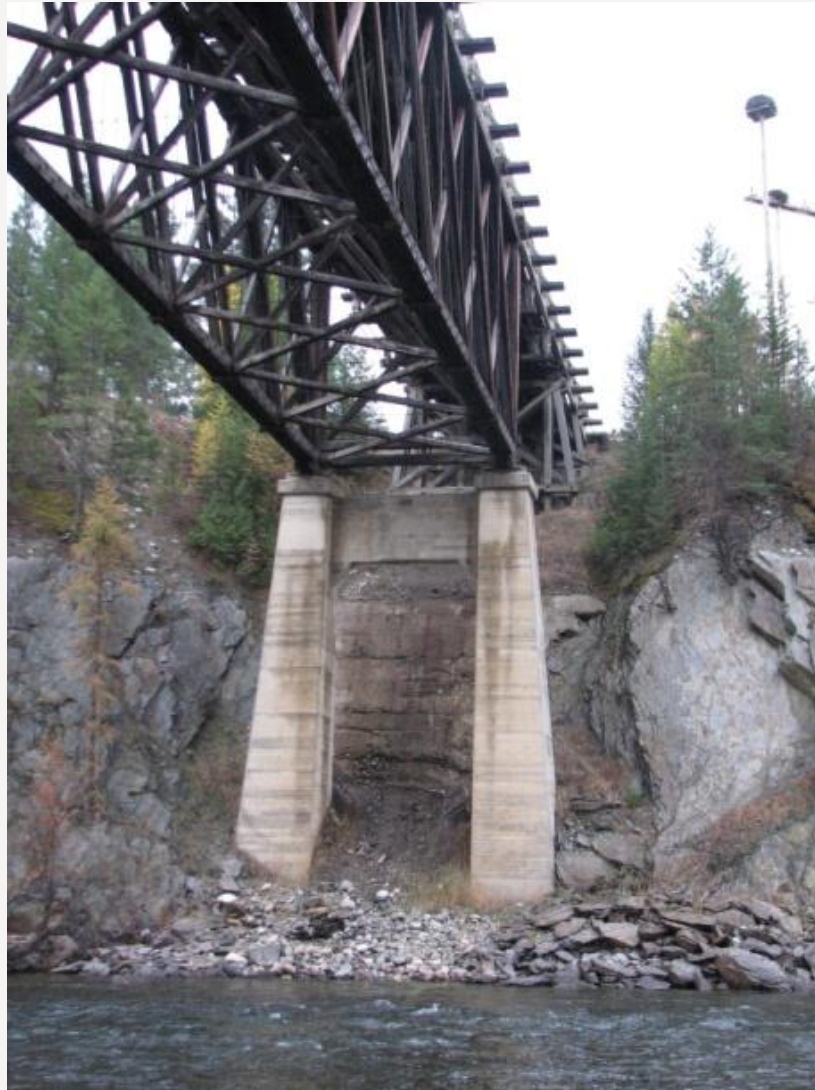
Inspection: Main Piers

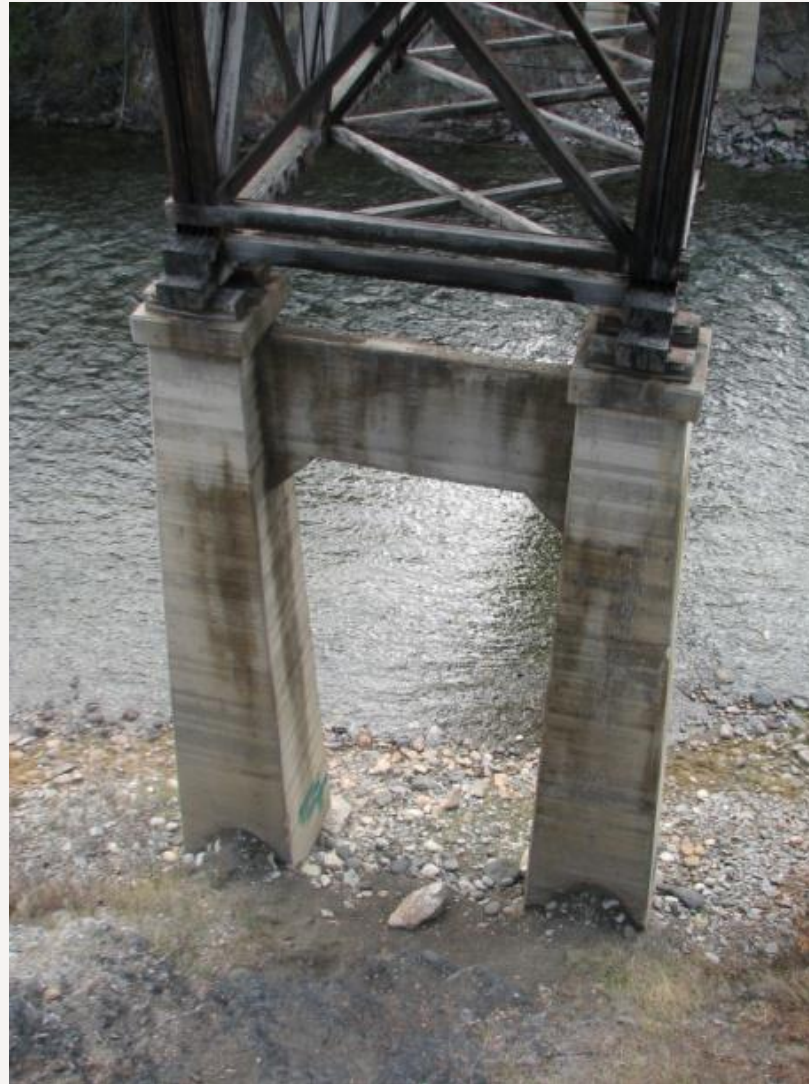
Inspection: Main Piers

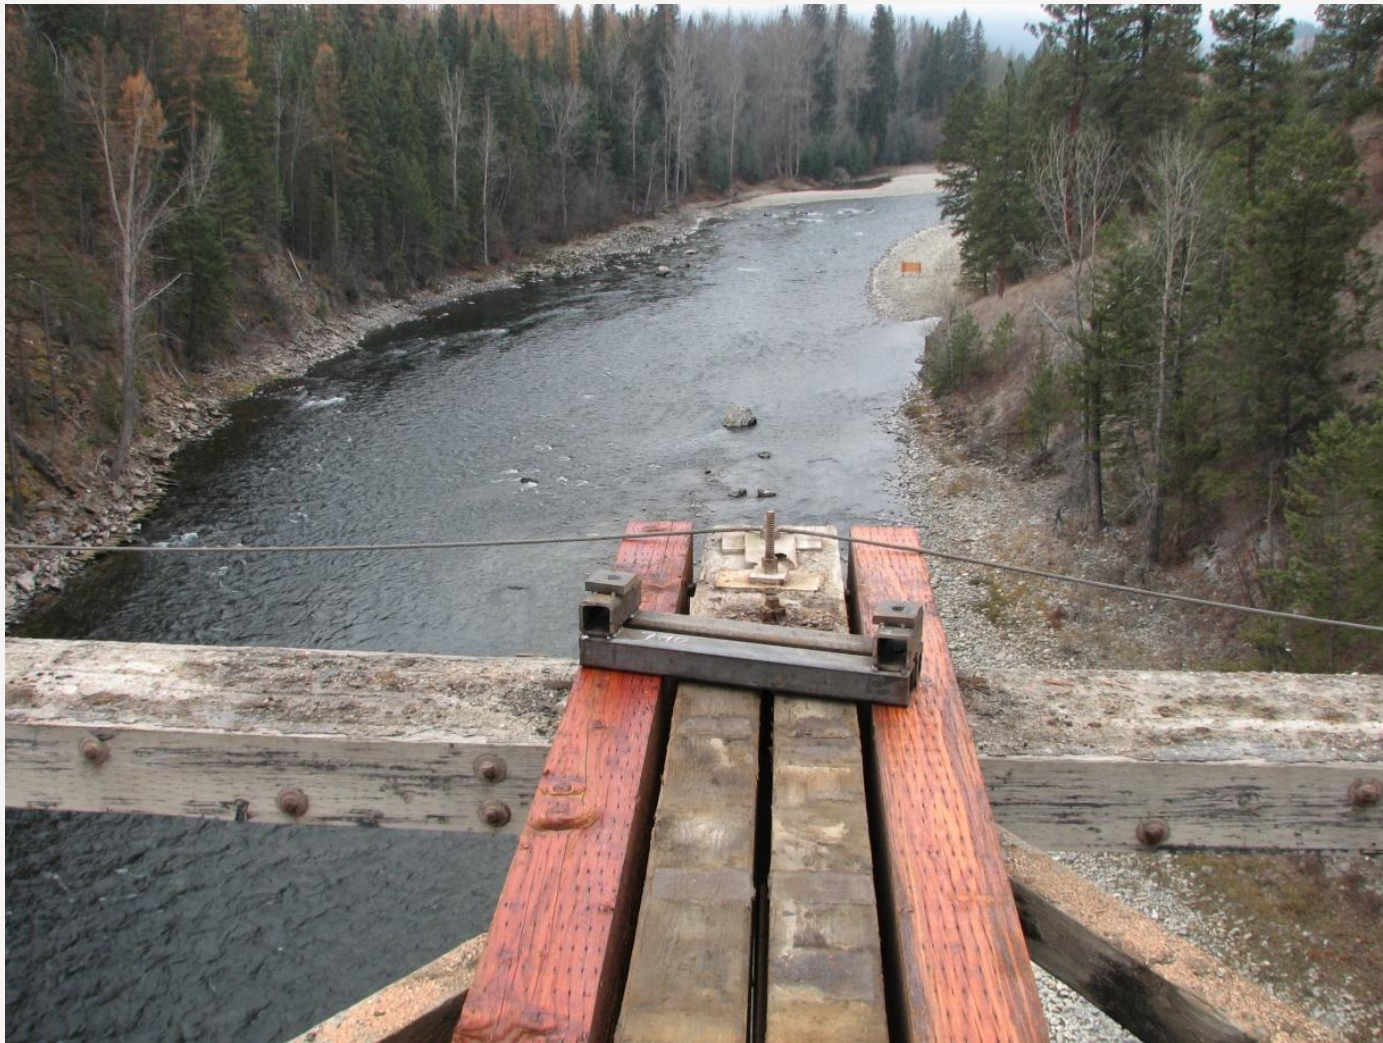
Supplemental Floorbeams

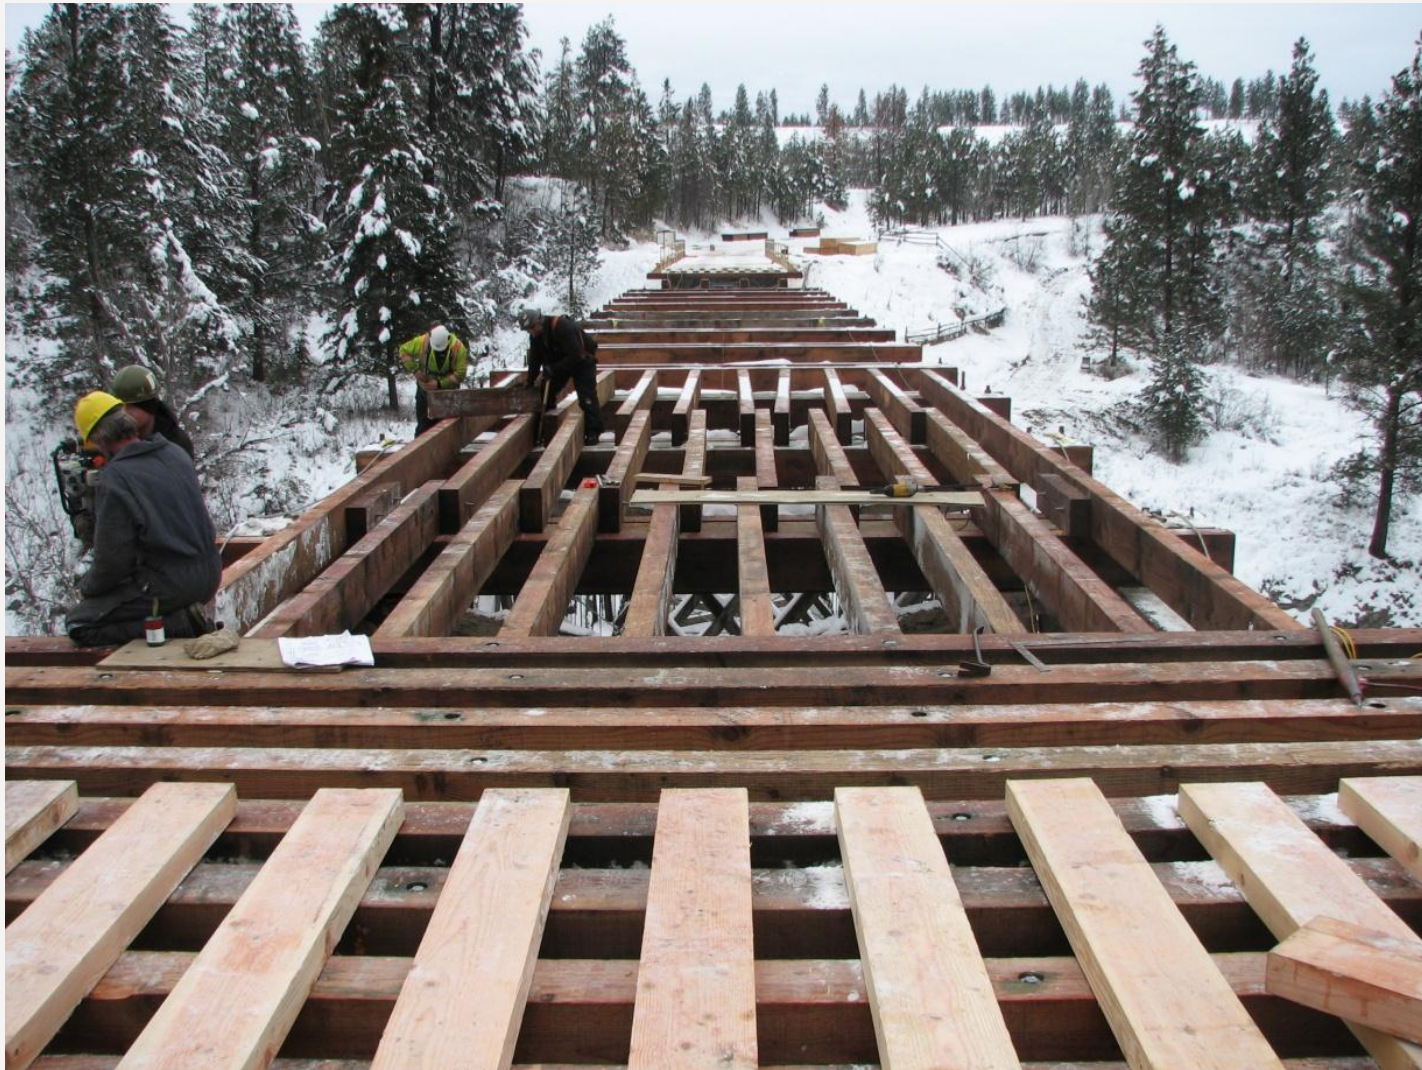
Stringer Installation

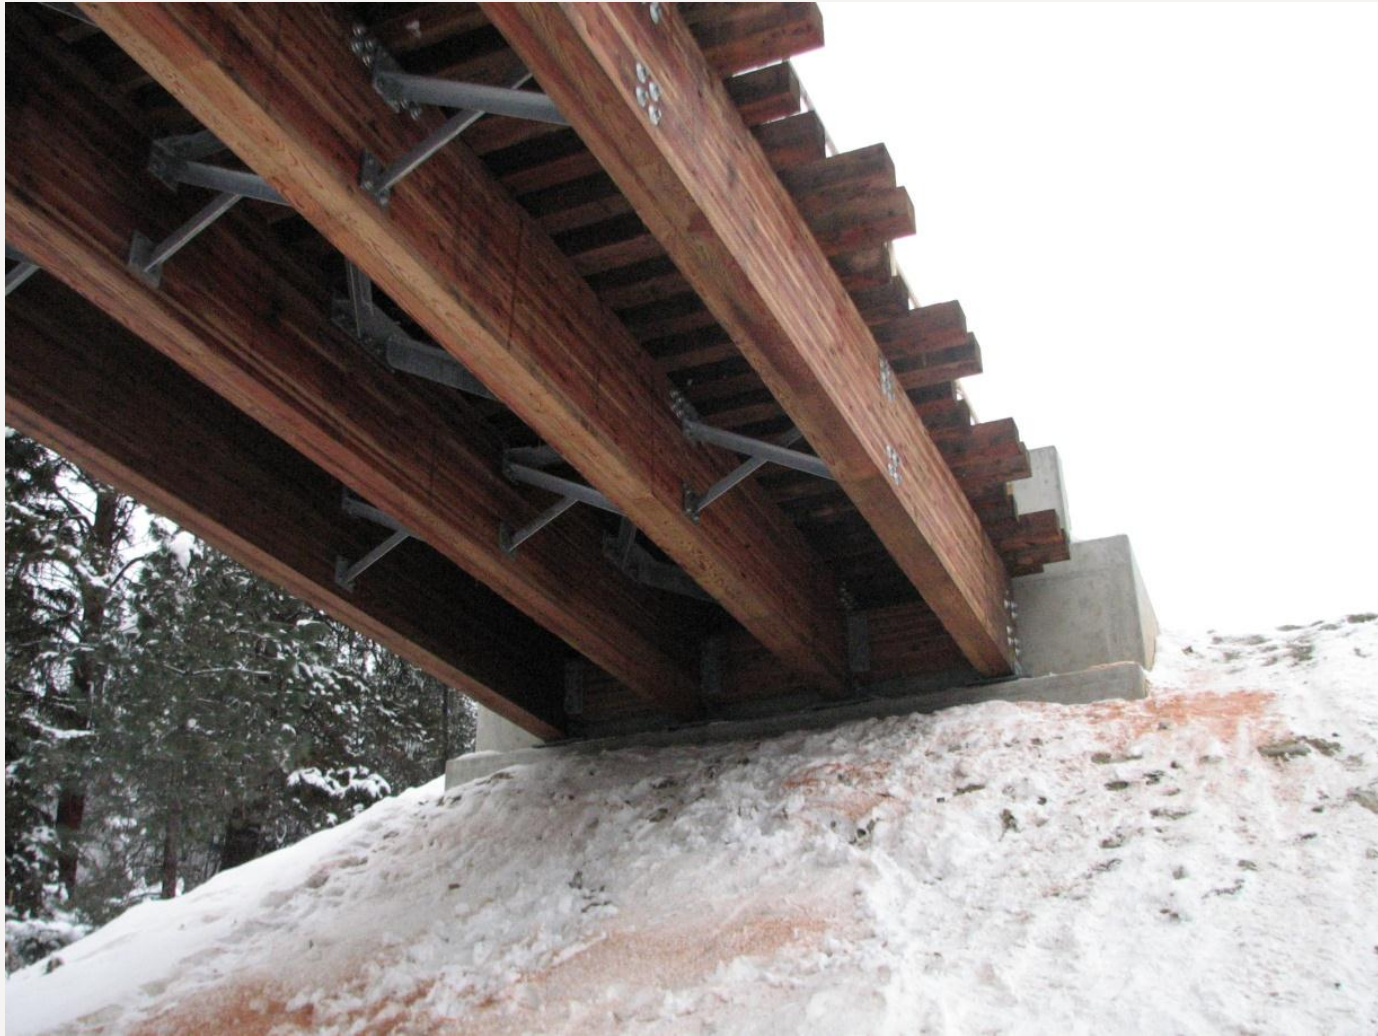
Glulam Girders

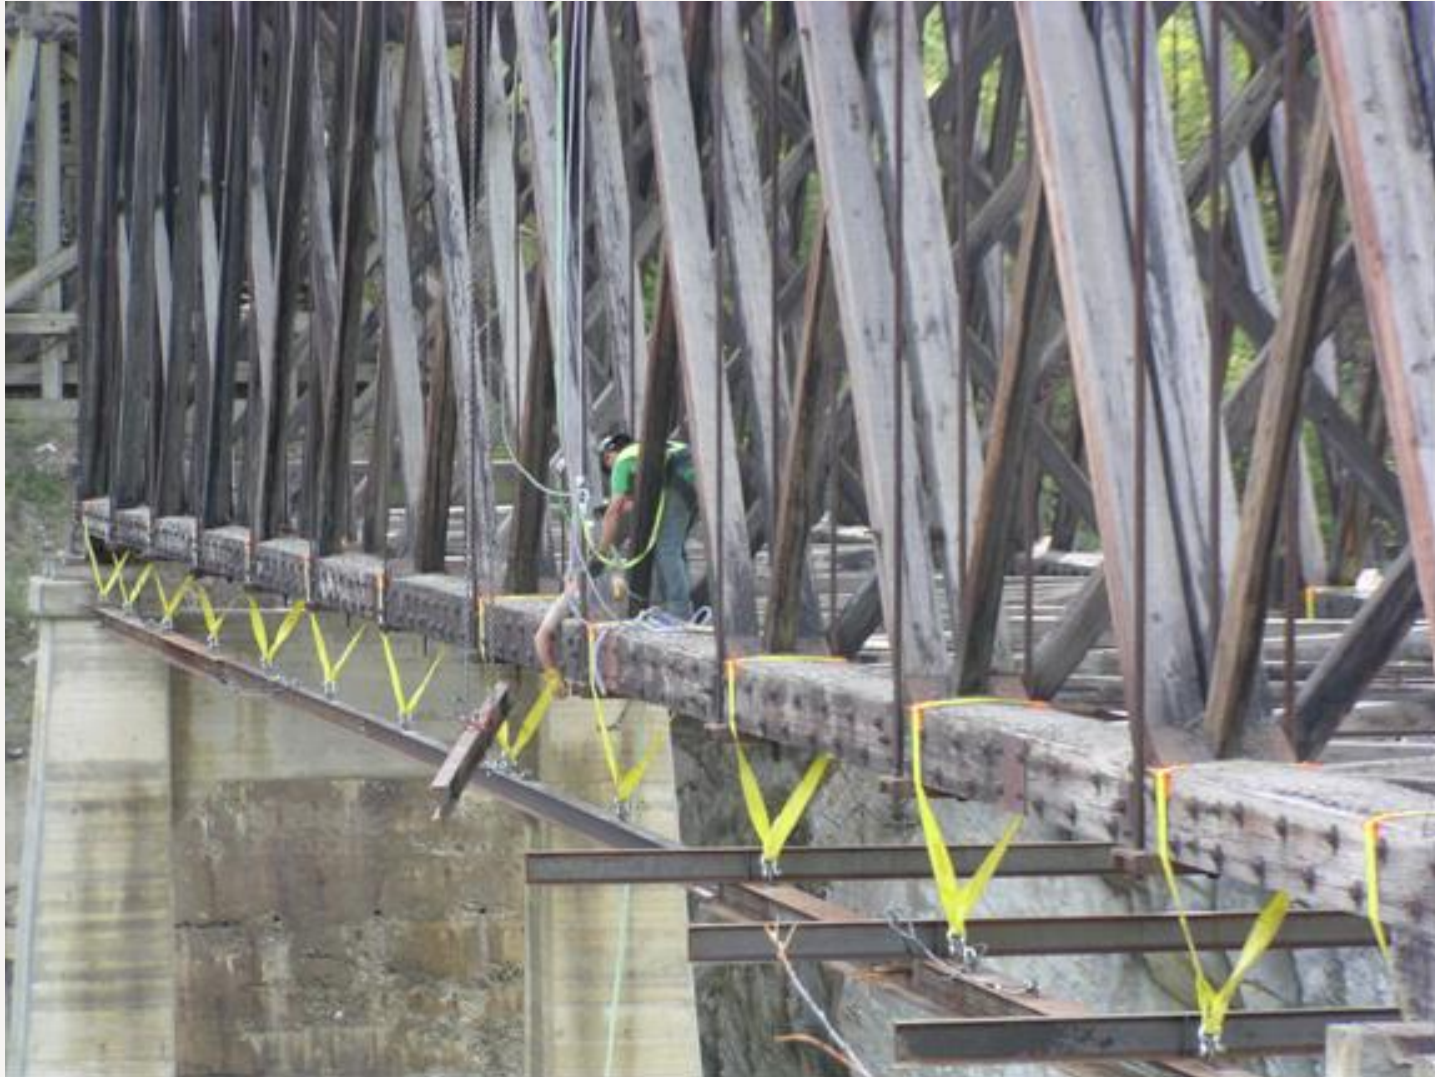
Truss Rehabilitation & Strengthening

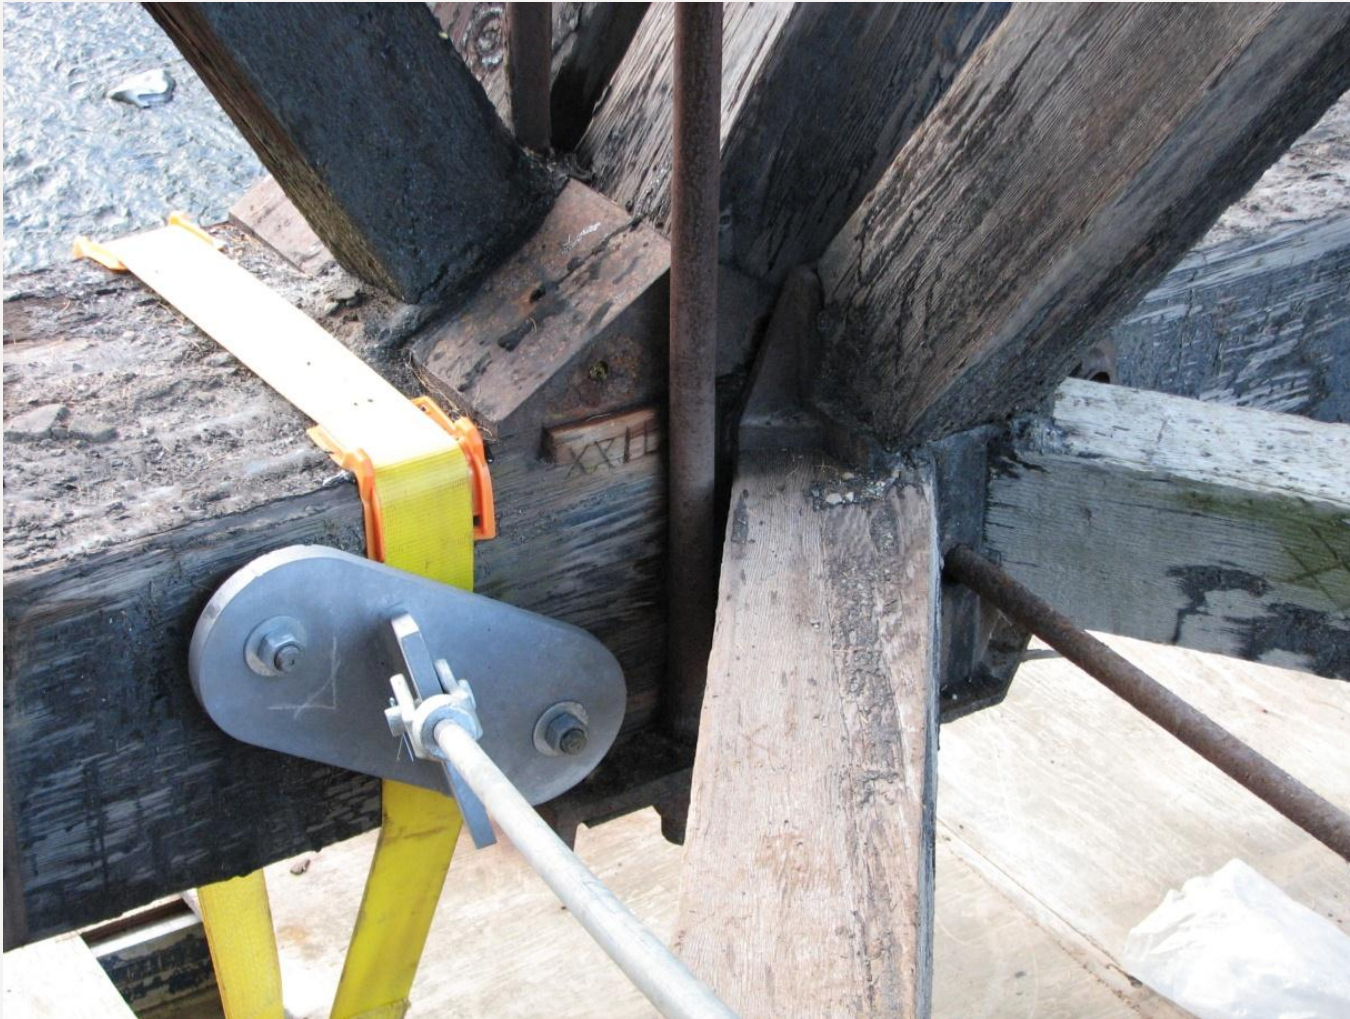
Truss Rehabilitation & Strengthening

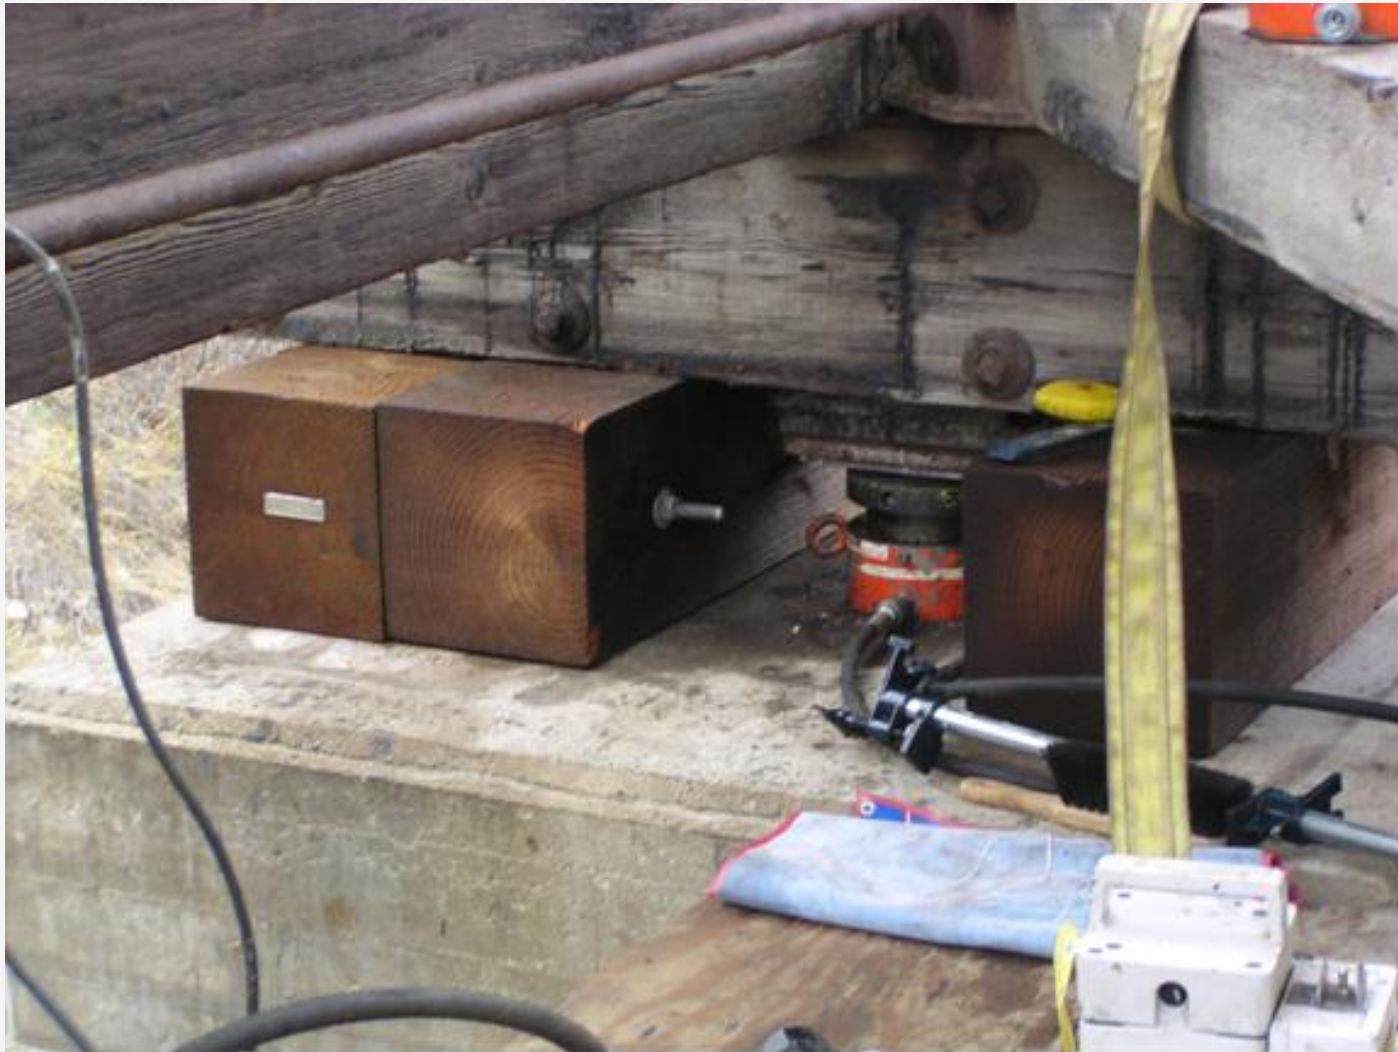
Truss Rehabilitation & Strengthening

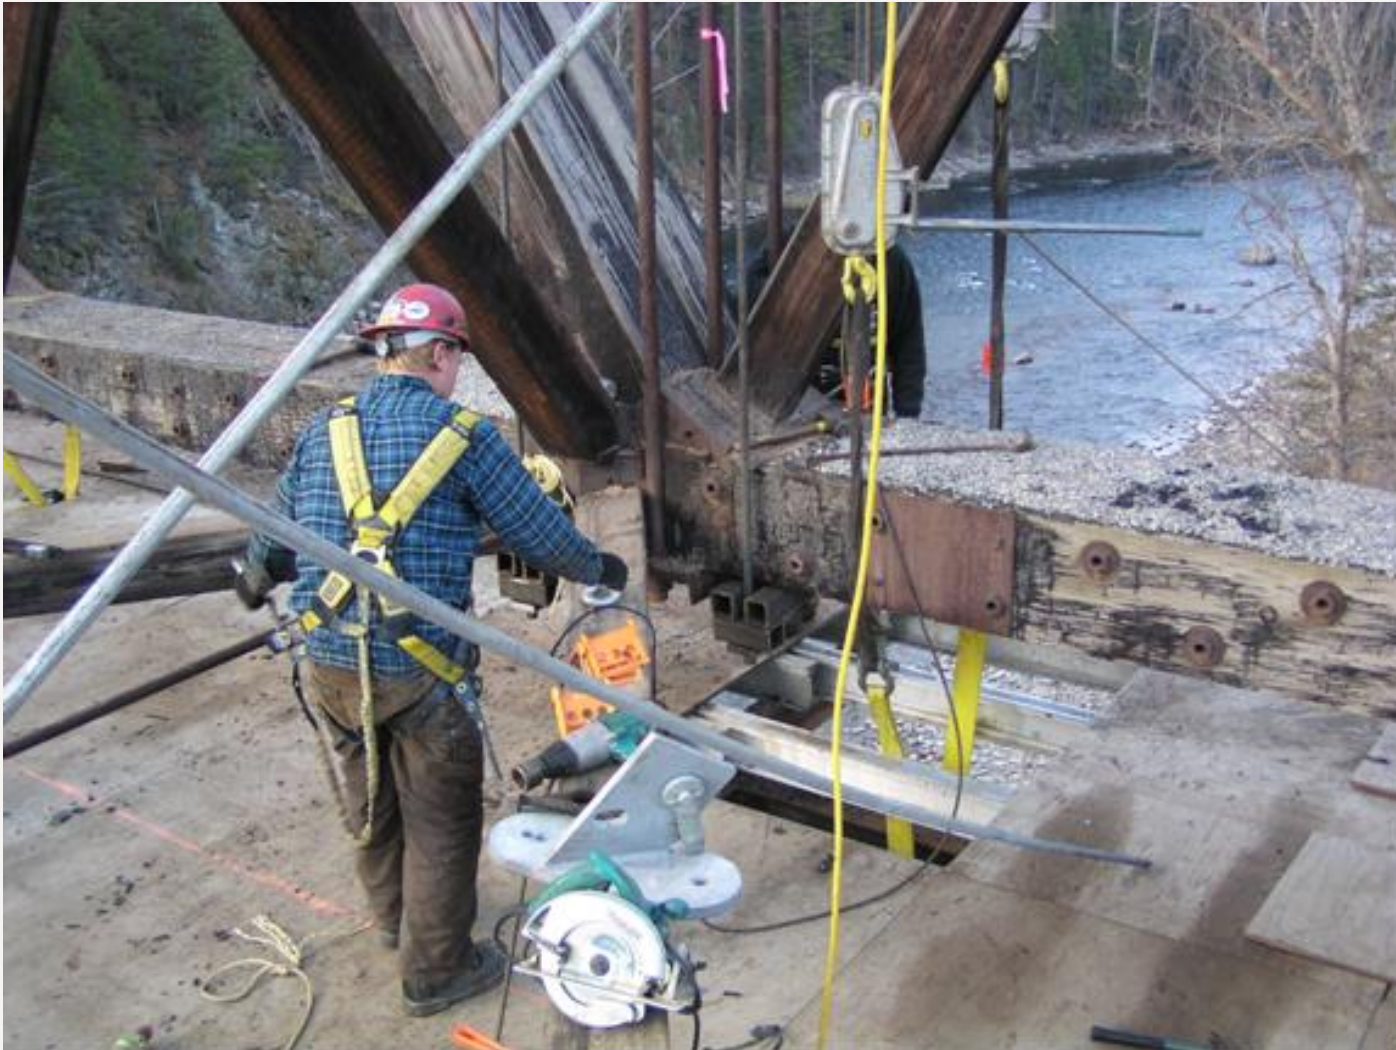
Truss Rehabilitation & Strengthening

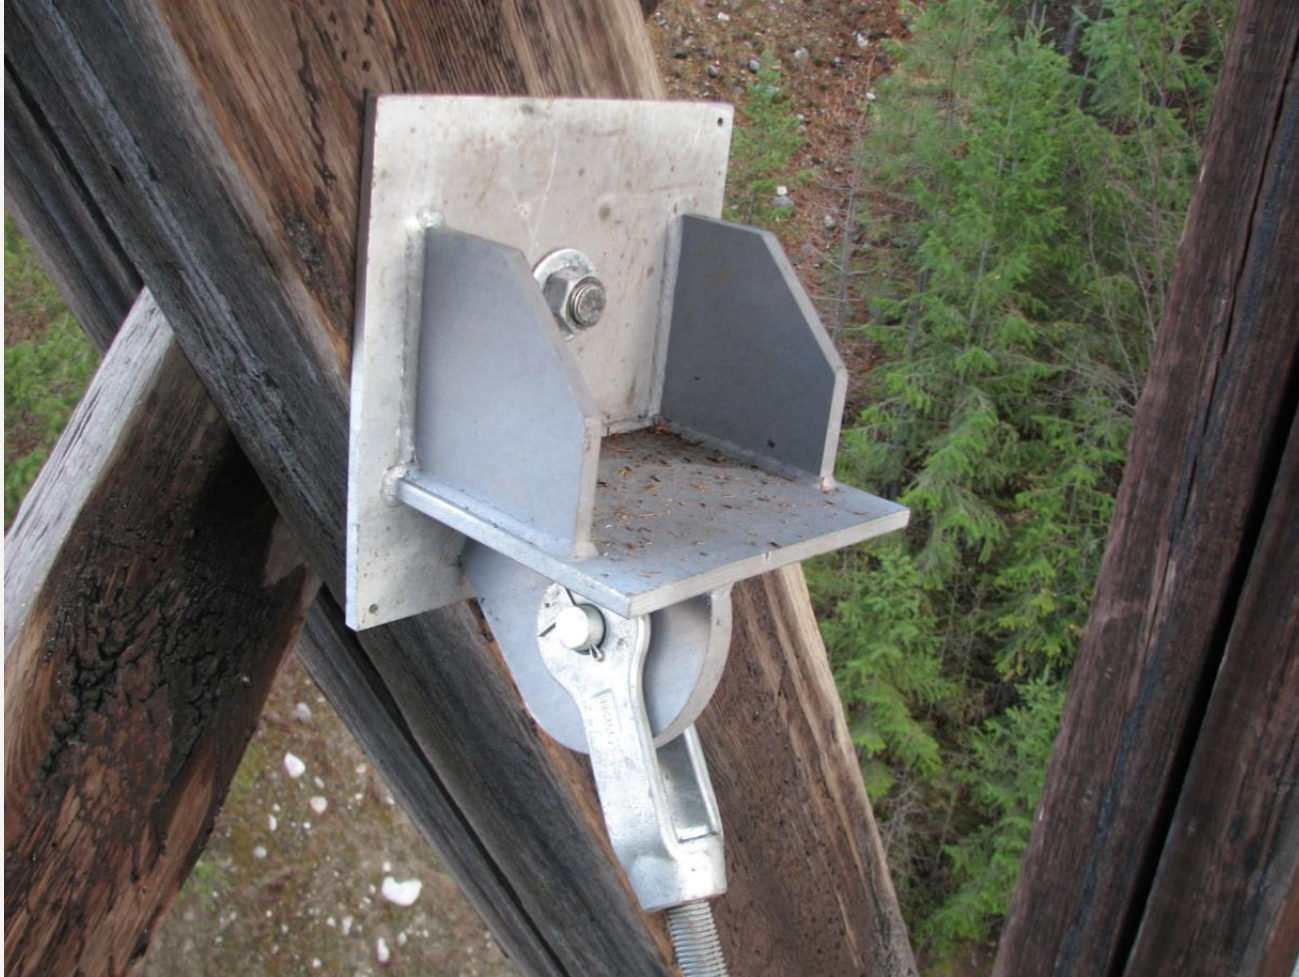
Truss Rehabilitation & Strengthening

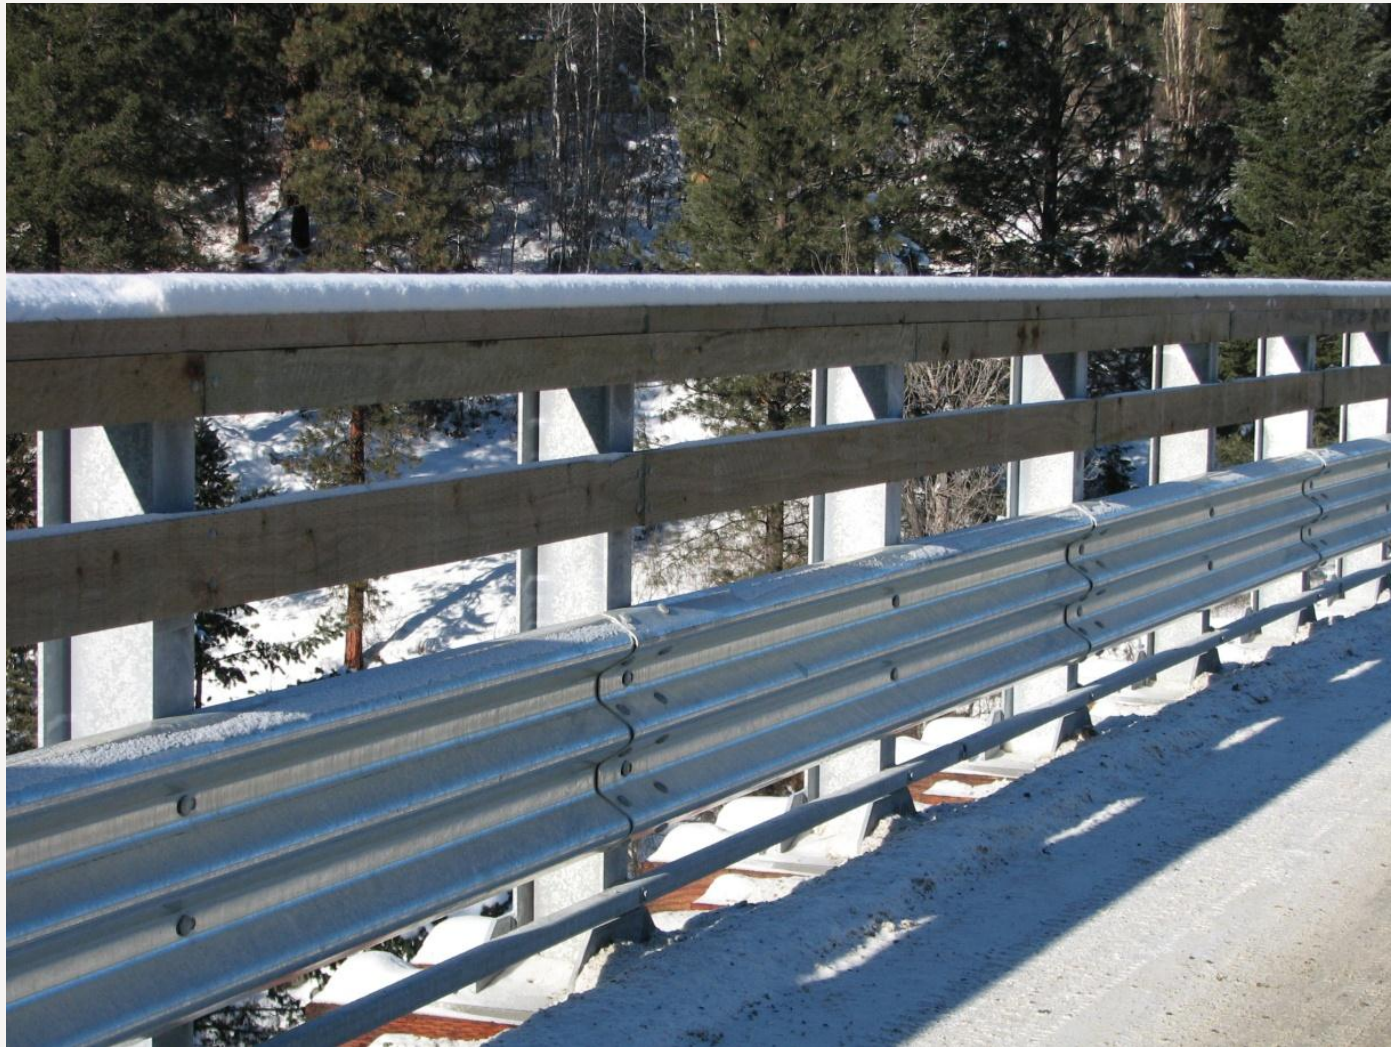
Completed Bridge: Barriers
