From “damage maps” to “condition inventories”: practically approved concept for inspecting modern & historic timber structures - not only bridges

Frank Rinn, Heidelberg/Germany

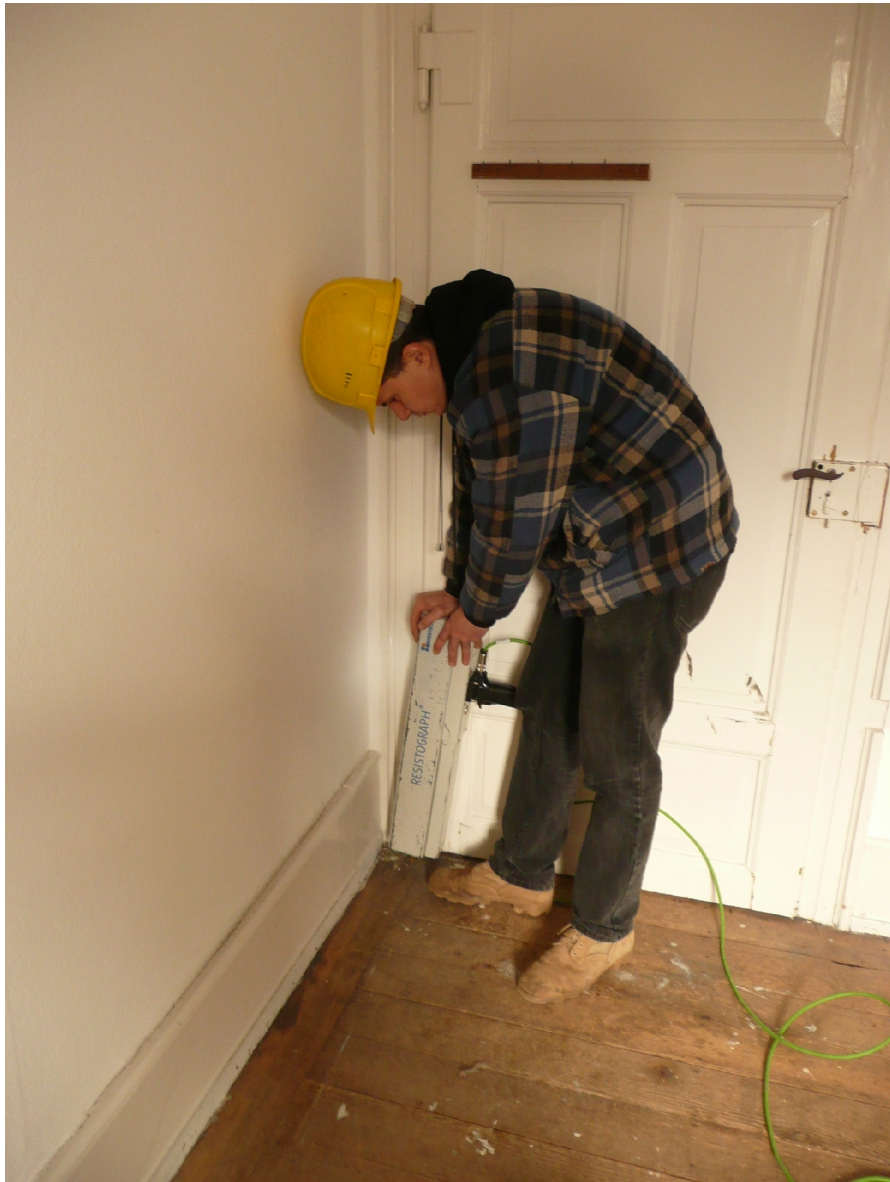
Locating 'hidden' beams and assessing their condition with resistance drilling without taking off the floor (or stucco).

This often requires many drillings but they are fast meanwhile. Sometimes needles break while searching for beams => old needles are commonly used for that.

Fungal decay types are then determined with samples taken with / from endoscopes.

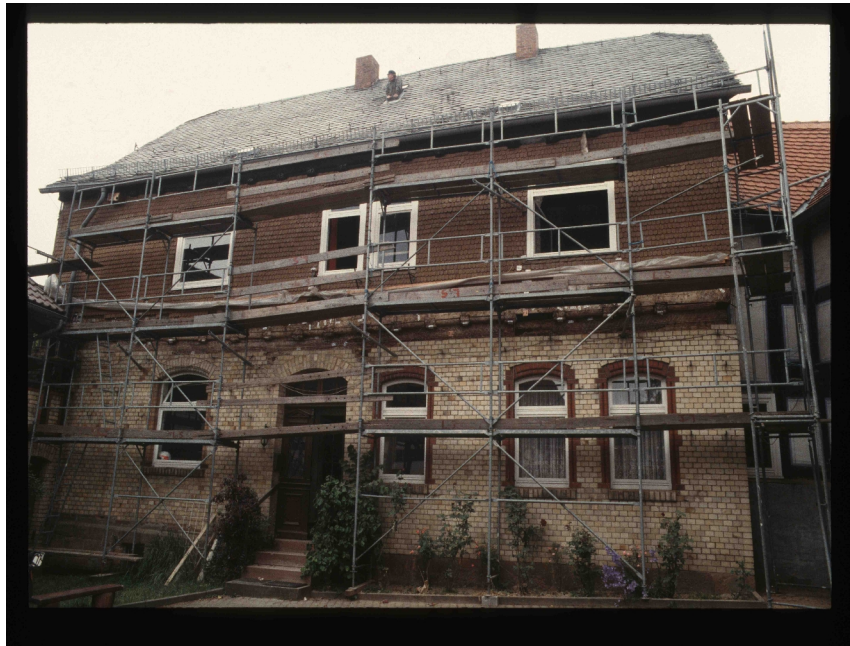
Historic building (1652): wall beams hidden behind wooden shindels and/or bricks => resistance drilling was used for locating beams and assessing their condition.

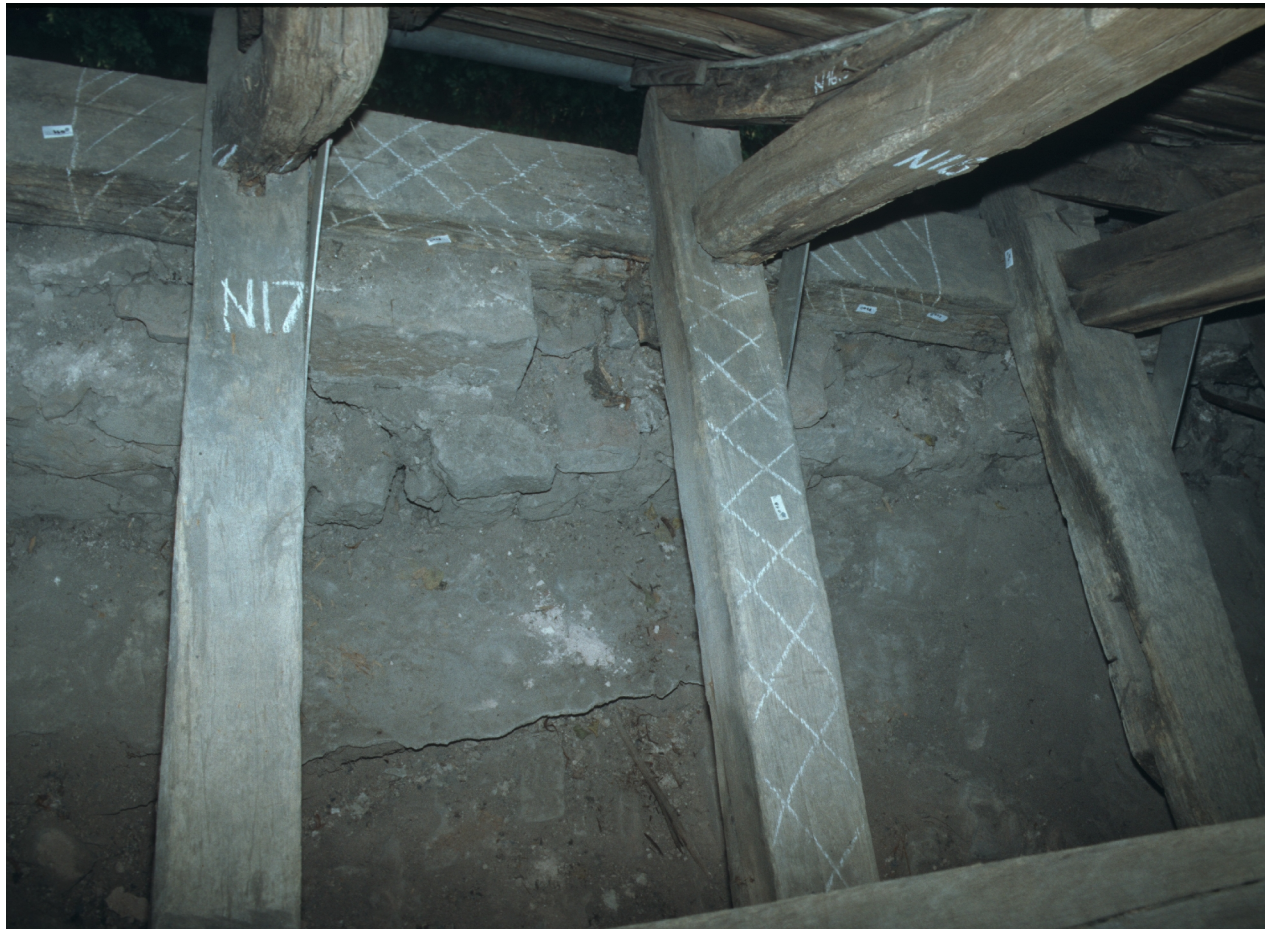
Historic church roof structure built from oak beams in 1252 AD near Marburg, Germany:

Marking of identified decay on beams with chalk for demonstrating that although both beams look similarly intact and sounded intact, one of the ceiling beams is decayed internally due to recent fungal decay (after roof leakages).

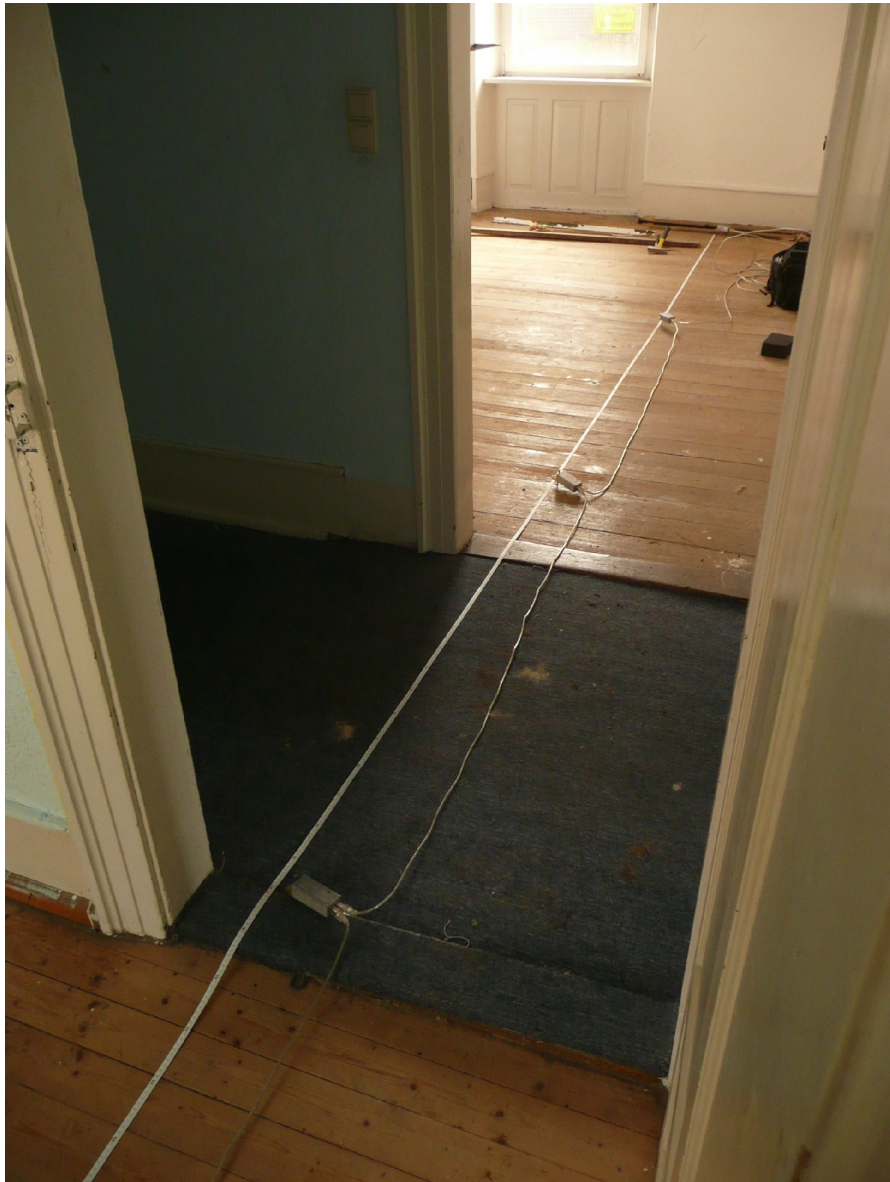
Determining length and potential connection of beams (on walls) across buildings without taking off the floor (or stucco) with the use of stress-wave sensors.

If one ceiling beam reaches from one side of the building to the other, this means different load carrying capacities as compared to several beams connected on internal wall support points.
