CHAMBERS COVERED RAILROAD BRIDGE

85-foot-long single-span Howe truss

International Conference on Timber Bridges, 2013

OBEC Consulting Engineers

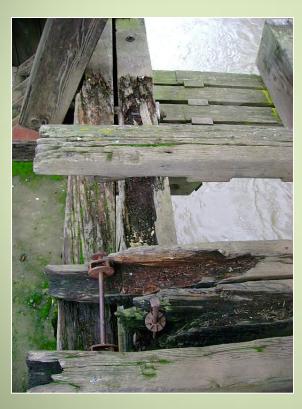
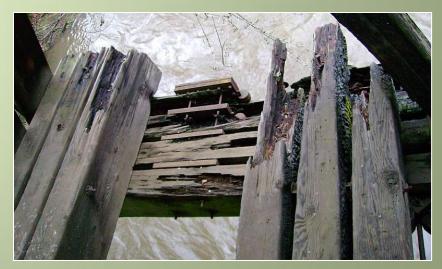
GAPING HOLES IN ROOF LED TO ADVANCED DECAY

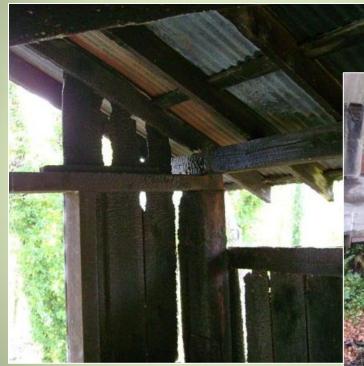
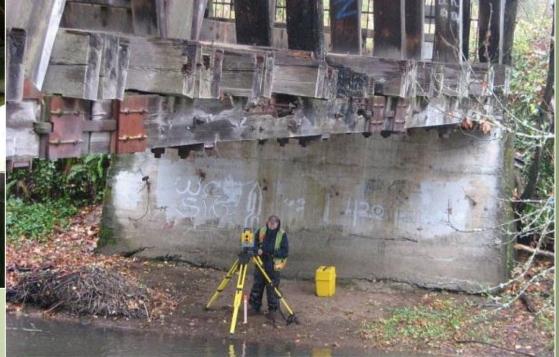
FIRES WERE BUILT INSIDE BRIDGE AT LEAST TWICE

Fire on bottom chord near mid-span

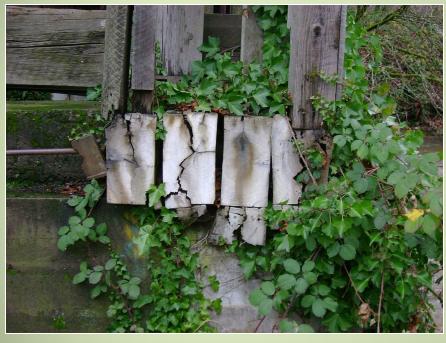
EXTENSIVE DETERIORATION

Corbels upstream side rotted away completely

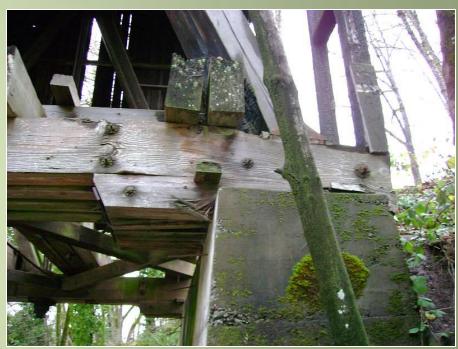
Bottom chord crushing at both ends
