# Field Load Testing of the First Vehicular Timber Bridge in Korea

**Oct. 1 2013**

Seoul National University

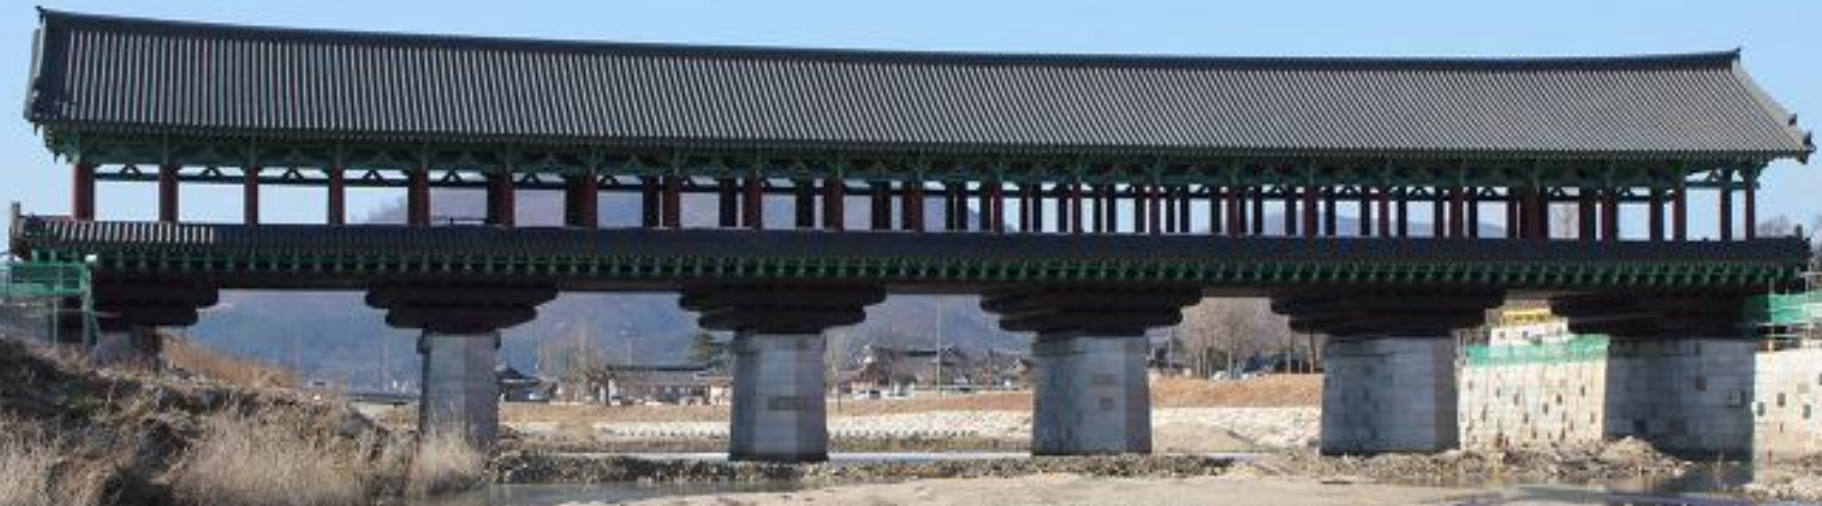
# Wol-jeong bridge (AD 760)

- Supposed to be the longest timber bridge ever in Korea (60.57m in length)
- Ship-shaped bridge legs with advantage of flow resistance
- Destroyed in unidentified past and was rebuilt in 2013

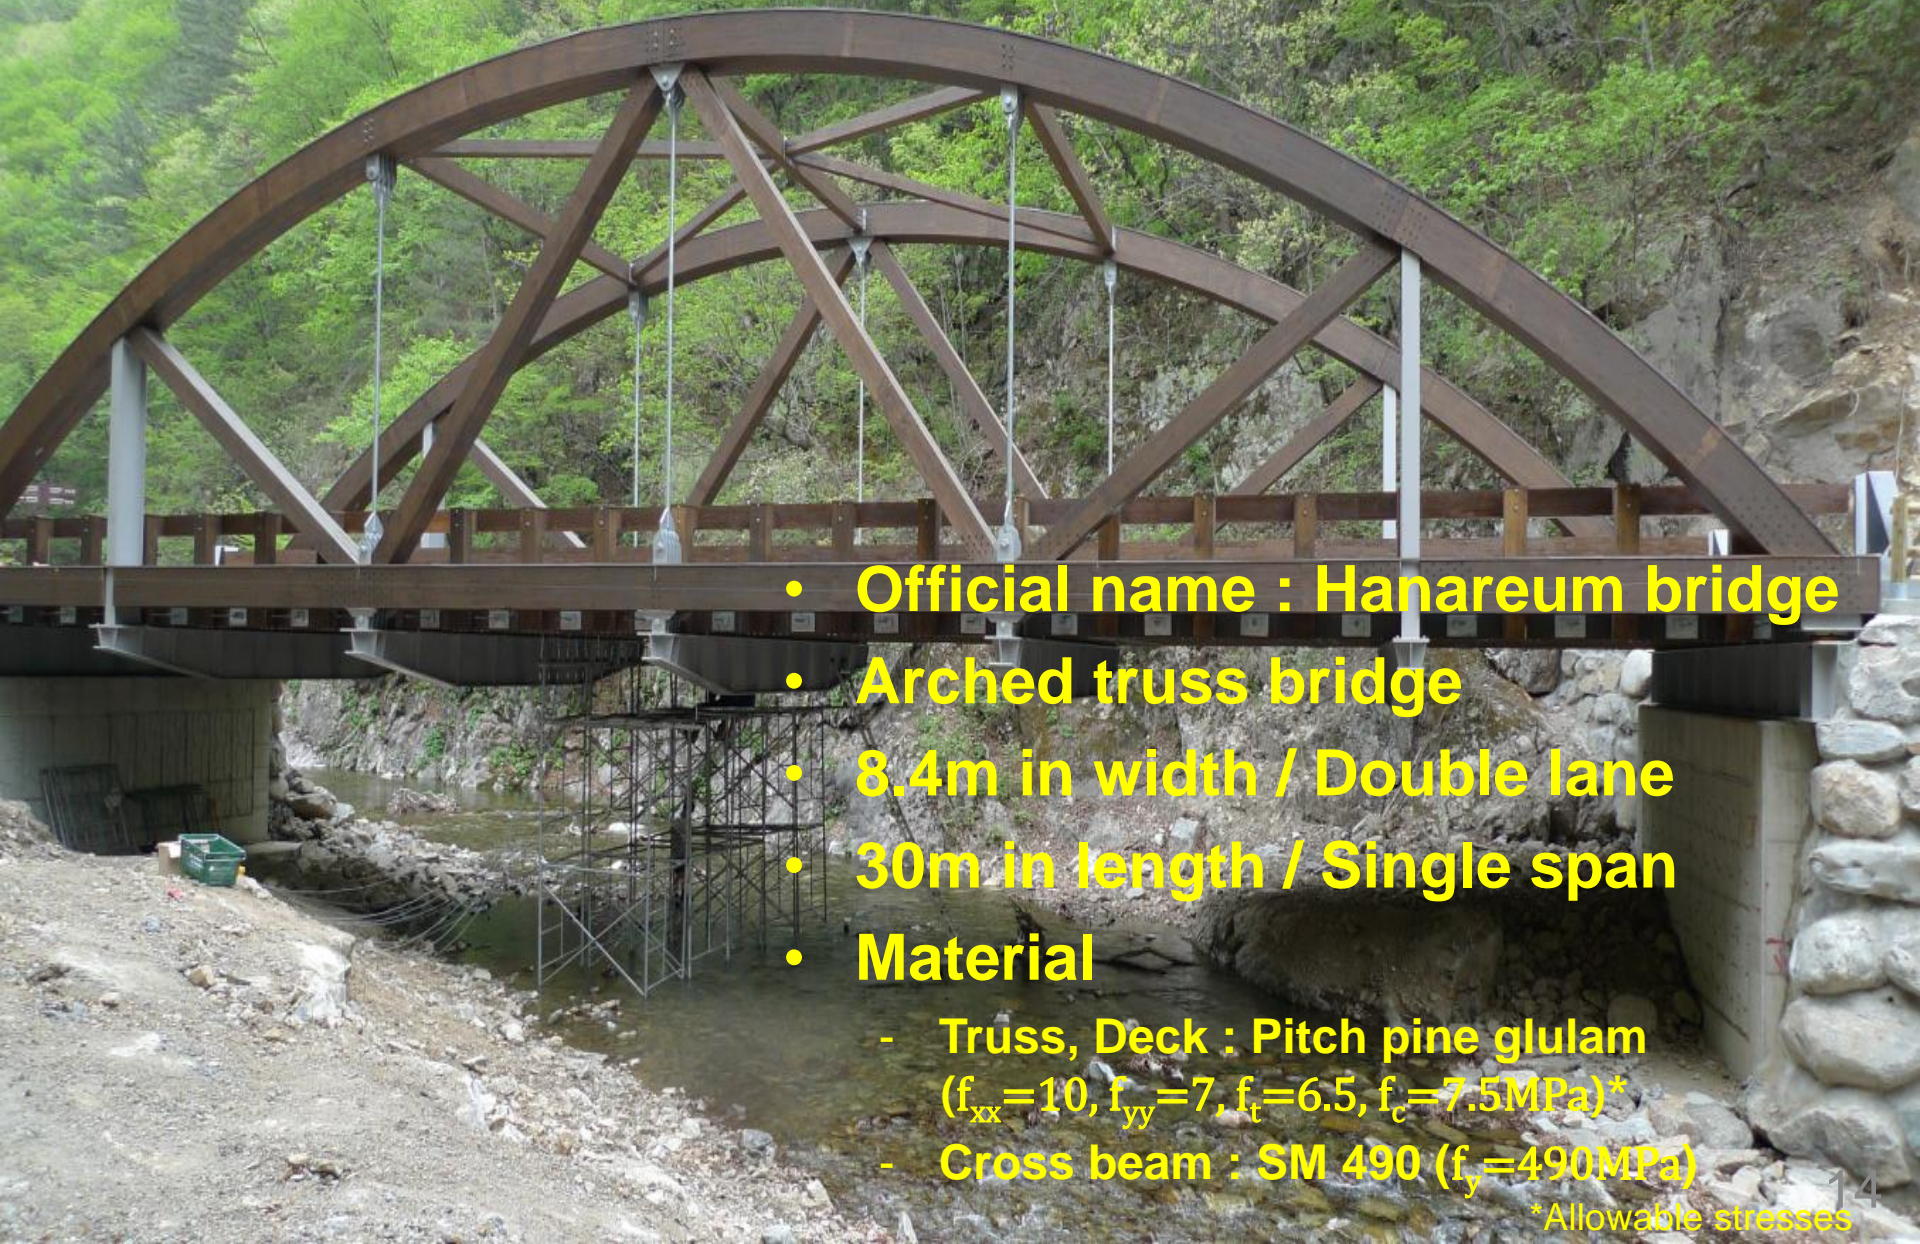
# 1<sup>st</sup> vehicular timber bridge in Korea (2012)

- Official name : Hanareum bridge
- Arched truss bridge
- 8.4m in width / Double lane
- 30m in length / Single span
- Material
  - Truss, Deck : Pitch pine glulam ( $f_{xx}=10, f_{yy}=7, f_t=6.5, f_c=7.5\text{MPa}$ )\*
  - Cross beam : SM 490 ( $f_y=490\text{MPa}$ )

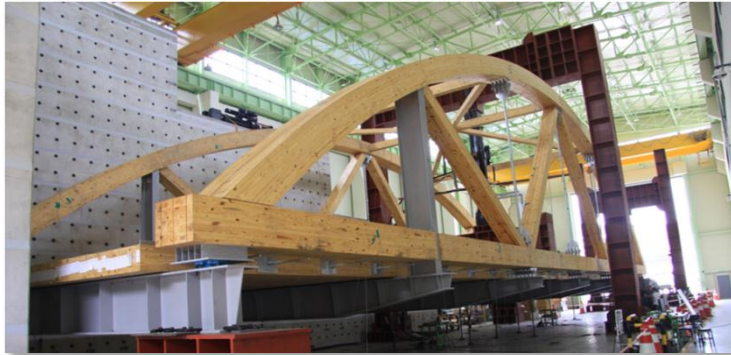
# Laboratory load test

- Static load test to examine the bridge performance
- Comparison of measured data with design value

Maximum deflection of  
cross beam and deck  
floor

Member forces (strain)  
of truss, cross beams,  
and deck floor

- Check the symmetric condition for verifying the manufacture and fabrication error

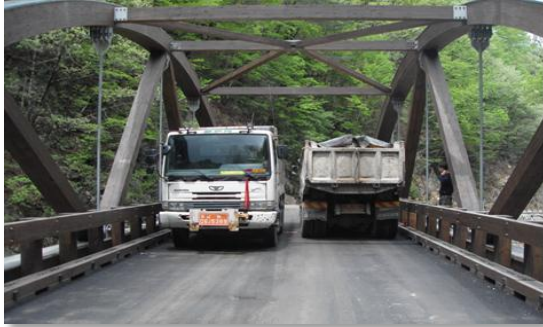
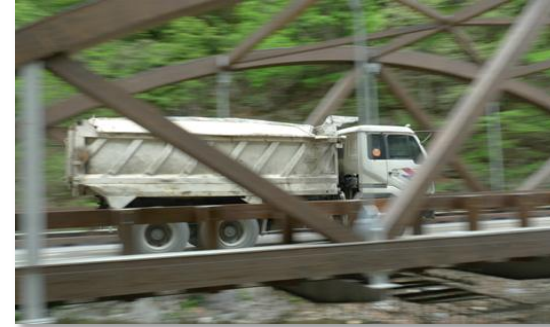
# Field load test

- Static and dynamic load test to verify the bridge performance
- Comparison of measured data with design value and lab test

Maximum deflection  
of cross beam and  
deck floor

Member forces  
(strain) of trusses  
and deck floor

Mode frequency  
(acceleration) of  
deck floor

- Check the symmetry and linearity condition for verifying the construction error
- Check the integrity condition of pre-stressed glulam deck floor

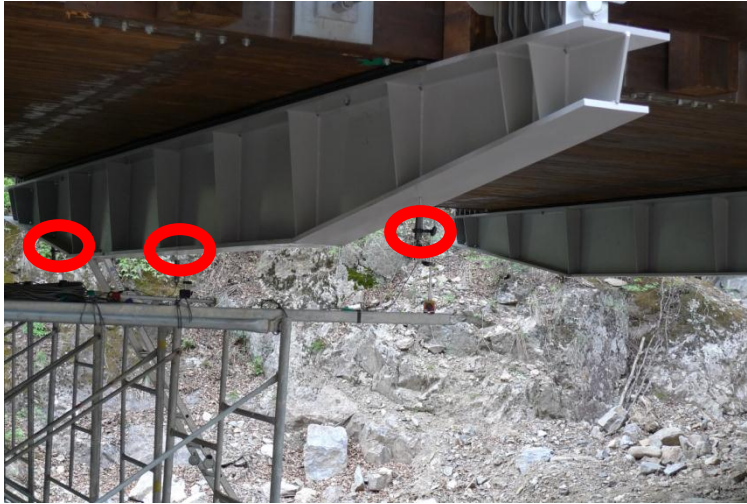
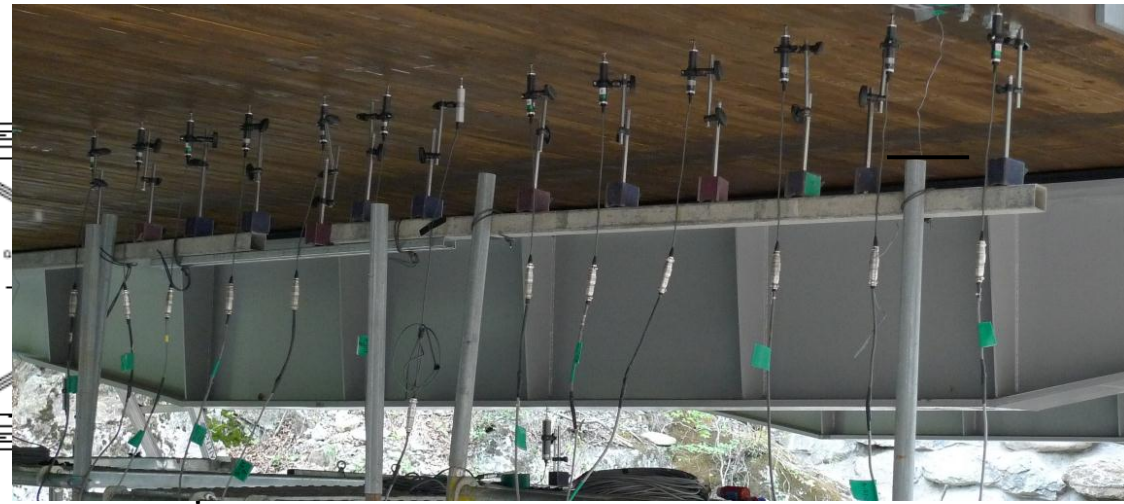
# Location of LVDTs

## Cross beam

- Three sensors : Deflection shape of center cross beam

## Deck floor

- 13 sensors : Located densely considering the chance for separation behavior of laminated timbers

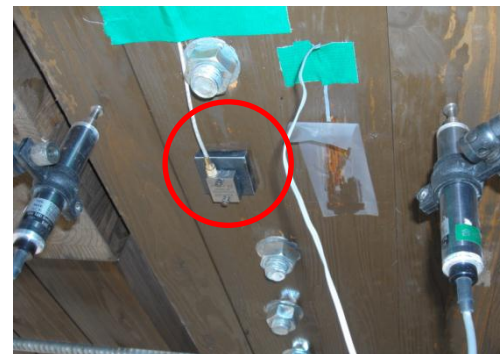
# Location of accelerometers

<Floor plan of deck floor>

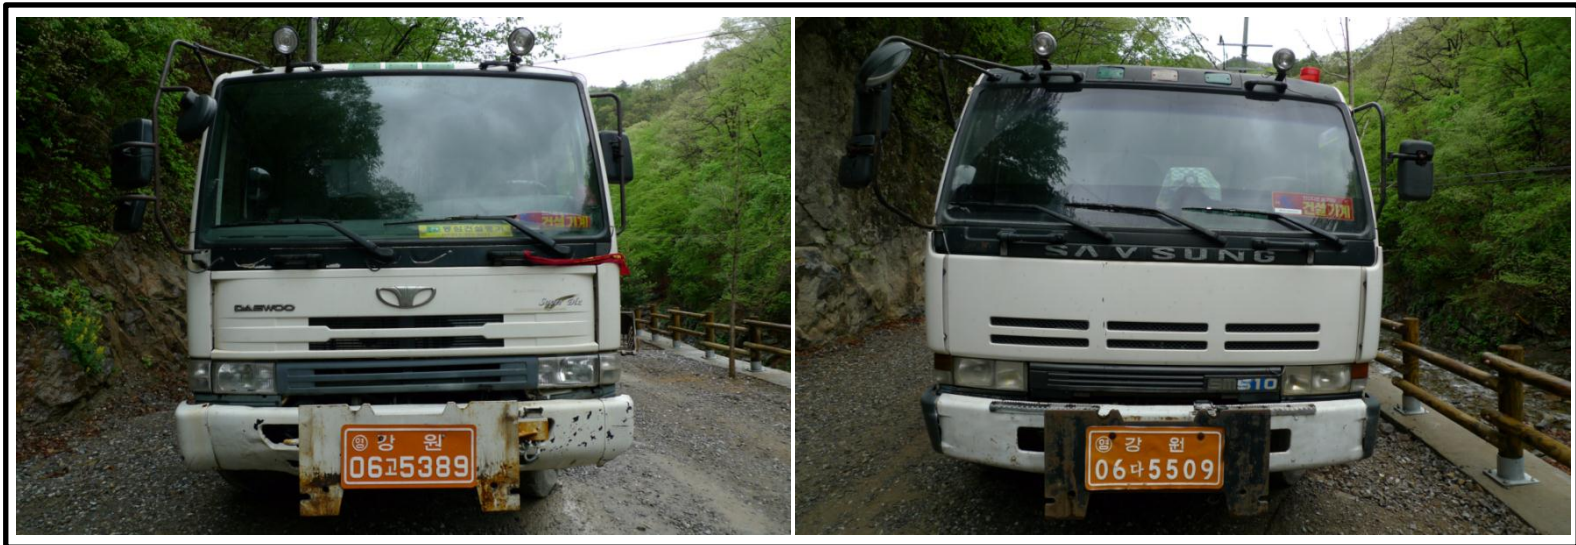
# Loading trucks

- Two gravel loaded 27 ton trucks

Car No.	5389	5509
Load(kg)	26,700	27,030

- 62.5% of design load(43.2ton) → To be calibrated for comparison
