## The Second National Covered Bridge Conference

# The Historic Eldean Covered Bridge

Presented by Douglas L. Christian, PE, PS

Miami County Engineer, retired - Troy, Ohio, USA - [dcsc305@msn.com](mailto:dcsc305@msn.com)

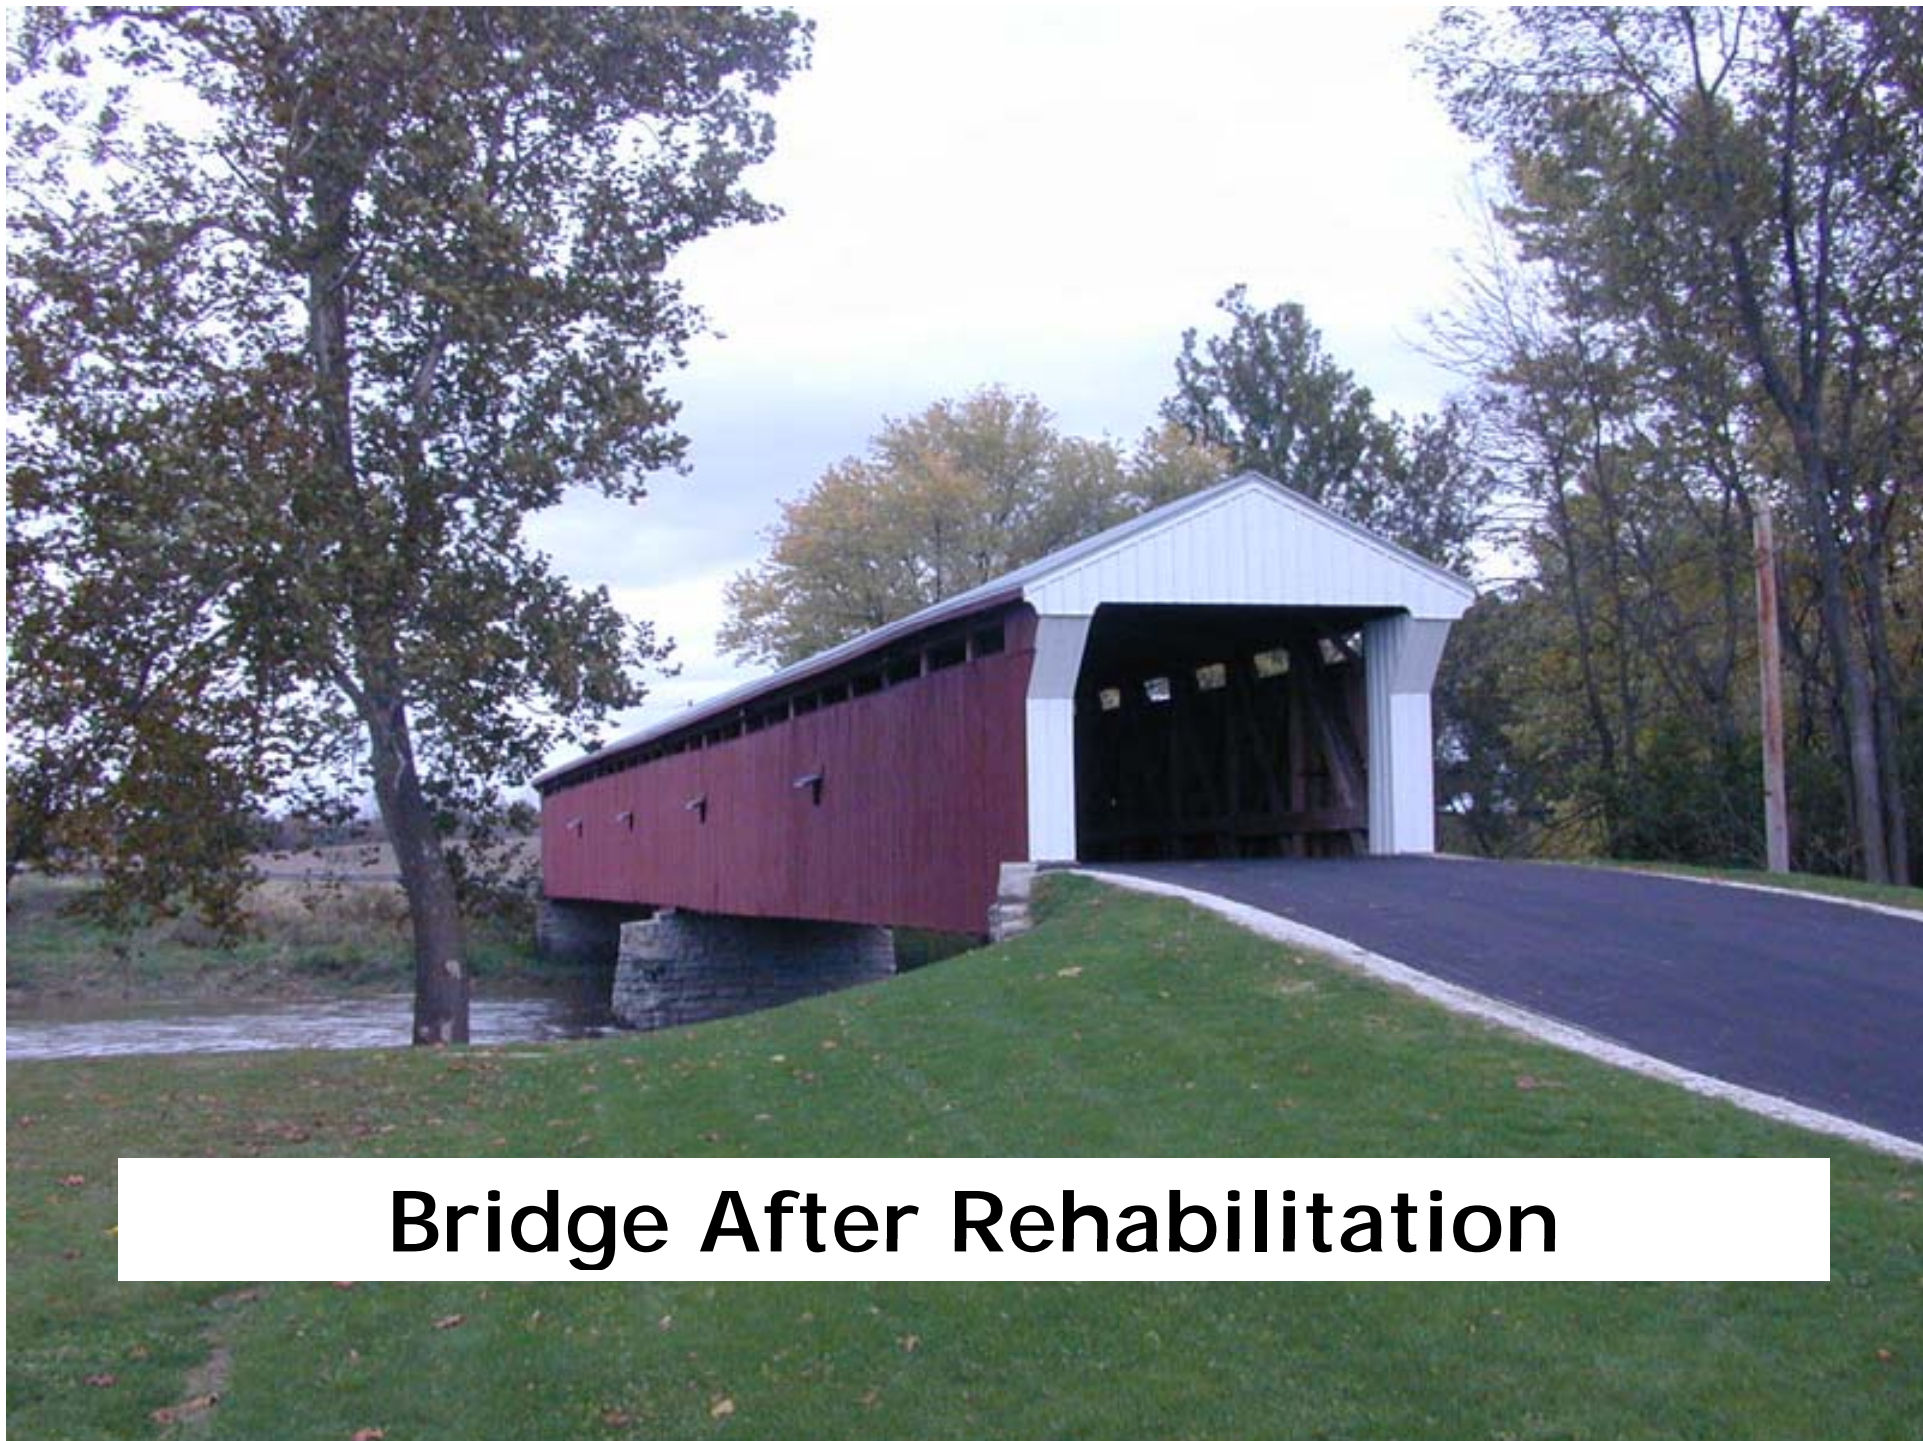
**Long's Wedge**

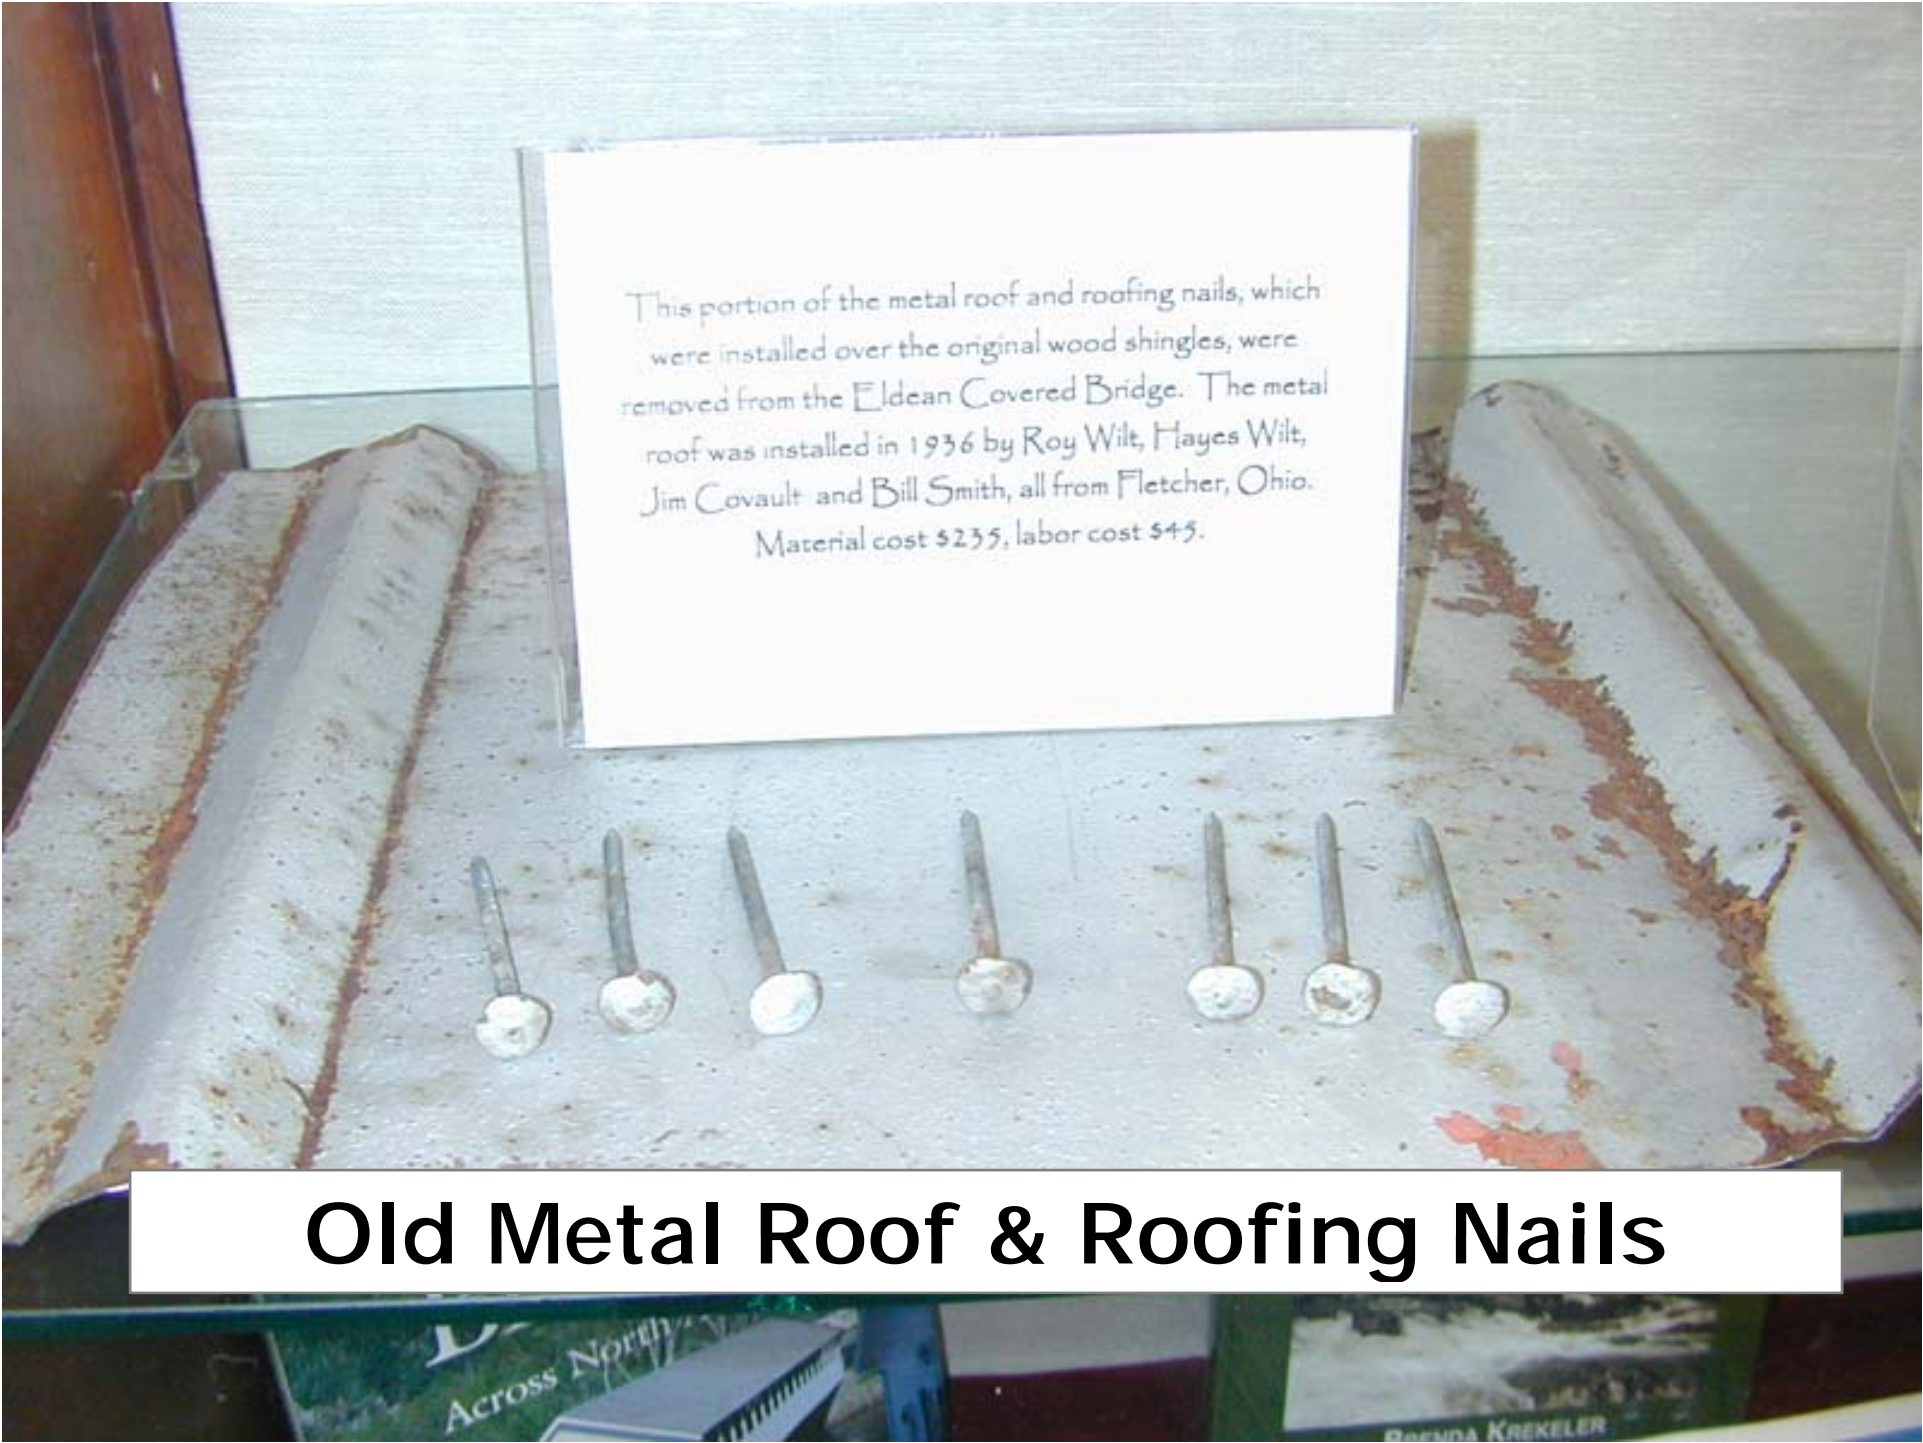
## Old Metal Roof & Roofing Nails

This portion of the metal roof and roofing nails, which were installed over the original wood shingles, were removed from the Eldean Covered Bridge. The metal roof was installed in 1936 by Roy Wilt, Hayes Wilt, Jim Covault and Bill Smith, all from Fletcher, Ohio. Material cost \$235, labor cost \$45.

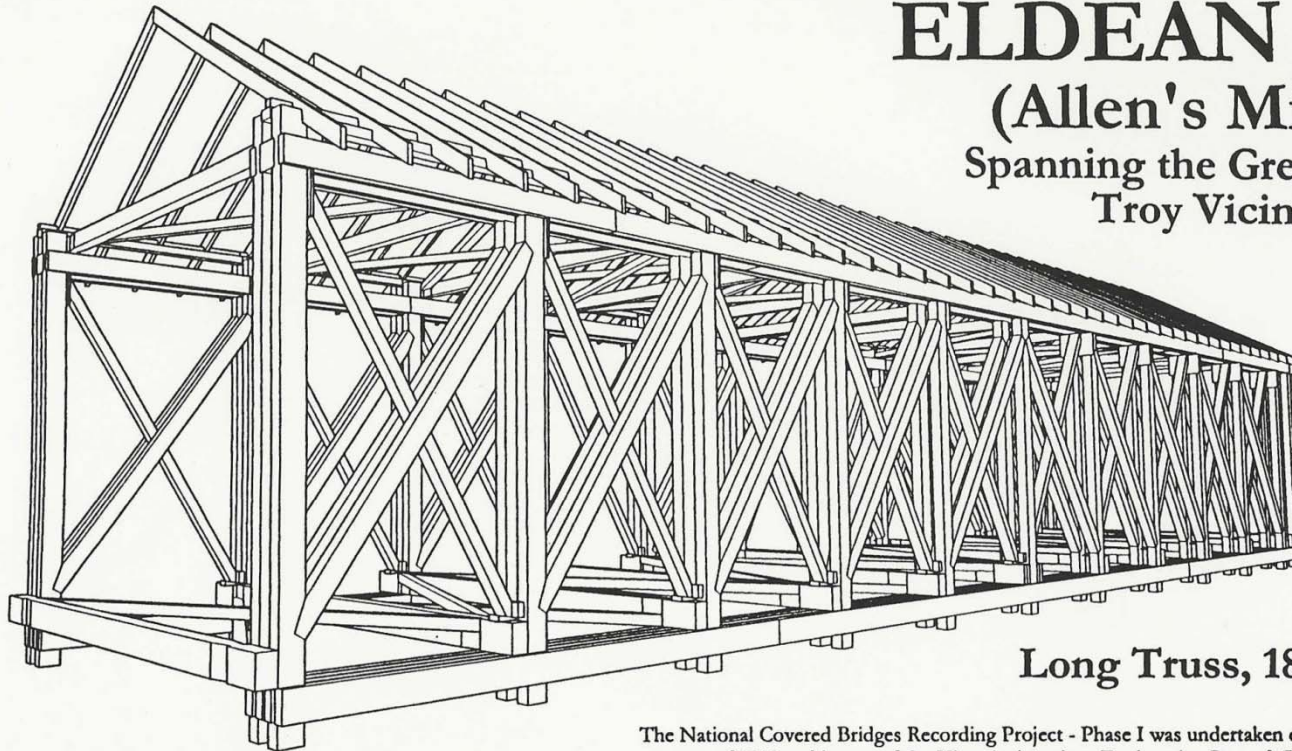
## HAER Drawing with Bridge Descriptions

Long Truss, 1860

The Eldean Bridge is one of the best surviving examples of a Long Truss, patented in 1830 by Col. Stephen H. Long of the United States Army Topographical Engineers. The Long truss features diagonal compression members and vertical tension members and is considered the first scientifically designed bridge truss type because the forces in the members can be determined mathematically, where earlier bridge trusses had been designed by empirical method. Central to Long's patent was the concept of driving wedges into the connections, which prestressed the structure, ensuring that the compression and tension members functioned efficiently. Long

wa  
to  
bu  
At  
the  
standing. At 218' 10" span, the two span Eldean Bridge is the second longest bridge in Ohio.

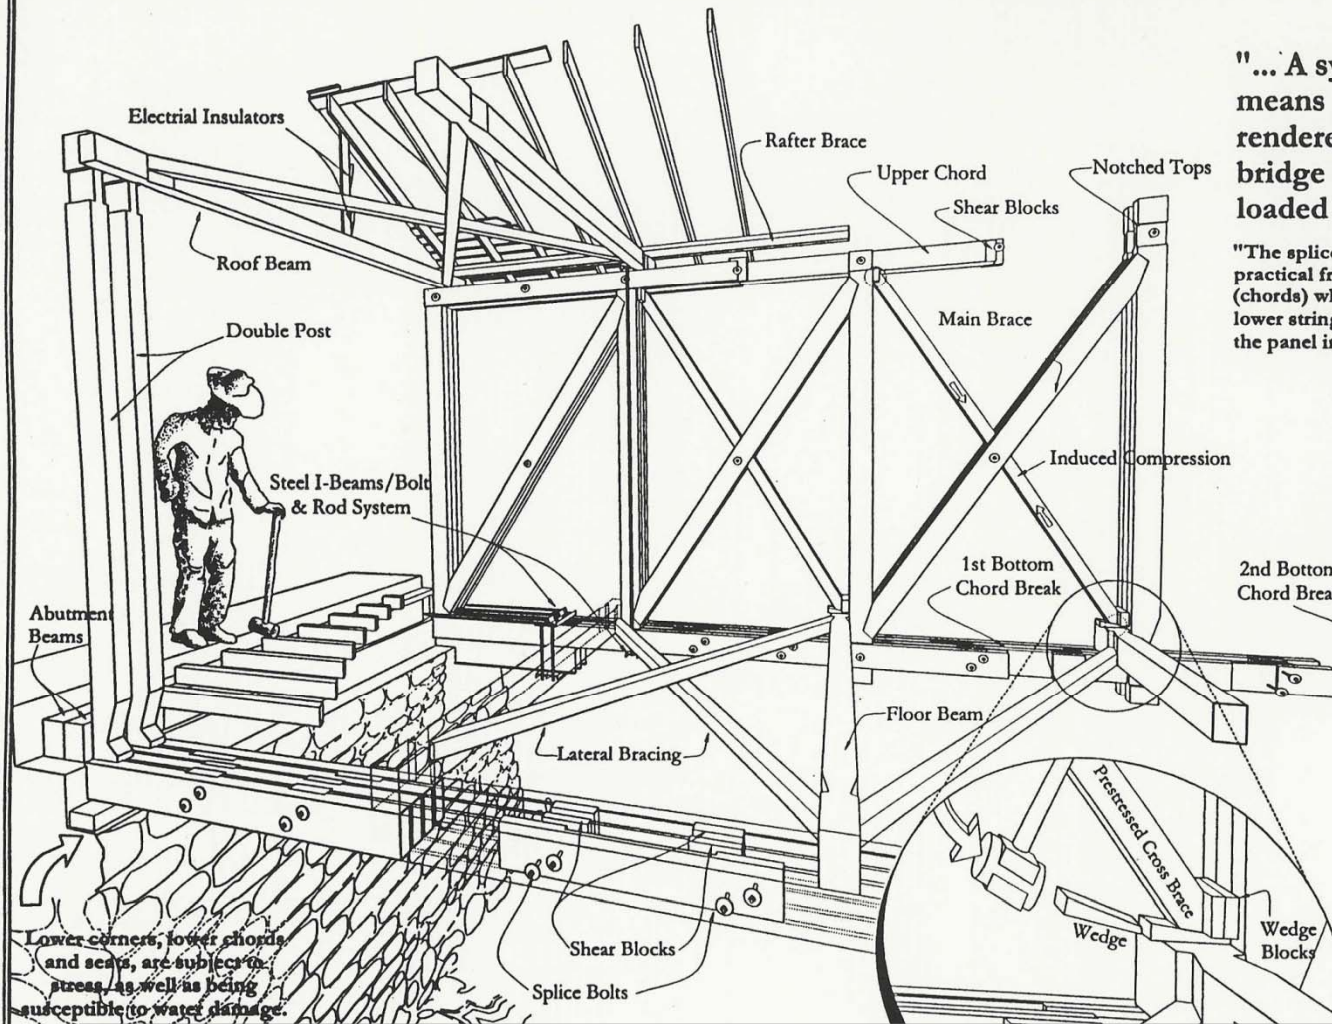
# HAER Drawing with Structural Details

In the original bridge design the ends of the lower chords were seated on wood sills, usually only an extra piece or two of wood, on top of the stone abutments and piers. Weather severely affected this part of the bridge. At the wood stone contact moisture slowly penetrates the wood. In 1936 several important modifications were made to the bridge to insure it's continual structural integrity, including inserting steel between these connections and replacing decayed wood.

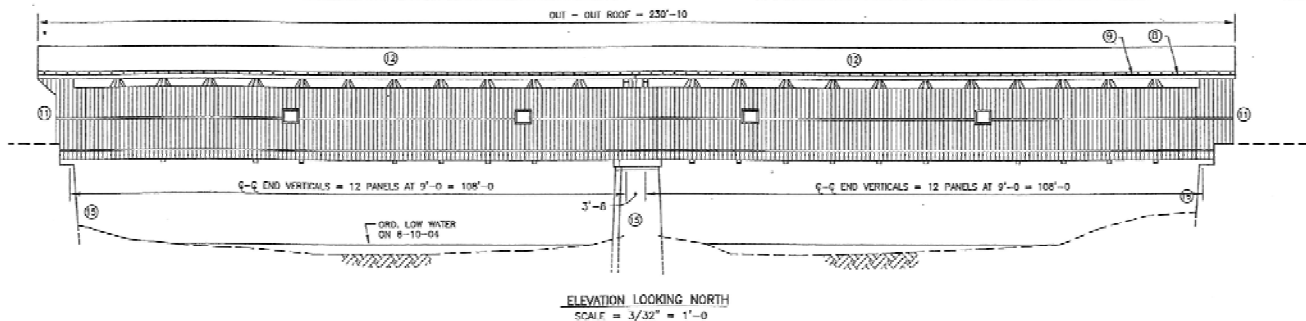
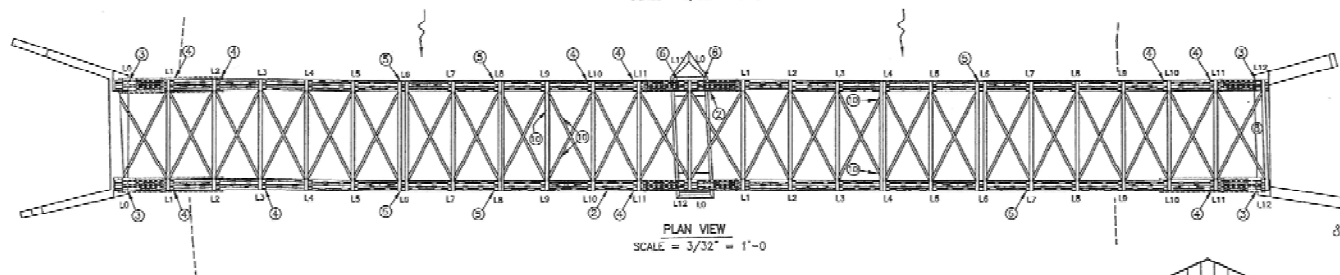
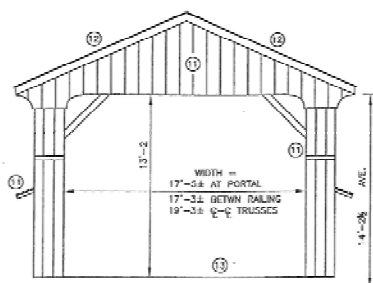
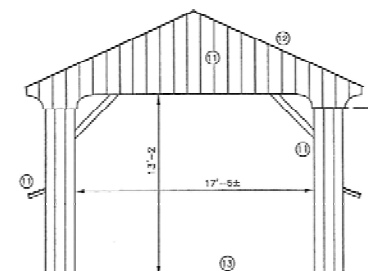
# James Barker's General Plan for Bridge Rehabilitation

#### EXISTING AND PROPOSED STRUCTURE

PROPOSED WORK: REHABILITATION OF THE ELEANOR COVERED BRIDGE WHILE MAINTAINING ITS HISTORICAL INTEGRITY. WORK WILL INCLUDE THE REPAIR OR REPLACEMENT OF DETRIORATED OR MISSING MEMBERS; AND MISCELLANEOUS REPAIRS.

TYPE: LONG TRUSS, BUILT IN 1880

SPAN: 2 SPANS AT 108'-0"± EACH

ROADWAY: 17'-3" FACE-TO-FACE BRIDGE RAIL

1. Install temporary shoring and bracing and jack each span slightly to remove present sag.
2. Replace deteriorated timbers in lower chord, removing steel reinforcements (two locations).

3. At all four corners of bridge, replace ends of lower chord timbers and lower ends of verticals, removing present steel rods & hardware and side channels there. Replace lower ends of diagonals at several of these corners.

4. Vertical timbers at these locations have failed. Replace both vertical timbers at these panel points with new ones, removing the present steel rods. (10 locations = 20 timbers)

5. Vertical timbers at these locations have failed. However they will not be replaced. Instead, replace the two present steel rods with a single new one. (6 locations)

6. Replace deteriorated lower ends of vertical timber(s) and/or diagonal timber(s).
7. Repair cracks & localized distress in lower chord timbers. (locations per sheets 8 & 9)

8. Replace missing upper chord timber near SE corner of bridge.
9. Replace missing upper lateral bracing.
10. Replace floorbeam and adjacent lower lateral bracing timbers. Reinforce ends of certain other lower lateral bracing timbers.

11. Rebuild east and west portals and repair holes in rest of siding. Provide small awnings above the windows.
12. Remove existing roof and install new roof.

13. Replace badly damaged floor boards. This engineer shall be responsible for determining which floor board are badly damaged.
14. Apply fire retardant treatment to bridge superstructure.

15. Repaint abutments and pier, & replace top of nose of pier.
