The Rehabilitation of Quebec's Powerscourt Bridge

Michael Grayson, Engineer

Second National Covered Bridge Conference

June 7, 2013

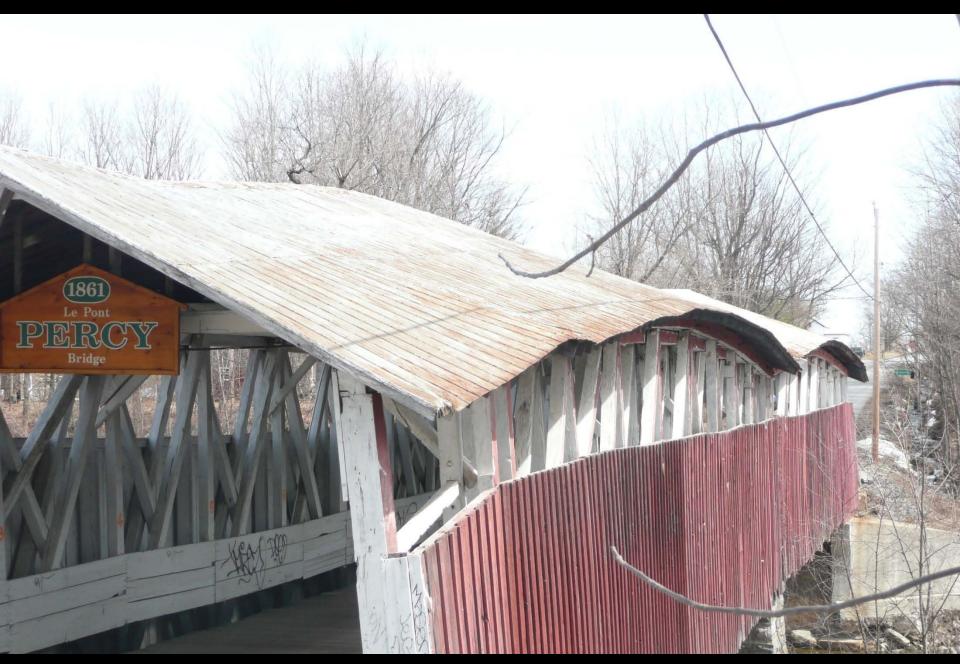
State of bridge during 2007 inspection

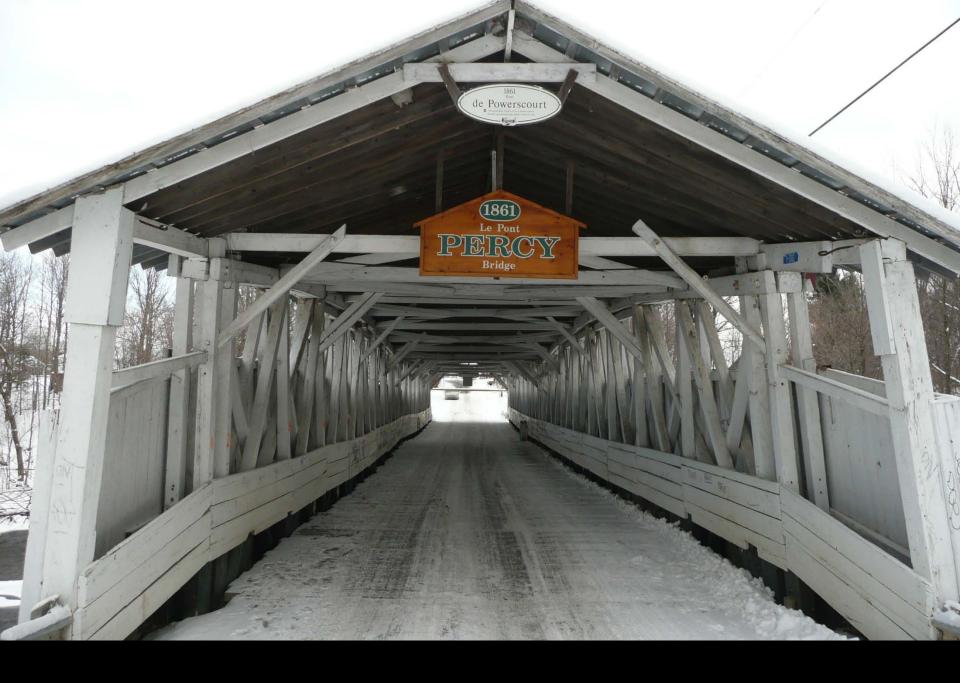
Major splay at east entry, 2007

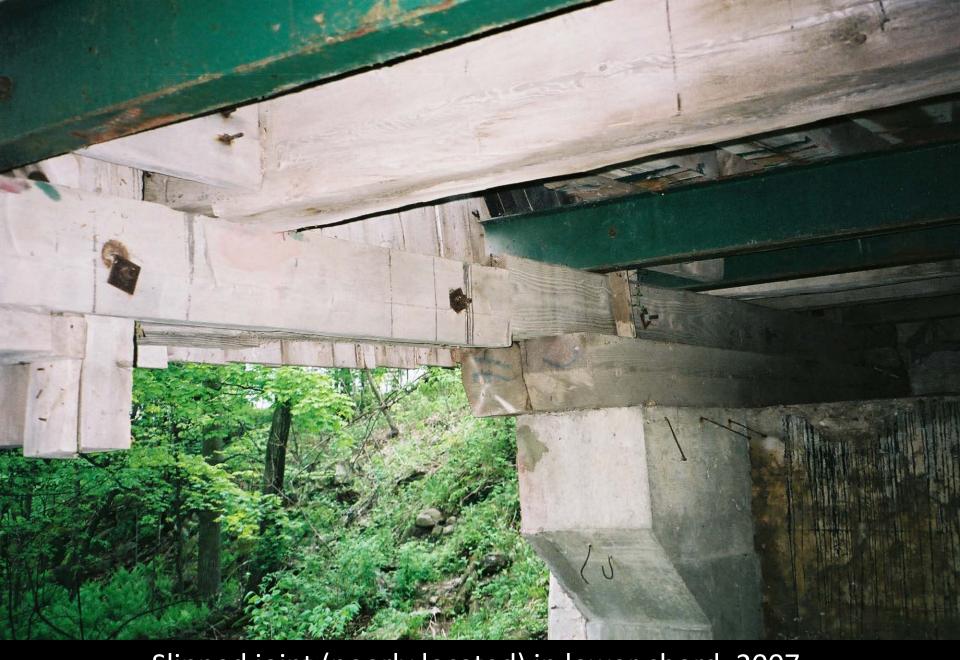
Slipped joint (poorly located) in lower chord, 2007. (Steel floor beams inserted in 1980s.)

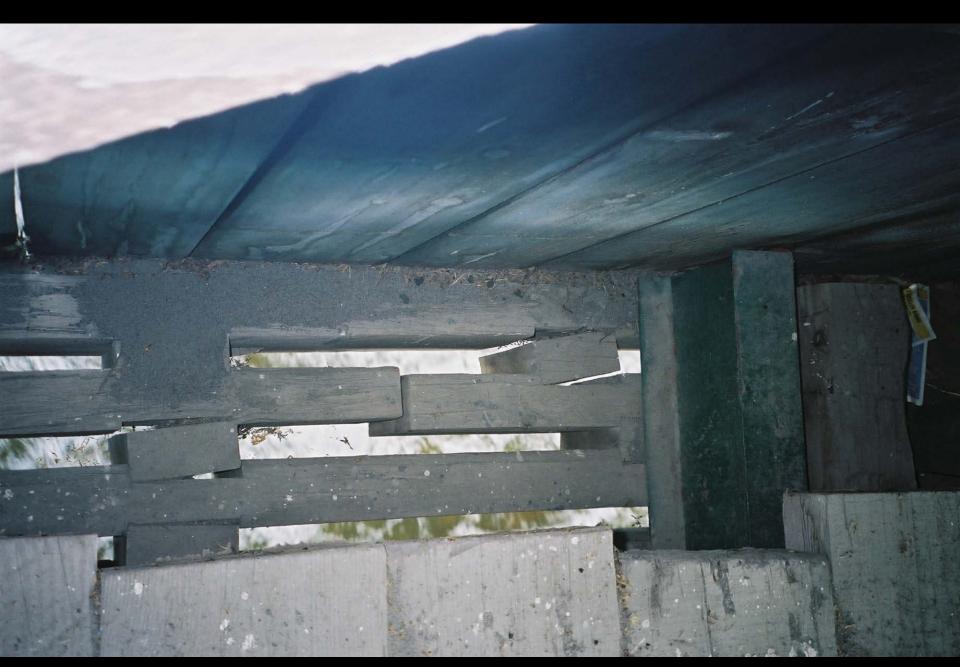
Rotating shear keys in lower chord, 2007

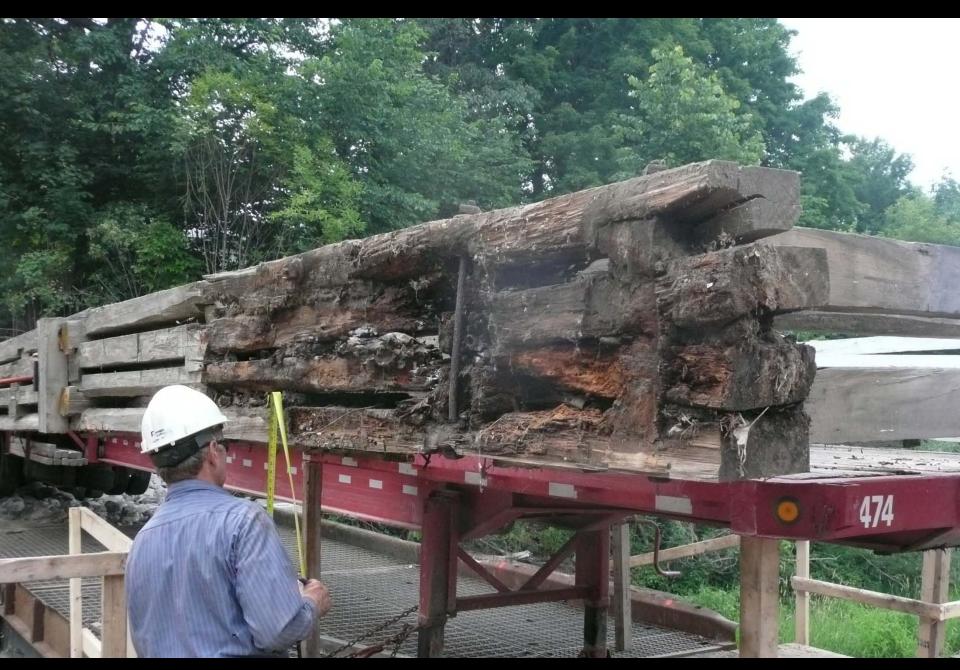
Deteriorated bottom chords at east abutment, 2009

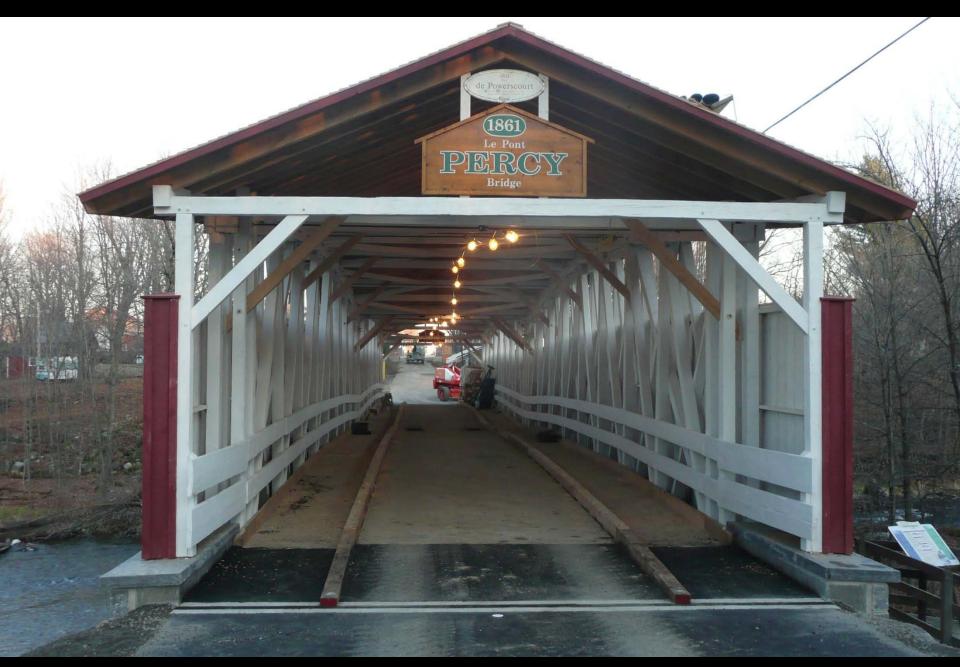
Completed portal, 2009. Powerscourt Bridge known as Percy locally.

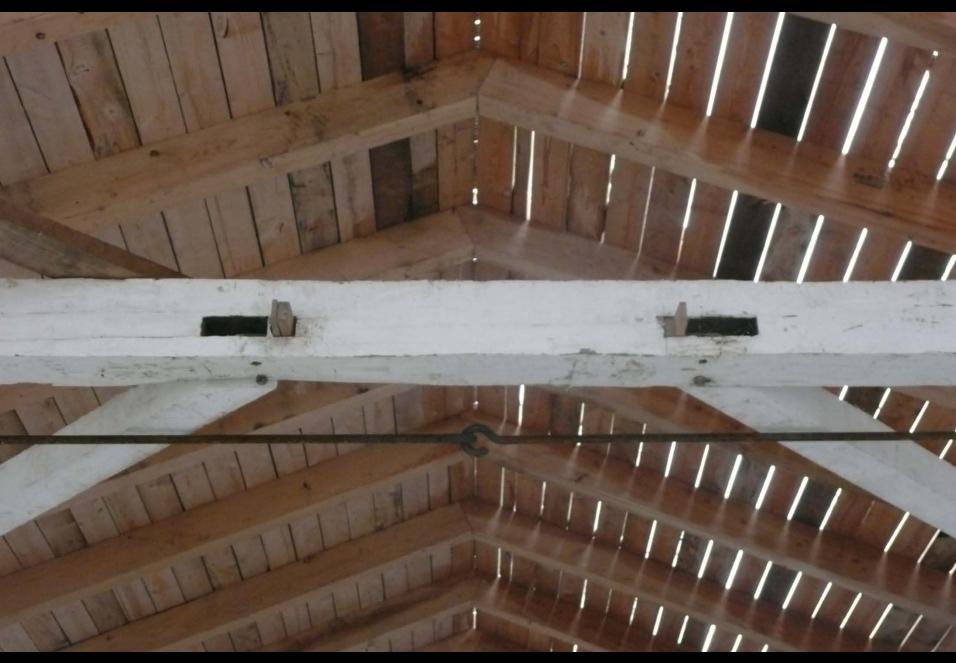
Modified roof structure with former tie rod

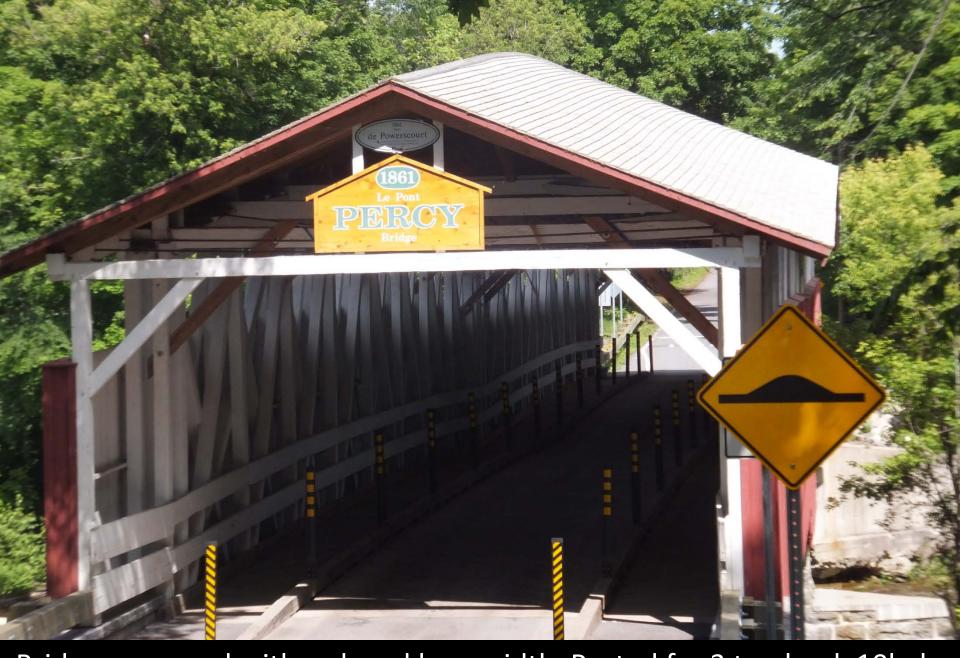
Bridge reopened with reduced lane width. Posted for 3 ton load, 10kph, with strong camber warning
