The Bartonville Covered Bridge Replacement

Summary

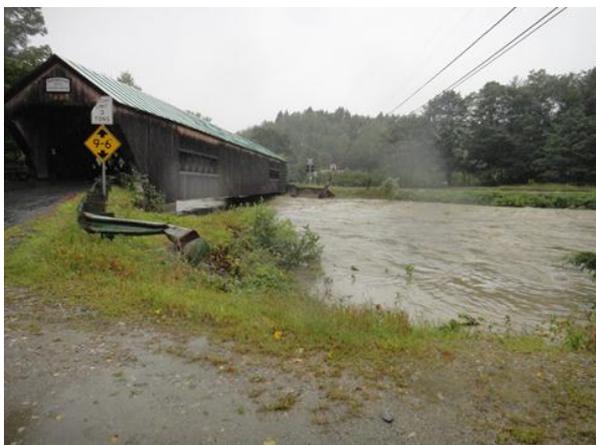
Figure 1 - The Bartonville Covered Bridge just prior to its destruction (photo provided by Susan Hammond)

The historic Bartonville Covered Bridge, built in 1870 and one of the longest single span covered bridges in the United States, was destroyed by the flooding caused by Hurricane Irene in August 2011, when the west abutment was scoured away from under the bridge – see Figures 1 and 2.

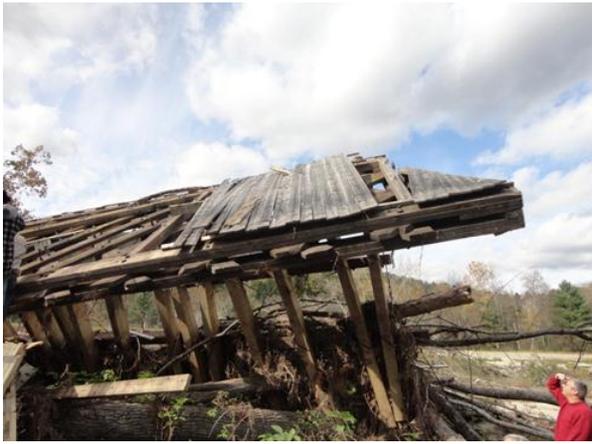
Figure 2 - Beyond salvage (photo provided by Susan Hammond)

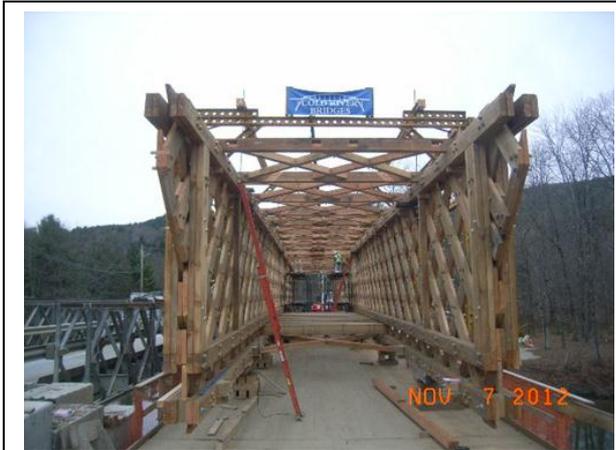
Figure 3 - Replacement timber bridge being built on a work platform bridge. The temporary vehicular bridge is at left in this photo. They were racing to beat bad weather, but looking good.

The new bridge was made 5.2m (17 feet) longer than the original structure to provide an increase in its hydraulic opening. The new superstructure (51.2m [168 ft] at deck level and 54.3m [178 ft] overall) will become the longest single-span covered bridge in the United States (if not the world) supported by Town lattice trusses. Figure 3 provides an image of the skeleton of the bridge showing construction of the Town lattice trusses with partial completion of overhead bracing and partial installation of floor beams. The timber structure is being erected on a work platform bridge alongside the temporary bridge, which sits atop the replacement permanent abutments.

It is interesting to note that the contractor, who won separate bids, built the abutments and installed a temporary Mabey pony truss superstructure. Then the permanent replacement timber covered bridge was built atop a work platform bridge, placed alongside the temporary bridge – thus three bridges to yield one. Construction of the \$1.2M superstructure was completed with ribbon cutting on January 26, 2013.

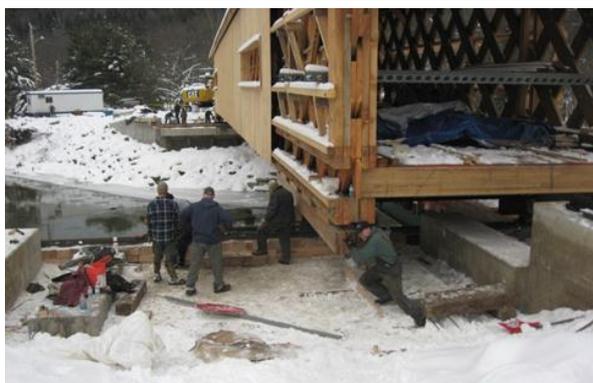
Figure 4 - Bridge being moved sideways into position atop the permanent abutments (with a bit of good-natured help from the owner of the construction company).
