The Salvage, Documentation, and Reconstruction of the Moose Brook Bridge

Christopher Marston, Tim Andrews, Vern Mesler

National Covered Bridge Conference
Dayton, June 7, 2013

Reconstructing the Moose Brook Bridge

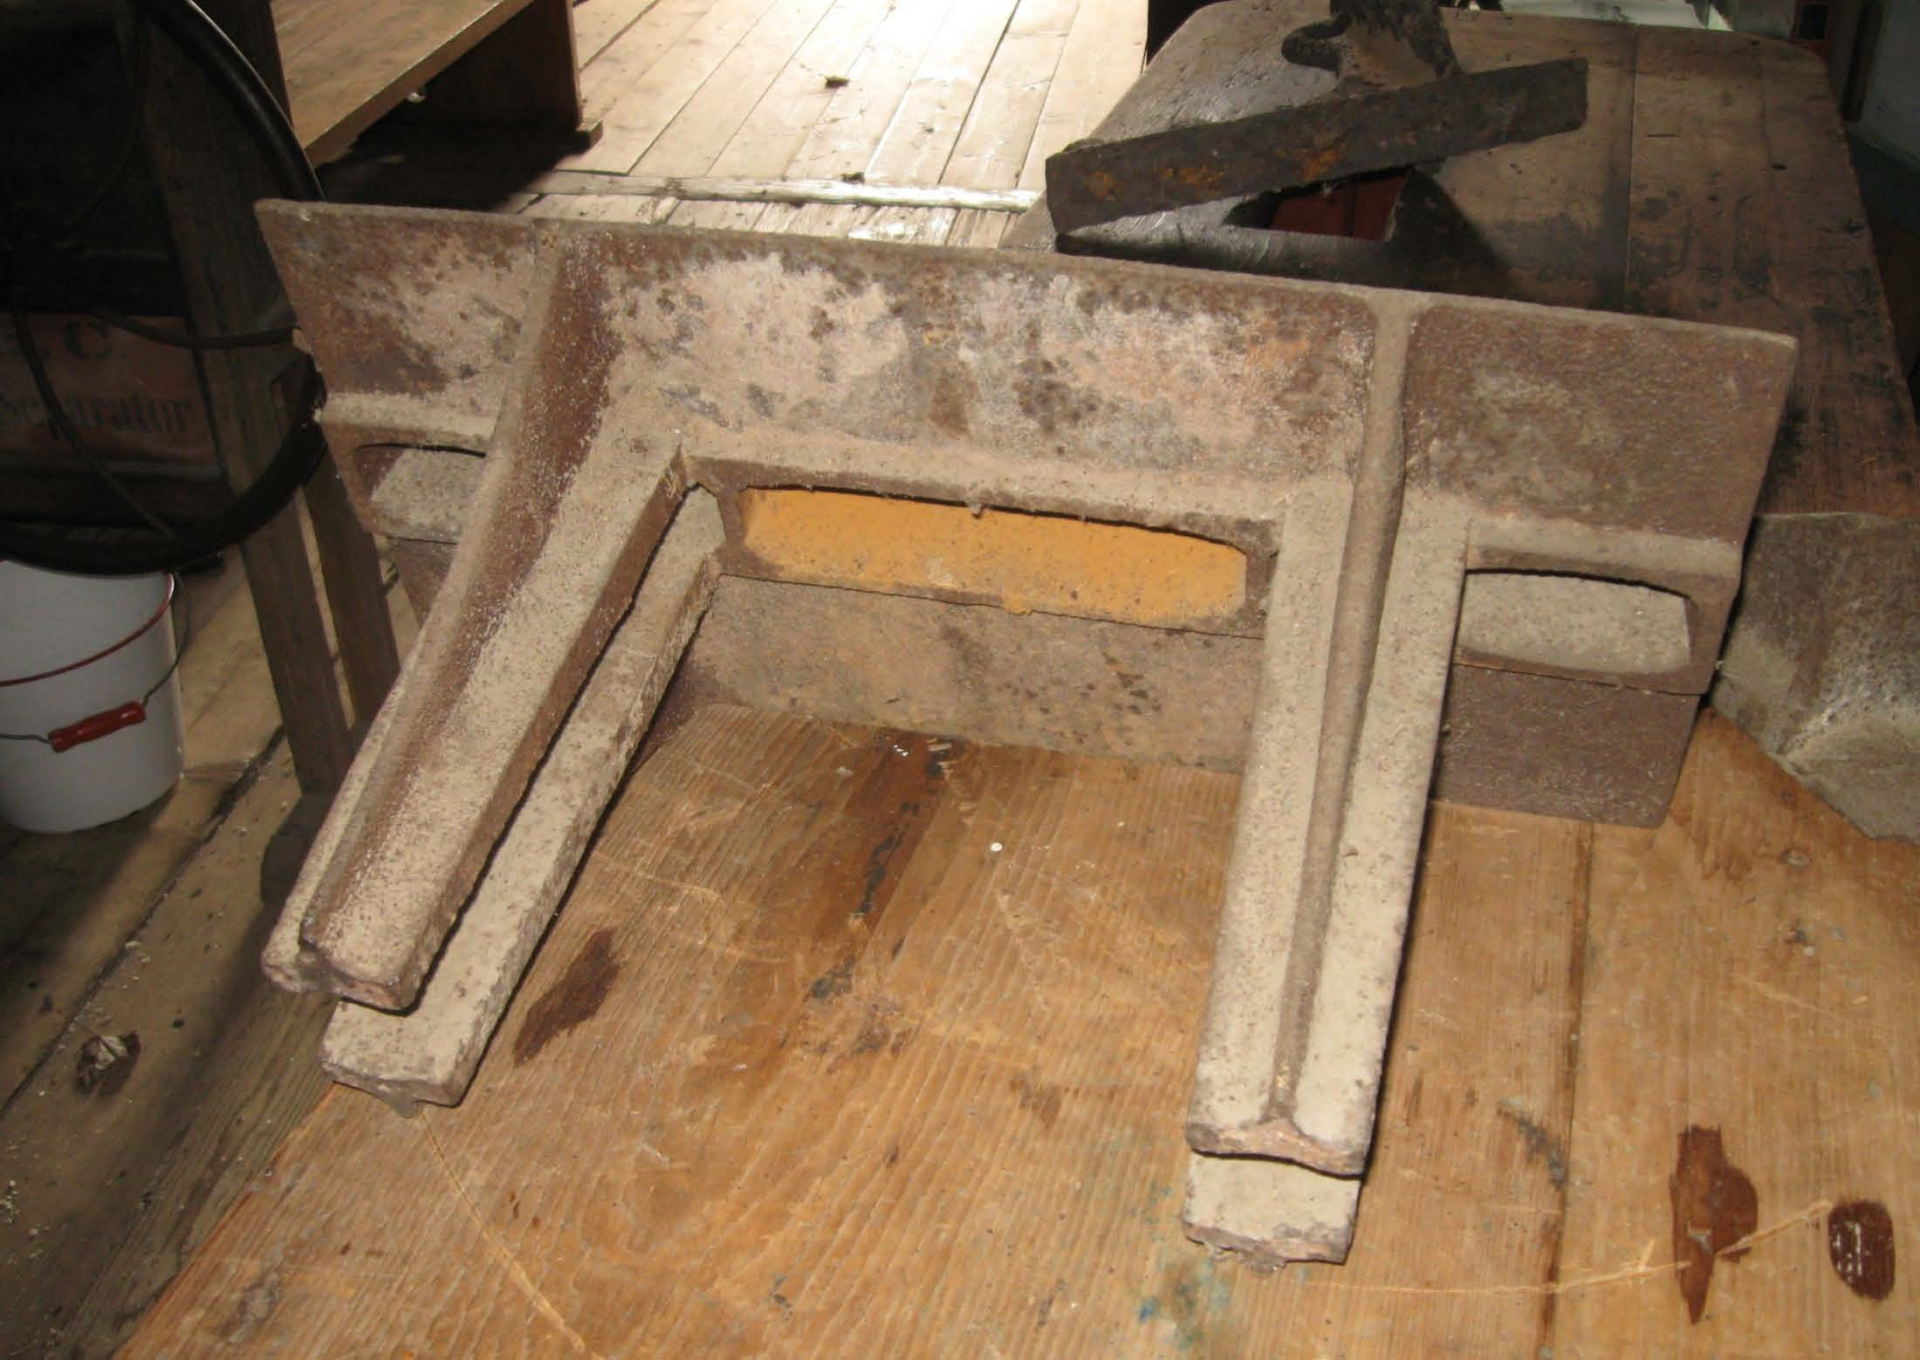
Nodal Castings from Rexleigh Covered Bridge, New York

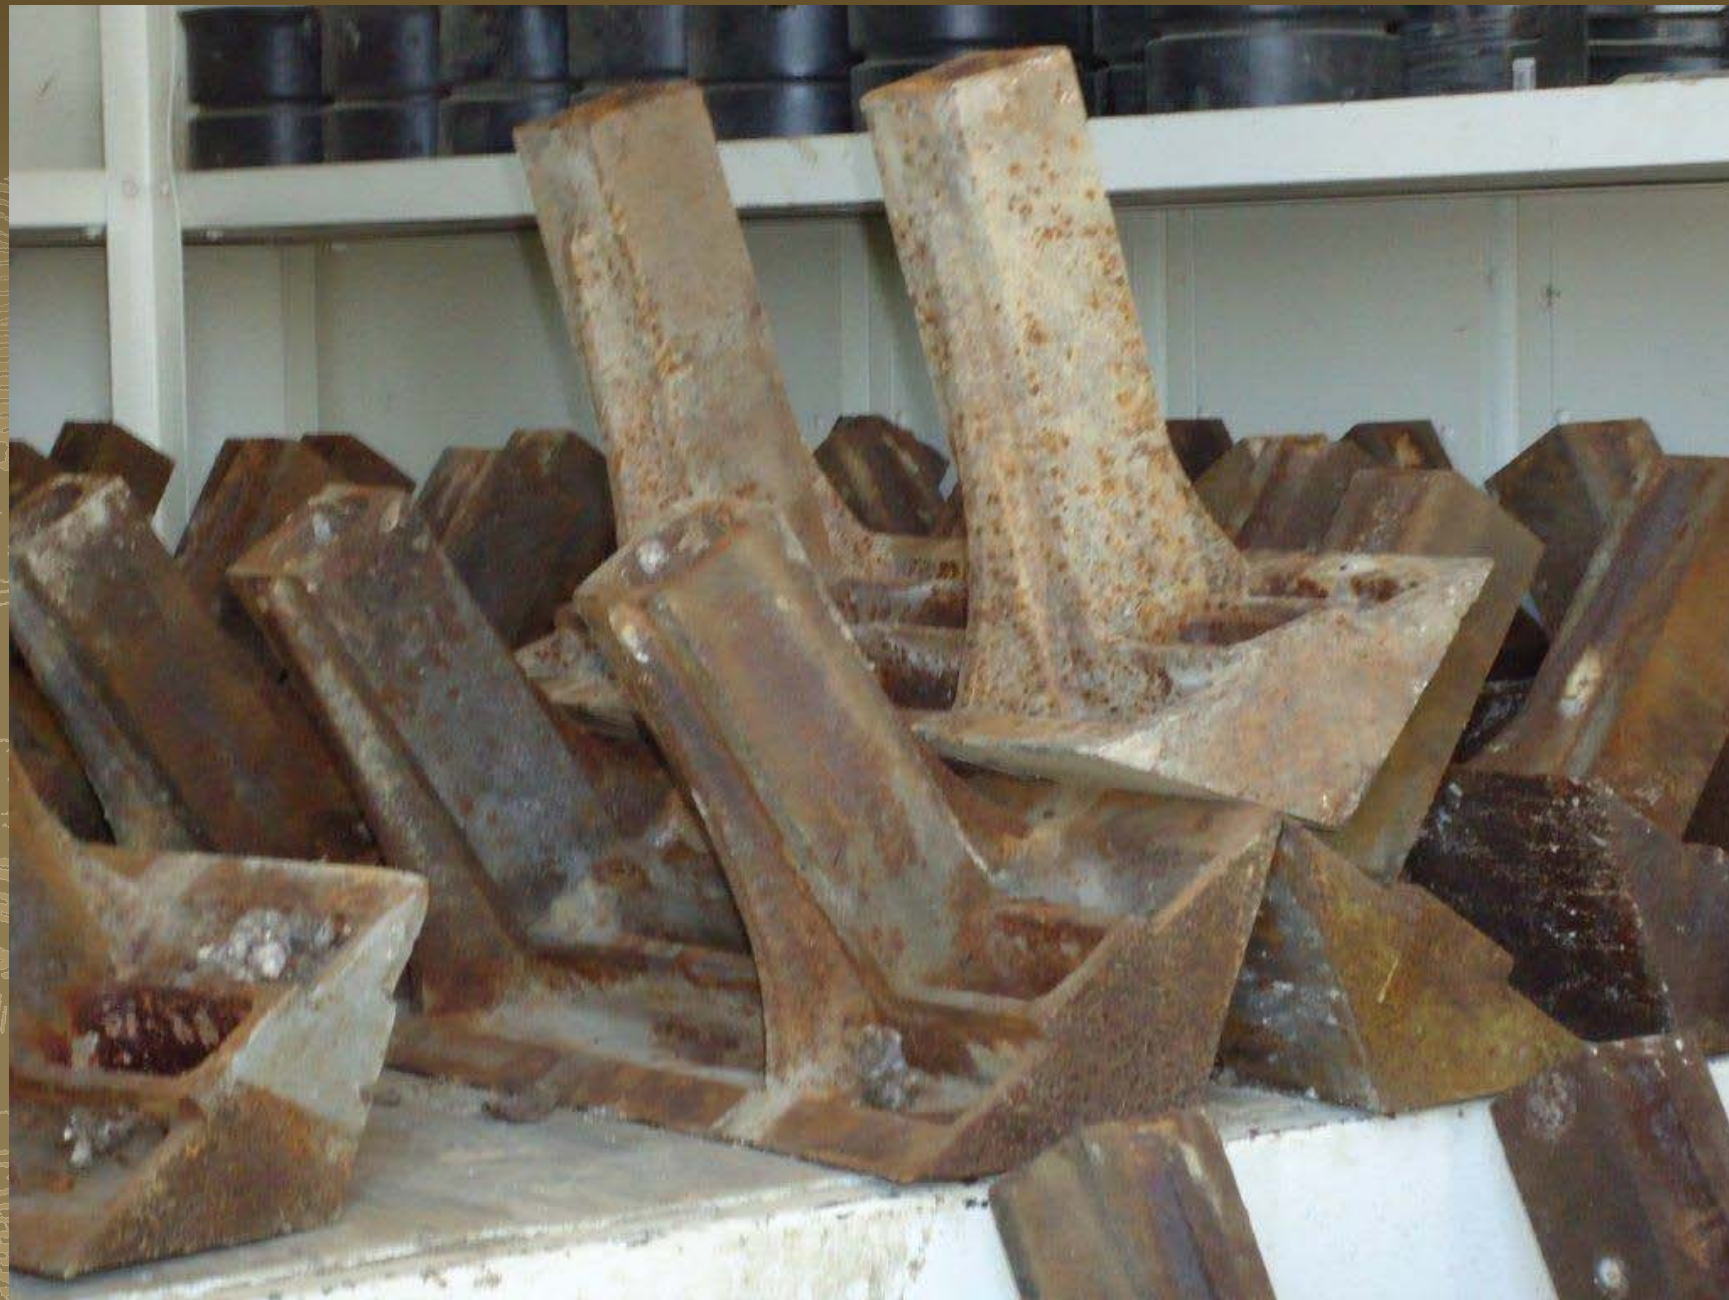
Nodal Castings from Ceylon Covered Bridge in Indiana

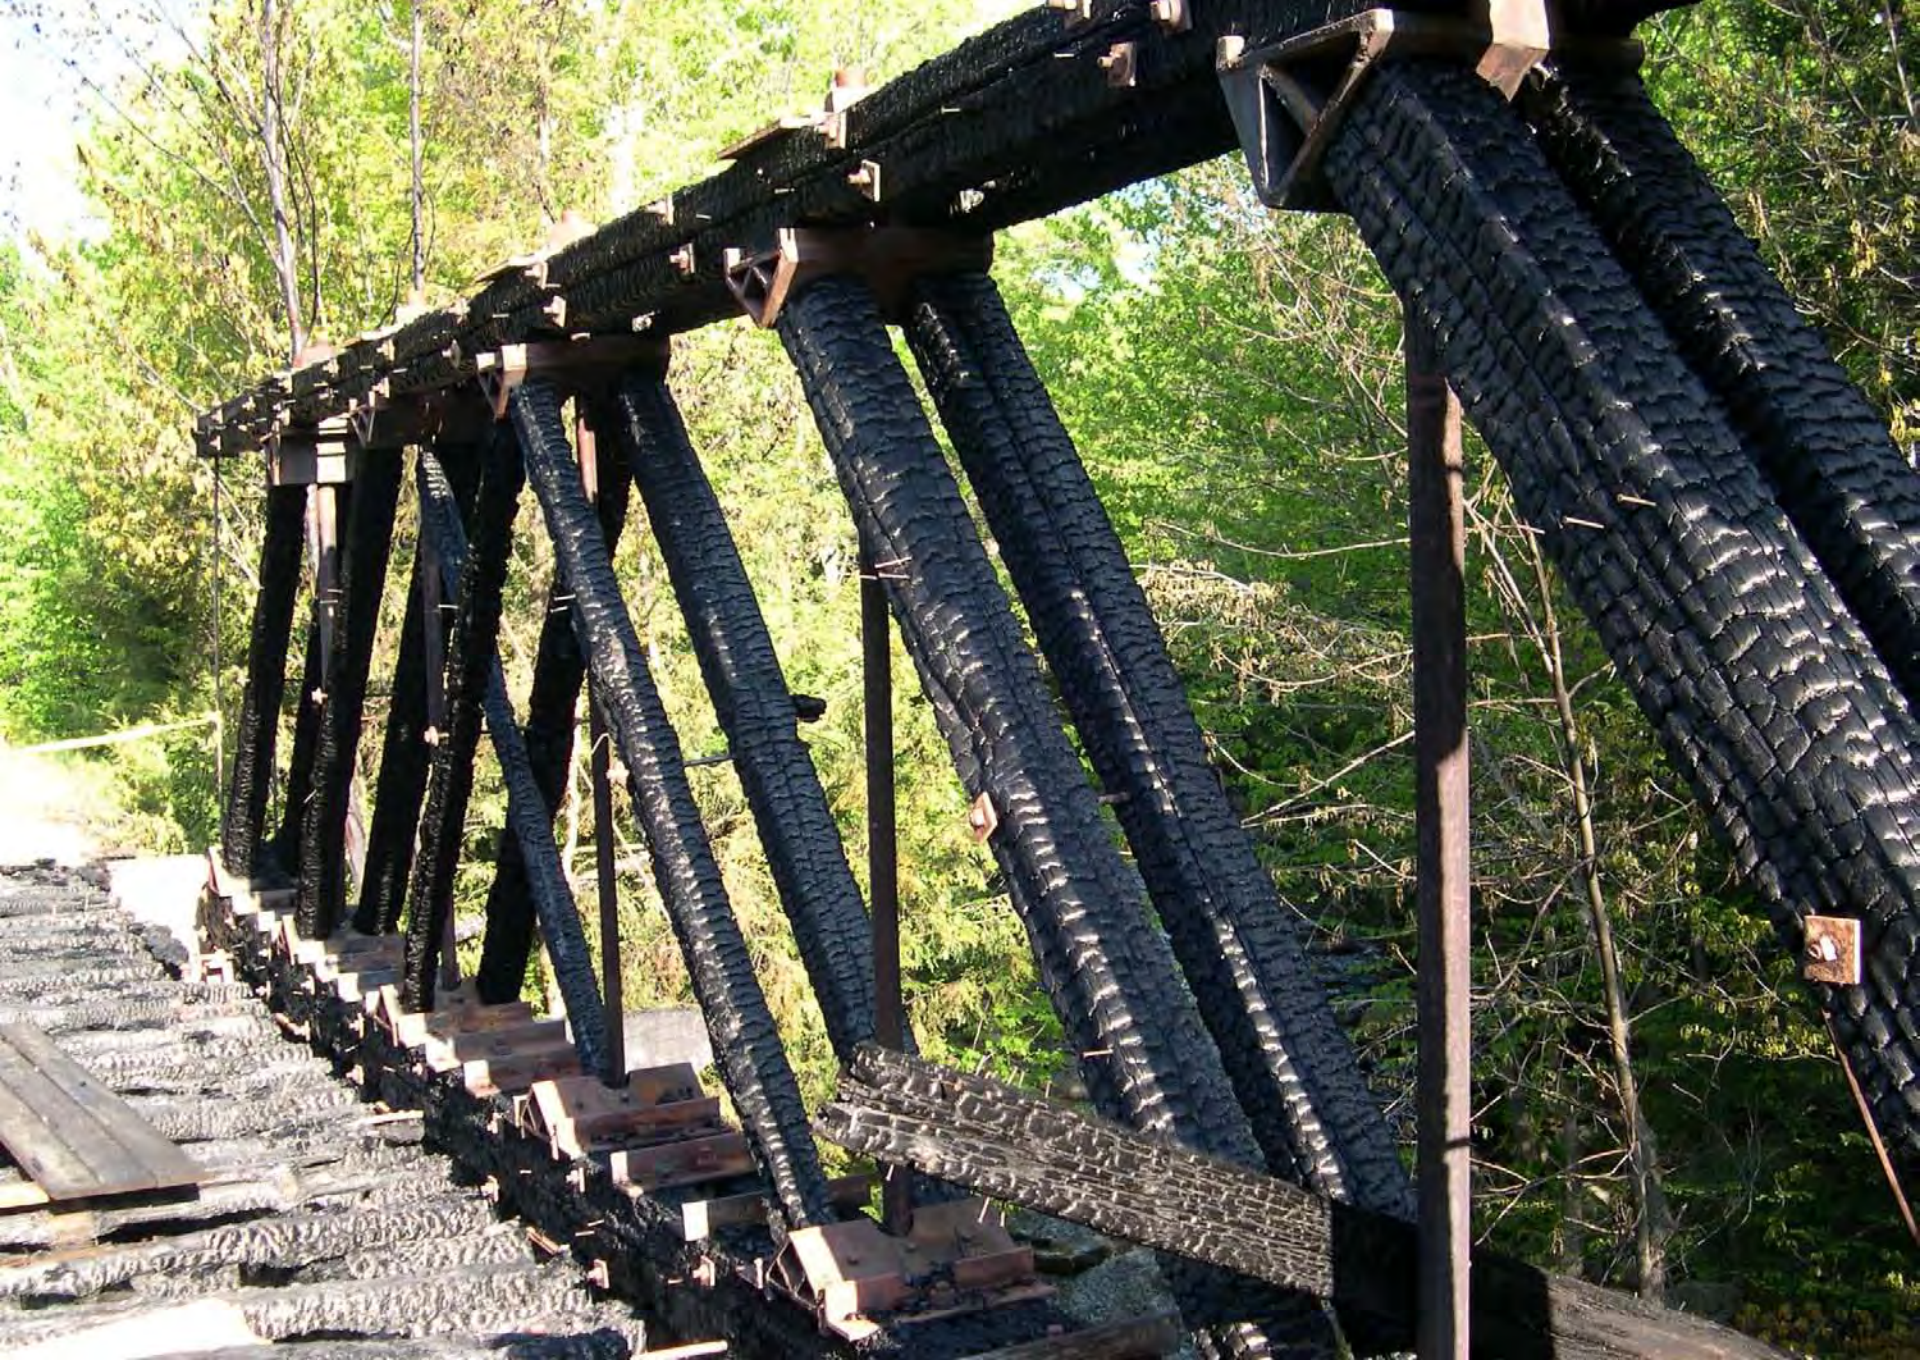
Arson, spring 2004: view after fire

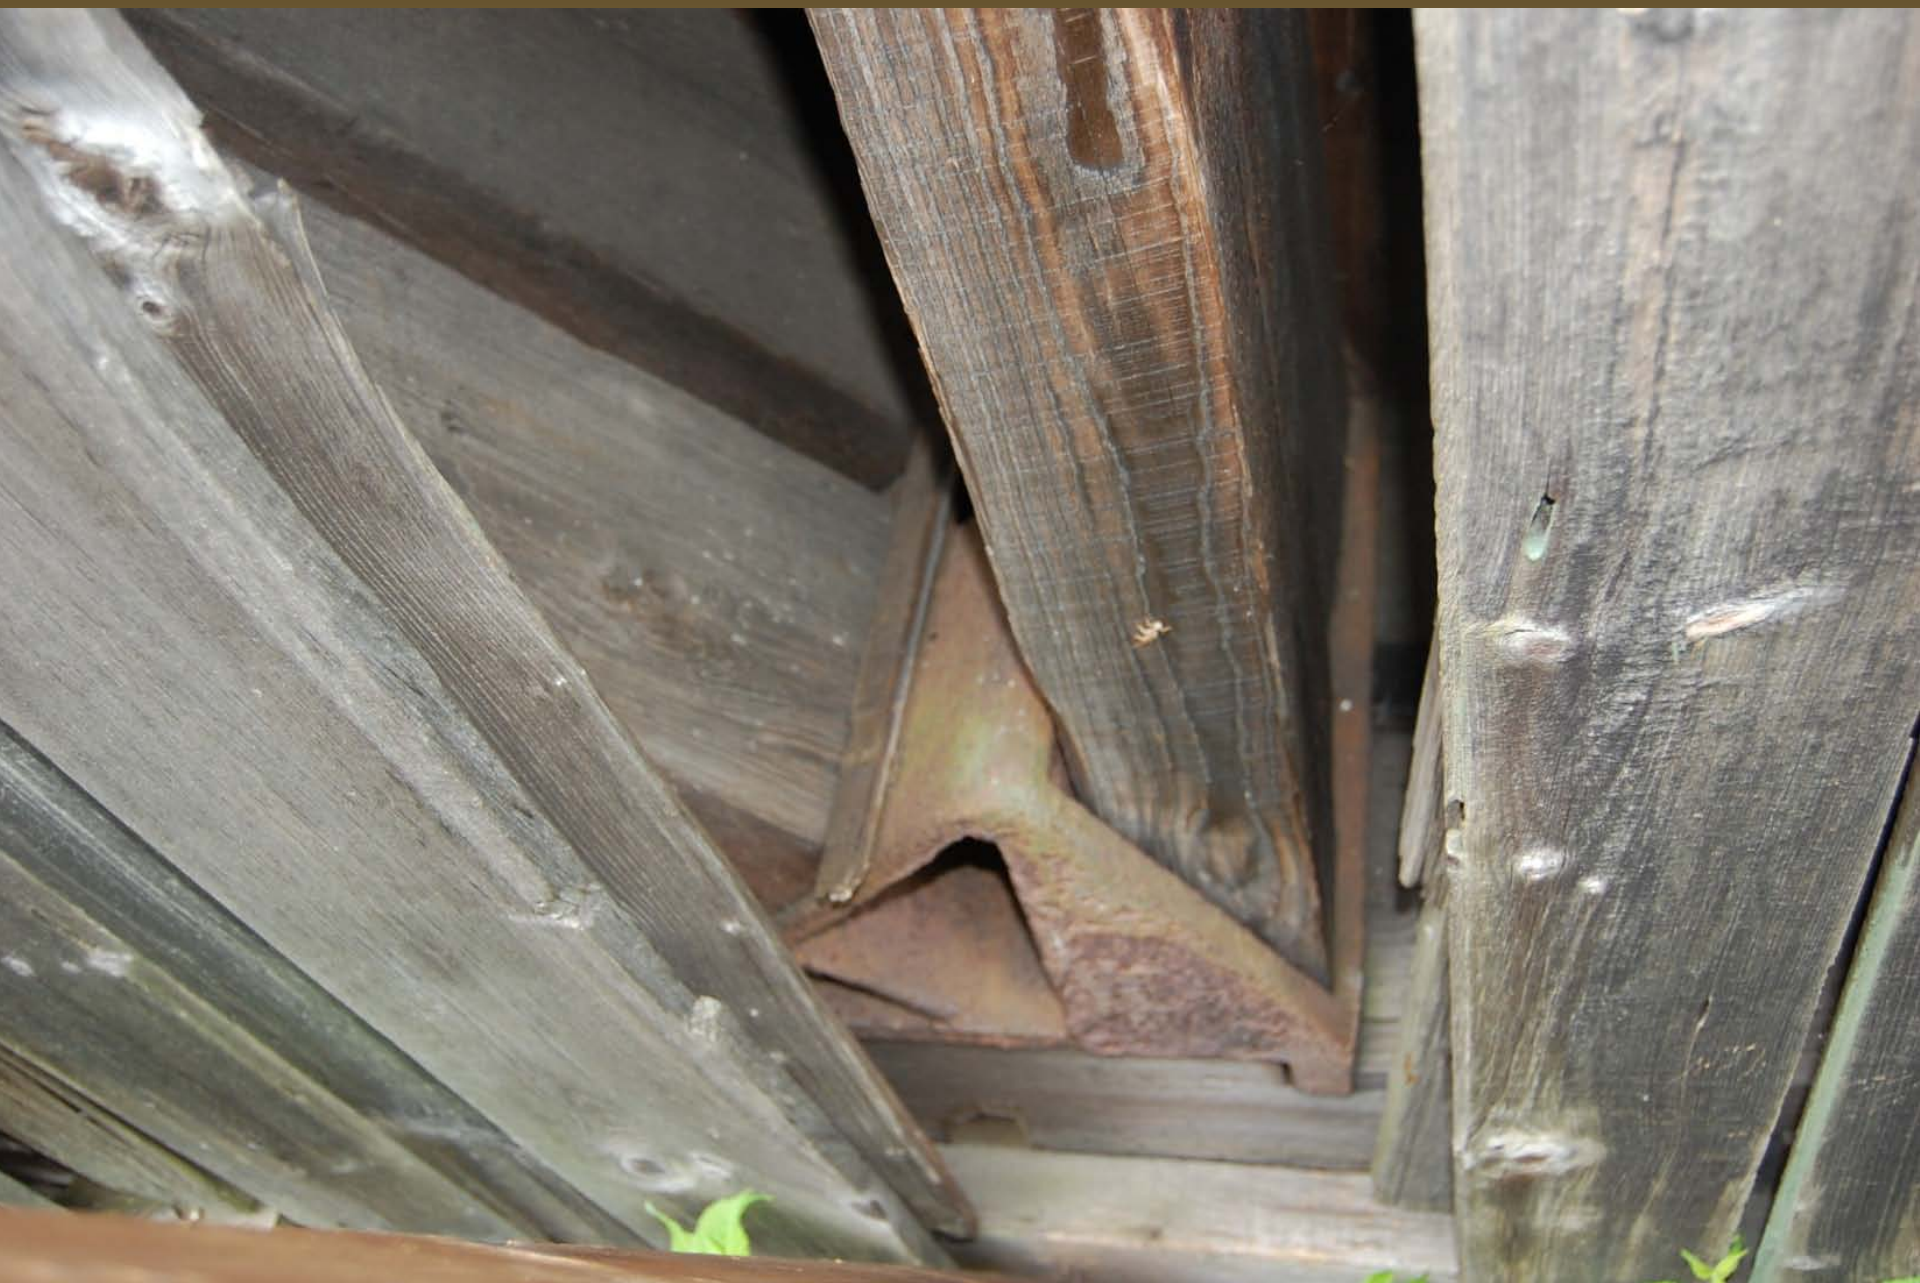
Revealed end post casting, Snyder Brook Bridge

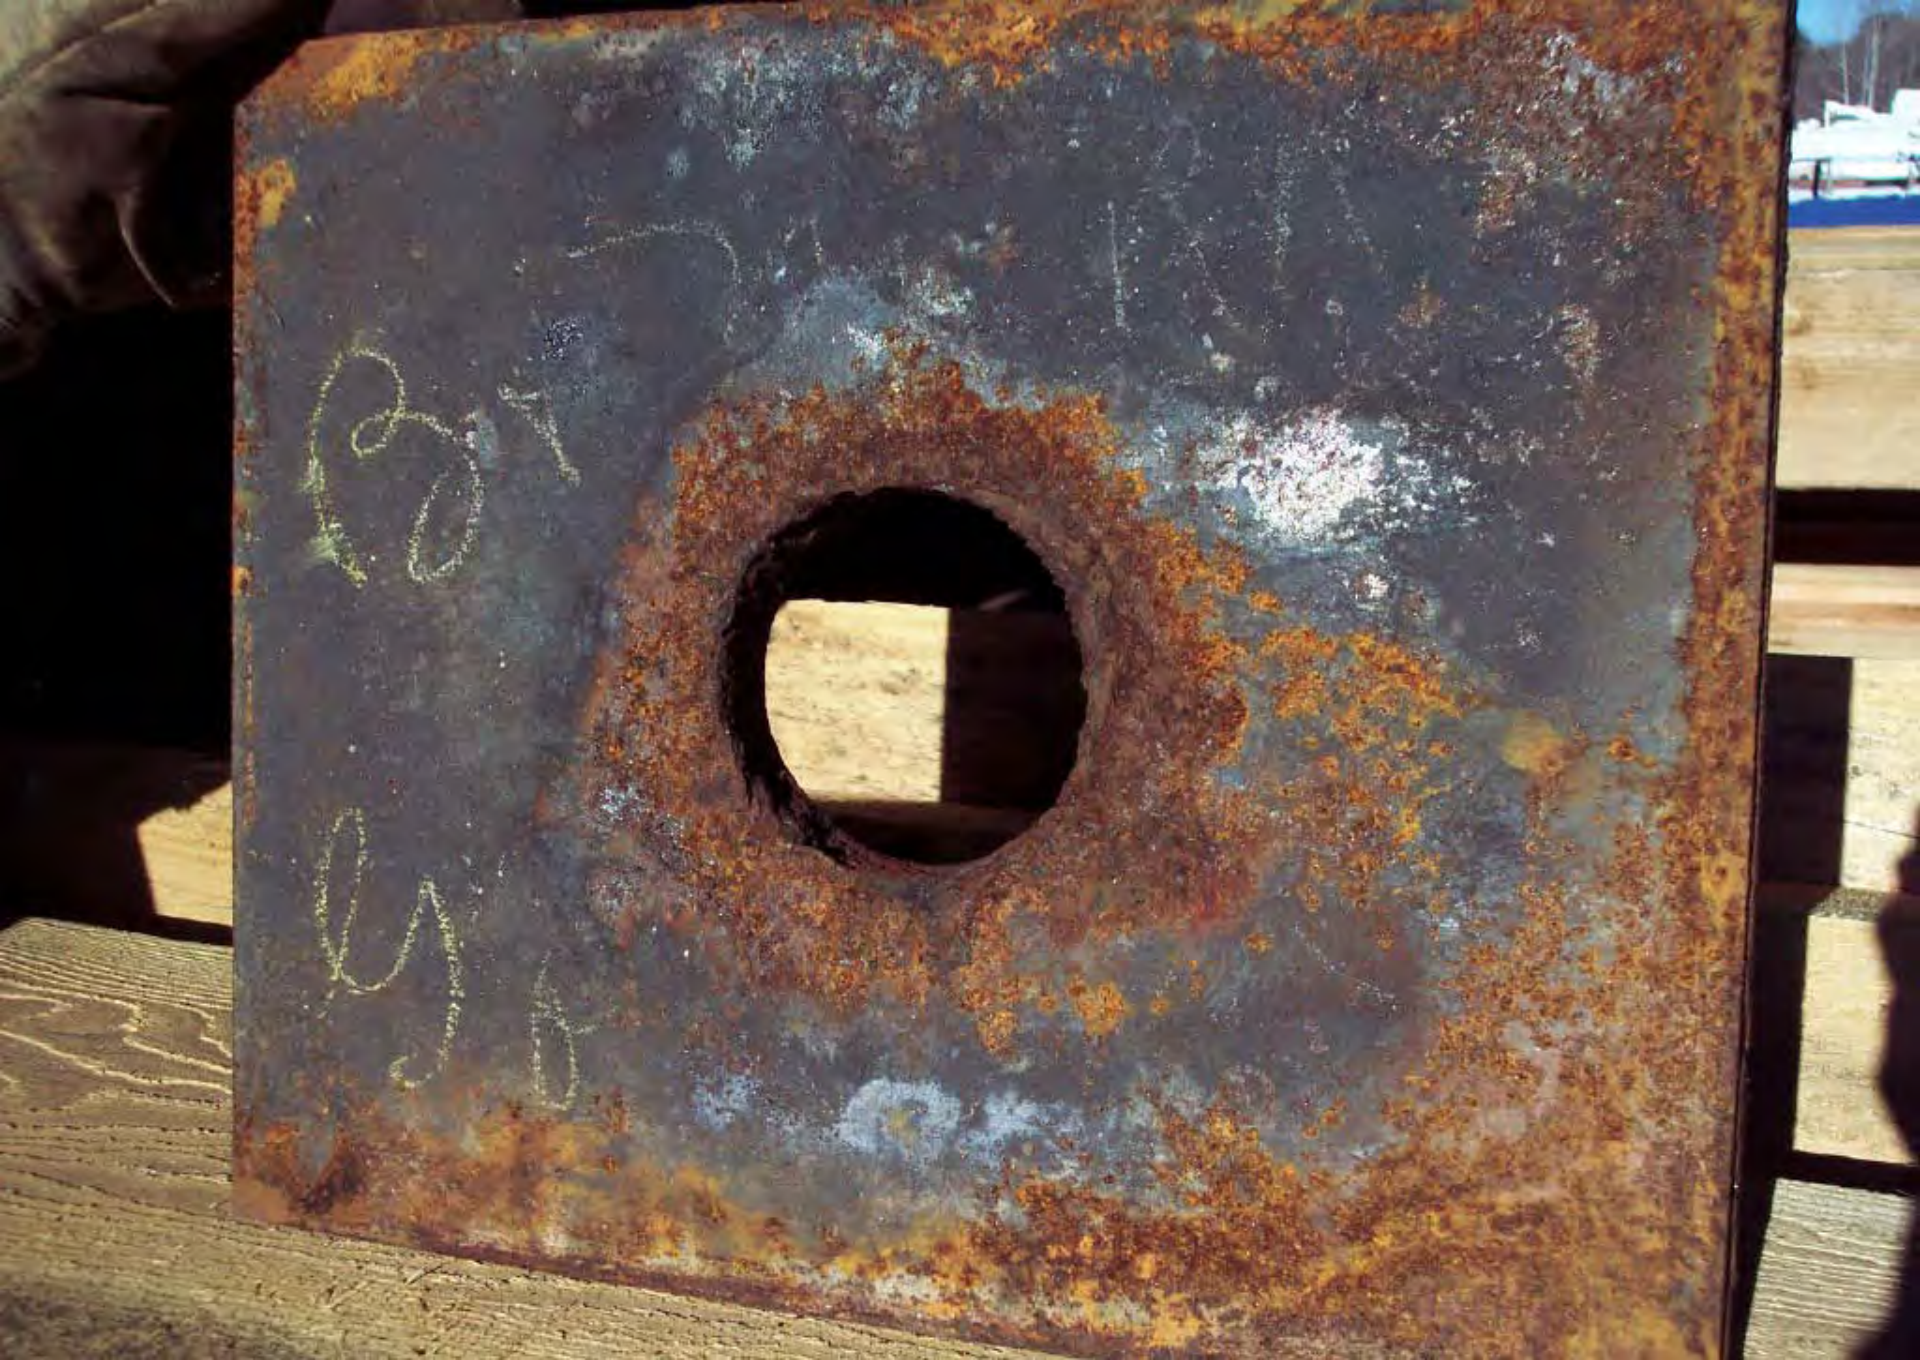
Chalk markings read "BYM RR, Gorham." Originally built elsewhere, assembled on site

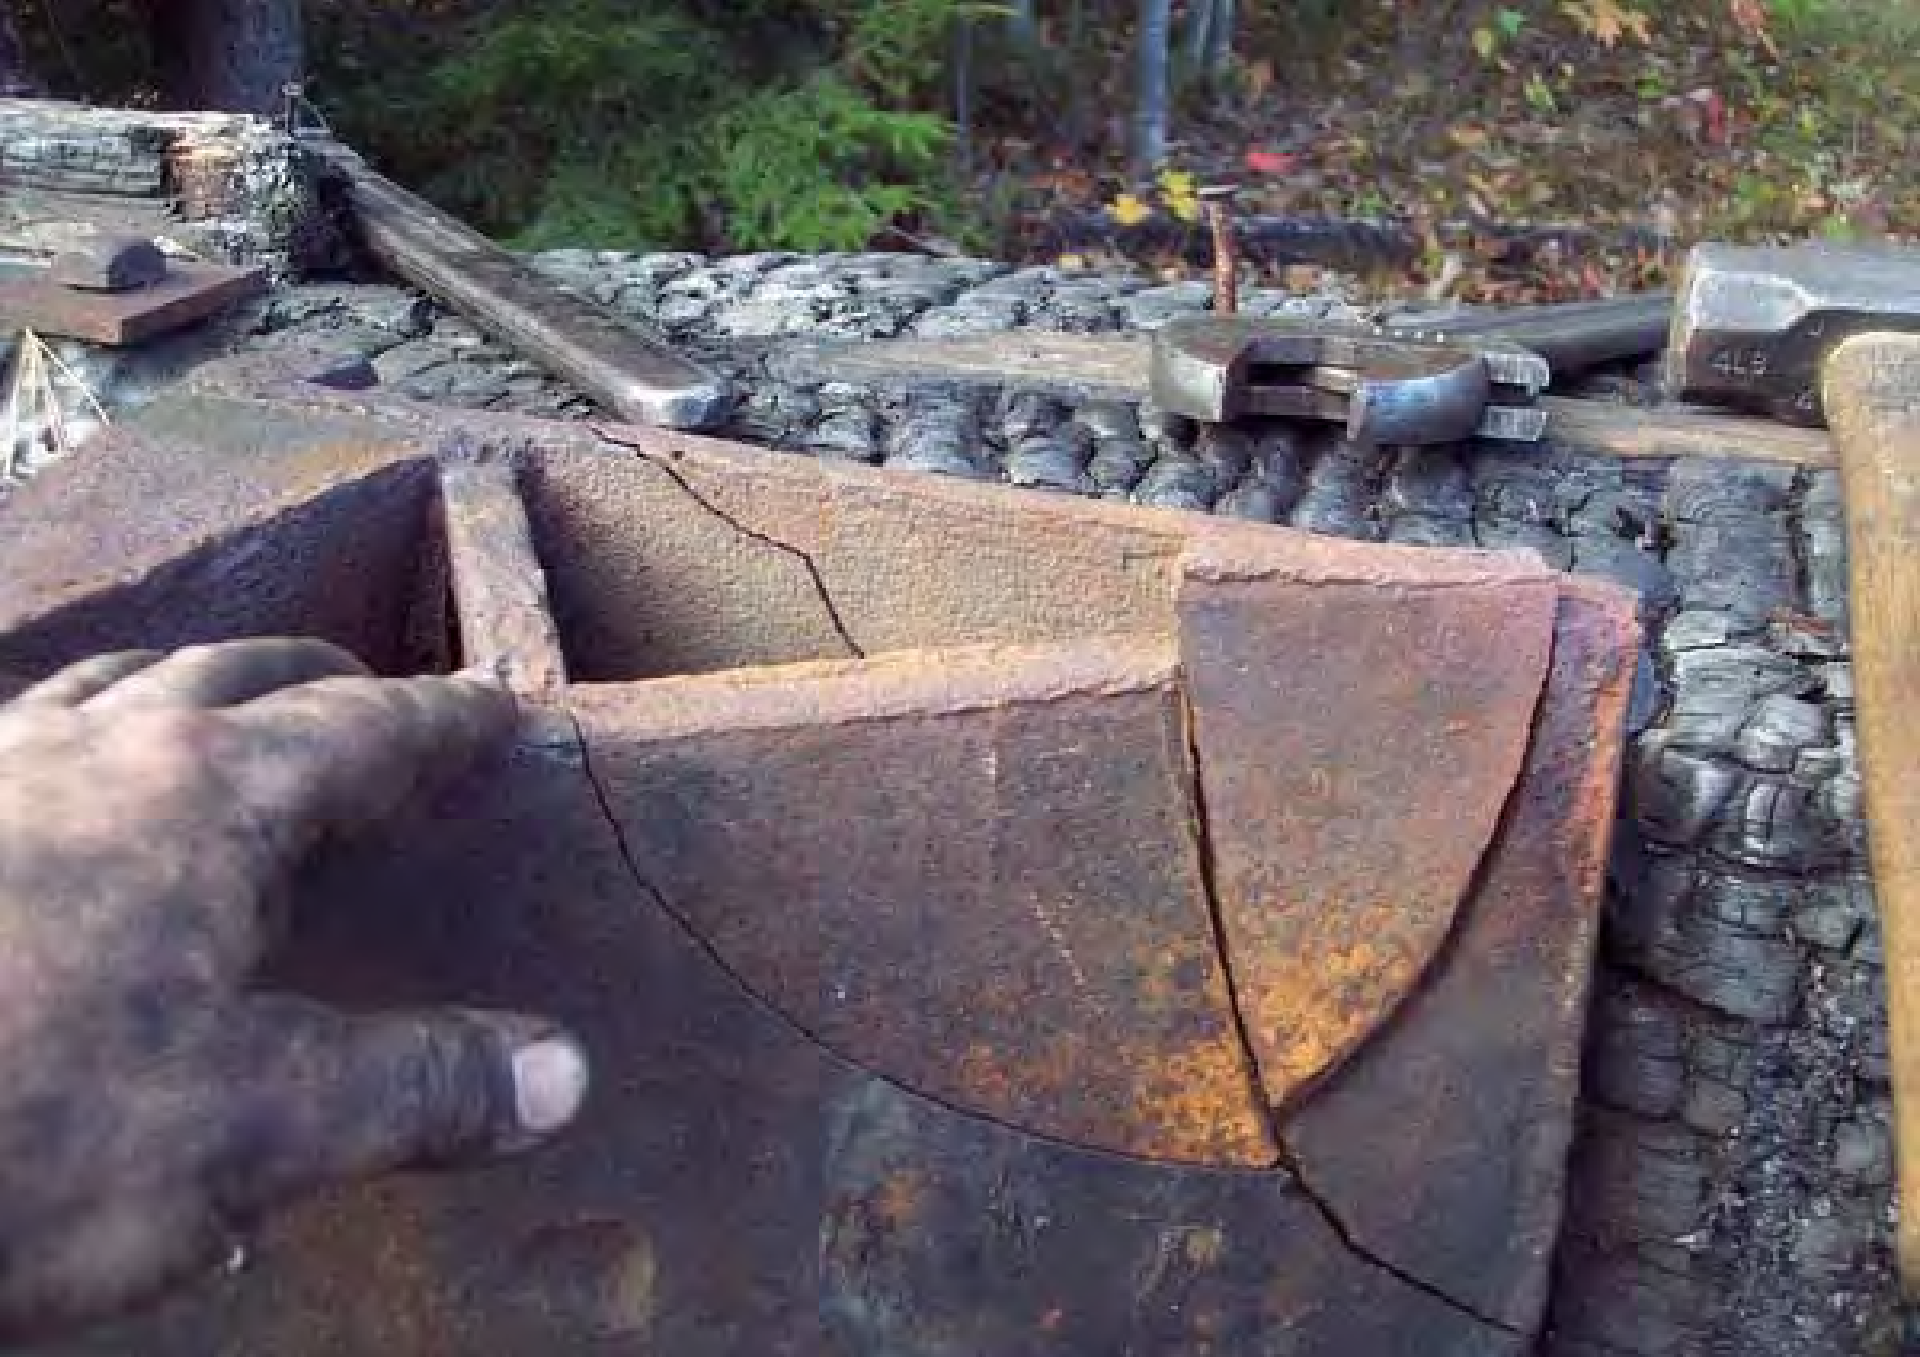
Fire-damaged end shoe

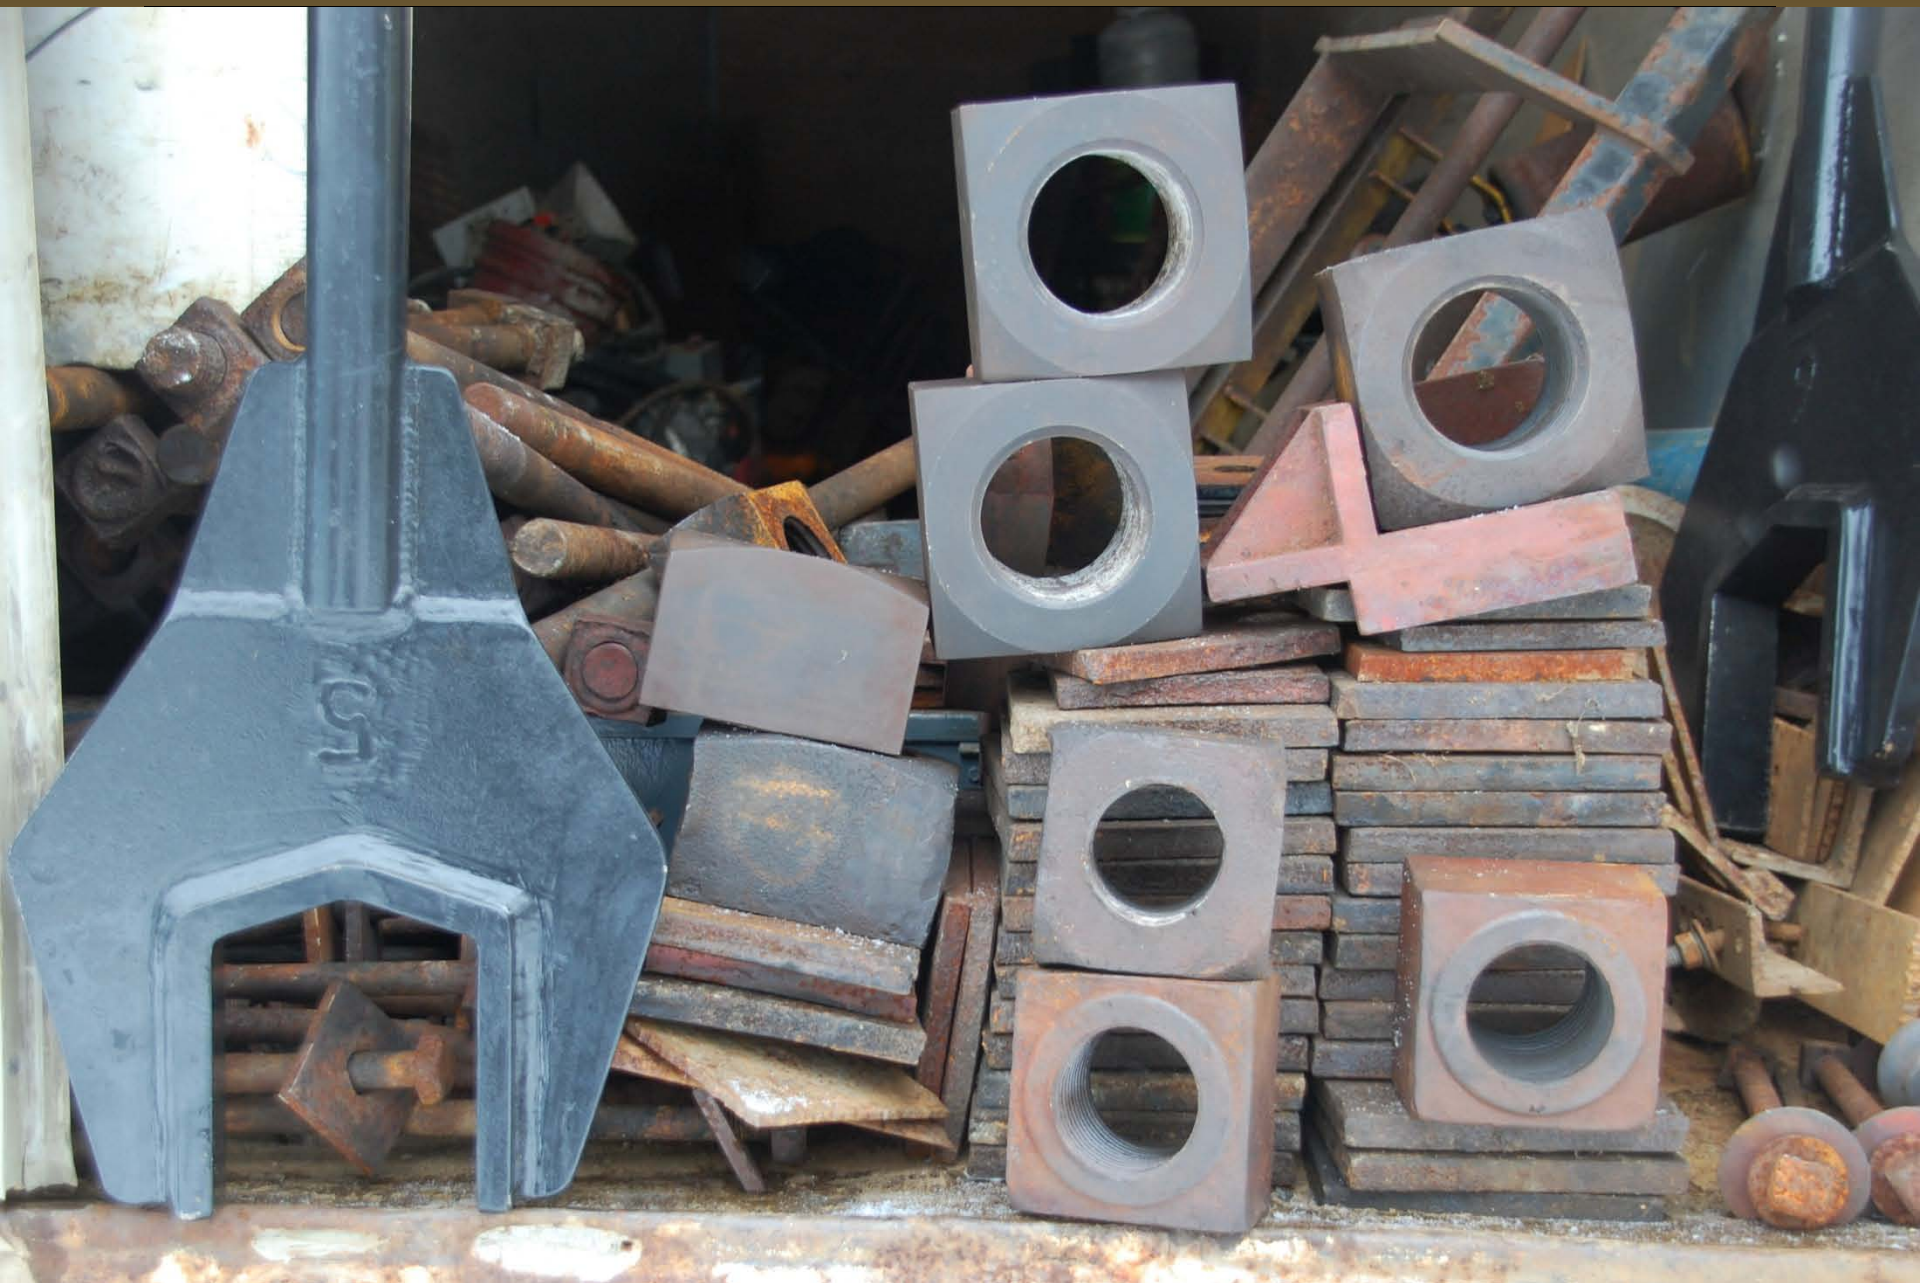
Homemade wrench, 5" for small nuts; three upper nuts are replications

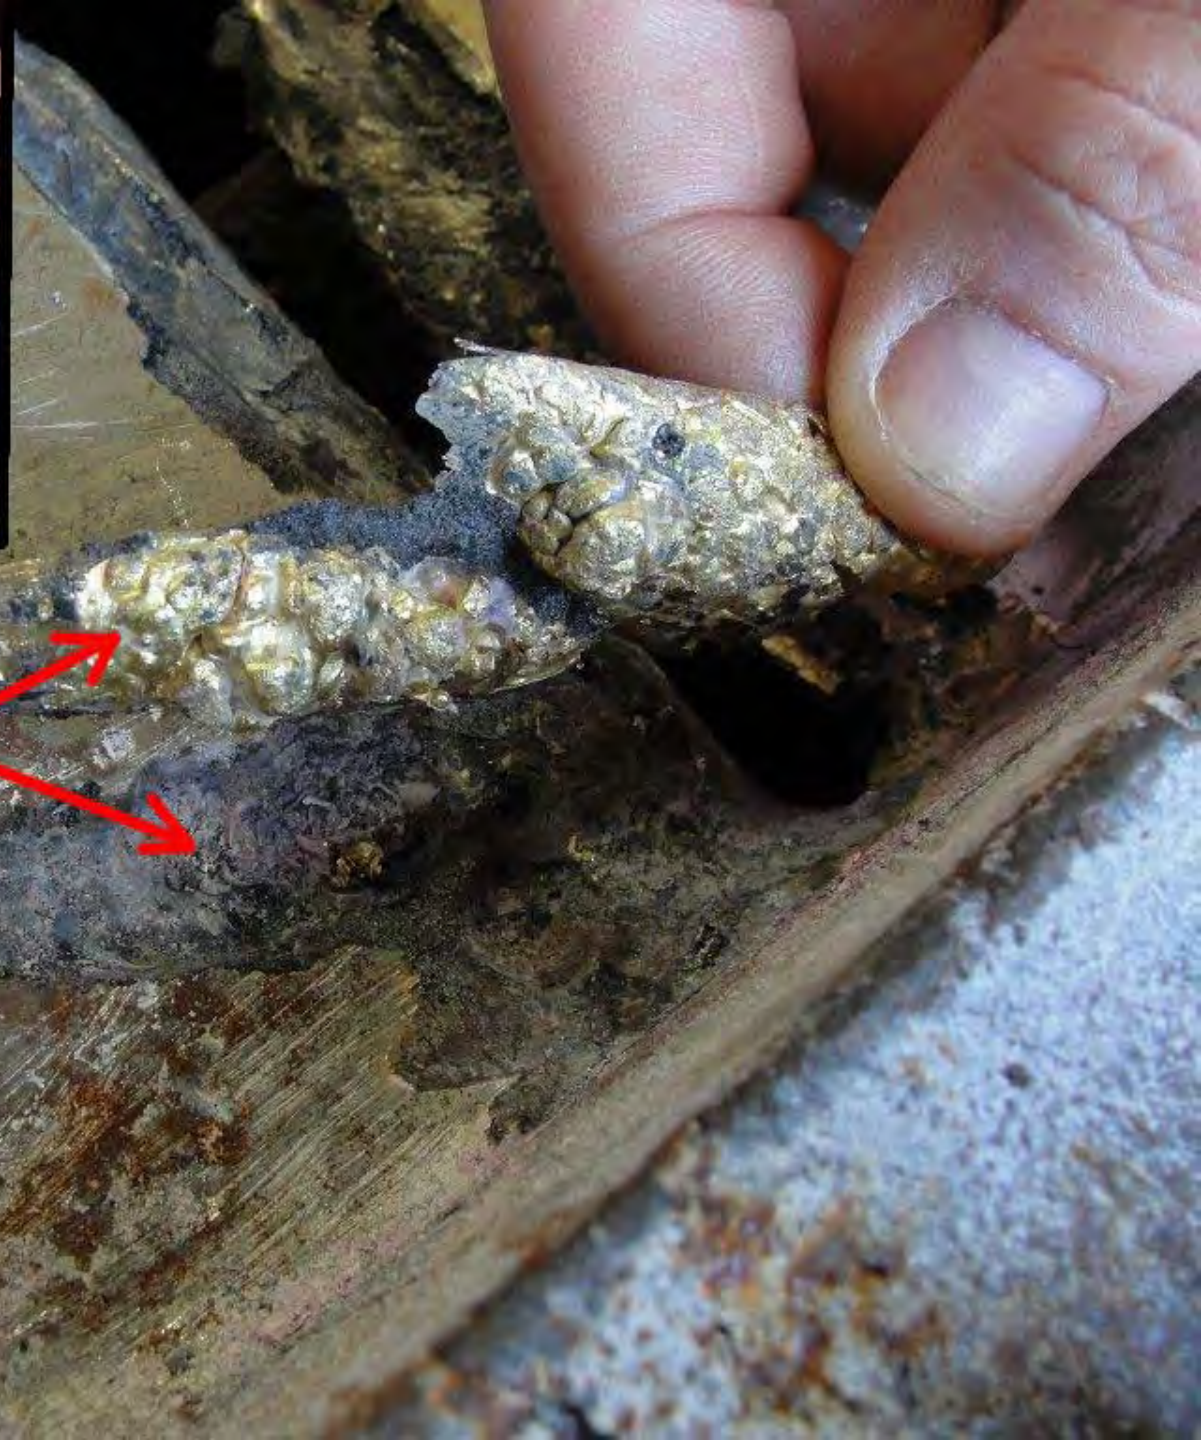
Braze filler
metal not
bonded to the
base metal

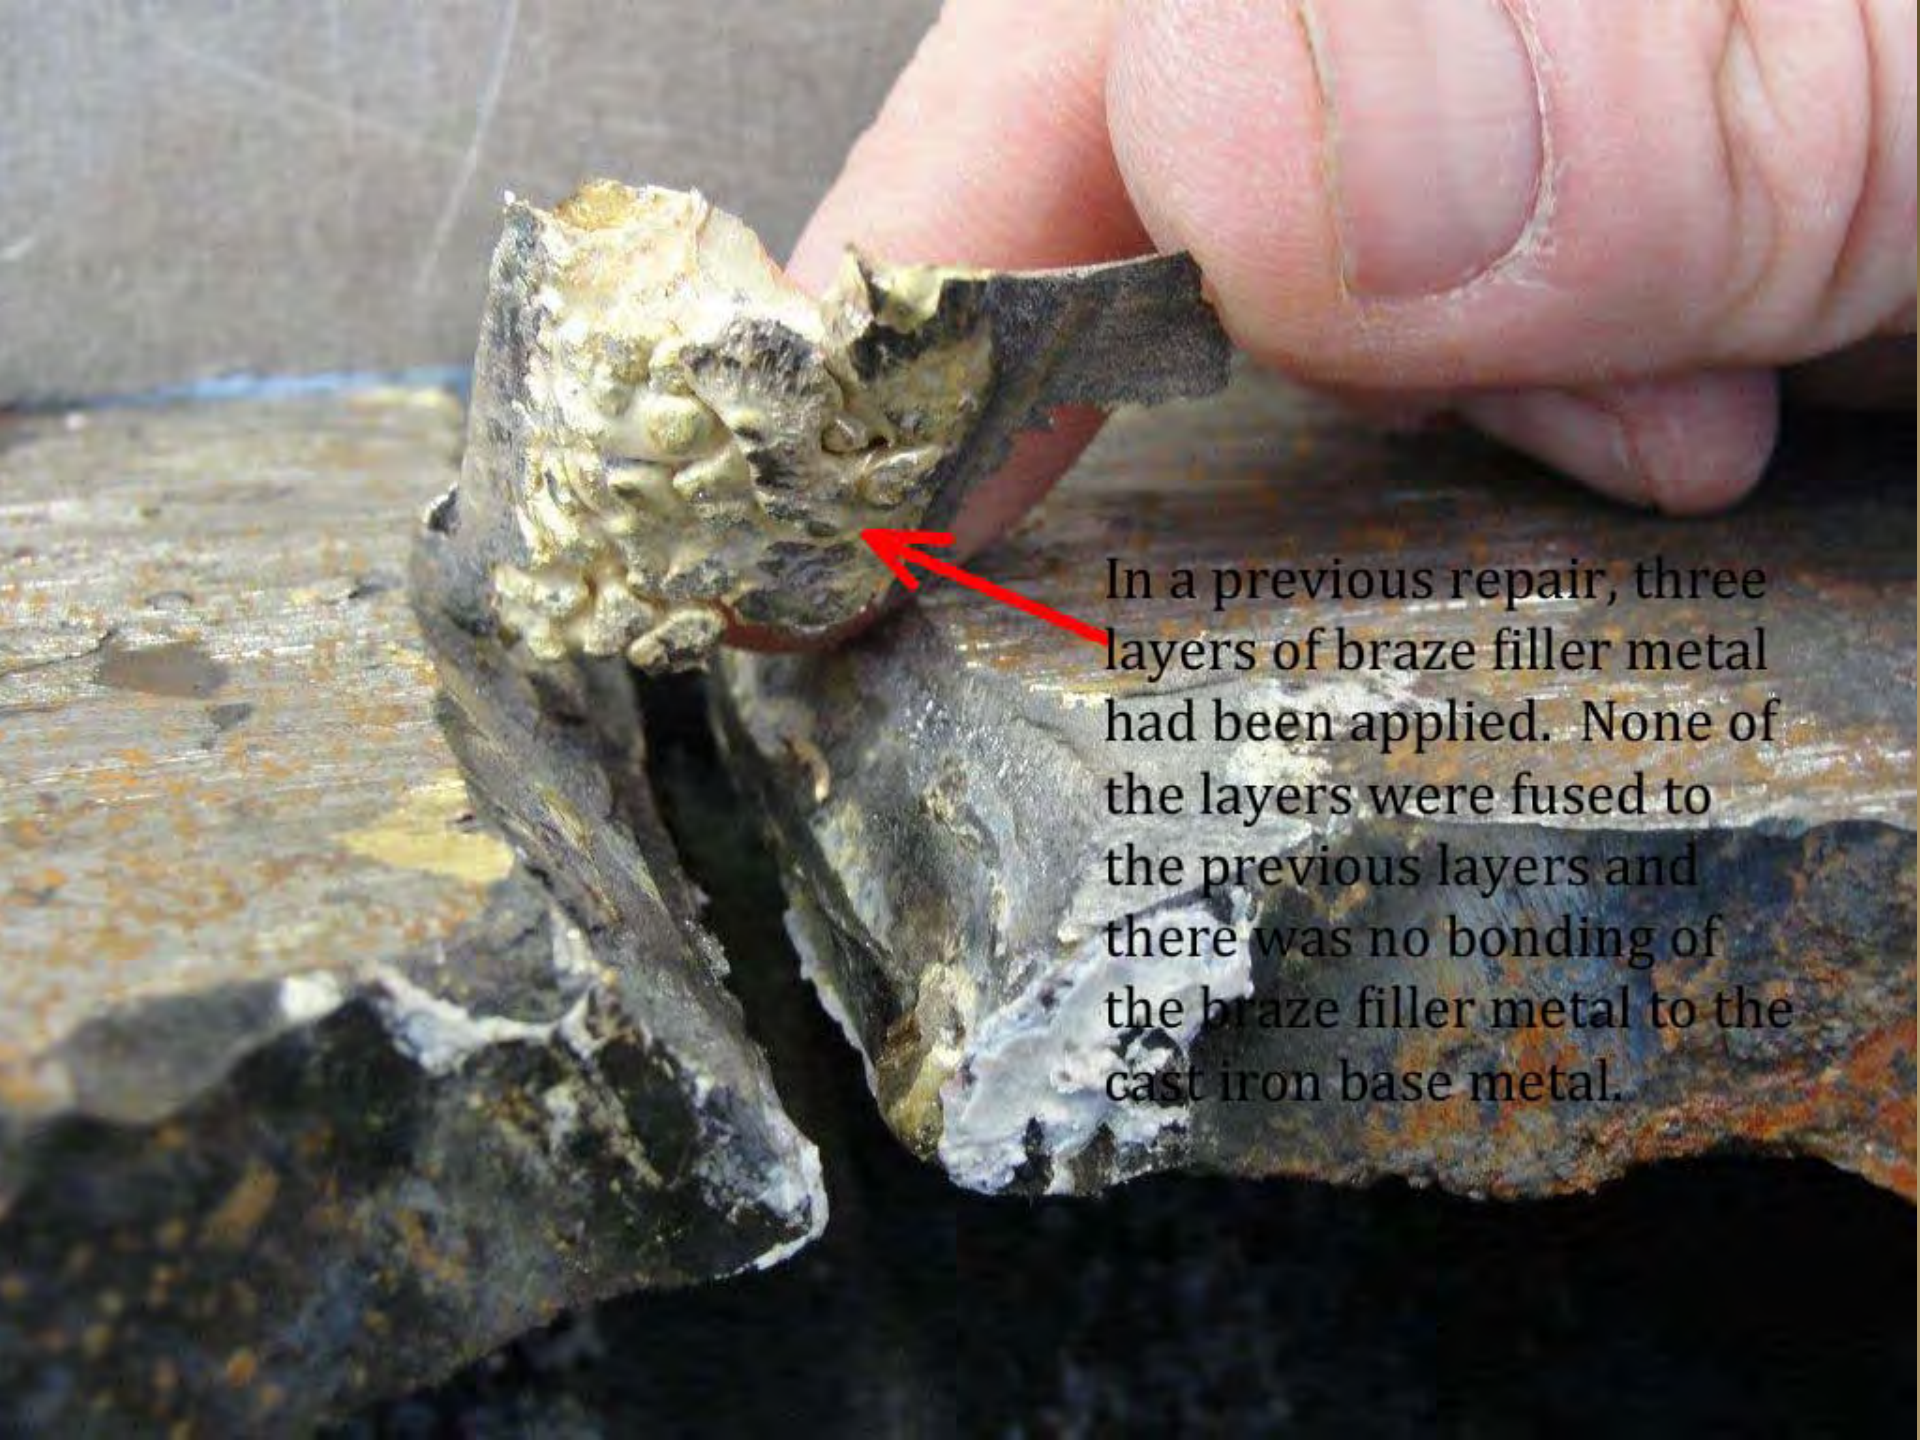
In a previous repair, three layers of braze filler metal had been applied. None of the layers were fused to the previous layers and there was no bonding of the braze filler metal to the cast iron base metal.
