Replacement of the Bartonsville Covered Bridge

It Takes Three to Yield One

by Phil Pierce, P.E.
Associate and Sr. Principal Engineer
CHA Consulting, Inc.

*SECOND NATIONAL COVERED BRIDGE CONFERENCE,
Dayton, Ohio*

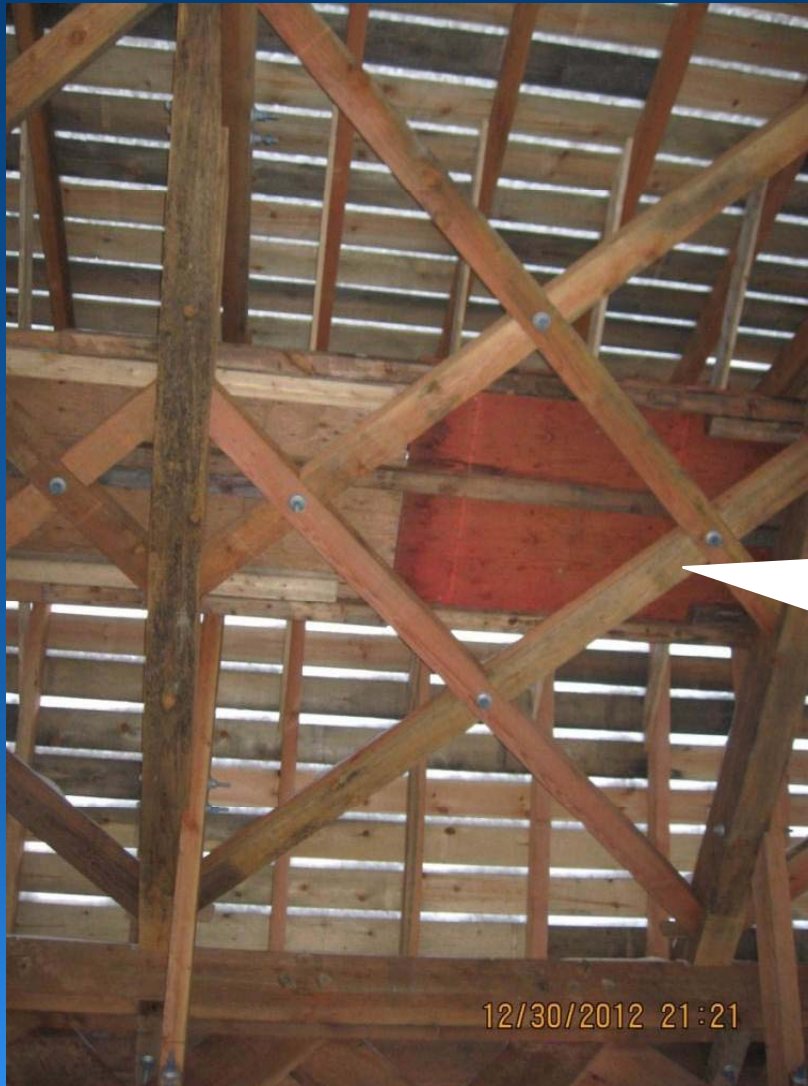
Unusual double intersection upper laterals to “mimic” the original detail

- Retain same entry portal shape (semi-elliptical)
- Retain windows (although the number of them was an issue)
- Retain metal roof
- Use same unusual double-intersection overhead lateral bracing system

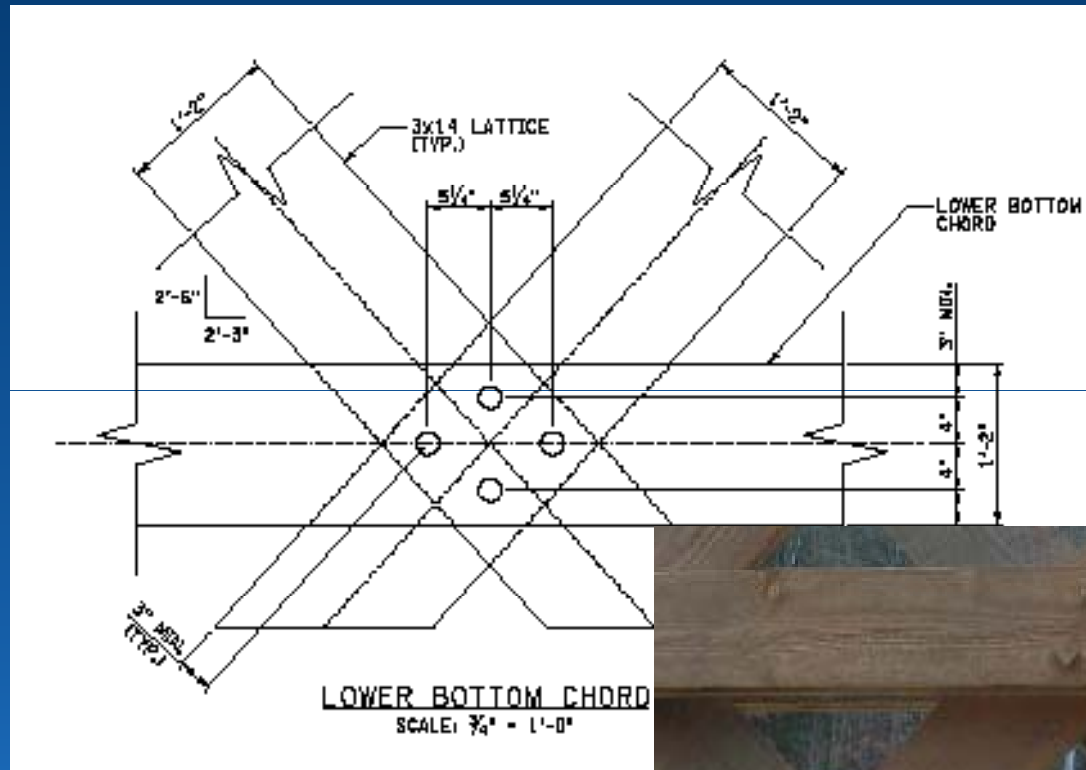
Traditional hardwood
pegs were used in the
truss connections—two,
three or four 2-inch
diameter pegs

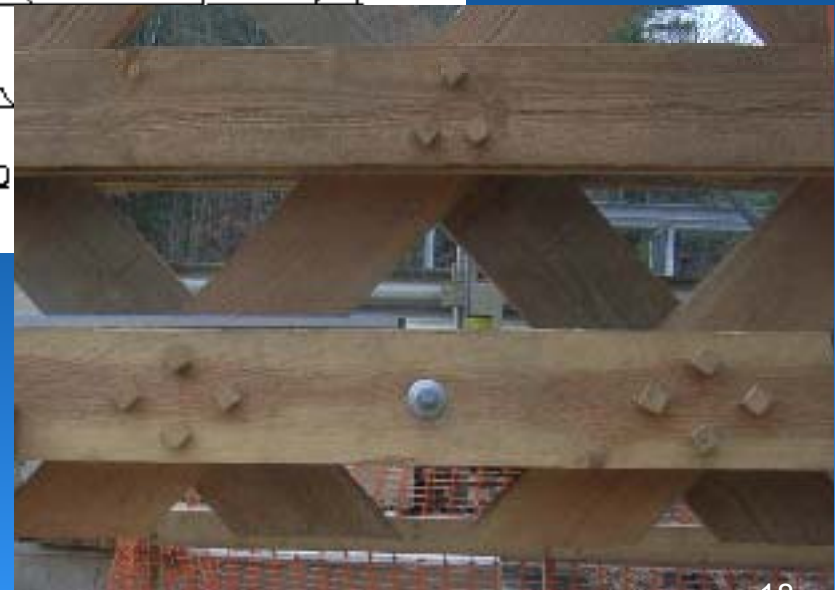
- The transverse floorbeams were made stronger to accommodate vehicle axle loads up to 24 tons (the design vehicle was selected as a two-axle 30 ton vehicle to provide ample reserve capacity)
- This desired capacity led to the use of glue-laminated floorbeams –often used in rehabilitation projects of historic covered bridges

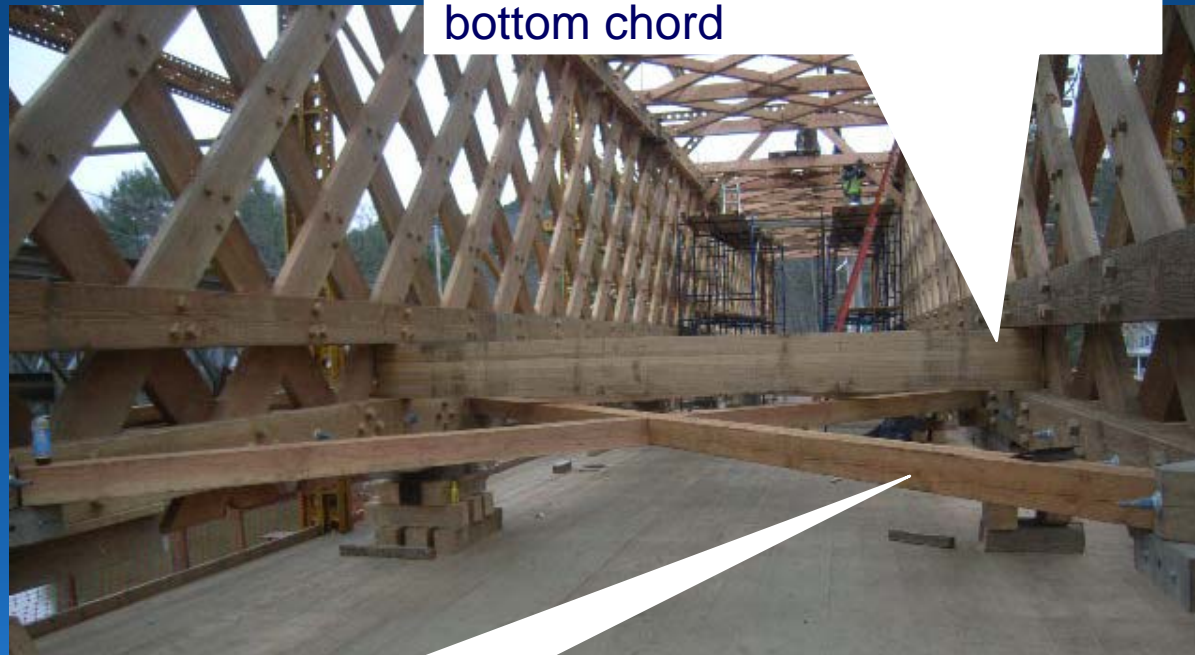
Glulam floorbeams supported by bottom chord

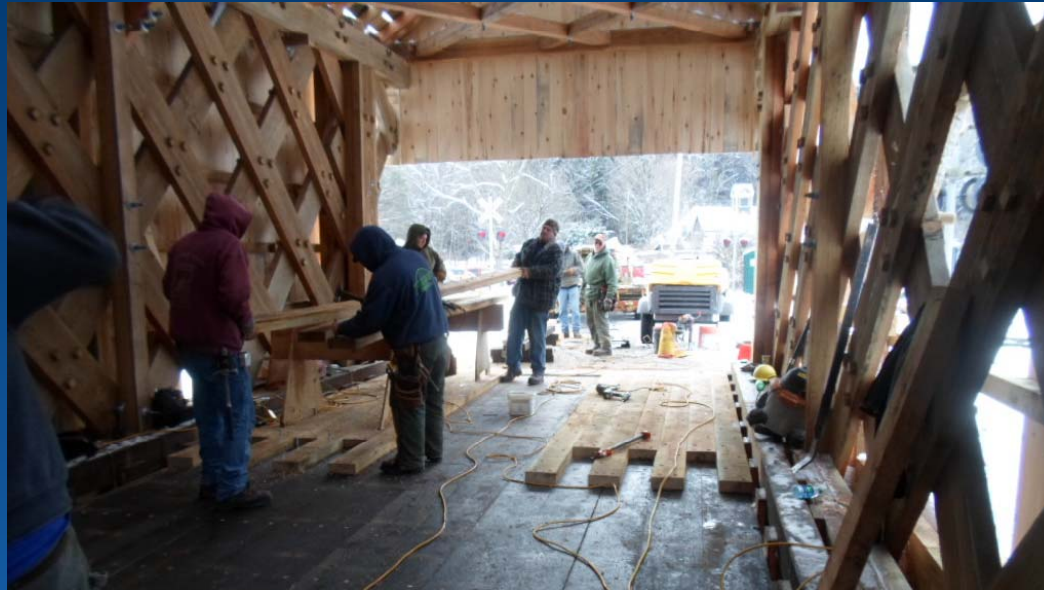
Lower “X” lateral system –
transverse steel tie rods with
turnbuckles not yet installed

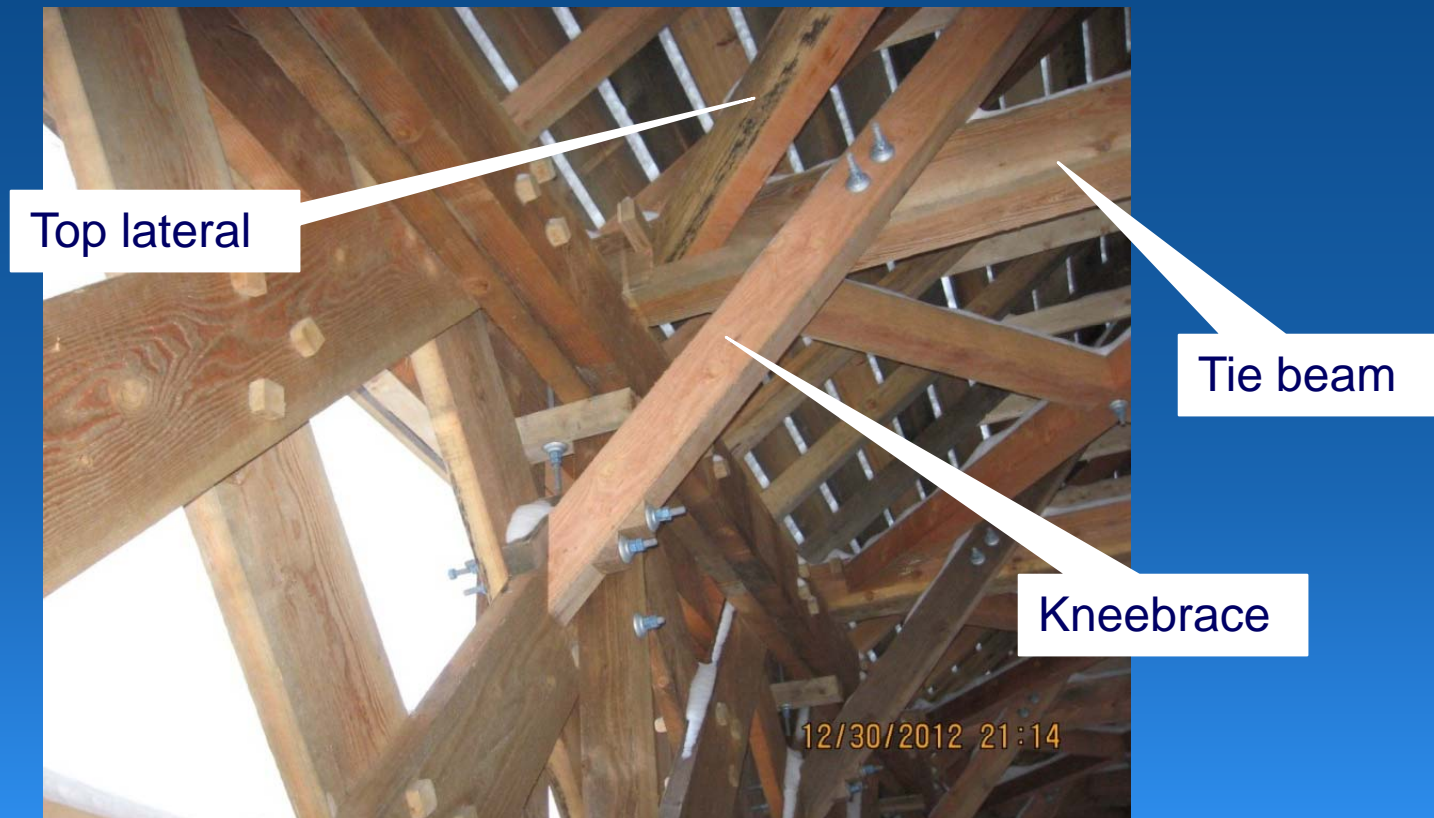
- The overhead kneebraces were increased in size - bolted to the sides of the lattice intersections and notched into the overhead transverse tie beams

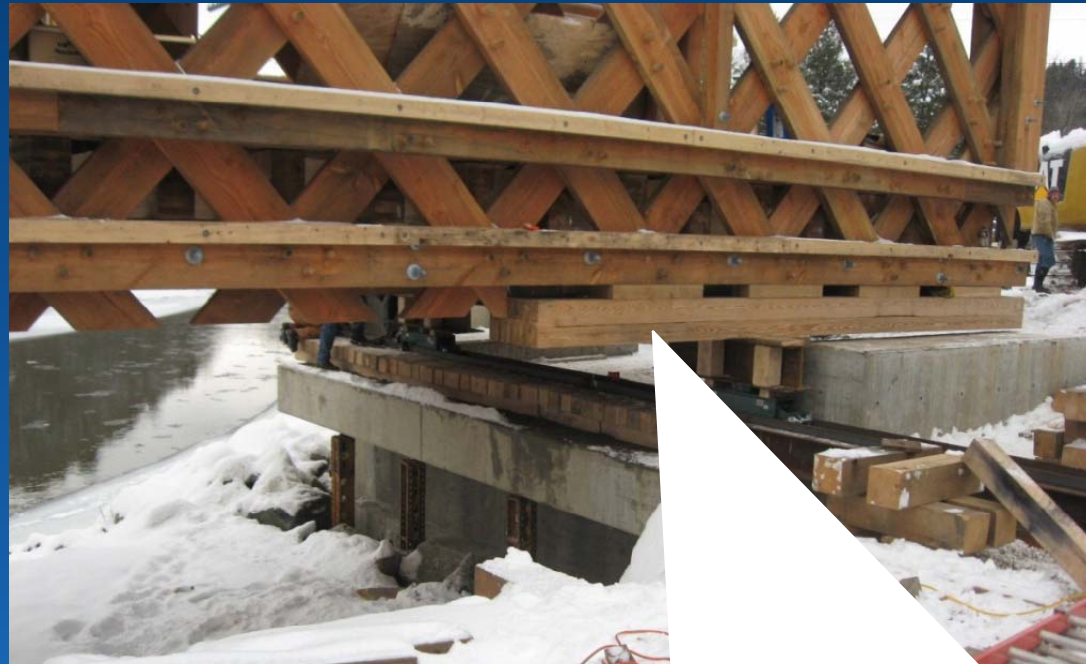
Large glue-laminated bolster beams were installed beneath the trusses at each corner – they function as “diving boards” spreading support of the truss over a longer distance – partially in front of the concrete of the abutment.

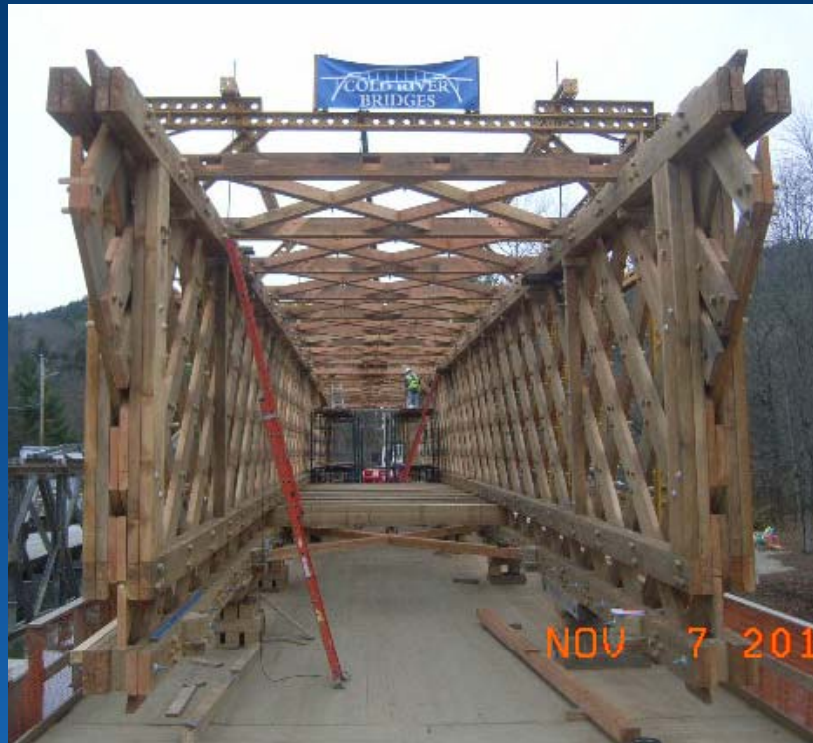
Town lattice trusses are highly indeterminate—in addition to such closely spaced components, there are six vertical planes of elements—2 layers of outer chords, 2 layers of lattice in opposite directions, and 2 layers of inner chords held together by the hardwood trunnels.

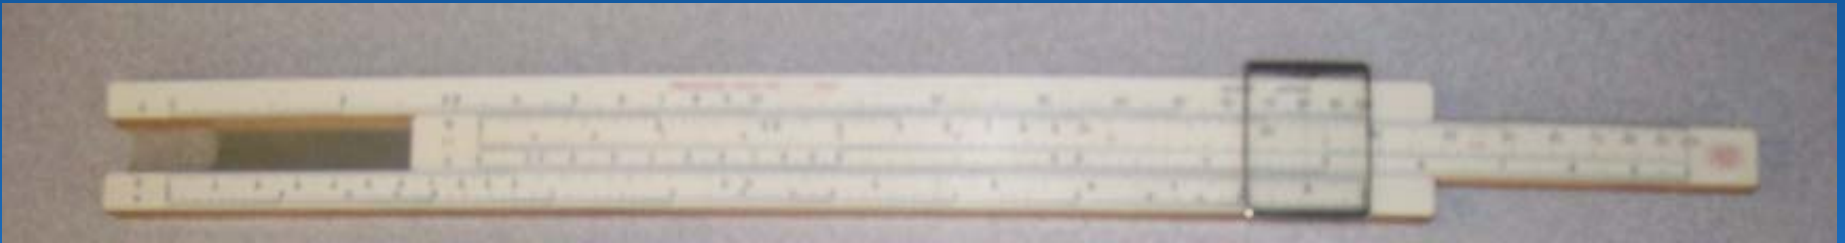
- Nonetheless..... the only way to "properly" evaluate stress and strength in such structures (*? – long story – I will forego an explanation for your sake ☺*) is with a first order three-dimensional finite element model of the six planes of components in each truss
- Each truss contained 84 lattice, 20 top chord, 20 upper bottom chord, and 20 lower bottom chord elements

- I have worked with a world-renown computer simulation company over the past 20 years on five separate Town lattice bridges – early work was based on laboratory and field research and each subsequent assignment has become a bit more refined
- The computer model included 3,124 nodes and way too many elements between the intersections connected with trunnels

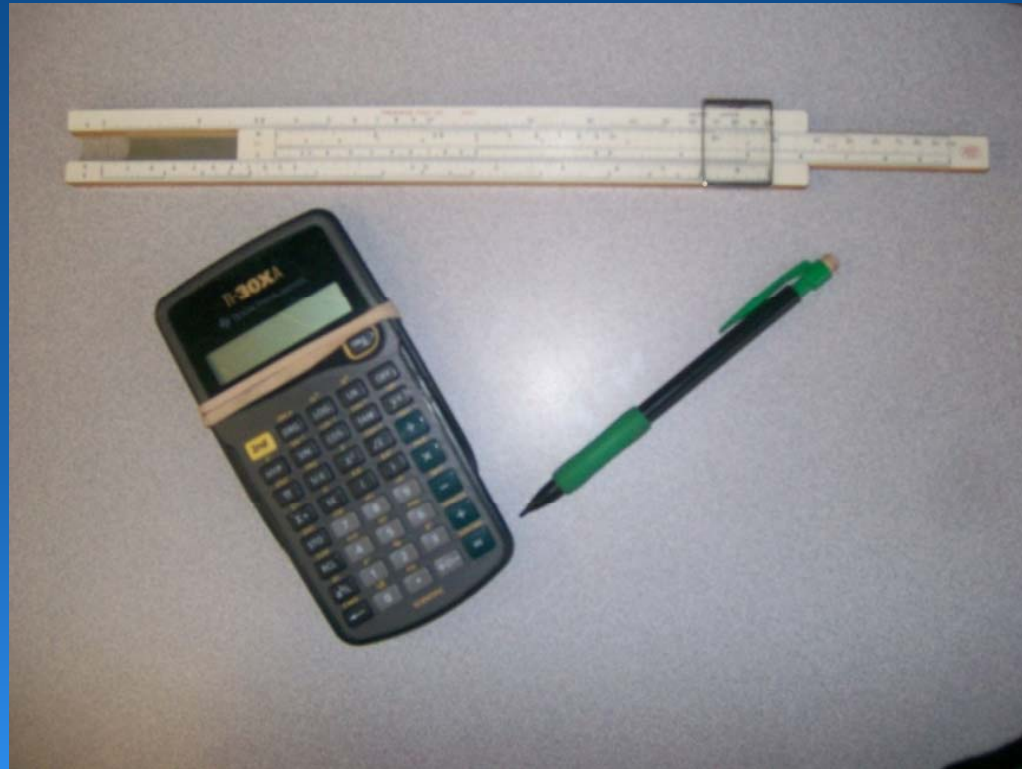
- Okay – we have a model – now to the force analysis for "dead" and "live" loads
- And then there is the issue of combined vehicular (i.e. "live") and snow load!
Remember – we're talking about Vermont
- And then there is design methodology – old school Allowable Stress versus the "new and improved" Load and Resistance Factor Design ?!?

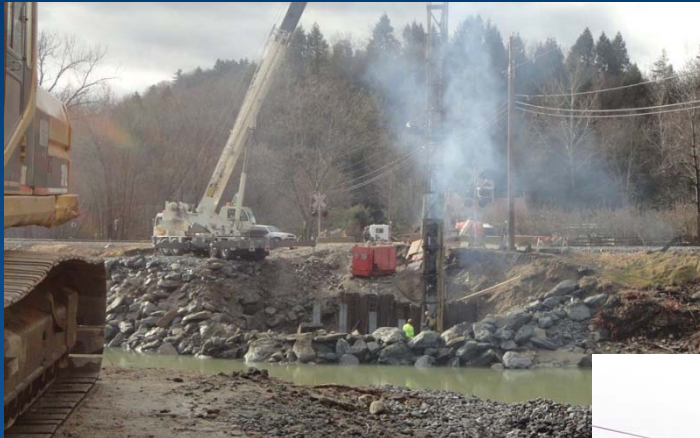
<= Piles driven to rock
– these abutments are going to stay!

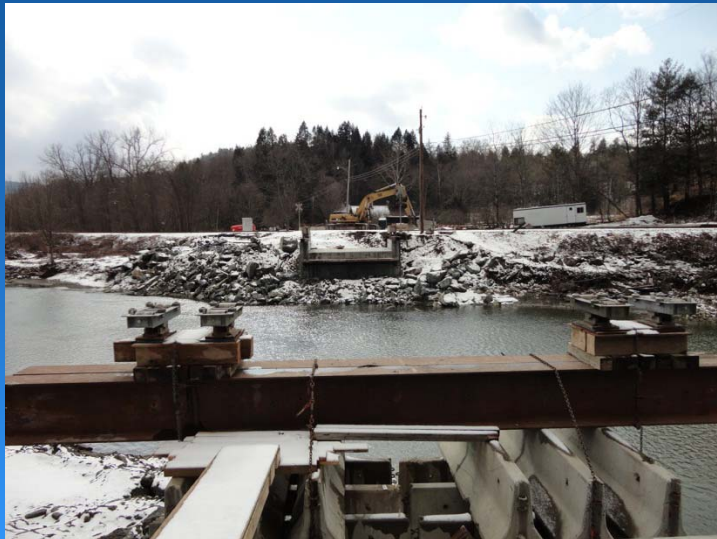
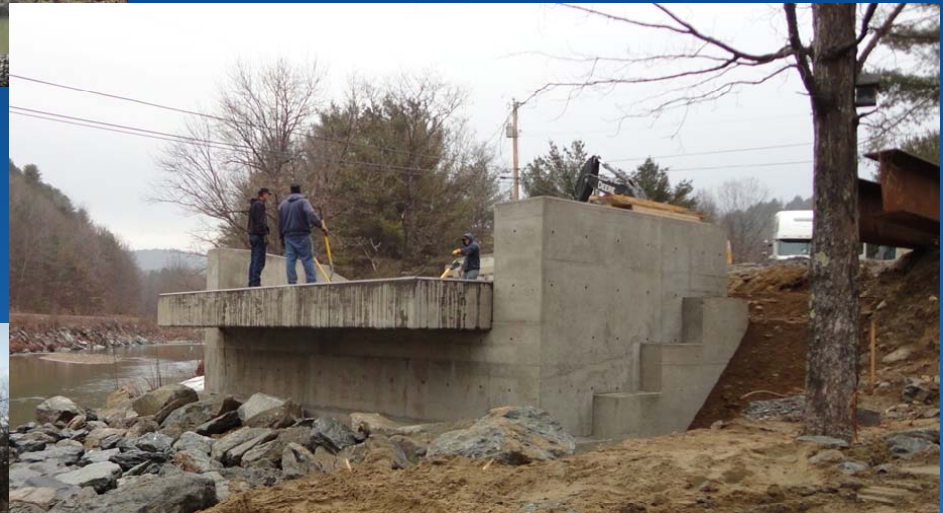
A shelf extension to help a bit with hydraulics =>

<= Getting ready to install the Mabey Bridge for traffic during construction

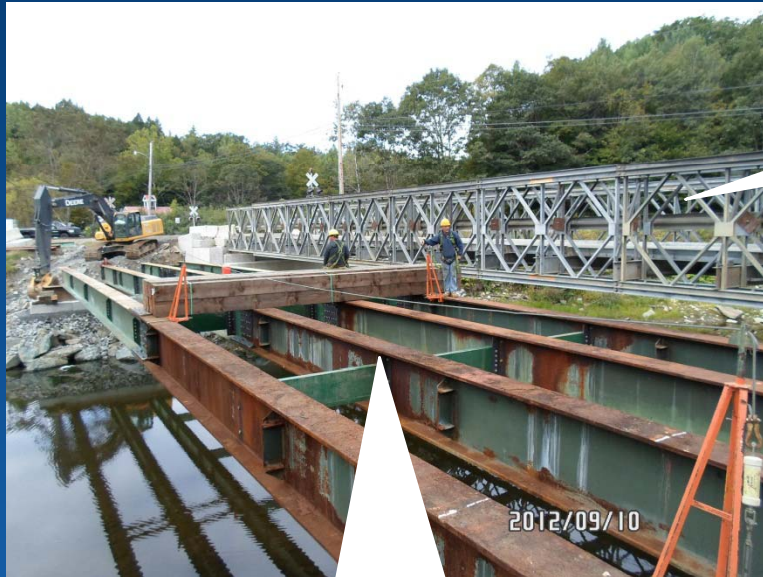
Temporary Mabey Bridge
for traffic maintenance

Work platform bridge
being erected

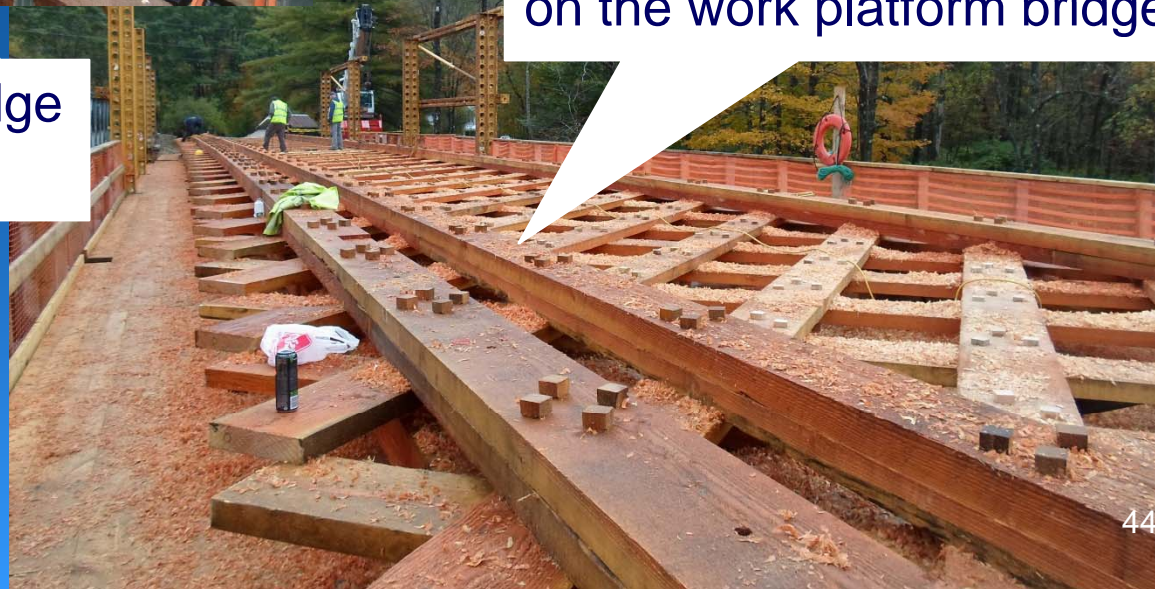
First timber truss built flat
on the work platform bridge

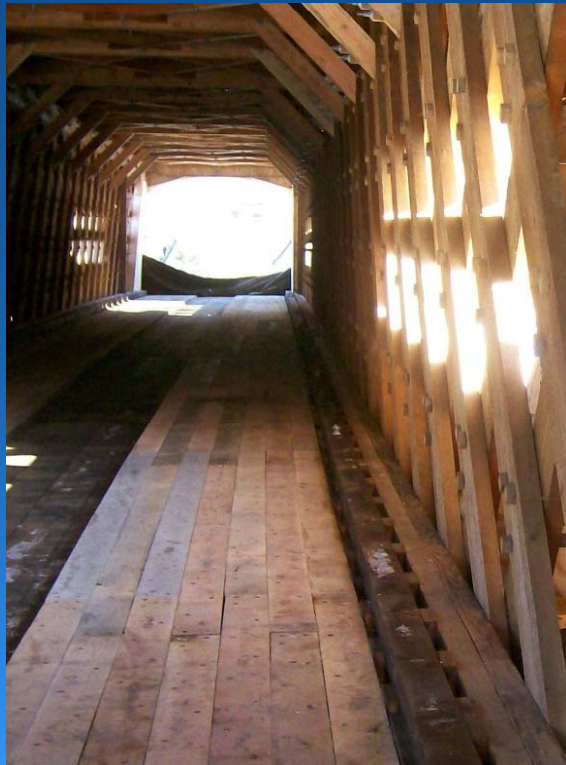
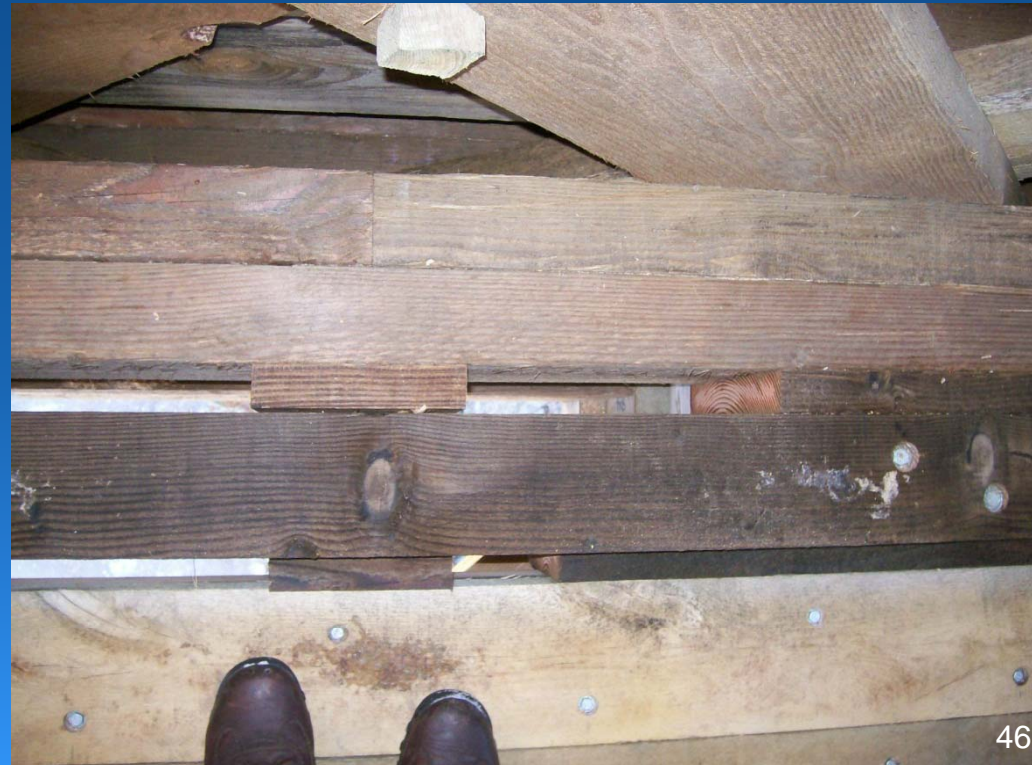
- “Drainage and ventilation slots” –were provided along the curb, but wood fills were installed over the floorbeams and bottom lateral system elements to prevent dripping onto the elements below

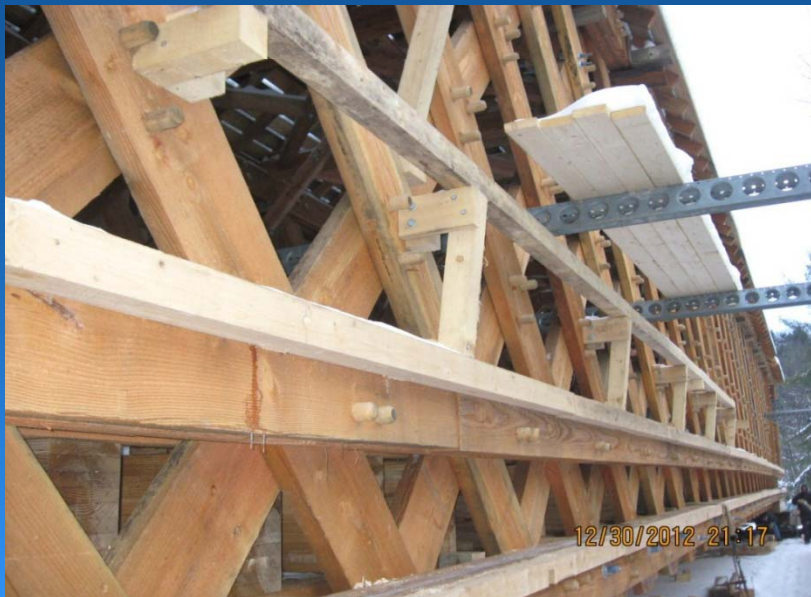
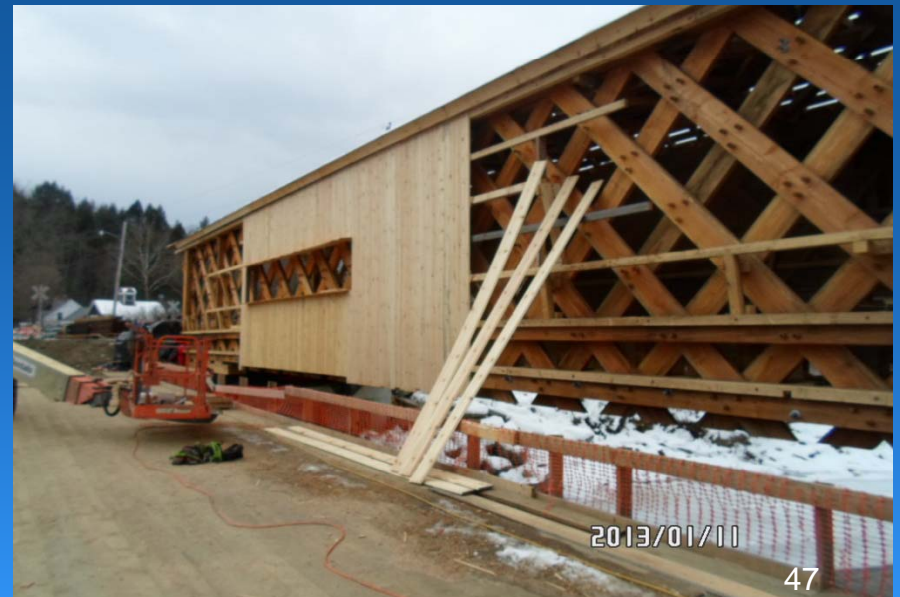
- Shiplap siding was used rather than vertical without battens which was on the bridge at the time of its destruction
- The siding was attached to spacer wood strips to avoid direct contact with the truss chords – face-to-face contact promotes rot

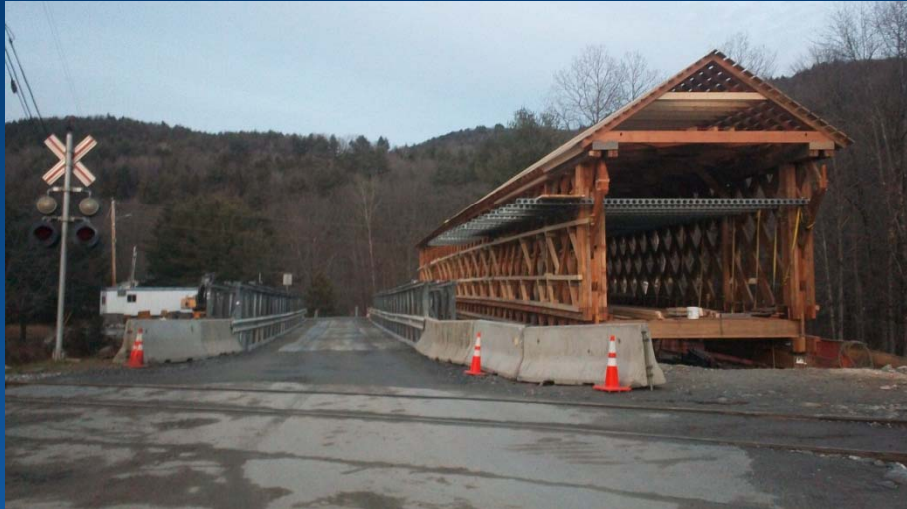
< = nearing completion of the new bridge atop the work platform bridge, while traffic still on the Mabey Bridge

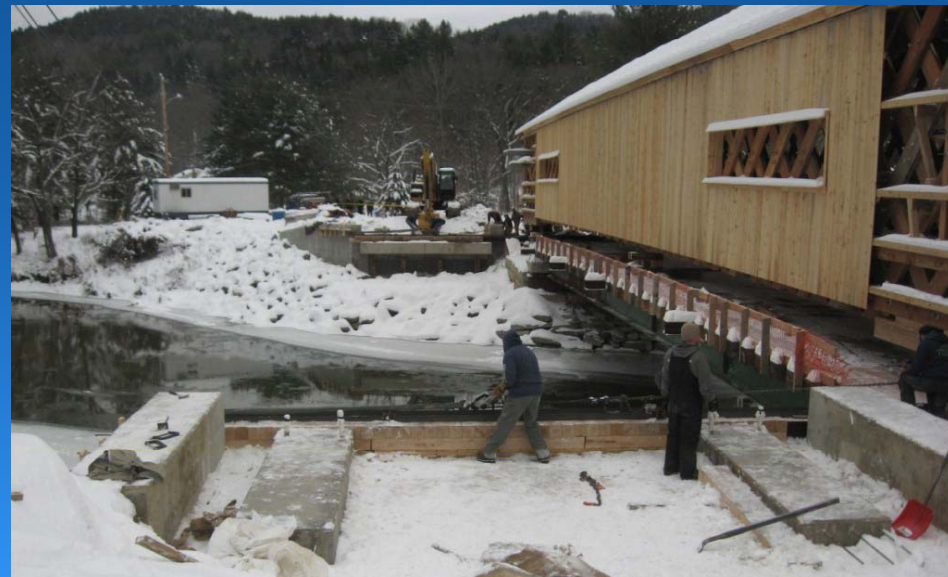
Mabey Bridge out, making ready to shift the new one sideways onto the abutments =>

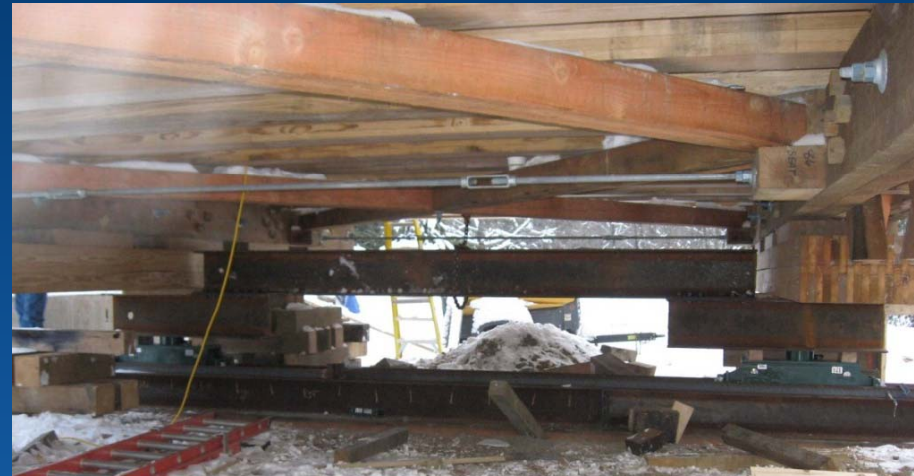
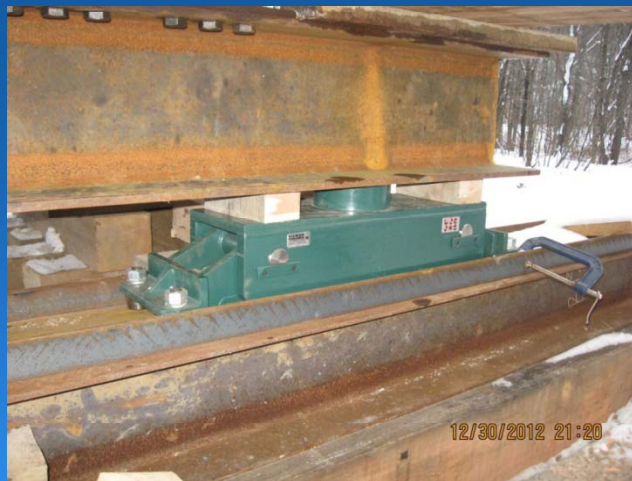
Underside at end –
lifted the timber
bridge (with the
bolster beams
strapped in place) –
then installed metal
frame with rollers =>

<= “Hilman rollers”
inside belly-up channel

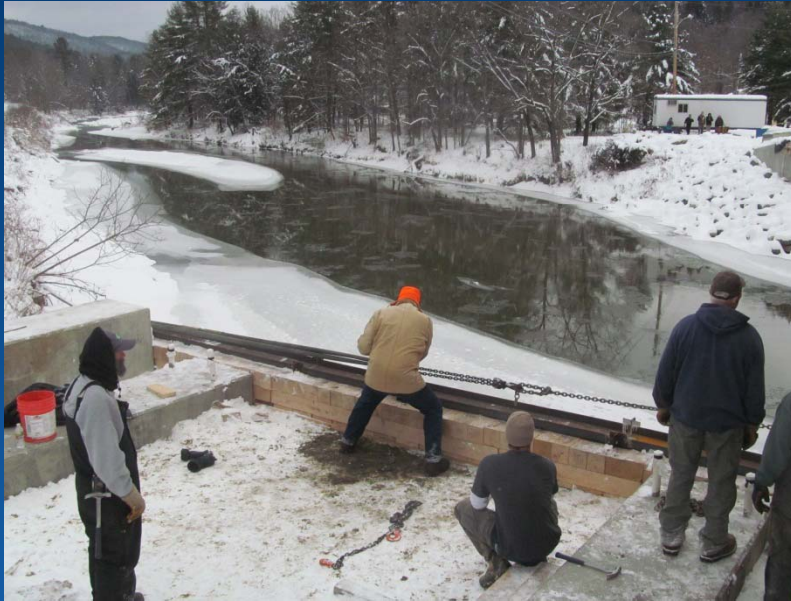
\leq 10-ton come-along
to pull the bridge
sideways – none of us
dreamed it would be this
hard, but they got a
“cheater bar” shortly
after I gave up

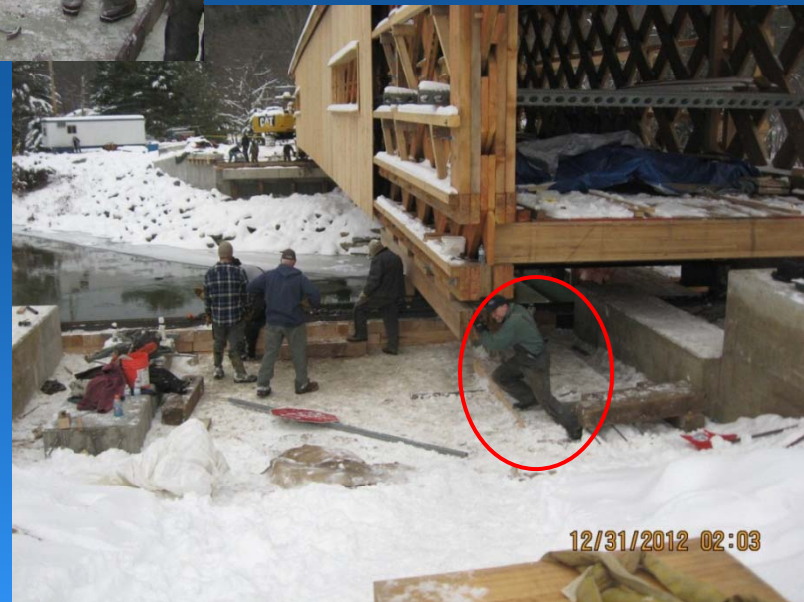
The contractor owner
(Jim Hollar of Cold
River Bridges) tried to
push it in place, but
not quite enough
oomph! =>

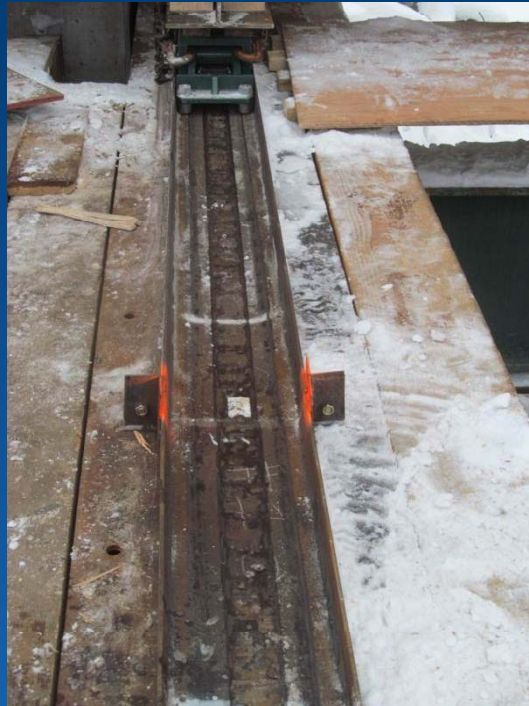
< = as it turns out, the channel web was so thin that it "curled" a bit, causing an interference with the base of the roller unit so that it had to be skidded, rather than rolling

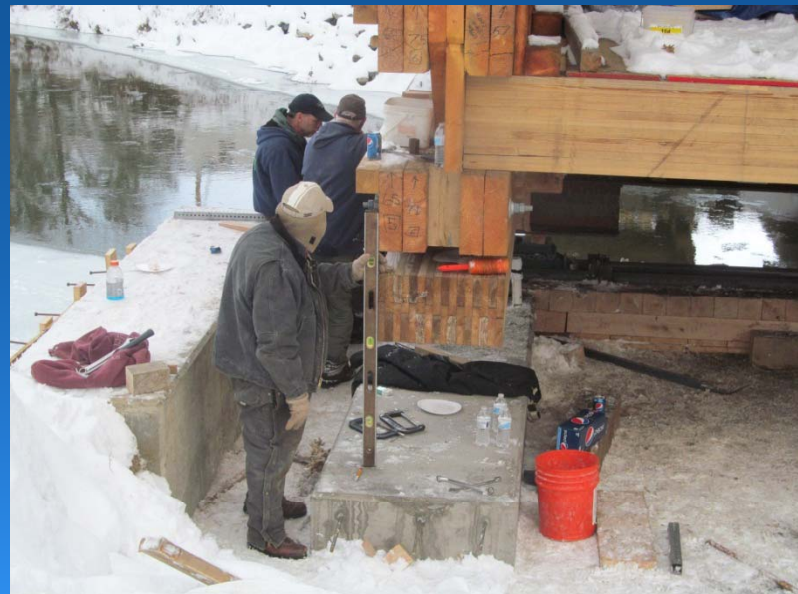
"X" marks the spot=>

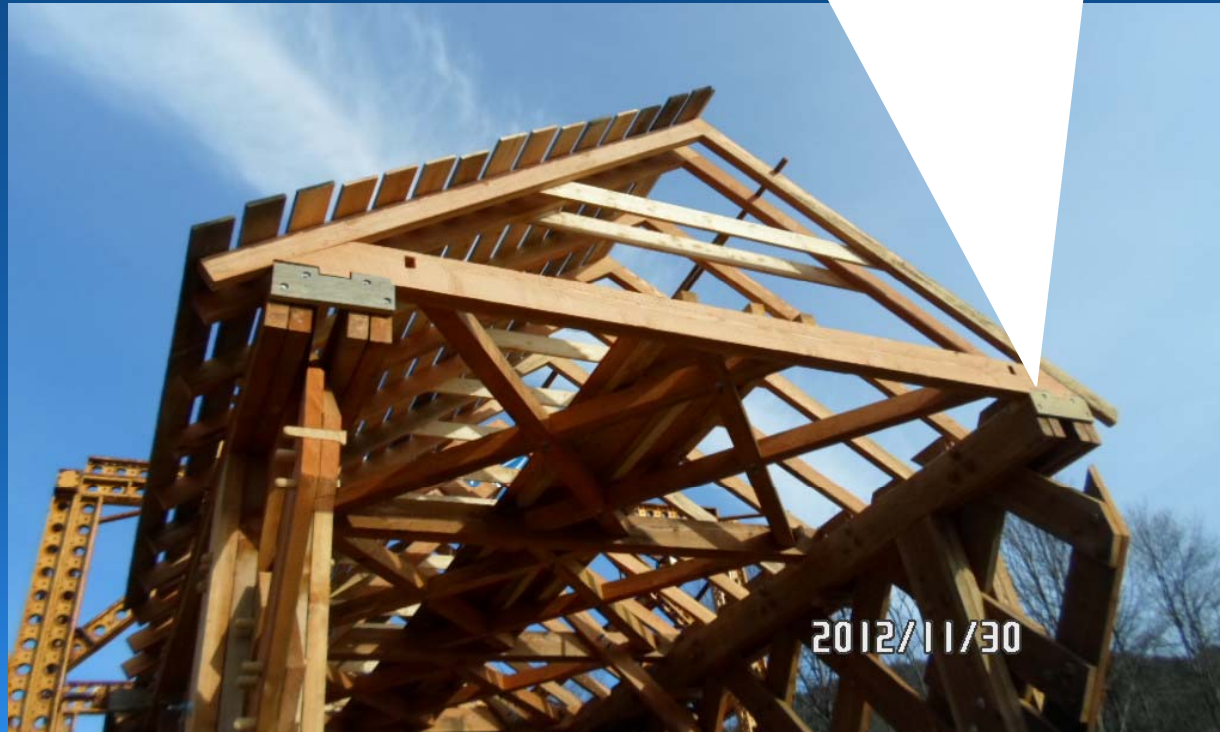
End tie beam cut more narrow and STILL overhung

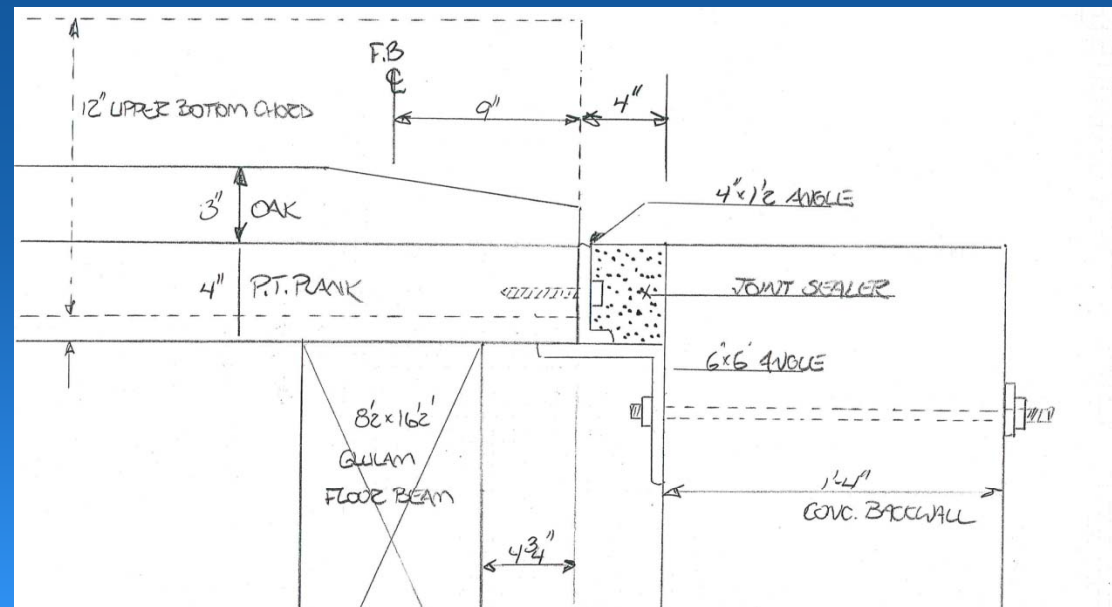
- Covered bridge detailing is becoming more and more thorough – you try to leave things up to the contractor, but then there are field questions – can't win.
- *E.g. – end joint*
