# Options for Evaluating Fire Damaged Components of Historic Covered Bridges

Second National Covered Bridge Conference, Dayton, Ohio, June 5-8, 2013

#### INTRODUCTION

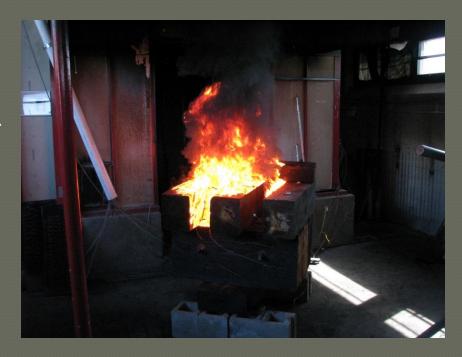
Creosote-treated wood bridge deck crib under fire test hood at FPL

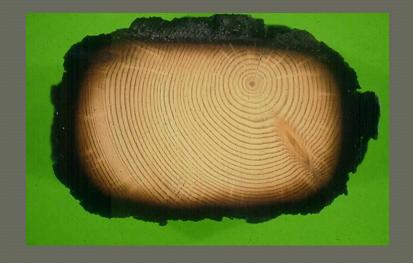
- Zones of degrees of the thermal degradation (pyrolysis)
- Combustible gases flaming combustion
- Char layer –reduced interior temperatures
- Density of the char layer approximately 20% of wood

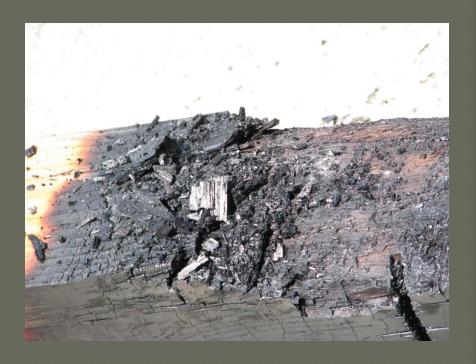
- For charred members, the first steps are:
  - Remove char and
  - Measure dimensions of residual cross sectional area
- Quick calculations to determine residual load capacity and need to replace members

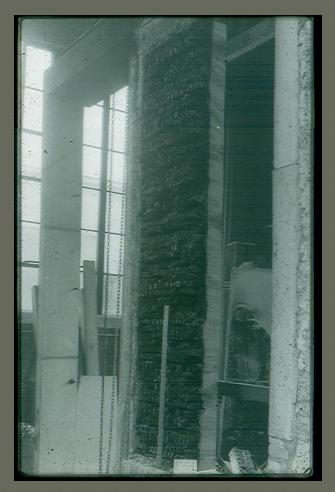
- Knowledge in this area is from research on fire resistance of structural member in standard fire test (ASTM E119)
- The normal assumption of 38 mm (1.5 in.) char depth per hour in the standard test should not part of a post-fire evaluation

Charred wood slab in FPL wall furnace

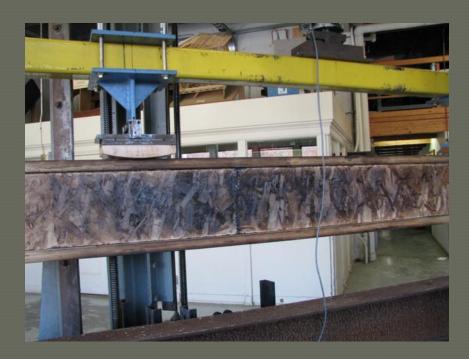
Bending test of slightly charred I-joist.

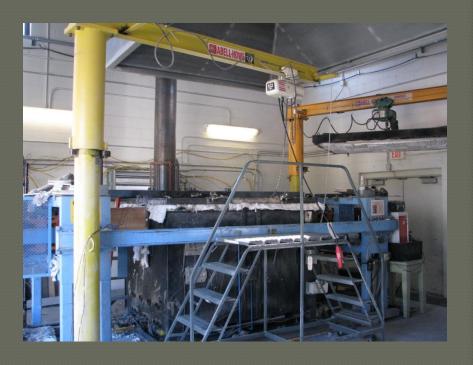
Horizontal/Tension Furnace at FPL

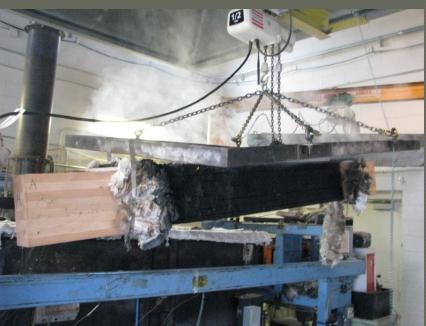
Temperature from exposed wood surface

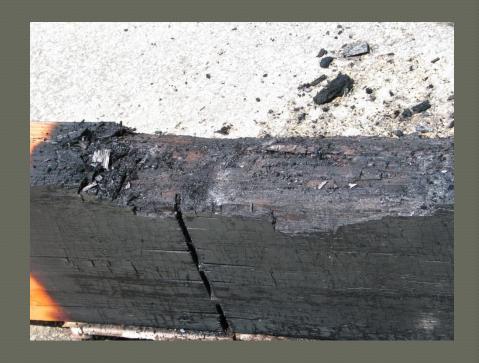
- 54% reduction in failure load (lbs.)
- 46% reduction in MOR (lbs/in²) based on the residual crosssectional areas
- 20% reduction in MOE

Equivalent to adding0.8 inch to the 0.3inch char depth

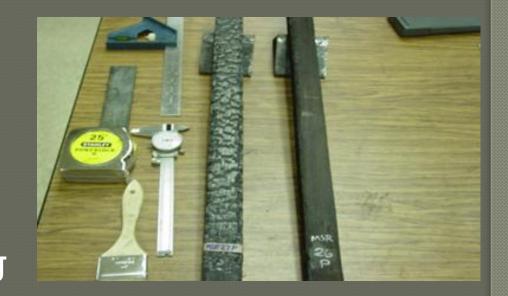
Technique developed at Montana Tech as part of Covered Bridge Project

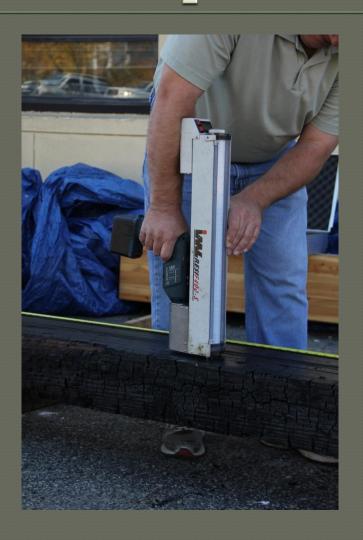
- Resistance microdrilling technology
- Being used to evaluate decayed damaged wood

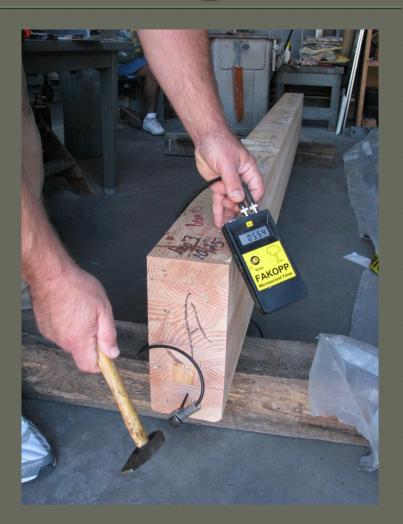
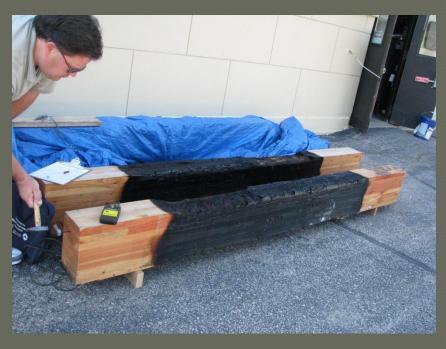
- Sound wave methodologies:
  - Used in evaluating decayed damaged wood
  - Evaluation based on entire cross-section
  - Assumes correlation between strength and stiffness

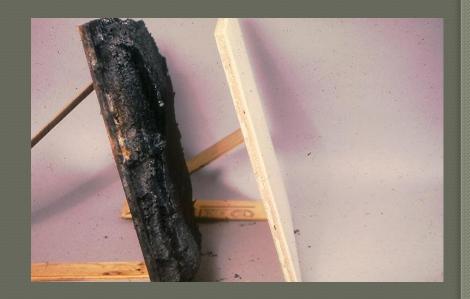
Intumescent coated plywood before and after fire exposure.
