Modified Sheet Pile Abutment for Low-Volume Road Bridge

Steel sheet piling, typically used for retaining structures in the United States, is a potential alternative for use as the primary component in low-volume road (LVR) bridge substructures. To investigate the viability of sheet pile abutments, a demonstration project was performed in Black Hawk County, Iowa. The project involved construction of a 40 ft single-span bridge utilizing axially loaded steel sheet piling as the primary foundation component. The site selected for the project had primarily silty clays underlain by shallow bedrock into which the sheet piling was driven. An instrumentation system (consisting of strain gages, deflection transducers, earth pressure cells, and piezometers) was installed on the bridge for obtaining service load test data as well as long-term performance data. This paper presents documentation of the design and construction of the demonstration bridge in Black Hawk County as well as an analysis of the design procedures used through information collected during load testing. Preliminary results indicate that steel sheet piling is an effective alternative for LVR substructures, and future demon

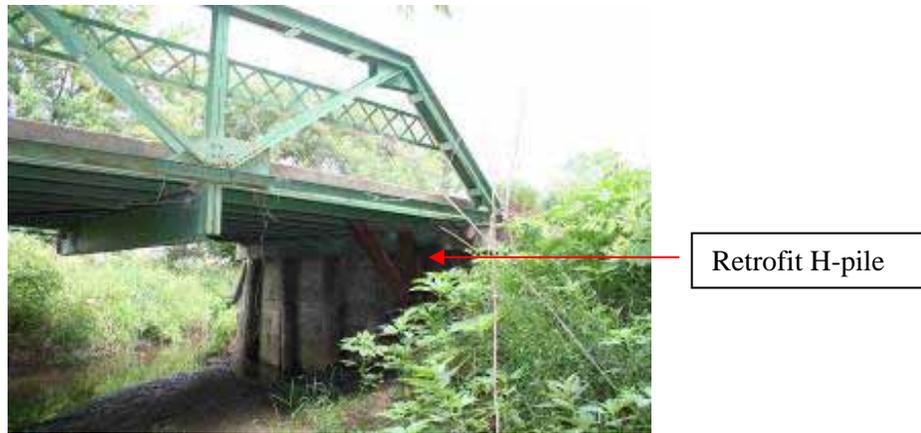
The structure that was replaced was a 40 ft single-span pony truss bridge supported on a timber pile foundation (see Figure 1). The bridge was approximately 10 ft above stream level. The structure was retrofitted at some point with steel H-piles, one per abutment. These retrofit piles are believed to have been driven into the existing shallow bedrock (about 8 ft below stream level) to provide reinforcement for the timber abutments; one of these piles can be seen in Figure 1.

Figure 1. Previous bridge in BHC with retrofit pile shown

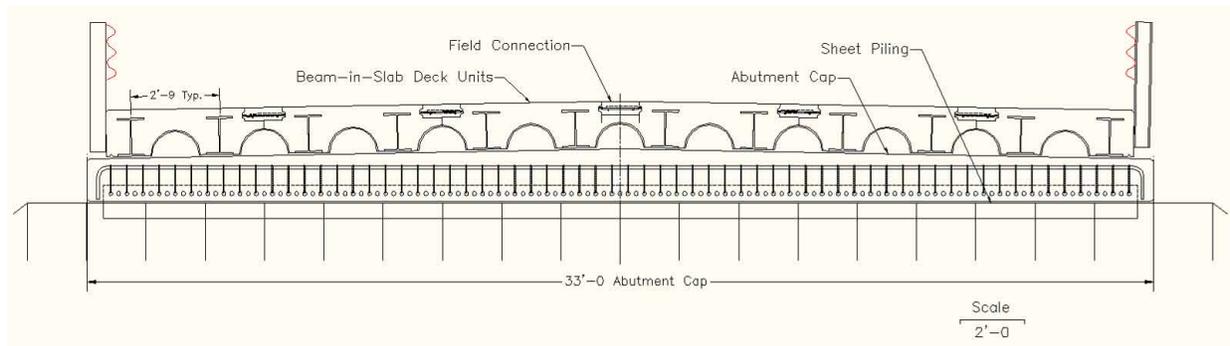
BHC used custom precast beam-in-slab units for the bridge superstructure. Each unit contained two W14x61 steel beams. A total of six units were required for the bridge, each unit spanning the entire length. Between each unit there was a cast-in-place joint that was poured after the units were placed. Figure 2 shows a profile of the bridge deck and abutment.

Figure 2. Cross section of replacement bridge deck

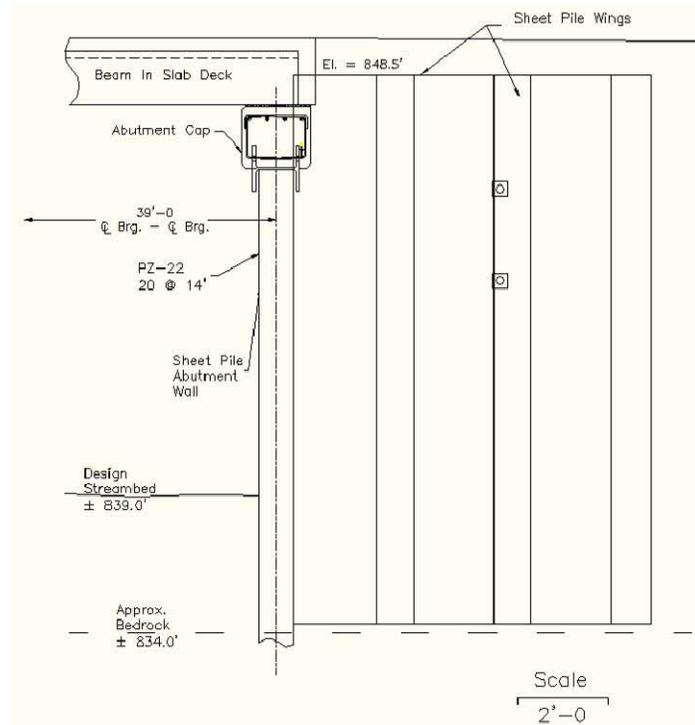
The abutment cap was a precast element designed by BHC that consisted of a W12x65 steel beam cast in reinforced concrete. The web of the steel beam cast in the abutment cap bore directly on top of the driven sheet piling with no attachment between them. The bridge deck units were placed on the abutment cap using bearing pads between the deck units and the reinforced concrete abutment cap. Figure 3 shows a cross section of the sheet pile abutment.

Figure 3. Cross-section of sheet pile abutment

Steel sheet piling was used for the foundation of the bridge structure. Each abutment consisted of a precast abutment cap bearing on sheet pile sections driven into shallow bedrock. A total of 64 PZ-22 sheet pile sections were required in each abutment.

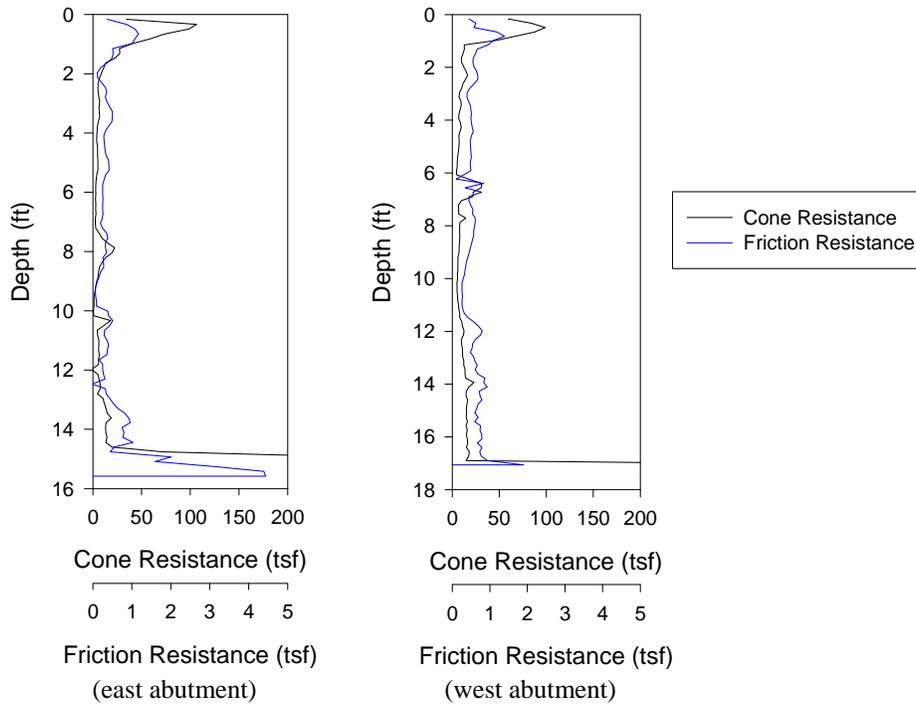
Before designing the abutments, a subsurface investigation was performed that involved cone penetrometer testing (CPT) as well as laboratory analysis of soil borings. CPTs were performed at each abutment and provided subsurface profiles (see Figure 4) that showed predominately clay with sand seams and bedrock at approximately 15 ft and 17 ft depths for the east and west abutments, respectively. The soil borings (also performed at each abutment) involved drilling and sampling of the soil at various depths for analysis of strength and other characteristics.

Figure 4. CPT results for BHC bridge site

CPT results showed refusal at 15 ft below grade for the east abutment. During impact driving, practical refusal (the 25 ton bearing) was not reached until significantly below what was shown in the CPT results. This was not an issue for the east abutment since pile lengths ordered were longer than necessary.

CPT results for the west abutment showed refusal at approximately 17 ft below grade. During the impact driving phase, it became evident that the piling lengths ordered were too short. The depth required for practical refusal on the west side of the stream was significantly lower than that predicted by the CPT results. All of the sheet piles along the main wall required splices to be added in order to achieve design elevations. In some cases, piles needed to be driven more than a foot lower than the adjacent section; this required splices to be made as well in order for the pile driving mechanism to fit in place.

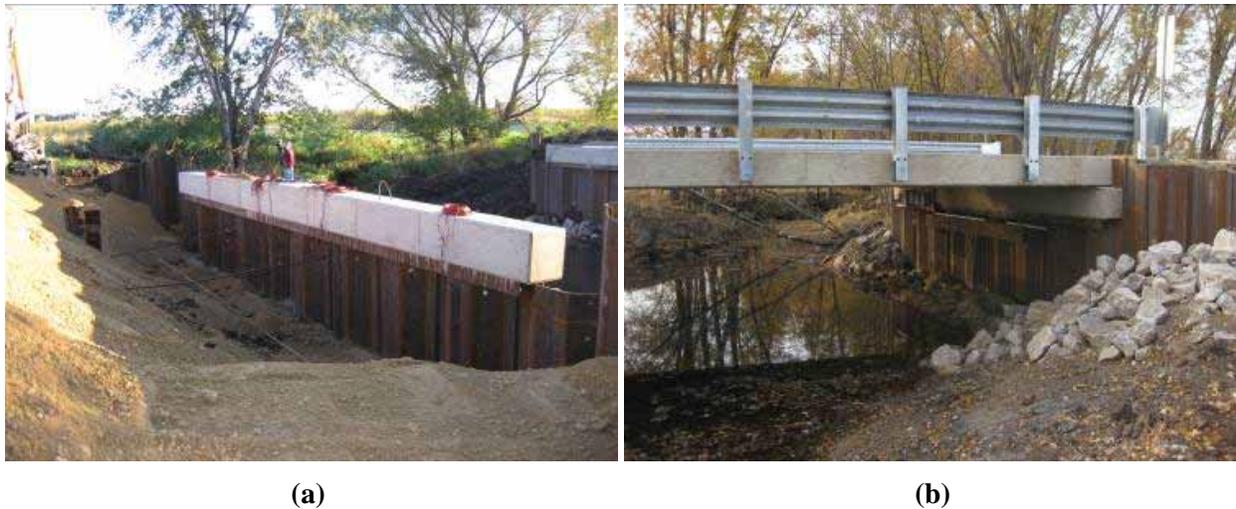
Before each abutment was backfilled, a layer of rip-rap was placed against the stream side face of the sheet pile walls. Both abutments were backfilled with ¾ in. roadstone within a short zone behind the sheet pile wall (shown in Figure 5a). Outside of these zones, existing material was left in place. On the east abutment, the existing material that was left consisted primarily of soil. On the west abutment, the majority of the abutment from the previous bridge was left in place. Backfill material was primarily used to fill the void between the sheet pile wall and the abutment from the previous bridge. The remainder of construction required placement of guardrails and finished grading of the roadway approaching the bridge. The bridge was opened for service on October 20, 2008. A view of the west abutment of the bridge after completion is shown in Figure 5b.

Figure 5. (a) Backfilling of west abutment with abutment cap in place, (b) west abutment of completed bridge in BHC

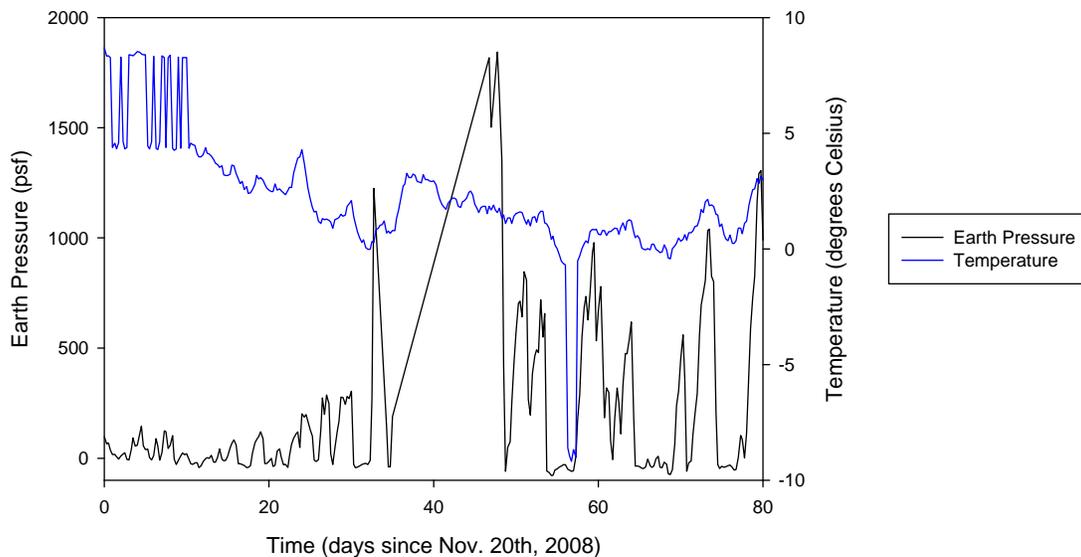
Long-term measurement of earth pressure (as well as temperature) in the cells one and three ft below TOC are presented in Figures 6 and 7, respectively. Although the monitoring system was destroyed in a flooding event in the spring of 2009, long-term data was recorded for 80 days after November 20, 2008. For the cell one ft below TOC, variations of earth pressure with time were recorded. In the cell just below it (three ft below TOC) the variation was less. Both cells experienced greater variations in stress during cold temperature cycles (perhaps attributed to stress development from ground freezing in the backfill behind the abutment).

Figure 6. Long-term readings for pressure cell #9489 (located one ft below top of abutment cap)

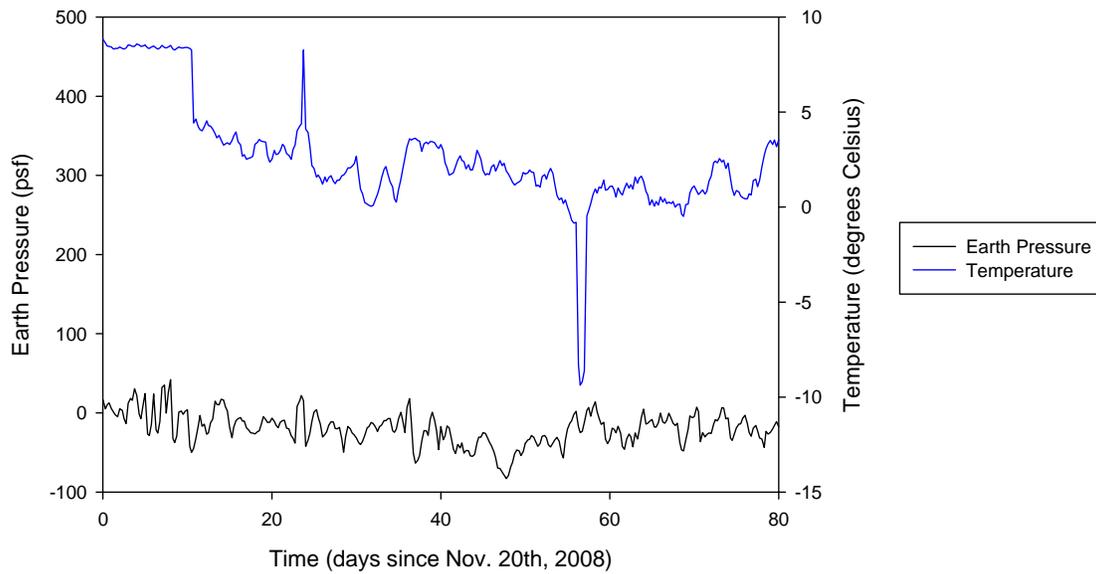
Figure 7. Long-term readings for pressure cell #8503 (located three ft below top of abutment cap)

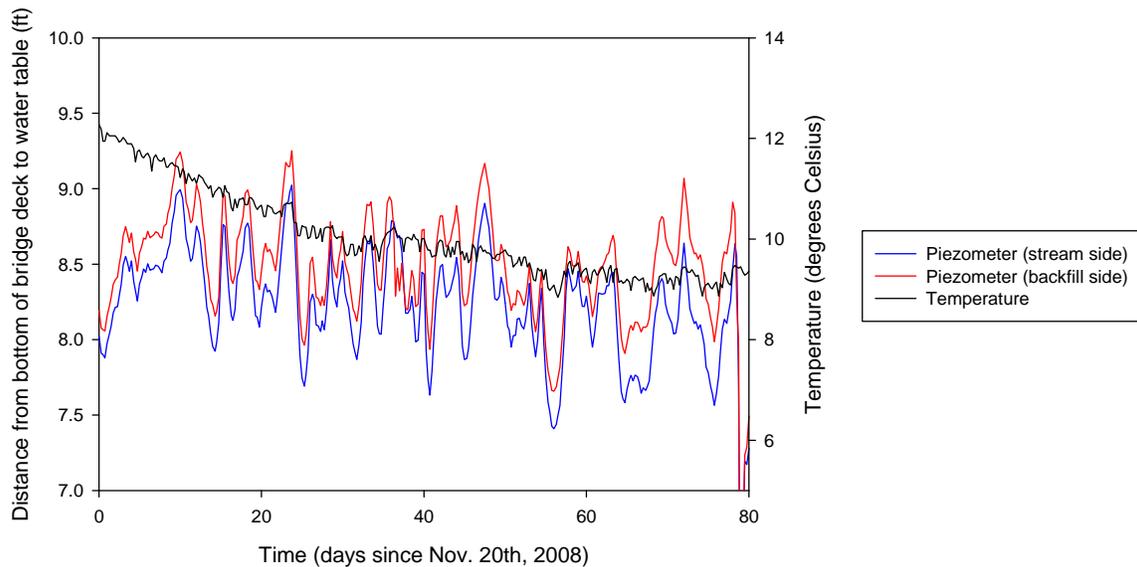
Long-term groundwater table measurements, given as the distance from the bottom of the bridge deck (at the abutments) to the water level, are shown in Figure 8 for both sides of the abutment. Although the two piezometers measured different levels of groundwater, the offset is constant at about three to four in. (attributable to human error), suggesting that no significant pressure head developed behind the abutment wall.

Figure 8. Long-term readings for piezometers (both sides of abutment)

Two piezometers were installed on the project to monitor the height of the water table. The instruments were placed at the centerline of the west abutment on opposite sides of the sheet piling (one on the backfill side and one on the stream side).
