# Case Studies in Concrete Pavement Recycling

Mark Snyder, Ph.D., P.E.  
Pavement Engineering and Research Consultants, LLC

# Case Study: Eden's Expressway – I-94 Northwest Chicago, IL (1978)

# Cost Savings From Using Recycled Concrete Aggregate in Tollway Reconstruction

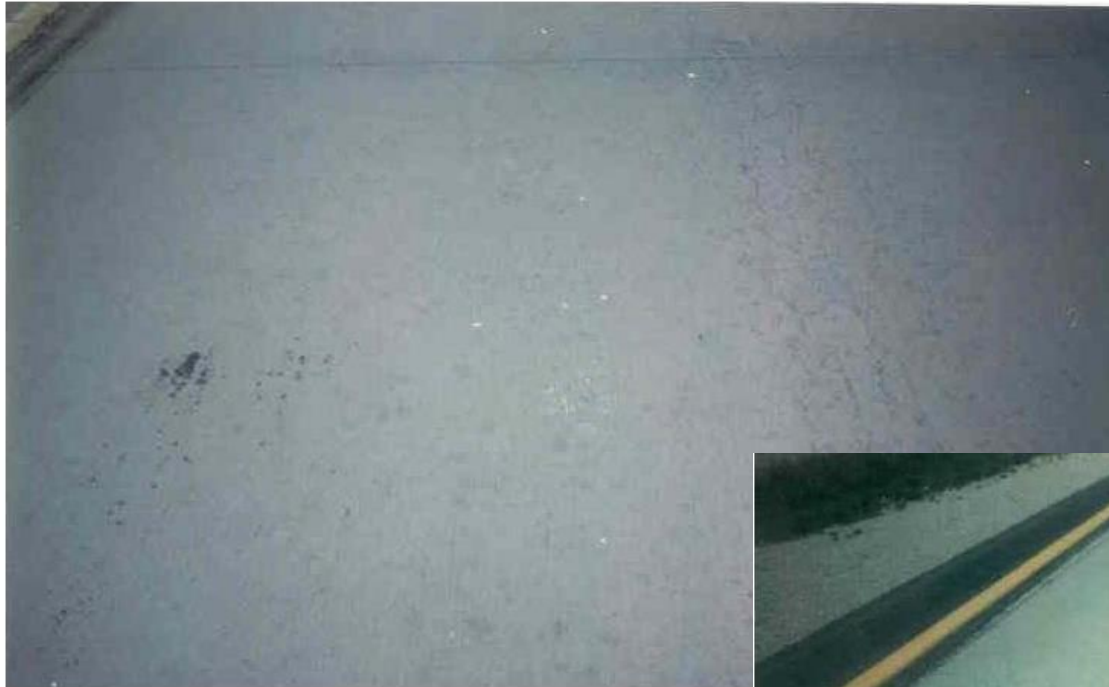
1975

# Alkali Silica Reactivity - MP 392 WB

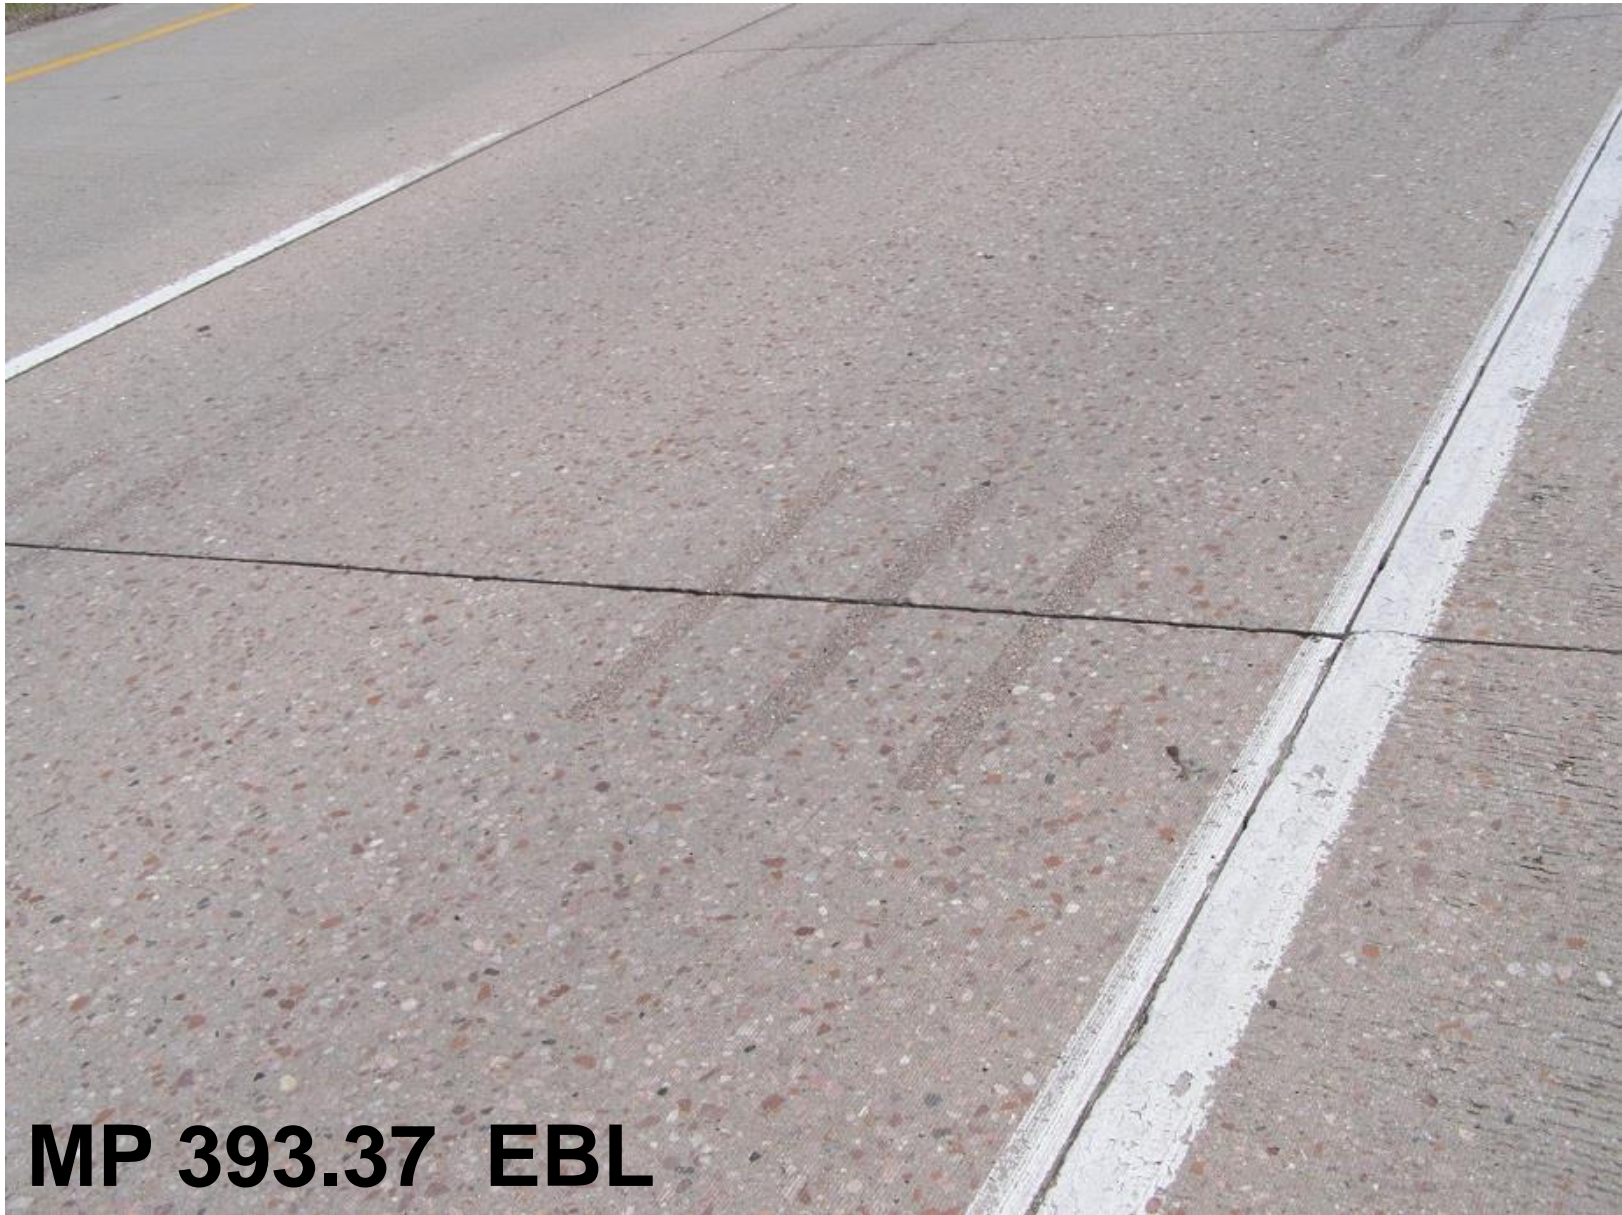
**MP 393.37 EBL**

# Successful DBR (MP 393 to 400)

- Mixed success related to the integrity of the existing concrete
  - MP 392 to 400: Successful
  - MP 382 to 392: No DBR
  - MP 372 to 382: Many areas exhibiting concrete failures adjacent to dowels
    - No DBR in WB lanes from MP 375 to 377

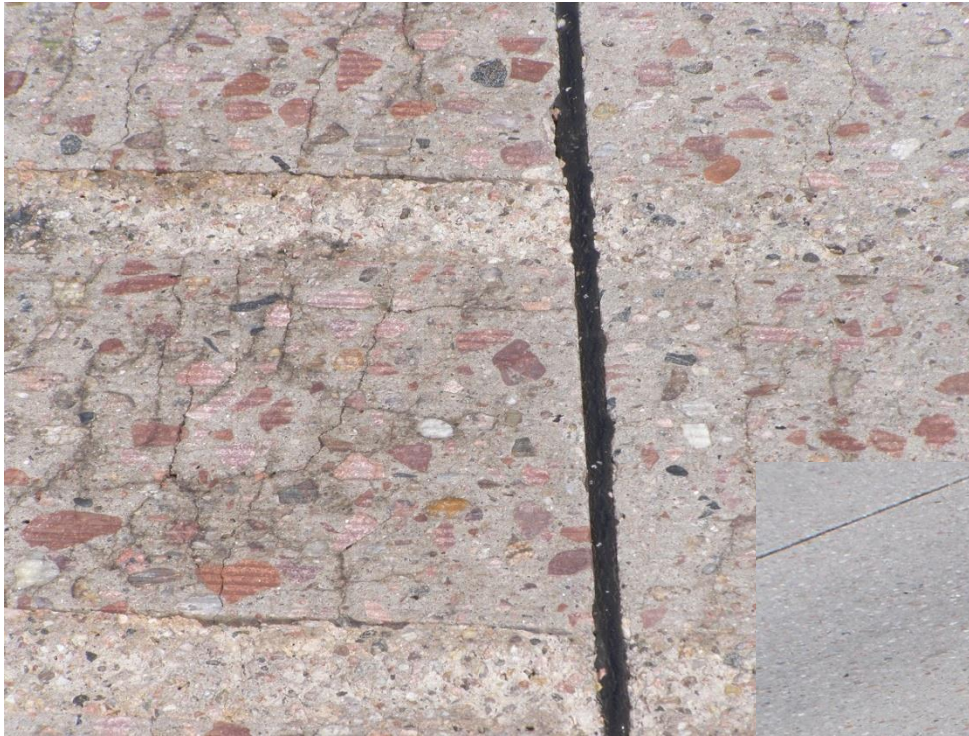
**MP 376 EB**

# Failing DBRs (MP 372 to 382)

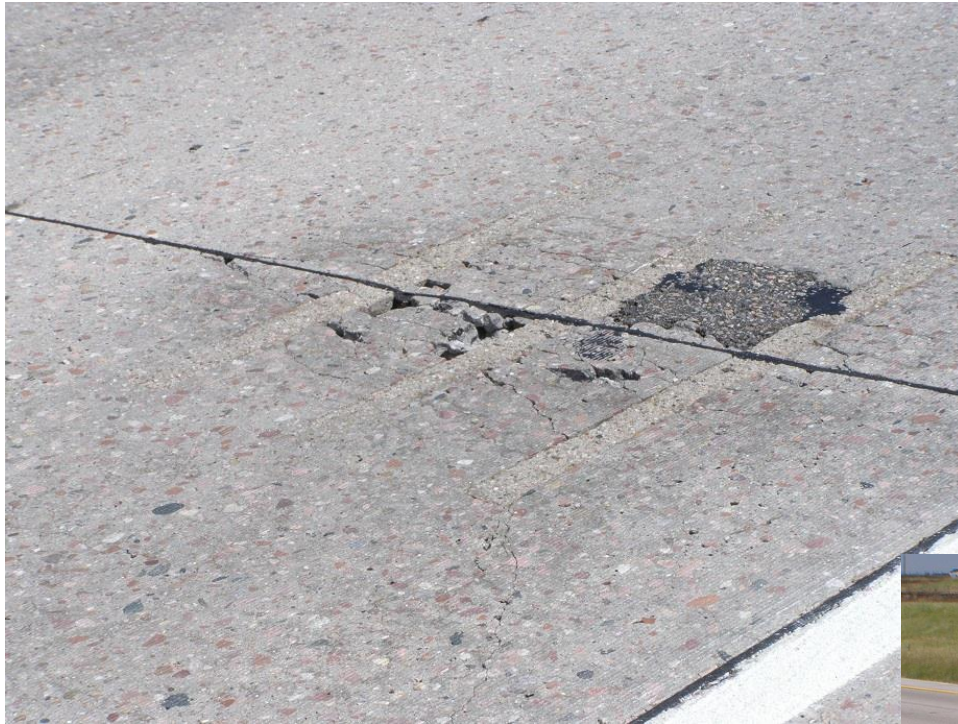
**MP 372.4 EB**

# Failing/Failed DBRs (MP 372 to 382)

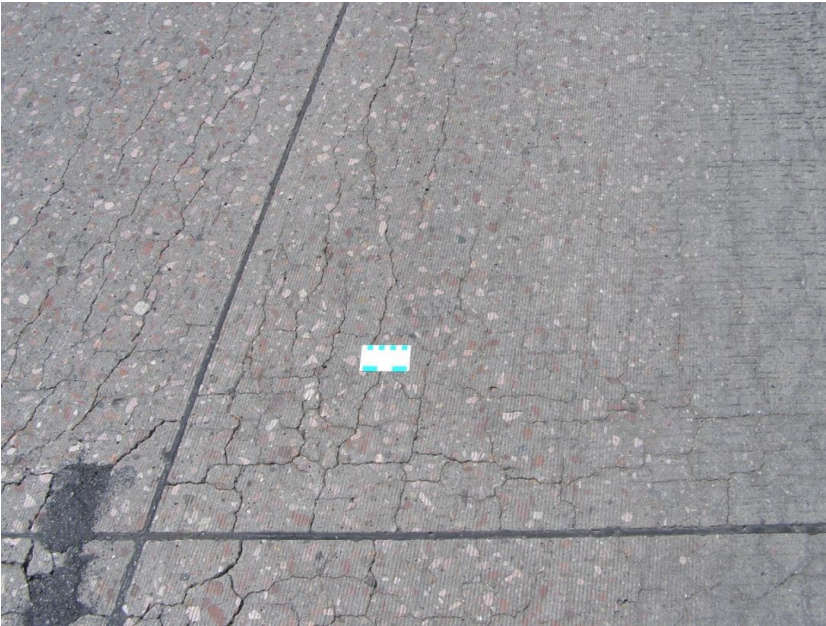
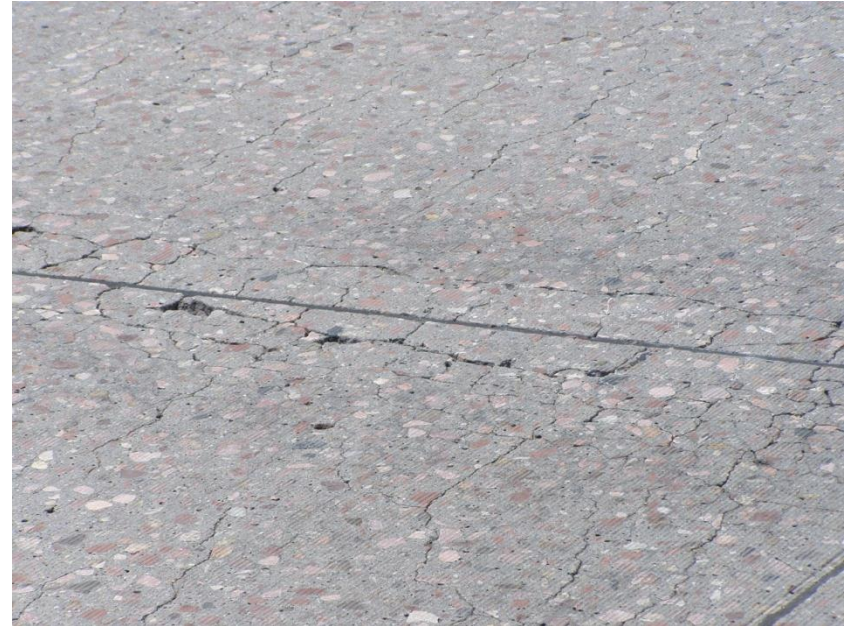
**MP 377 WBL**

# MP 375.3 to 377.3 WB No Dowels

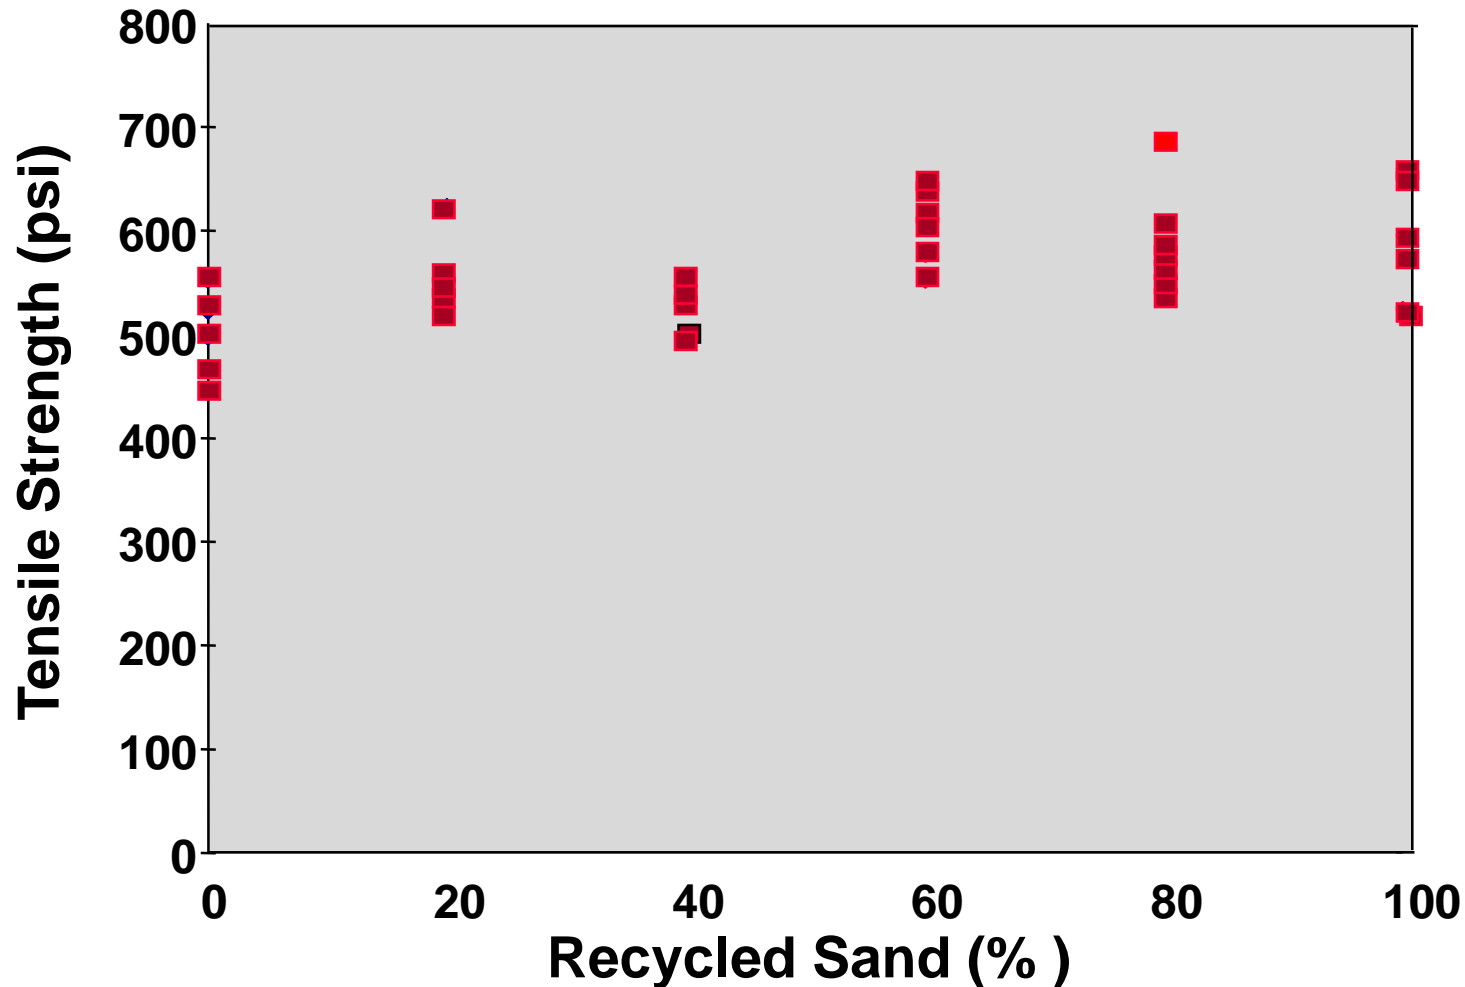
# Effect of Recycled Sand on Tensile Strength

- Recycled fine aggregate has an adverse effect on strength.
- The use of both recycled coarse and fine aggregates reduces modulus of elasticity of concrete substantially.
- Thermal coefficient of concrete with 100% RCA is higher than that of virgin aggregate concrete.
- The effect of recycled aggregate on the abrasion resistance of concrete is inconclusive.

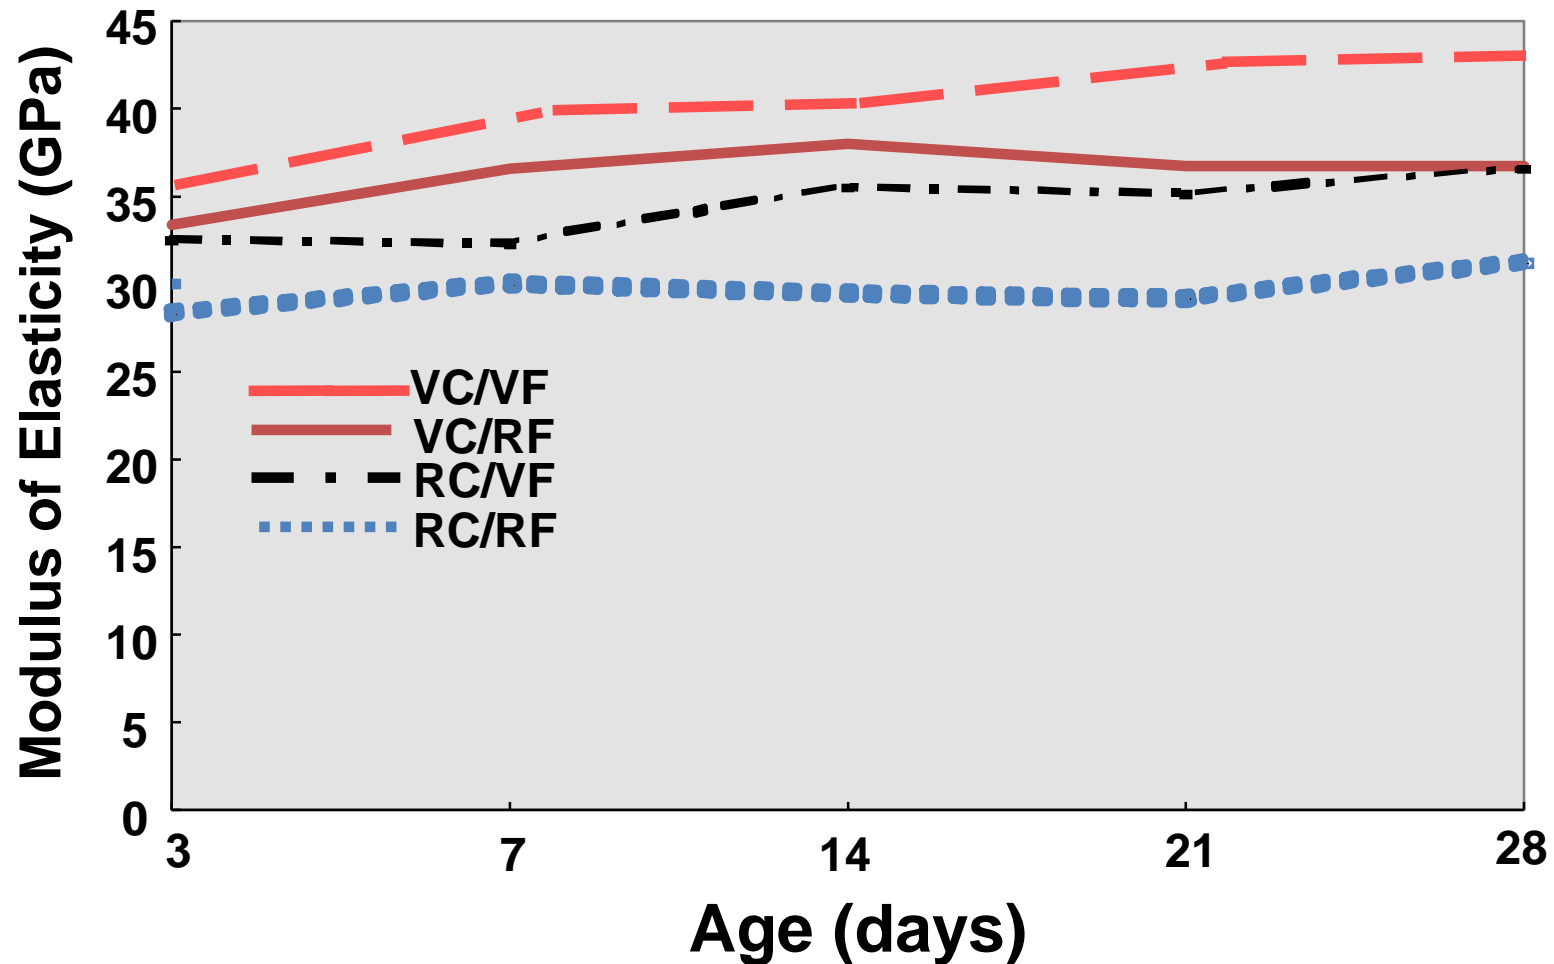
# Modulus of Elasticity of Various Aggregate Mixes
