# IMPLEMENTATION SUPPORT FOR STRATEGIC HIGHWAY RESEARCH PROGRAM II (SHRP2) RENEWAL PROJECT R21 NEW COMPOSITE PAVEMENT SYSTEMS

# Tennessee DOT Two-Lift Concrete Pavement Construction Project: I-65 NB Shoulder

As part of the SHRP2 Implementation Assistance Program, the Tennessee Department of Transportation (TDOT) integrated a two-lift (wet-on-wet) concrete composite pavement into a full-depth shoulder adjacent to a mainline reconstruction project on I-65 in Nashville. TDOT's interest in the two-lift concrete pavement was driven by a recent specification change requiring a higher quality surface aggregate, and the I-65 project offered the opportunity to evaluate the viability and cost-competitiveness of the two-lift system. This document describes the construction of the two-lift composite pavement, including critical aspects of the batching, transport, placement, and post-paving aspects of the construction as pertaining to two-lift systems.

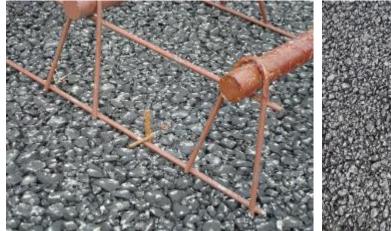
Dowel baskets were anchored to the base, with the first dowel being located 3 to 6 inches from the adjacent travel lane joint (see figure 4a). A bond breaker was applied on one-half of each dowel, alternating ends across the basket length (see figure 4b).

- a. Dowel bar basket anchors.
- b. Bond breaker on opposite dowel bar ends.

The shoulder is transversely jointed at 15-foot intervals to match the joint spacing of the adjacent travel lane. Load transfer is provided by 1.5-inch epoxy-coated cylindrical steel dowels on 12-inch centers that were mounted in baskets that provided a mid-depth dowel placement in the 13-inch shoulder pavement. Since the dowel baskets cannot extend beyond the width of the bottom lift placement, there are no dowels in outer 1.5 feet of the concrete shoulder. It appears that the assembled baskets were dipped in epoxy for corrosion protection.

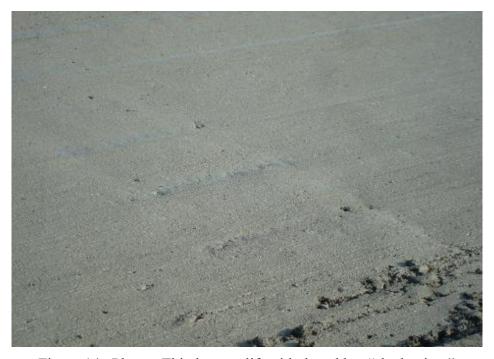
Figure 14. Photo. Thin bottom lift with dowel bar "shadowing."

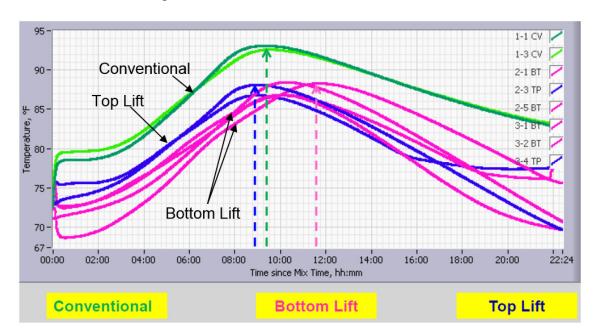
Figure 20. Graph. Heat signature curves.

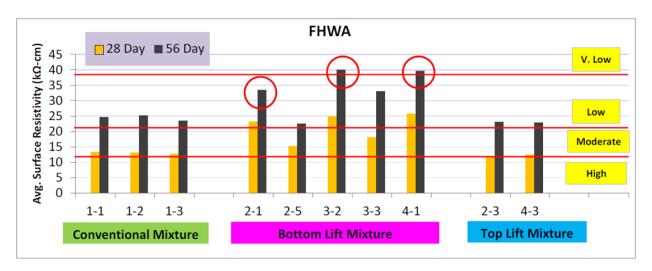
Figure 22. Graph. SR meter test results.

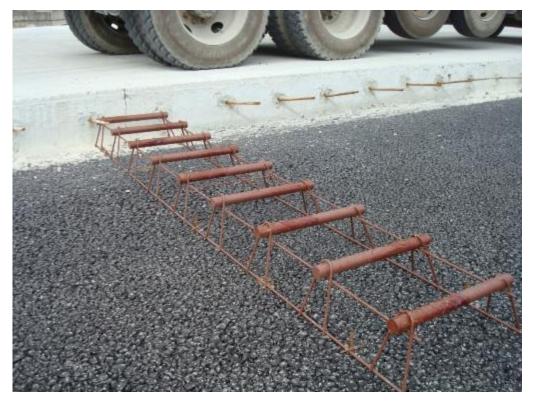
Photo E-3. Dowel basket anchored to asphalt-treated permeable base.

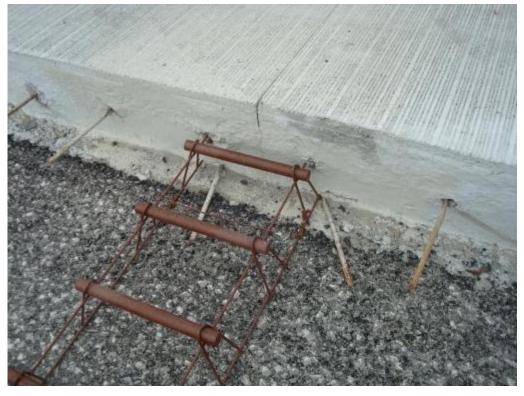
Photo E-4. Dowel basket placement showing proximity to travel lane and interfering with tie bars.

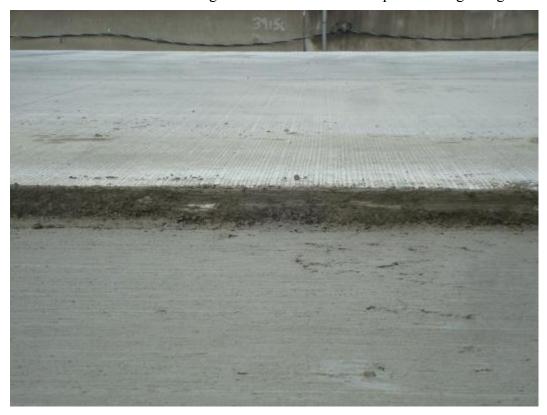
Photo E-20. Bottom lift surface behind paver (note: top lift will need to be more than 3 inches thick in this area).

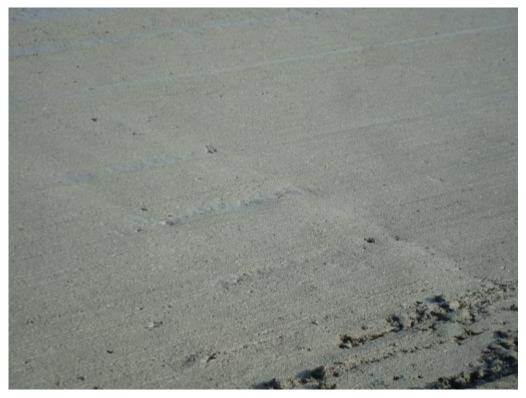
Photo E-22. Bottom lift surface "shadowing" due to proximity of dowels (thin lift).

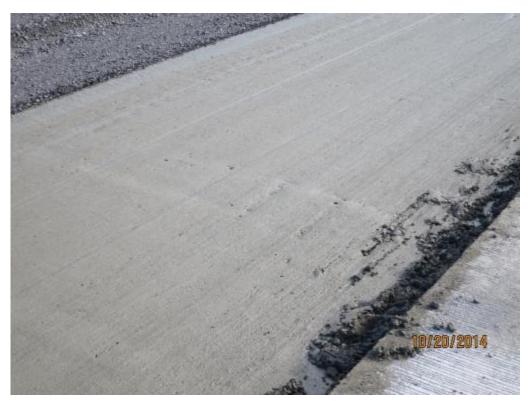
Photo E-23. Dowel "shadowing" and surface depressions and debris near end of Day 1 placement of bottom lift.

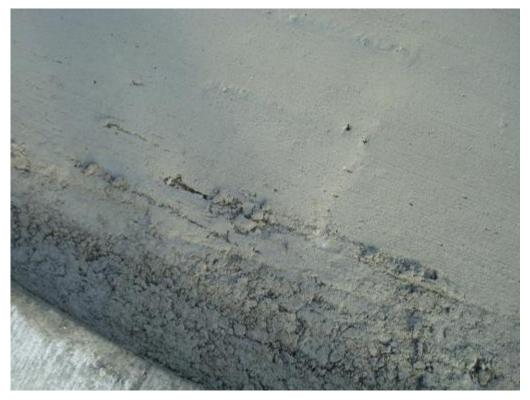
Photo E-24. Exposed dowel end in bottom lift due to thin lift.

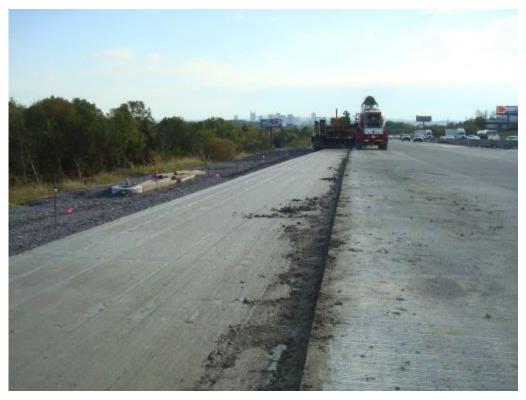
Photo E-25. Dowel "shadowing" in bottom lift surface and surface condition ahead of top lift placement at end of Day 1.

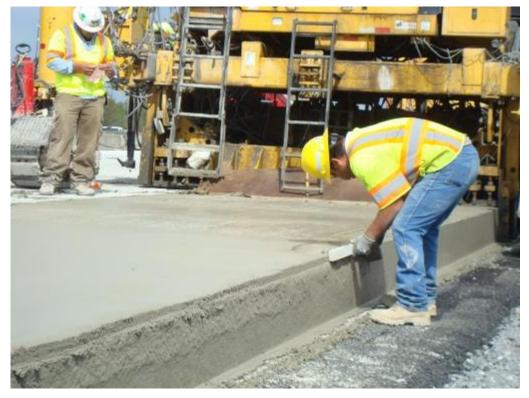
Photo E-28. Workers attempting to correct second lift edge slump.

The top lift concrete mixture appeared to have a higher slump than expected, particularly on the first day of paving. Since this mixture was encapsulating the bottom lift by as much as 12 inches wide on the outside and to a depth of 13 inches, there were some areas with significant amounts of edge slump and "blowouts" (see figures 12a and 12b). The workers struggled valiantly to repair and shore up these areas (see figure 12c), but the result was a wandering shoulder edge and probably some edge depressions (although this was not verified with a straightedge) (see

figure 12d). It seems likely that these problems were caused by a combination of the higher-slump top lift material and the very wide encapsulation.

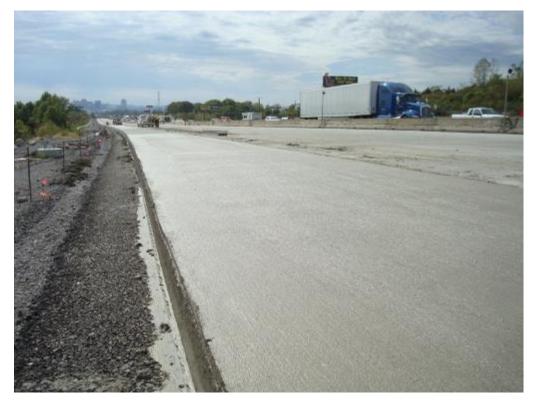
Photo E-30. Shoulder edge line after second edge slump correction effort.

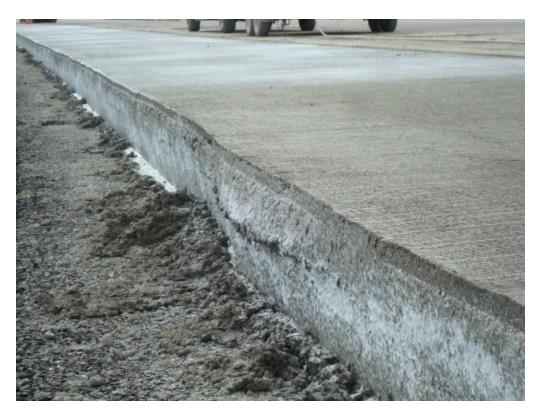
Photo E-31. Edge blowout #1.

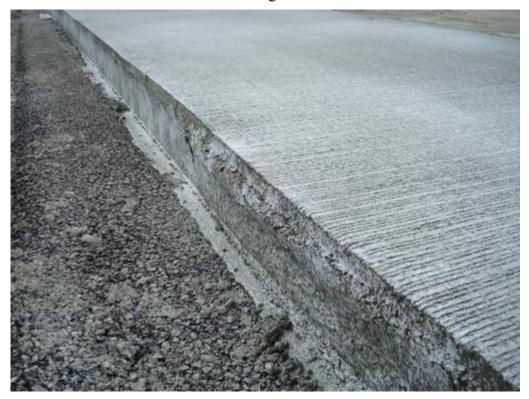
Photo E-32. Edge blowout #2.

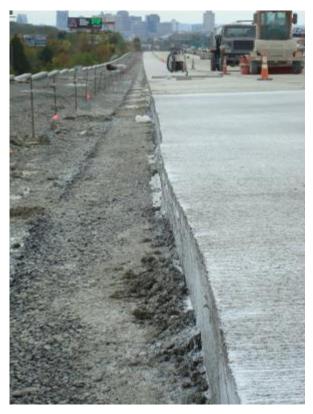
Photo E-33. Edge blowout #2 after repair.

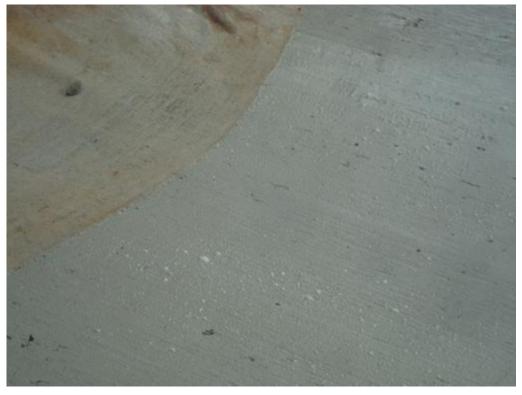
Photo E-34. Free water and bubbles on surface of bottom lift due to excessive water application to burlap drag.

The paver operators were frequently observed spraying water on the mixture in front of the paver and on the burlap and pavement behind the paver (see figure 13a). This was true for both the bottom and top lifts. In some cases, the trailing burlap for the top lift was so wet that bubbles and excess water were clearly visible on the pavement surface, and the finishers frequently pulled "waves" of mortar off of the pavement surface with bull floats (see figure 13b). Conversations with the paver operators indicated that the crews were not well-informed about the concepts and fundamentals concerning two-lift paving. The main concern with the presence of excessive surface water include reduced surface durability (scaling, poor wear resistance), as well as a higher potential for map/shrinkage cracking.

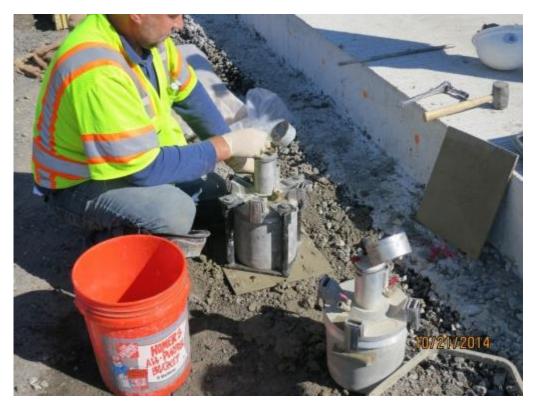
Photo E-47. Testing concrete using Super Air Meter (SAM).

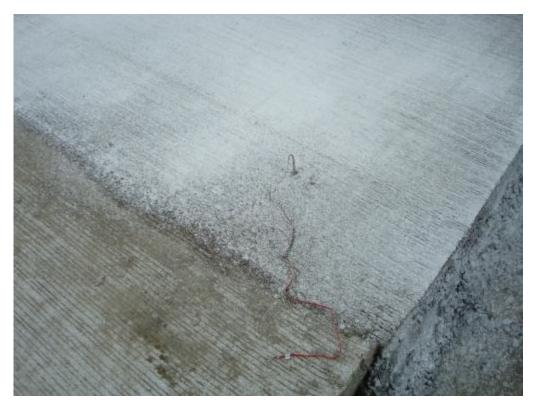
Photo E-55. Thermocouple/maturity sensor installation at south end of project.

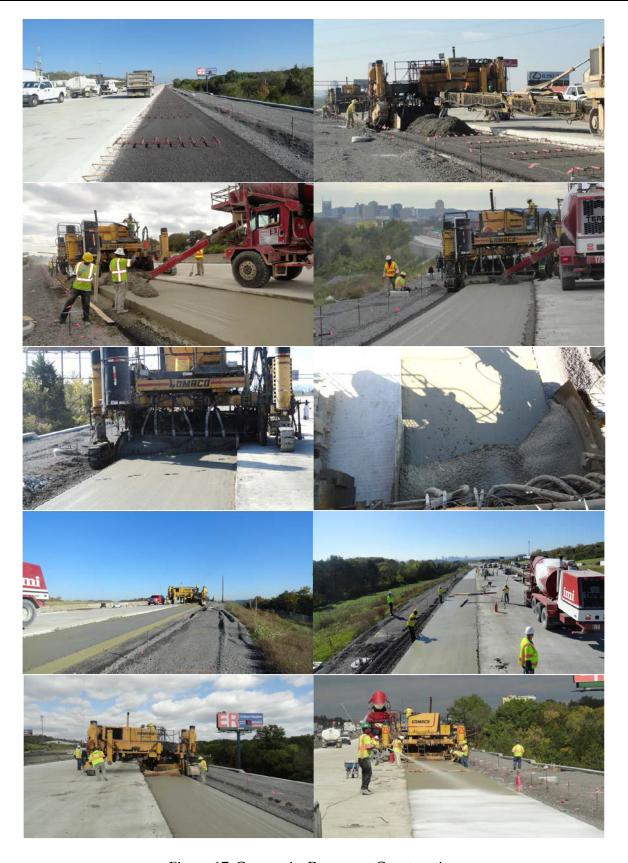
Photos in Figure 17 show some of the activities that took place during construction of the composite pavement shoulder. The bottom lift concrete was placed on HMA base. Dowels were placed using dowel baskets and shipping wires were left uncut. The shoulder was tied to the existing concrete pavement using tie bars. The operation consisted of two pavers; one for each lift. Concrete for the bottom lift was placed using a belt placer. After the bottom lift was paved, concrete for the top lift was directly placed on top of the bottom lift from ready mixed trucks. Due to paving equipment limitation, the top lift was placed one foot wider than the bottom. The 5000' long section was completed in four days. The finished pavement was burlap dragged. Figures 18 and 19 show the overall paving train. One of the interesting features of this project is the use of maturity concept for opening pavements to construction traffic.

Figure 17: Composite Pavement Construction

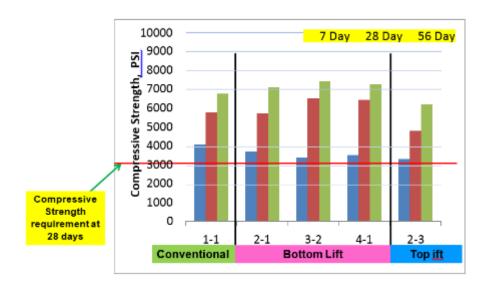
It is interesting to note that even though the top lift mixture had a higher cementitious content than the bottom lift mixture, the compressive strength of the top lift mixture sample was lower than that of the bottom lift samples. The gap gradation of the top lift mixture could have contributed to the difference in strength with the bottom lift. It could also be noted that for the 3-2 and 4-1 samples from the bottom mixture the rate of increase in strength from 7 to 28 days is significantly higher than the other three samples (1-1, 2-1 and 2-3).

Figure 26: Compressive Strength versus Age

Overall, in all three mixtures (five samples), the 28 day minimum compressive strength requirement of 3000 psi is exceed in only 7 days. Even though the three mixtures used in this project had low cementitious contents (between 526-571 lbs/yd3) and SCMs were used, it appears that there is still an opportunity to optimize the mixture design by reducing the cement content. Reducing the cement content would reduce cost as well as the potential for shrinkage (thereby reducing the risk of cracking) and would result in an environmentally "greener" concrete.

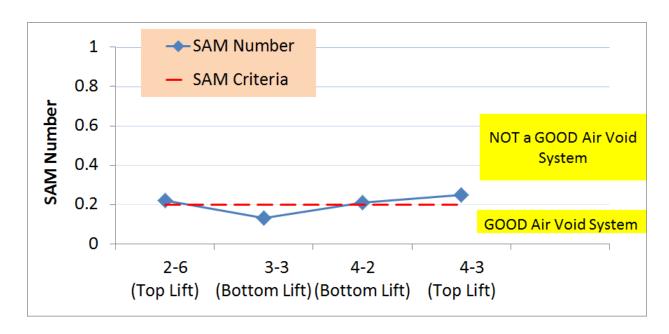
Figure 33: The Super Air Meter (SAM) Test Results

The SAM is a state of the art technology for measuring the air void system of fresh concrete. As mentioned previously, the MCL is currently evaluating the SAM by using it in several field projects and correlating SAM data with Freeze-Thaw and Hardened Air Content Test (ASTM C457) tests. The SAM has the potential to revolutionize the way air is tested in concrete. Some of the advantages of SAM are its ease of use, economical, rapid results, and field implementable.

- 7. All the four samples (two from bottom lift and two from the top lift) tested in this project using the Super Air Meter had a "SAM" number close to 0.2 which is classified as having a GOOD air void system to resist damage from freezing and thawing. The SAM is a state of the art technology for measuring the air void system of fresh concrete. It has the potential to revolutionize the way air is tested in concrete. Some of the advantages of SAM are its ease of use, economical, rapid results, and field implementable.

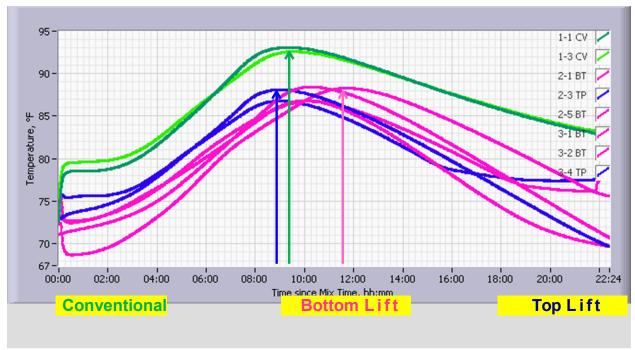
- 3. The heat gain of the conventional and top lift mixtures were similar ( $\Delta t = 14-15^{\circ}F$ )
- 4. The heat signature curves of the two samples of the conventional mixtures were very consistent (green curves) which indicates that the cementitious contents for these samples did not vary. This was also the case with the top lift mixture (blue). For the bottom lift mixture, the four curves (pink) were not consistent. This indicates that the cementitious contents or admixtures may have varied between samples from the bottom mixture.

- 5. One of the bottom lift sample had a much lower starting temperature (~5°F) compared to the other bottom lift samples. This sample had delayed time of peak temperature.
- 6. The calorimeter data matches well with the 56 day strength data (Figure 30).

Figure 35: Heat Signature Curves from all three Mixtures

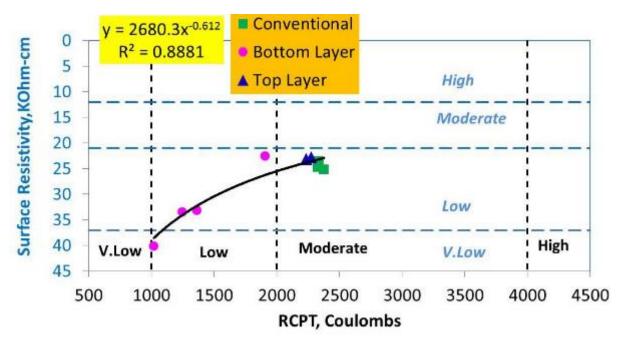
Figure 41: Relationship between RCPT and Surface Resistivity

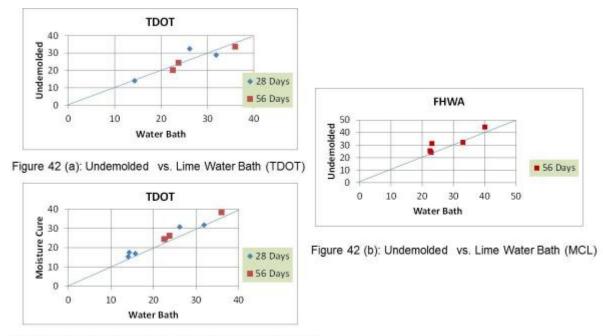
Figure 42 shows the results between various curing conditions from TDOT and the MCL. The figures show that there was not a significant difference in resistivity measurements between specimens that were demolded and cured in limewater bath and those that was non-demolded and left in lime water baths.

Interestingly, there was slight difference in resistivity measurements between moisture cured and lime water bath cured specimens. Almost all the data points in Figure 42 fell slightly above the line of equality. The SR results of the moisture cured specimen in Figure 42c were corrected per AASHTO TP95 (increased the actual measurements by 10% by multiplying the measured SR measurements with 1.1).

Figure 42 (c): Moisture Cured vs. Lime Water Bath (TDOT)

Figure 42: Comparison of various curing conditions

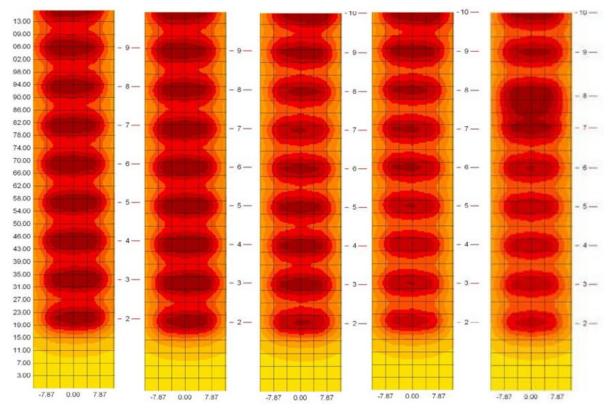
Figure 47: Magnetic Intensity Plot of Dowel Bars

For Figure 48, the individual magnetic images for the first two joints appear to be distinct. However, the magnetic images at the remaining three joints appear to coalesce together. This is because the shipping wires were not cut at these joints and due to this a magnetic loop is formed around the basket. This magnetic loop yields a large area of red instead of distinct red horizontal bars as seen at the other joints where the shipping wires were cut. Overall, however, based on all the magnetic images in Figure 47 and 48, it appears that all the dowels were well aligned without any issues at these ten joints. Appendix C shows the results for all the joints in Figure 47 and the first two joints in Figure 48 in a tabular form.

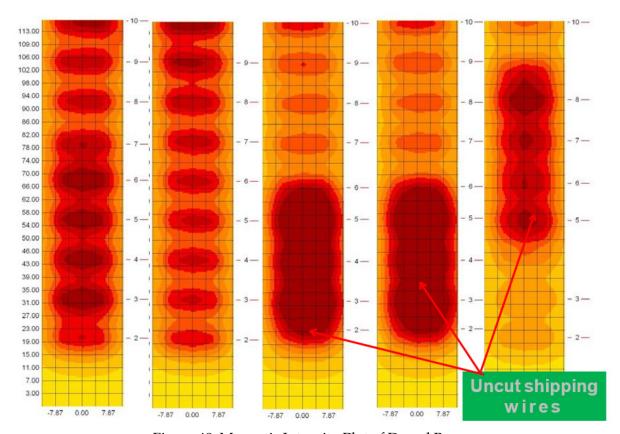
Figure 48: Magnetic Intensity Plot of Dowel Bars

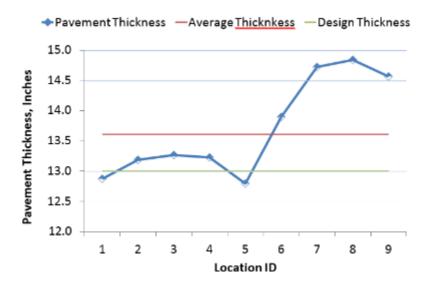
Figure 51: Pavement Thickness Measurements using the Scan T2

Even though data presented in Table 13 is only for one pavement thickness, there is published research which shows that the MIT Scan T2 works well and is accurate over a wide range of concrete pavement thicknesses and base conditions (5) and can be used in lieu of taking cores for measuring pavement thickness. MIT Scan T2 offers several benefits such as cost savings (in general, it is at least four times cheaper than taking cores in the long run), faster measurements (can take measurements as soon as the pavement can be walked upon), larger number of locations (more robust statistical analysis) and finally, it eliminates the need to cut cores on new pavements and thereby reducing the need to patch the core holes. Iowa DOT has adopted the and has using started it part of their specifications (http://www.iowadot.gov/specifications/dev\_specs/DS-09063.pdf).
