IMPLEMENTATION OF COMPOSITE PAVEMENT SYSTEMS

Texas DOT Two-Lift Concrete Pavement Construction Project: Frontage Road Along SB U.S. 59

March 2019

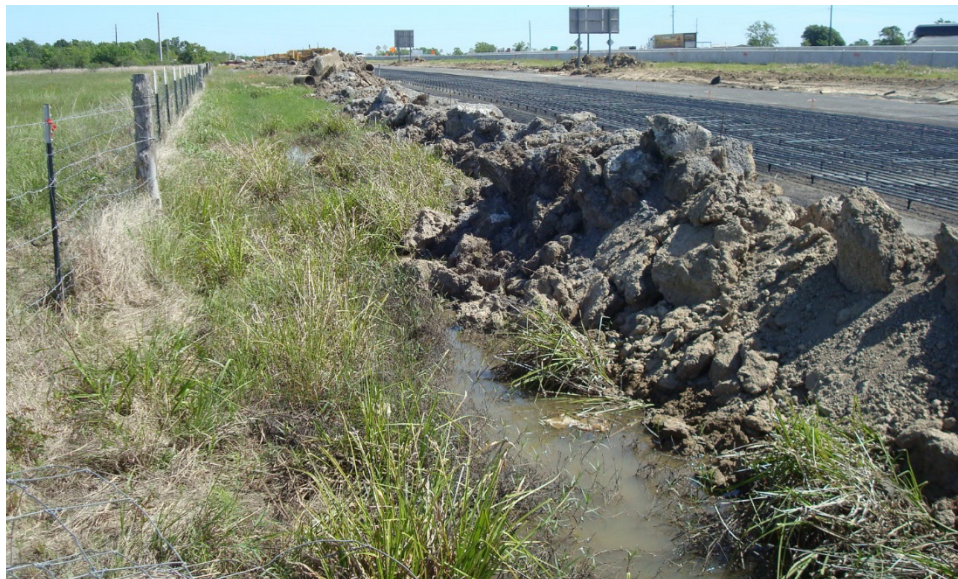
Preparation of the lime-treated subgrade was conducted in accordance with Item 260, *Lime Treatment (Road-Mixed)*. This section of the Texas DOT Standard Specifications (2014) describes materials, equipment, and construction procedures for subgrade preparation and the mixing and compaction of lime, water and subgrade or base materials in the roadway. Lime stabilization was performed to a depth of 6 inches (152 mm) with required compaction of at least 95 percent of maximum density at a moisture content that is within -1 to +2 percent of optimum. It is likely that at least lower levels of the subgrade are saturated, as indicated by the presence of standing water in ditches along the new roadway (see figure 3).

Figure 3. Typical wet ditch conditions along north side of project roadway near west end.

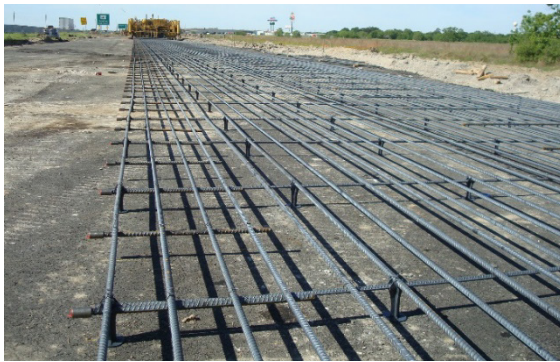
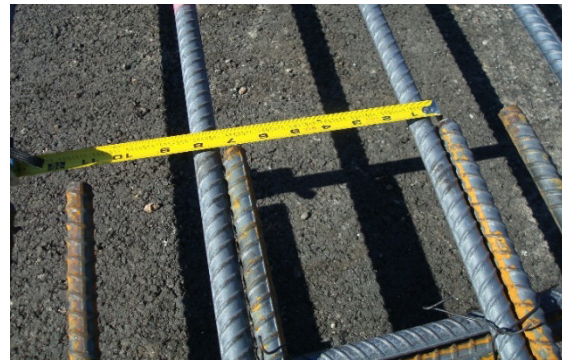
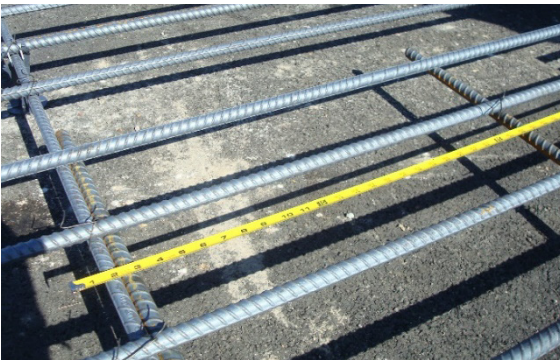
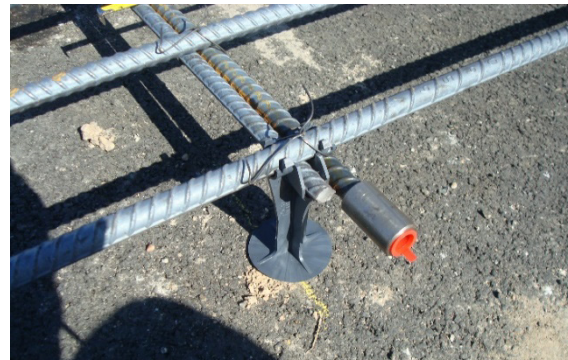
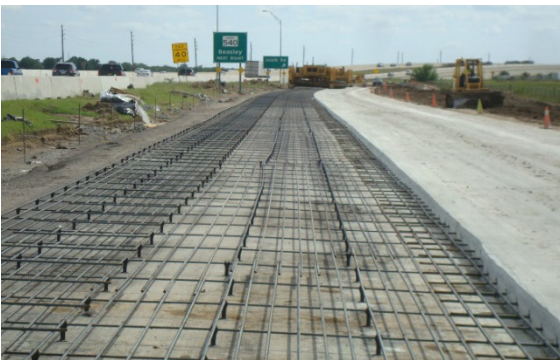
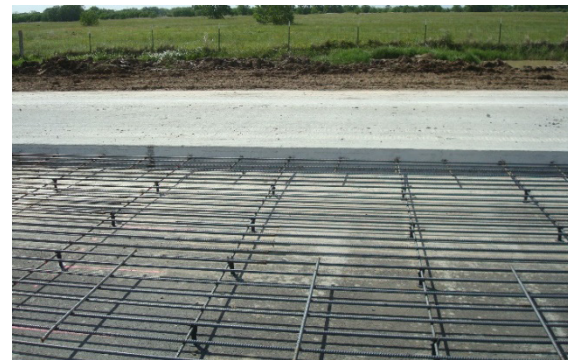
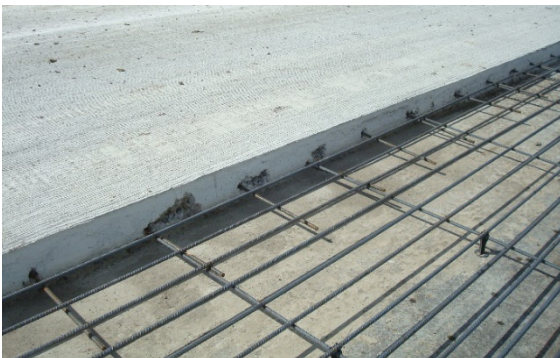
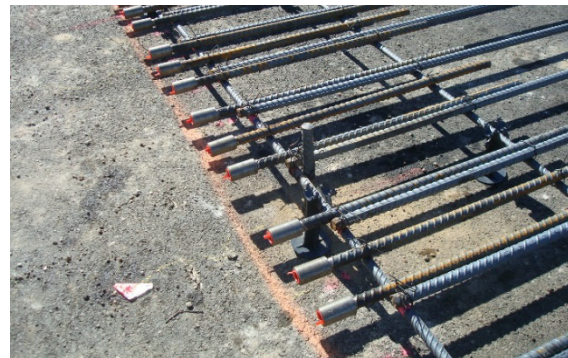
a. Steel placement overview, April 7 (Day 1), looking south.

b. Longitudinal steel, No. 6 bars at 7-inch (178-mm) spacings.

c. Transverse steel, No. bars at 48-inch (1219-mm) spacings.

d. Transverse tie bar coupler between lanes.

e. Steel placement overview, April 13 (Day 2), looking south.

f. Coupled transverse reinforcement and tie bars (Day 2).

g. Example of concrete loss near some transverse steel couplers.

h. Construction header and reinforcing (transverse construction joint).

Figure 4. Reinforcing steel configuration and assembly.

Longitudinal steel comprising bare No. 6 (0.75-inch [19-mm] diameter) Grade 60 deformed steel reinforcing bars were placed on and tied to the transverse steel (resulting in placement of the longitudinal steel approximately at the planned mid-depth of the composite 10-inch [254-mm] concrete pavement) on approximately 7-inch (178-mm) centers (see figure 4b), with a distance of 3 to 4 inches (76 to 102 mm) from the pavement or joint edges to the first bar. Longitudinal steel lap lengths ranged from 24 inches (610 mm) to several feet and varied with bar length (which also varied). Lap locations were supposed to be staggered a minimum of 25 inches (635 mm) (see figure 4e) such that no more than one-third of the longitudinal steel would be spliced in any given 12-ft (3.7-m) width and 2-ft (0.61 m) pavement length; however, higher amounts of steel were spliced in some areas where excessively long bars were not cut, resulting in very long lap lengths.

Additional No. 5 (0.625-inch [16-mm] diameter) bars, approximately 48 inches (1219 mm) long, were placed on top of and tied to the longitudinal steel between the primary transverse steel bars and were centered on the lane-shoulder joint locations, effectively creating a 24-inch (610-mm) tie bar spacing (see figures 4a, 4e and 4f). Half-length (24-inch[610-mm]) No. 5 (0.625-inch [16-mm] diameter) tie bars were also placed below and tied to longitudinal bars in between transverse bars at the longitudinal construction joint between travel lanes (see figure 4a).

The ends of all transverse steel along the longitudinal construction joint between the two travel lanes were threaded. Threaded steel couplers were installed on each transverse bar for the first night of paving and were positioned such that the plugged end of the coupler was flush with or slightly recessed from the planned edge of concrete (see figure 4d). After passage of the paver on the first night, the coupler ends were exposed using probing techniques and/or water flushing. In some cases, this process resulted in significant damage to the joint face (see figure 4g).

Prior to the second night of paving, the coupler plugs were removed and 24-inch (610 mm), No. 5 (0.625-inch [16-mm] diameter) threaded deformed bars were attached to the couplers to provide tie bars across the longitudinal construction joint and to provide a tied lap connection between transverse reinforcing steel in the two lanes (see figures 4e, 4f and 4g).

The project plans for transverse construction joint headers called for the use of one 50-inch (1270-mm), No. 6 (0.75-inch [19-mm] diameter) threaded deformed bar and coupler for every longitudinal bar in the pavement, plus an additional 50-inch (1270-mm), No. 6 (0.75-inch [19-mm] diameter) and coupler on 14-inch (356-mm) centers, but it appeared that the actual bars used were only approximately 30 inches (762 mm) long (see figure 4h). An additional transverse steel bar was provided for supporting the extra longitudinal bars at the header.

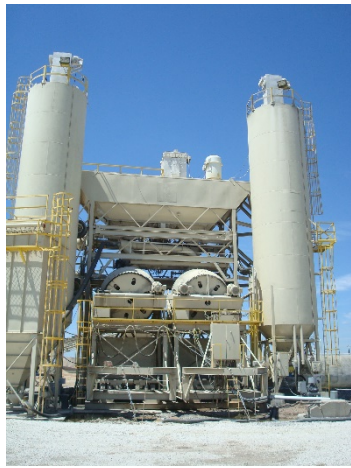
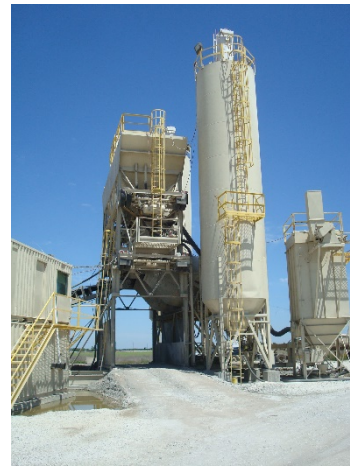
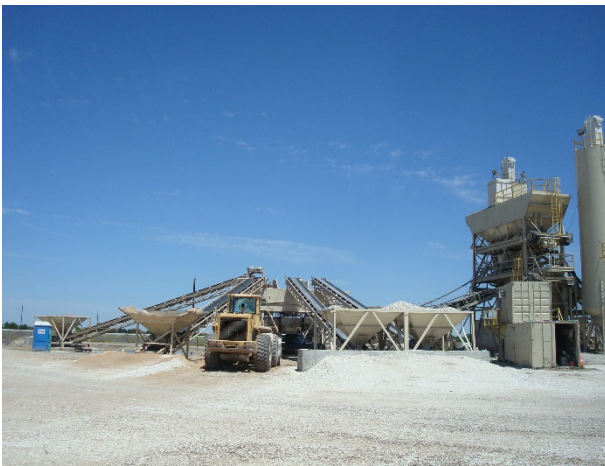
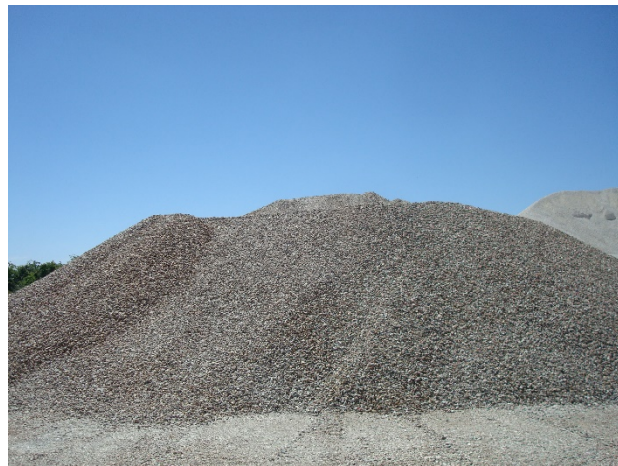
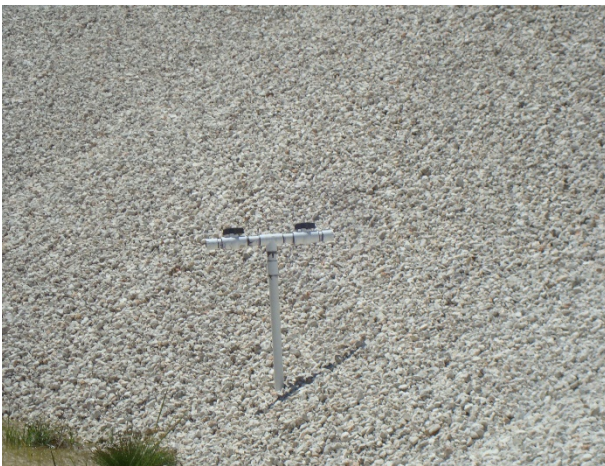
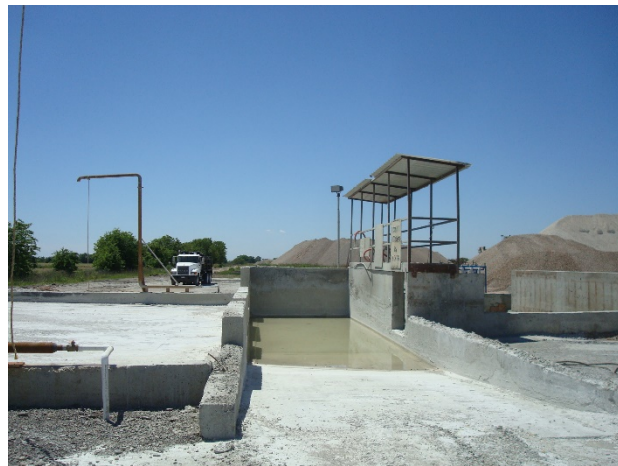
a. Top-lift concrete batch plant.

b. Top-lift batch plant – side view.

c. Aggregate loading bins and conveyors.

d. Coarse aggregate stockpile.

e. Aggregate stockpile sprayer.

f. Truck wash-out facility.

Figure 5. Mix production facilities for top-lift concrete.

Concrete mixes were wet-batched at separate facilities. Concrete for the 3-inch (76-mm) top lift (featuring a lower CTE) was produced in a double-drum batch plant (see figures 5a and 5b) located near Beasley. The facility appeared to be well-managed and maintained with clean aggregate sources in well-separated, moisture-controlled stockpiles (see figures 5c, 5d and 5e) and a truck washout facility (figure 5f).

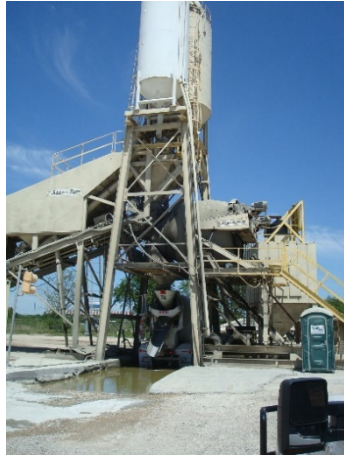
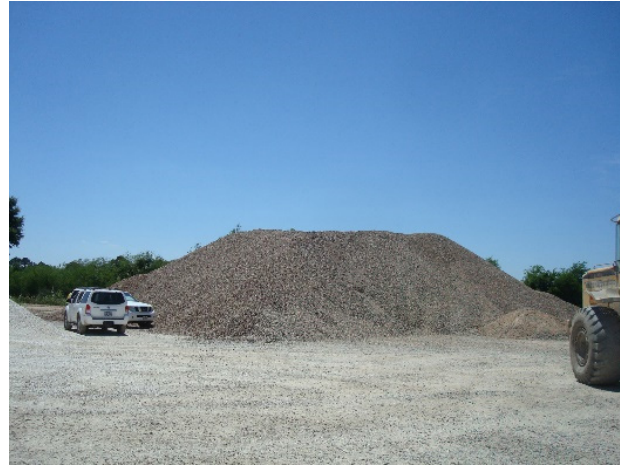
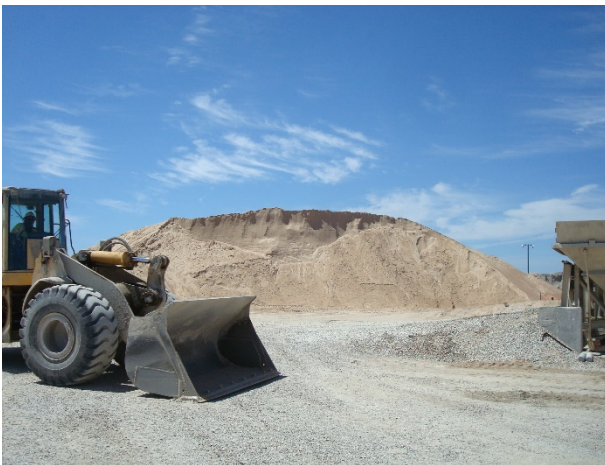
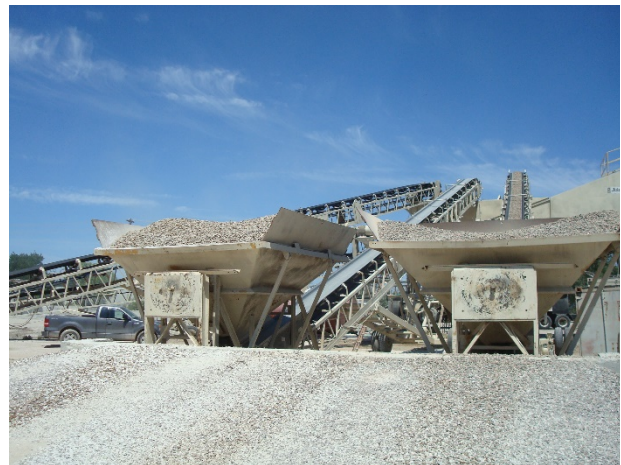
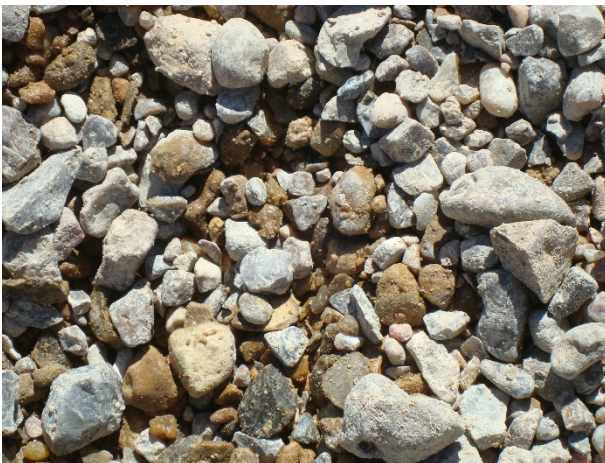
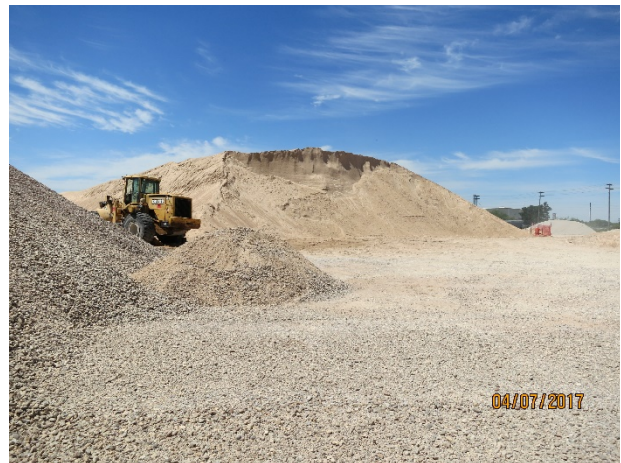
a. Bottom-lift concrete batch plant.

b. Coarse aggregate stockpile.

c. Fine aggregate stockpile and end loader.

d. Aggregate bins and conveyors.

e. Close-up of coarse aggregate.

f. Aggregate storage and handling - general.

Figure 6. Mix production facilities for bottom-lift concrete.

Concrete for the 7-inch (178-mm) bottom lift (featuring a higher CTE) was produced in a single-drum Johnson-Ross plant at a location in Rosenberg, TX about 10 to 15 minutes away from the paving site (see figures 6a and 6b). Aggregate stockpiles, handling, and storage generally appeared to be adequate (see figures 6c, 6d, and 6f), although the coarse aggregate appeared to be unwashed (see figure 6e).

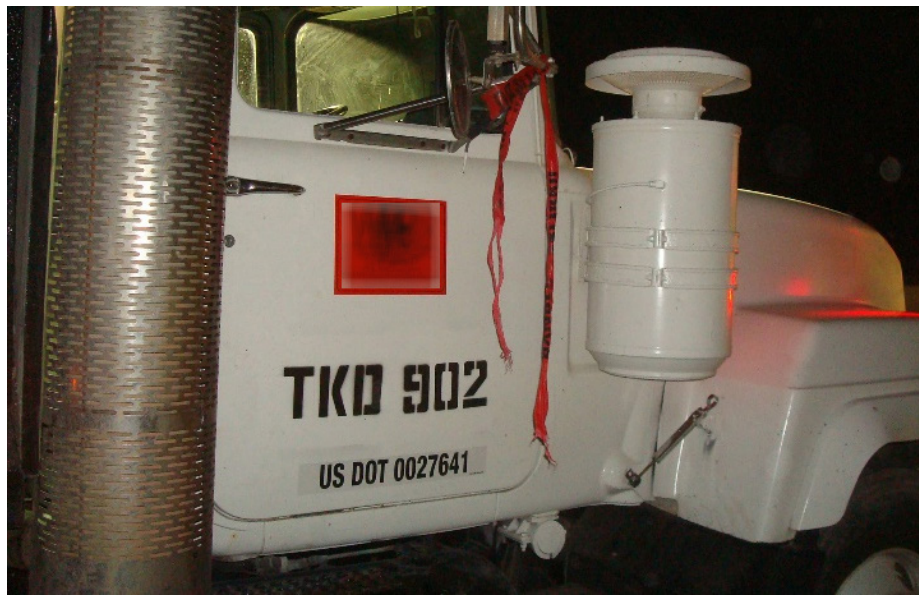
Figure 7. Transport truck for bottom-lift concrete (note red flagging on side mirror).

Concrete for both top and bottom lifts was transported using end-dump trucks. To avoid possible job site confusion, trucks transporting bottom-lift concrete were flagged with red ribbon (see figure 7) while white ribbon was used to mark trucks transporting top-lift concrete. Bottom and top lift concrete batches were prepared and delivered at a ratio of about 2.5-to-1 because of the much higher demand for concrete for the thicker bottom lift. All concrete was placed on grade or on the lower lift using a side-loading belt placer (see figure 8).

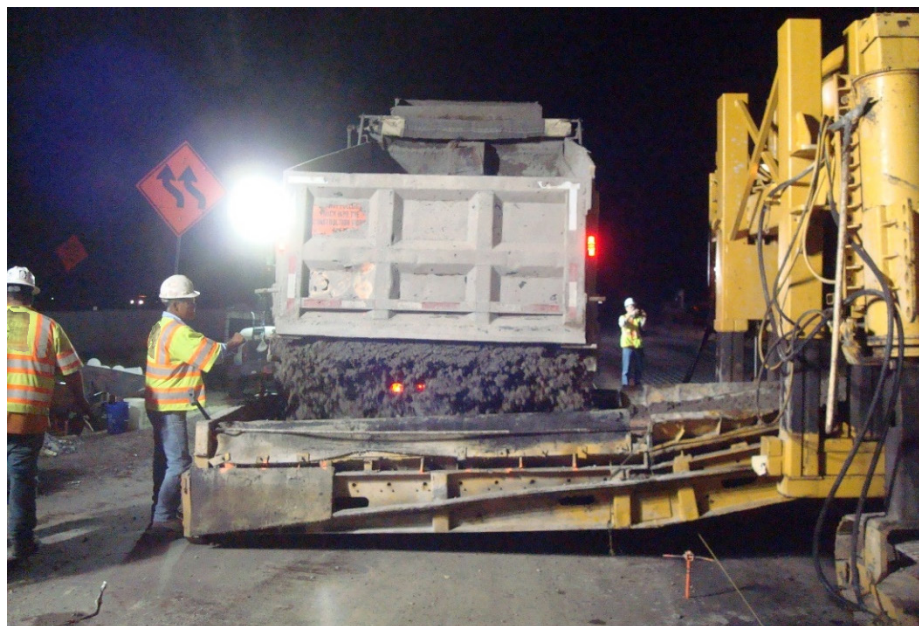
Figure 8. Concrete dump truck discharging load into conveyor for placement machine.

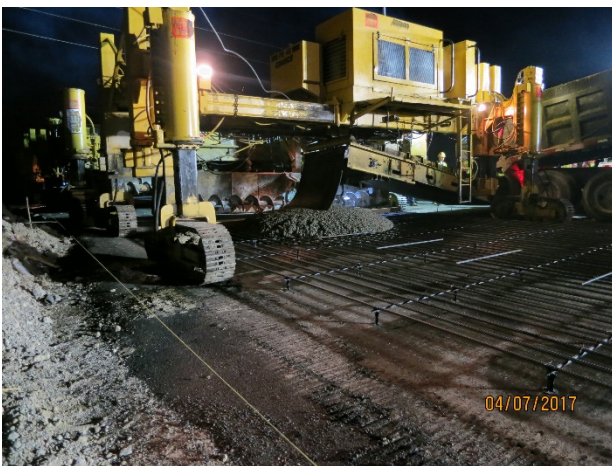
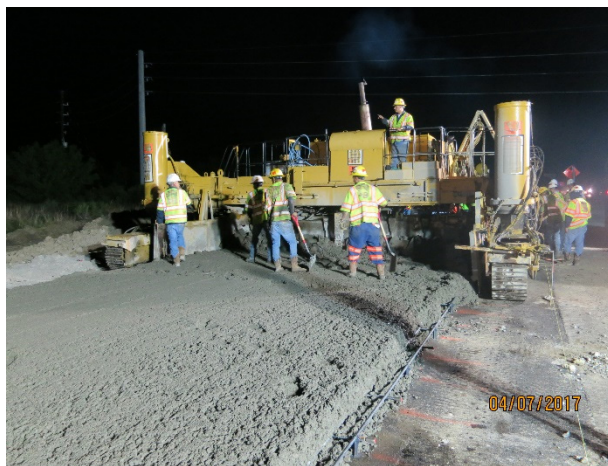
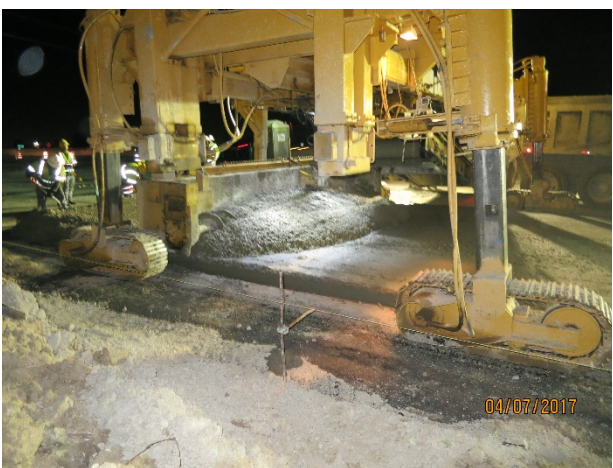
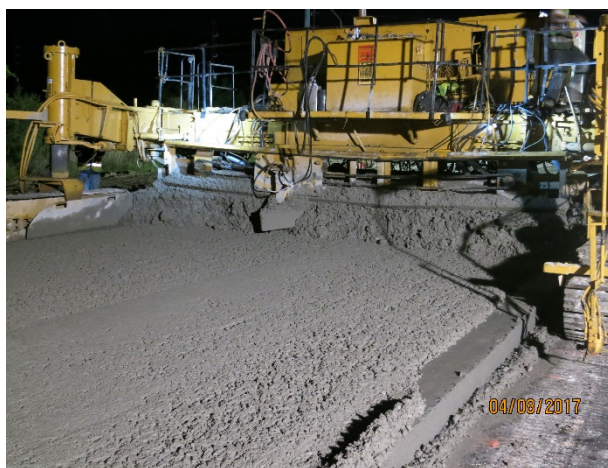
a. Bottom lift placer-spreader.

b. Bottom-lift paving.

c. Top lift placer-spreader.

d. Top lift placer-spreader.

Figure 9. Paving equipment and operations.

The bottom lift concrete was placed using dual-stringline paving techniques, a Gomaco Model PS-48 Placer-Spreader (see figure 9a), paving was performed using a CMI SF 350 4-track slip form paving machine (see figure 9b). Minor bull and hand float work was performed behind the paver to correct surface imperfections, but no significant finishing or texture was applied to the surface of the bottom lift. Evaporative retardant between the first and second lifts was not permitted.

The top lift concrete was generally placed within 90 minutes of placement of the bottom lift concrete. The equipment used to place the top lift was similar to that used for the bottom lift (see figures 9c and 9d).

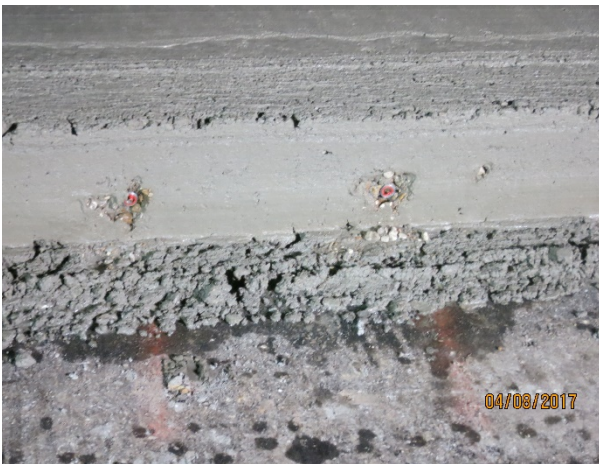
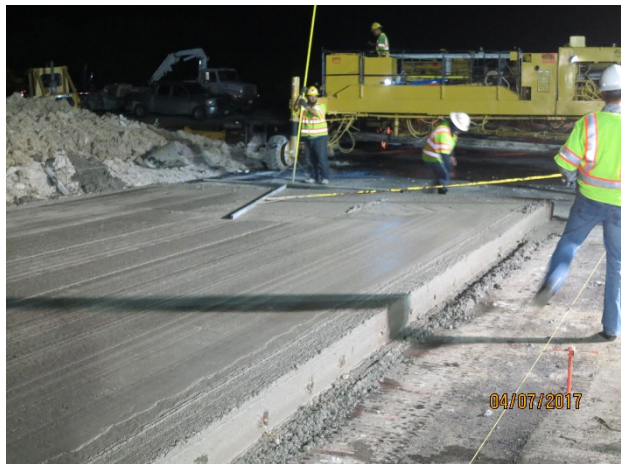
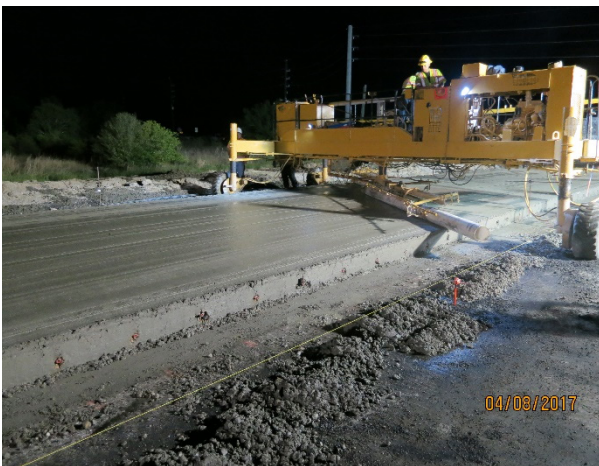
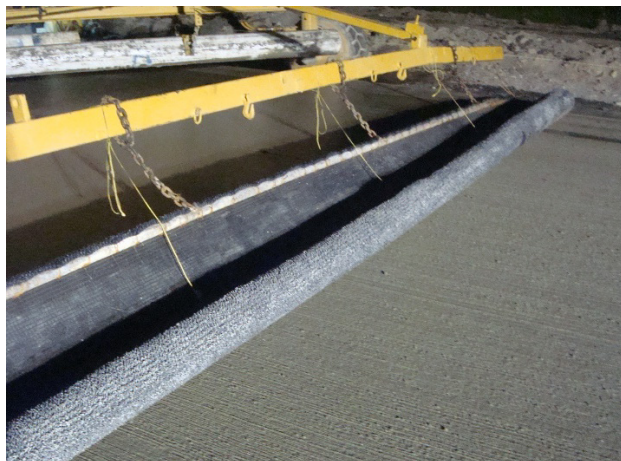
a. Exposed rebar couplers.

b. Hand work behind paver near header.

c. Tube float finishing.

d. Turf drag texturing.

Figure 10. Surface finishing operations.

On the first night only, transverse rebar couplers along the longitudinal construction joint between travel lanes were exposed using hand excavation or water flushing techniques (see figure 10a). This was done immediately behind the top lift paving operation.

The top lift was finished and textured in several steps. Hand work was performed using bull floats and hand floats, as required (figure 10b). A PVC tube float was suspended diagonally from a CMI self-propelled construction bridge and used to uniformly float the entire pavement surface (see figure 10c). The bridge also included a rear-mounted turf drag, which was used to provide longitudinal macrotexture to the entire pavement surface after the completion of floating (see figure 10d).

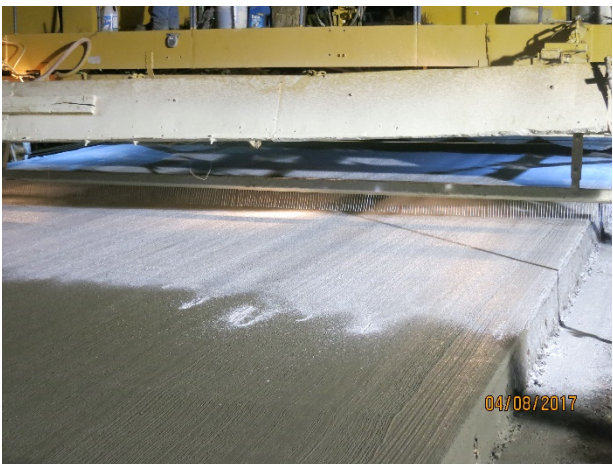
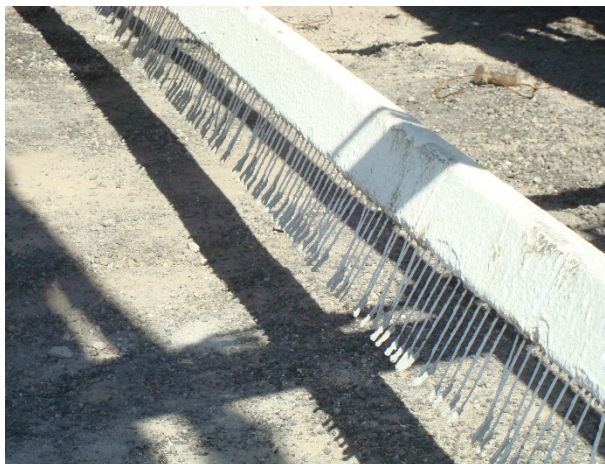
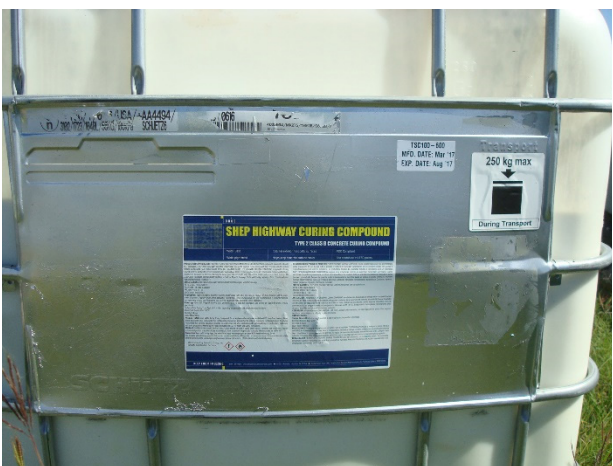
a. Tining and curing the pavement surface.

b. Rake for longitudinal tining.

c. Curing compound transport container.

d. Final surface with turf-drag texture, tining and curing compound.

Figure 11. Tining and curing operations.

The tube float-turf drag cart was followed by a texture-cure cart that provided longitudinal tining and white pigmented spray cure (see figures 11a through 11d). The curing compound was required to confirm to ASTM C 309 Type 2 Class A and was placed in two coats at a coverage rate not exceeding 180 ft²/gal (4.4 m²/L), with the first coat placed within 10 minutes of tining and “as soon as the free moisture has disappeared” and the second coat within 30 minutes of tining. Curing was to be maintained for at least 3 days, but curing was effectively much longer on this project because it was not to be opened to traffic for several months.

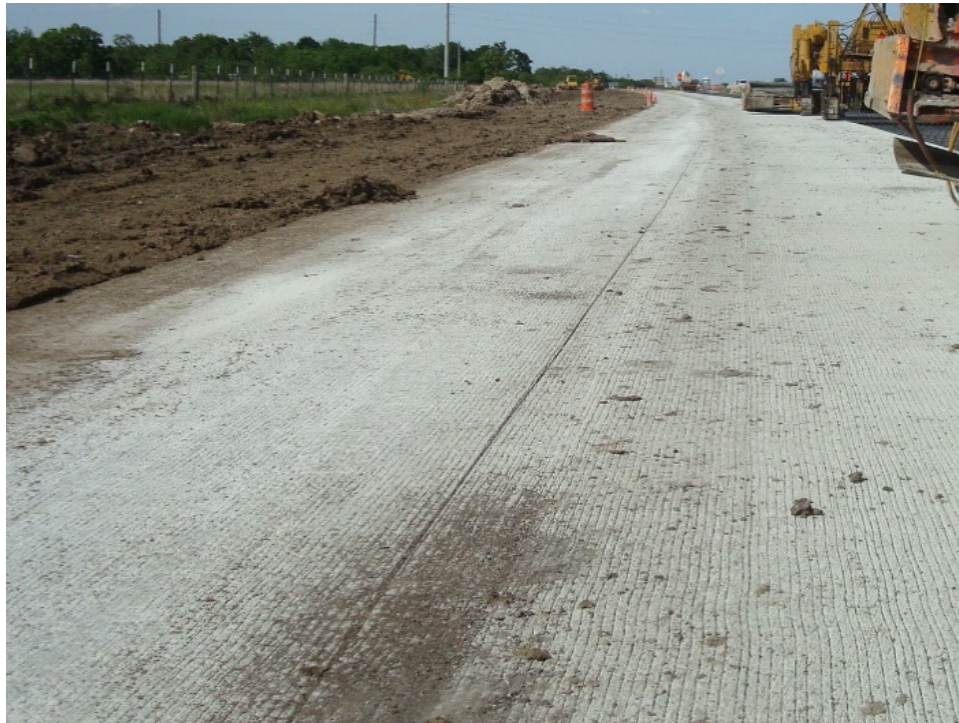
Figure 12. Lane-shoulder joint sawed in concrete placed on first night of paving.

The longitudinal lane-shoulder joints were to be sawed to approximately $D/3 + 1/2$ inch (13 mm) “as soon as possible without damage to the pavement” (see figure 12). A joint sealant reservoir measuring 0.62 inches (16 mm) deep and 0.25 inches (6 mm) wide was provided (by additional saw cut, if necessary) in all longitudinal construction and contraction joints prior to installing joint sealant. Sealant material was specified to be TxDOT DMS-6310 Class 5 or 8 (low-modulus silicone or polyurethane, self-leveling).

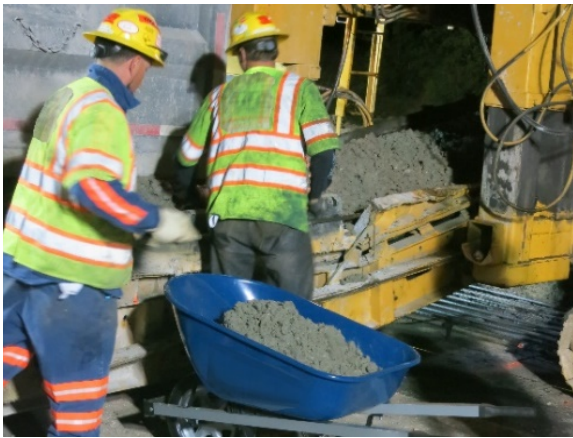
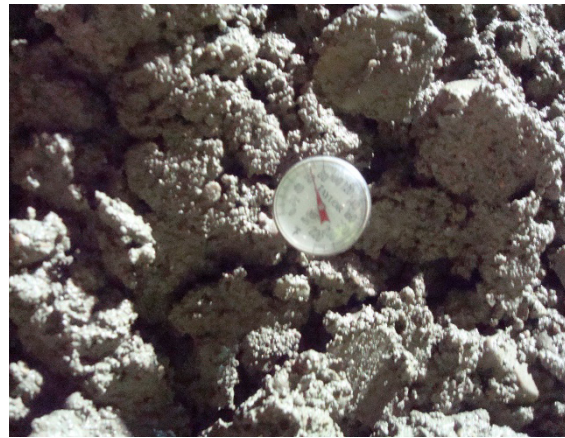
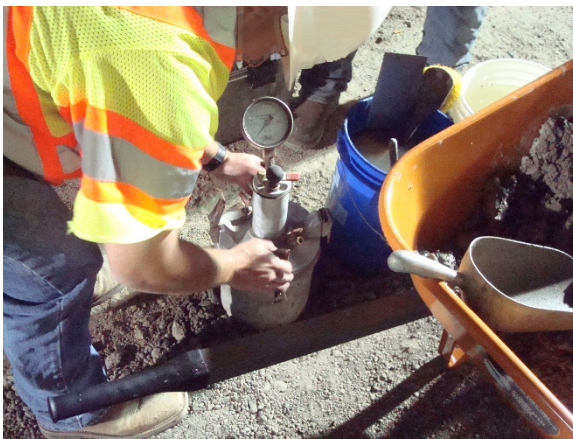
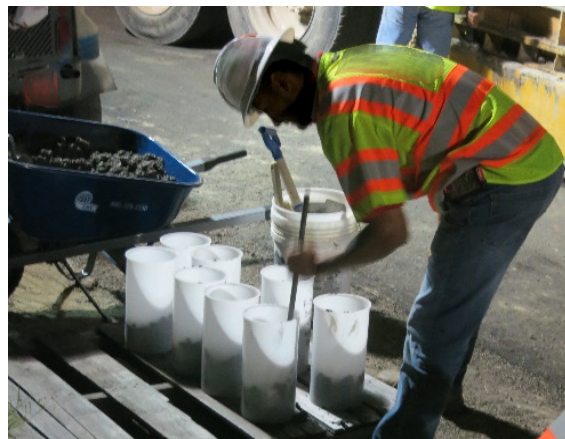
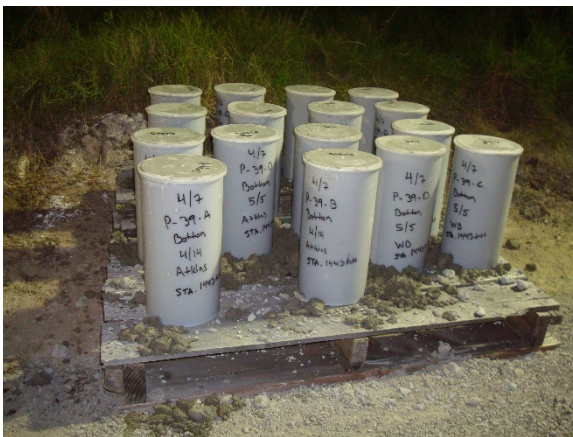
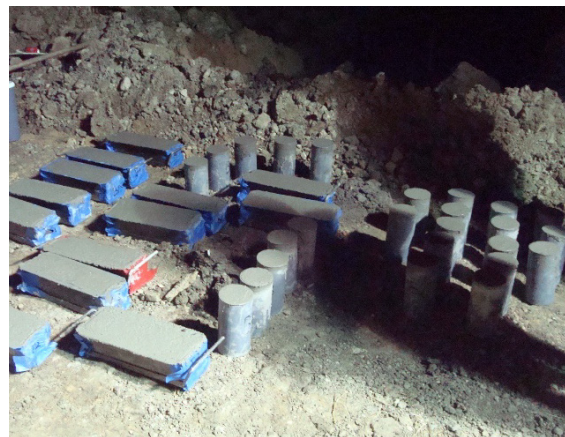
a. Mixture sampling.

b. Mixture temperature measurement.

c. Air content test.

d. Preparation of test cylinders.

e. Concrete test cylinders.

f. UT test beams and cylinders.

Figure 13. Field sampling, testing and preparation of test specimens.

Contractor, TxDOT, and University of Texas (UT) staff performed concrete material sampling and testing during placement of both the bottom and top lifts. Testing of plastic (fresh) concrete included mixture slump, temperature and air content. All three organizations cast cylinders for compressive strength testing while the UT team also cast additional cylinders and beams for determination of elastic modulus, coefficient of thermal expansion, and flexural strength. Photos of the field testing and preparation of test specimens are presented in figure 13. Results of these tests are described in the following sections.

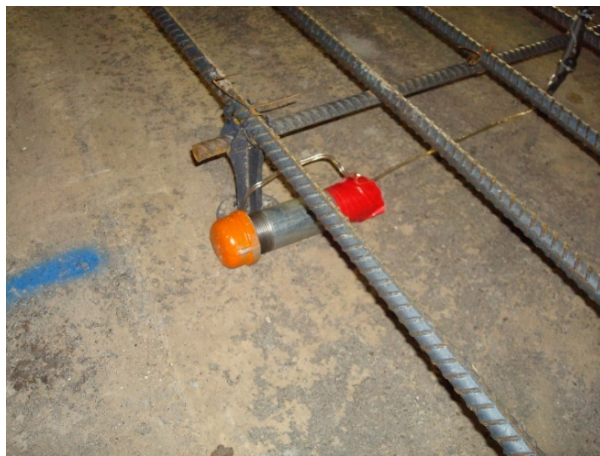
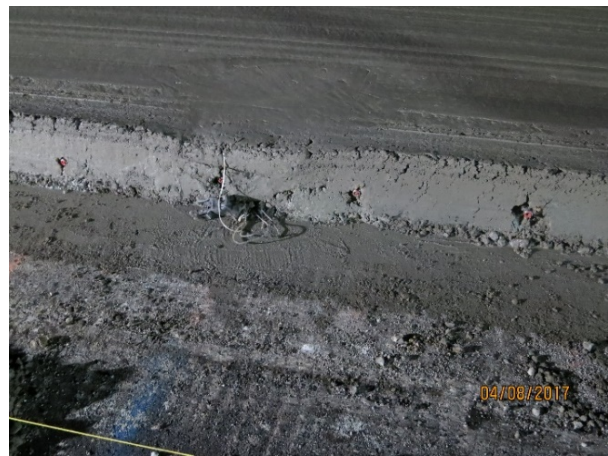
a. Sensors before paving

b. Sensors after paving

The University of Texas team installed temperature-logging “iButtons” near the pavement edge at each of the locations listed in tables 3, 4 and 5. Figure 14 presents photos of an example instrument mounting just prior to and just after paving.

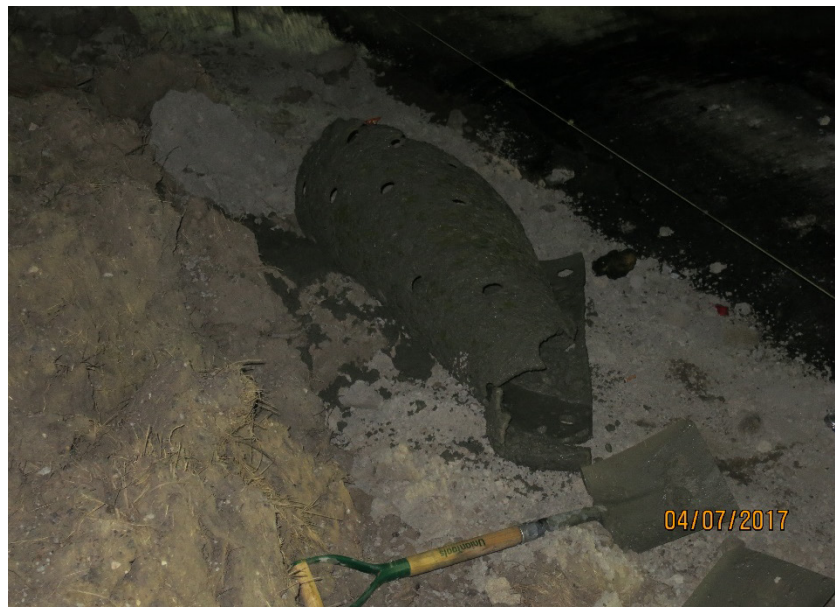
- On the first night of paving, a drum liner from the concrete mixer got introduced into the concrete and was deposited on grade but was removed ahead of the paver (see figure 15).
- Some areas of the longitudinal construction joint face along the night 1 placement showed signs of poor consolidation, shrinkage cracking, and excessive damage as a result of locating the reinforcing steel couplers (see figure 16). In addition, the paver hit several of the couplers that caused some alignment issues (see figure 16c).

Figure 15. Drum liner from concrete mixer.

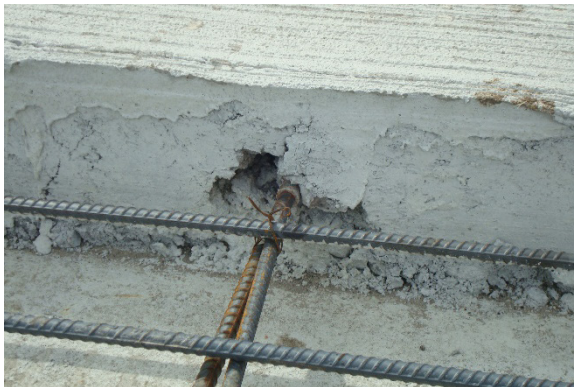
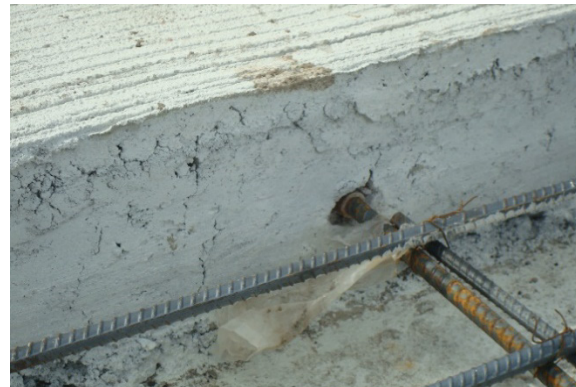
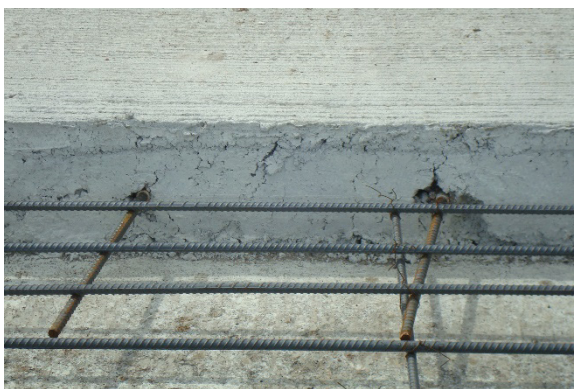
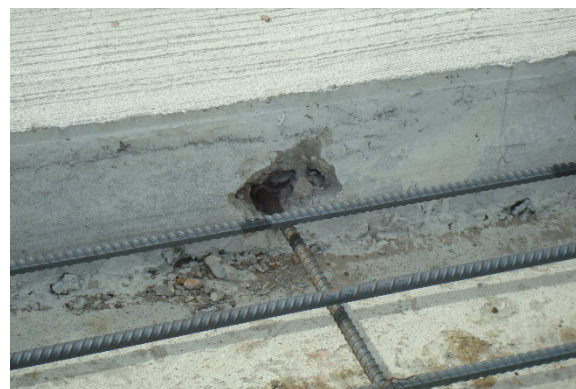
a. Excessive loss of concrete at steel coupler.

b. Consolidation issues and shrinkage cracking at longitudinal construction joint.

c. Shrinkage cracking and concrete loss at couplers along longitudinal construction joint.

d. Consolidation problem and concrete loss at coupler along longitudinal construction joint.

Figure 16. Longitudinal construction joint defects in first night paving.

- Some areas of the longitudinal construction joint face (first night placement) showed signs of poor consolidation, shrinkage cracking, and excessive loss of concrete around rebar couplers.
- The bottom lift paver experienced chronic control problems on the second night of paving, which caused one track to lift and resulting pavement surface irregularities that had to be corrected by hand or with additional concrete from the top lift paving operation.
- The top lift paver frequently left a rough shoulder edge on the second night of paving, which required hand work to repair.
- There was some exceptionally deep tining and some errant tining (intersecting the pavement edge) in localized areas (not widespread) on the second night.
- The overall quality of construction appeared to be good considering the various challenges that were encountered.

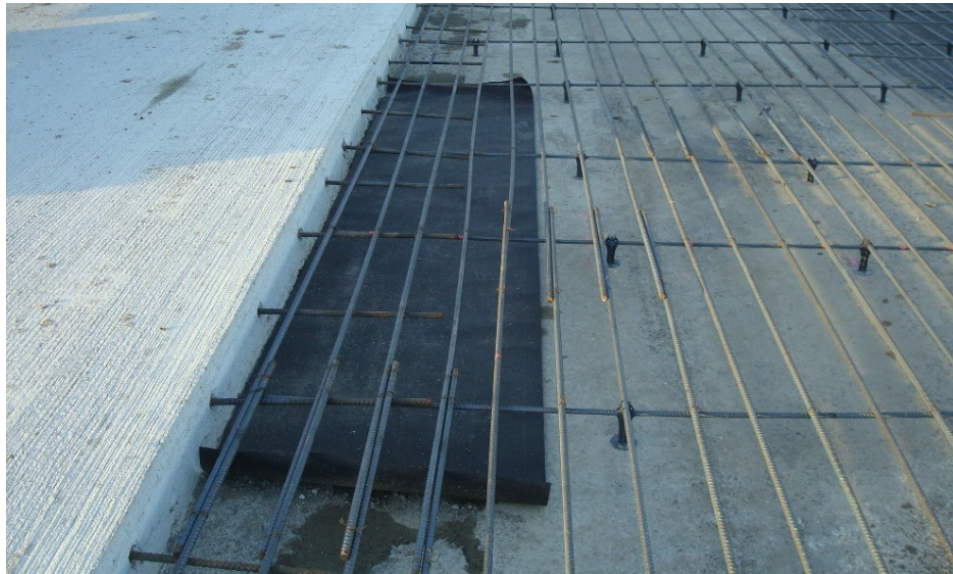
- On the second night of paving, “tar paper” was placed over areas of the asphalt interlayer that were damaged during the first night paving operations, as shown in figure 17. This was done to provide a smoother interface plane under the CRCP and to prevent the CRCP from interlocking with the asphalt.

Figure 17. “Tar paper” covering paver track damage to asphalt interlayer.

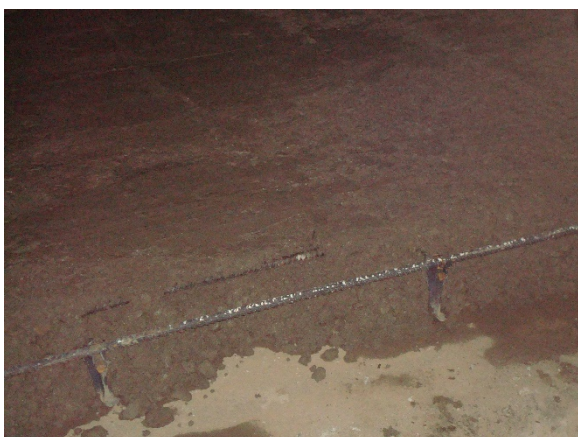
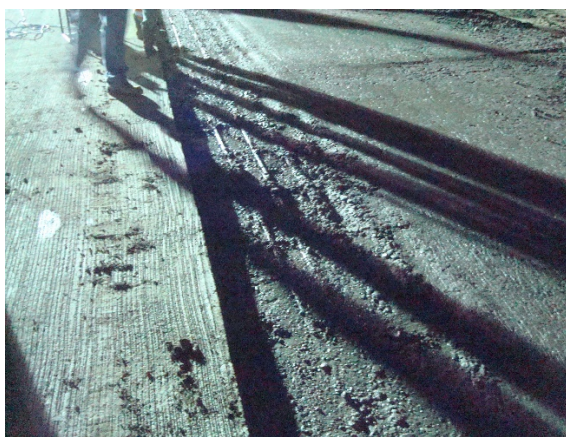
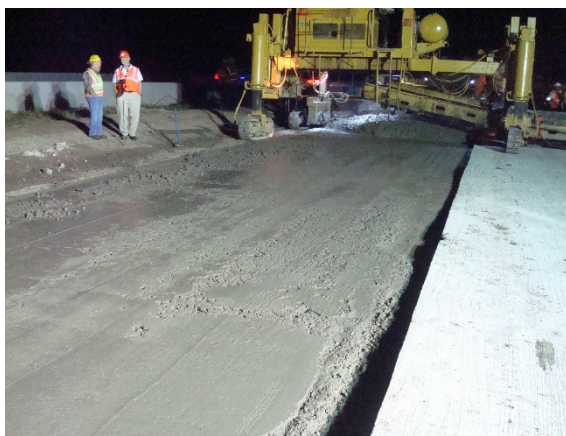
- There were several difficulties at the beginning of the second night of paving. It was difficult to get the first (lower lift) paver up the hill and onto the header and the east track lifted in the air about 12 inches (305 mm) before settling in. There also appeared to be insufficient volume of concrete (or inadequate spreading) during the first 50 ft (15 m) of lower lift paving, which left exposed rebar behind the paver (see figures 18a and 18b). This required a significant amount of hand work to cover the steel (figure 18c). Additional fill was eventually accomplished with top lift material (figure 18d). There was a delay of approximately 2 hours before the second lift of paving was placed in this area.

a. Exposed steel, start of night 2 paving.

b. Exposed steel, start of night 2 paving.

c. Hand work to fill low edge areas.

d. Filling low bottom lift areas with top lift.

Figure 18. Exposed rebar and hand work, south end of night 2 bottom lift paving.

- The bottom lift paver experienced continual difficulties with one of the vertical string line sensors throughout the second night, which resulted in frequent lifting of the east front track and resulting irregularities in the paving surface. The paving crew would sometimes manually manipulate the sensor to effect a correction when the track was lifting.

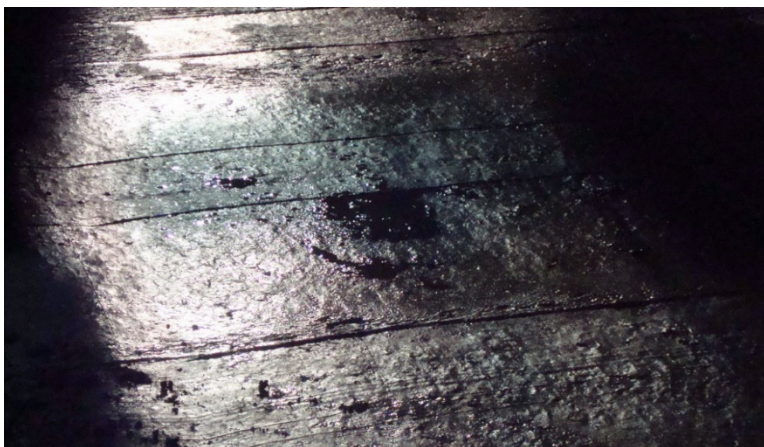
- Approximately 275 ft from the south end (start of 2nd night paving) it was noted that an oily material was leaking from the top lift spreader (see figure 19); this continued indefinitely.

Figure 19. Oil leaked on pavement surface from top lift spreader at approximately Station 1433+75, night 2.

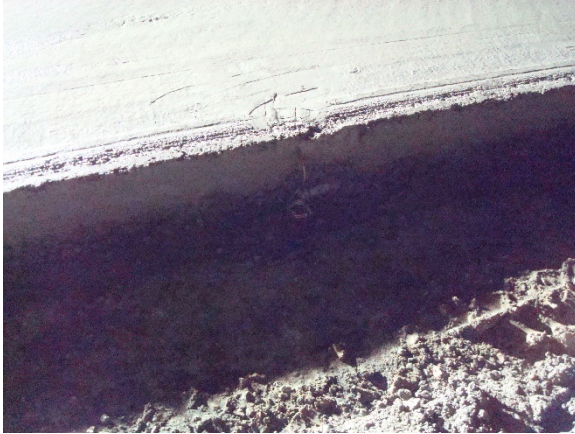
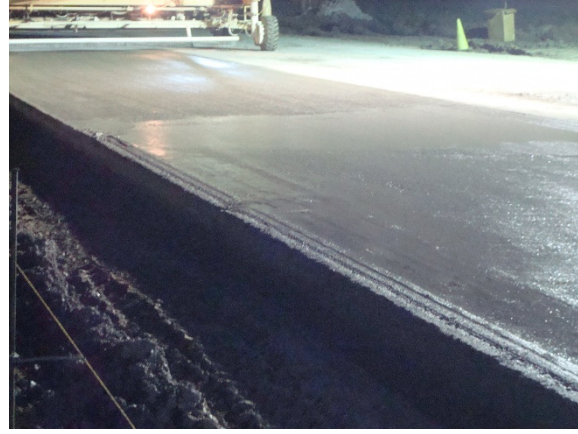
- The top lift paver frequently left a rough outside (east) edge on night 2 (see figure 20). This required significant hand work for correction.

a. Example of rough top surface edge in top surface paving, night 2.

b. Example of rough top surface edge in top surface paving, night 2.

Figure 20. Exposed rebar and hand work, south end of night 2 bottom lift paving.

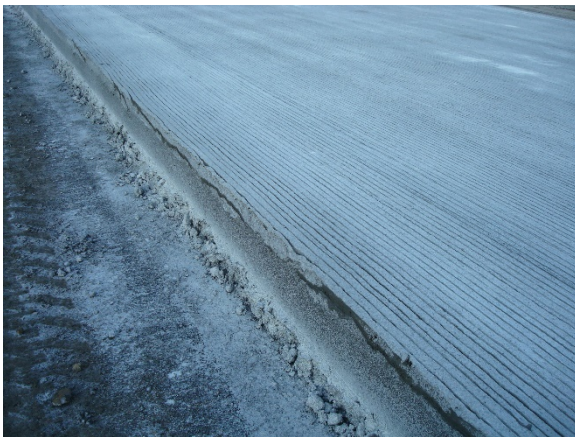
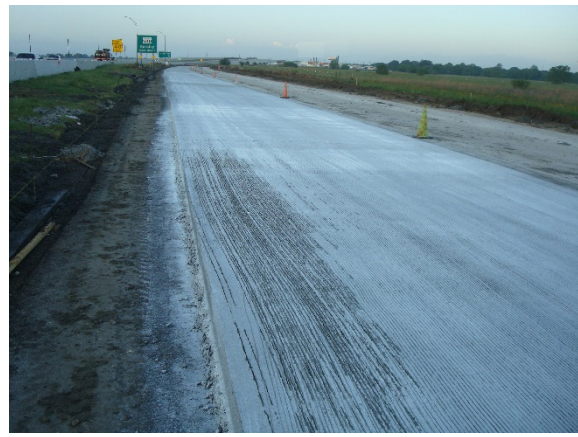
- The tining operations experienced some problems on night 2, including some localized areas where tining intersected the shoulder edge (rather than maintaining a few inches of non-tined surface) and one area where the tining was exceptionally deep. These conditions are both documented in figure 21. These problem areas notwithstanding, the tining on night 2 was generally straighter (less “wavy”) than the tining on the first night of paving.

a. Tining intersecting shoulder pavement edge, night 2.

b. Deep, wandering tining near north end of night 2 paving.

Figure 21. Tining problems on second night of paving.

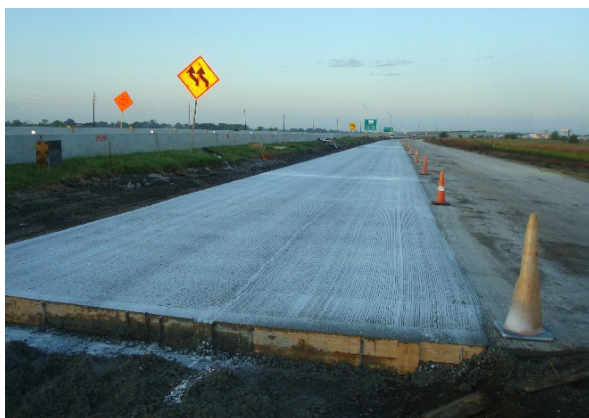
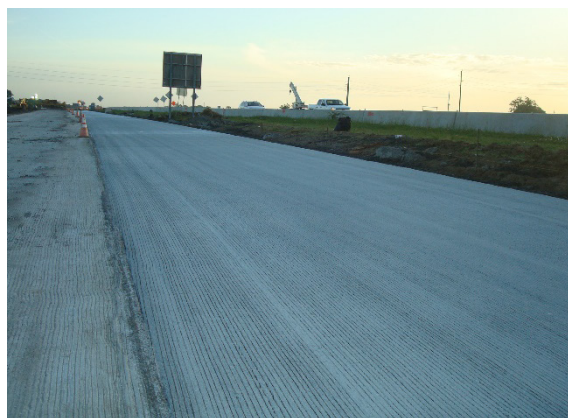
- The difficulties documented above are not representative of the overall quality of paving, which was generally considered to be very good. The final finished pavement appeared to be quite acceptable at the end of the second night of paving, as illustrated in figure 22.

a. Overview of finished pavement, looking south.

b. Overview of finished pavement, looking north.
