Curing Methods to Mitigate Early-Age Bridge Deck Cracking

Todd Nelson, P.E. – Associate Principal

- Montana DoT Case Study: Curing Methods to Mitigate Early Age Cracking
- Project Background
- Field Investigations
- Laboratory Evaluations
- Thermal and Stress Modeling
- Curing Recommendations

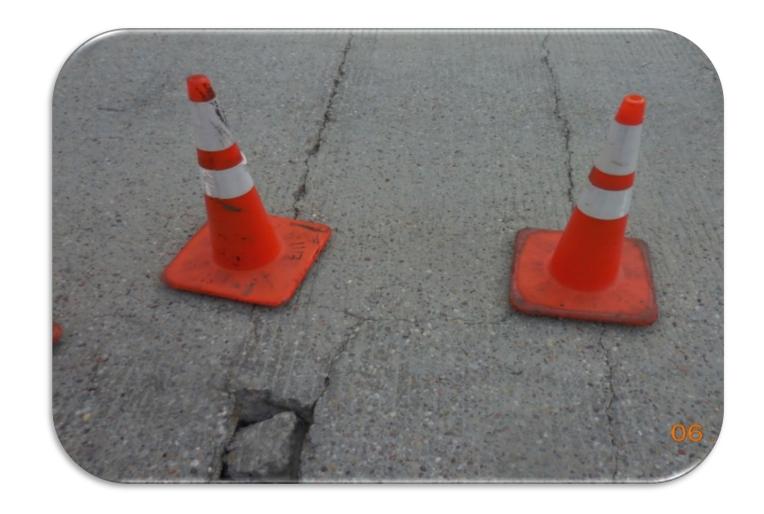
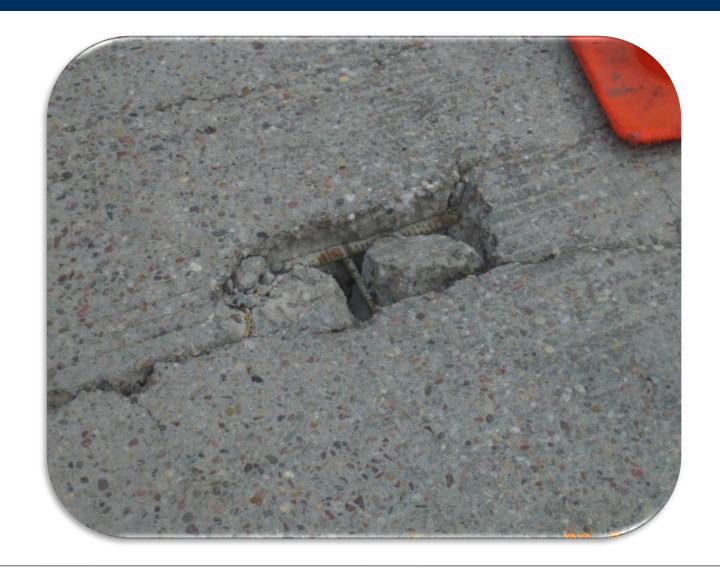
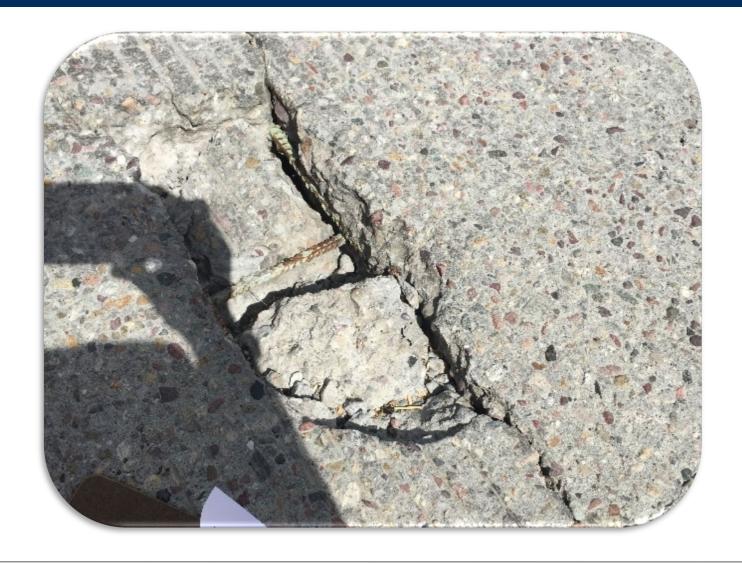
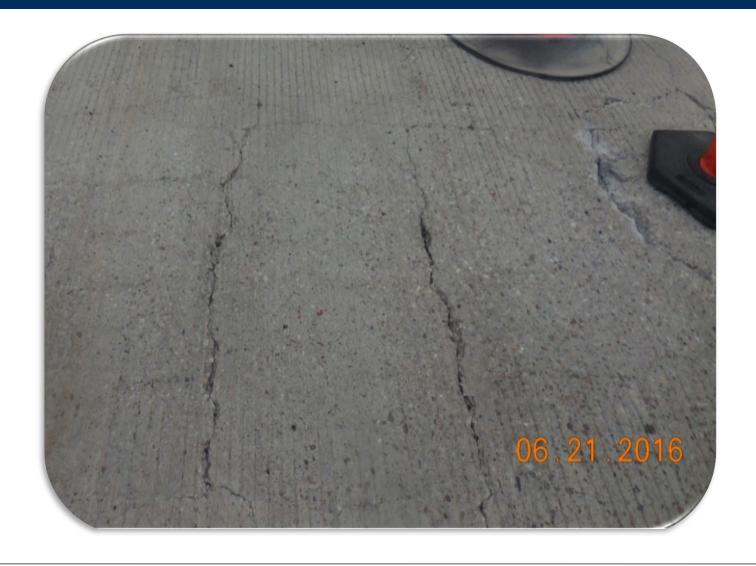
Project Background – MDT Documentation

- In 2016, MDT communicated to WJE that severe transverse cracking was noted on a number of bridge decks in western Montana
- In three bridges, cracking led to deck penetrations (holes in the deck)
- Concrete decks were only 1 to 9 years old
- MDT and FHWA commissioned WJE in early 2016 to investigate the problem

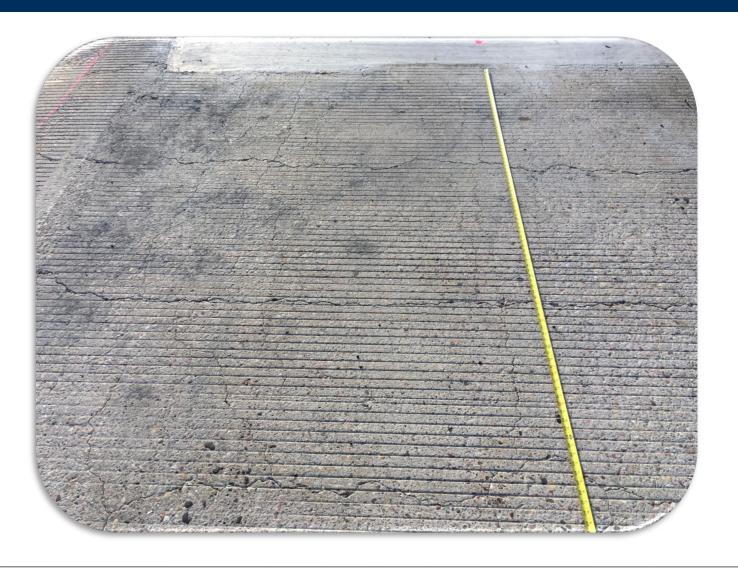
Field Investigations – Transverse Cracking

- Transverse crack spacing varied from 2 to 4 feet on most bridges
 - More frequent than typical
- Transverse cracks predominately over transverse bars (GPR)
- Width of transverse cracks were typically 15 to 25 mils
- Plastic shrinkage cracking noted on some decks, most severe on Florence-East MP 10.640 - 1 year old and contained silica fume concrete.
- Longitudinal cracking noted, but not significant

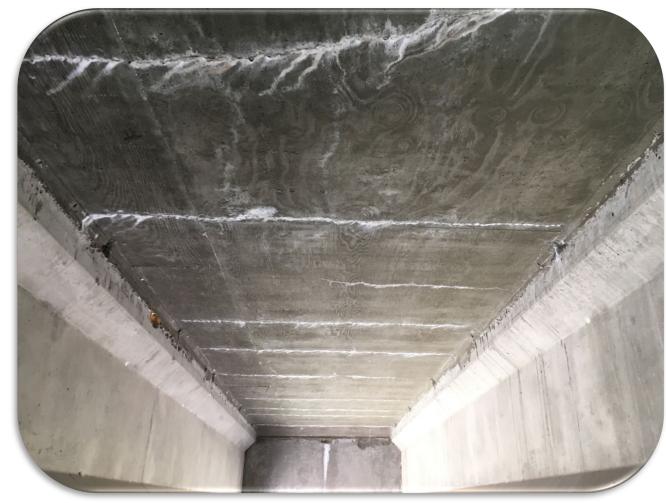
Transverse cracking - Underside

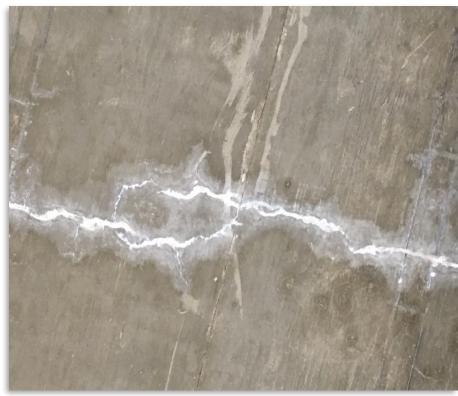
"Jump" cracking

- Transverse cracks develop, likely early to be investigated further
- 2. Transverse cracks progress over time
- 3. Closely-spaced transverse cracks form "jump" cracks
- 4. Continued volumetric movement and traffic loading widen and ravel transverse and "jump" cracks
- 5. Deck penetrations may develop at "jump" cracks with the right conditions:
 - Deck penetrations more prone to occur with top and bottom mats aligned
 - The more closely spaced the transverse cracks, the more likely deck penetrations will occur

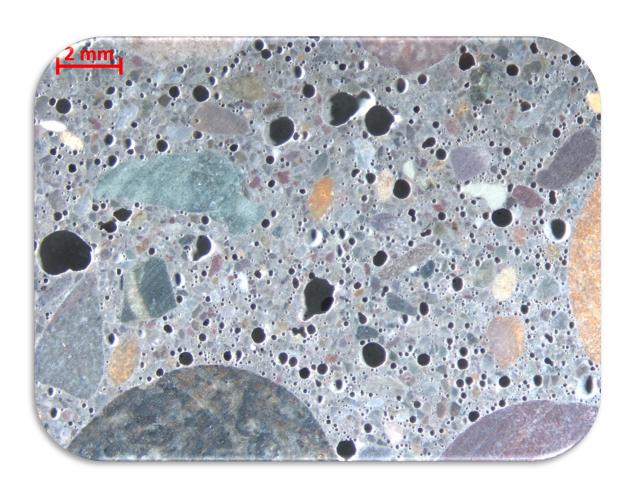
Laboratory Evaluations - Petrography

- All transverse and "jump" cracks appeared to have initiated very early – cracks propagate around aggregates
- No signs of internal distress
- Air void system is good for freeze/thaw durability
- Aggregates are sound
- W/cm ratios were adequate, occasionally slightly elevated
