ACCELERATED IMPLEMENTATION OF INTELLIGENT COMPACTION TECHNOLOGY FOR EMBANKMENT SUBGRADE SOILS, AGGREGATE BASE, AND ASPHALT PAVEMENT MATERIALS: US 84 WAYNESBORO, MISSISSIPPI

Final Report ER10-03
US84, Waynesboro, MS, Field Project
July 13 to 17, 2009

David J. White, Ph.D.
Pavana KR. Vennapusa, Ph.D.
Heath Gieselman
Bradley Fleming
Stephen Quist
Luke Johanson

Earthworks Engineering Research Center (EERC)
Department of Civil Construction and Environmental Engineering
Iowa State University
2711 South Loop Drive, Suite 4600
Ames, IA 50010-8664
Phone: 515-294-7910
www.eerc.iastate.edu

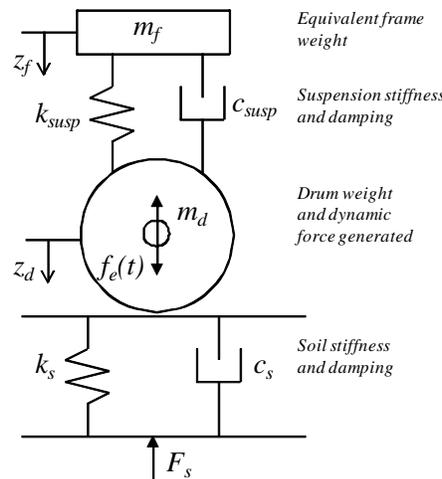
Figure 2. Lumped parameter two-degree-of-freedom spring dashpot model representing vibratory compactor and soil behavior (reproduced from Yoo and Selig 1980)

The k_s measurement system was introduced by Ammann during late 1990's based on a lumped parameter two-degree-of-freedom spring dashpot system illustrated in Figure 2 (Anderegg and Kauffmann 2004). The spring dashpot model has been found effective in representing the drum-ground interaction behavior (Yoo and Selig 1980). The drum inertia force and eccentric force time histories are determined from drum acceleration data and eccentric position (neglecting frame inertia). The drum displacement (z_d) is determined by double integrating the measured peak drum accelerations. The roller-integrated stiffness (k_s) is determined using Eq. 5, where f is the excitation frequency, m_d is the drum mass, $m_e r_e$ is the eccentric moment of the unbalanced mass, ϕ is the phase angle, a is vibration amplitude. The k_s value represents a quasi-static stiffness value and is reportedly independent of the excitation frequency between 25 to 40 Hz (Anderegg and Kaufmann 2004).

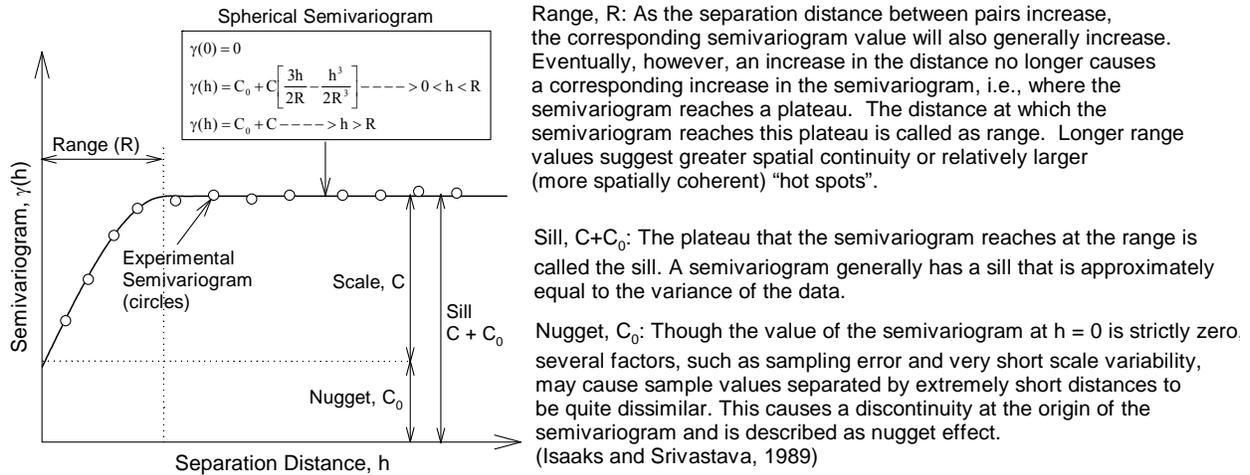
Figure 4. Description of a typical experimental and spherical semivariogram and its parameters

Some of the results presented in this report revealed nested structures with short-range and long-range components in the experimental semivariograms. Nested structures have been observed in geological applications where different physical processes are responsible for spatial variations

at different scale (see Chiles and Delfiner 1999). For the cases with nested structures, nested spherical variograms combining two spherical models (with two sill values and two range values) are fit to the experimental semivariogram data.

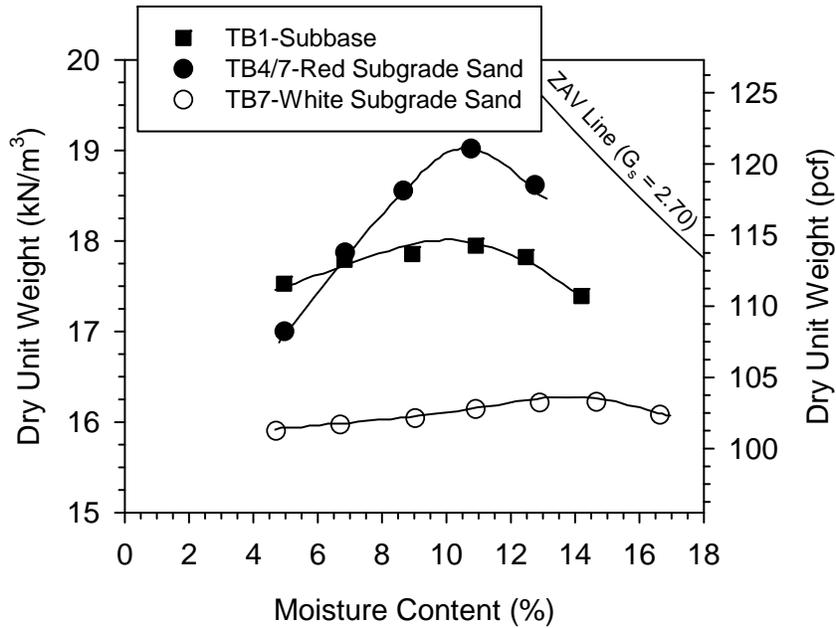
Figure 6. Laboratory standard Proctor moisture-density relationships for base and subgrade materials

Maximum dry unit weight (γ_{dmax}) and optimum moisture content (w_{opt}) results from Proctor tests are summarized in 3. Proctor tests were also conducted on treated subgrade and base material samples obtained from the test beds during construction.

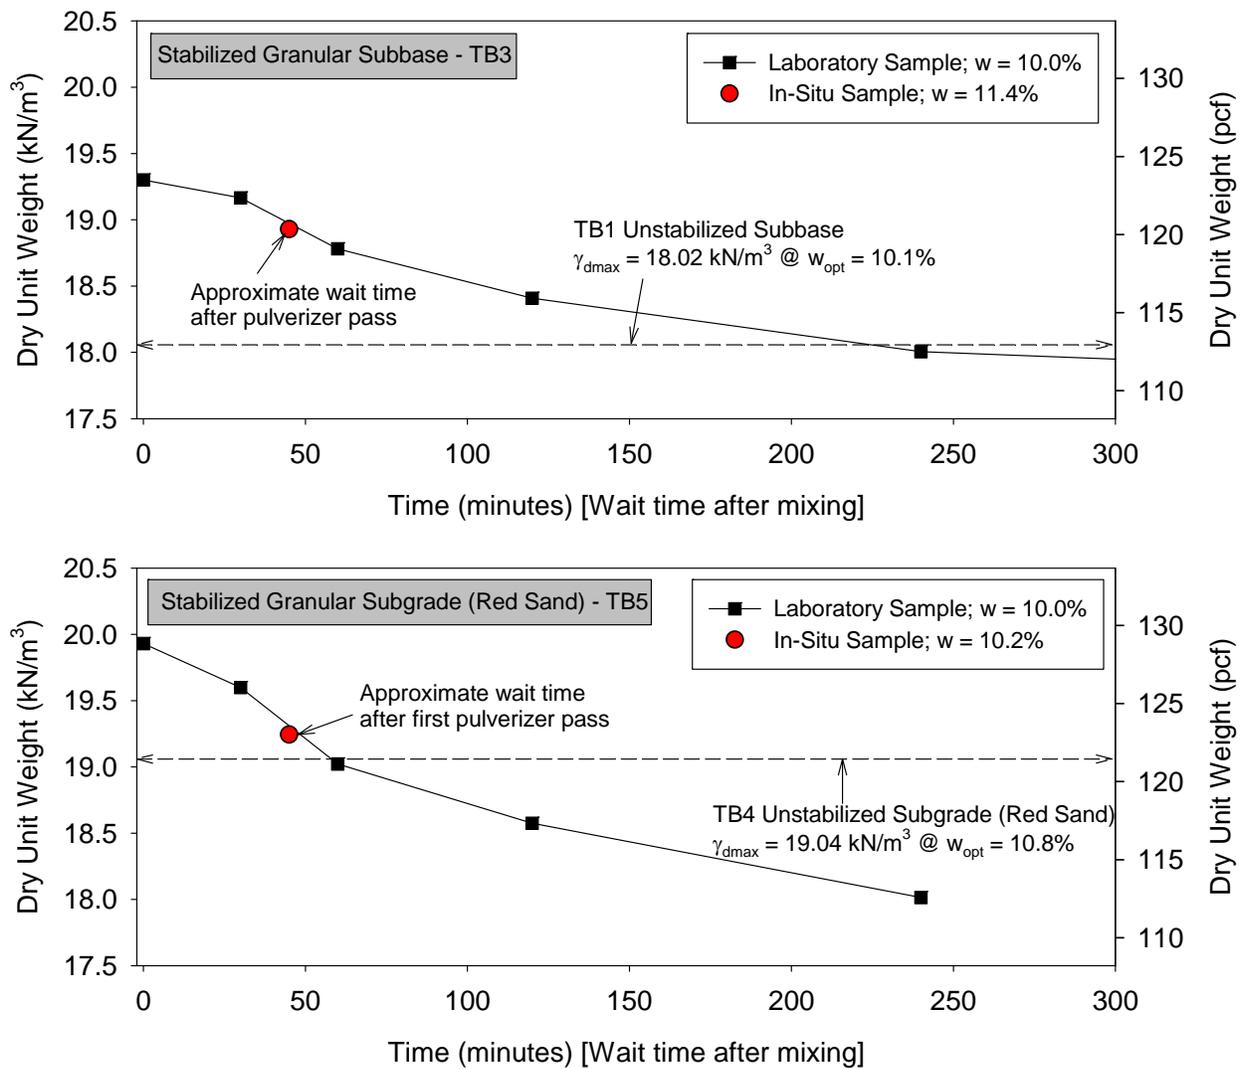
Figure 7. Effect of wait time (after mixing) on dry unit weight of treated base and subgrade materials

mixing. Similar results have been demonstrated by Arman and Saifan (1967) and indicated that a delay of two or more hours in compaction after mixing results in reduced durability, compressive strength, and density of the soil-cement mixture. Arman and Saifan (1967) recommended that compaction of soil-cement mixture should not be delayed beyond 0.80 times the initial setting time of the cement gel. Cowell and Irwin (1979) noted that delays beyond 3 hours may increase the required compactive effort to a level that may be beyond the capabilities of ordinary field compaction equipment. Specifications for the project indicated that the soil-cement mixture be compacted to required density within two hours after mixing (see earlier discussion under Overview of Earthwork Specifications section).

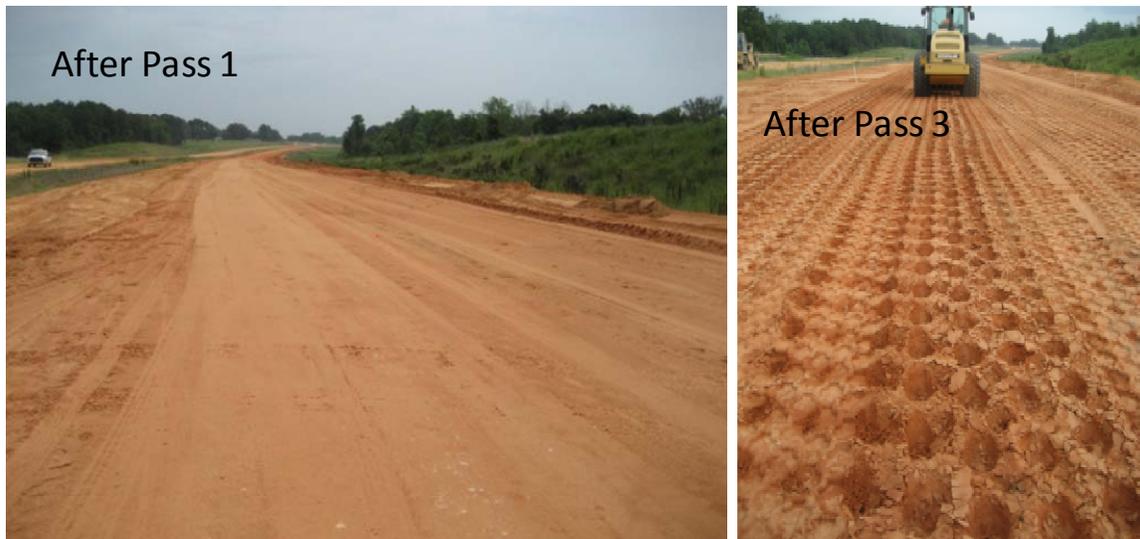
Figure 10. TB1 granular base material after pass 1 with Sakai smooth drum roller (left) and pass 3 with Caterpillar padfoot roller (right)

TB1 consisted of mapping the existing compacted granular base layer (untreated) with the Sakai smooth drum IC roller for one roller pass and Caterpillar padfoot IC roller for six roller passes (Figure 10). The area was mapped in four roller lanes. CCV IC-MVs were obtained from the Sakai roller using $a = 0.30$ mm, $f = 50$ Hz, and $v = 5$ km/h nominal settings. MDP_{40} and CMV IC-MVs were obtained from the Caterpillar roller using $a = 0.90$ mm, $f = 30$ Hz, and $v = 4$ km/h nominal settings. Point MVs (LWD, FWD, NG, PLT, and DCP) were performed at 6 randomly selected test locations following the Sakai roller pass.

The box plots presented in Figure 12 present the range of the data observed for each pass. The bottom boundary of the box indicates the 25th percentile, the line within the box indicates the median, and the top boundary of the box indicates the 75th percentile of the IC-MV data. The error bars above and below the box indicate the 90th and 10th percentile, respectively. The circles outside the error bars are statistical outliers. On average, the MDP_{40} values decreased with increasing pass (pass 1 to 6 = 105.7 to 98.3), while the CMV measurements increased only slightly with increasing pass (pass 1 to 6 = 4.9 to 6.8). The decrease in MDP_{40} likely due to loosening of the material at the surface from padfoot indentations (see Figure 10).

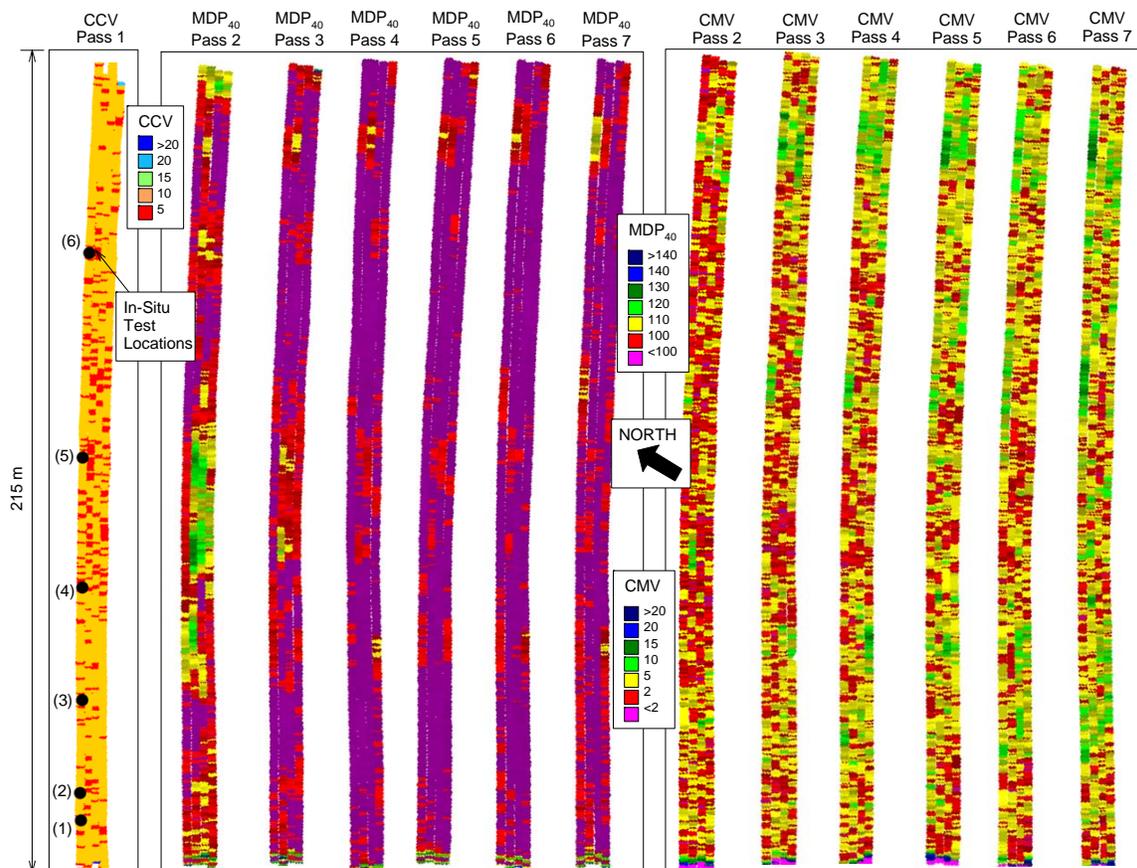
Figure 11. CCV, MDP_{40} , and CMV maps for passes 1 to 7 – TB1 granular base material

The experimental semivariograms of the MDP_{40} values showed a nested spatial structure with short-range and long-range components. A nested spherical variogram was fit to the experimental semivariogram data. The CCV and CMV experimental semivariograms did not exhibit nested structures. Similar nested structures were observed for MDP_{40} measurements in an earlier field study (see NY field study report). The long-range spatial structure is attributed to the spatial variation in the underlying layer support conditions while the short-range spatial

- On average, MDP_{40} decreased (from 105.7 to 98.3) while CMV increased slightly (from 4.9 to 6.8) from pass 1 to 6. MDP_{40} values decreased due to material loosening at the surface from padfoot indentations.

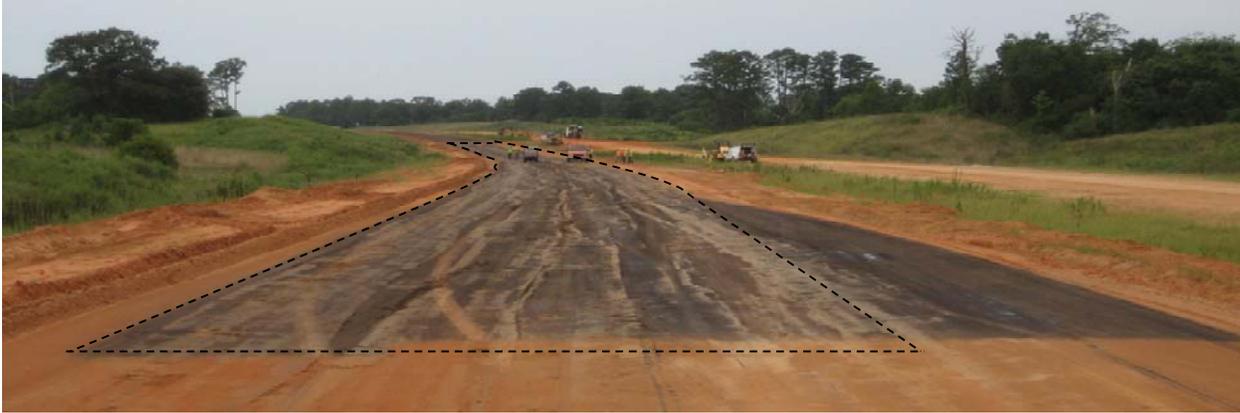
Figure 14. Picture of the test bed – TB2 treated base material

The test bed was located adjacent to TB1 and consisted of a 5-day cured 150 mm thick (nominal thickness) cement treated granular base layer (Figure 14). The test bed surface was coated with an asphalt binder to help retain moisture content in the treated base layer. The area was mapped in four roller lanes with the Sakai IC roller. CCV IC-MVs were obtained from the roller using $a = 0.30$ mm, $f = 50$ Hz, and $v = 5$ km/h nominal settings. Following the mapping pass, in-situ point-MVs (LWD, FWD, NG, PLT, and DCP) were performed at 17 to 20 test locations selected based on the IC-MV map over a wide range of CCV measurement values (CCV range = 4 to 25).

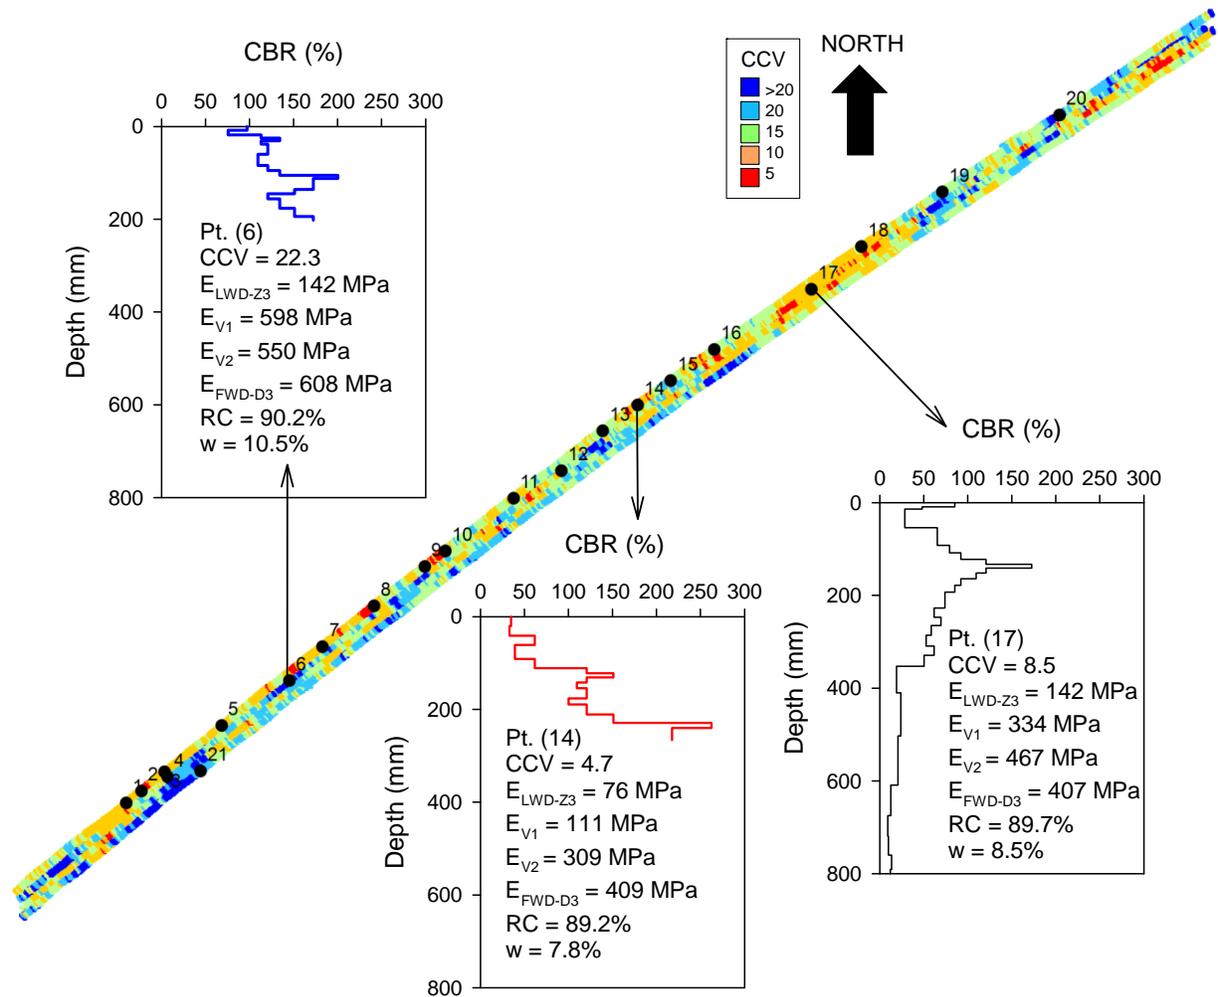
Figure 15. CCV map and CBR profiles at three select locations with low, medium, and high CCV values – TB2 treated base material ($a = 0.30$ mm, $f = 55$ Hz, $v = 4$ km/h nominal settings)

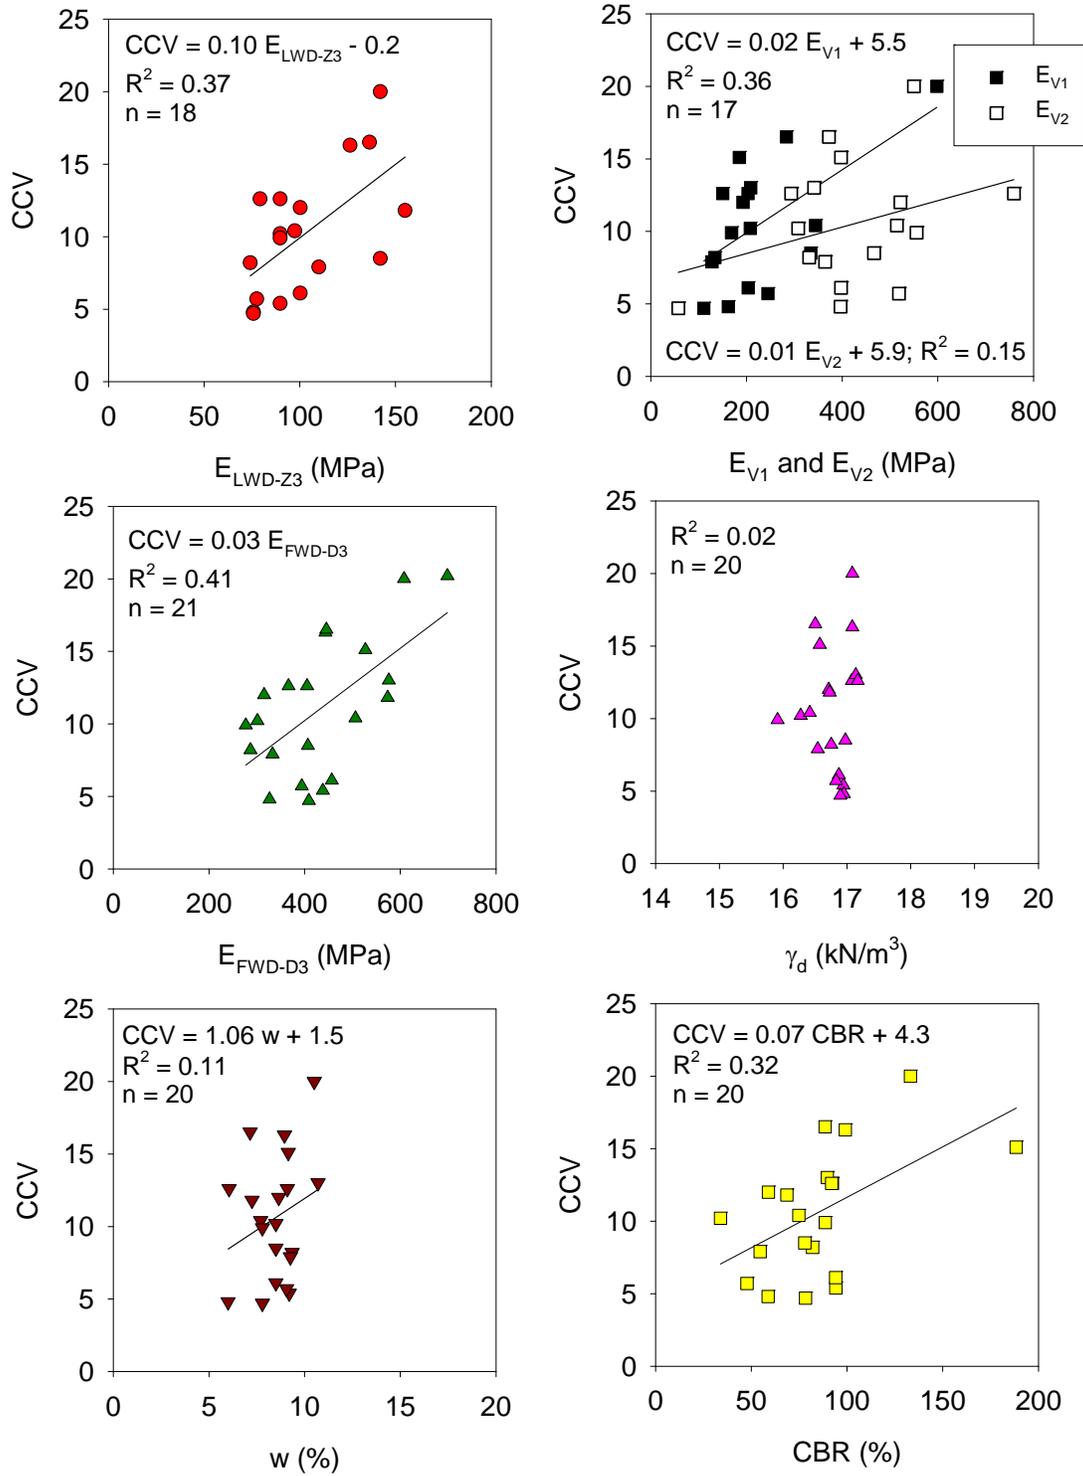
Figure 17. Regression analyses between CCV and in-situ point measurements – TB2 treated base material (5 day cure)

Regression analysis results between CCV IC-MVs and in-situ point-MVs are presented in Figure 17. The relationships showed weak correlations with R^2 values in the range of 0 to 0.41. However, positive trends are evident in CCV relationships with CBR and modulus point-MVs (i.e., E_{LWD-Z3} , E_{V1} , E_{V2} , and E_{FWD-D3}). No trend is observed in CCV relationships with density point-MVs. The primary reason for weak correlations despite a wide CCV measurement range is attributed to surface cracks observed following the vibratory roller pass (see Figure 18). The vibratory roller mapping pass was performed solely for research purposes, and is not recommended on treated layers as it can potentially break the cementitious bonds and cause a reduction in the strength/stiffness properties. Further, for such conditions it is recommended that the point MVs be performed before rolling.

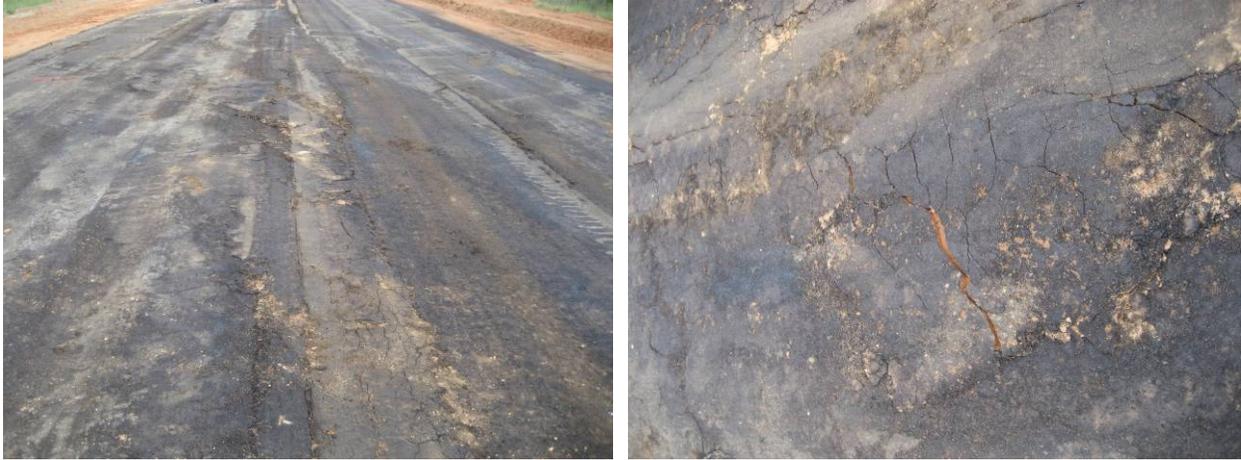
Figure 18. Cracks observed on the treated base material following the Sakai vibratory roller pass – TB2

- Regressions on TB8 between k_s IC-MVs and E_{FWD-D3} showed good correlations with $R^2 = 0.53$, while regressions with other point-MVs produced relatively weak correlations ($R^2 < 0.41$). The reason for better correlations with E_{FWD-D3} measurements is that the measurements were obtained prior to roller mapping passes, while all other point-MVs were obtained after mapping passes. Similar to observations on TB2, surface cracks were observed on TB8 following vibratory roller passes.

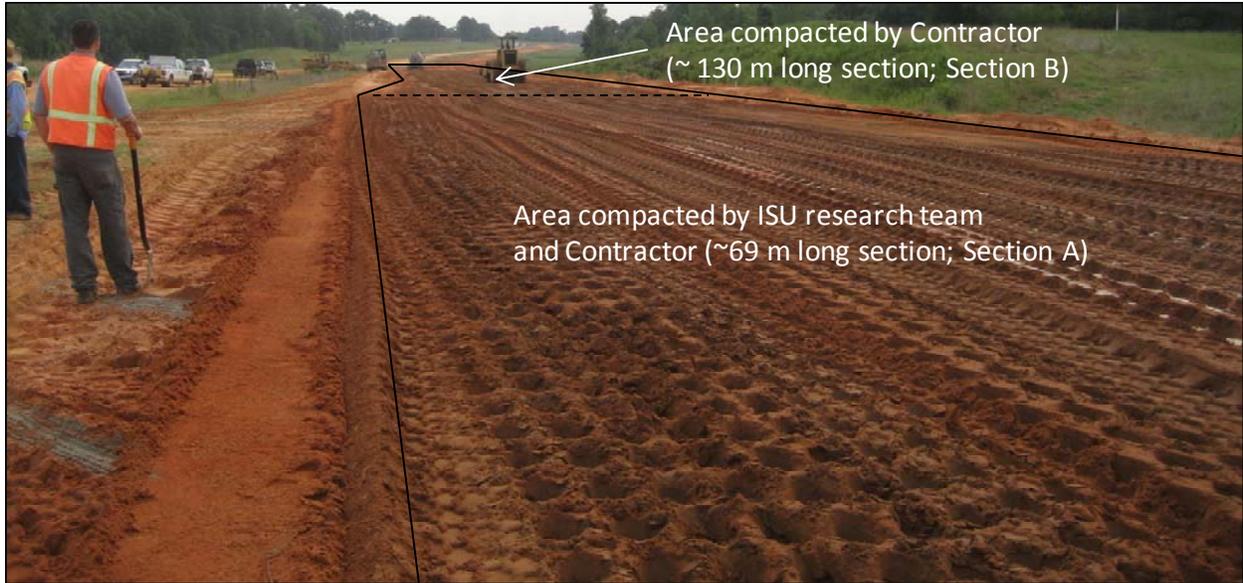
Figure 19. TB3 treated base material compacted by ISU research team (section A) and contractor (section B)

IC-MV roller map (on Sections A and B) was obtained using the Case/Ammann smooth drum IC roller using $Ecc. = 15\%$, $f = 27$ Hz, and $v = 4.2$ km/h nominal settings. Two days after treatment, the area was again mapped (referred to as TB8) using the Case/Ammann smooth drum IC roller in manual and AFC mode settings. For manual mode, the nominal settings used during mapping were $Ecc. = 10\%$, $f = 27$ Hz, and $v = 4.2$ km/h. For AFC mode, a low performance level with nominal $v = 4.2$ km/h was used for mapping. FWD point-MVs were obtained prior to mapping operations while other Point MVs (LWD, NG, PLT, and DCP) were obtained after the mapping operations. Tests were performed at 25 locations selected using the k_s IC-MV map.

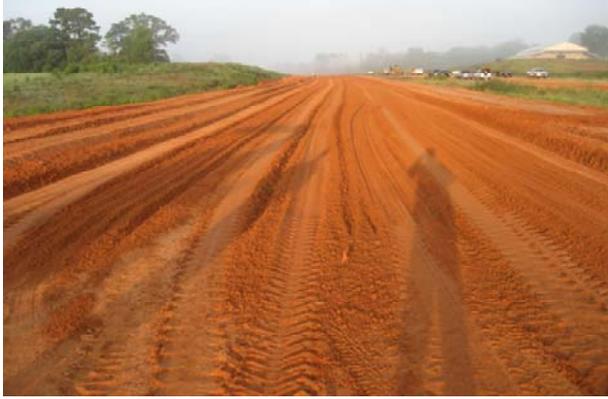
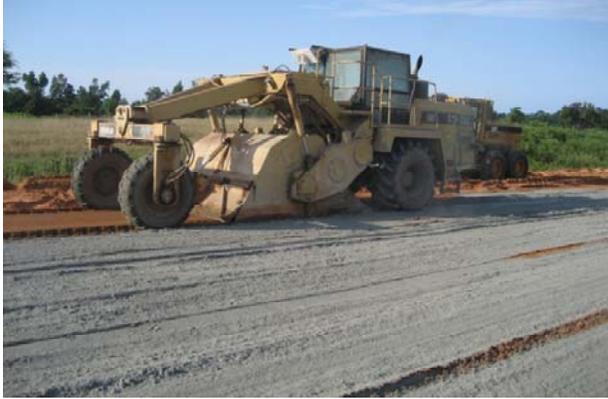
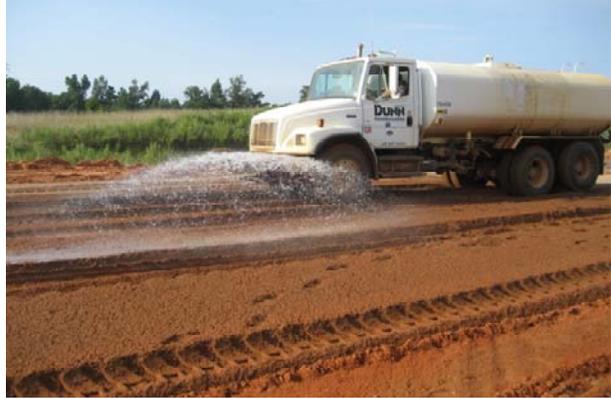
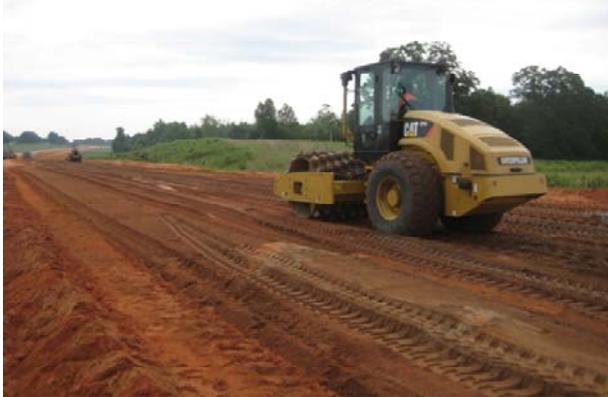
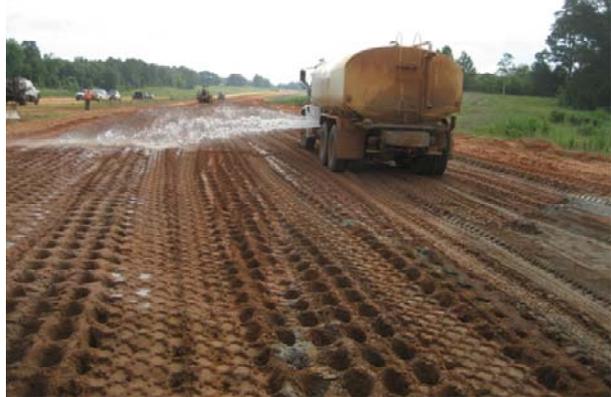
Scarified and moisture-conditioned subbase

Placement of cement stabilizer on subbase

Soil-cement mixing process using pulverizer

Moisture-conditioning the soil-cement mixture

Compaction using Caterpillar padfoot IC roller

Moisture-conditioning after first pass

Figure 20. Pictures showing construction process on TB3 treated base

- a) scarified the base layer to about 150 mm depth and moisture-conditioning the base material to at target $w = 10\%$ [prior to 6:30 am],
- b) spreaded stabilizer on the test bed [6:45 to 7:45 am],

- c) preparing the soil-cement mixture using a rotary mixer (with two passes) [7:45 to 8:30 am],
- d) compacted the area using a padfoot roller for one static pass and moisture-conditioning the soil-cement mixture with a water truck [8:30 to 9:15 am] (in-situ sample was obtained for laboratory Proctor test at 8:50 am),

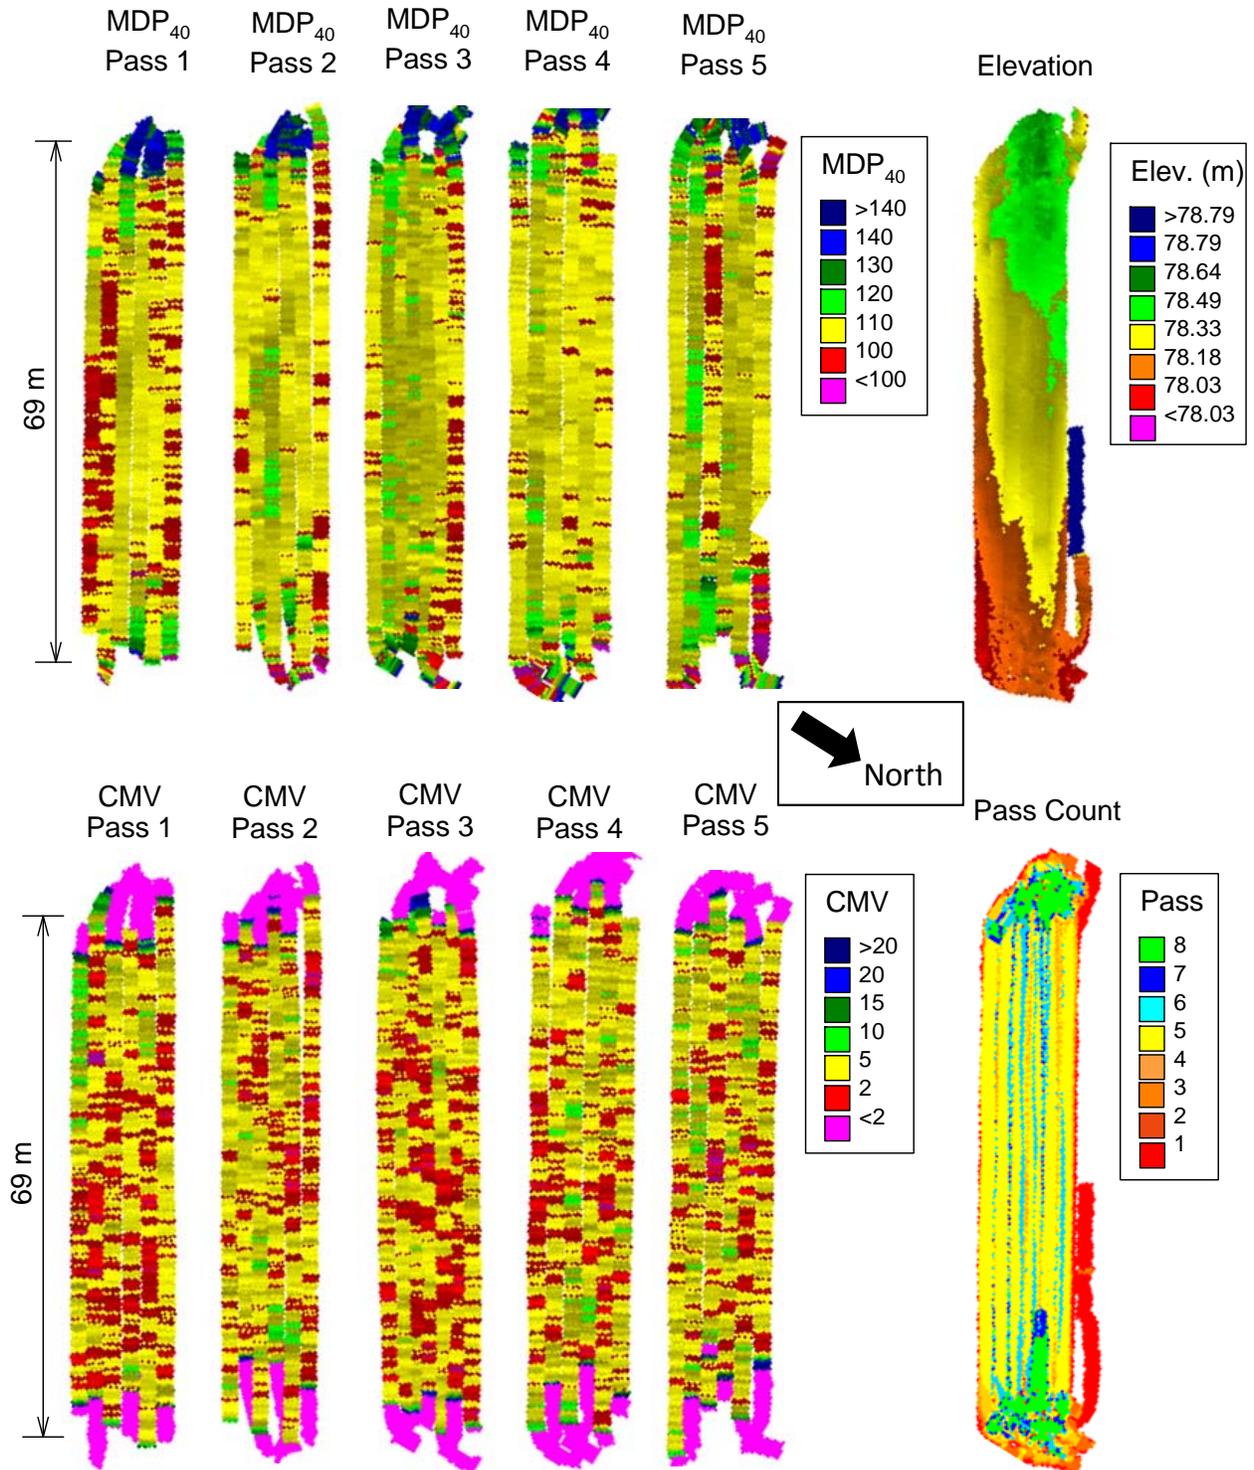
Figure 22. MDP₄₀ and CMV maps for passes 1 to 5, and elevation and number of roller passes maps – TB3 (section A) treated base material ($a = 0.90$ mm, $f = 30$ Hz, and $v = 4$ km/h nominal settings)

MDP₄₀ and CMV IC-MV maps from compaction roller passes are presented in Figure 22. Box plots showing the range of data for each compaction pass is presented in Figure 23. Results indicate that on average MDP₄₀ increased from about 112.4 to 115.3 from pass 1 to 5. No significant change in CMV was observed from pass 1 to 5 (average CMV = 6.2 to 6.8).

- During initial compaction on TB3 using Caterpillar padfoot IC roller, the average MDP_{40} increased from about 112.4 to 115.3, while no significant change in CMV was observed (average CMV = 6.2 to 6.8) from pass 1 to 5.

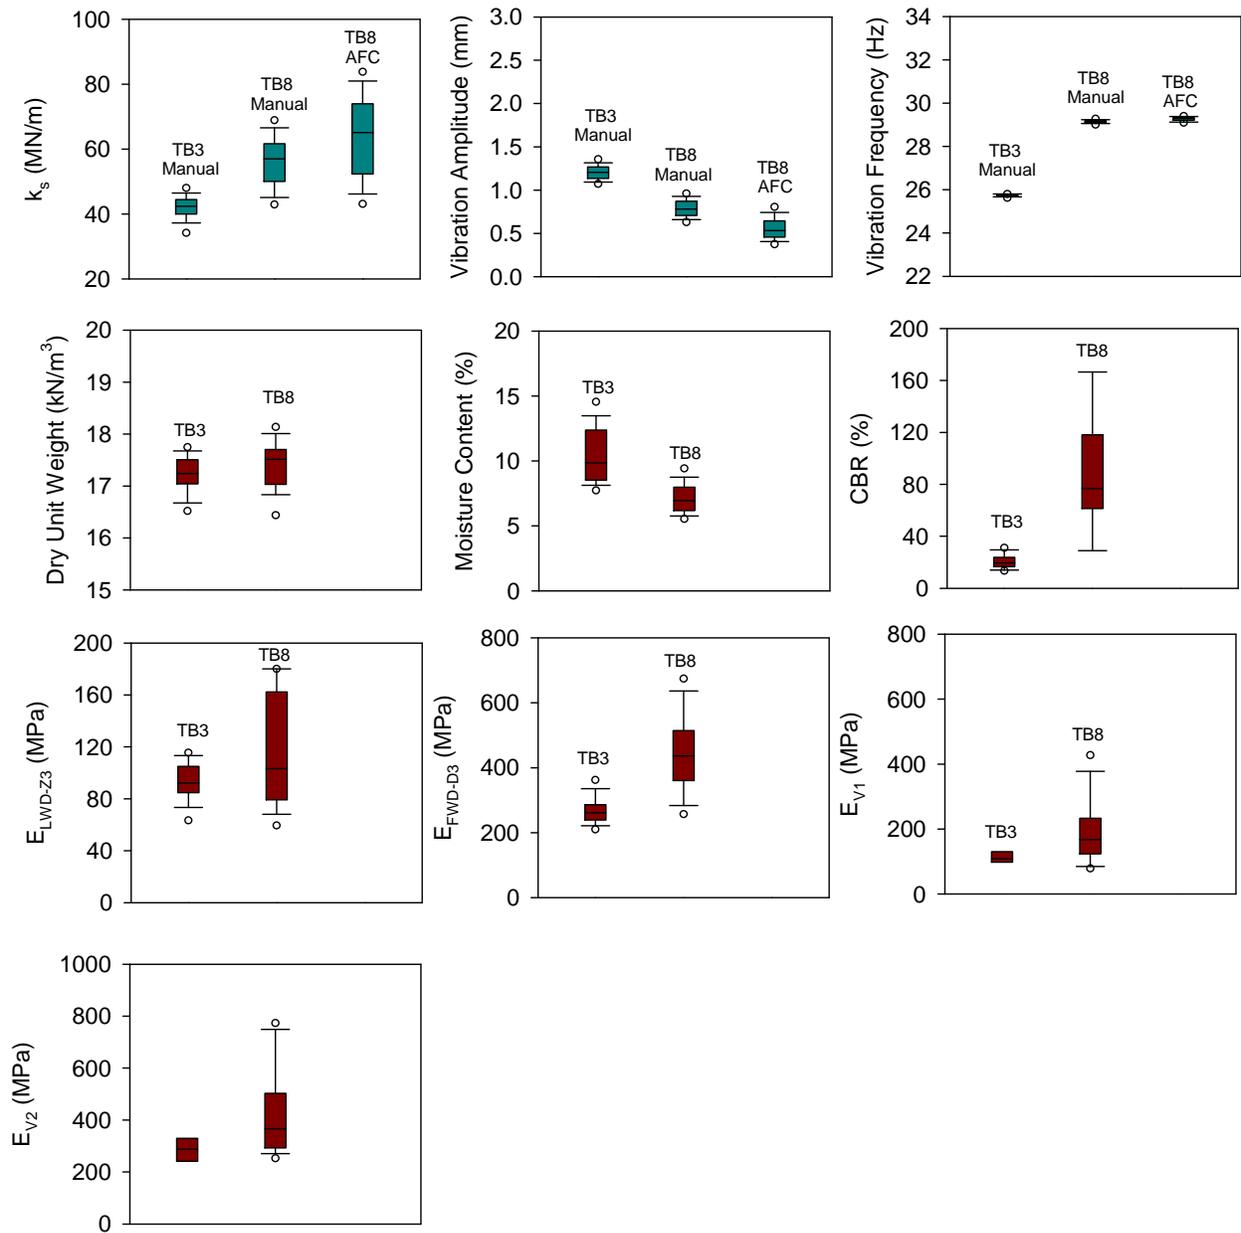
Figure 27. Box plots comparing measurements obtained shortly after compaction (TB3) and after 2-days curing (TB8)

measurement values increased by about 33%, 15%, 75%, 49%, 66%, and 320% after 2-day curing. Moisture content of the material decreased on average from about 10.5% to 7.1%. As a result of this decrease in moisture content, the average RC of the material increased slightly from about 91 to 92%.

- As expected, the k_s IC-MVs and modulus/CBR point-MVs improved after 2 days of curing. Results indicated that on average the k_s IC-MV, E_{LWD-Z3} , E_{FWD-D3} , E_{V1} , E_{V2} , and CBR measurement values increased by about 33%, 15%, 75%, 49%, 66%, and 320% after 2 days of curing. Moisture content of the material decreased on average from about 10.5% to 7.1%. As a result of decrease in the moisture content, the average RC of the material increased slightly from about 91 to 92%.

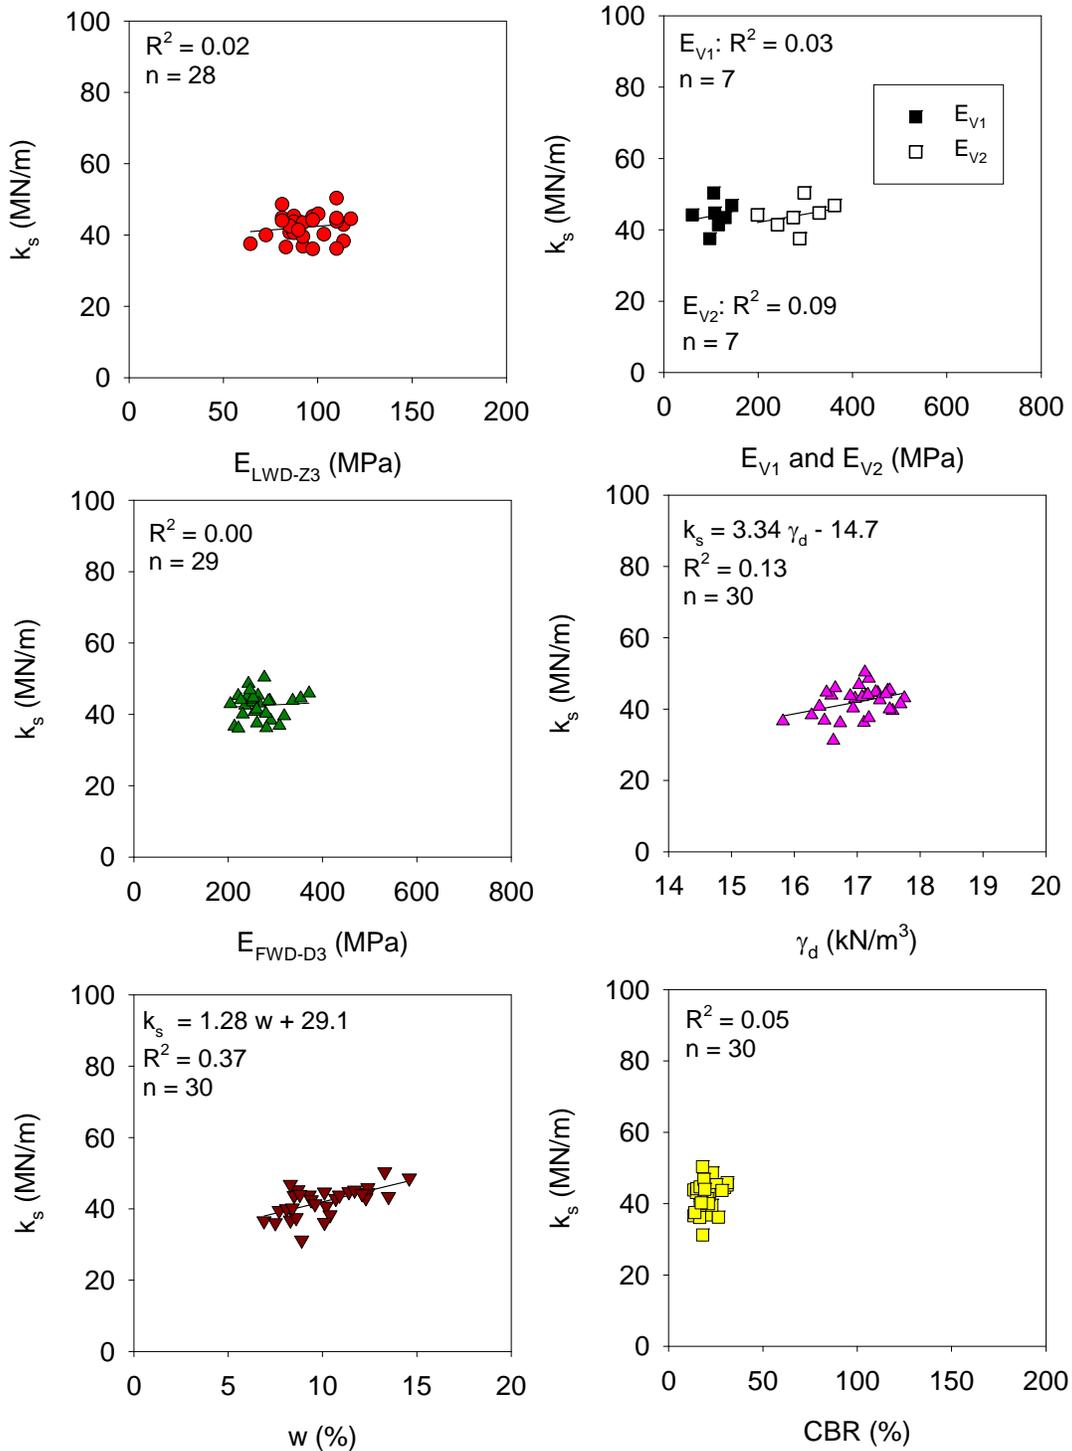
Figure 29. Regression analyses between k_s and in-situ point measurements – TB3 treated base material (shortly after compaction; manual mode)

Correlations between k_s IC-MVs obtained in manual mode and in-situ point-MVs from TB3 and TB8 are presented in Figure 29 and Figure 30, respectively. Regressions on TB3 showed weak correlations with $R^2 < 0.13$ due to narrow range of measurements. k_s results on TB3 showed influence of moisture content with $R^2 = 0.37$. Regressions on TB8 between k_s IC-MVs and E_{FWD-D3} showed good correlations with $R^2 = 0.53$, while regressions with other point-MVs produced relatively weak correlations ($R^2 < 0.41$). Note that the E_{FWD-D3} measurements were obtained prior to roller mapping passes, while all other point-MVs were obtained after mapping passes. Similar to observations on TB2, surface cracks were observed on TB8 following vibratory roller passes which likely affected the point MVs and therefore the correlations.

- Regressions on TB3 between k_s IC-MVs and in-situ point-MVs on TB3 showed weak correlations with $R^2 < 0.13$ due to narrow range of measurements. k_s IC-MV results on TB3 showed influence of moisture content with $R^2 = 0.37$.

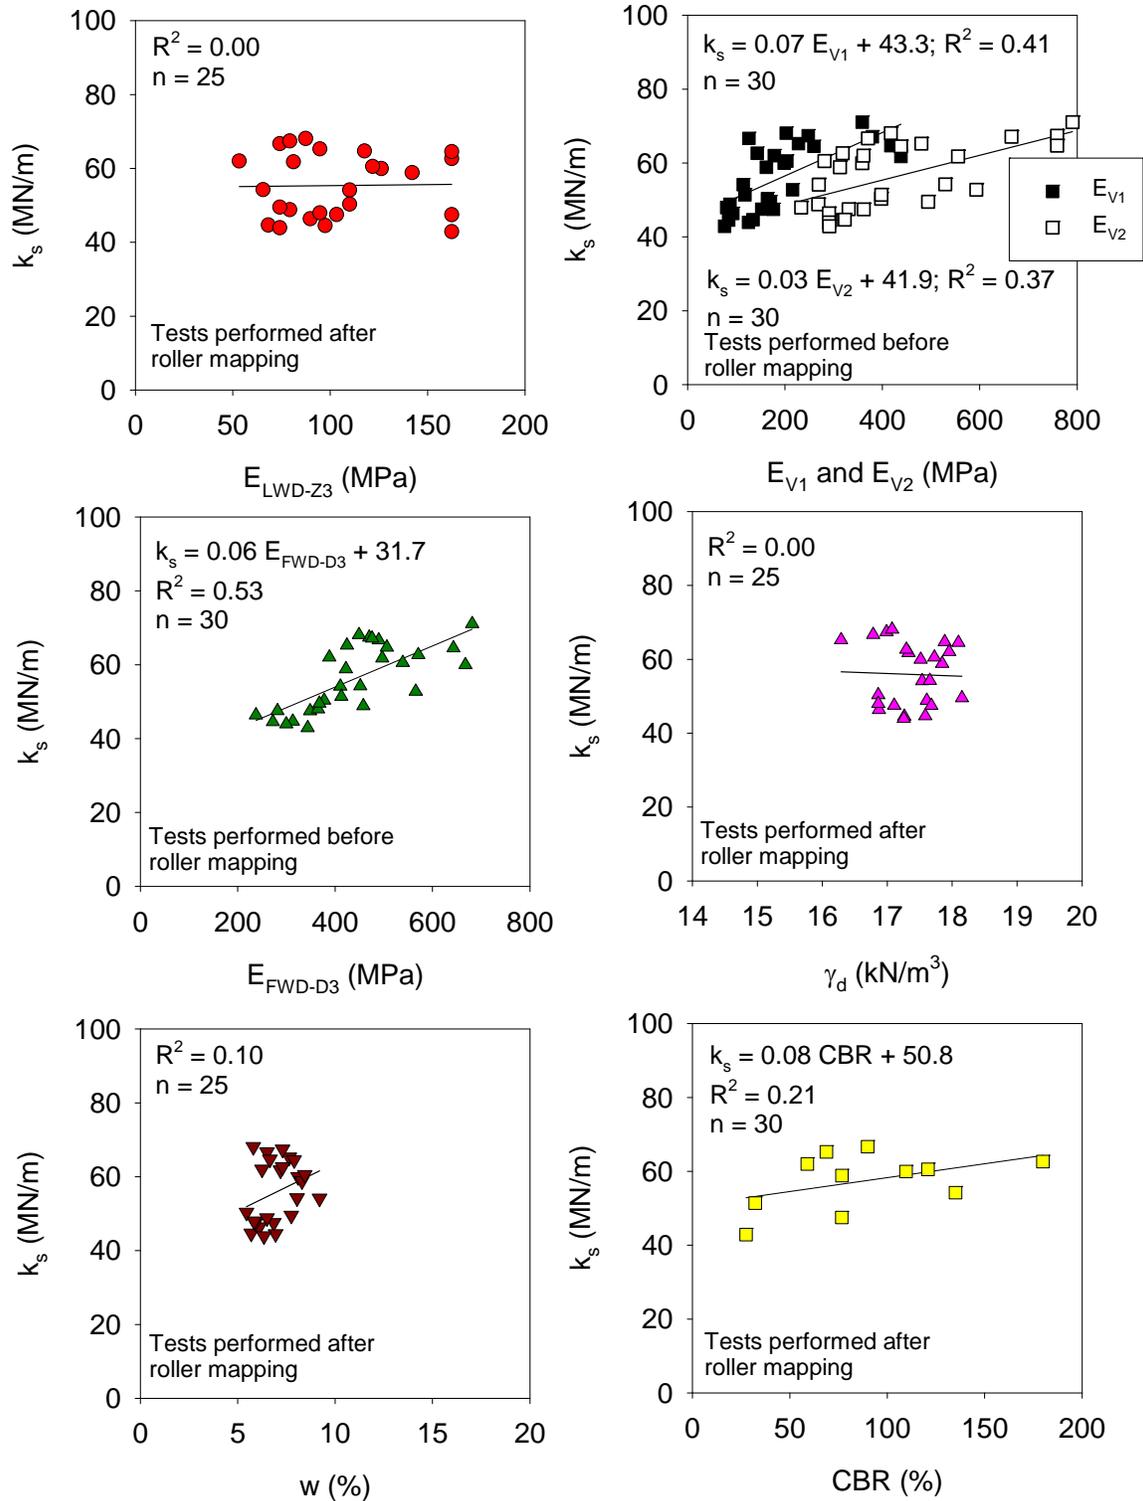
Figure 30. Regression analyses between k_s and in-situ point measurements – TB8 treated base material (after 2-day cure; manual mode)

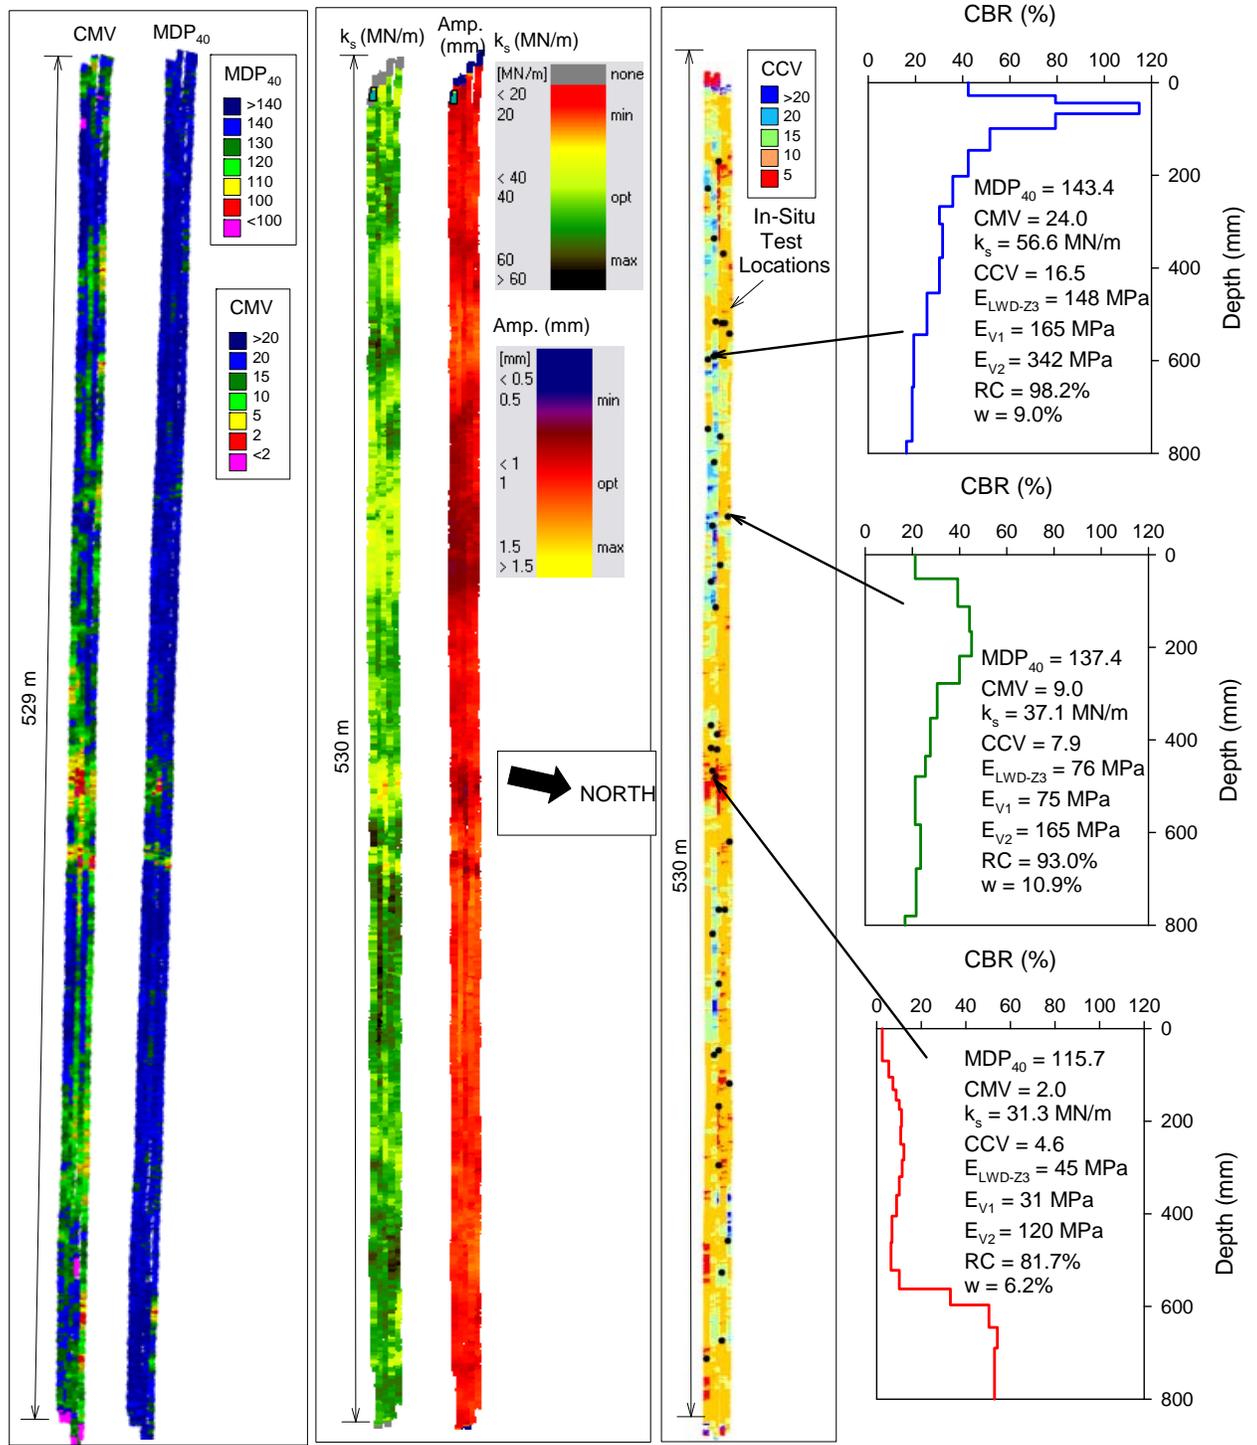
Figure 32. CMV, MDP₄₀, k_s (and a^*), and CCV maps on TB4 compacted granular subgrade material along with DCP-CBR profiles at three selected locations
