ACCELERATED IMPLEMENTATION OF INTELLIGENT COMPACTION TECHNOLOGY FOR EMBANKMENT SUBGRADE SOILS, AGGREGATE BASE, AND ASPHALT PAVEMENT MATERIALS: US 84 WAYNESBORO, MISSISSIPPI

Final Report ER10-03
US84, Waynesboro, MS, Field Project
July 13 to 17, 2009

David J. White, Ph.D.
Pavana KR. Vennapusa, Ph.D.
Heath Gieselman
Bradley Fleming
Stephen Quist
Luke Johanson

Earthworks Engineering Research Center (EERC)
Department of Civil Construction and Environmental Engineering
Iowa State University
2711 South Loop Drive, Suite 4600
Ames, IA 50010-8664
Phone: 515-294-7910
www.eerc.iastate.edu

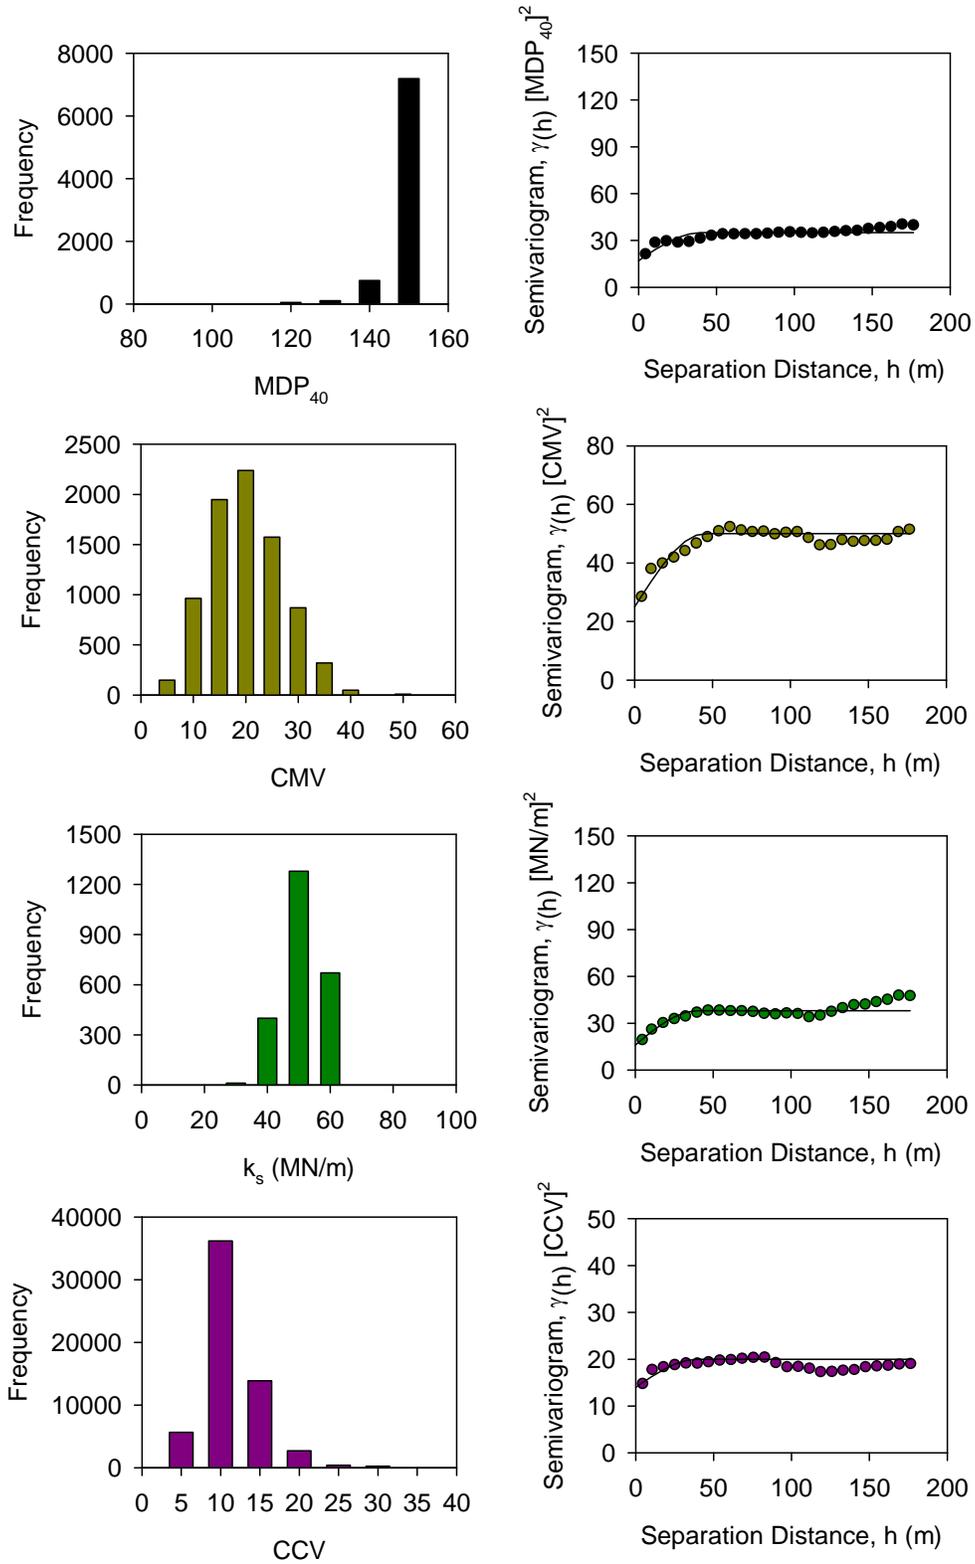
Figure 33. Histogram and semivariogram plots of CMV, MDP_{40} , k_s and CCV measurements – TB4 compacted granular subgrade material

MV	Nugget	Sill	Range
CMV	25	50	45
MDP ₄₀	17	35	40
k _s	16	38	40
CCV	14	20	40

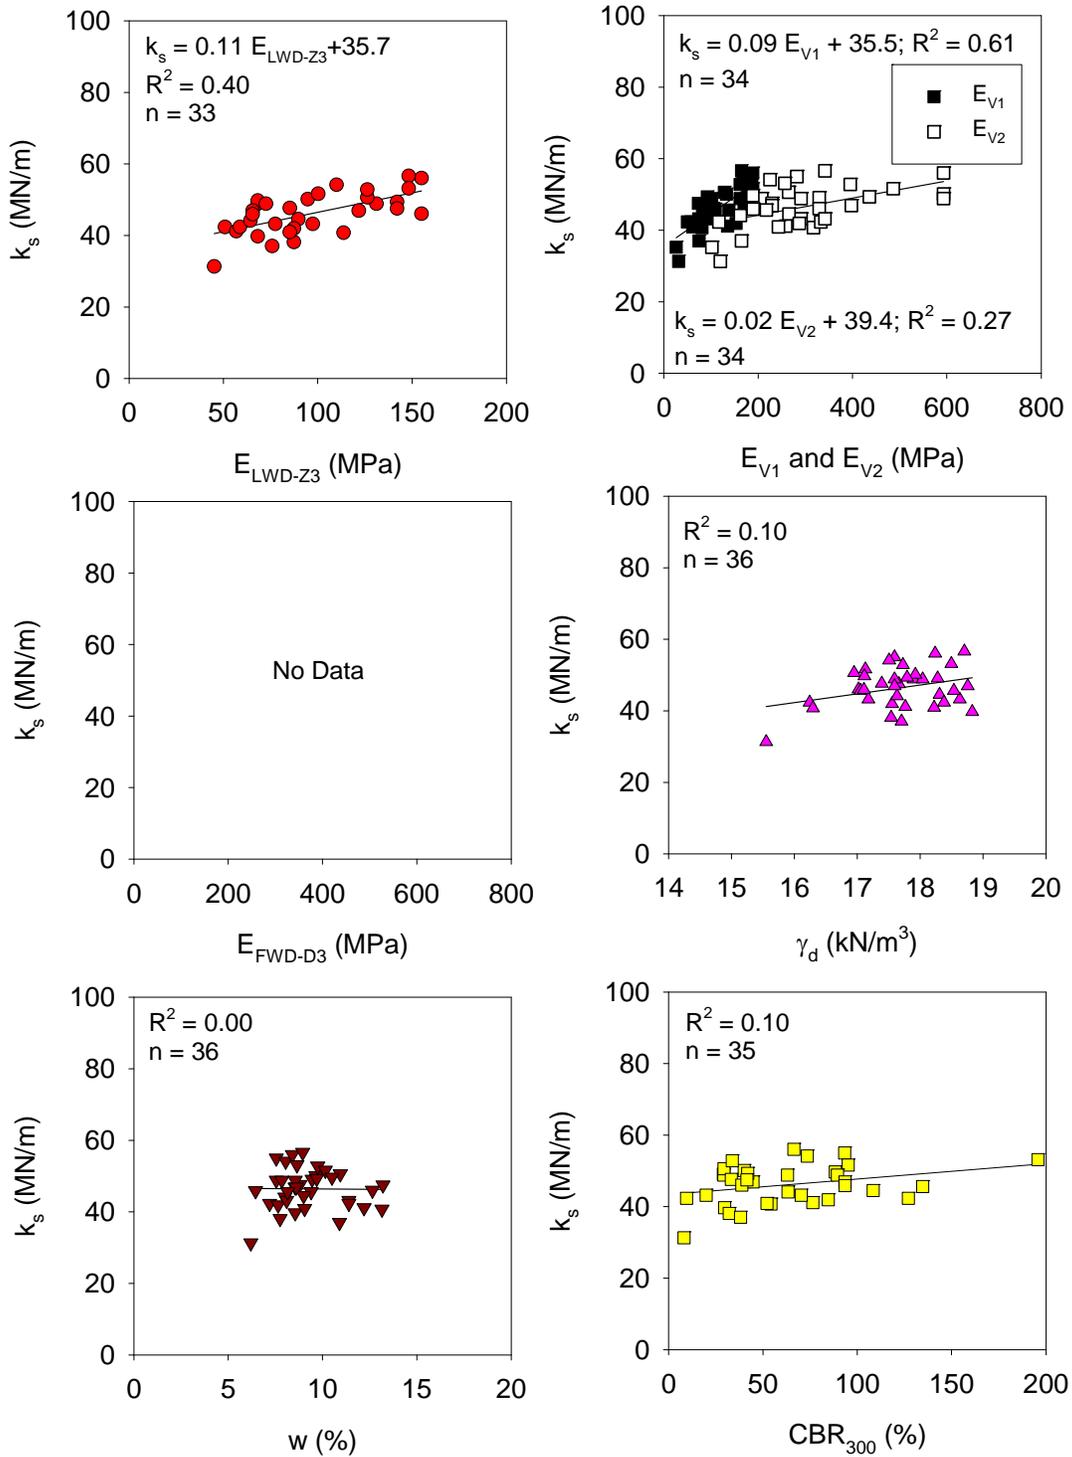
Figure 34. Regression analyses between k_s and in-situ point measurements – TB4 granular subgrade material

- Linear regression relationships are observed in correlations between k_s and E_{LWD-Z3} , E_{V1} , E_{V2} , γ_d , and CBR point-MVs. Relationships with E_{V1} and E_{LWD-Z3} showed $R^2 = 0.61$ and 0.40, respectively, while relationship with other point-MVs showed $R^2 < 0.30$. No influence of w is observed in the relationships.

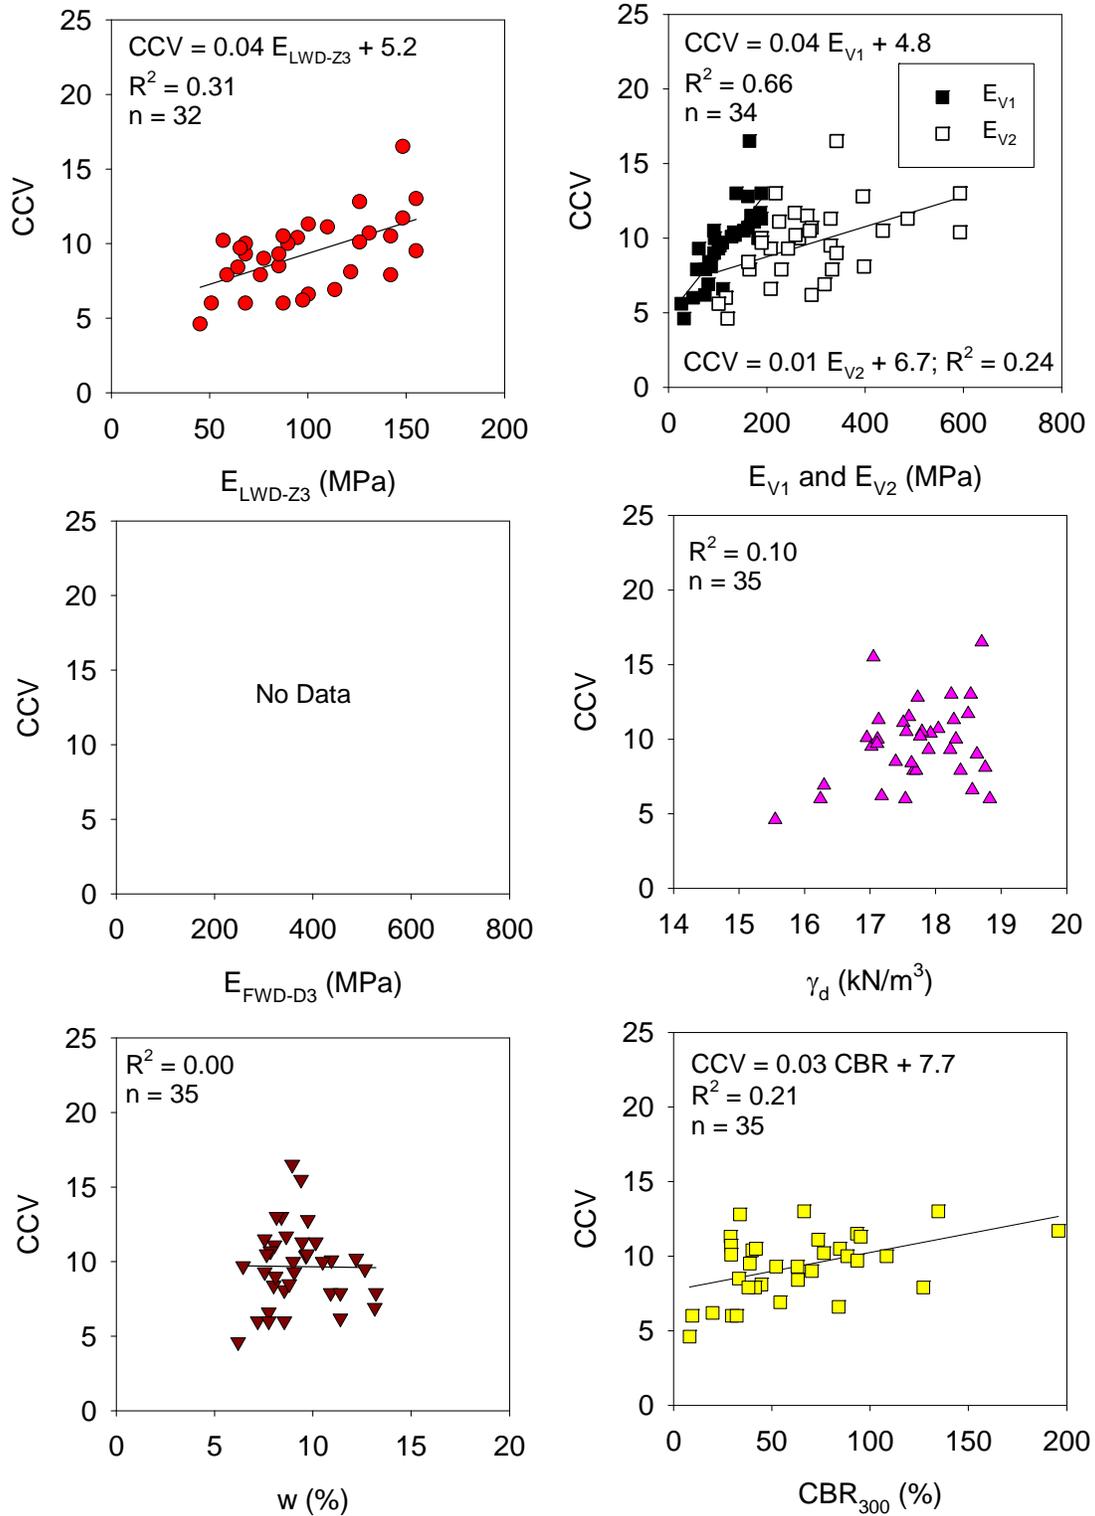
Figure 35. Regression analyses between CCV and in-situ point measurements – TB4 granular subgrade material

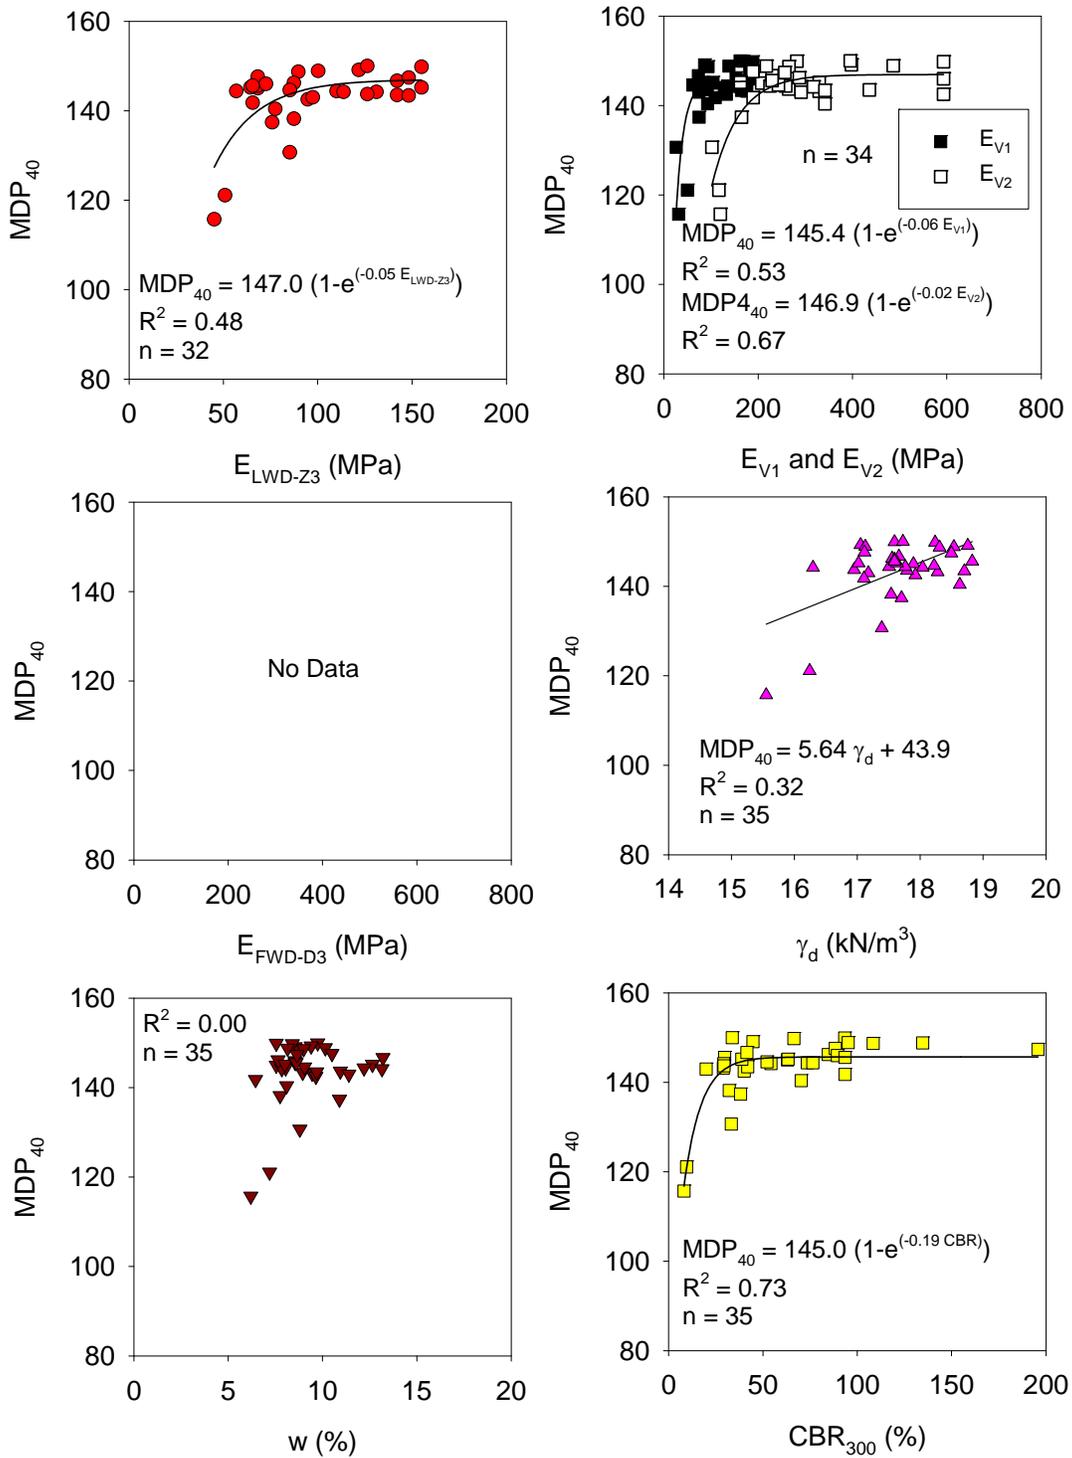
Figure 36. Regression analyses between MDP_{40} and in-situ point measurements – TB4 granular subgrade material

- On average, the MDP_{40} measurements on this test bed are about 1.4 times greater than on TB1 untreated granular base layer.
- MDP_{40} semivariograms indicate comparatively lower non-uniformity on this test bed (sill = 35) compared to on TB1 untreated granular base (sill₁ = 82 and sill₂ = 130 for pass 1).
- Non-linear exponential relationships are observed in correlations between MDP_{40} and E_{LWD-Z3} , E_{V1} , E_{V2} , and CBR point-MVs. R^2 values for these relationships varied from 0.48 to 0.73. MDP_{40} values tend to reach an asymptotic value of 150, which is set as the maximum value in the AccuGrade software. Linear regression relationship is observed

between MDP_{40} and γ_d with relatively low R^2 value (0.32). No influence of w is observed in the relationships. It appears that the MDP measurement was not set to provide an adequate measurement range relative to the measurement range of plate load test modulus values.

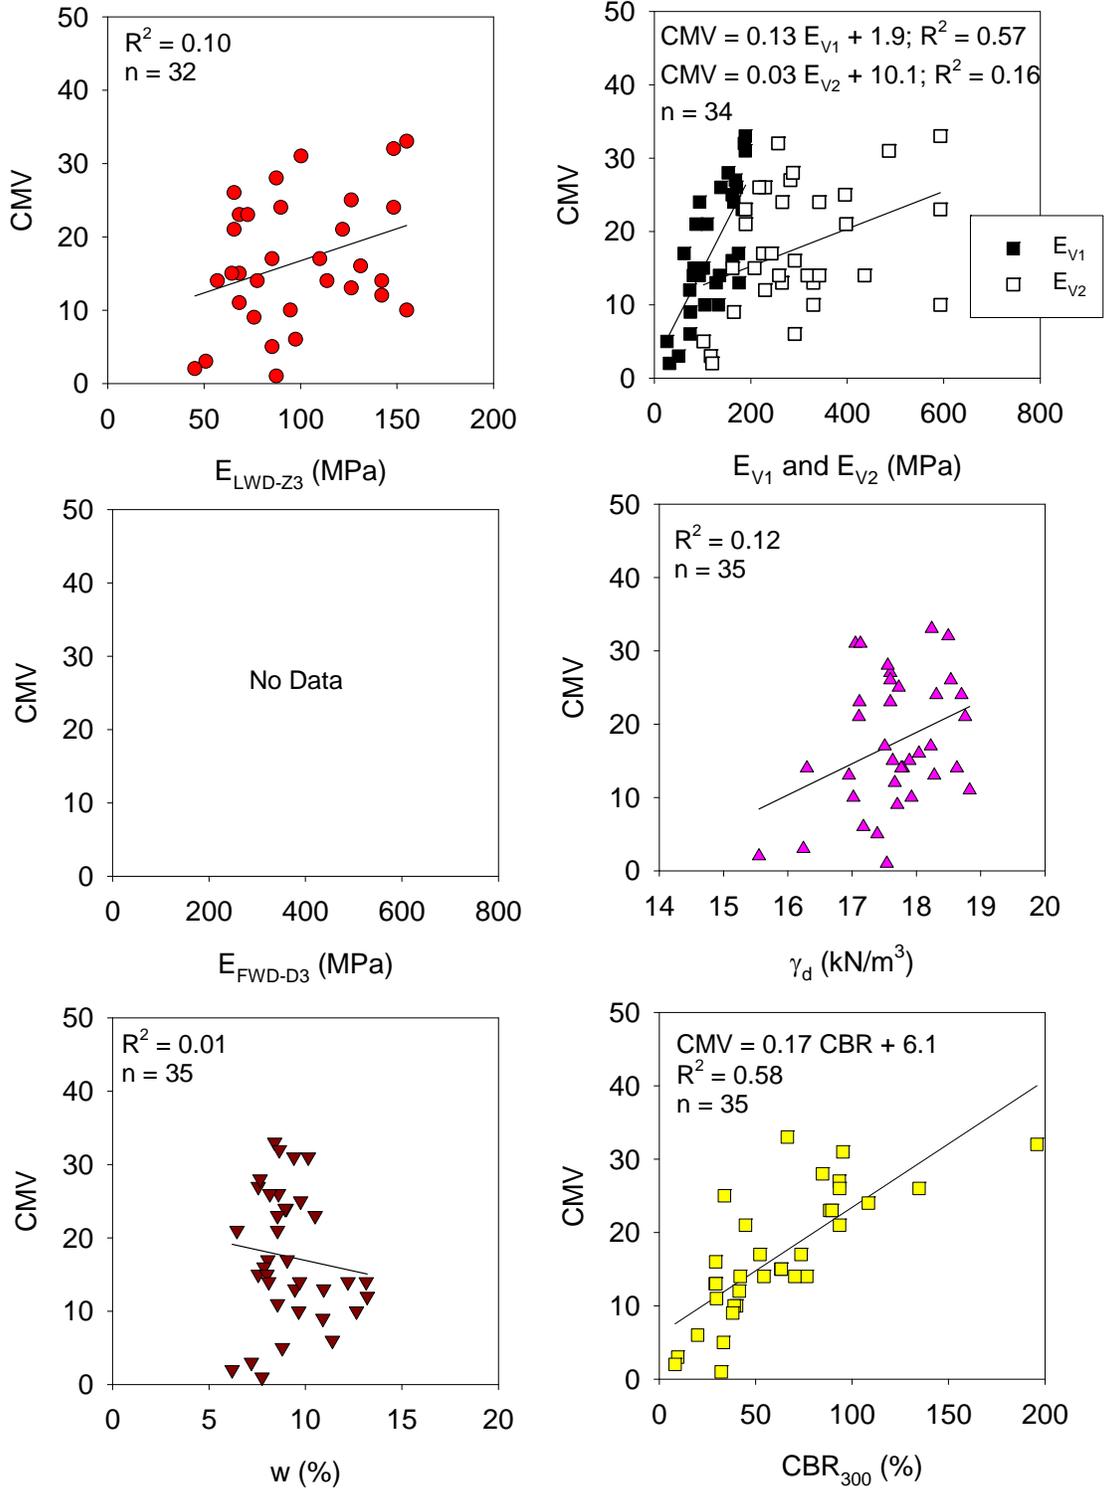
Figure 37. Regression analyses between CMV and in-situ point measurements – TB4 granular subgrade material

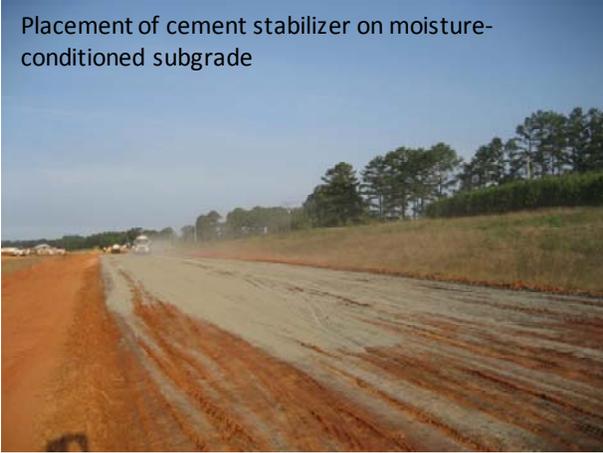
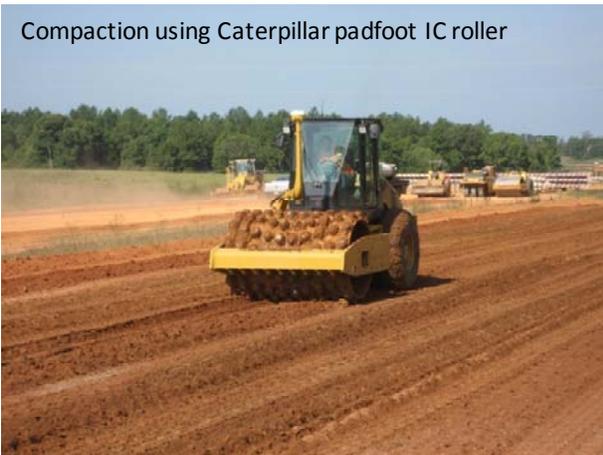
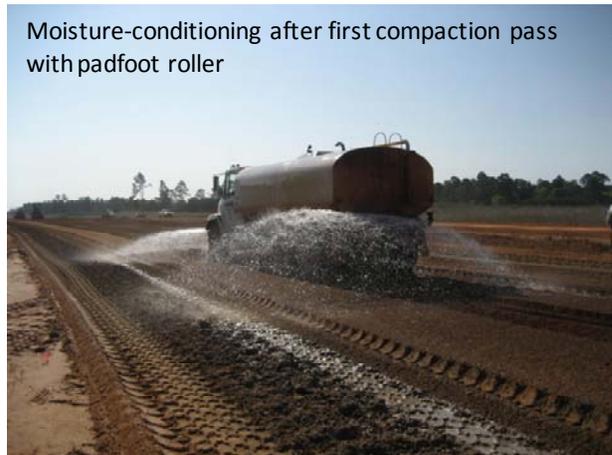
Placement of cement stabilizer on moisture-conditioned subgrade

Soil-cement mixing using rotary mixer

Compaction using Caterpillar padfoot IC roller

Moisture-conditioning after first compaction pass with padfoot roller

Compaction using Sakai smooth drum roller

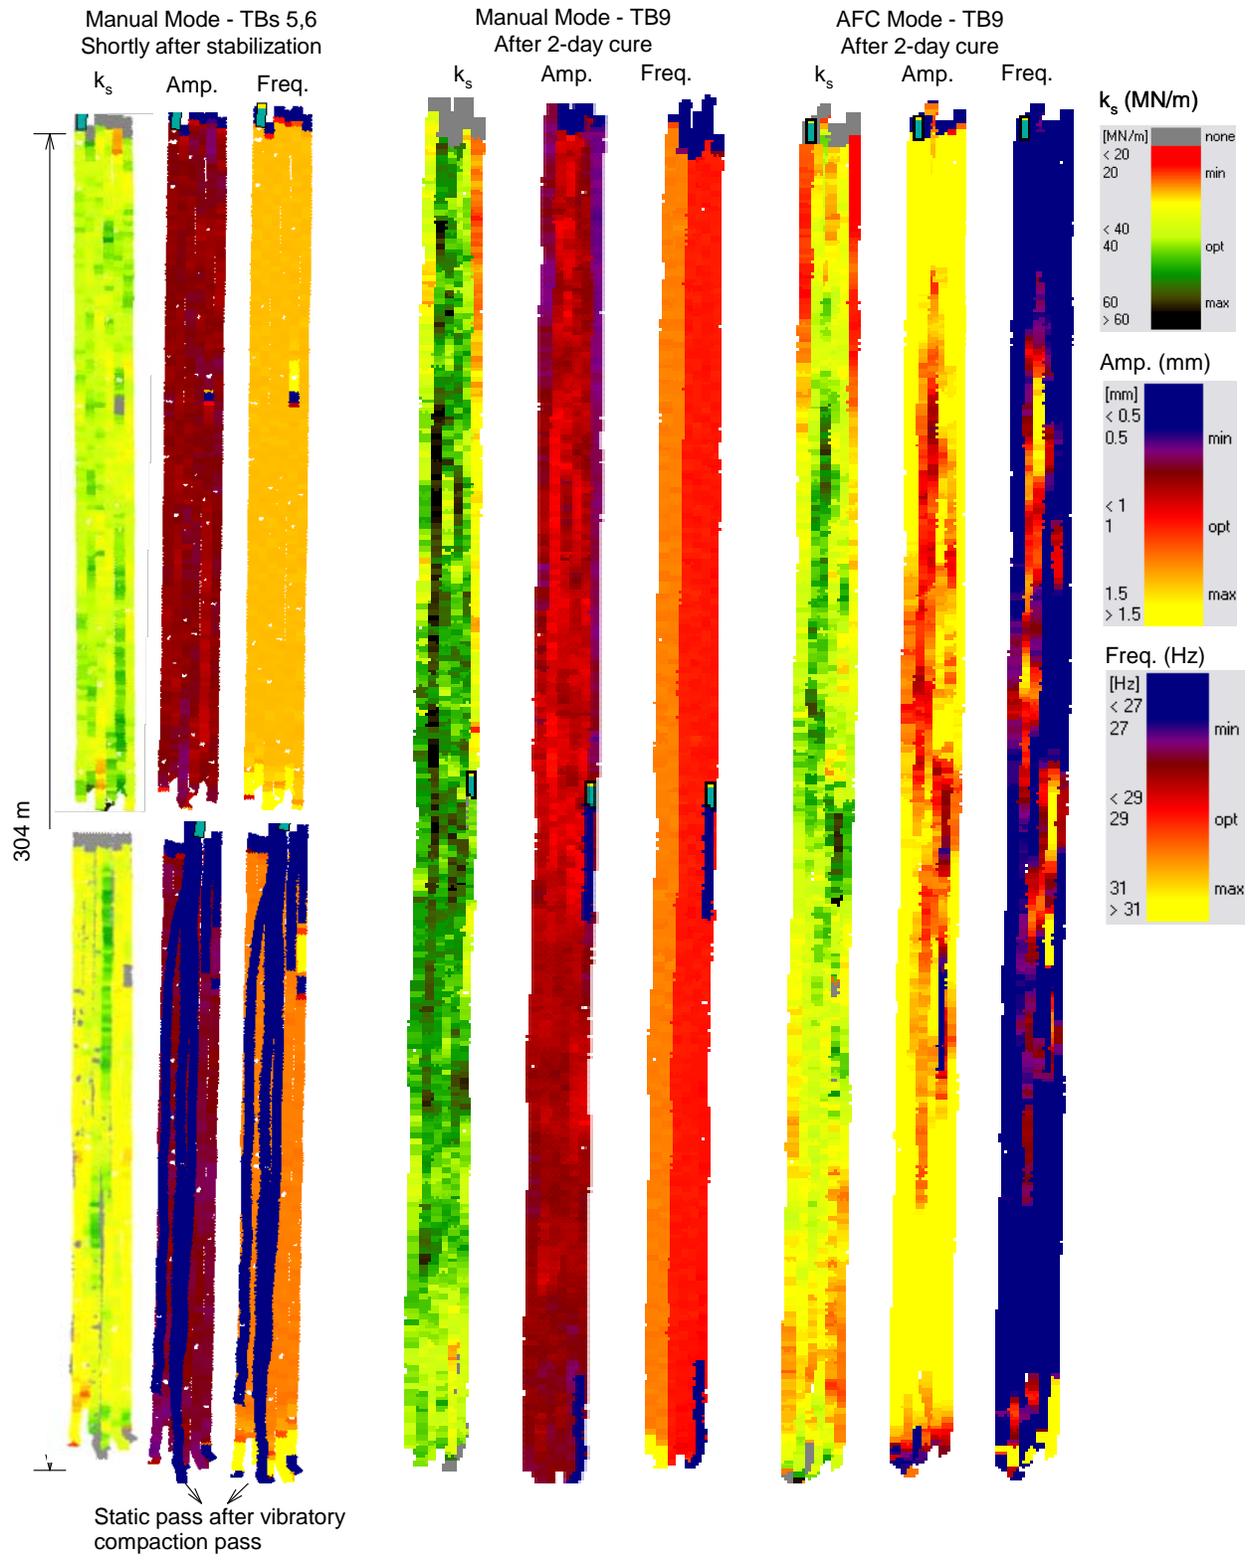
Figure 43. Comparison of k_s , a^* , and f maps obtained shortly after compaction (TB5/6) and after 2-day cure in manual and AFC modes (TB9)

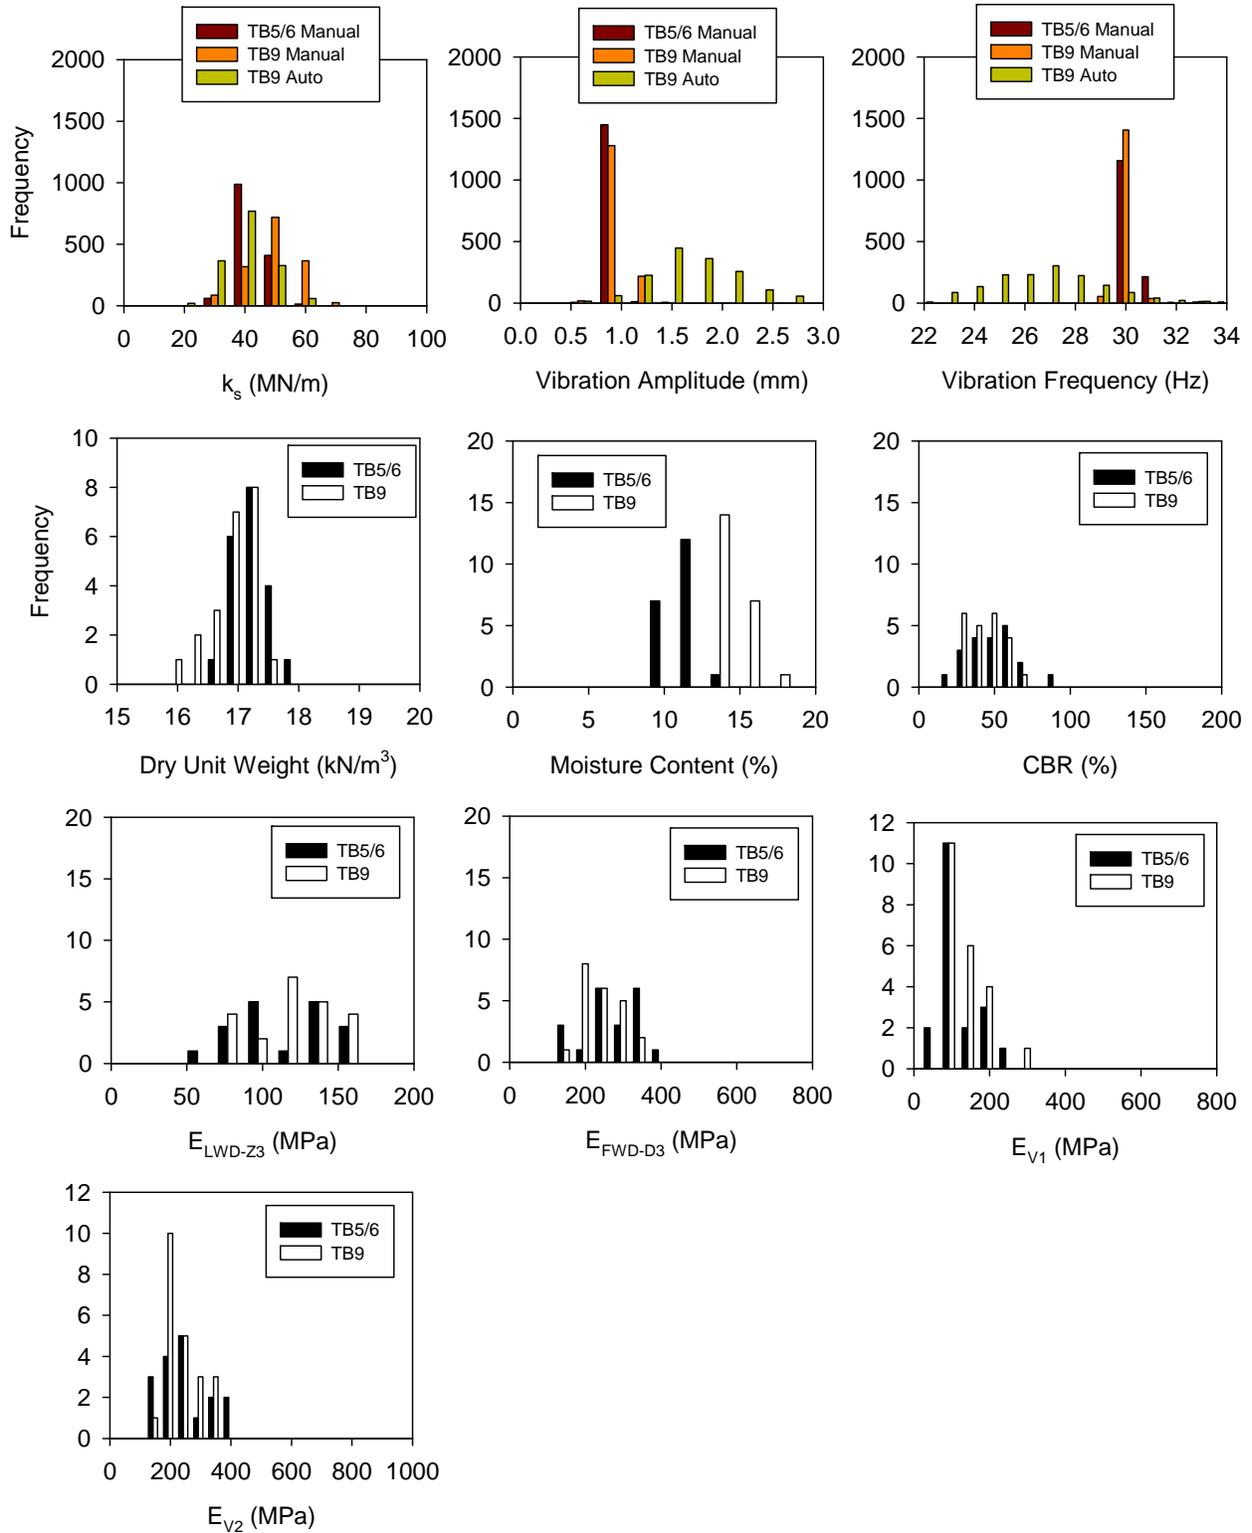
Figure 44. Histogram plots comparing measurements obtained shortly after compaction (TB5/6) and after 2-days curing (TB9)

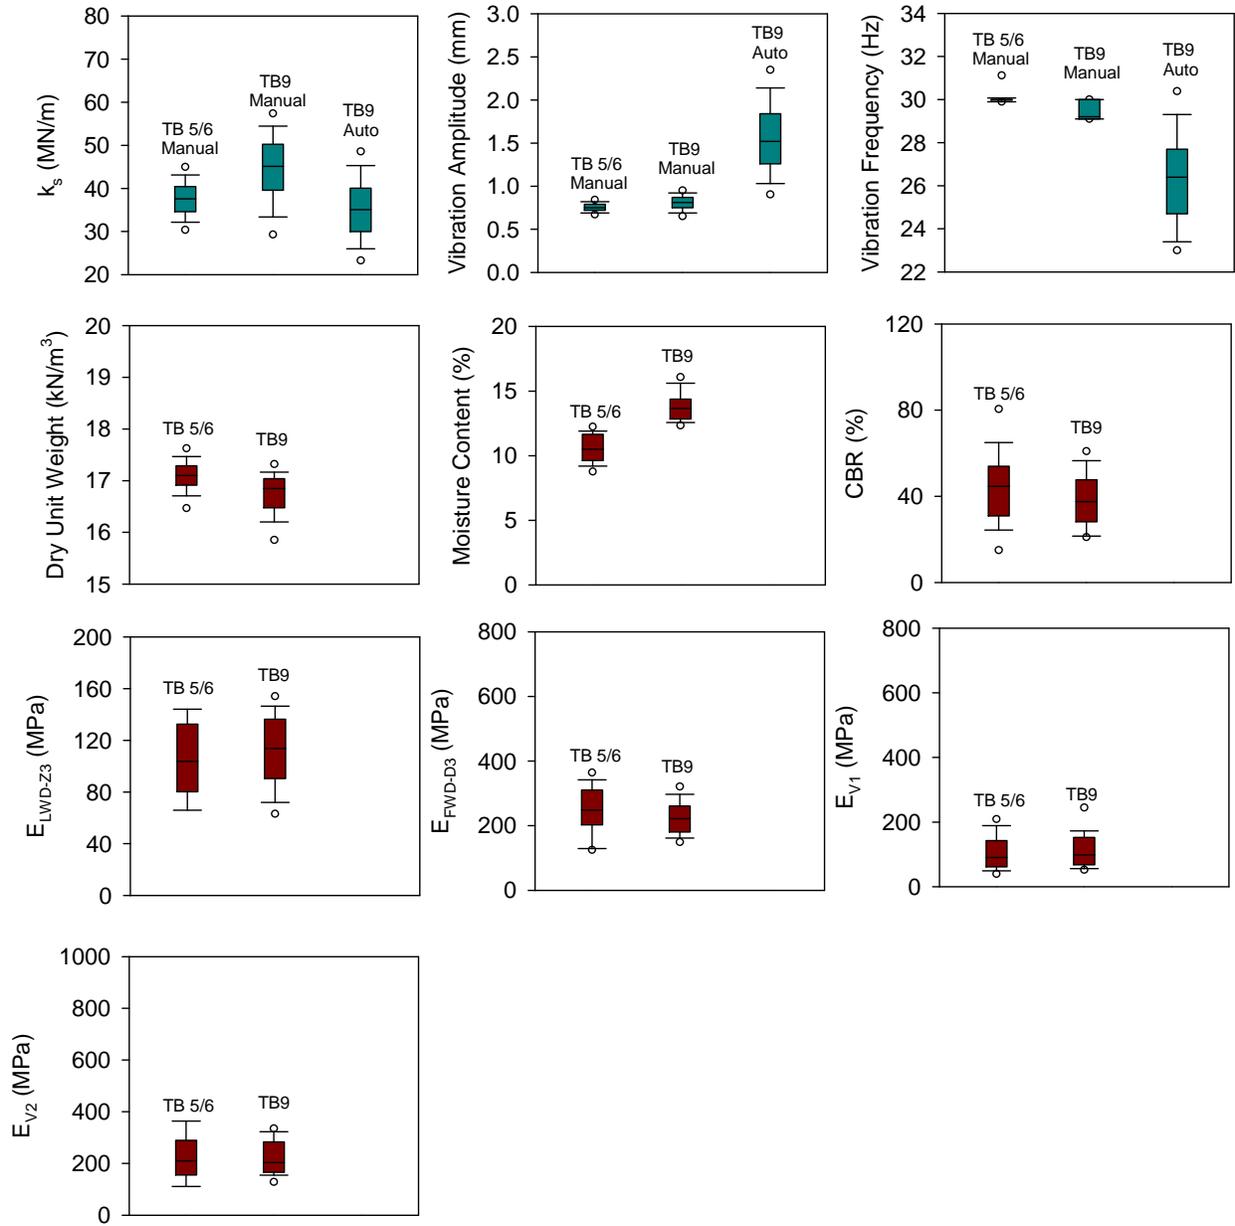
Figure 45. Box plots comparing measurements obtained shortly after compaction (TB5/6) and after 2-days curing (TB9)

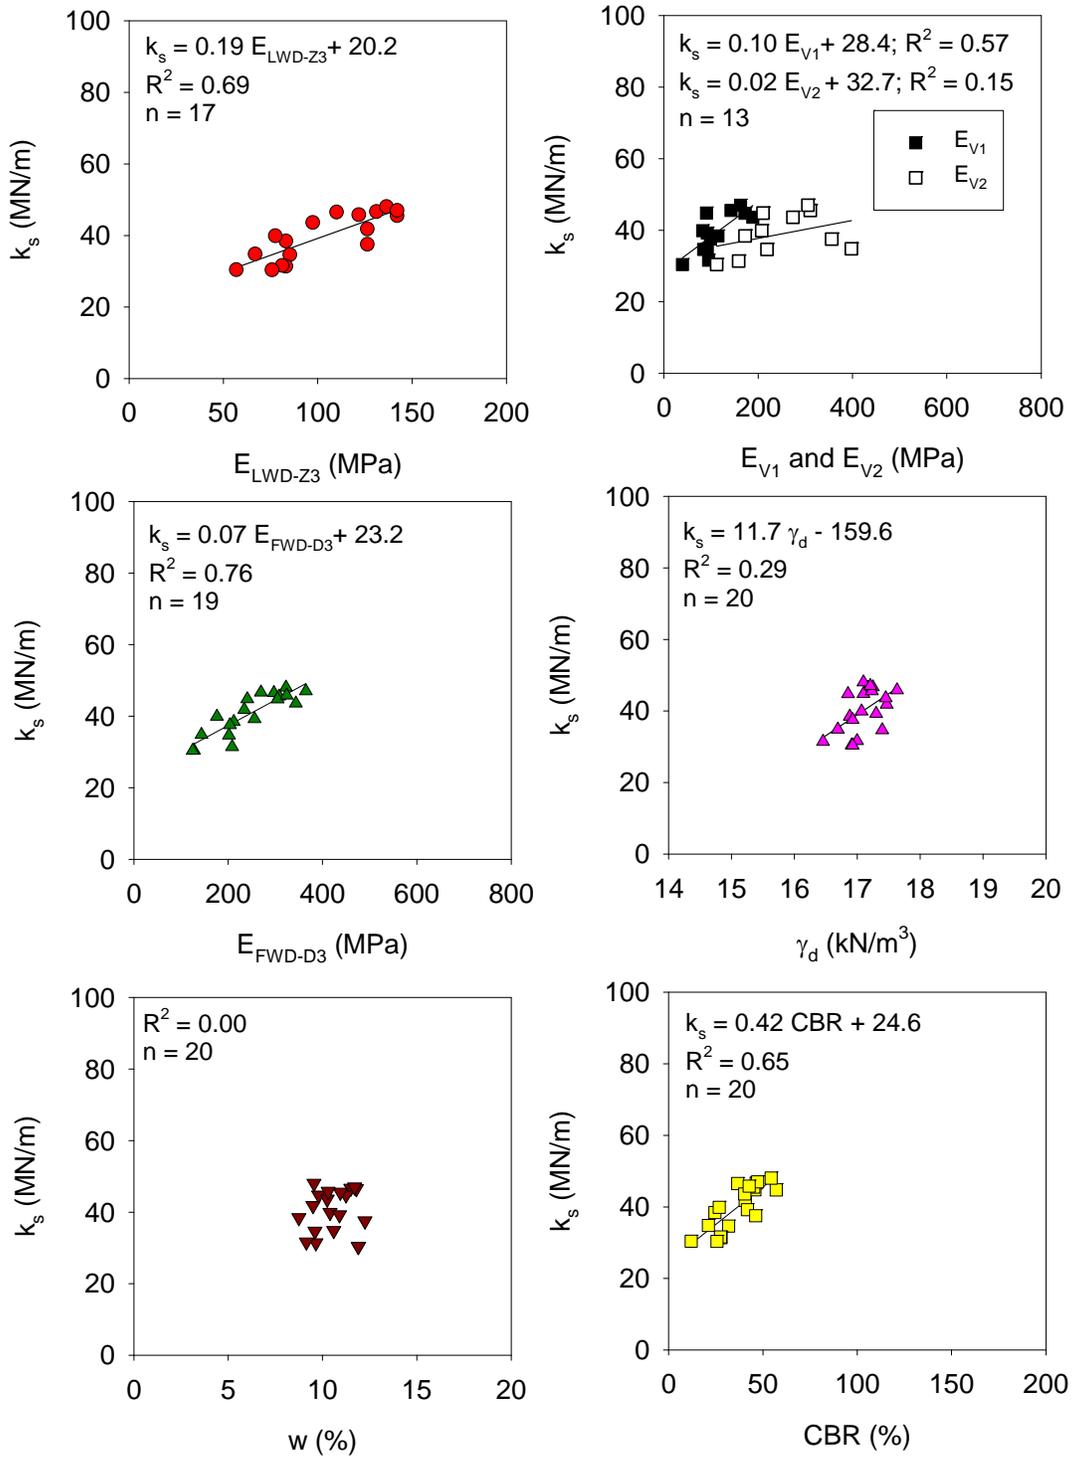
Figure 47. Regression analyses between k_s and in-situ point measurements – TB5 treated subgrade material (shortly after compaction; manual mode)

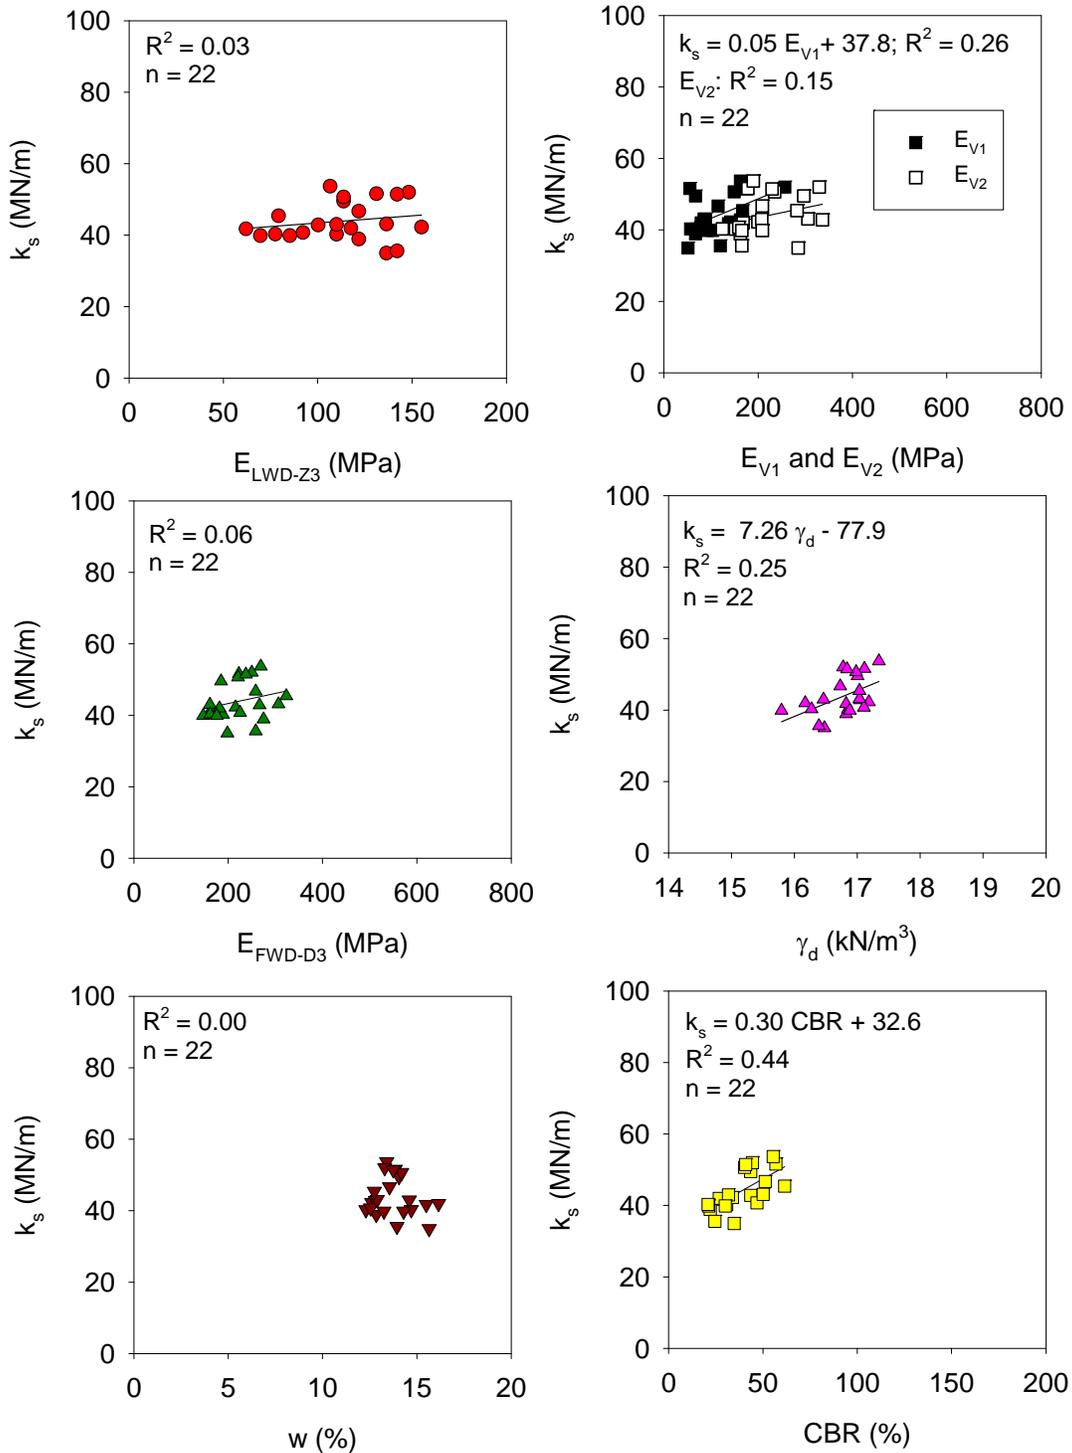
Figure 48. Regression analyses between k_s and in-situ point measurements – TB9 treated subgrade material (after 2-day cure; manual mode)

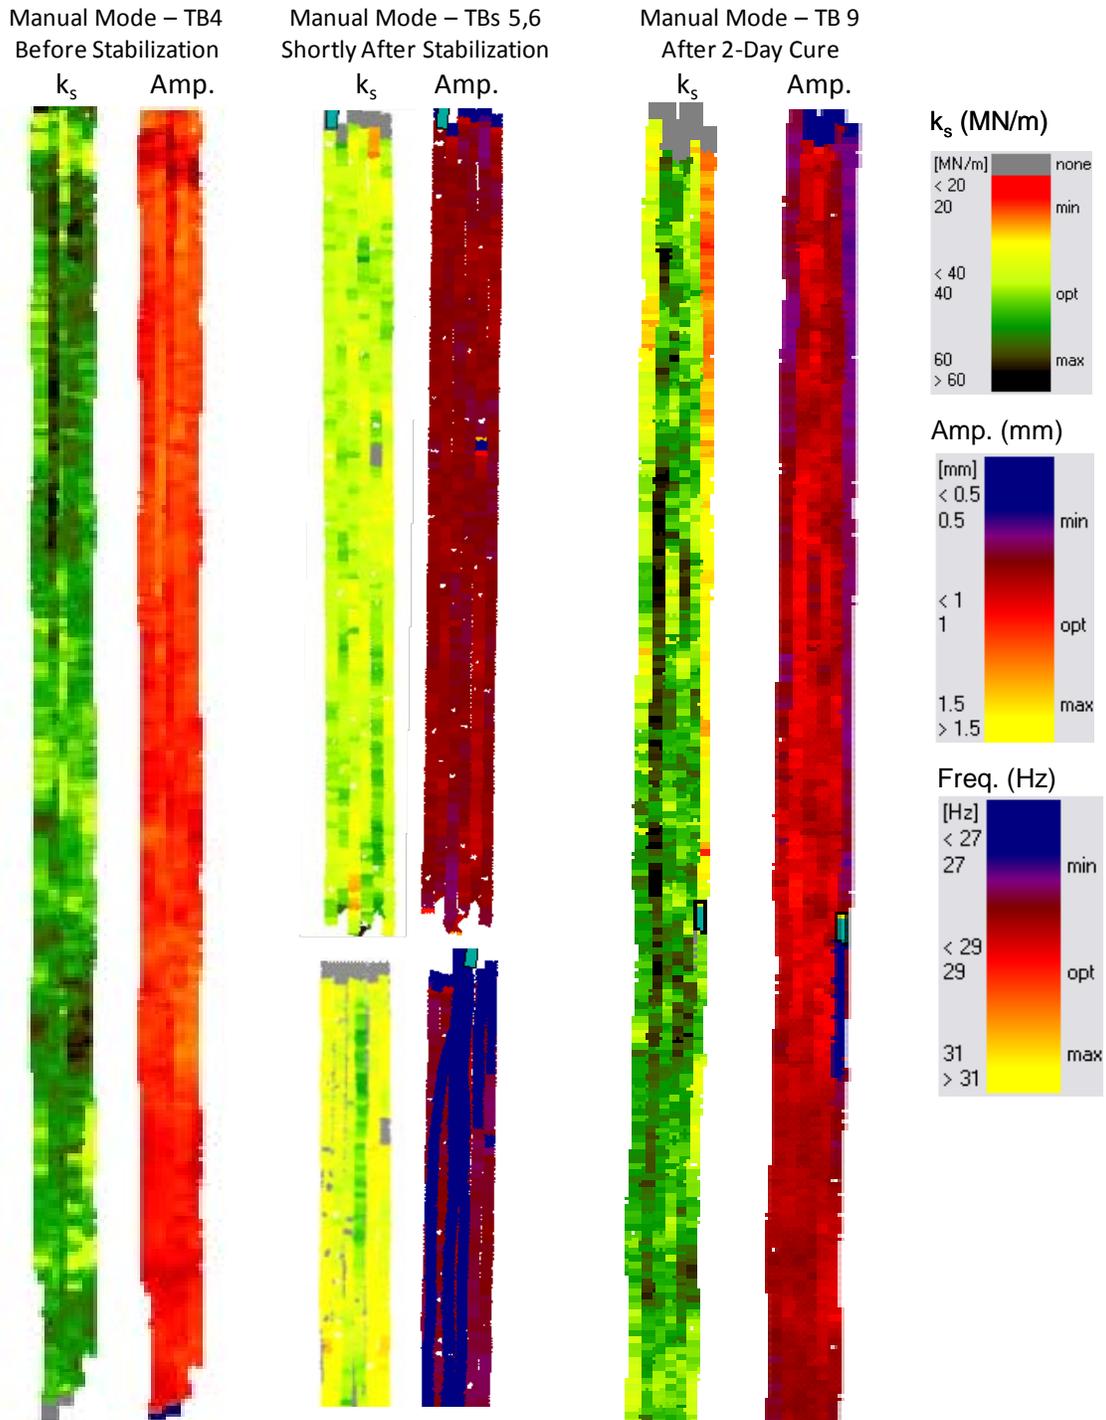
Figure 49. Comparison of k_s and a^* maps obtained in manual mode on granular subgrade material before stabilization (TB4), shortly after stabilization (TB5/6), and 2-days after stabilization (TB9)

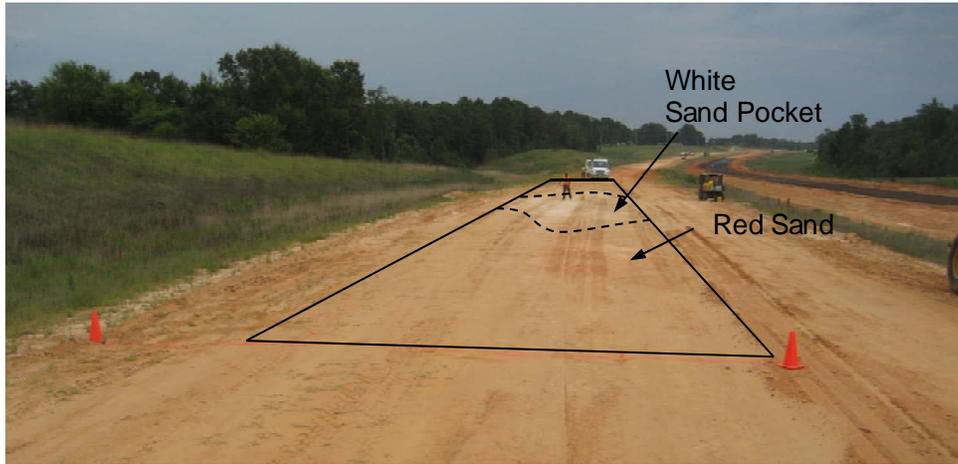
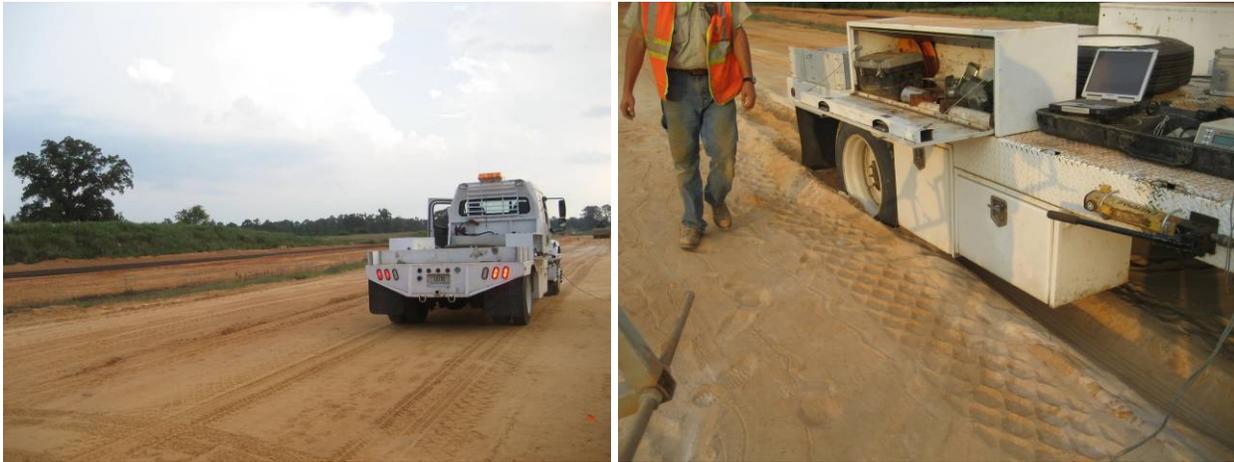
Figure 51. TB7 granular subgrade material (red sand subgrade with isolated white sand pocket)

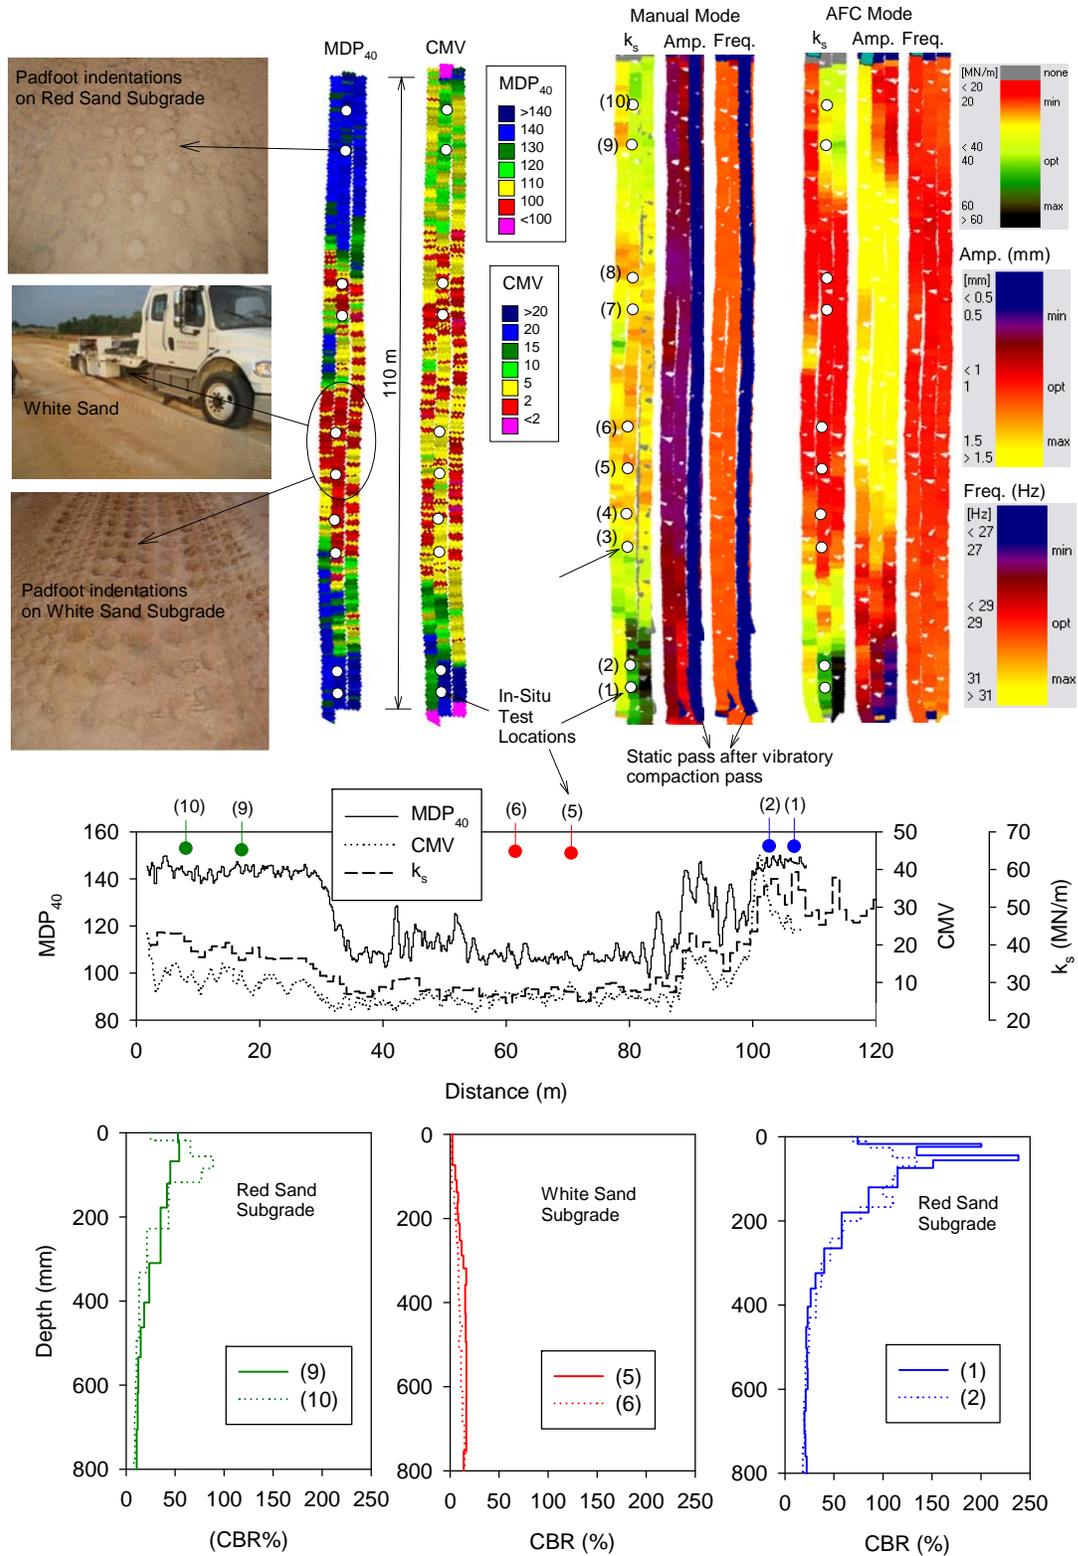
Figure 52. Roller spatial maps, MDP₄₀, CMV, and k_s measurements along the middle lane, and DCP-CBR profiles at selected locations – TB7 granular subgrade material
