ACCELERATED IMPLEMENTATION OF INTELLIGENT COMPACTION TECHNOLOGY FOR EMBANKMENT SUBGRADE SOILS, AGGREGATE BASE, AND ASPHALT PAVEMENT MATERIALS: US 84 WAYNESBORO, MISSISSIPPI

Final Report ER10-03
US84, Waynesboro, MS, Field Project
July 13 to 17, 2009

David J. White, Ph.D.
Pavana KR. Vennapusa, Ph.D.
Heath Gieselman
Bradley Fleming
Stephen Quist
Luke Johanson

Earthworks Engineering Research Center (EERC)
Department of Civil Construction and Environmental Engineering
Iowa State University
2711 South Loop Drive, Suite 4600
Ames, IA 50010-8664
Phone: 515-294-7910
www.eerc.iastate.edu

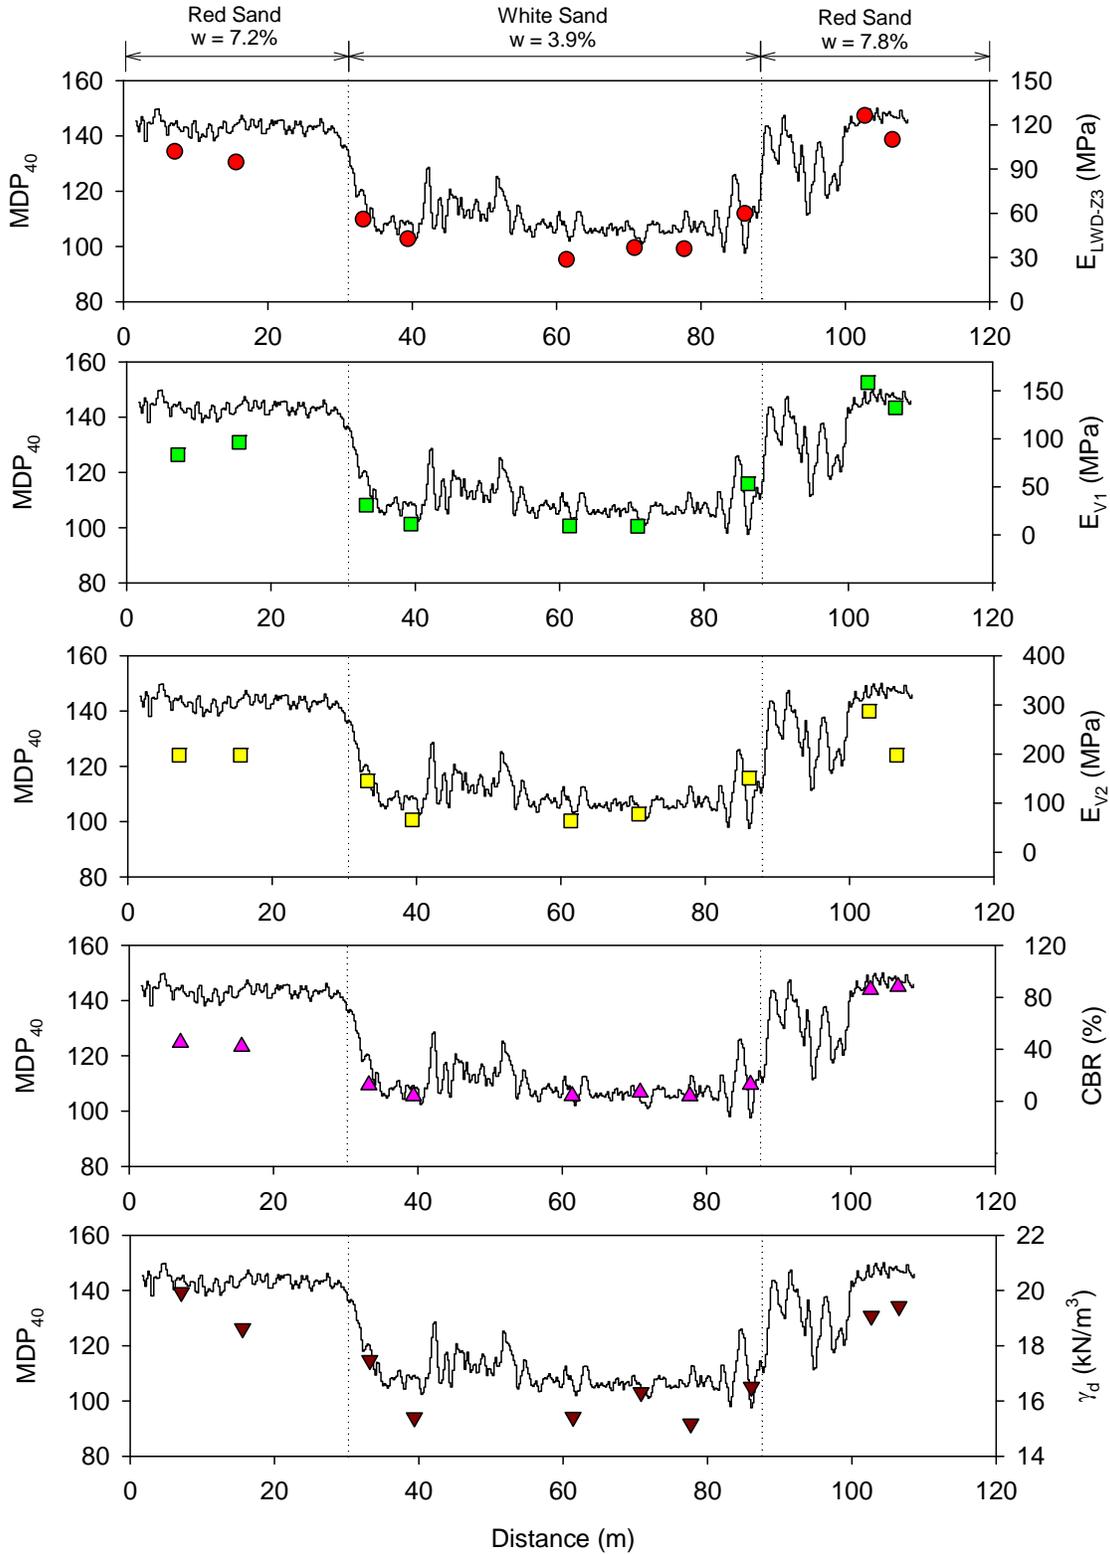
Figure 53. Comparison between MDP_{40} and in-situ point measurements – TB7 granular subgrade material

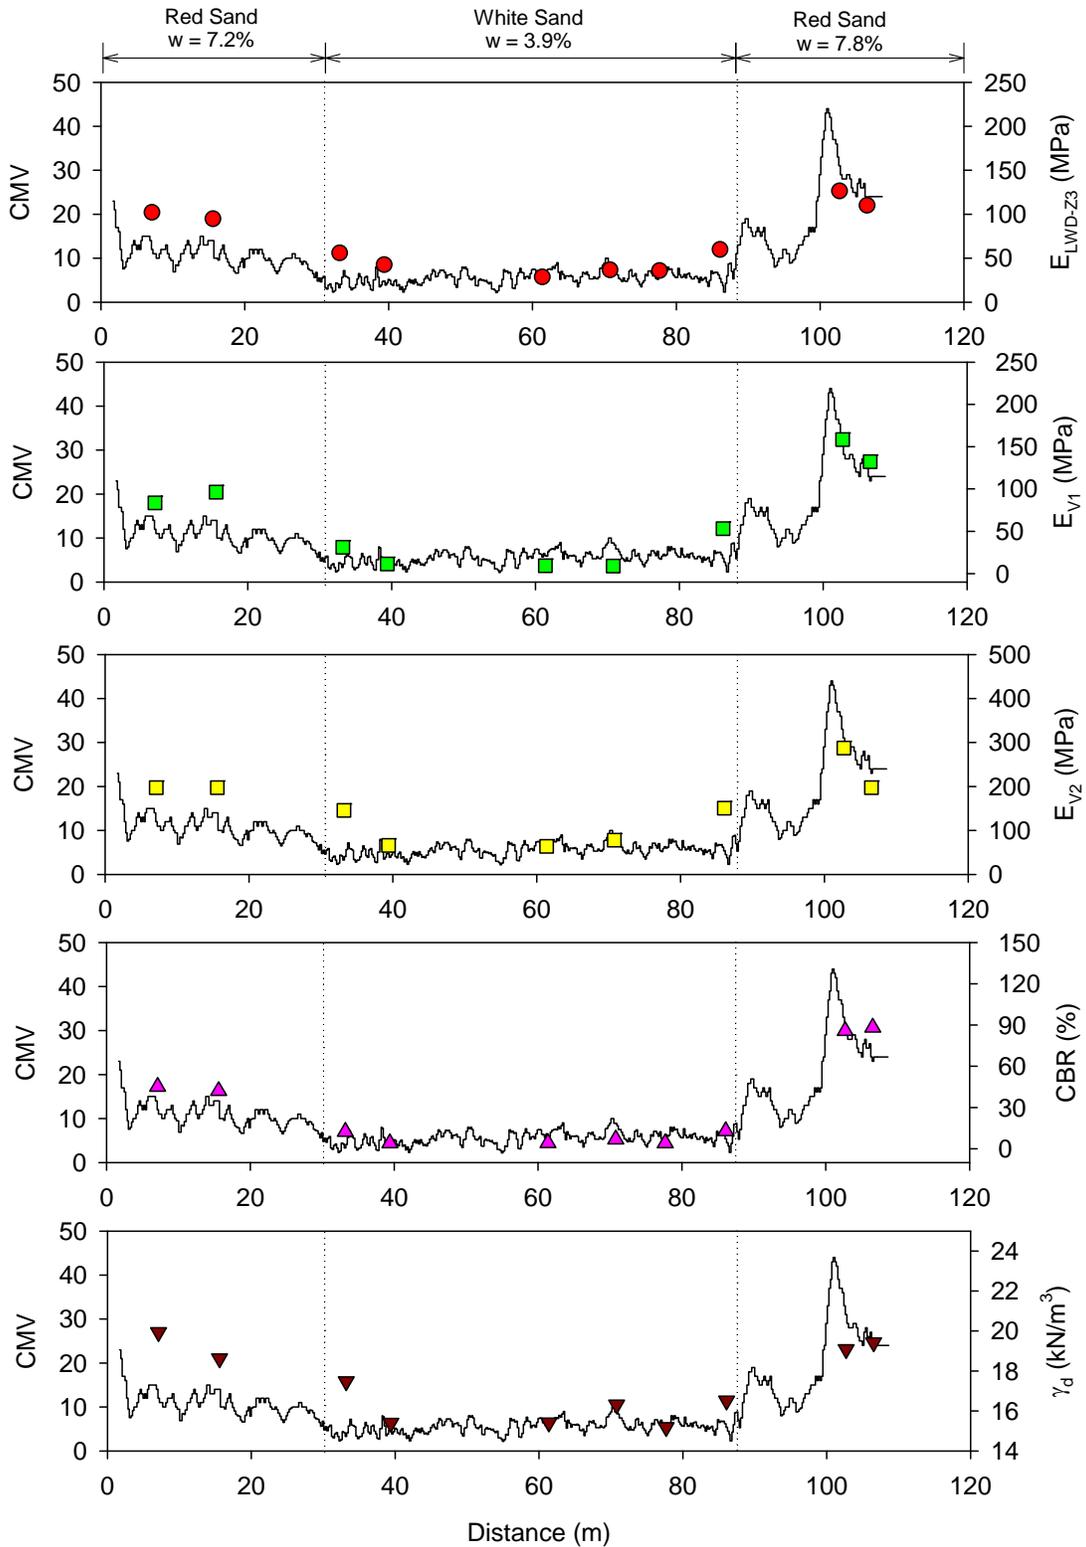
Figure 54. Comparison between CMV and in-situ point measurements – TB7 granular subgrade material

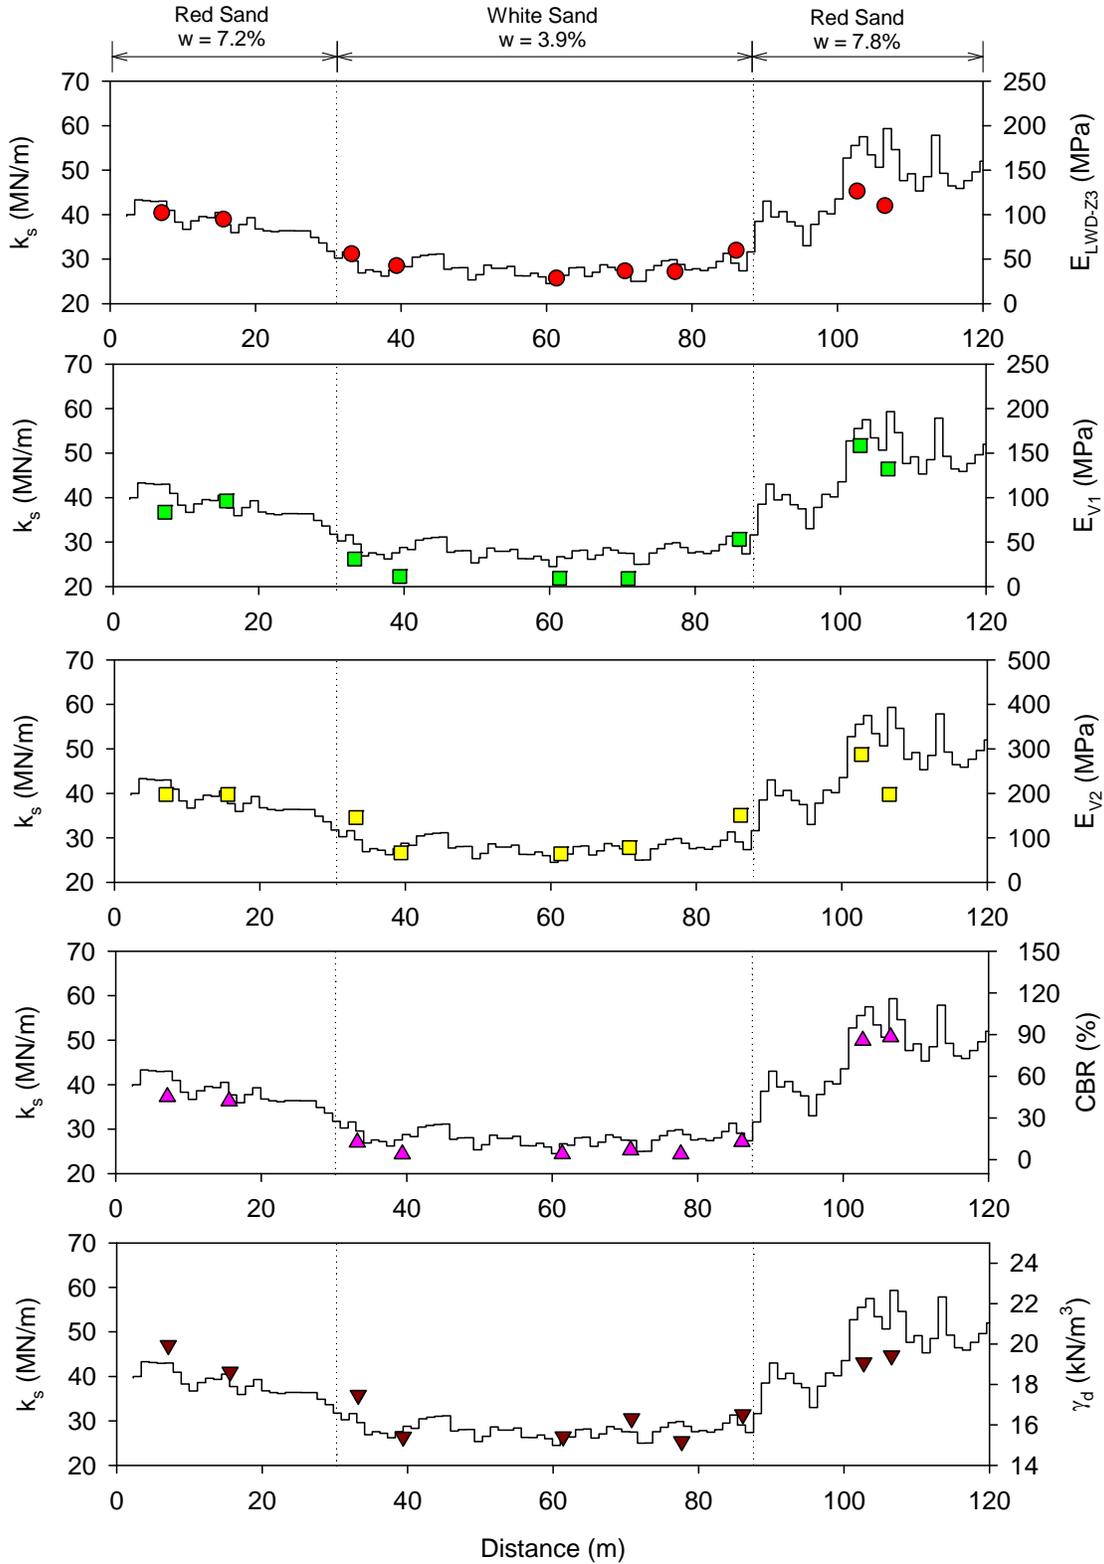
Figure 55. Comparison between k_s and in-situ point measurements – TB7 granular subgrade material

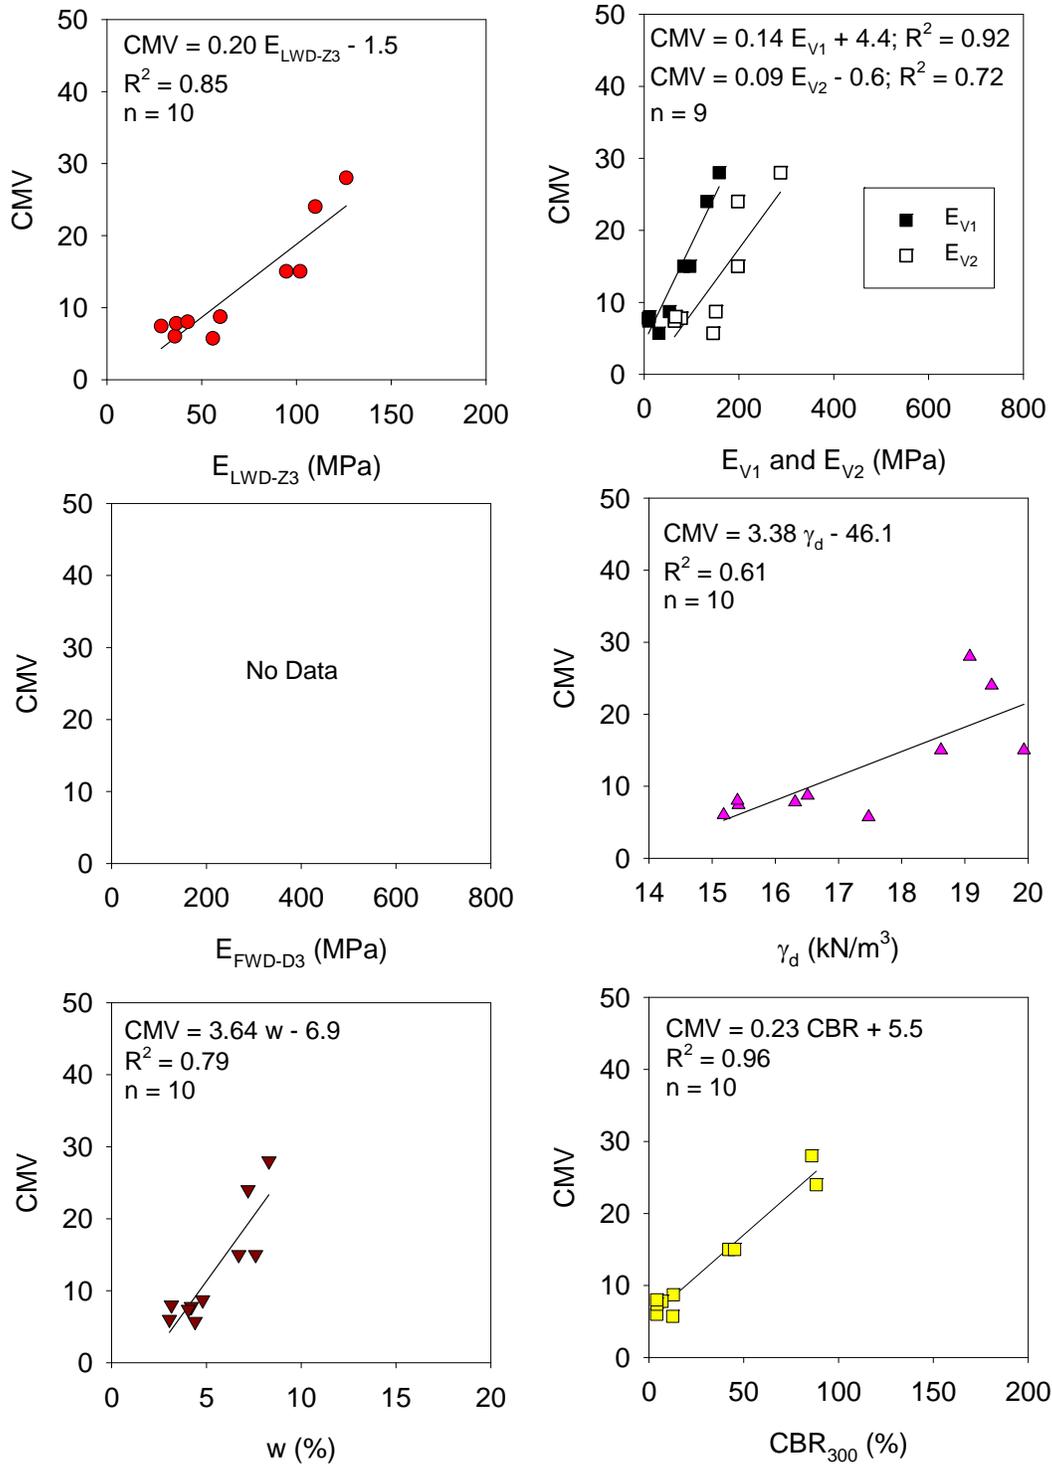
Figure 57. Regression analyses between CMV and in-situ point measurements – TB7 granular subgrade material

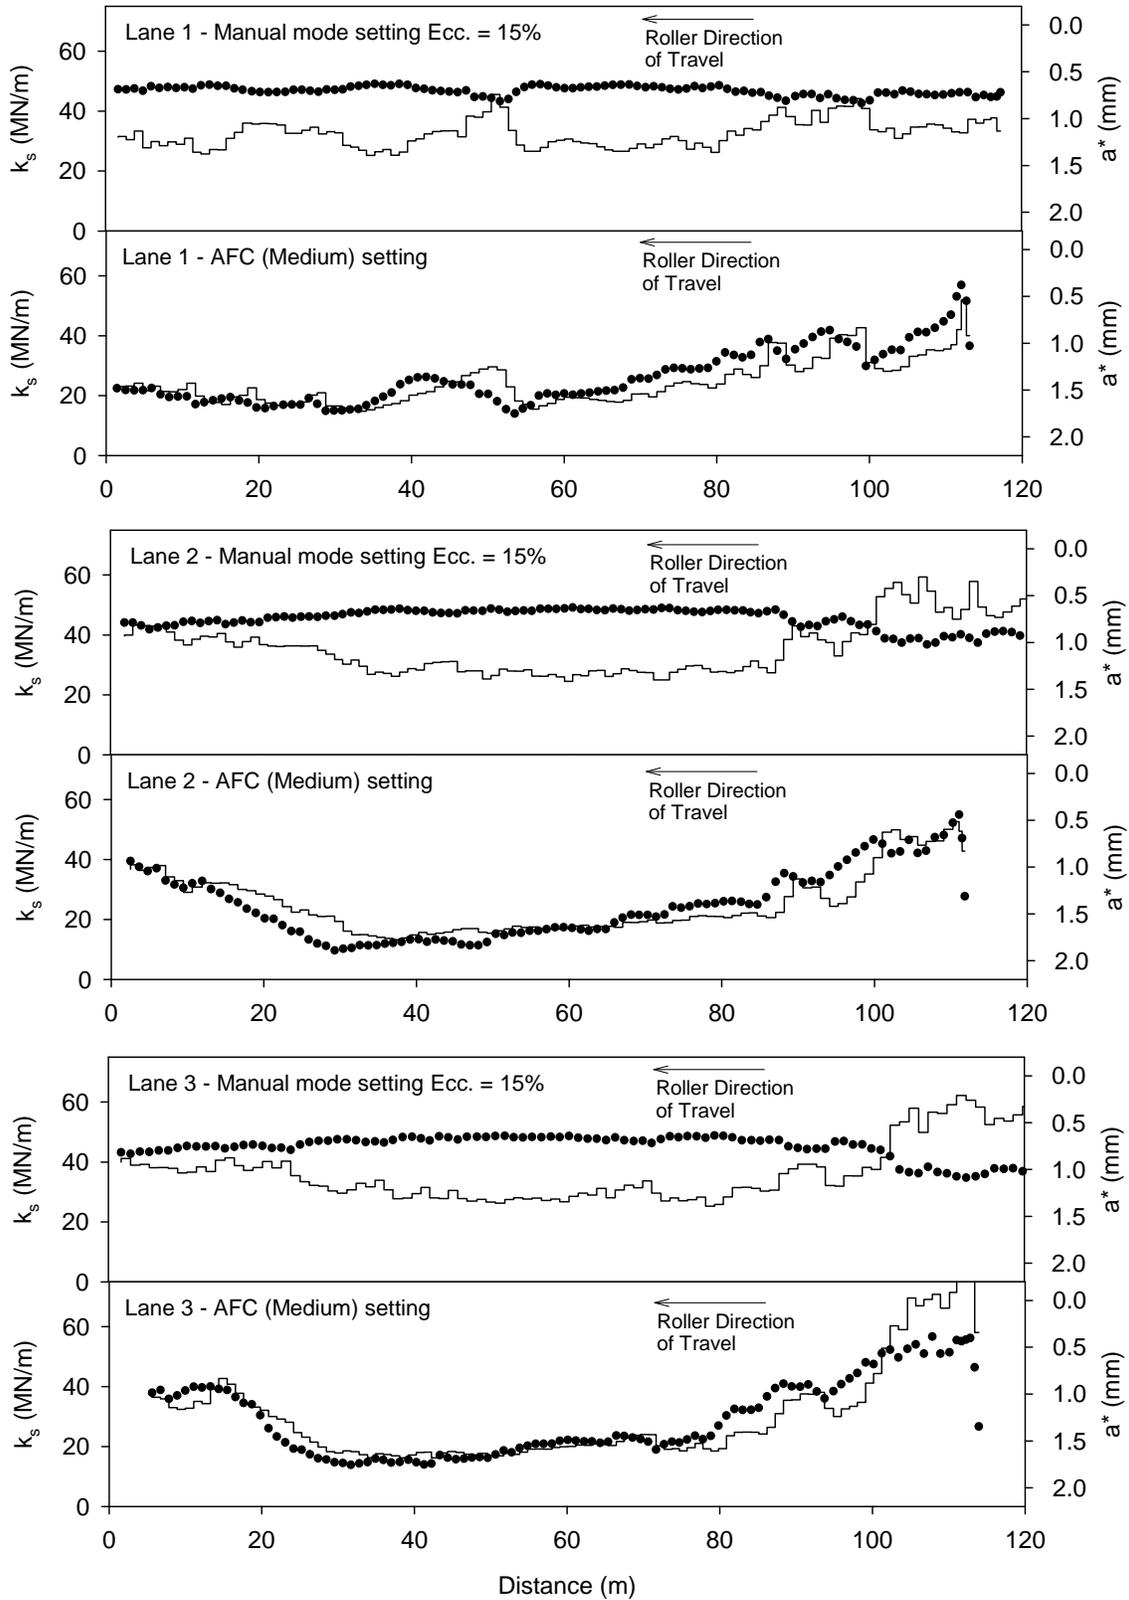
Figure 59. k_s (solid line) and a^* (black circles) measurements in manual and AFC mode settings – TB7 granular subgrade material

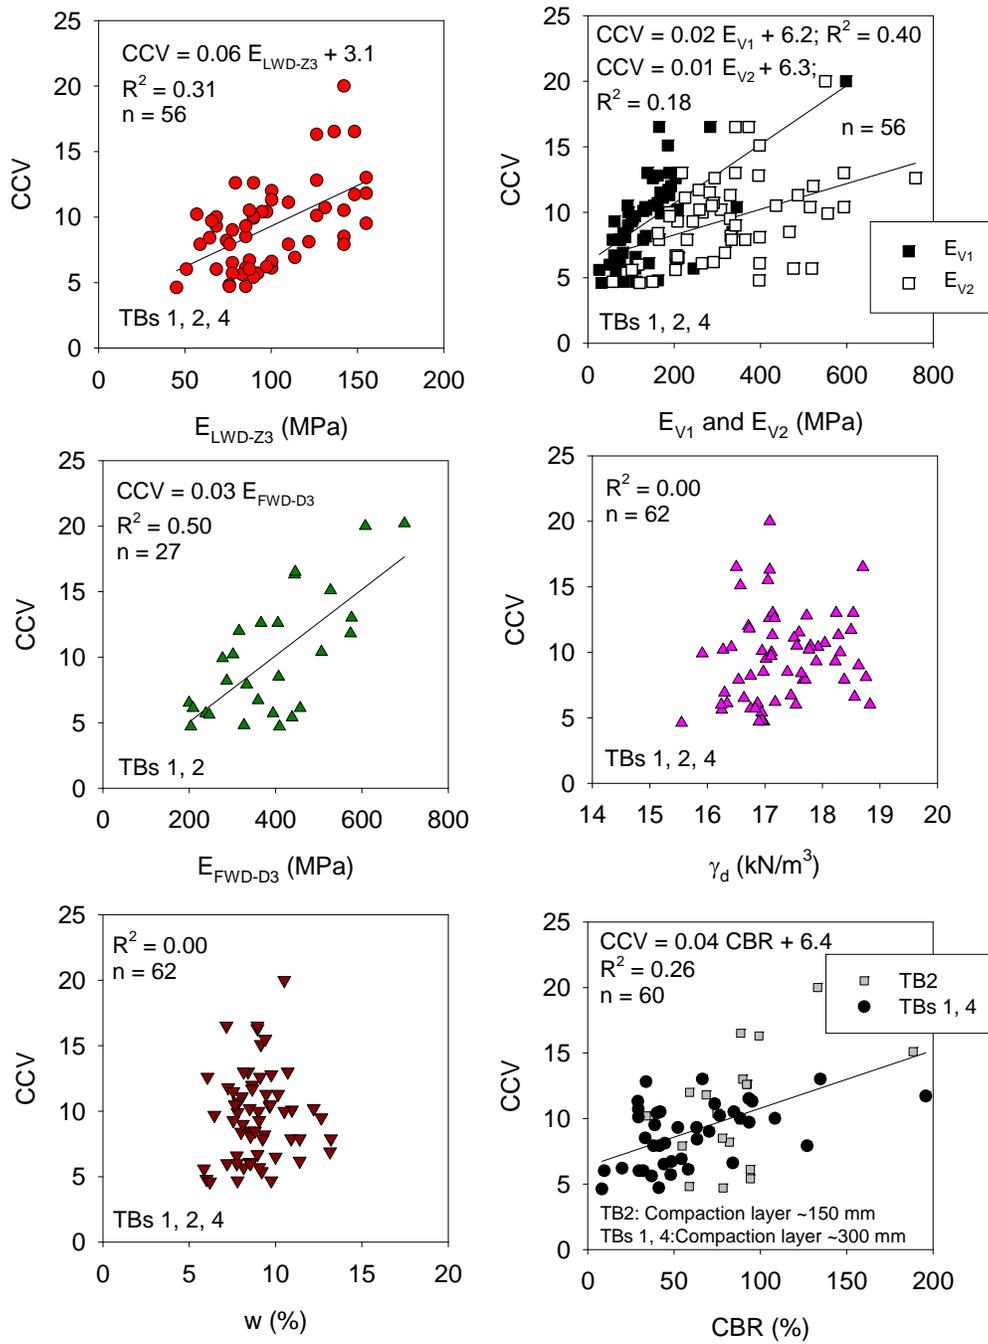
Figure 60. Regression analyses between CCV and in-situ point measurements – TBs 1, 2, and 4

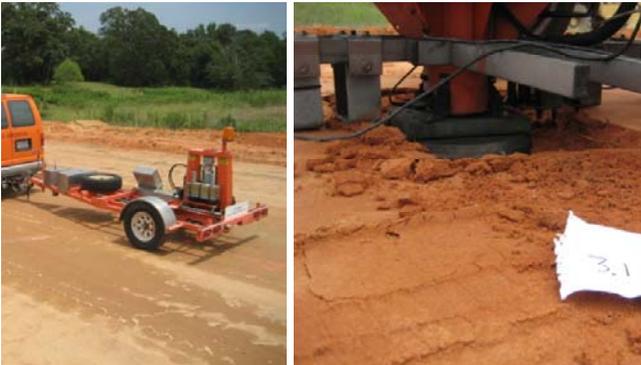
In-situ testing methods used on the test bed (left to right): Static plate load test (PLT), Nuclear moisture-density gauge (NG), Dynatest falling weight deflectometer (FWD), FWD measurements in excavation

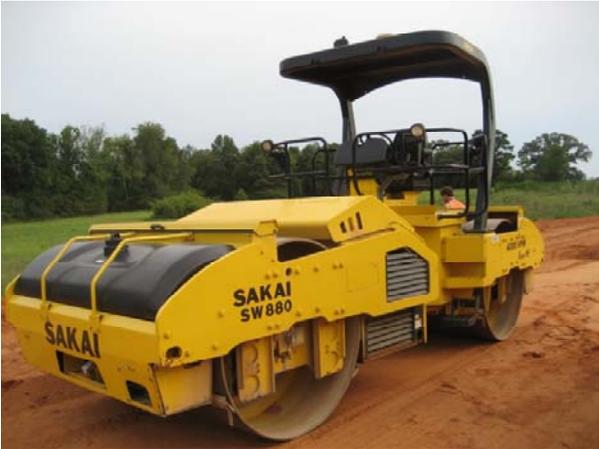
Sakai SW880 roller used on the test bed

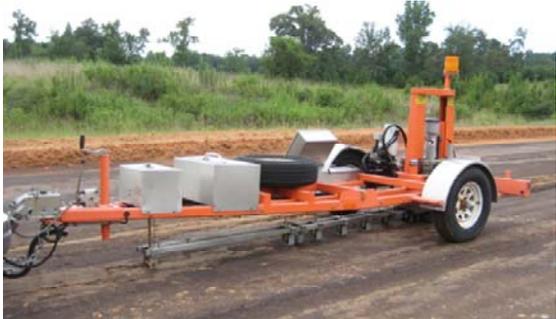
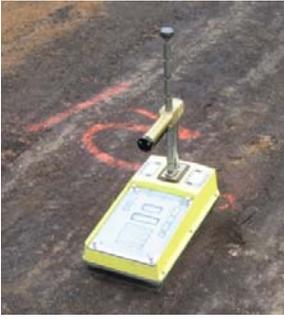
In-situ testing methods used on the test bed (left to right): Dynatest falling weight deflectometer (FWD), Nuclear moisture-density gauge (NG), 300mm plate Zorn light weight deflectometer (LWD)

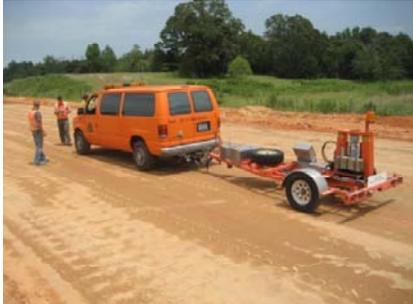
In-situ testing methods used on the test bed (left to right): Dynatest falling weight deflectometer (FWD), Nuclear moisture-density gauge (NG), 300mm plate Zorn light weight deflectometer (LWD)

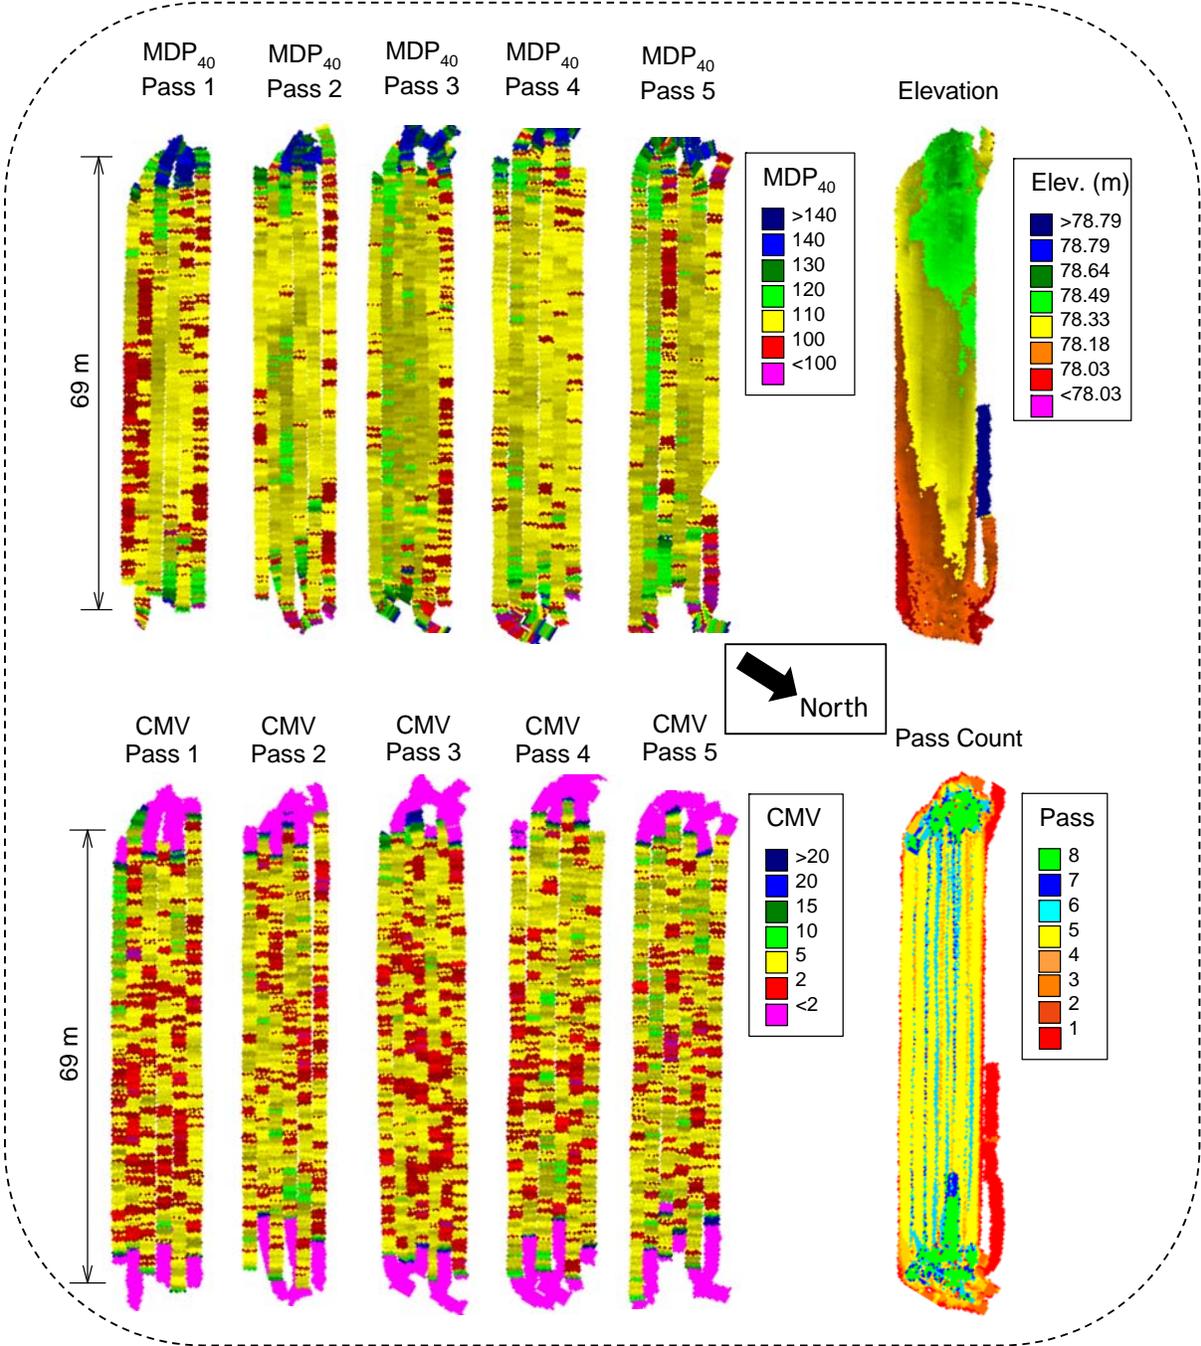
IC-MV, Elevation, and Pass Count maps of Section A compacted by ISU research team
