Concrete Overlay Performance on Iowa's Roadways

**Field Data Report
July 2017**

National Concrete Pavement
Technology Center

Sponsored by
Iowa Highway Research Board
(IHRB Project TR-698)
Iowa Department of Transportation
(InTrans Project 15-559)

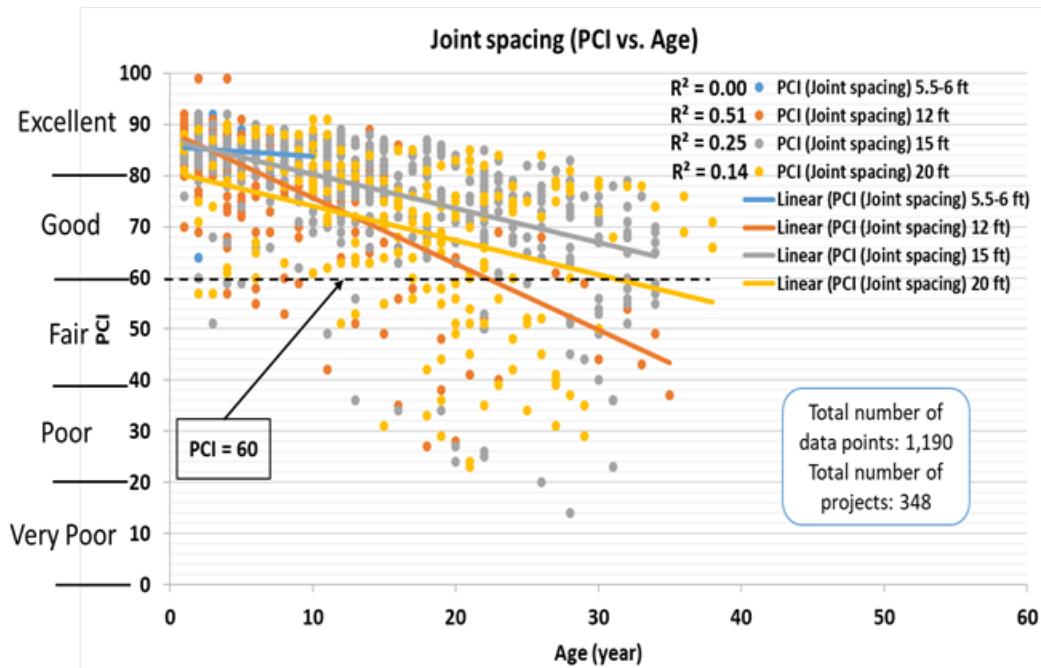
Figure 42. Iowa concrete overlay PCI performance history for four different concrete overlay joint spacing projects

- The PCI trend line for 5.5- to 6-ft transverse joint spacing decreased modestly and remained above 80 during the first 10 years of service life.
- The PCI trend line for 12-ft transverse joint spacing decreased rapidly during the first 22 years of service life before dropping below 60.
- The PCI trend line for 15-ft transverse joint spacing decreased gradually but remained above 60 during the first 33 years of service life.
- The PCI trend line for 20-ft transverse joint spacing decreased gradually during the first 33 years of service life before dropping below 60.
- Shorter slab sizes have only been used since roughly 2004 and have exhibited good performance.
- PCI values for older Iowa concrete overlays (i.e., those after 20 years of life) have shown that larger slab sizes can provide good long-term performance.

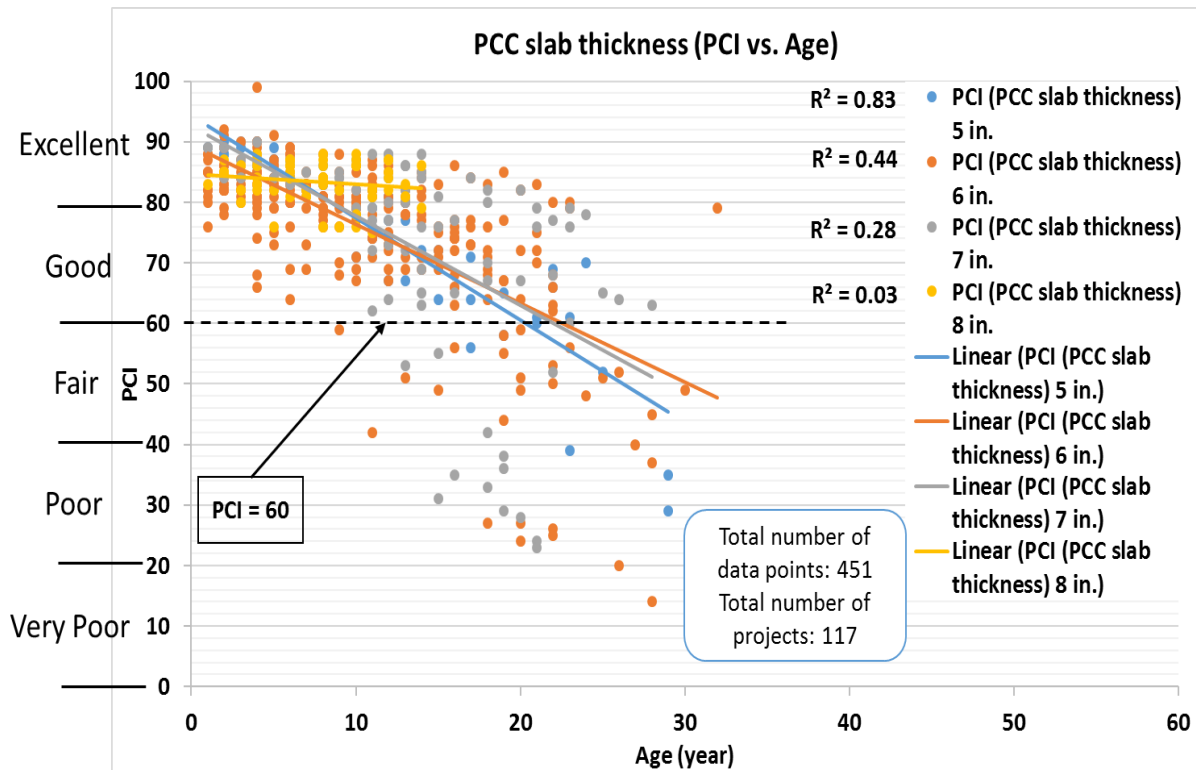
Figure 48. UBCOC PCI performance history categorized by concrete overlay thickness

- Higher overlay thickness leads to increased overlay service life in terms of PCI values. This is more evident in UBCOCs. Refer to Figure 48.
- UBCOCs with short joint spacing (i.e., 12 ft and 15 ft) perform better than those with longer joint spacing (i.e., 20 ft.) in terms of IRI values. Refer to Figures 50 and 51.

- The PCI trend line for 5-in. thickness decreased gradually during the first 20 years of service life before dropping below 60.
- The PCI trend line for 6-in. thickness decreased gradually during the first 22 years of service life before dropping below 60.
- The PCI values trend line for 7-in. thickness decreased gradually during the first 22 years of service life before dropping below 60.
- The PCI values trend line for 8-in. thickness remained above 80 during the first 15 years of service life.
- Higher overlay thickness led to increased overlay service life.

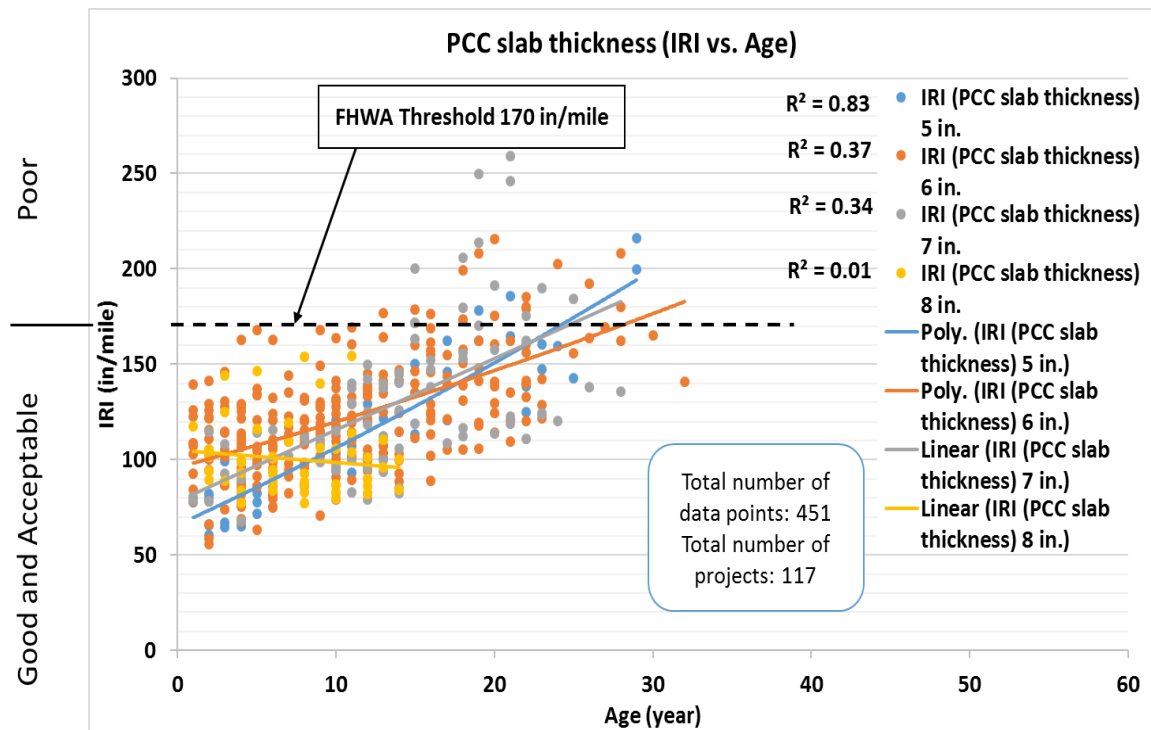
Figure 49. UBCOC IRI performance history categorized by concrete overlay thickness

- The IRI trend line for this data set appears to be trending in the opposite direction as expected—i.e., smoothness slightly increasing over time. The collection method changed from a point laser to band laser around 2010–2011. This resulted in a minimal decrease (5–10 in/mi) in IRI for many concrete pavements. With a small data set in which values were relatively constant, this change likely caused the data to trend in the opposite direction as expected.

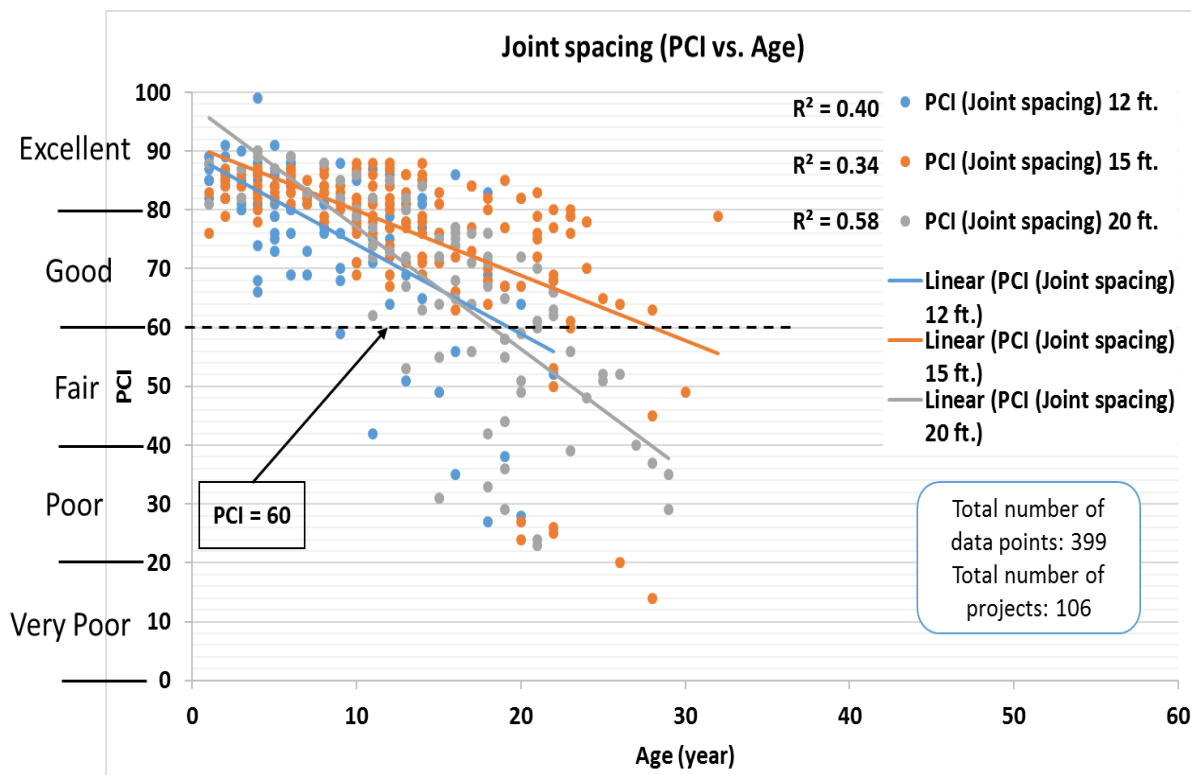
Figure 50. UBCOC PCI performance history categorized by concrete overlay joint spacing

- The PCI trend line for 12-ft transverse joint spacing decreased rapidly during the first 20 years of service life before dropping below 60.
- The PCI trend line for 15-ft transverse joint spacing decreased gradually during the first 28 years of service life before dropping below 60.
- The PCI trend line for 20-ft transverse joint spacing decreased rapidly during the first 19 years of service life before dropping below 60.

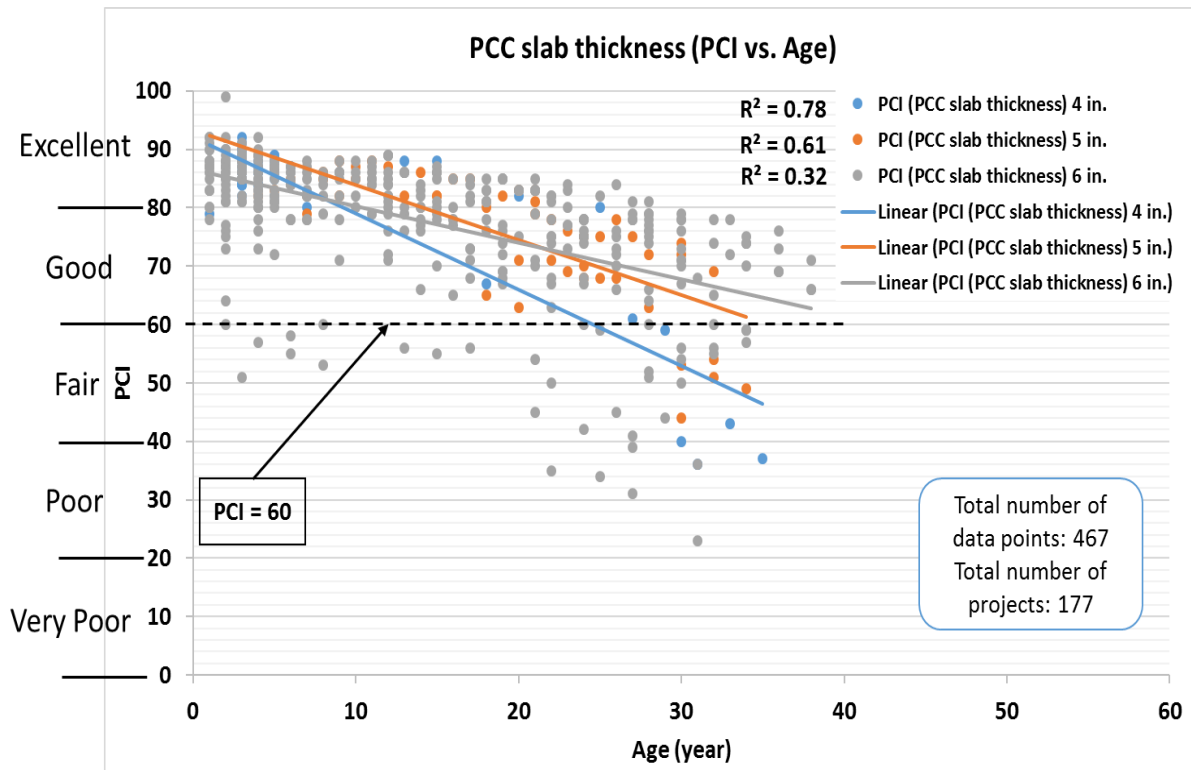
Figure 52. BCOA PCI performance history categorized by concrete overlay thickness

- The PCI trend line for 4-in. thickness decreased gradually during the first 25 years of service life before dropping below 60.
- The PCI trend line for 5-in. thickness decreased gradually but remained above 60 during the first 35 years of service life.
- The PCI trend line for 6-in. thickness decreased gradually but remained above 60 during the first 37 years of service life.
- Higher overlay thickness led to increased service life.

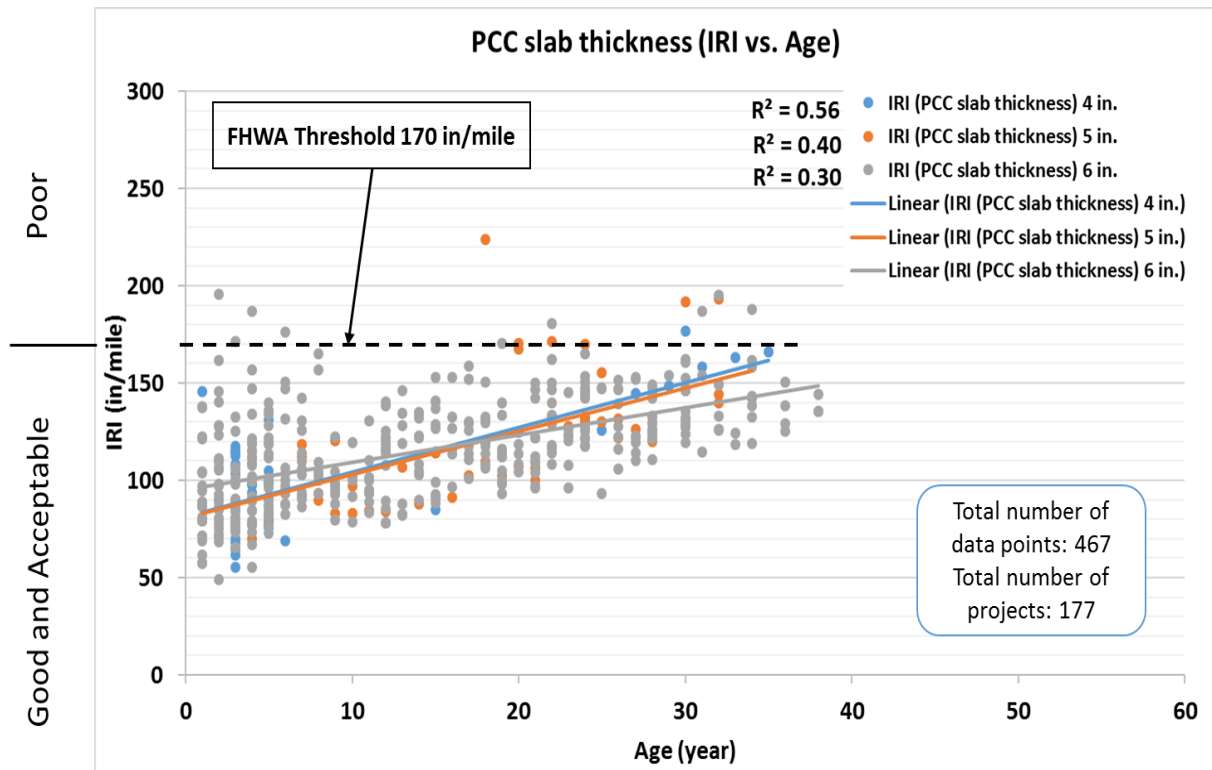
Figure 53. BCOA IRI performance history categorized by concrete overlay thickness

- The IRI trend line for 4-in. thickness increased gradually but remained below 170 in/mi during the first 35 years of service life.
- The IRI trend line for 5-in. thickness increased gradually but remained below 170 in/mi during the first 35 years of service life.
- The IRI values trend line for 6-in. thickness increased gradually but remained below 170 in/mi during the first 37 years of service life.

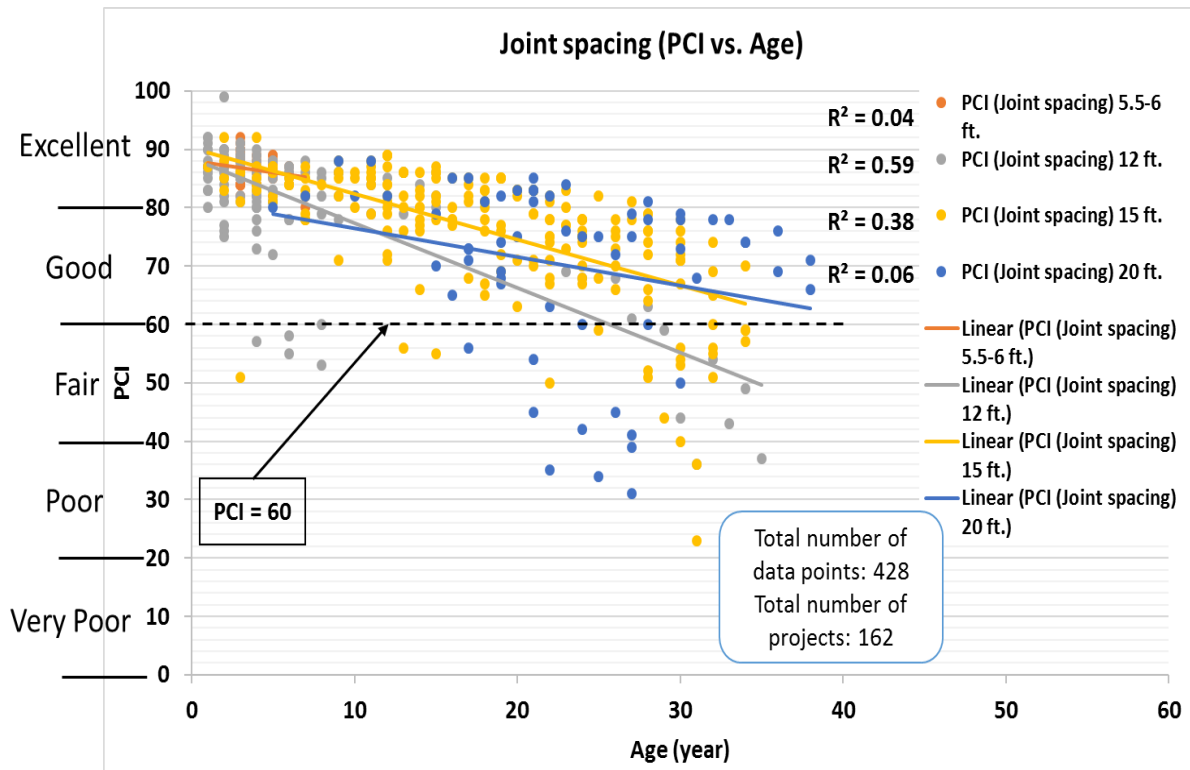
Figure 54. BCOA PCI performance history categorized by concrete overlay joint spacing

- Although only in existence since about 2004, BCOAs with shorter transverse joint spacing (5.5 and 6 ft) have shown better performance with respect to PCI and IRI compared to 12-, 15-, and 20-ft spacings. Refer to Figures 54 and 55.

- The PCI trend line for 5.5- to 6-ft transverse joint spacing decreased modestly and remained above 80 during the first 10 years of service life.
- The PCI trend line for 12-ft transverse joint spacing decreased rapidly during the first 25 years of service life before dropping below 60.
- The PCI trend line for 15-ft transverse joint spacing decreased gradually during the first 35 years of service life before dropping below 60.
- The PCI values trend line for 20-ft transverse joint spacing decreased gradually but remained above 60 during the first 37 years of service life.

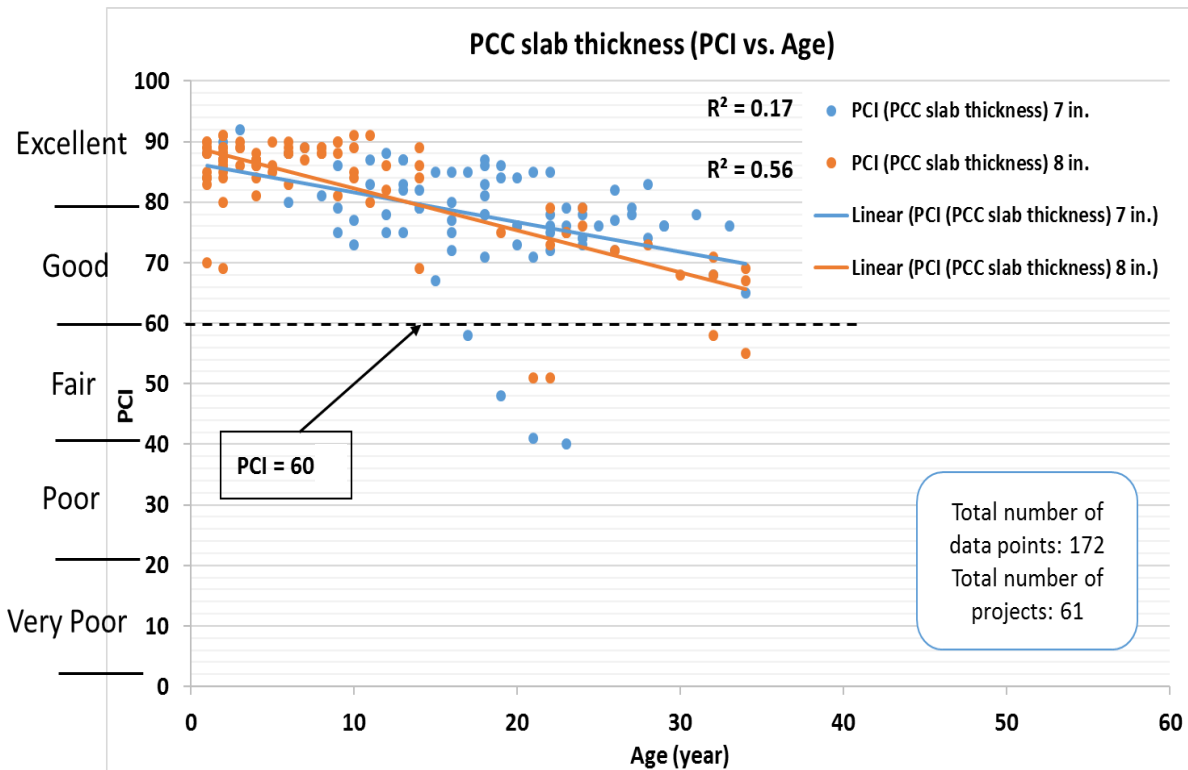
Figure 56. UBCOA PCI performance history categorized by concrete overlay thickness

- The PCI values trend line for UBCOAs with 7-in. and 8-in. thicknesses maintained at or above 60 during the first 35 years of service life. Refer to Figure 56.

- The PCI values trend line for 7-in. and 8-in. thicknesses decreased gradually but remained above 60 during the first 35 years of service life.

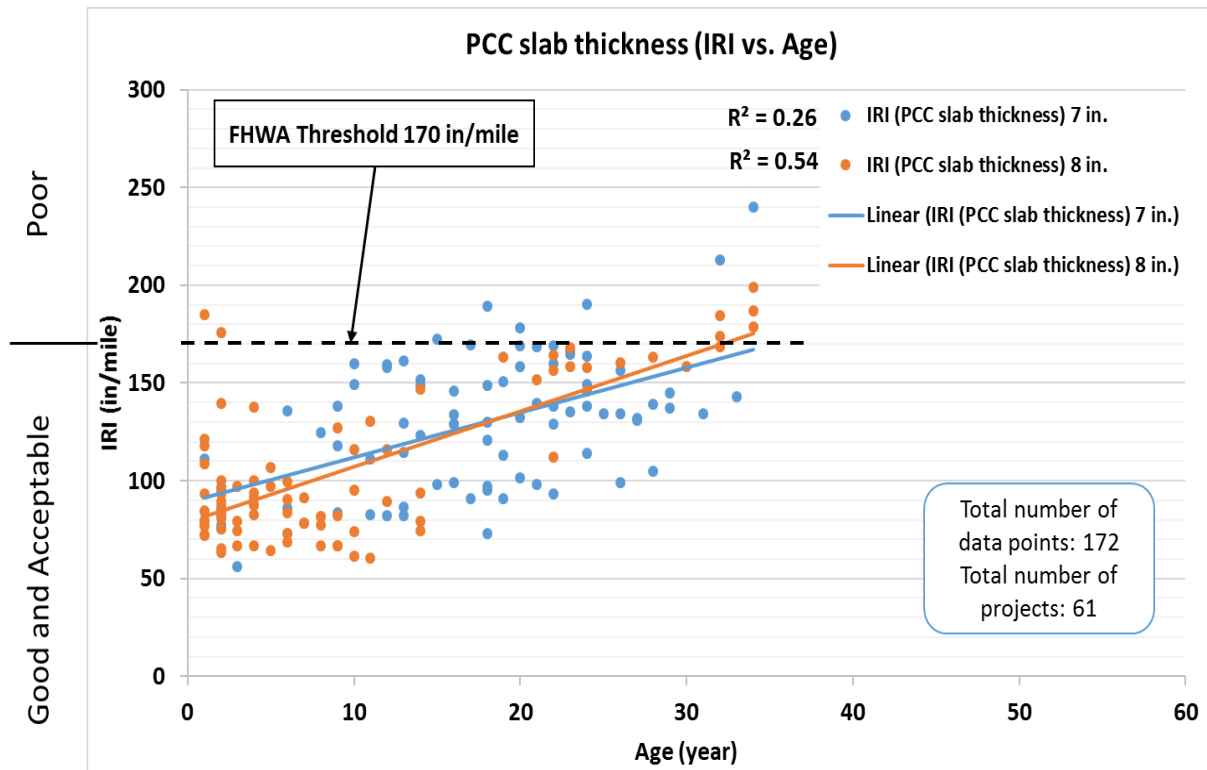
Figure 57. UBCOA IRI performance history categorized by concrete overlay thickness

- The IRI trend line for 7-in. thickness increased gradually but remained below 170 in/mi during the first 35 years of service life.
- The IRI trend line for 8-in. thickness increased gradually during the first 33 years of service life before exceeding 170 in/mi.

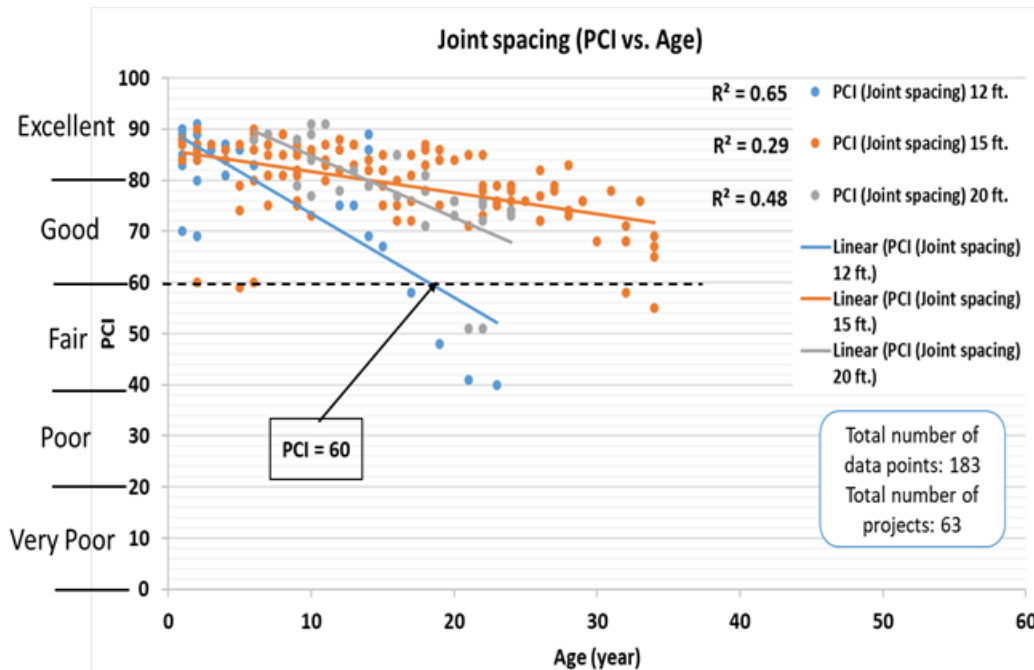
Figure 58. UBCOA PCI performance history categorized by concrete overlay joint spacing

- The PCI trend line for 12-ft transverse joint spacing decreased rapidly during the first 18 years of service life before dropping below 60.
- The PCI trend line for 15-ft transverse joint spacing decreased gradually but remained above 70 during the first 35 years of service life.
- The PCI trend line for 20-ft transverse joint spacing decreased gradually but remained above 70 during the first 22 years of service life.

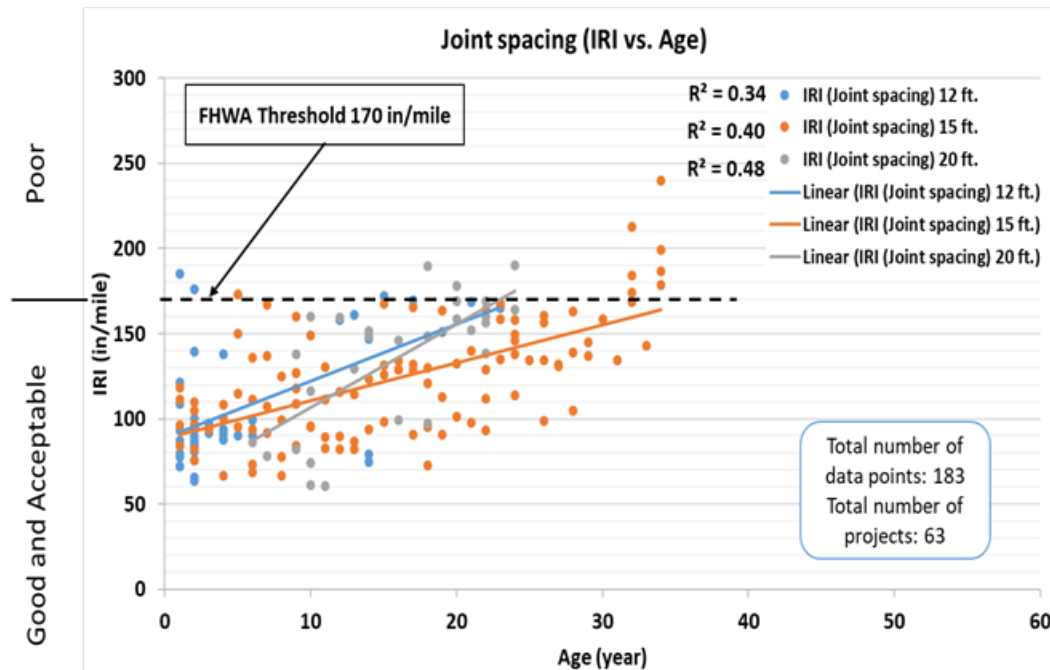
Figure 59. UBCOA IRI performance history categorized by concrete overlay joint spacing

- The IRI values trend line for 12-ft transverse joint spacing increased gradually and remained below 170 in/mi during the first 22 years of service life.
- The IRI values trend line for 15-ft transverse joint spacing increased gradually but remained below 170 in/mi during the first 35 years of service life.
- The IRI values trend line for 20-ft transverse joint spacing increased gradually but remained below 170 in/mi during the first 22 years of service life.

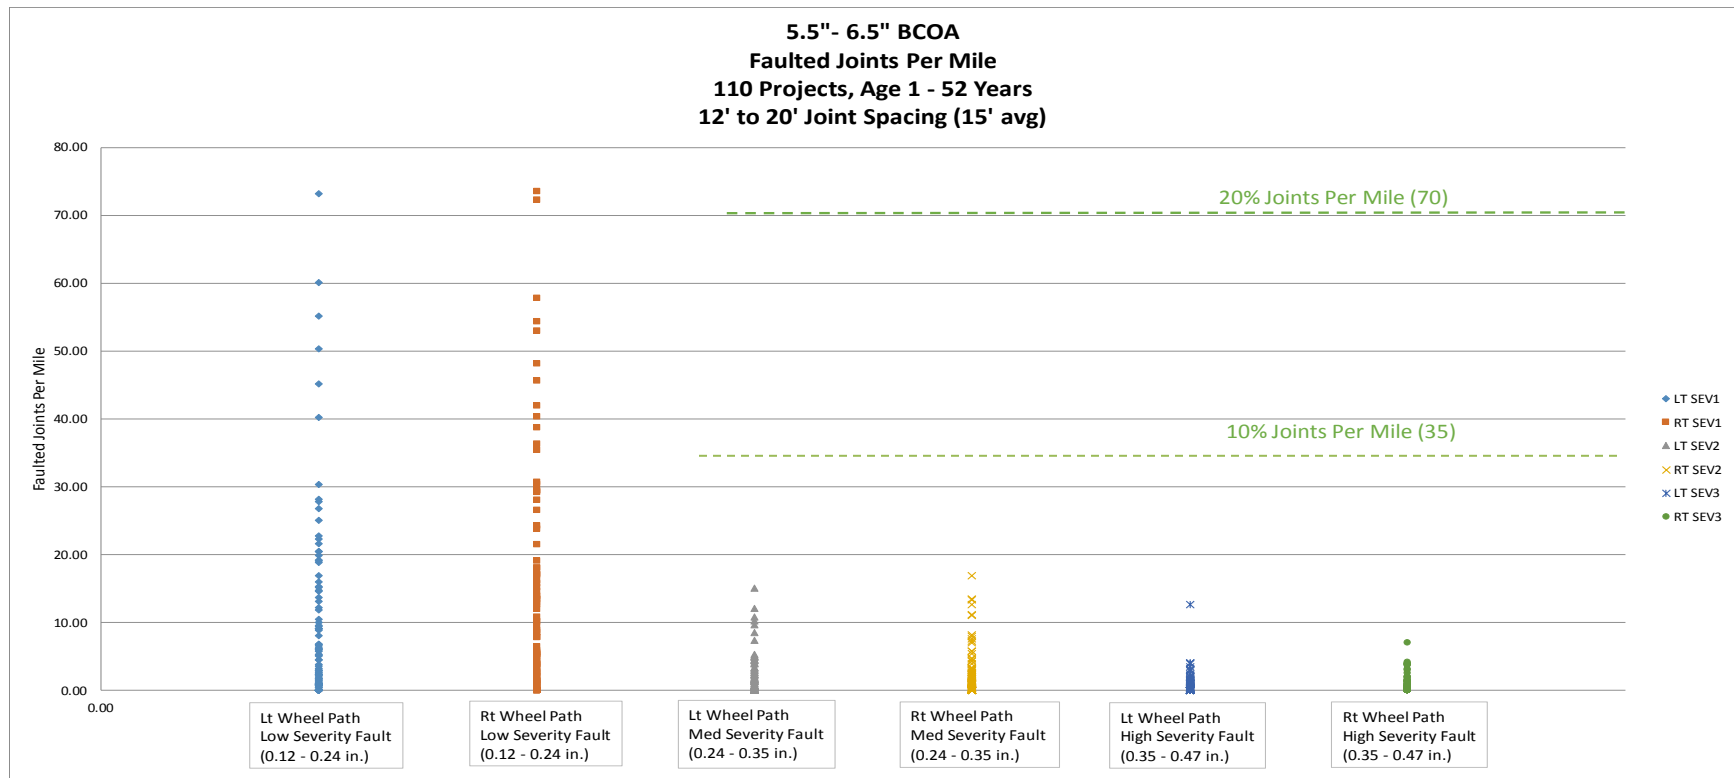
Figure 64. Faulted joints per mile (5.5- to 6.5-in. BCOA) based on severity levels 1–3

The x-axis shows faulting at the left and right wheel paths for severity levels 1–3. Faulting in severity level 4 was not displayed because of the low values. In Figures 64 through 66, the data show the majority of faulting per mile is in the severity 1 level, which exhibits faulting between 0.12 and 0.24 in. (3 to 6 mm).

As seen in Figure 64, 8% (9 of 110) of the 5.5- to 6.5-in. BCOA projects have more than 40 faulted joints in the right wheel path in the low-severity category. Assuming an average joint spacing of 15 ft for these projects (352 joints per mile), 40 faulted joints per mile represent 11.3% of the total joints per mile.

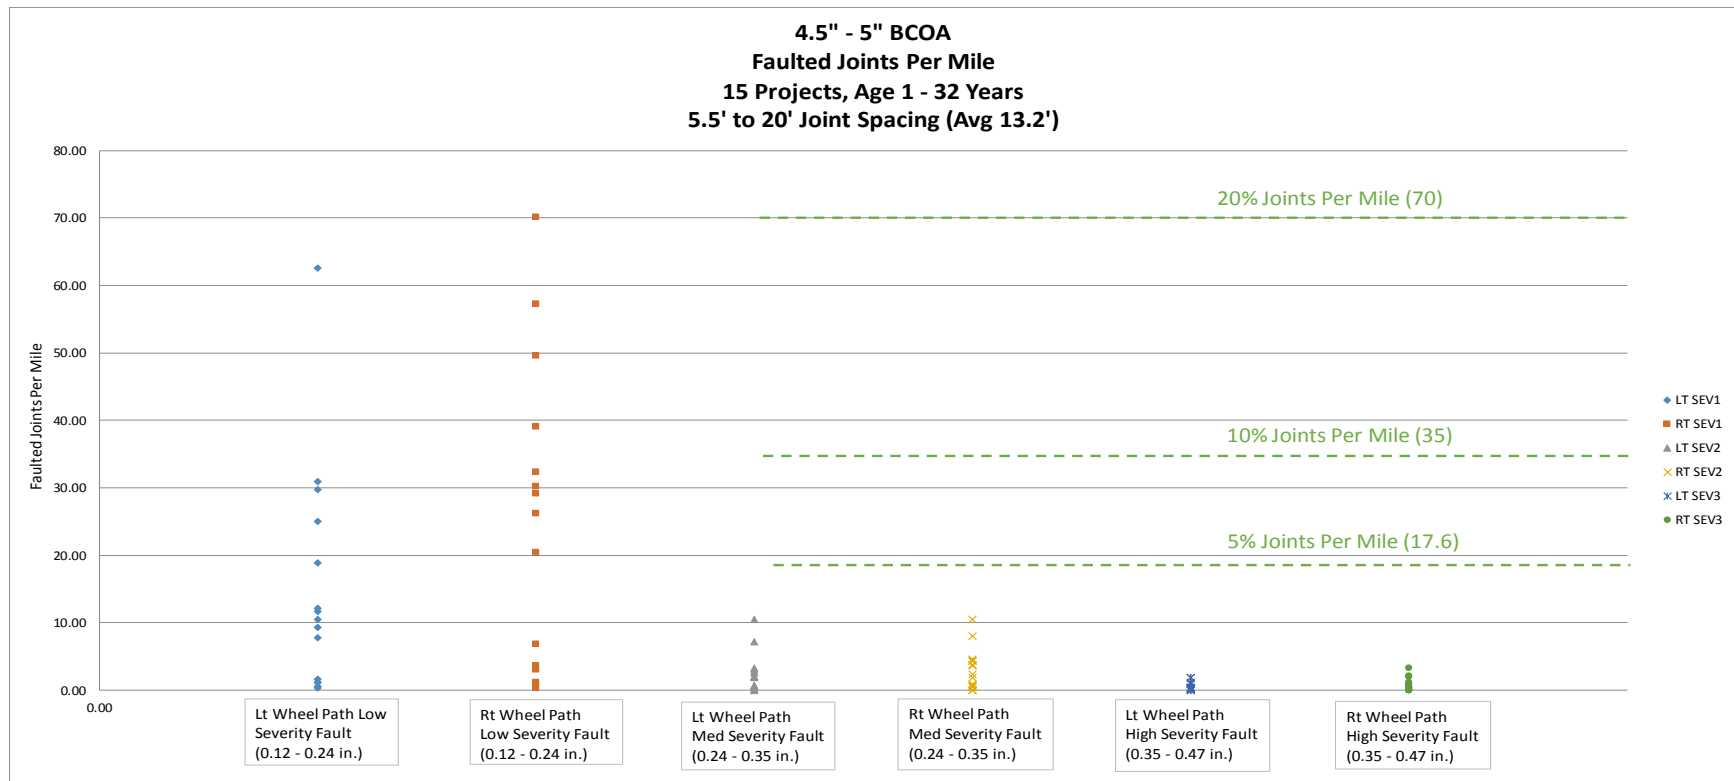
Figure 65. Faulted joints per mile (4.5- to 5-in. BCOA) based on severity levels 1–3

As seen in Figure 65, 20% (3 of 15) of the 4.5- to 5-in. BCOA projects have more than 40 faulted joints per mile in the right wheel path in the low-severity category. Assuming an average joint spacing of 15 ft for these projects (352 joints per mile), 40 faulted joints per mile represents 11.3% of the total joints per mile.

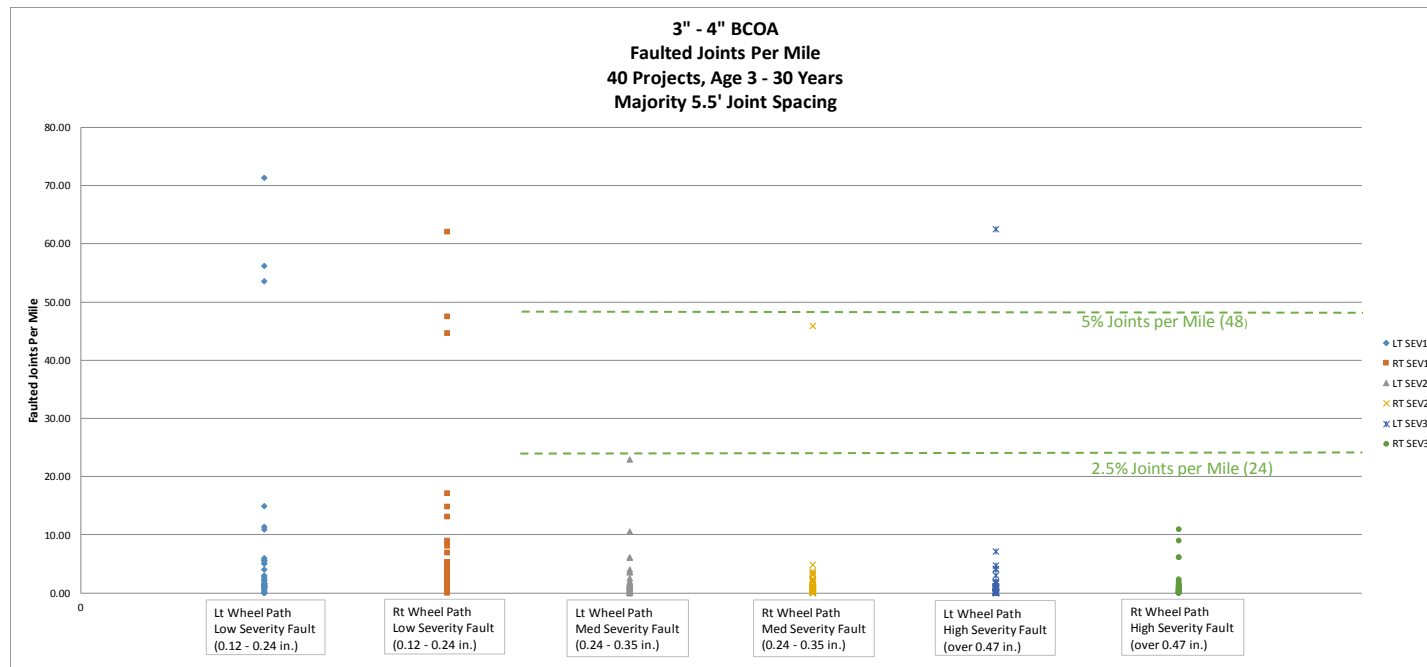
Figure 66. Faulted joints per mile (3- to 4-in. BCOA) based on individual severity levels 1–3

As seen in Figure 66, 7.5% (3 of 40) of the 3- to 4-in. BCOA projects had more than 40 faulted joints per mile in the low-severity category. Assuming an average joint spacing of 5.5 ft for these projects (960 joints per mile), 40 faulted joints represents 4.2% of the total joints per mile.

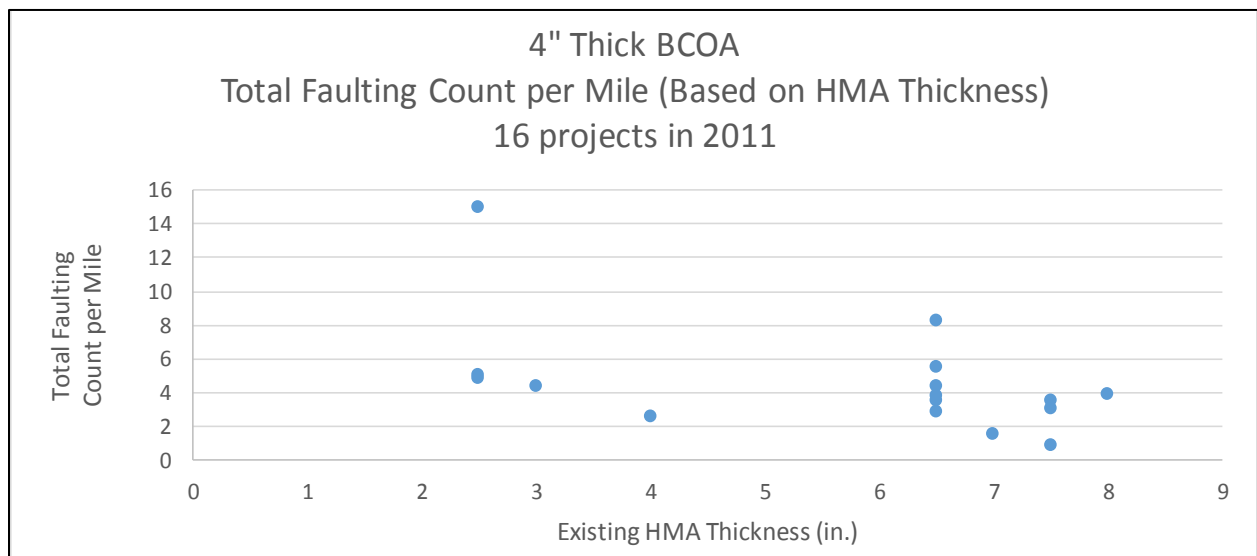
Figure 67. Total faulting count per mile (4-in. BCOA)

Both Figure 67 and Figure 68 show little correlation between existing hot-mix asphalt (HMA) thickness and faulting count per mile.

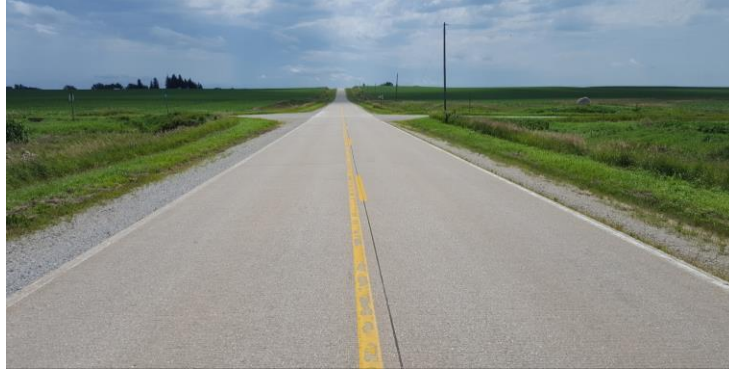
Figure 81. 1978 Grundy County T-55, PCI = 78, IRI = 122 in/mi

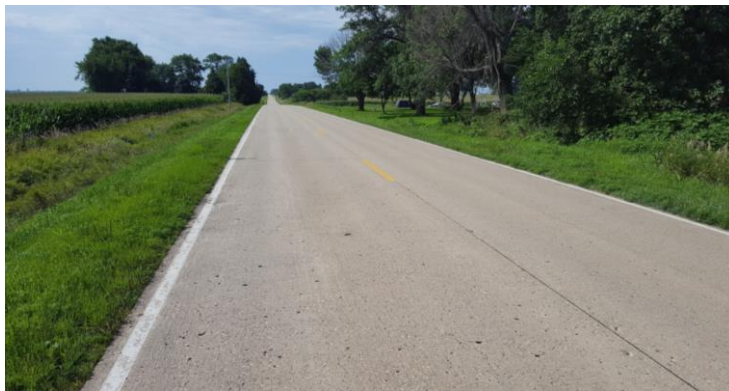
Figure 82. 1977 Boone County R-18, PCI = 72, IRI = 115 in/mi

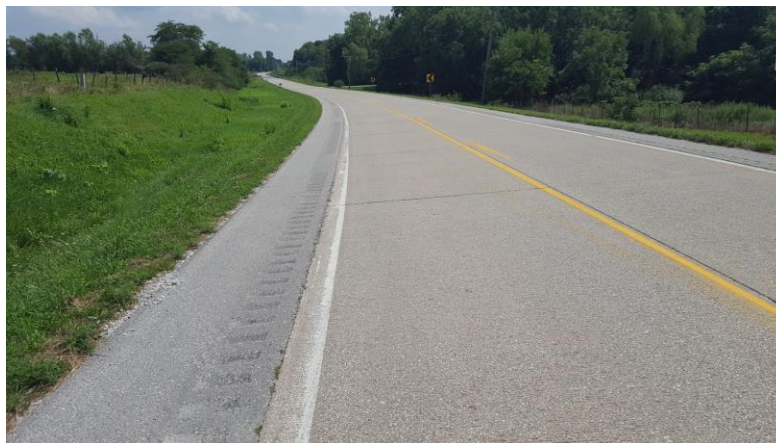
Figure 83. 1977 Washington County W-55, PCI = 78, IRI = 122 in/mi

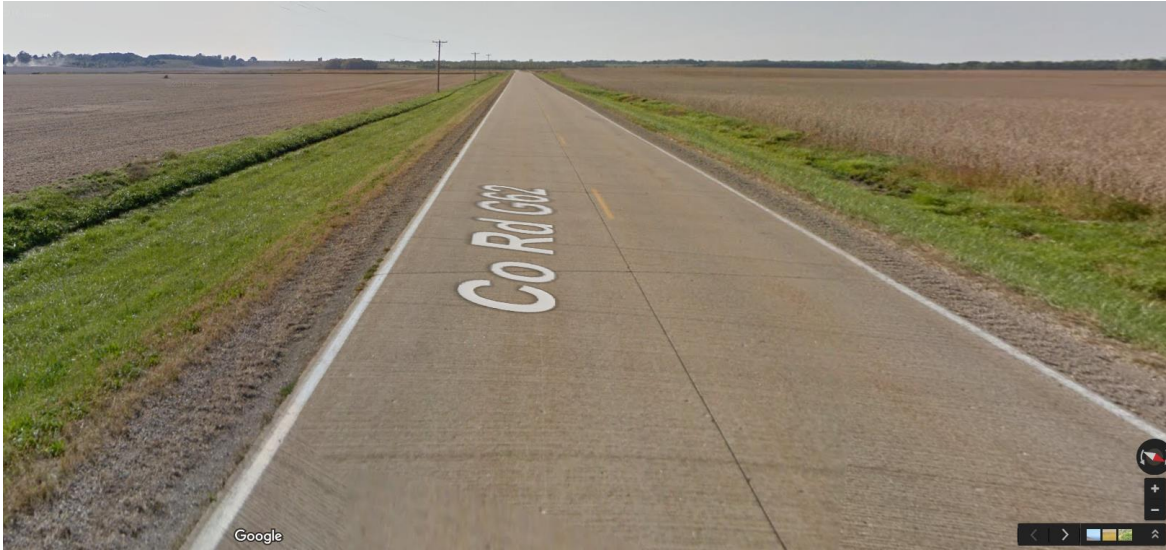
Figure 84. Louisa County G-62, 6-in. BCOA, PCI = 81, age 18 years

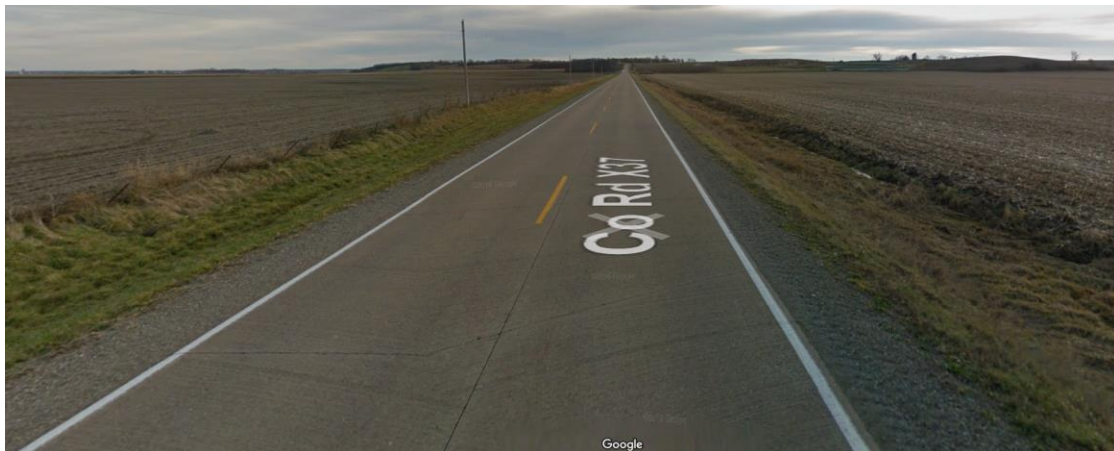
Figure 85. Louisa County X-37, 6-in. BCOA, PCI = 81, age 18 years

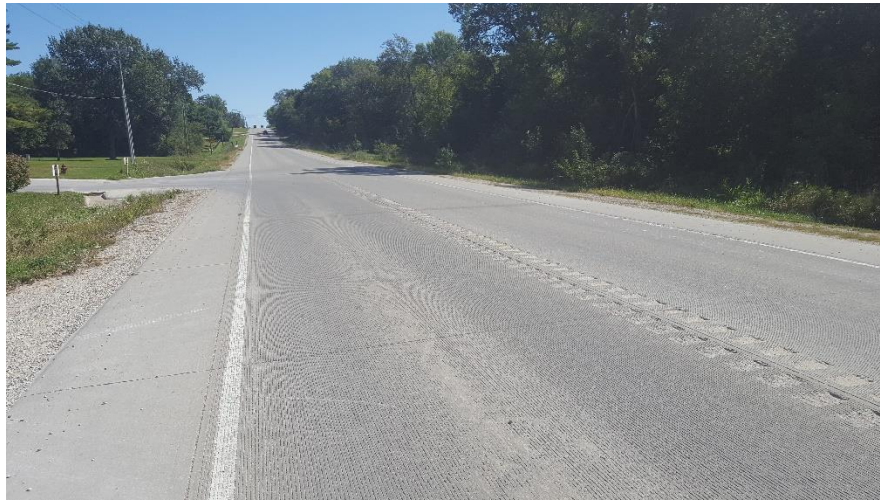
Figure A.1. Overview of Buchanan County D-22, September 2016

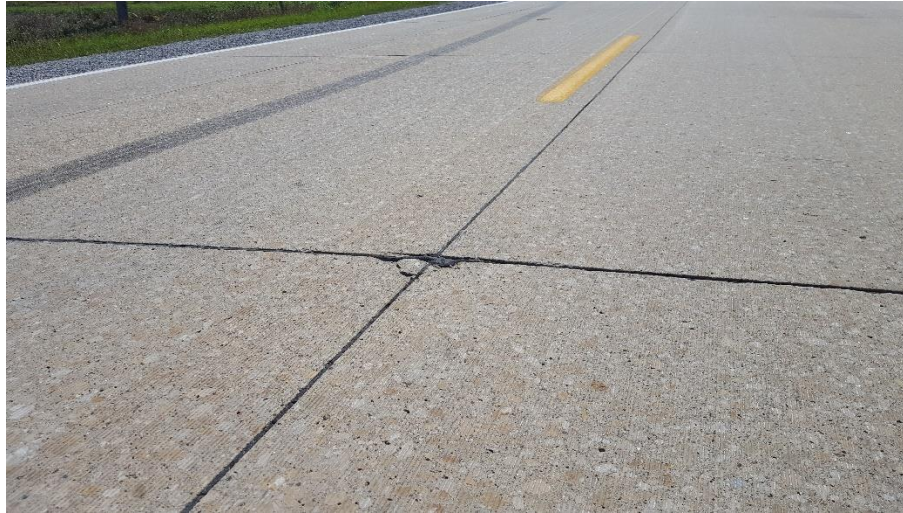
This project was selected for review mainly because of its high IRI value, which measured 172 in/mi in 2014 at a pavement age of 18 years. Discussion with the county engineer confirmed that the overlay had a rough ride, which was attributed to roughness upon original construction and curling and warping (as opposed to faulting). As a result, the entirety of the project was rehabilitated with diamond grinding in 2015. A close-up of the ground surface of the overlay taken at the time of the field review in 2016 is shown in Figure A.5.

Figure A.5. Surface post diamond grinding on Buchanan County V-62, September 2016

Although the most recently collected performance data predates the diamond grind, as of 2016, considerable smoothness had been restored to the overlay.

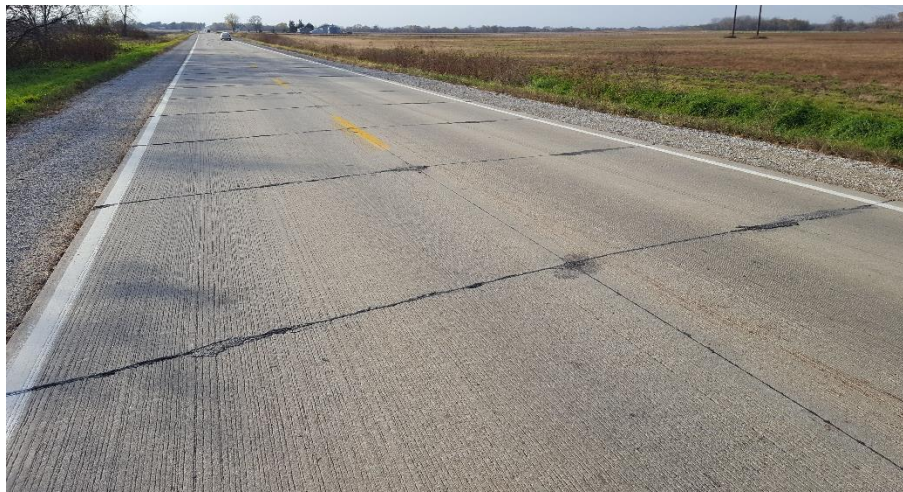
Figure A.15. Overview of Dallas County F-31 west of Granger, November 2016

As is evident in Figure A.15, transverse joint deterioration developed at certain locations along Dallas County F-31, particularly as the overlay approached a creek crossing. Despite sunny conditions on the afternoon of the field review, shadowing from moisture was observed at many of the deteriorated joints and water was found sitting within a spalled joint area, as shown in Figure A.18.

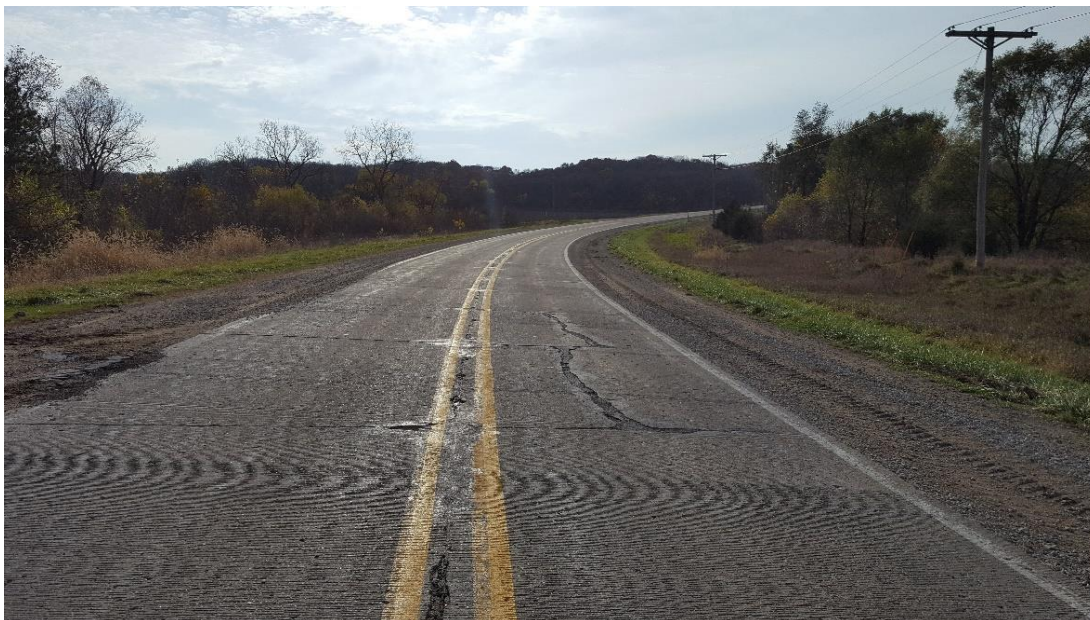
Figure A.20. Overview of Dallas County F-31 west of Minburn, November 2016

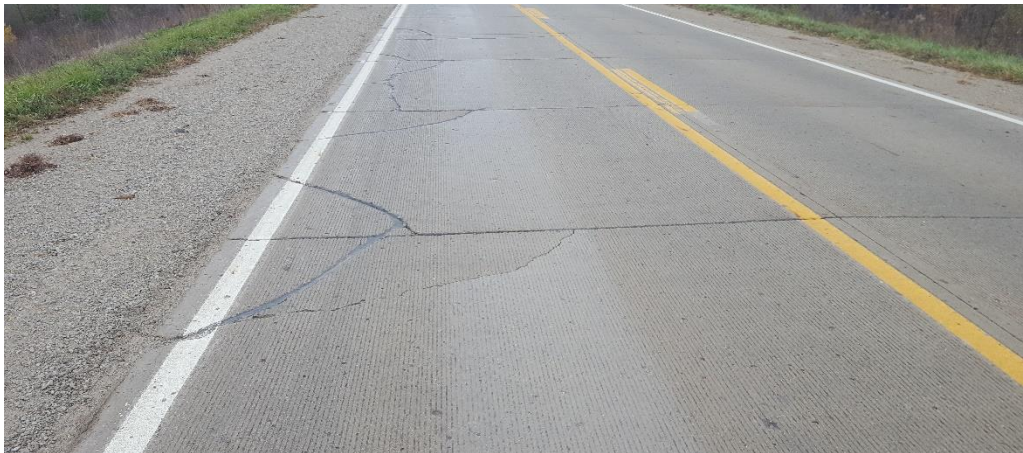
Figure A.24. Overview of Dallas County F-90, November 2016

Dallas County F-90 was observed to have a significant amount of corner and longitudinal cracking, which can be seen in Figure A.24, contributing to a quickly declining PCI of 68 at an age of 9 years. Faulting was also beginning to develop at the joints.

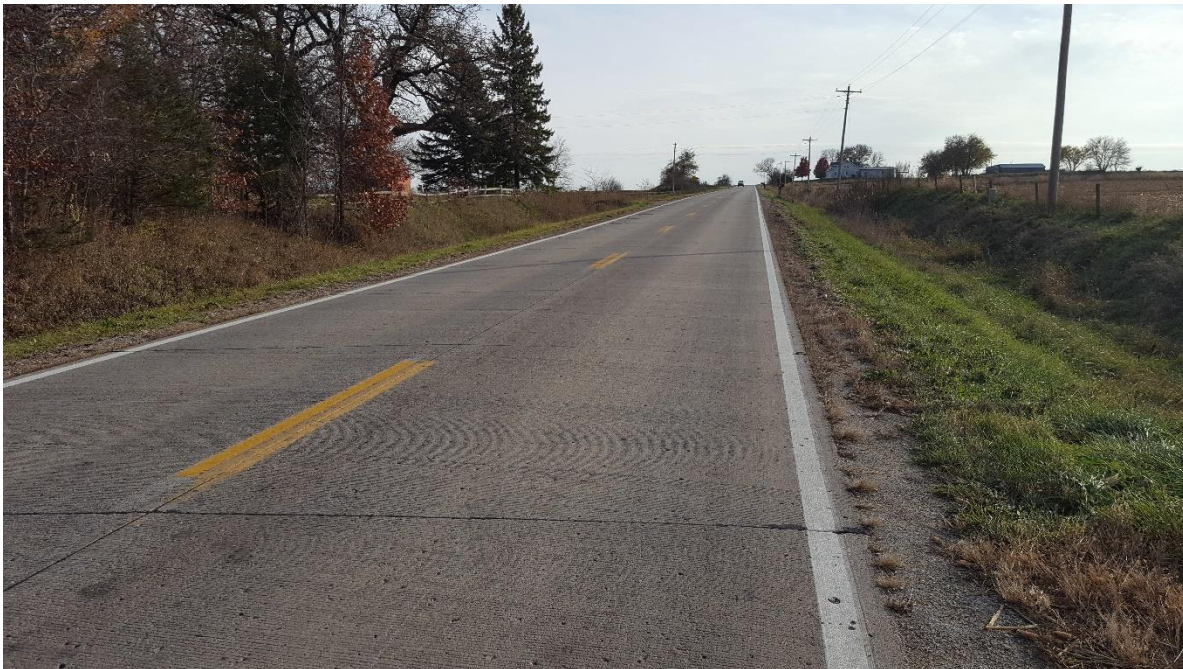
Figure A.27. Overview of Dallas County R-22, November 2016

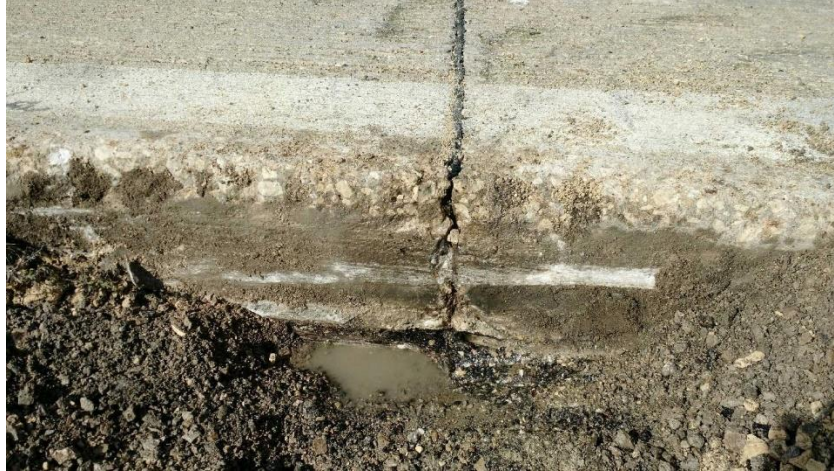
One hypothesis for the development of these faults and accompanying distresses was that they may have occurred over areas of D-cracking in the original, underlying concrete pavement. Another hypothesis was that the faults may have developed because some or most transverse joints may never have activated, leading to wide working cracks where the joints did manage to activate. When repairing a joint distress area in late 2016, county crews dug along the shoulder at the transverse joints in the adjacent slabs and confirmed that the transverse joints in the adjacent slabs had indeed activated, as shown in Figure A.37.

Figure A.37. Activated transverse joint in slab adjacent to blow-up on Linn County North 10th Street
