Best Practices for Bridge Approaches

tech transfer summary

Identification of the Best Practices for the Design, Construction, and Repair of Bridge Approaches (TR-481)

January 2005

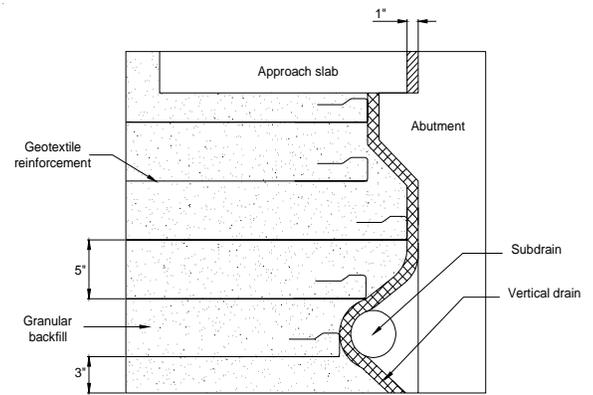
Schematic diagram of drainage details incorporating vertical drain

Drainage capacity results from scale model abutment tests

1. Use a combination of porous backfill and geocomposite drainage systems behind the abutment to improve drainage capacity and reduce erosion around the abutment. Several alternative design details are provided for these recommendations and can be implemented on new construction or rehabilitation of existing bridges.
