Laboratory and Field Testing of an Accelerated Bridge Construction Demonstration Bridge: US Highway 6 Bridge over Keg Creek

Final Report
April 2013

Sponsored by
Federal Highway Administration
Iowa Department of Transportation
(InTrans Project 11-411)

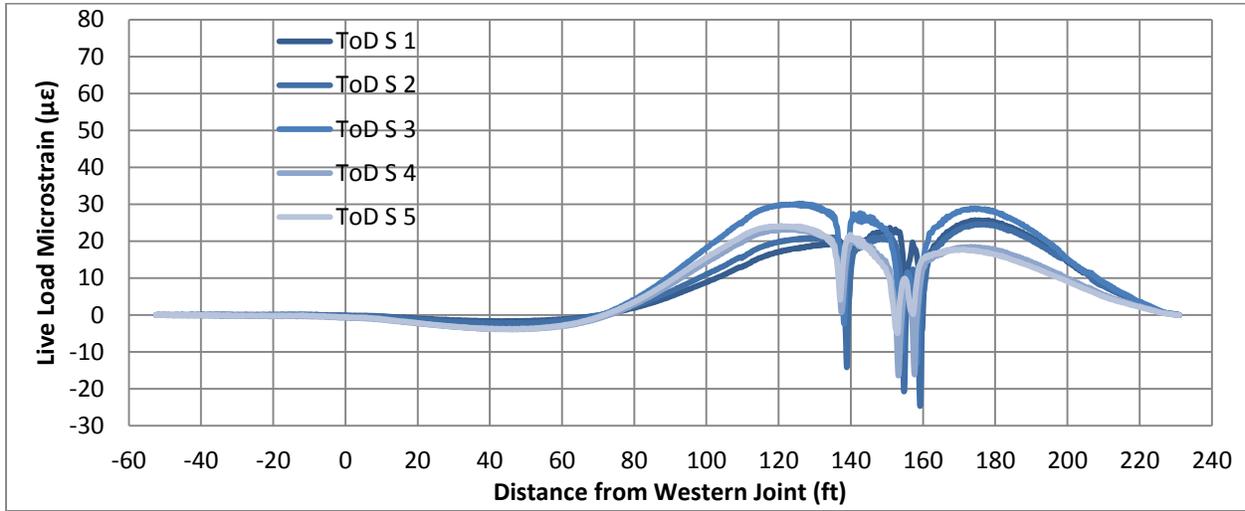
Figure 4.7. Representative data from load path 3 of 2011 live load strains of top of deck gauges south line

There is a distinct difference in the behavior between the north and south lines of the surface-mounted gauges. Reviewing the results from the gauges mounted on the top of the deck along the south instrumentation line, all recorded strain values were very similar throughout the test with maximum strain values being recorded by the transducer located at the centerline of the UHPC joint, which is to be expected. This can be seen in Figure 4.7.

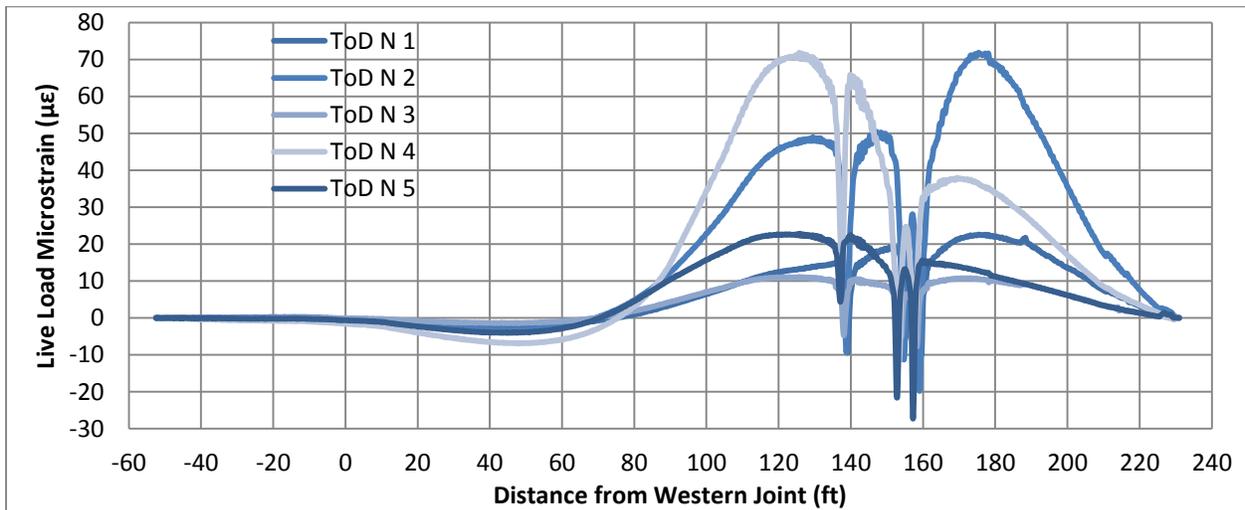
Figure 4.8. Representative data from load path 3 of 2011 live load strains of top of deck gauges north line

For the north line of gauges on the top of the deck, much greater maximum strain values were recorded consistently by the transducers spanning the interface between the HPC precast deck panels and the transverse UHPC joint. Figure 4.8 also shows that these interface gauges are reading significantly higher strains than adjacent gauges along the same north line.

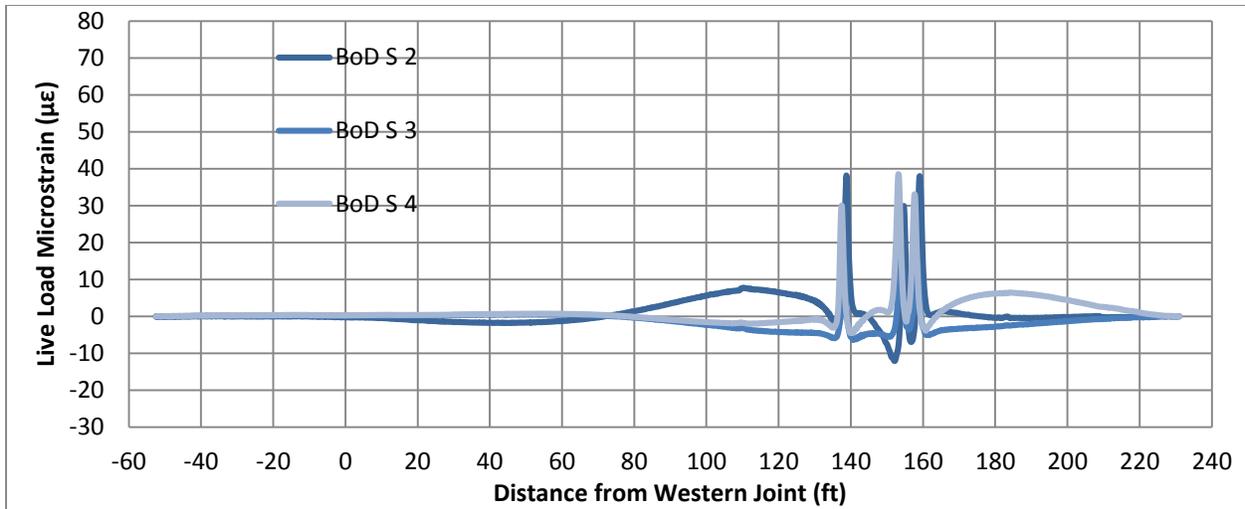
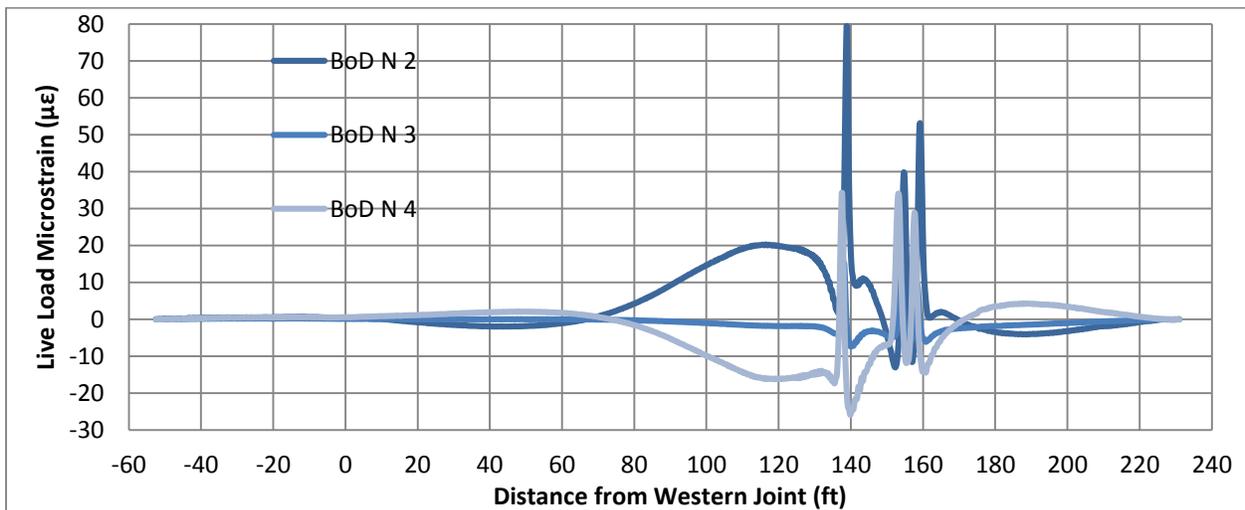
Similar behavior was found in the gauges attached to the bottom of the deck in that there are noticeably higher strains recorded in the north line of gauges as can be seen when comparing Figure 4.9 and Figure 4.10. This could imply failure to fully develop a bond between the UHPC and HPC consistently throughout the transverse joint as was seen in the laboratory testing.

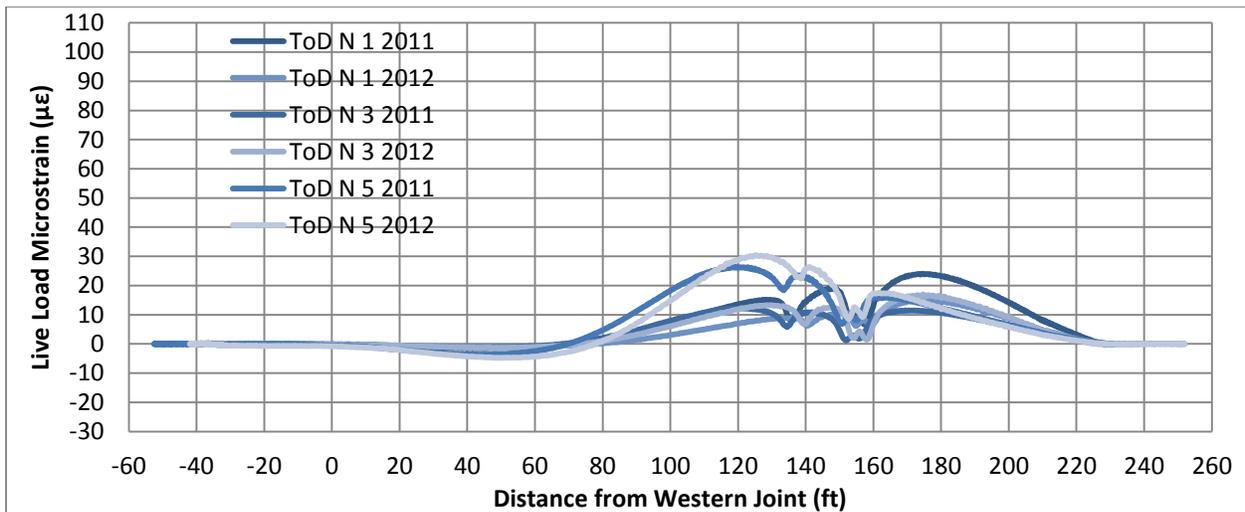
Figure 4.12. Comparison of live load strains from 2011 to 2012 of surface-mounted transducers away from interface load path 2

There also seems to be a consistent increase in maximum strain values between the 2011 and 2012 test with almost all maximum strains now being found at the HPC/UHPC interface locations. The most drastic increases in strains seem to be occurring at these interface locations

as can be seen by investigating the representative data from load path 2 of both tests as shown in Figure 4.11 and Figure 4.12.

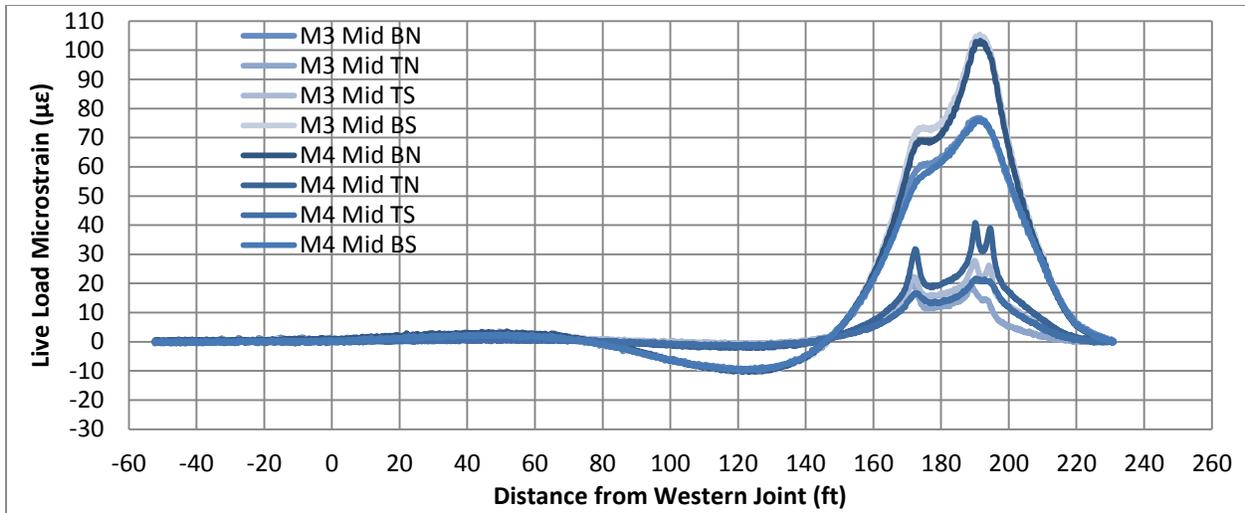
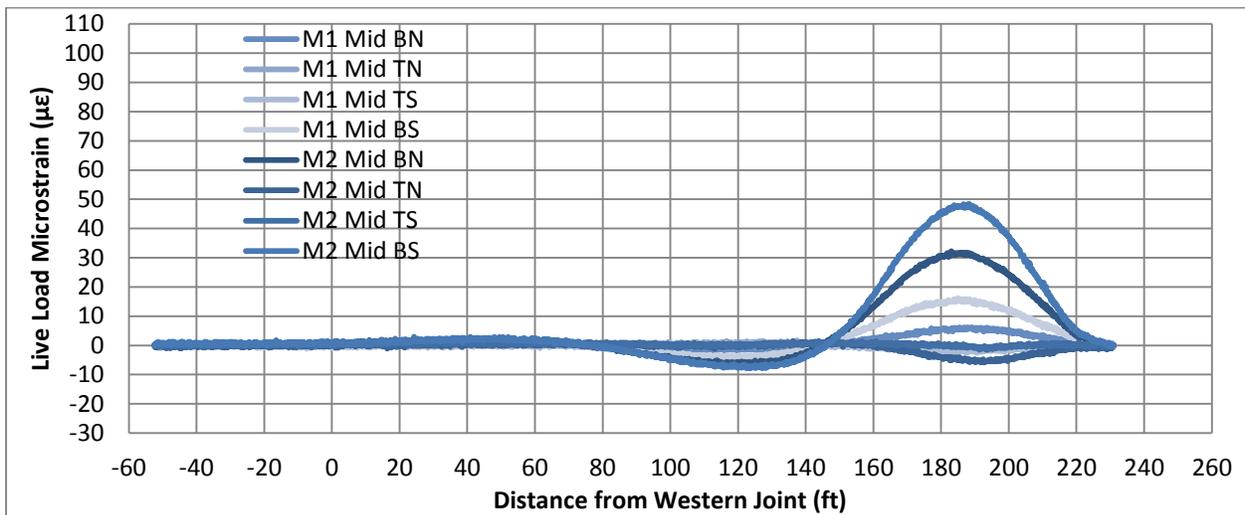
The results also show a difference in strain response between the more heavily loaded girders and the girders farther away from the load path, while the test truck is on the east end span. For girders farther away from the load path, strain values recorded in the bottom flange are tensile strains while strains in the top flange are recorded as compressive strains, indicating the neutral axis is located somewhere within the steel beam.

For modules 1 and 2 the neutral axis is typically calculated between 24 and 29 in. from the underside of the bottom flange of the steel girders which are W30X99 steel beams having a depth of 29.65 in. For the girders underneath the load path, transducers on both the bottom and top flange are recording tensile strains, indicating a neutral axis above the top flange.

These results are not necessarily unexpected due to the precast deck panels being compositely constructed with the steel girders, but the extent to which the neutral axis is above the steel girders is unexpected. At the extreme, the neutral axis is calculated to even exceed the height of the precast deck by as much as 10 in. (This is discussed further later in this report.)

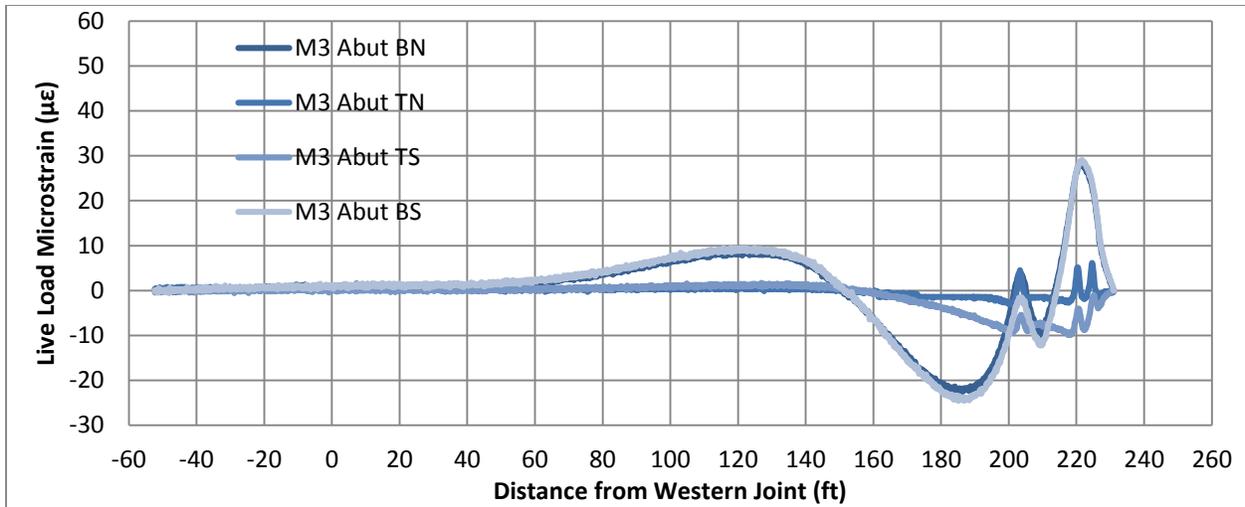
Figure 4.19. Representative data from load path 3 of 2011 live load strains for steel girders of module 3 at abutment

For gauges located at the abutment, maximum strains were recorded as tensile strains in the girders closest to the specified load path after the front axle of the truck had exited off of the bridge while the rear axle was still on the east end span. These maxima were seen in the bottom flange registering just over +30 $\mu\epsilon$. Another local maximum occurs as the test truck is near the midspan of the east end span. When the test truck is located at this position, the bottom flange of the girders at the abutment registers compressive strains indicating a negative moment at the abutment as expected due to the semi-integral abutments. Strains recorded in the top flange of the girders at the abutment never registered above 10 $\mu\epsilon$, tensile or compressive.

A representative data set is shown in Figure 4.19 for gauges mounted to the girders under module 3 at the abutment for load path 3 showing this behavior. Due to the stopping of data collection in the 2011 test immediately after the rear axle passed the east joint, full behavior of the semi-integral abutment was not able to be seen, but is discussed in greater detail in the subsequent section related to the 2012 test data.

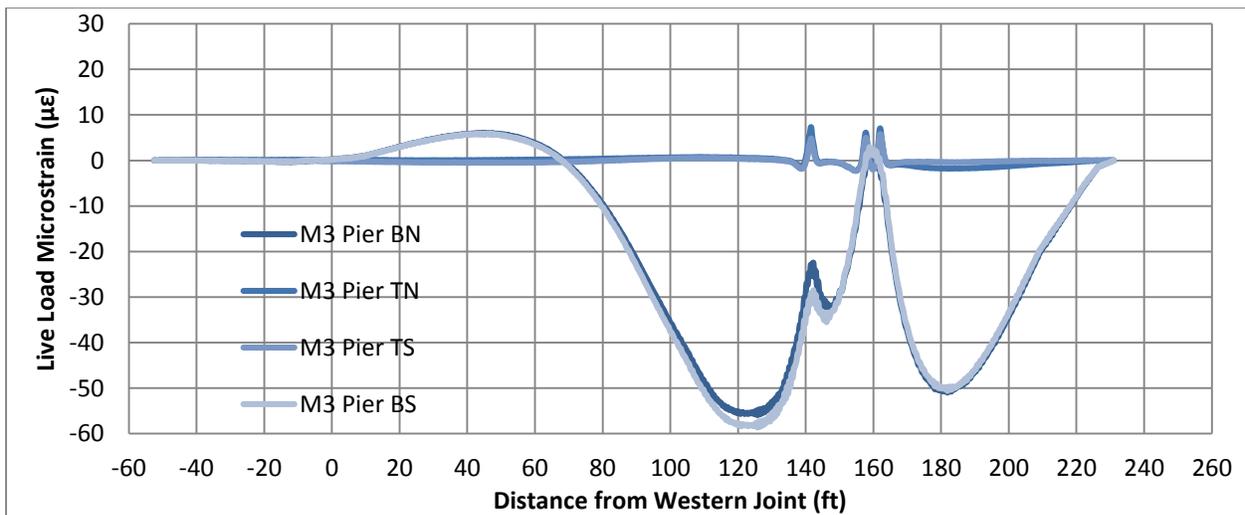
Figure 4.20. Representative data from load path 3 of 2011 live load strains for steel girders of module 3 at pier

For gauges located at the pier, maximum strains were recorded as compressive strains in the bottom flange of the girder closest to the specified load path as the truck approached the pier from the west. Compressive strains in the bottom flange imply a negative moment region at the pier. This is to be expected based on the fact that the bridge was designed to be continuous for live loads. The greatest strains recorded in the top flange of the girders at the pier location never registered above 10 $\mu\epsilon$, tensile or compressive. A representative sample of these data from load path 3 is shown in Figure 4.20.

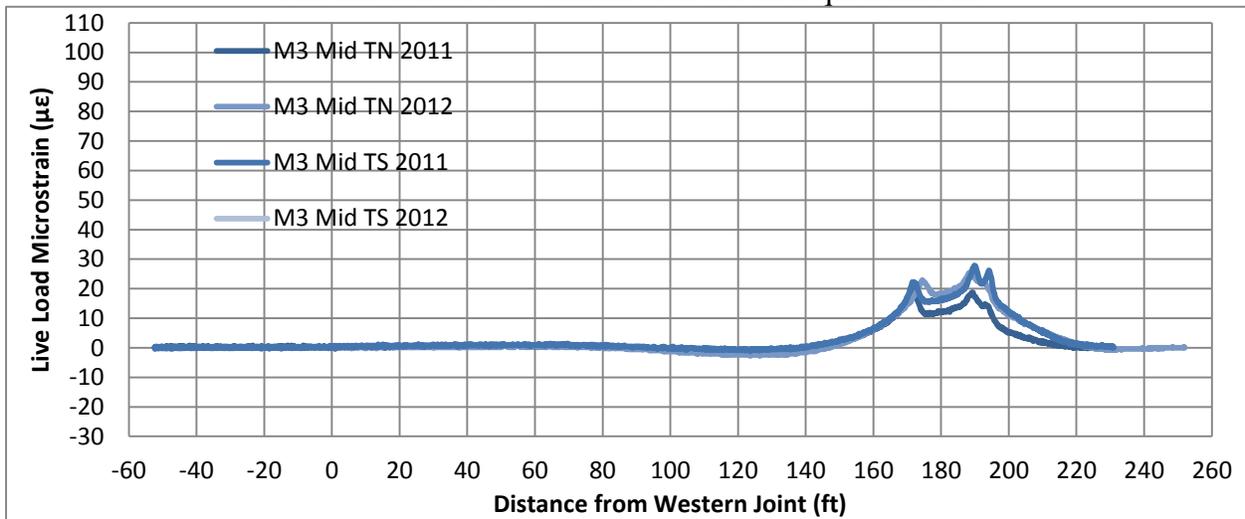
Figure 4.22. Comparison of live load strains from 2011 to 2012 of transducers on top flange of girder at midspan for module 3 from load path 4

Figure 4.21 and Figure 4.22 show comparisons of representative samples of data between the 2011 and 2012 test for module 3 strains recorded in the top and bottom flanges for load path 4. The differences between the tests are then quantified in

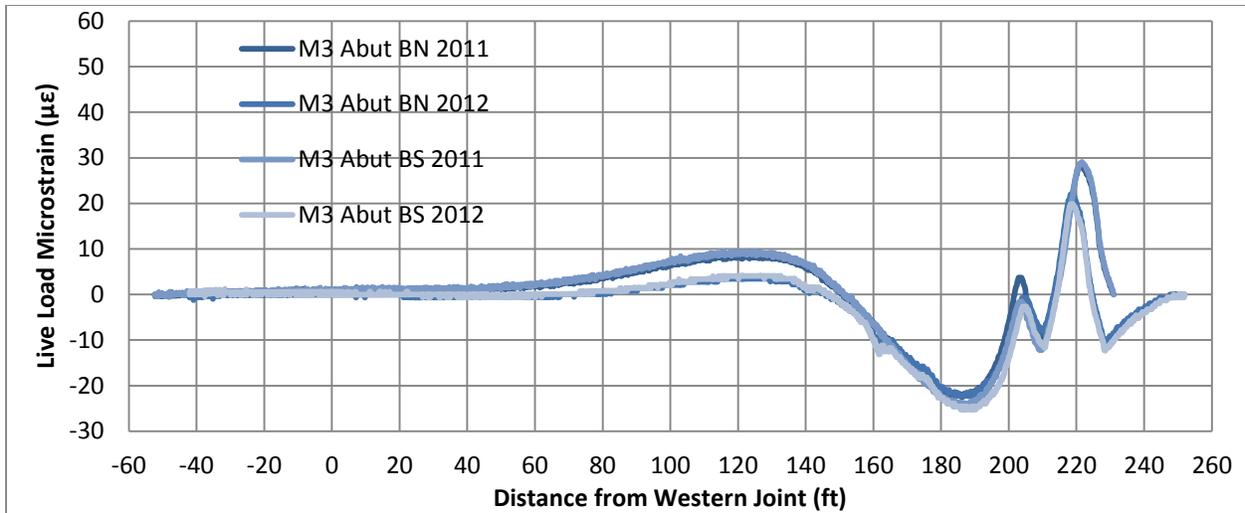
Figure 4.23. Comparison of live load strains from 2011 to 2012 of transducers on bottom flange of girder at abutment for module 3 from load path 3

As in the 2011 test, all strain values recorded by the transducers at the abutment are well below the yield strain of the steel girders with the greatest being -25 $\mu\epsilon$. Maximum strains recorded in the top flanges at the abutment again never registered higher than 10 $\mu\epsilon$, tensile or compressive.

Representative sets of data comparing results from the 2011 test to the 2012 test are shown in Figure 4.23.

In this figure, it can be seen that maximum strain values recorded in the bottom flange for a majority of the load paths have shifted from tensile in the 2011 test to compressive in the 2012 test. This is due to the fact that data stopped being collected as soon as the rear axle left the bridge span in the first test while, in the second test, data was collected until the rear axle was approximately 20 ft past the east joint. Therefore, the behavior of the semi-integral abutment was captured as the test truck exited on the approach slab in the data from the 2012 test.
