Repair of Damaged Prestressed Concrete Bridges Using CFRP

F. Wayne Klaiber, Terry J. Wipf

Brian J. Kempers

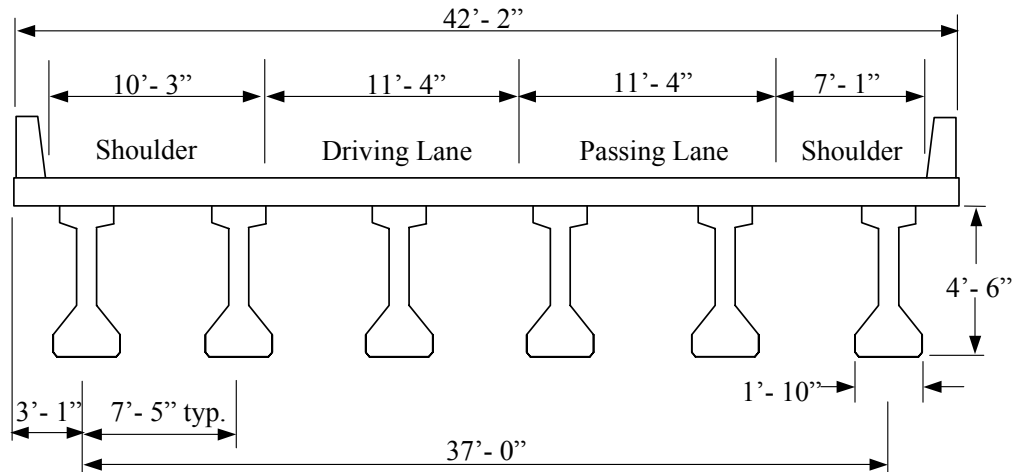
FIGURE 1. Cross section of Altoona Bridge

The bridge that was damaged was on the south bound portion of the IA Highway 65 bridge that crosses IA Highway 6 in the vicinity of Altoona, Iowa. This four span bridge consists of two 96.5 ft main spans and two approach spans – the north one 36 ft long and the south one 46 ft long. A cross-section of this bridge is presented in Fig. 1. All six of the LXD P/C girders in one of the main spans were damaged by an overheight vehicle traveling east on IA Highway 6. Although, as illustrated in Fig. 2, all 6 girders were damaged approximately 30 ft from the center pier, most of the damage was to the first two girders. Damage to Beam 1 consisted of spalling of concrete from the bottom flange and the severing of one strand. Damage to Beam 2 (shown in Fig. 3) was the most severe in that significantly more concrete spalled from the bottom flange exposing five strands two of which were severed.
