DETERMINE INITIAL CAUSE FOR CURRENT PREMATURE PORTLAND CEMENT CONCRETE PAVEMENT DETERIORATION

FINAL REPORT

Sponsored by the Project Development Division
of the Iowa Department of Transportation
and the Iowa Highway Research Board
Iowa DOT Project TR-406
CTRE Management Project 97-13

OCTOBER 2000

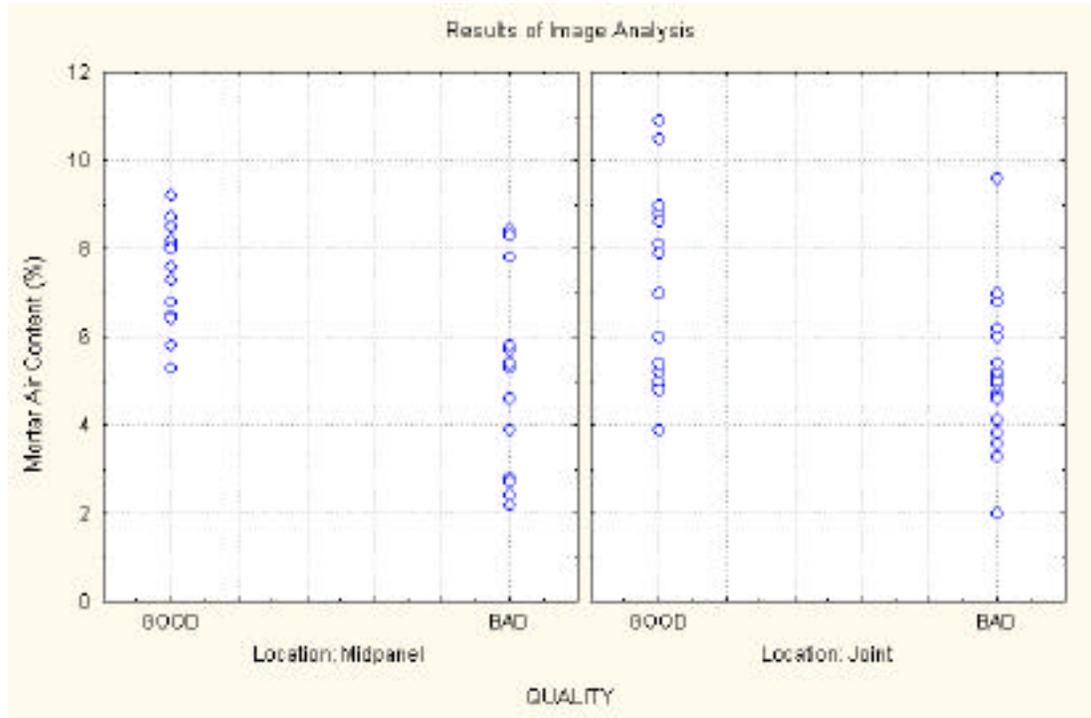
The results summarized in Table 3 and shown in Figure 7 indicate that the pavements that exhibited premature deterioration tended to have a wide range of mortar air contents (roughly from two to 10 percent). The average mortar air content for the pavements that exhibited premature distress was 5.1 percent, and only seven out of the 39 specimens that were tested had

air contents greater than 6 percent. In contrast, the pavements that exhibited good field performance had a slightly narrower range of air contents (range from four to 11 percent). The average mortar air content for the good pavements was 7.3 percent and only eight out of the 32 specimens that were tested had air contents less than 6 percent.

FIGURE 7 Results of the image analysis measurements for air content.

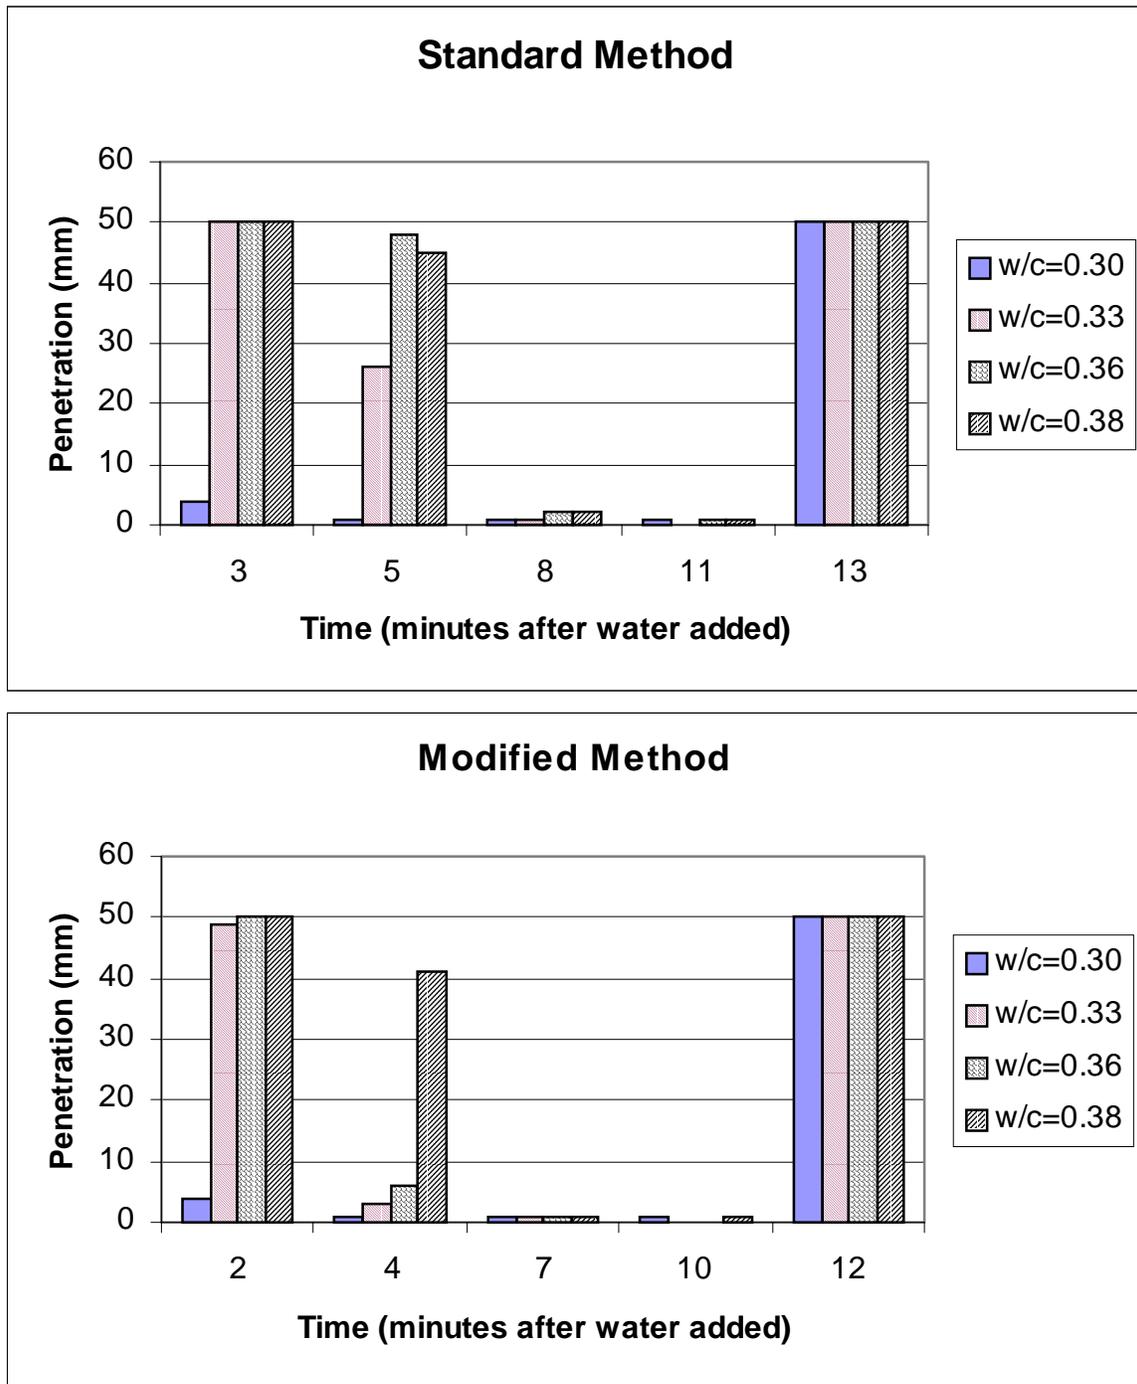
The different mix cycles also had an influence on the test results. Typically, the modified mix cycle aggravated the premature stiffing problems. This is best illustrated by the Kaiser cement (see Figure 12). This particular cement contained only bassanite ($\text{CaSO}_4-0.5\text{H}_2\text{O}$) and it had a very low concentration of tricalcium aluminate (about 3 percent). Hence, it is a good example of a cement that is prone to false set. The cement exhibited similar behavior using either the standard or the modified test procedure. The mortar always regained its plasticity after the remix cycle. In fact, the Kaiser cement even exhibited premature stiffening when the standard C 109 mortar cube mixing procedure was used. This mix cycle consists of 90 seconds of mixing, 90 seconds of rest, and then an additional 60 seconds of mixing.

FIGURE 12 Influence of water-cement ratio on the premature stiffening tests.

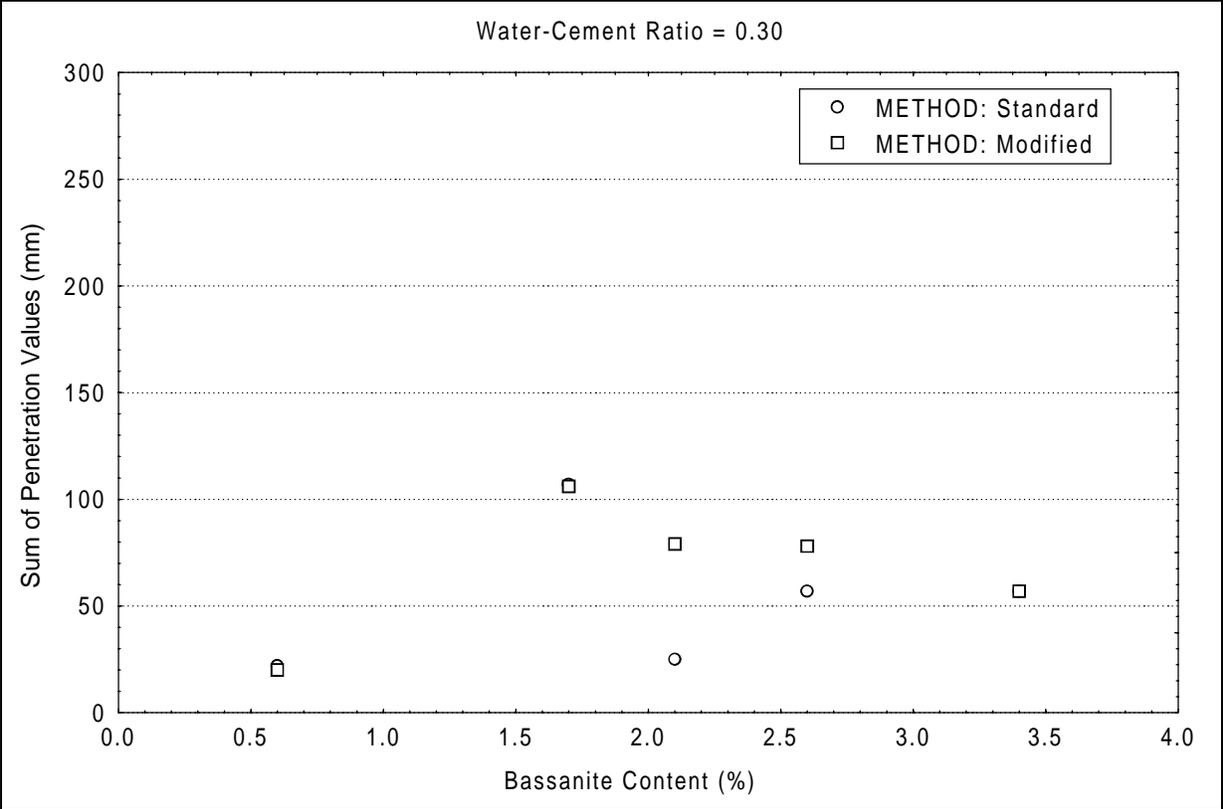
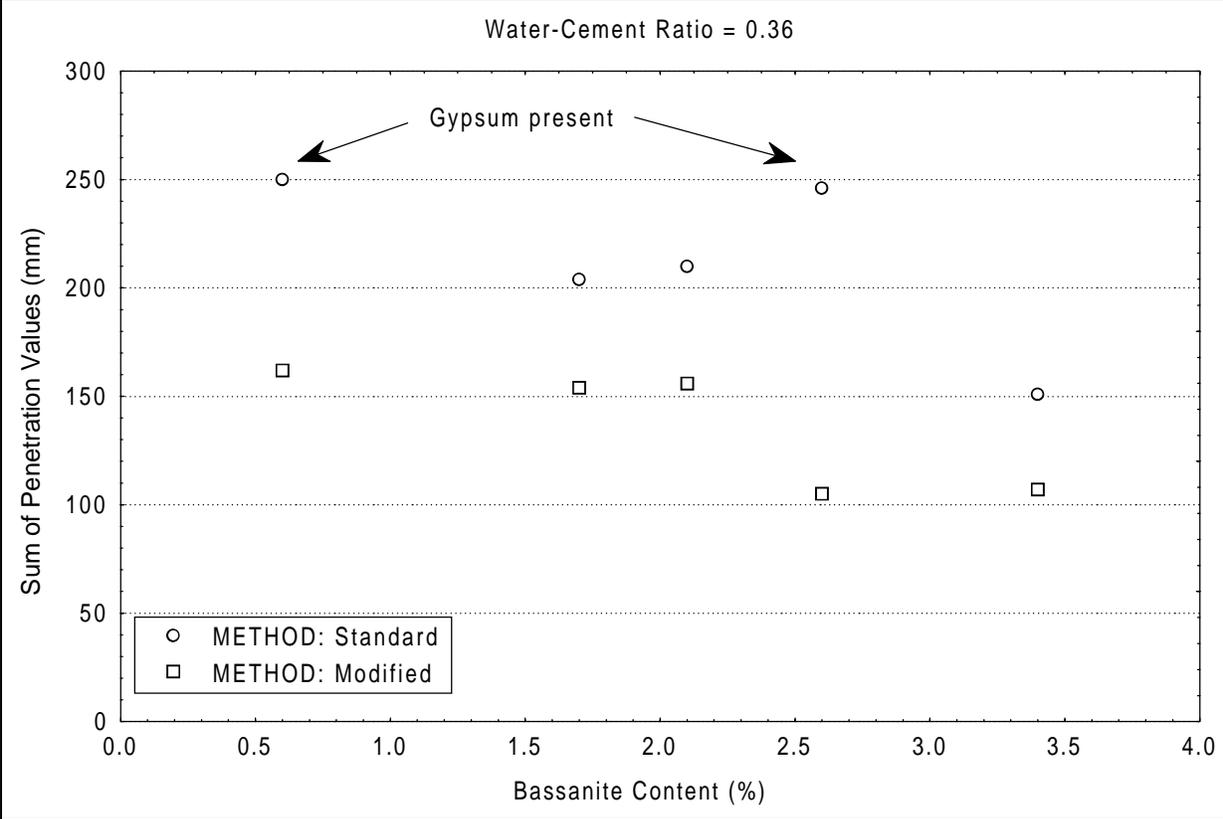
FIGURE 13 Relationship between premature stiffening and bassanite content.

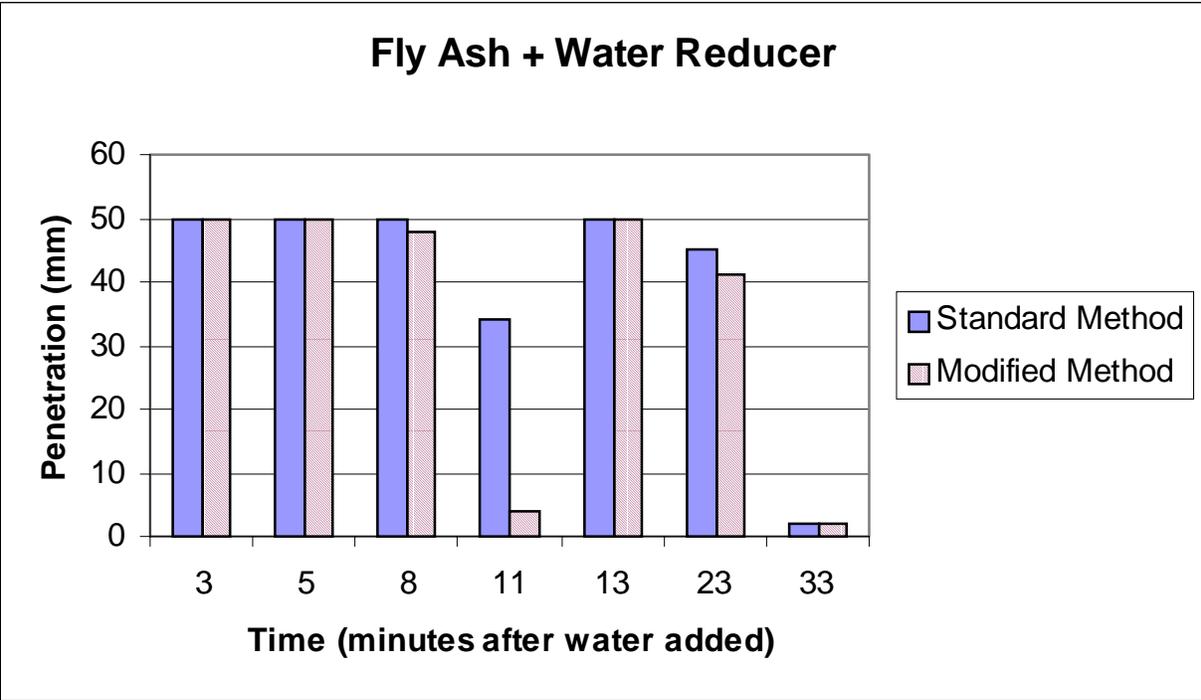
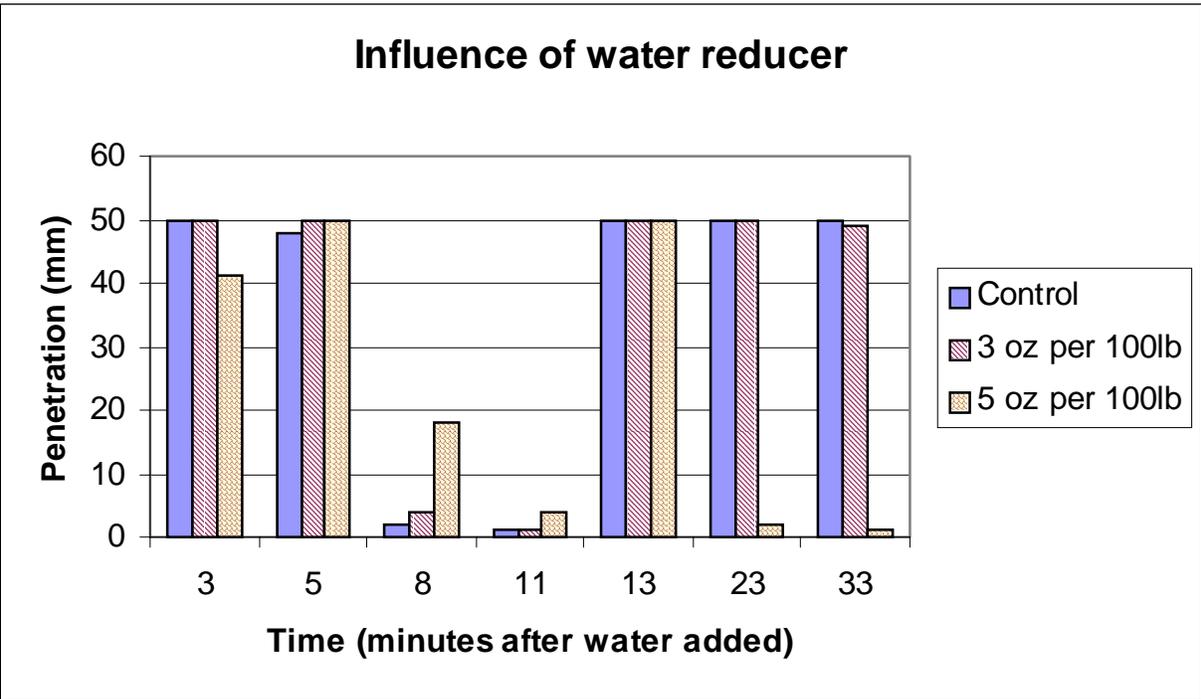
The combined use of fly ash and water reducer tended to eliminate the premature stiffening problems in all of the mortars that were prepared using the standard mixing procedure. Premature stiffening was still evident in some of the mortars prepared using the modified mixing procedure. All of the instances of premature stiffening were classified as false set. The mortars containing the Kaiser cement behaved oddly during this testing regime. The odd behavior is illustrated in Figure 14. The mortar penetration data indicated that the mixes were experiencing premature stiffening again, approximately 10 to 20 minutes after the remix cycle (refer to the top panel of Figure 14). This behavior appeared to be associated with the water reducer dosage (see the bottom panel of Figure 14). The mortars were not subjected to a second remix cycle. This odd behavior does tend to indicate an admixture incompatibility. It also suggests that the observation period used in this study (about 30 minutes after the water was added to the mortar) may not have been long enough to catch all instances of this type of behavior. Future studies

FIGURE 14 Abnormal behavior in the premature stiffening tests caused by admixtures.

should place more emphasis on fundamental aspects of this behavior because it suggests that the solubility of bassanite has been drastically reduced during the early stages of hydration (about the first 10 to 20 minutes).

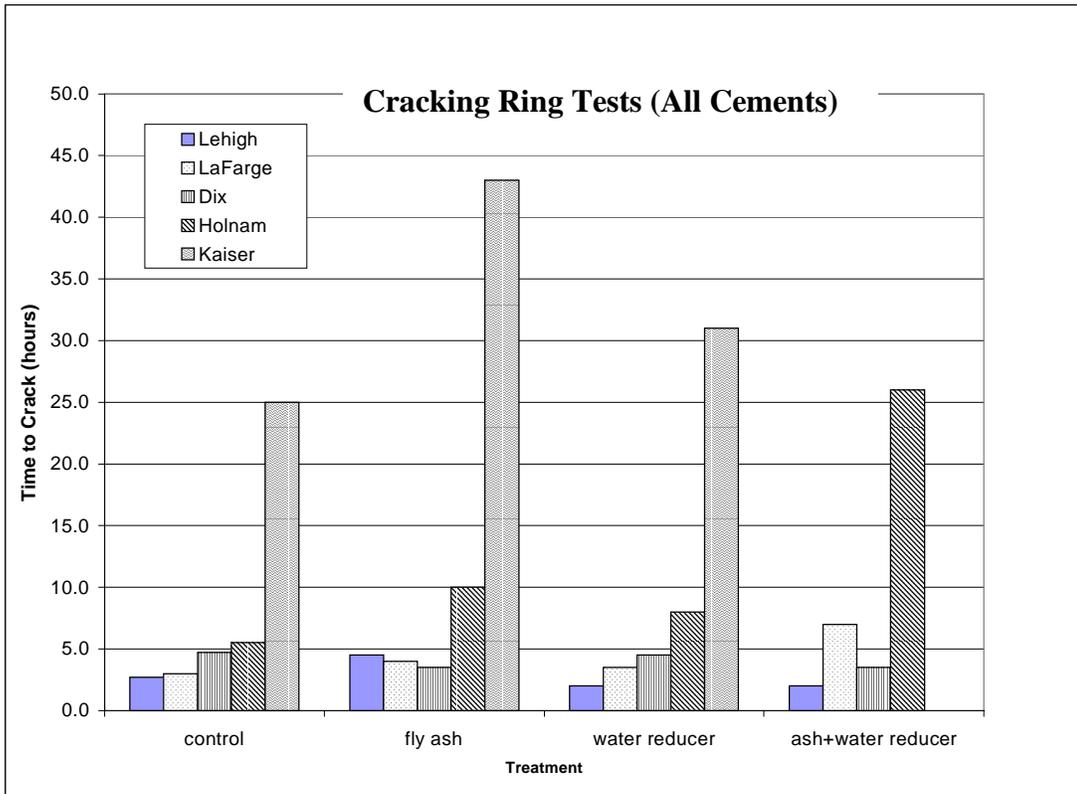
The results of the restrained shrinkage tests are shown in Figure 15. The raw data are given in Appendix E. The rating scheme appropriate for this test has already been presented in Figure 2. A tabular summary of the test results for the control specimens is given in Table 10. Only the results for the control specimens were given in the table because it was not clear whether the rating scheme was appropriate for the cement pastes containing admixtures. The dosage rate for the water reducer was five ounces per 100 pounds of cement, and 20 percent fly ash was used to replace an equivalent mass of cement. None of the cements received a poor rating.

FIGURE 15 Results of the restrained shrinkage tests (cracking ring tests).

The largest variable in the test appeared to be the brand of cement that was used. The Kaiser cement exhibited exceptional behavior in this test. However, since it had a chemical composition similar to a type V cement (but was marketed as a type I-II), it will not be considered further in this discussion. The tests indicated that the use of the class C fly ash normally increased the time to cracking (refer to Figure 16). Only the Dixon Marquette cement exhibited a reduction in the time to cracking when used with 20 percent fly ash. Water reducer tended to have little influence on the time to cracking. Only the Holnam cement exhibited a significant benefit from the use of the water reducer. The other three cements (Lehigh, LaFarge, and Dixon Marquette) tended to show only small changes from the control specimens. The use of a combination of fly ash and water reducer increased the time to cracking for the mixtures containing Holnam and LaFarge cements. The remaining two cements, Lehigh and Dixon Marquette, exhibited slight reductions in the time to cracking.

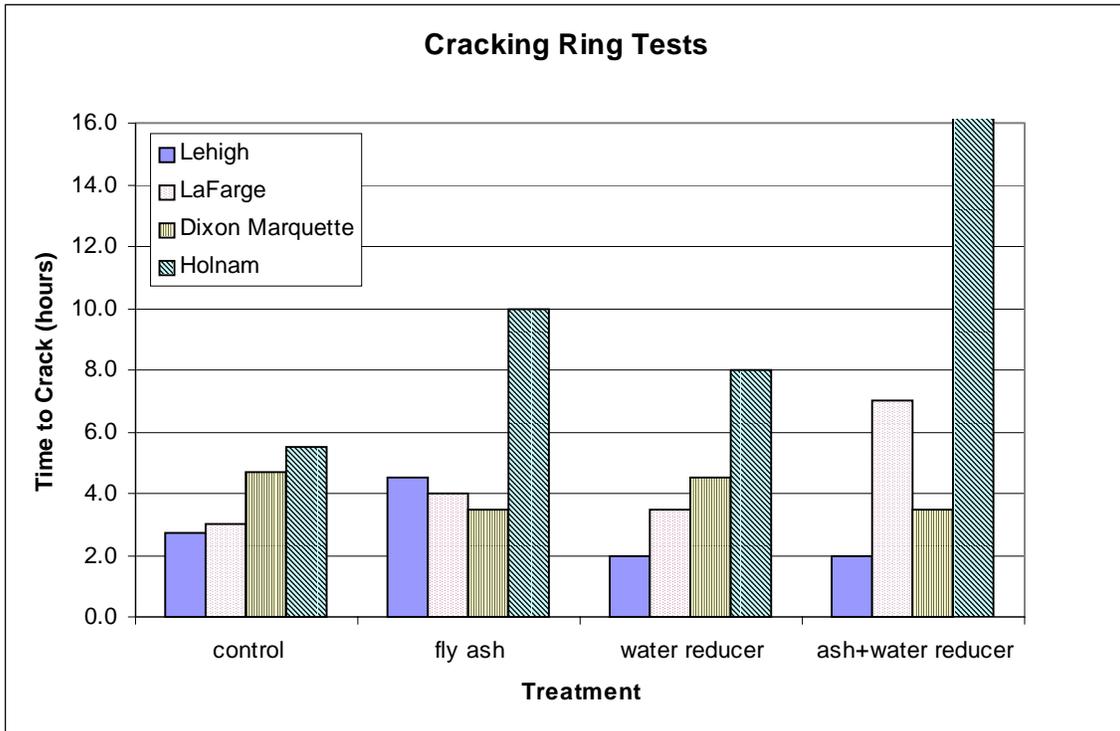
FIGURE 16 Expanded view of the restrained shrinkage tests (no Kaiser cement).

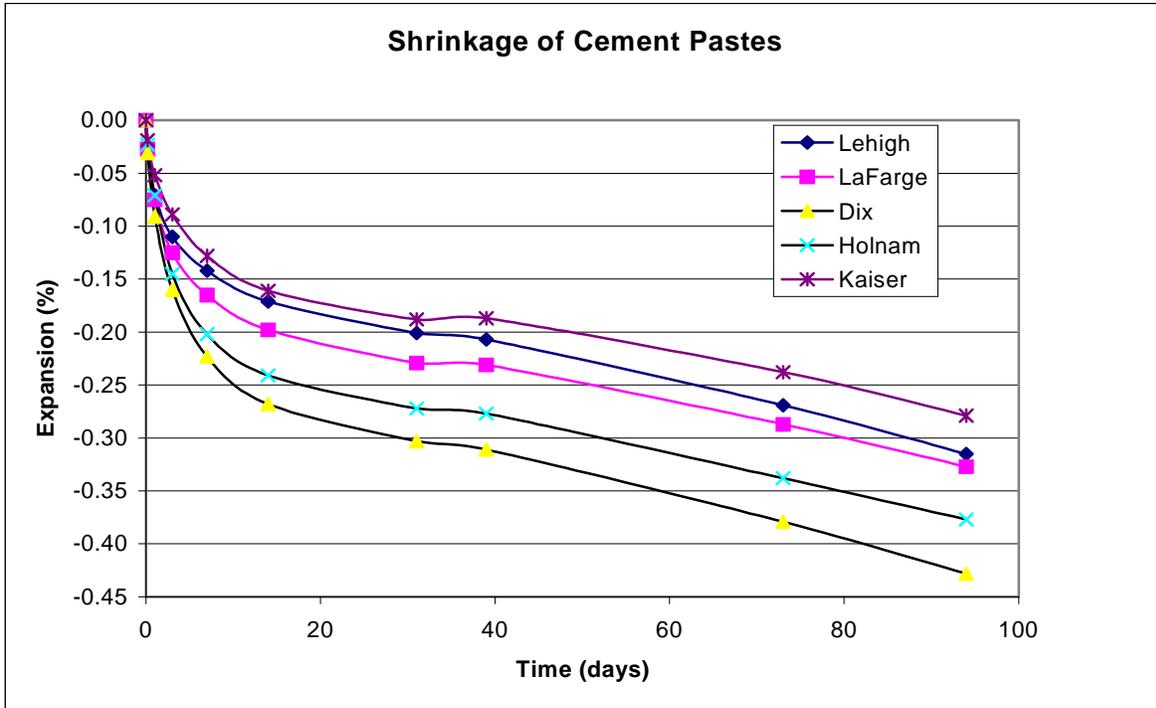
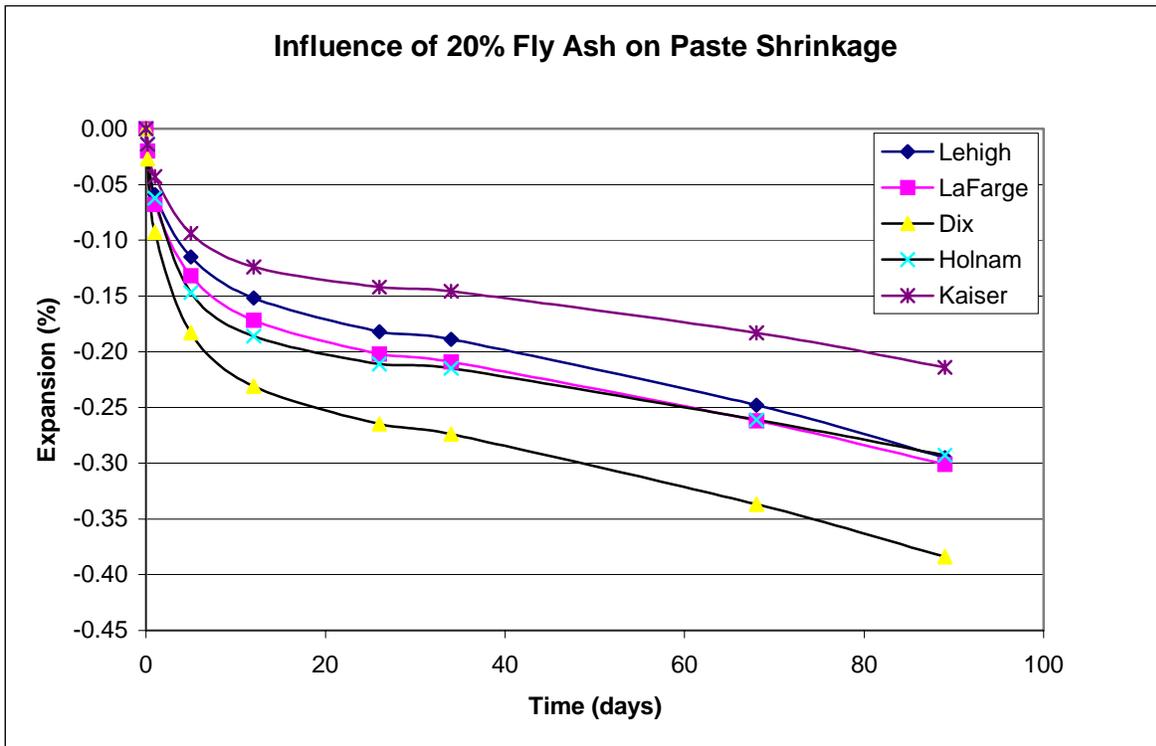
The results of the unrestrained shrinkage tests are shown in Figure 17. The raw data are given in Appendix E. The test results were considerably different than those obtained from the restrained shrinkage tests. The Kaiser cement still performed the best; however, it was only slightly better than the Lehigh and LaFarge cements. Holnam cement and Dixon Marquette cement performed the worst in this test. It is interesting to note that these last two cements, Holnam and Dixon Marquette, were the only cements that contained significant amounts of gypsum (i.e., greater than one percent by mass). In contrast, the restrained shrinkage tests indicated that Kaiser cement greatly outperformed the remaining cements (almost by an order of magnitude in some instances). This was followed by Dixon Marquette cement, then Holnam cement, then LaFarge cement, and finally the Lehigh cement. Hence, the two test methods only agreed on the fact that the Kaiser cement performed the best out of the five that were tested. The performance of the remaining cements almost appeared to be inversely categorized by the two different test methods.

The use of 20 percent fly ash in a mixture reduced the unrestrained shrinkage for all of the cements that were included in this study (see Figure 17). This was in general agreement with the cracking ring study, where four out of five of the cements exhibited improved performance when fly ash was added to the mixture. Companion test specimens that were submerged in water, rather than allowed to dry in air, indicated that the fly ash had a mixed effect on the expansion of the test specimens (see Figure 18). Three of the mixes expanded slightly more than the control specimens (on the average, about 0.02 percent more expansion). Of the remaining mixes, one was too close to call, while the other mix exhibited a slight reduction in expansion (about 0.02 percent less than the control specimen). The overall effect was to reduce the extreme values in the data set (i.e., low values increased while high values decreased).

FIGURE 17 Unrestrained shrinkage during air curing for the various mixes.

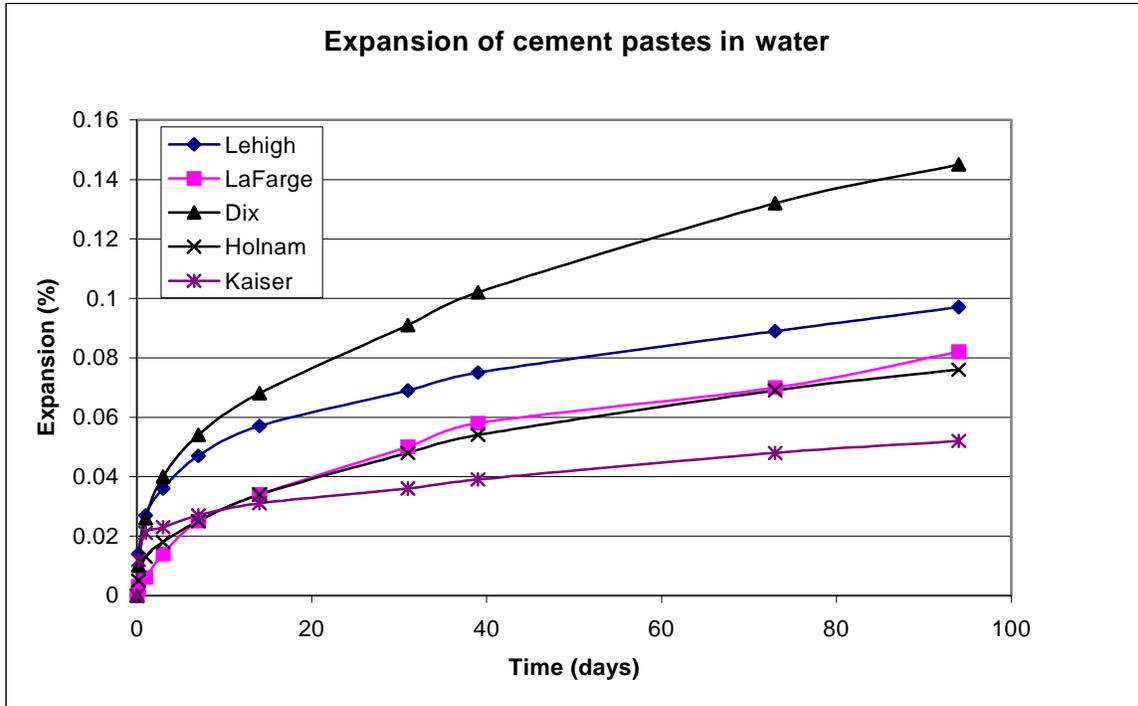
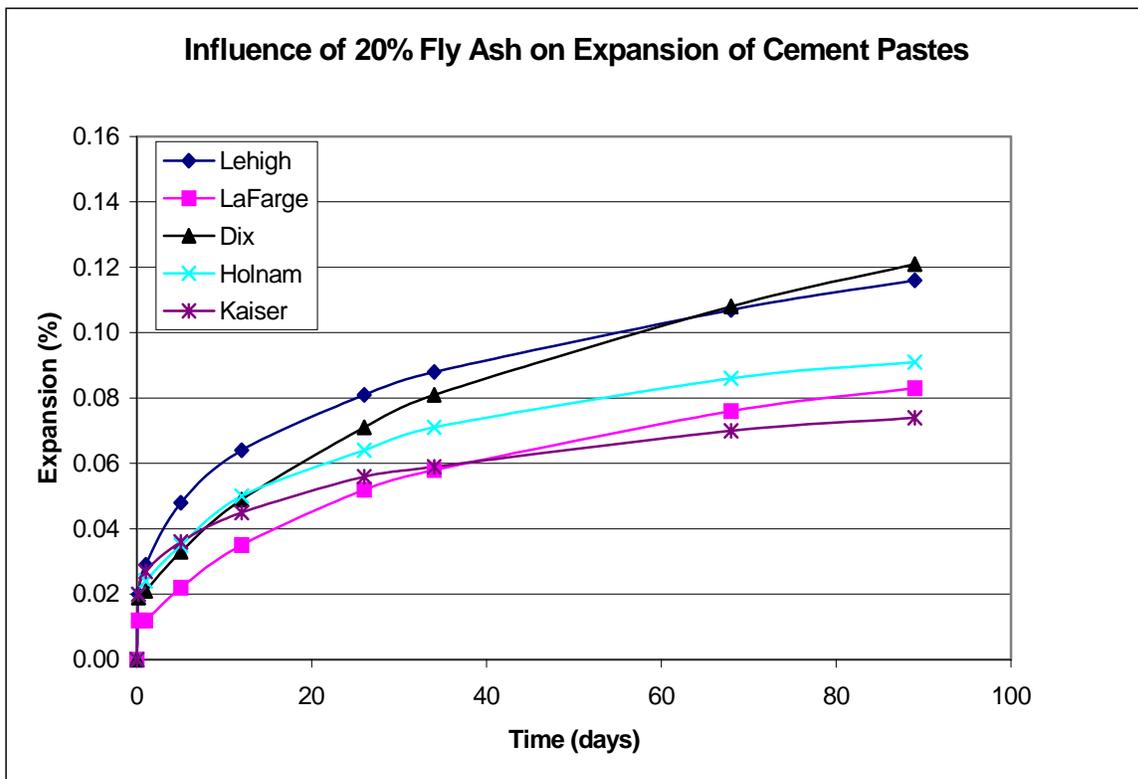
Test specimens were also subjected to water curing to evaluate the expansion potential of the various cements (see Figure 18). Again, the Kaiser cement performed the best (i.e., least expansion during the test). It was followed by the Holnam and LaFarge cements, then the Lehigh cement, and finally the Dixon Marquette.

FIGURE 18 Unrestrained expansion during water curing for the various mixes.

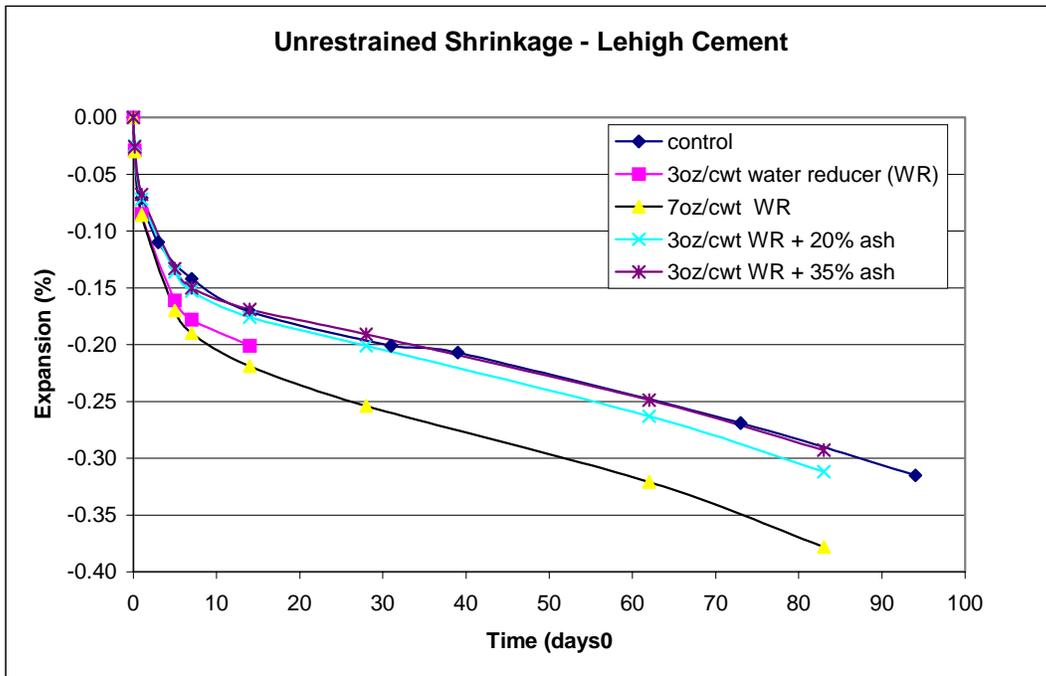
FIGURE 20 Influence of water reducer and fly ash on unrestrained shrinkage.

influence of water reducer and water reducer plus fly ash on the unrestrained shrinkage of the paste specimens. It is evident that the unrestrained shrinkage was increased by the presence of water reducer. Increased dosage of water reducer tended to increase the early shrinkage. The beneficial influence of the fly ash was not evident when water reducer was incorporated into the mixtures.

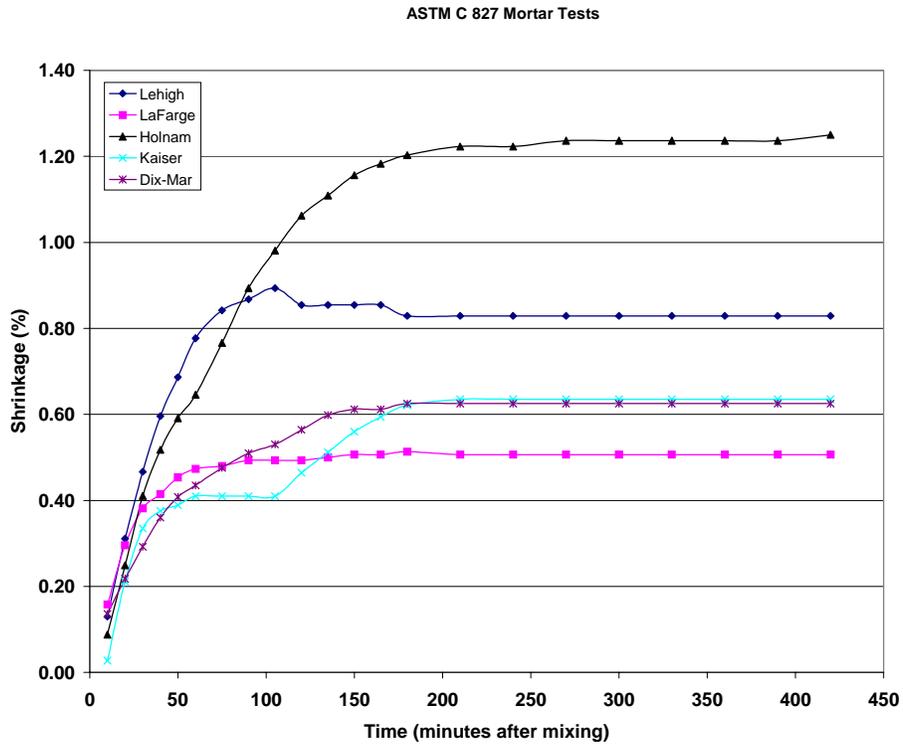
FIGURE 21 Results of the ASTM C 827 tests for the five control cements.

The results of the ASTM C 827 tests are illustrated in Figure 21. The raw data are given in Appendix E. The experiments indicated that all five of the cements exhibited shrinkage during setting and hardening. The addition of fly ash and water reducer did cause some changes in the shrinkage versus time curves (see Figure 22); however, the changes were within the range of behaviors that were observed for the five control mortars. The total number of experiments was limited because of lack of sufficient materials. None of the experiments produced any significant evidence of expansive behavior during setting and hardening.
