1. Report No. 0092-15-02	2. Government Accession No	3. Recipient's Catalog No	
4. Title and Subtitle Evaluation of Performance of Innovative Bridges in Wisconsin		5. Report Date July 2016

EVALUATION OF PERFORMANCE OF INNOVATIVE BRIDGES IN WISCONSIN

**Final Report
July 2016**

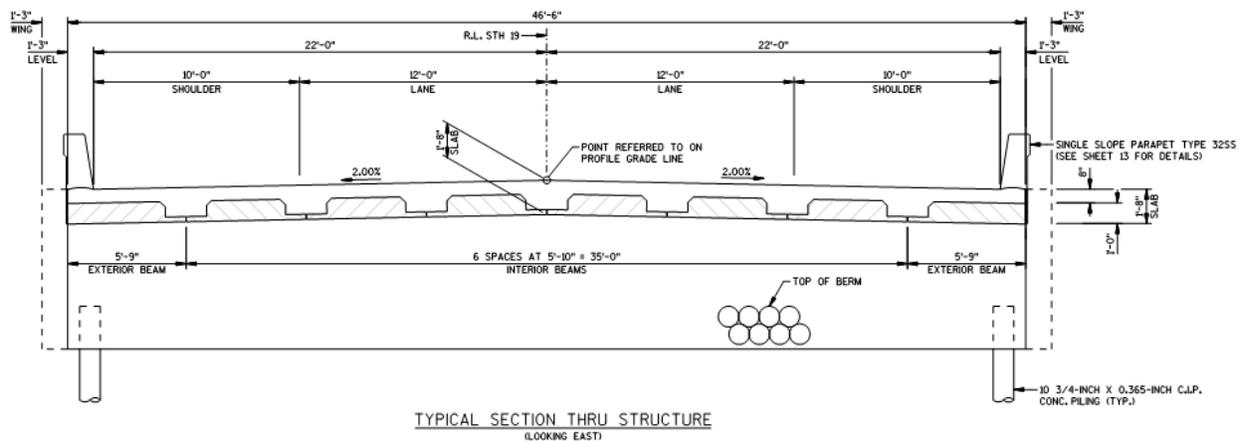
Figure 1. STH 19 over Token Creek Tributary bridge superstructure

The bridge measures 37' 1 1/2" x 46'-6" in total length and width, respectively. The cross section, shown in Figure 1, indicates a total of eight precast inverted Ts set side by side.

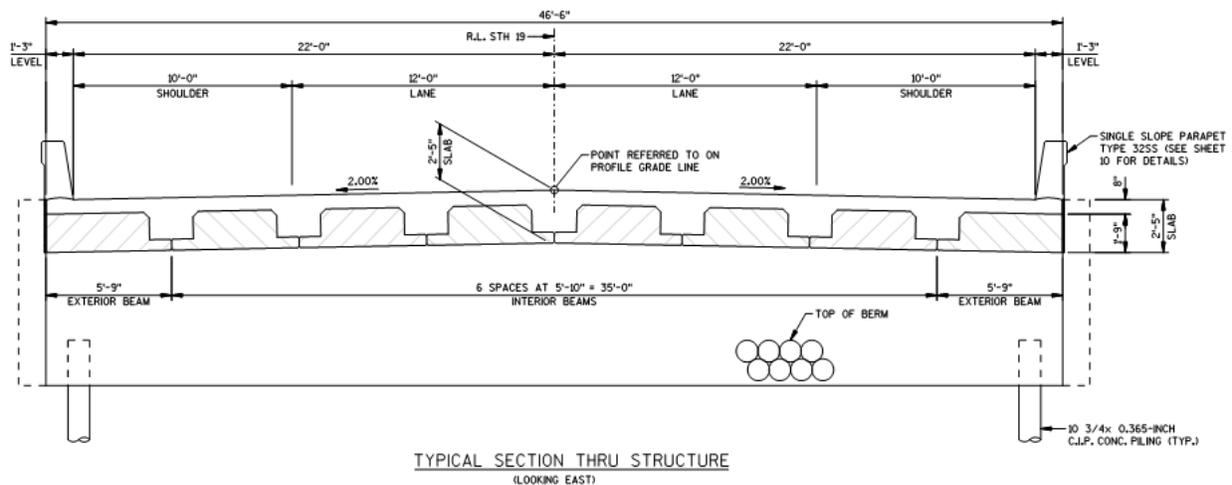
Figure 6. STH 19 over Token Creek bridge superstructure

The bridge measures 53'-0" x 46'-6" in total length and width, respectively. The cross section, shown in Figure 6, indicates a total of eight precast inverted Ts set side by side.

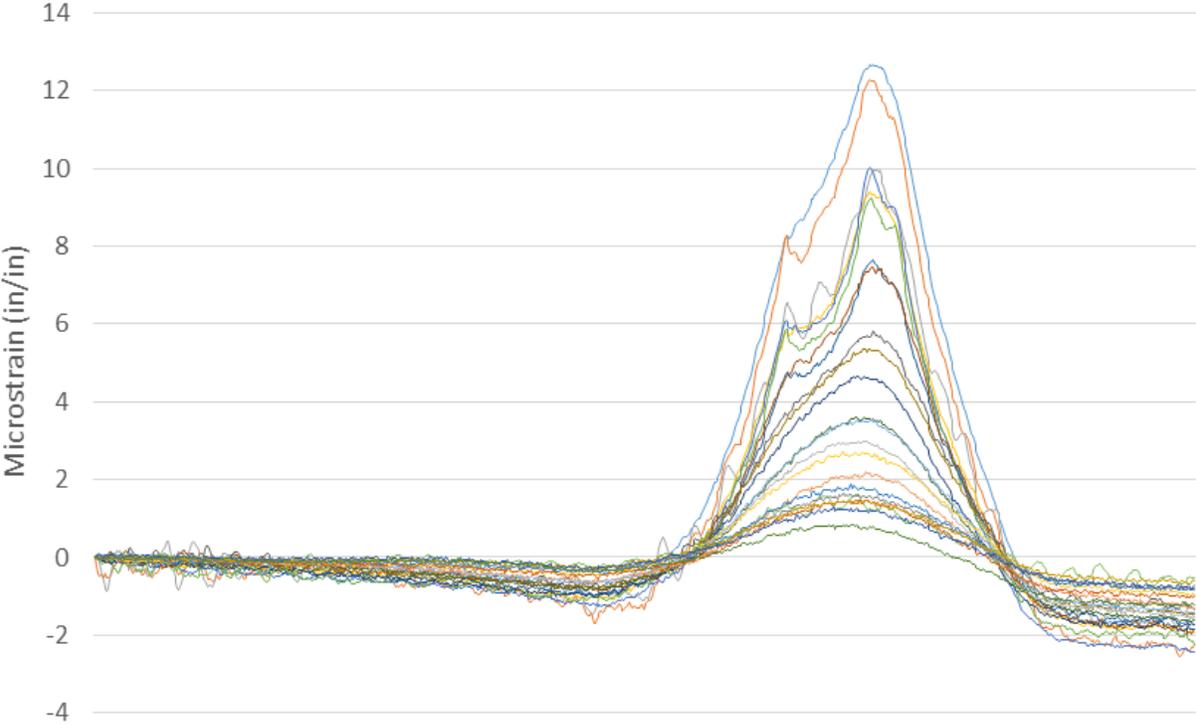
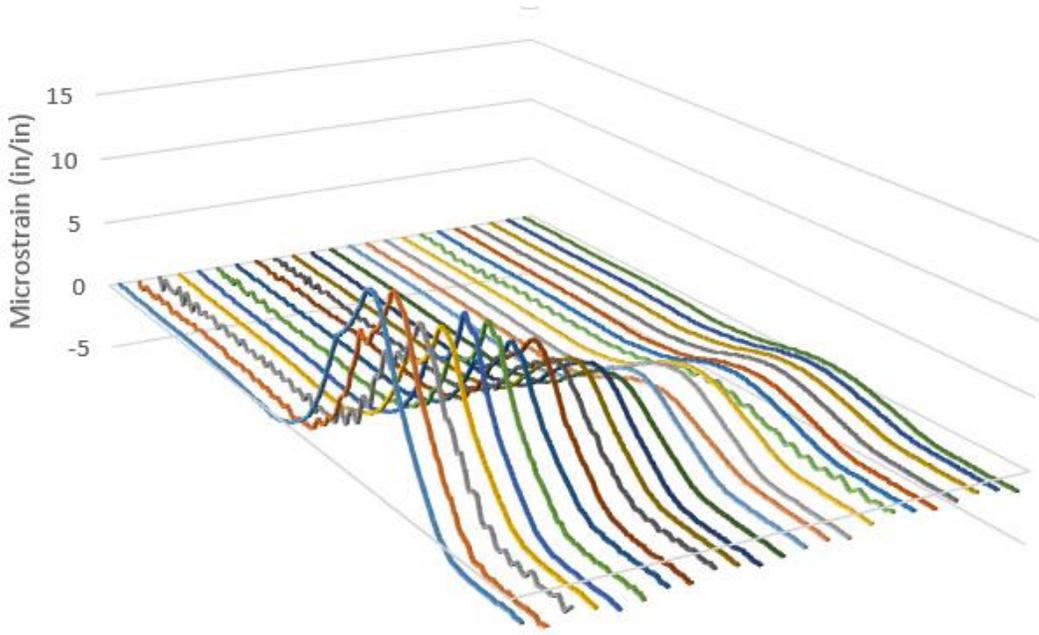
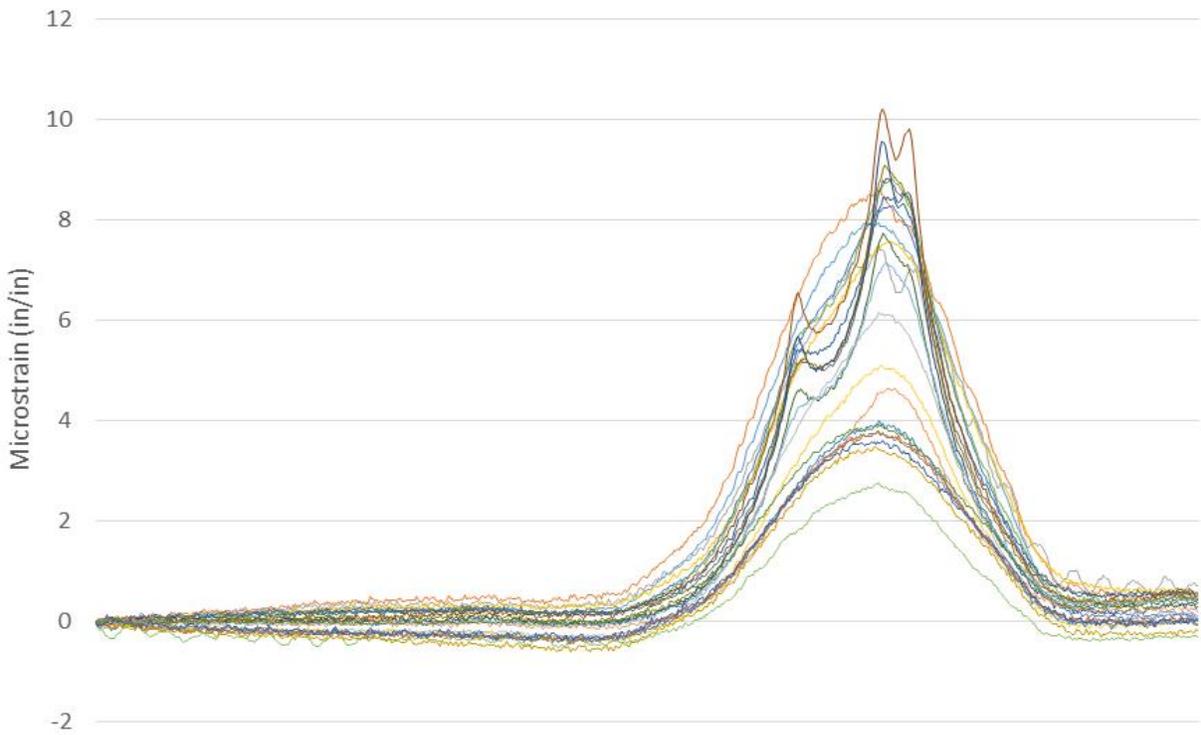
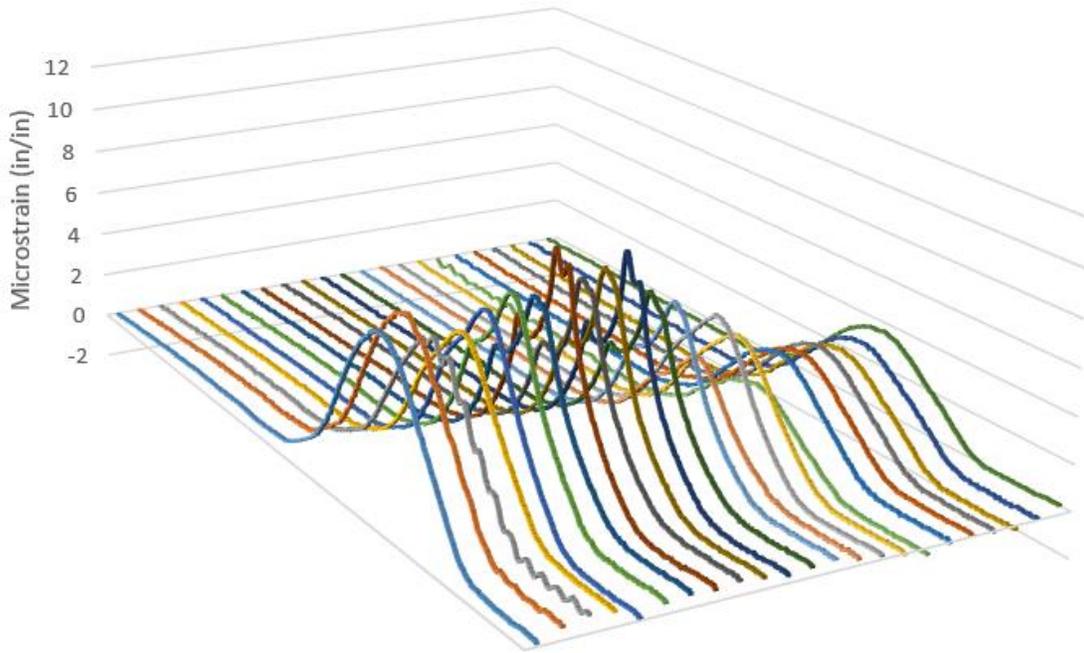
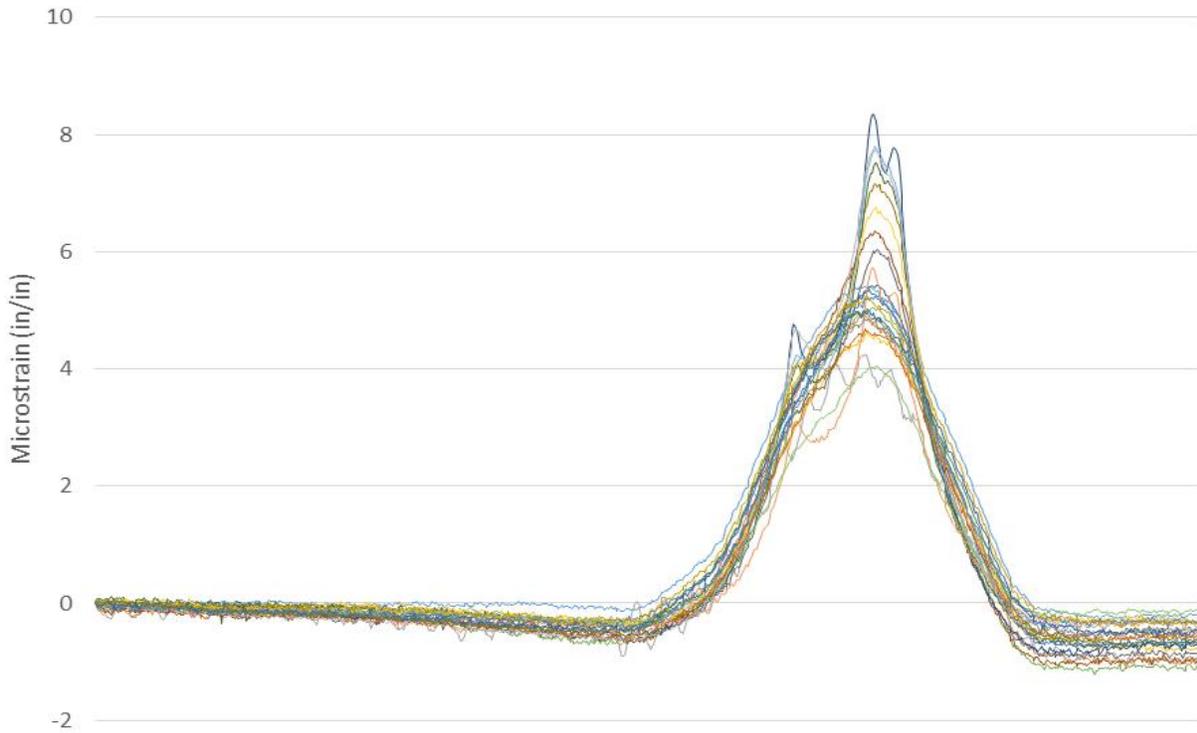
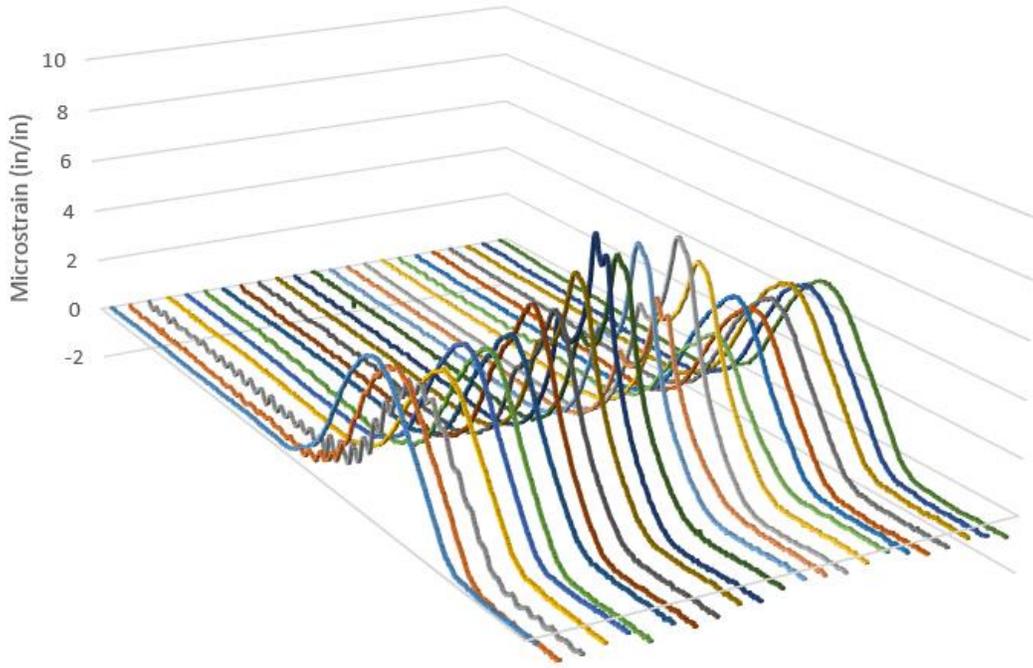
From the collected strain data for each load case shown in Figure 15 through Figure 24, one can see the overall magnitude of strain and relative distribution of load across the bridge. The maximum strain achieved in any one load case is approximately 14 ms (load path 5), equating to a relatively low stress. The strain pattern across the bridge indicates that the load is being distributed, at least in part, across the entire bridge, a good indicator of uniform stiffness and connectivity between panels.

The differential deflection measured between panels was less than the magnitude of the inherent instrumentation noise (10,000th of an inch), thus not illustrated in graphical form in the results below. The differential deflection is effectively zero across panels and thus reflective cracking in the deck directly above the panel joints is not anticipated (and was not observed).

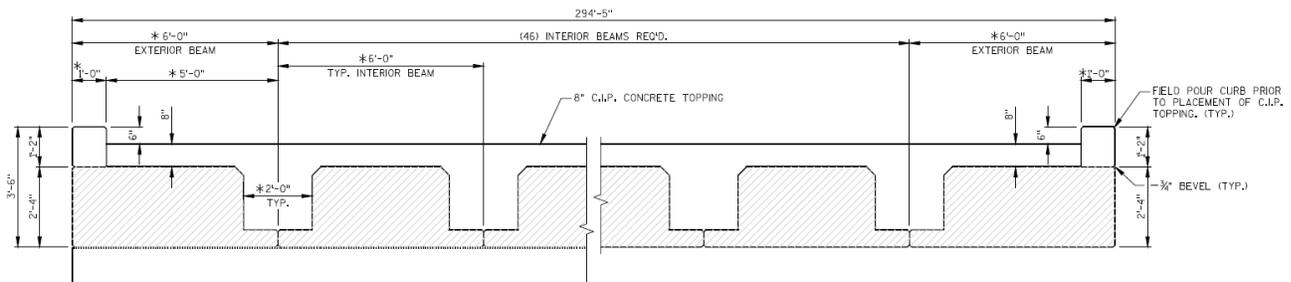
Figure 25. US 41 over Ashwaubenon Creek inverted T superstructure

The precast inverted T feature of the Ashwaubenon Bridge, seen in Figure 25, was first used within the United States in Minnesota.

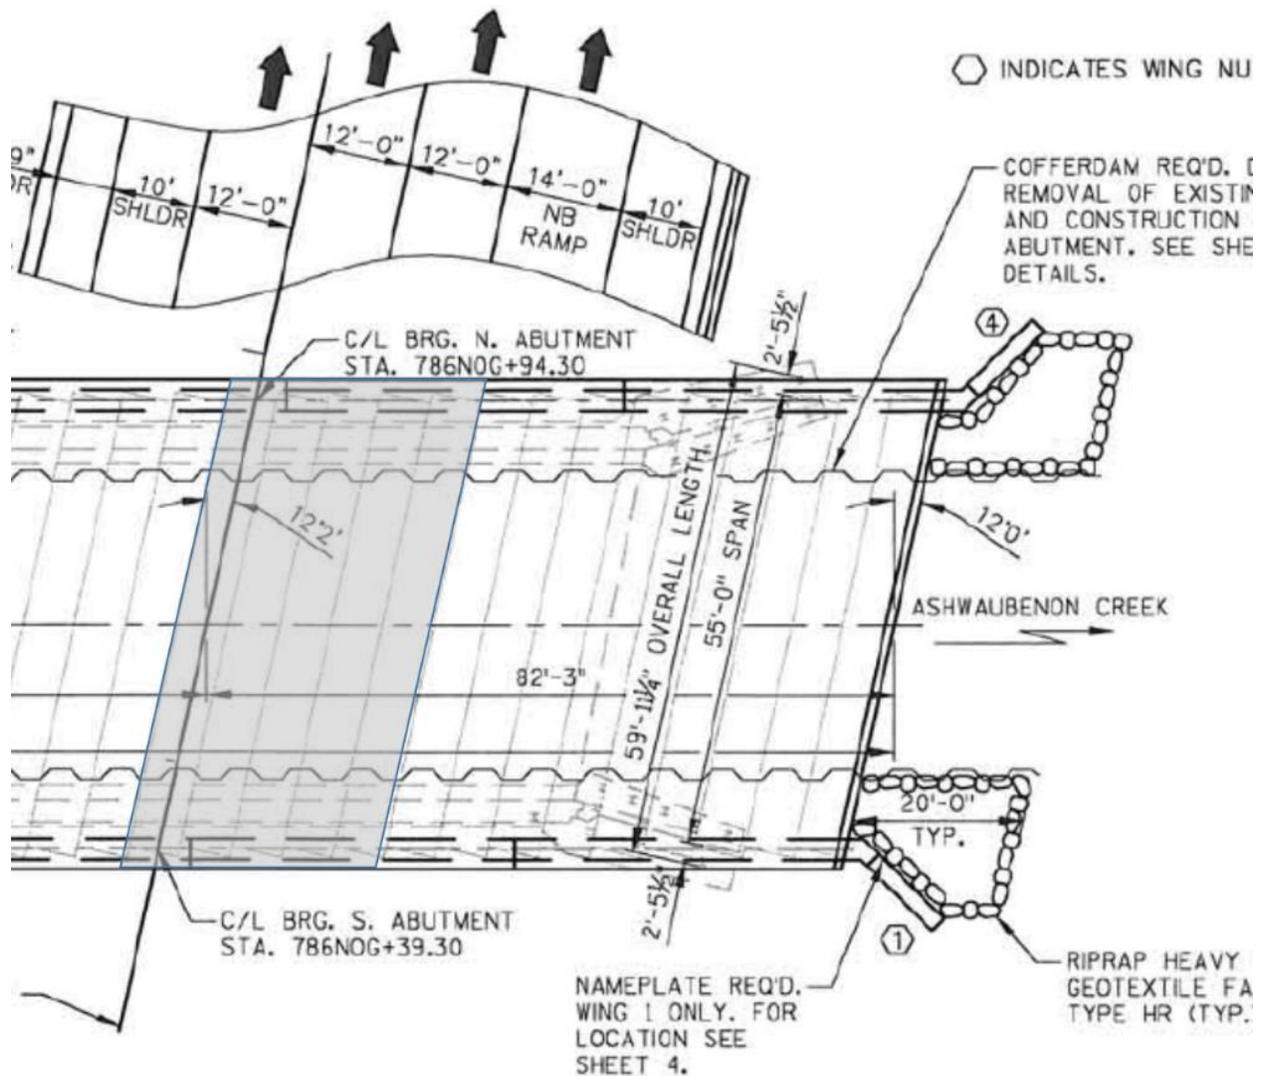
Figure 27. US 41 over Ashwaubenon Creek instrumented panels

The instrumented panels included five panels directly beneath the two rightmost 12'-0" northbound lanes; each panel measures 6'-0" wide. The instrumented panels are shaded in Figure 27.

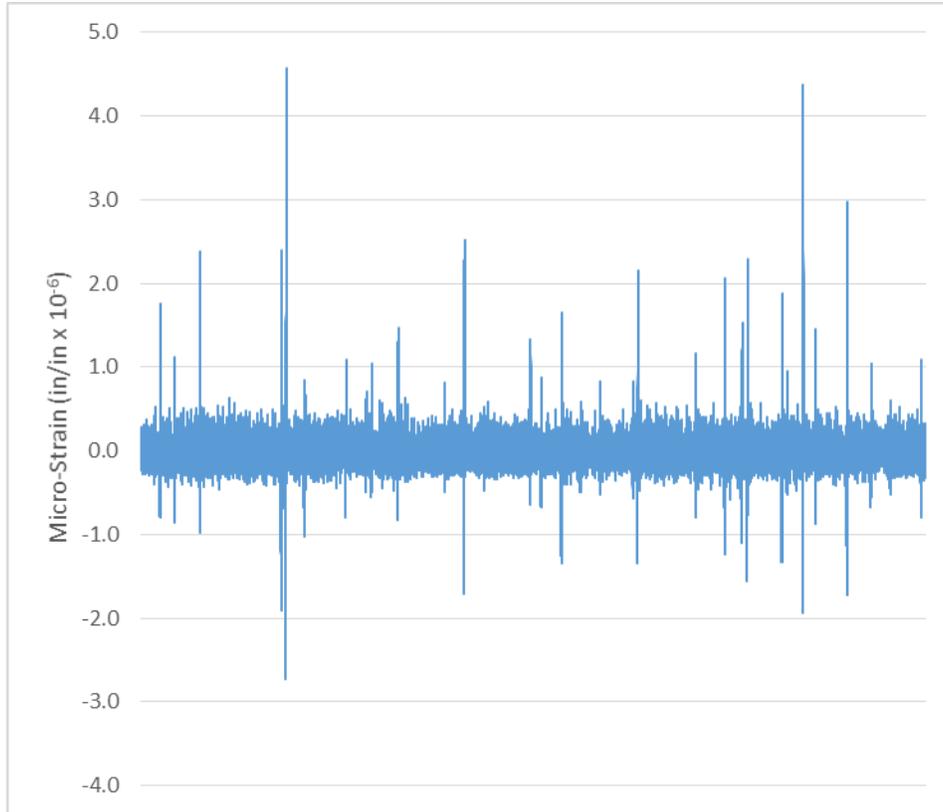
Figure 32. US 41 over Ashwaubenon Creek strain time history

The results depict how the bridge is behaving under ambient traffic. As shown in Figure 32, the strain history is characterized by individual peaks, which indicate vehicle events; larger peaks indicate heavier vehicles, while smaller peaks indicate lighter vehicles.

Although it is clear that individual vehicles were detected, note that the greatest recorded strains were relatively low in comparison to what one might expect at the midspan of a concrete girder on a typical highway bridge (i.e., concrete girder/concrete deck). The strain history of this particular gage did not exceed five microstrain. In terms of stress, this is approximately a 15 to 20 psi tensile stress. In other words, the strain and corresponding stress level is quite low considering the loads that the bridge is carrying.

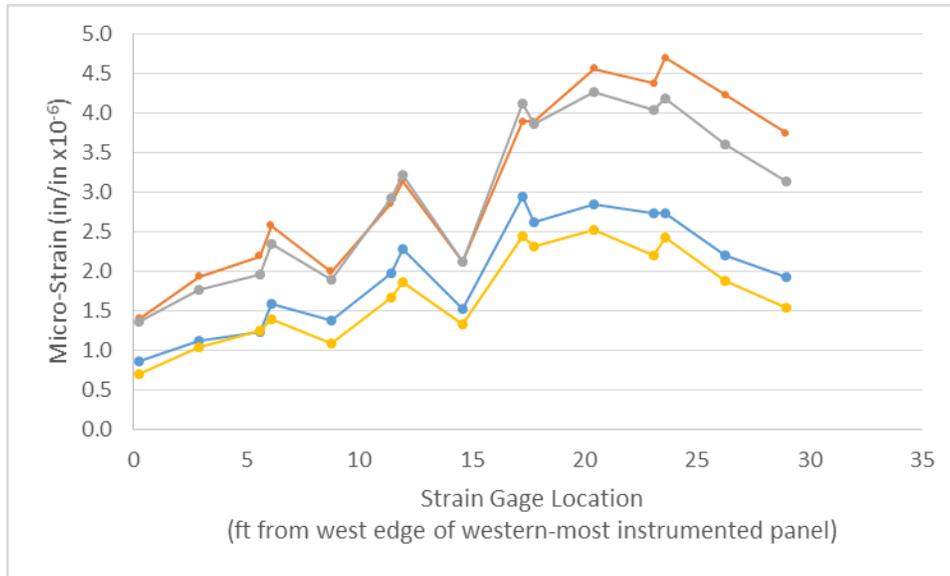
Figure 33. US 41 over Ashwaubenon Creek strain distribution under load

The vehicle events that resulted in the four highest recorded strain values were extracted from the data. A plot, shown in Figure 33, was then created using the strain value of each gage at the point in time when the maximum strain was recorded.

The lines in the plot show the transverse distribution of the four loads. The plot shows the strain gage locations relative to the west edge of the western-most instrumented panel. Each of the cases shown have similar distribution patterns and were likely the result of a heavily loaded vehicle traveling in the eastern-most travel lane. The load distribution does not strictly follow a gradually increasing nor decreasing trend. Nonetheless, the overall trend indicates that the load is being shared amongst multiple panels load sharing among the adjacent panels. In addition to the global distribution of live loads, Figure 33 shows that strains on both sides of the joint were basically identical. This, coupled with the differential deflection data discussed next, indicates that the entire bridge is basically acting as one monolithic unit.

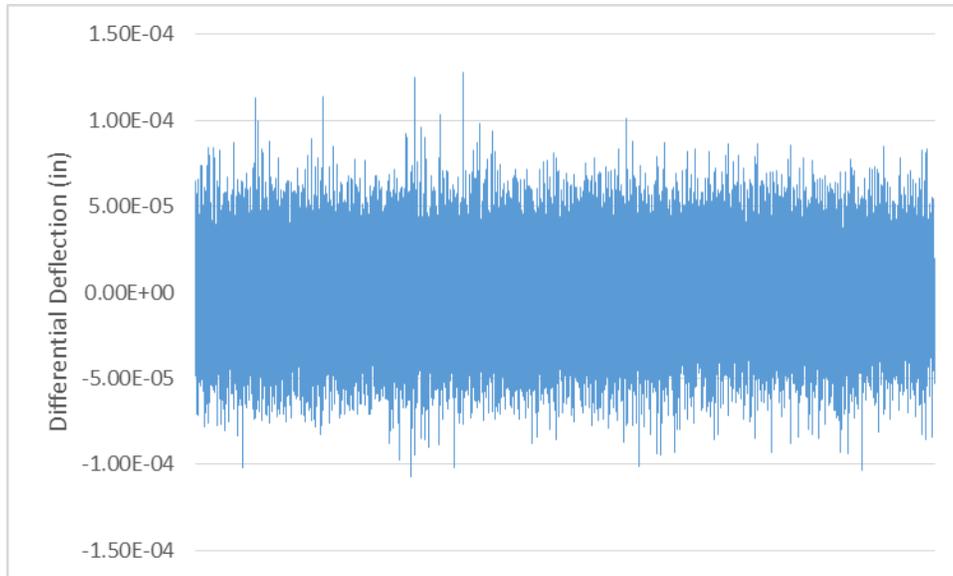
Figure 34. US 41 over Ashwaubenon Creek differential deflection under load

The differential deflection measurements indicated essentially no differential movement between adjacent panels (maximum values approximately 1/1000th of an inch). The measurements for one typical gage are shown in Figure 34.

It seems that the combination of cast-in-place concrete and shear transfer reinforcement is acting like a fully composite system. Even more, the depth of section relative to the span length has created a very stiff superstructure with stress/strain levels on the bottom surface being very close to zero.

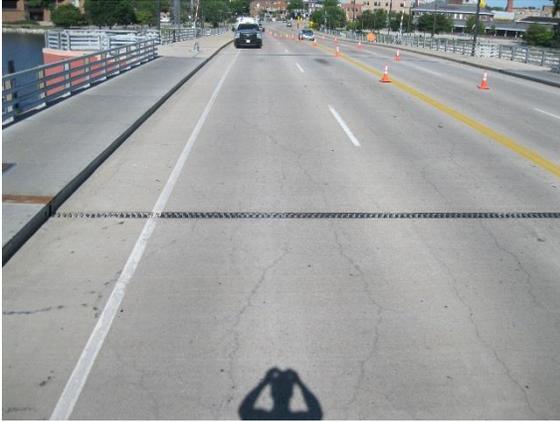
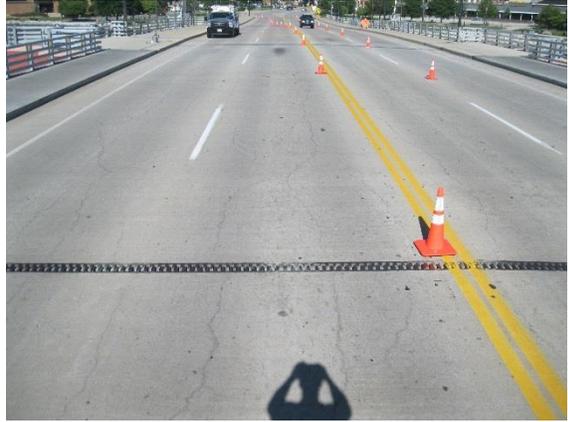
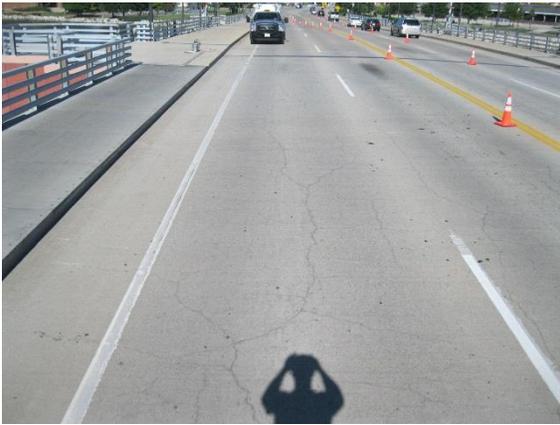
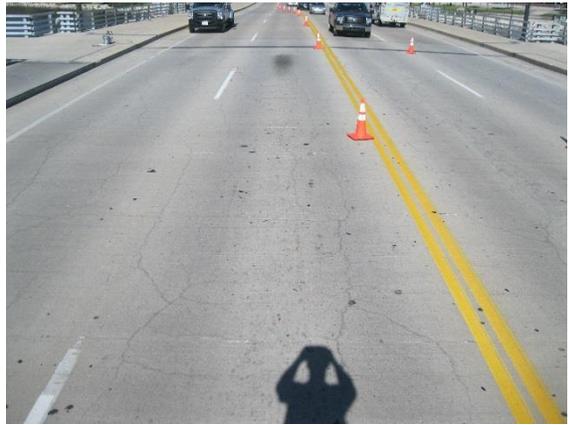
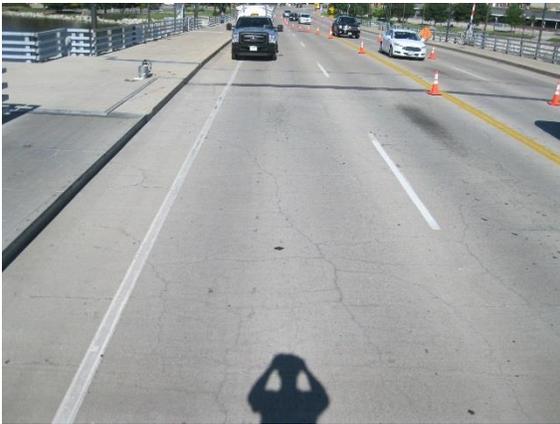
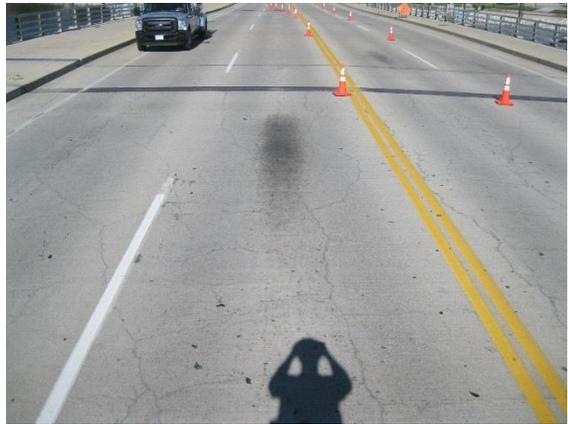
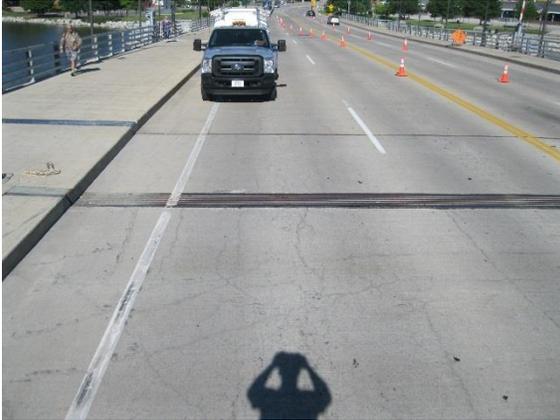
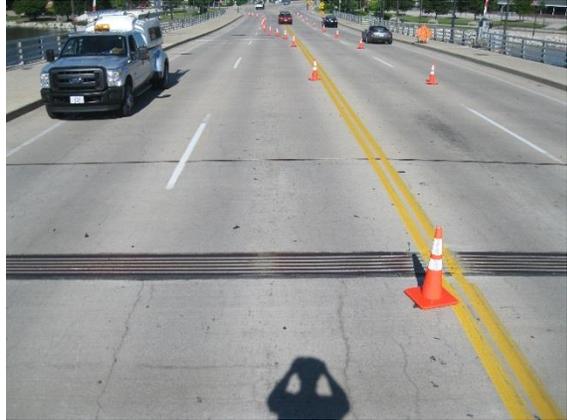
Figure 37. US 141-Main Street over the Fox River eastbound lanes looking west

Overall, the surface of the deck appeared in good condition with only very small surface cracking visible. Cracks of this size and extent are similar to that that might be expected on a non-exodermic deck of similar age. Previous reports have indicated this cracking was present from a very early age likely due to initial shrinkage. A series of photos are shown in Figure 37 and Figure 38, for the eastbound and westbound lanes, respectively. These photos provide an overall view of the deck condition where the surface cracking can be seen.

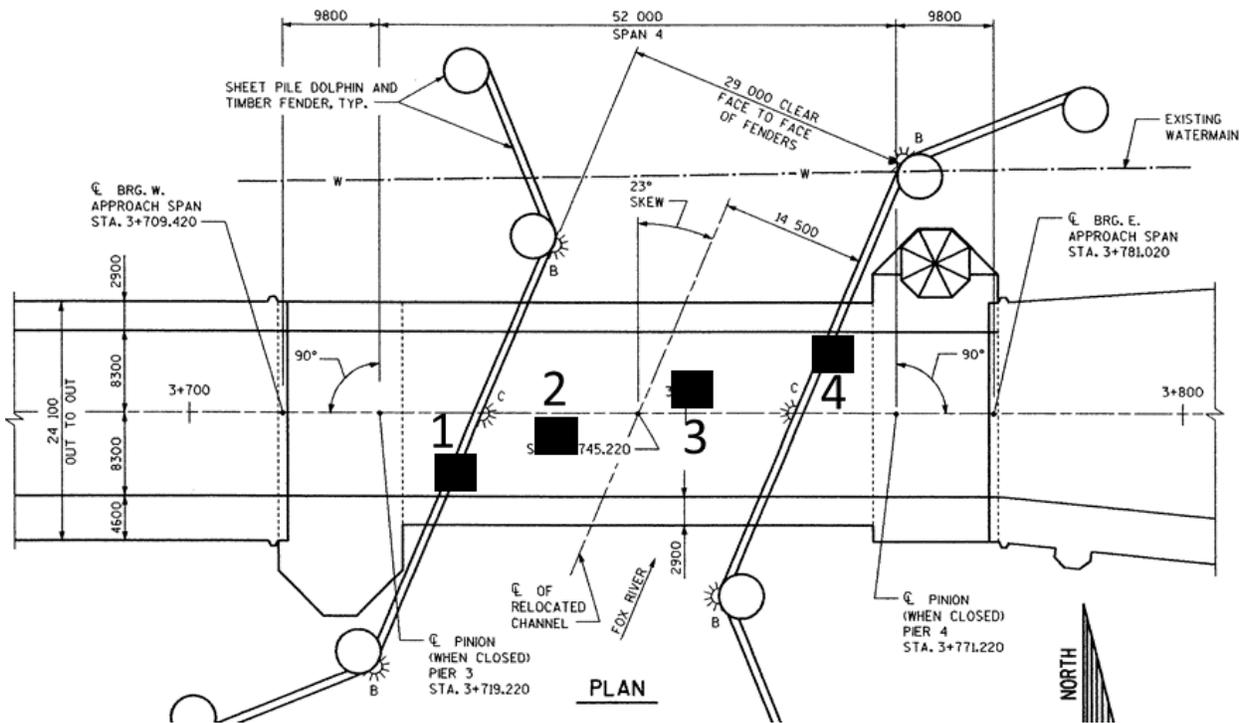
Figure 42. US 141-Main Street over the Fox River crack survey locations

In order to better quantify the amount of deck surface cracking, a detailed crack survey was completed in four areas, each approximately 100 ft². The areas were randomly selected along the length of the bridge, although an area was purposely selected in each of the travel lanes. The approximate locations of the areas selected are indicated and labeled in Figure 42; photographs and crack maps of each area are given in Figure 43 through Figure 46.

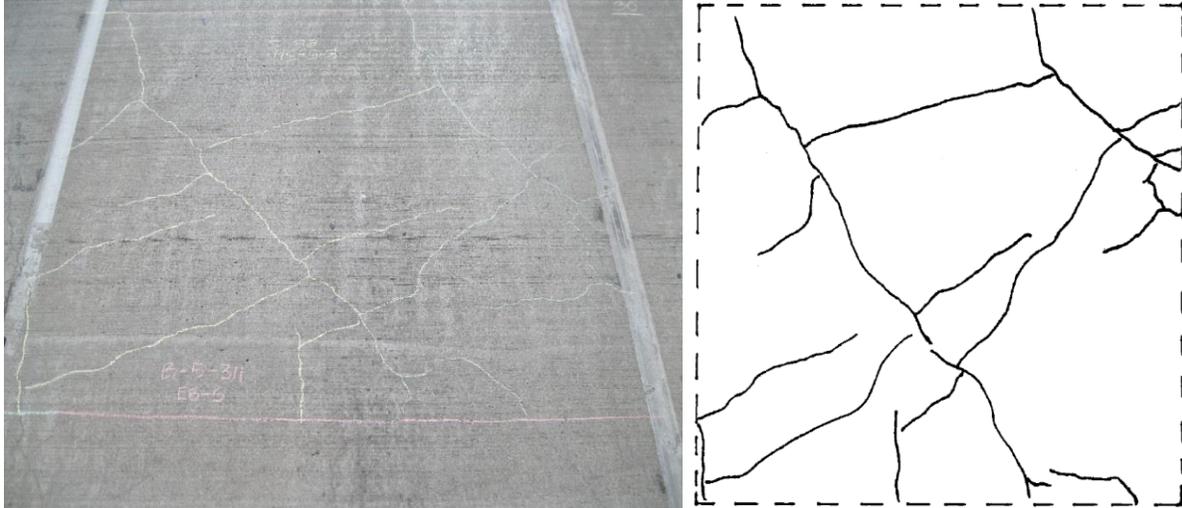
Figure 43. US 141-Main Street over the Fox River Area 1: south lane of eastbound traffic

The crack patterns varied among each of the selected areas. There was not a well-established pattern in any one lane or side of the bascule opening, although a cursory review would indicate that cracks in the eastbound lanes on the western half of the bascule (1 and 2) varied with both transverse and longitudinal cracking; whereas, those in westbound lanes on the eastern half of the bridge (3 and 4) tend to be more consistently longitudinal.

One can see from the quantitative results that the frequency and overall length of cracking was found to be greater in the eastbound lanes on the western half of the bascule—nearly 75 percent greater. Even though there appears to be some consistency within the results from eastbound and westbound lanes and/or the east and west halves of the bascule, one is cautioned not to broadly apply this trend over the entirety of the bridge surface area given the total area surveyed is only a small percentage of the total deck surface.

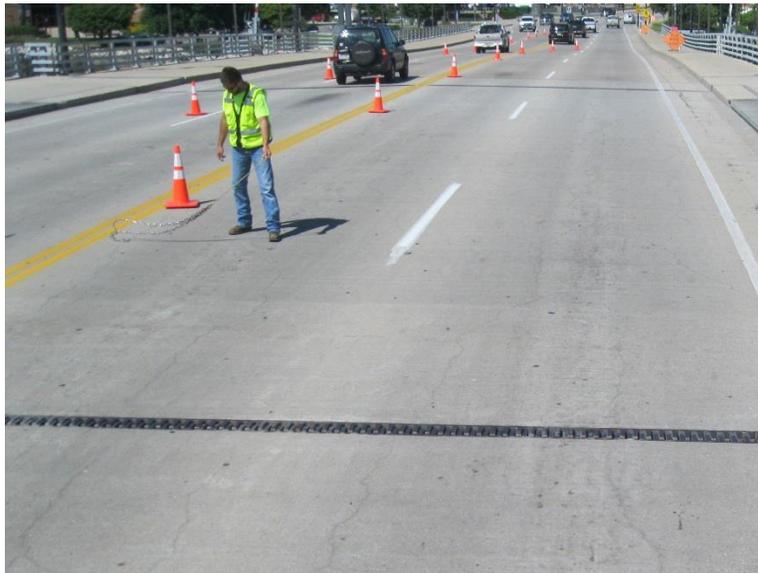
Figure 47. US 141-Main Street over the Fox River chain sounding

The entirety of the bascule deck was sounded using a 3/8" chain. Using this method, shown in Figure 47, no areas of delamination were detected indicating no areas of significant deterioration were present.

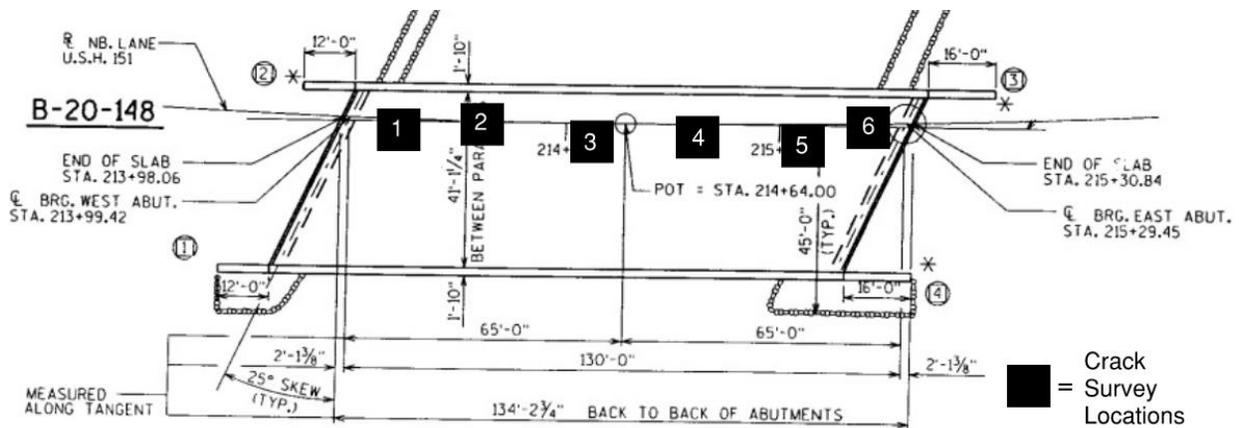
Figure 95. US 151 over De Neveu Creek crack survey locations

In order to better quantify the amount of deck surface cracking, a crack survey was completed in six areas, each 100 ft². The areas were randomly selected along the length of the bridge in the north lane, which was closed to traffic. The approximate locations of the areas selected are indicated and labeled in Figure 95 followed by photographs and crack maps of each area in Figure 96 through Figure 101.

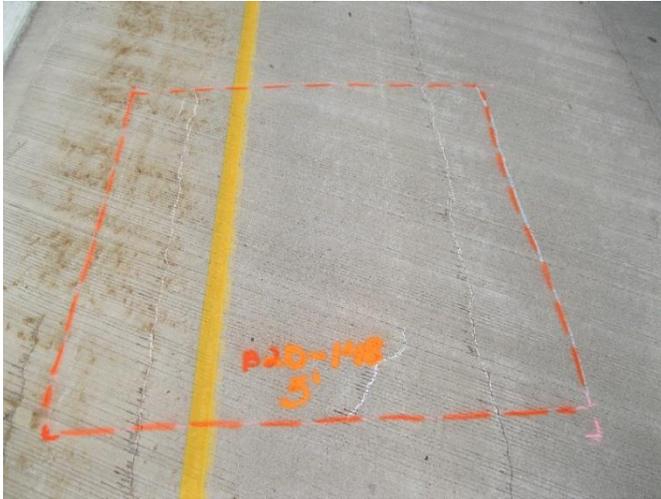
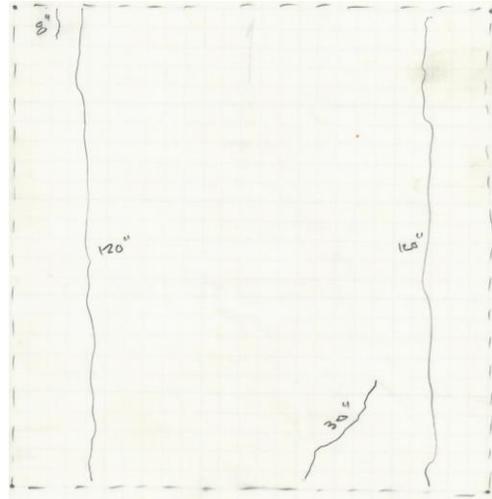
Figure 96. US 151 over De Neveu Creek crack survey – Area 1

The crack patterns varied among each of the selected areas. There was not a well-established pattern in any area aside from the primary crack direction being longitudinal. The quantity of cracking also varied. As means for quantitatively assessing the observed cracks, measurements of the crack lengths were summed for each of the selected areas. The quantitative results of the crack survey are provided in Table 2.

One can see from the quantitative results that the sum length of cracking varied considerably between areas surveyed, with as little as 0.10 ft/sq. ft to 0.30 ft/sq. ft. That said, only one of the areas came near to the 0.30 ft/sq. ft, (the area at the east end of the bridge), with most of the other areas in the range of 0.10 to 0.17 ft/sq. ft. The greater amount of cracking in area 6 can seemingly be attributed to the several cracks propagating perpendicular to the deck edge. This crack pattern has been a common observation at deck ends especially on skewed bridges.

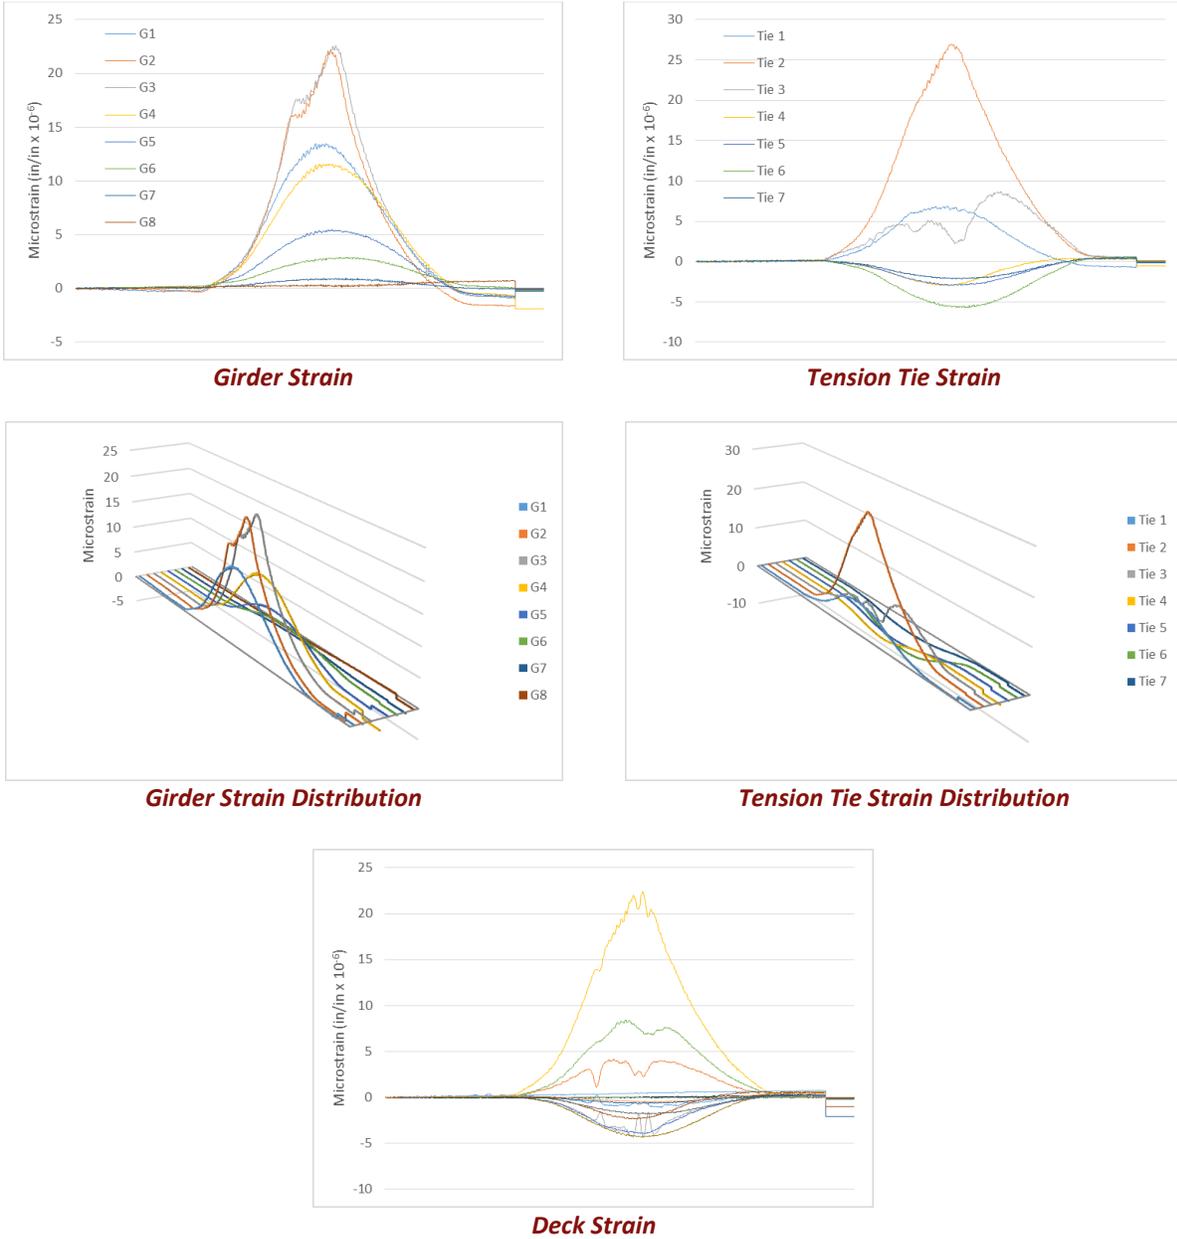
Figure 113. US 12 over Coffee Creek Load Path 1 results

The girder strain never exceeded 30 microstrain and the maximum never fell below 25 microstrain for any load path. To put this in terms of stress, the maximum never exceeded 120 psi (assuming a 5,000 psi compressive strength and associated modulus of elasticity). Note that the girder strain gages were not placed directly at midspan where a greater strain is likely to occur, so the maximum strain values on the structure are probably slightly higher. The strain distribution appeared a bit unusual in comparison to traditionally constructed bridges. For example, typically the maximum strains will be located on girders directly under the load path. For each of the load paths evaluated in this work, the maximum strains tended to be at the middle girders of the bridge. Some of this phenomenon is likely due to the additional stiffness of the bridge near the east and west sides due to the sidewalk and railing assembly. Since the strain is a

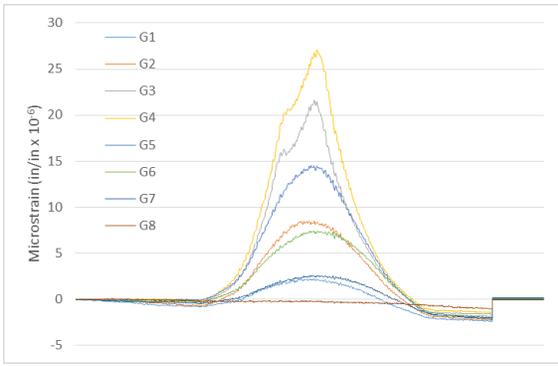
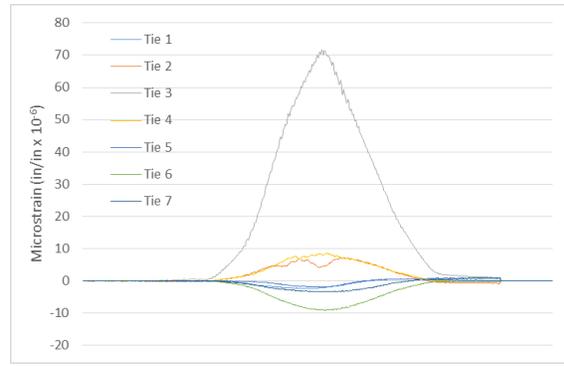
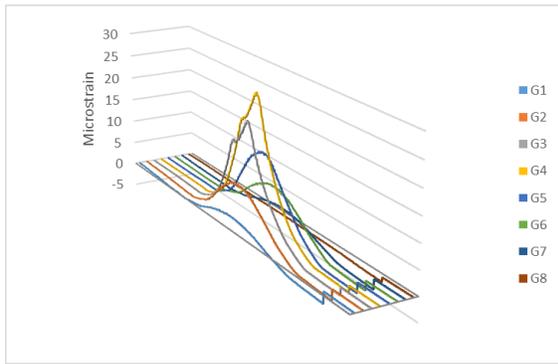
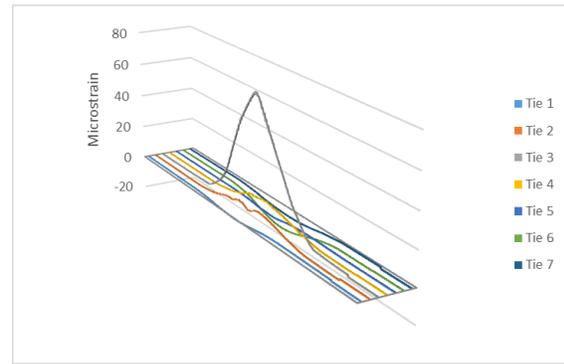
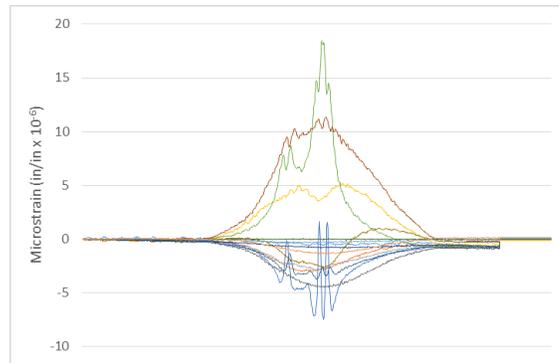
In a similar way, the behavior of the tension ties appeared unusual with respect to the range of strain magnitudes. For all of the load cases except for load path 4, all tension ties aside from one had strains in the range of approximately ± 10 microstrain. For the tension tie located in the third bay from the east the strain measurement consistently exceeded the average strain magnitude by a significant amount (e.g., 70 microstrain for load path 1). Only in load path 4 did the strain magnitude come into the range of the other tension ties. Keep in mind that measurements were only taken on one line of the many tension tie sets across the bridge. It is possible that discrepancies in the measurements could be seen across many sets and in different patterns. Nonetheless, the strain data speak to the likelihood that achieving a consistent tautness in the ties is very slim causing variation in the load transfer behavior. Even more, the tension tie is an important part of the entire system contributing to the strength of the deck. It is the opinion of the research team that the tension ties may have been placed too low in the girder cross section to allow for the full development of the strut-and-tie behavior. Visually, the tension ties appeared to be in good condition.

this case, the maximum girder strain magnitudes were generally nearer the centerline of the bridge regardless of the respective load path position. In future designs, it is recommended that either greater than normal distribution factors be used or that an analytical model be created that considers the reduced deck stiffness.

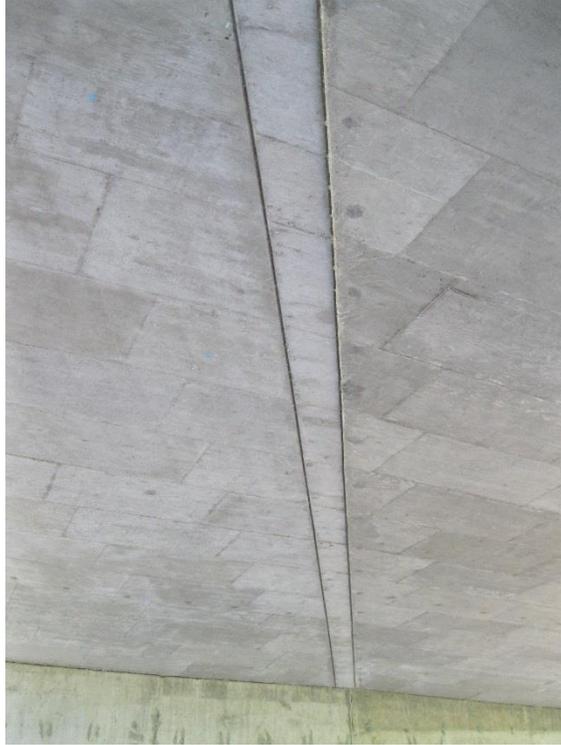
The two main stages of bridge construction are divided by a closure pour through which the transverse post tensioned tendons pass. The condition of the closure pour was of particular interest since there is a cold joint present on either side between the north and south halves of the bridge. The closure pour, seen in Figure 123 and Figure 124, did not appear to be in a condition any poorer than what was observed on the remaining superstructure.

Figure 123.STH 33 over the Milwaukee River closure pour condition

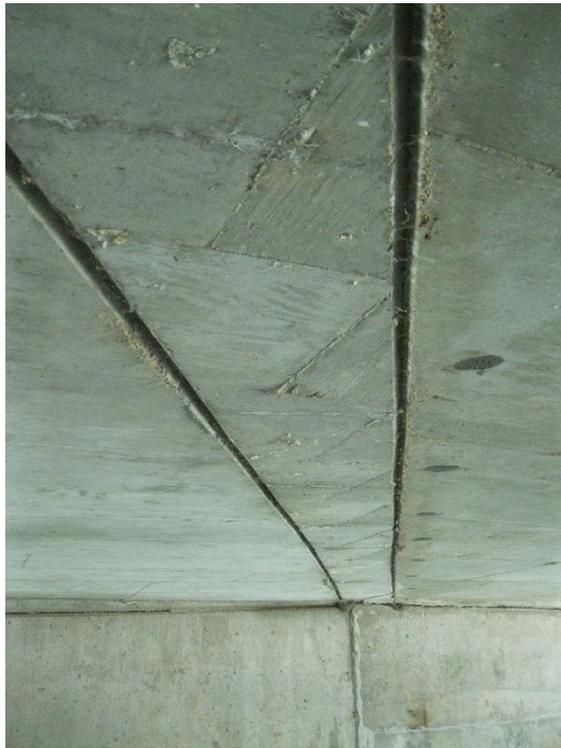
Figure 124.STH 33 over the Milwaukee River closure pour close-up

No signs of water infiltration were present, which could indicate a relaxation in the transverse tendons.

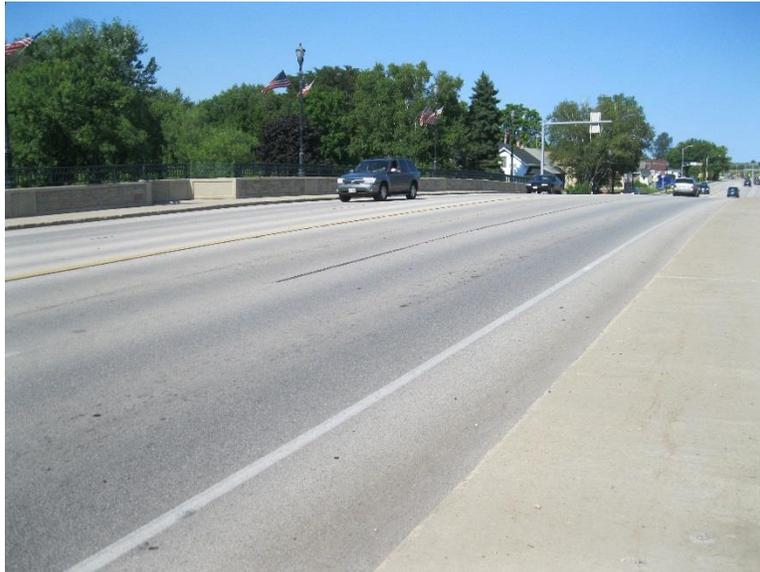
The top surface of the bridge, shown in Figure 125, has been overlaid with asphalt and thus the condition of the concrete surface could not be verified. The overlay was placed in 2006 primarily to seal the deck and secondarily to improve the ride.

Figure 125.STH 33 over the Milwaukee River asphalt overlay

Even so, the asphalt appeared in very good condition and given the condition of the underside of the deck, it is assumed the top surface is also in very good condition.
