Evaluation and Repair of Damaged Prestressed Concrete Girder Bridges

FRANCESCO M. RUSSO, TERRY J. WIPF, F. WAYNE KLAIBER, AND RYAN PARADIS

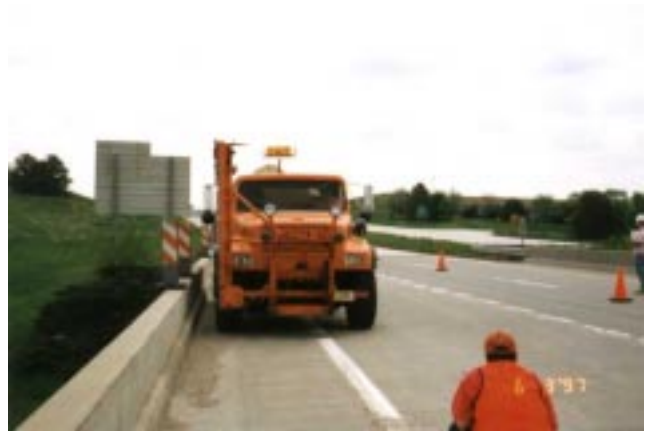
FIGURE 3 Lane 1W loaded with a single test truck

For the tests conducted in Lane 1W/1E, the position where the test truck is closest to the edge beams on the flared side of the bridge, the center span data indicate a different deflected shape in the WB and EB bridges with the damaged WB bridge deflecting more over a number of beam lines including those known to be undamaged. The deflections indicate that load is "shed" from the damaged beam lines in the WB bridge; this was later confirmed analytically. The maximum center span midspan deflection in the WB and EB bridges was measured to be 0.064 in. (1.6 mm) and 0.053 in. (1.3 mm), respectively. Diaphragm strains in both bridges were small during the Lane 1W/E loading, the maximum being approximately $+15\mu\epsilon$ in both bridges, and agree with the findings of others that the diaphragm plays an insignificant role in live load distribution. Replacement of the damaged beams results in the WB repaired bridge behaving essentially the same as the undamaged EB bridge, thus, the change in behavior of the original WB and EB bridge data can be directly attributed to the presence of isolated main member damage.

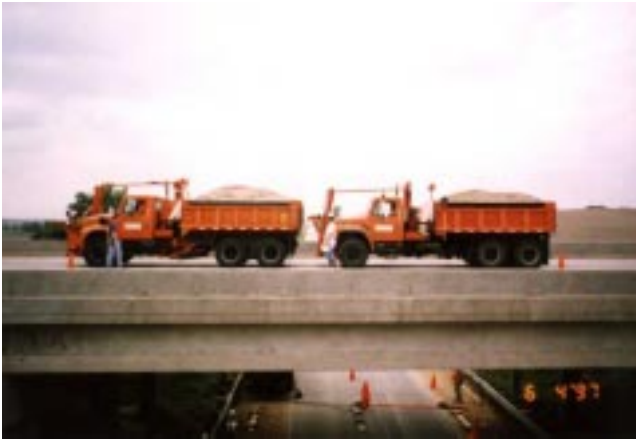
The correlation between the effects of two trucks placed in adjacent lanes or in the same lane (i.e., multiple trucks on the bridge) is excellent compared to the effects of linear superposition of individual truck test results. The most significant deflection for Beams 1 and 2 in both bridges occurred when the two trucks were placed end-to-end in Lane 1, L1W/E-P4&P6 (see Figure 4). The deflection of the

center span of the WB bridge was 0.085 in. (2.16 mm), approximately $L/7,900$ and was 0.083 in. (2.11 mm), $L/8,100$ in the EB bridge. Other beams in the WB bridge deflected more than their counterparts in the EB bridge by a small amount, i.e., 0.01 in. (0.25 mm) for most of the beams. The beams in both bridges typically deflect as if they are simply supported and have uniform stiffness or only slightly non-uniform as for the WB bridge. The maximum exposed strand strains were also recorded during the test with two trucks in Lane 1. The maximum strain recorded in Beam 1W was $+186\mu\epsilon$ and in Beam 2W, $+169\mu\epsilon$. These strains correspond to a stress range of approximately 5,300 psi (36.5 MPa) and 4,800 psi (33.1 MPa) in the two strands, respectively. These stress ranges are small and represent a stress range of less than 2% of the ultimate strength of the strand.

FIGURE 4 Truck location L1W-P4 and P6

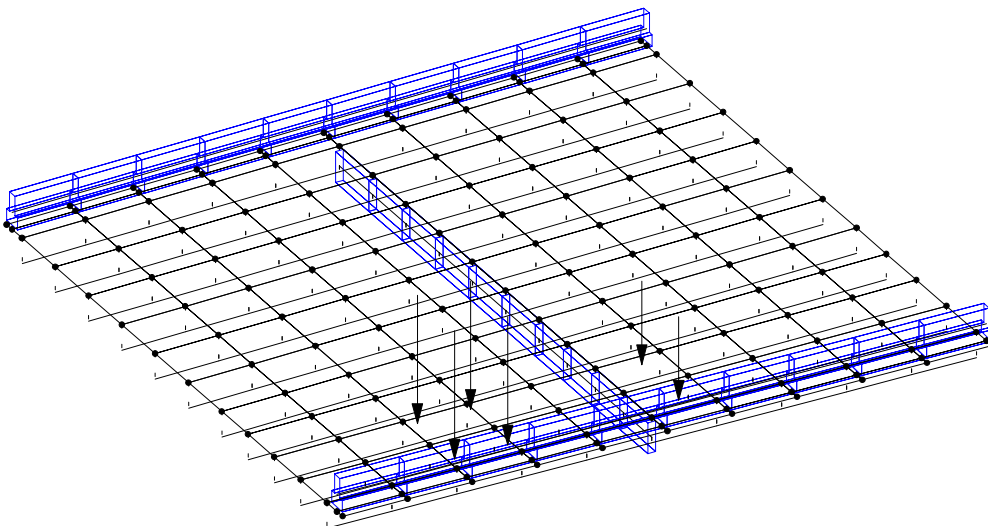
Figure 5 depicts the analytical model and an example load placement for the repaired WB bridge. The figure depicts a stiffened plate model created using the STAAD-III software program. The deck was modeled using a shell element while the beams were modeled using eccentrically linked beam elements having the properties of the P/C beams. Loads were applied as point loads on the surface of the deck. In addition to the stiffened plate model, three-dimensional grillage models were also created in order to test the ability of different modeling techniques to capture the experimental response. Both types of models were able to reasonably simulate the experimental behavior. For the load case of two test trucks placed side-by-side in adjacent lanes as close to the damaged beams as possible, the analytical model predicts a live load moment in the most heavily loaded beam, Beam 2W, of 191 ft-kips (259 kN-m) as opposed to 252 ft-kips (342 kN-m) using the AASHTO distribution factor of $S/5.5$ for multi-lane loading. This demonstrates the significant conservatism of the AASHTO formulas for this bridge. A significant amount of moment is carried in the curb and rail section adjacent the loaded edge of the bridge.

FIGURE 5 Analytical model of the repaired WB bridge center span; load at L1W-P4

analytical results indicates that for the isolated main members in this bridge, that is to Beams 1W and 2W, for loads placed over the damaged beam lines, a significant redistribution of moment occurs, much of it being taken up by the adjacent curb and rail as well as the nearest undamaged beam lines. The amount of load carried by beams remote from the damage is insignificant. The primary means of load redistribution is via transverse flexure of the slab.
