Stabilization Procedures to Mitigate Edge Rutting for Granular Shoulders – Phase II

Final Report
January 2011

IOWA STATE UNIVERSITY
Institute for Transportation

Sponsored by
Iowa Highway Research Board
(IHRB Project TR-591)
Iowa Department of Transportation
(InTrans 08-319)

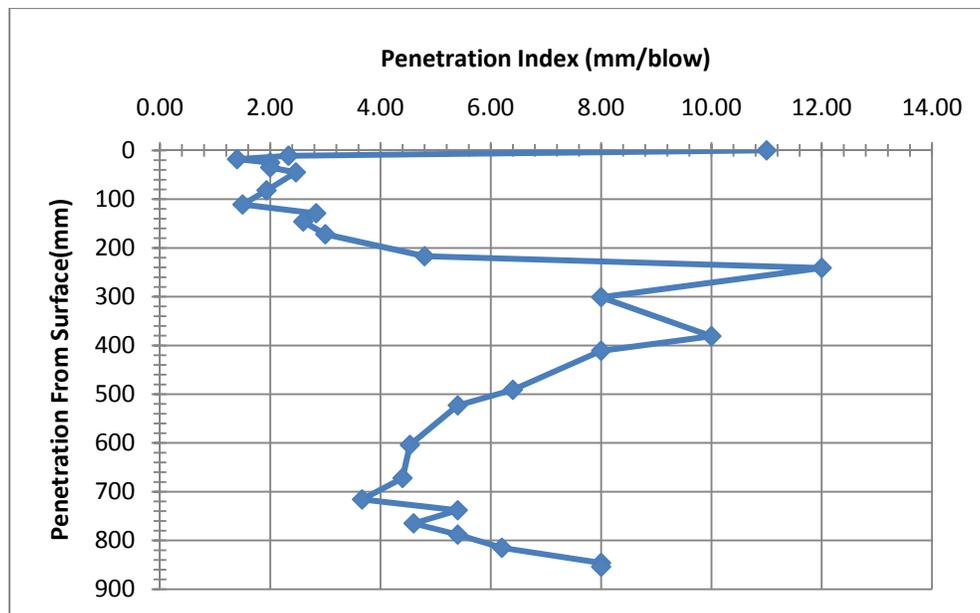
Figure 4. DCP test results Highway 3 milepost 215.16-215.63 June 4, 2008

Using the DCP field data, California Bearing Ratio (CBR) plots of the problematic shoulders were developed for each location (See Figures 4 and 5). In addition to the DCP field data, elevation profile data from each location was reduced to illustrate the shoulder's elevation progressing away from the pavement's edge (See Figure 6). For each location, the results of laboratory testing for grain size and Atterberg limits were summarized (See Figure 7). The results from the field and test data collection effort are provided in Appendix A.

The test results are summarized in Table 2. Gradations generally were 10 to 20% finer than the fine gradation limit for Iowa DOT Class A aggregate. This would be consistent with a shoulder material that was delivered within specification tolerance and worn to a finer gradation through use. An exception to this observation was US 65 around mileposts 210 to 215. The old aggregate here was 30 to 50% above the fine gradation limit. At most of these locations, new aggregate had just been spread and the new aggregate samples were within specification tolerances.

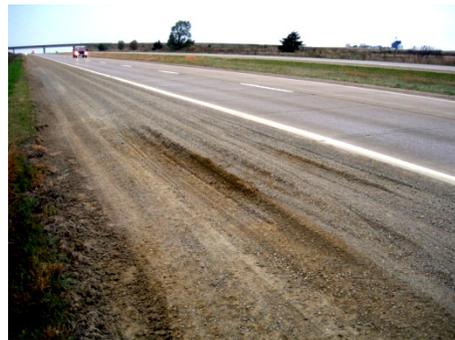
Figure 18. No stabilizer, full-depth, still soft one week later

By the following week, much of the shoulder had stabilized, so it could support a 3/4 ton pickup truck (See Figure 17), but a few soft spots remained (See Figure 18).

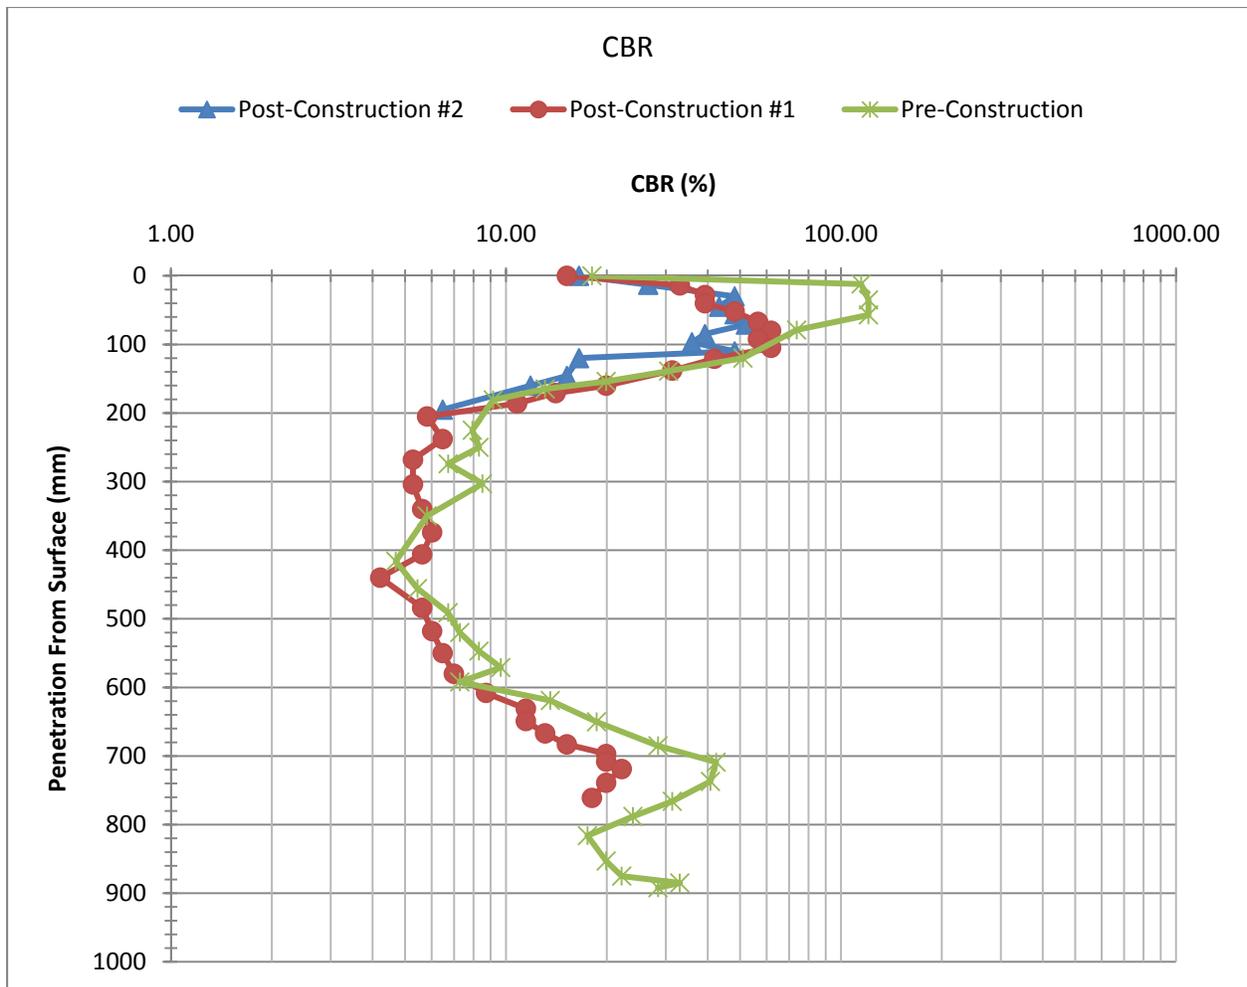
Figure 19. Sample CBR measurements plotted for magnesium chloride test section near Waterloo, Iowa

Field data for the Waterloo test sections was reduced in the same manner as the 29 problematic shoulder locations located throughout District 2. In addition, CBR measurements for each reconnaissance trip were plotted together (See Figure 19).

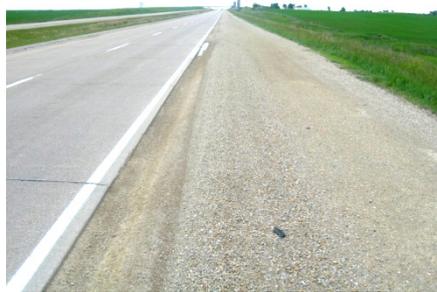
Figure 22. Calcium chloride scarify twice June 2009

However, some research team members have performed some informal photo documentation after formal field reconnaissance ended. Conditions appeared to be little changed from those that were present before test section construction took place (See Figure 21). And, difficulties maintaining the shoulder near the pavement edge prevailed (See Figure 22).

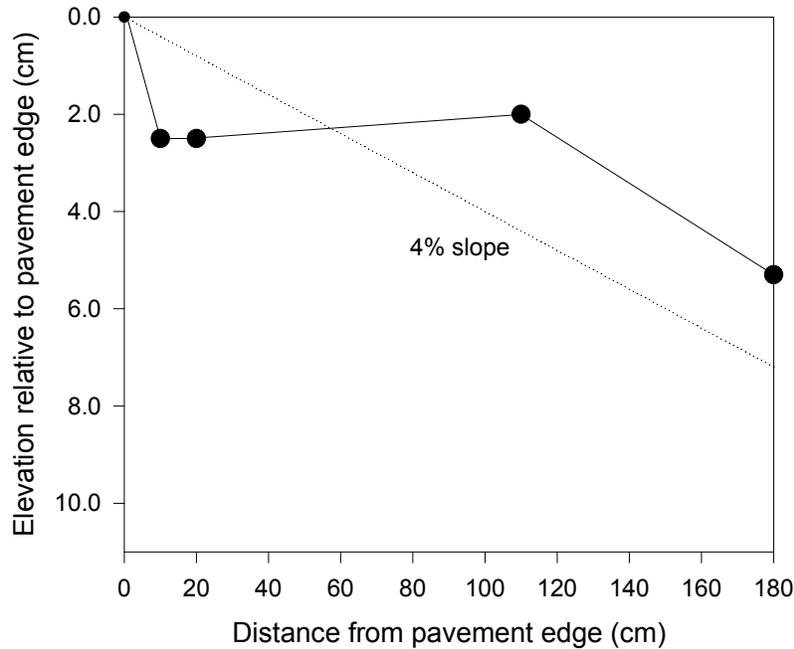
Figure 51. Typical elevation profile of shoulder in Test Area I before stabilization

A preconstruction field investigation indicated that the granular shoulder along US 75 in the area was rutted due to heavy traffic. Rutting usually occurred on the shoulder surface within 12 in. (300 mm) from the pavement edge to a depth of 2.54 in. (50 mm) (See Figures 49 and 50).

Cross sectional elevation profiles, DCP tests, and samples were taken from the shoulder before it was stabilized. The depth of pavement drop-off was measured as part of the process of obtaining the cross-sectional elevation profiles. Typical elevation profile of the shoulder before stabilization is shown in Figure 51.

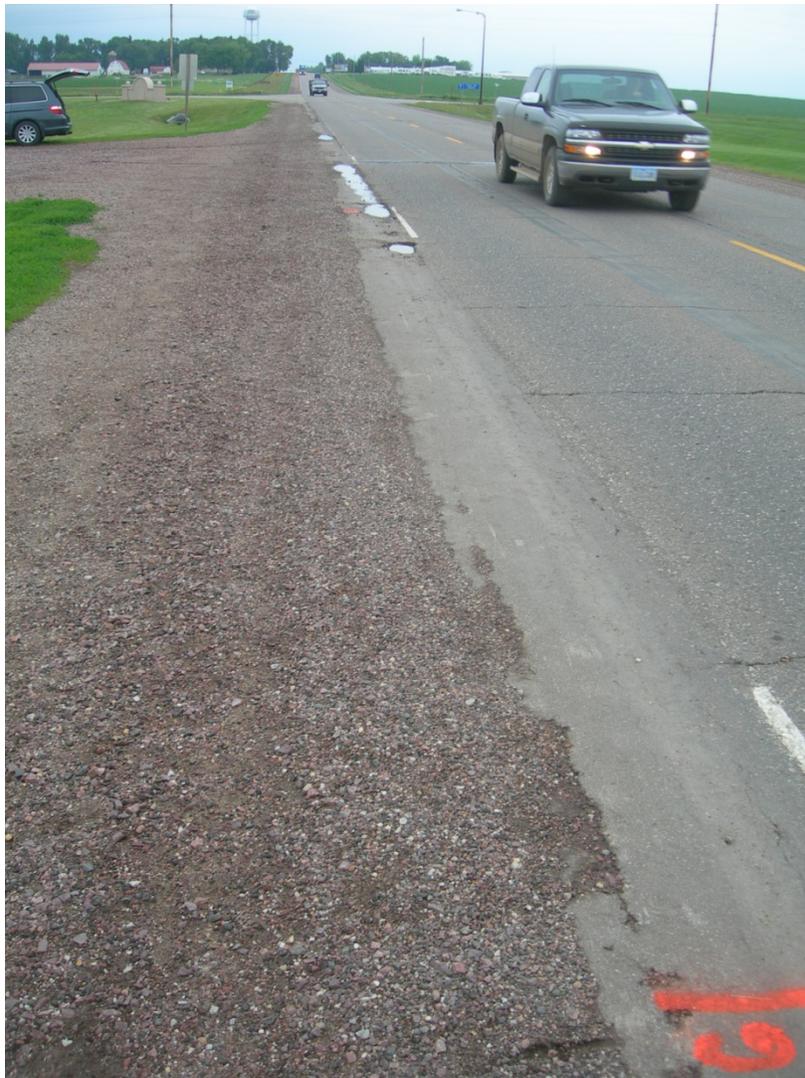
Figure 56. Looking north from Point 9 at Test Area I on southbound shoulder of US 75 near Sioux Center, Iowa June 8, 2010.

In the elevation profile, the solid line represents the elevation of the first measurement, the dashed red line with dots at the measurement points represents the second measurement, and the dashed blue line represents the third measurement. The profiles show that the shoulder generally lost elevation after two years in service and that the edge rut had returned in places after 10 months in service (See Figures 56 and 57). Repeated trafficking was considered as the likely cause. Despite the previously mentioned damage noted on many parts of the test section (especially away from the driveway area), the stabilized shoulder material remained completely intact.

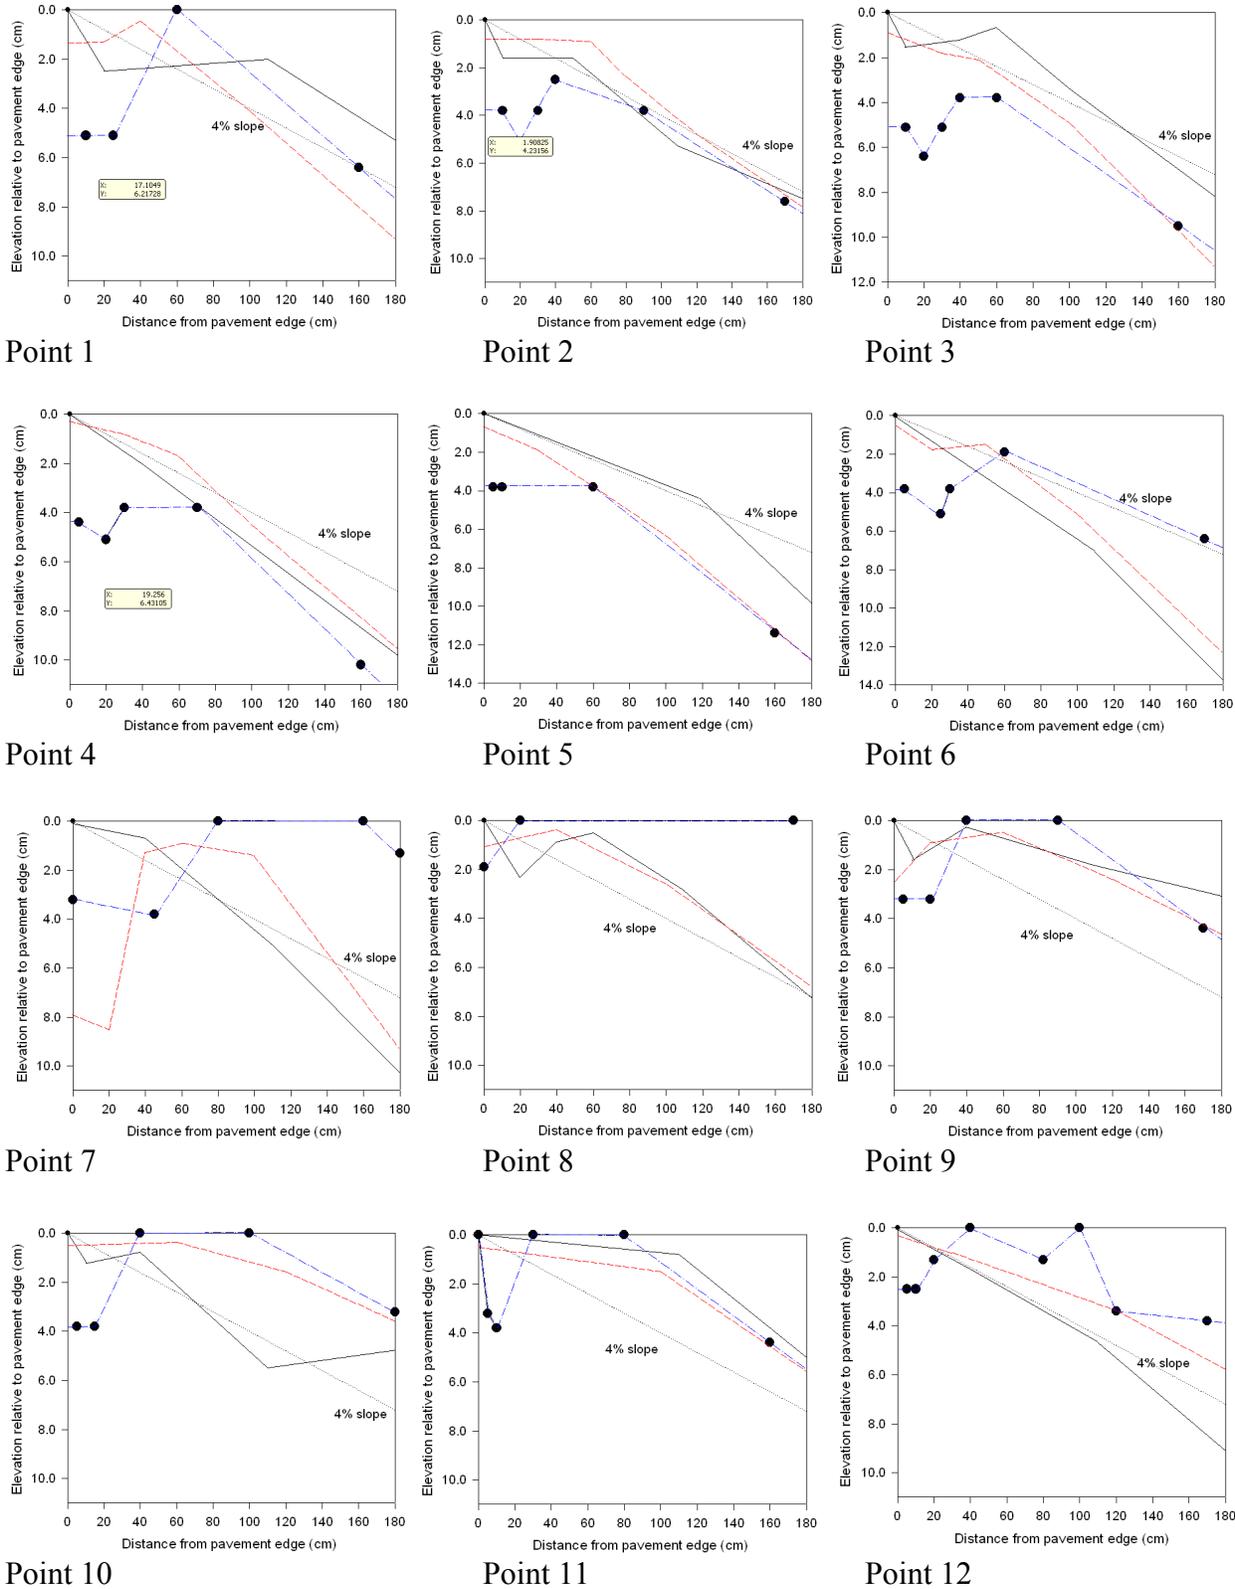
Figure 67. Elevation profiles of Test Area III on the southbound shoulder of US 75 near Sioux Center, Iowa

The elevation profiles showed that the elevation of the shoulder surface at the test points changed over several months. By October 2009, at some test points, the shoulder surface elevation had increased, while it decreased at the other points. The DUSTLOCK shoulder surface was observed to be damaged at several areas after about two months of construction.

The damage was observed in particular at Test Point 7 (See Figures 67 and 68). By June 2010, the stabilized material had mostly disappeared from the entire area (See Figure 69).

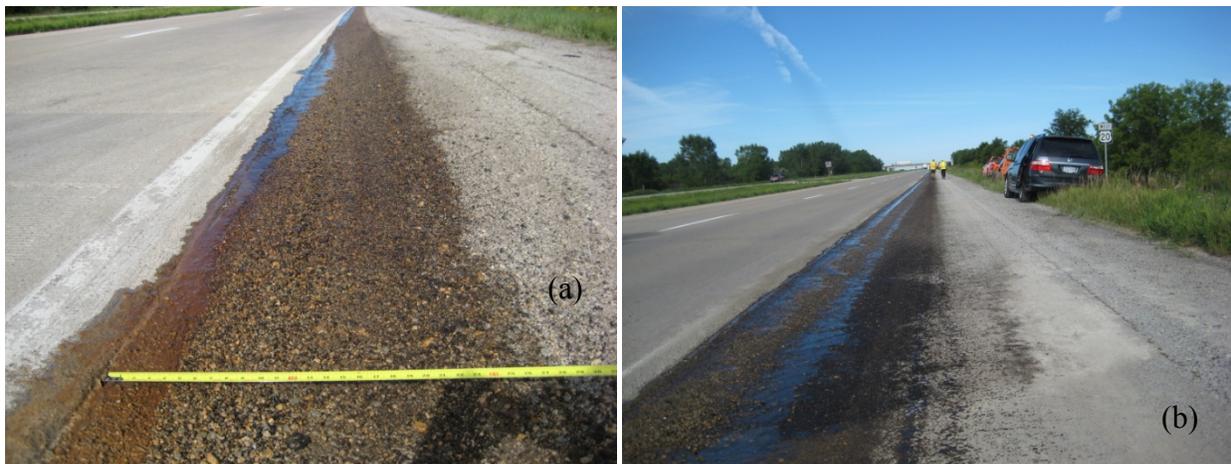
Figure 76. Topical application of DUSTLOCK: a) 2 ft (0.6 m) strip (sprayed with one tip) and b) 4 ft (1.2 m) strip (sprayed with two tips) August 18, 2009

The grain size distribution for the granular shoulder material at Section I is shown in Figure 75. The stabilizing agent was topically applied to the section. DUSTLOCK was initially sprayed with one tip of the distributor, creating a strip that was 137 ft (41.8 m) long and 2 ft (0.6 m) wide. Two tips were used for the remainder of the test sections providing an average strip width of 4 ft (1.2 m) of DUSTLOCK (See Figure 76).

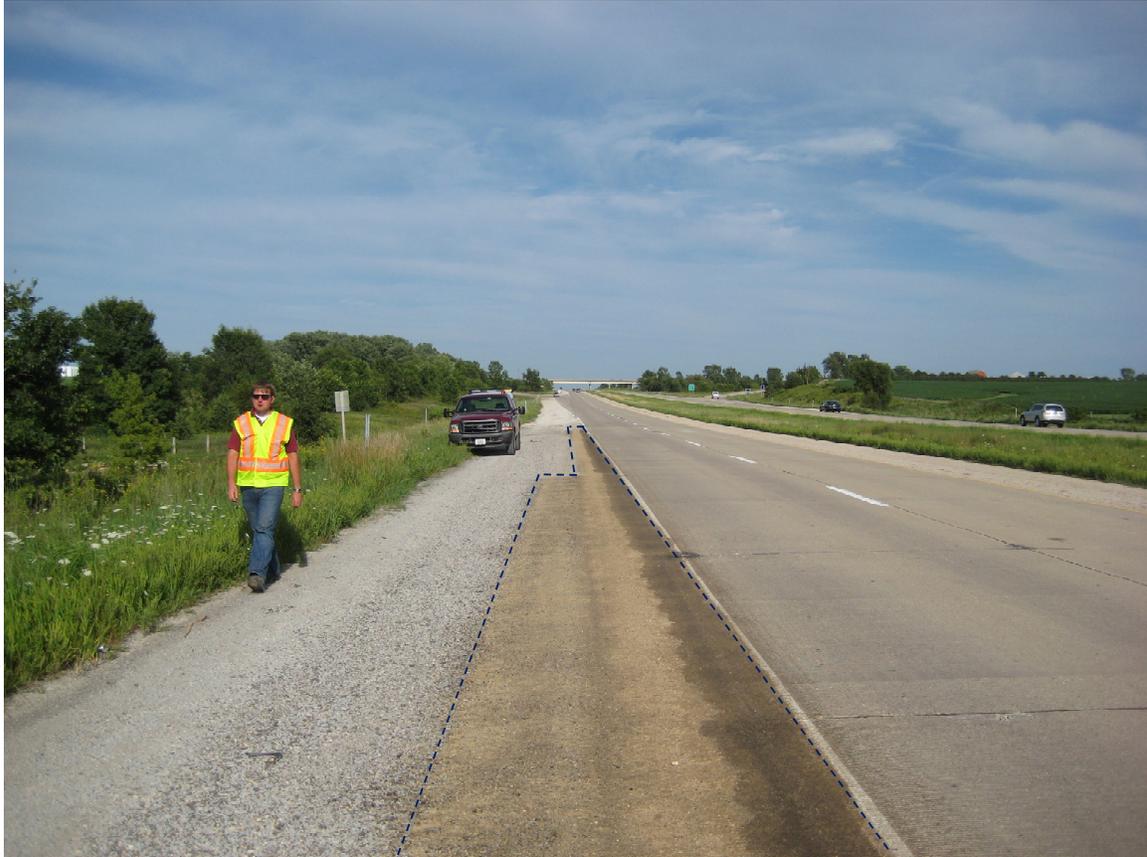
Figure 77. Section I after construction August 18, 2009

The shoulder surface was covered with sand provided by three passes of a dump truck with a sand spinner. The surface was then allowed to set for 15 minutes before being compacted by the roller. The construction period for this section, began at 9:34 a.m. and ended at 10:32 a.m., accounting for 58 minutes. The finished surface of the section is shown in Figure 77.

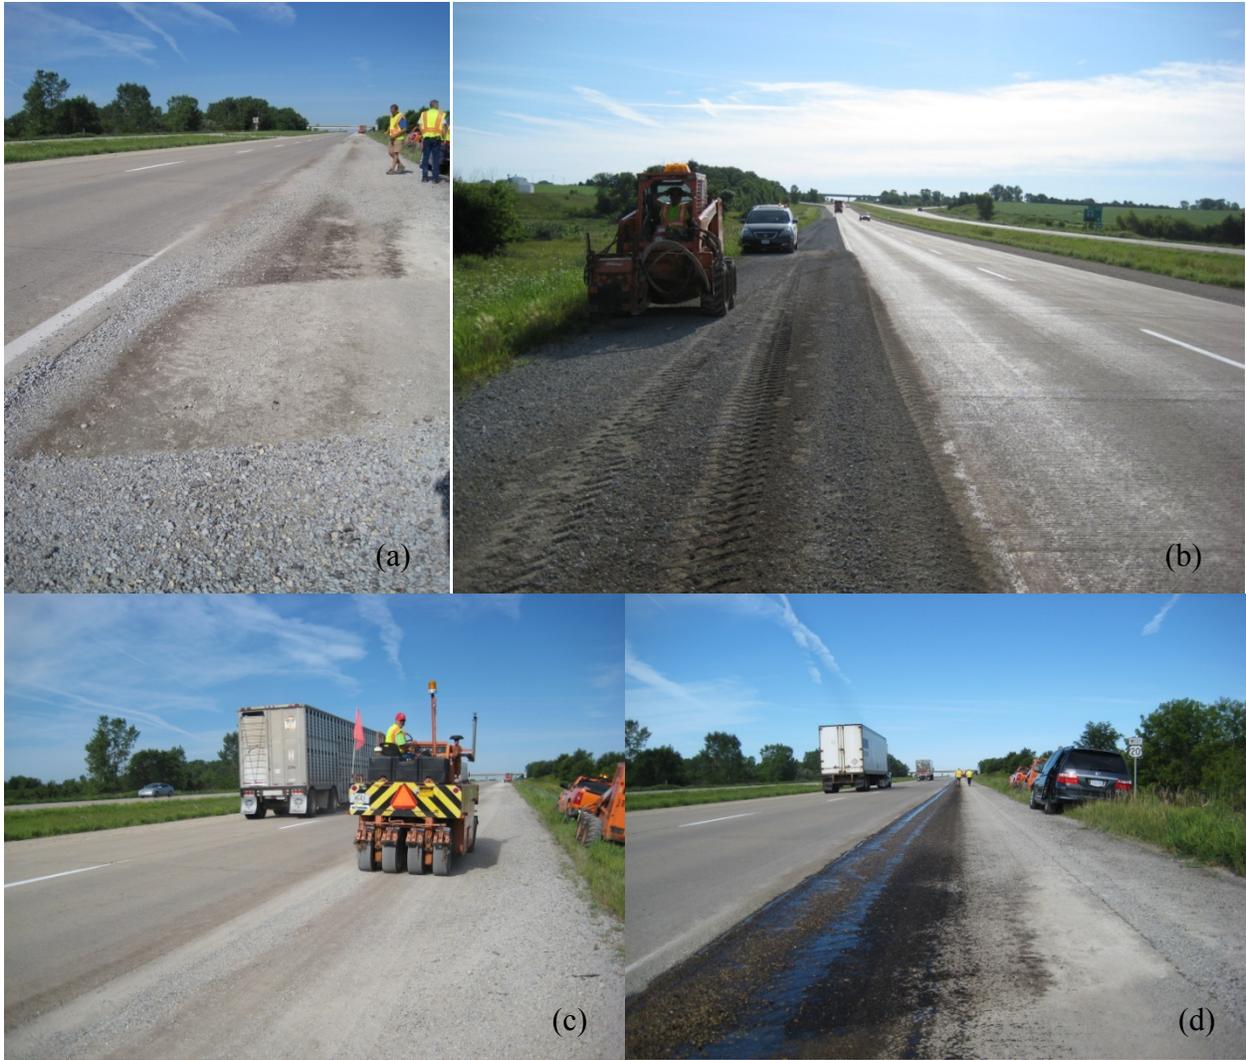
The grain size distribution for the granular shoulder materials at Test Section II is shown in Figure 78. The deepest edge rutting mostly occurred in this section. The shoulder surface was heavily graded by a motor grader on August 18, 2009. Loose aggregate was leveled to fill the edge rut along the pavement edge. This filled layer was from 1/2 to 1 in. (1.2 to 2.5 cm) thick, resulting in a surface that appeared to the researchers to be equivalent to a scarified surface. The loose surface was compacted with a pneumatic roller and then DUSTLOCK was topically applied (See Figure 79). Three passes of sand was broadcast on the surface. The roller was then used to compact the section.

Figure 79. Section II: a) grading, b) filling and leveling, c) compaction, and d) application of DUSTLOCK August 18, 2009

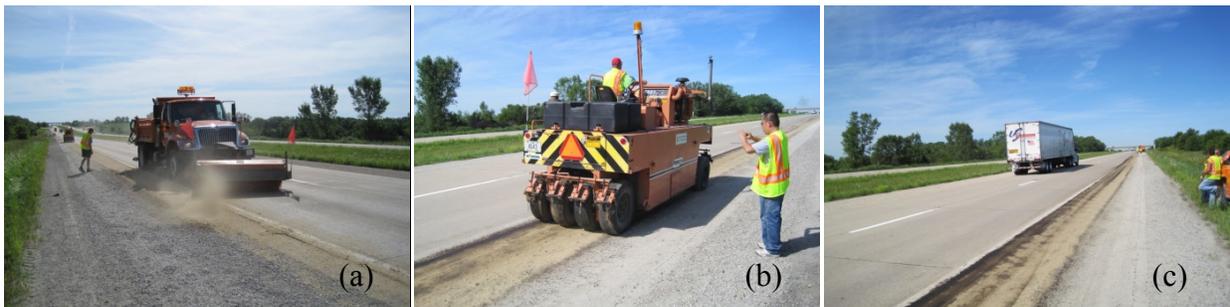
Figure 80. Section II: a) pavement cleaning, b) compaction, and c) finished surface August 18, 2009

The construction duration of the section was 1 hour 20 minutes, from 9:18 a.m. to 10:38 a.m. The completed section is shown in Figure 80 (c).

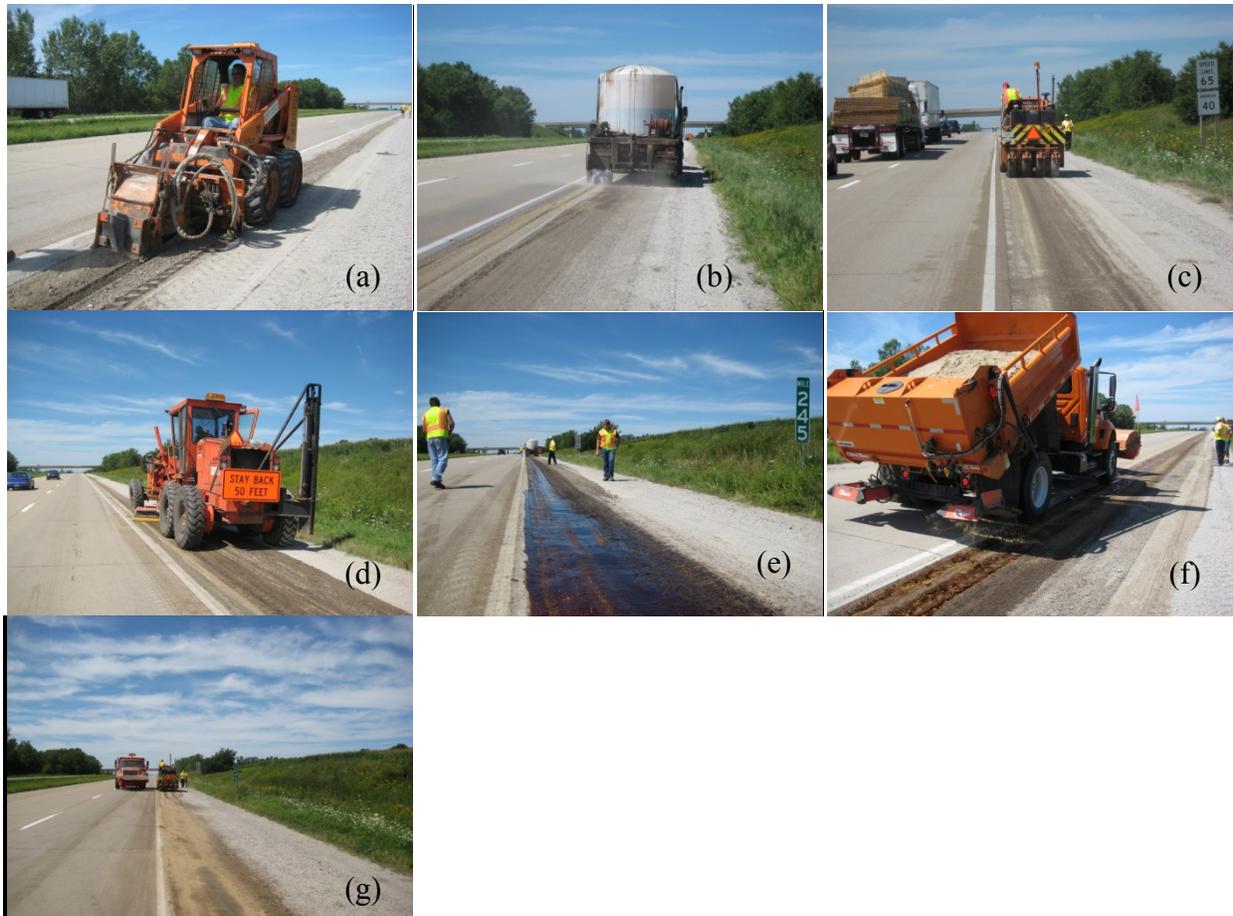
Figure 83. Section III: a) shoulder scarification, b) moisturizing, c) roller compaction, d) surface grading, e) DUSTLOCK application, f) sand spraying, and g) roller compaction August 18, 2009

Although the construction process included surface grading after the initial compaction, the shoulder surface after construction did not have a cross slope that was as constant as desired. The moist aggregate materials that were bound with the high-viscosity binder (DUSTLOCK) and the rubber wheels of the roller might have interacted to create an uneven surface. The shoulder surface along the pavement edge was still slightly lower than the surrounding area.

A skid steer mounted milling head was used to scarify the hardpan surface, creating a scarified strip of 4 ft (1.2 m) width and $\frac{1}{2}$ in. (1.2 cm) depth. Three passes of overlapping scarification were required to provide the 4 ft (1.2 m) test section width. The scarified layer was then sprayed with water and compacted with six passes of the pneumatic roller. The motor grader was then struck off the compacted shoulder surface, providing a surface with a constant cross slope. DUSTLOCK was then topically applied to the shoulder surface before the application of five passes of sand from the sand spinner of a dump truck. The DUSTLOCK and sand were allowed to set for 15 minutes before they were compacted by the pneumatic roller (See Figure 83). Section III was constructed from 10:44 a.m. to 1:04 p.m. for a duration of 2 hours 22 minutes.

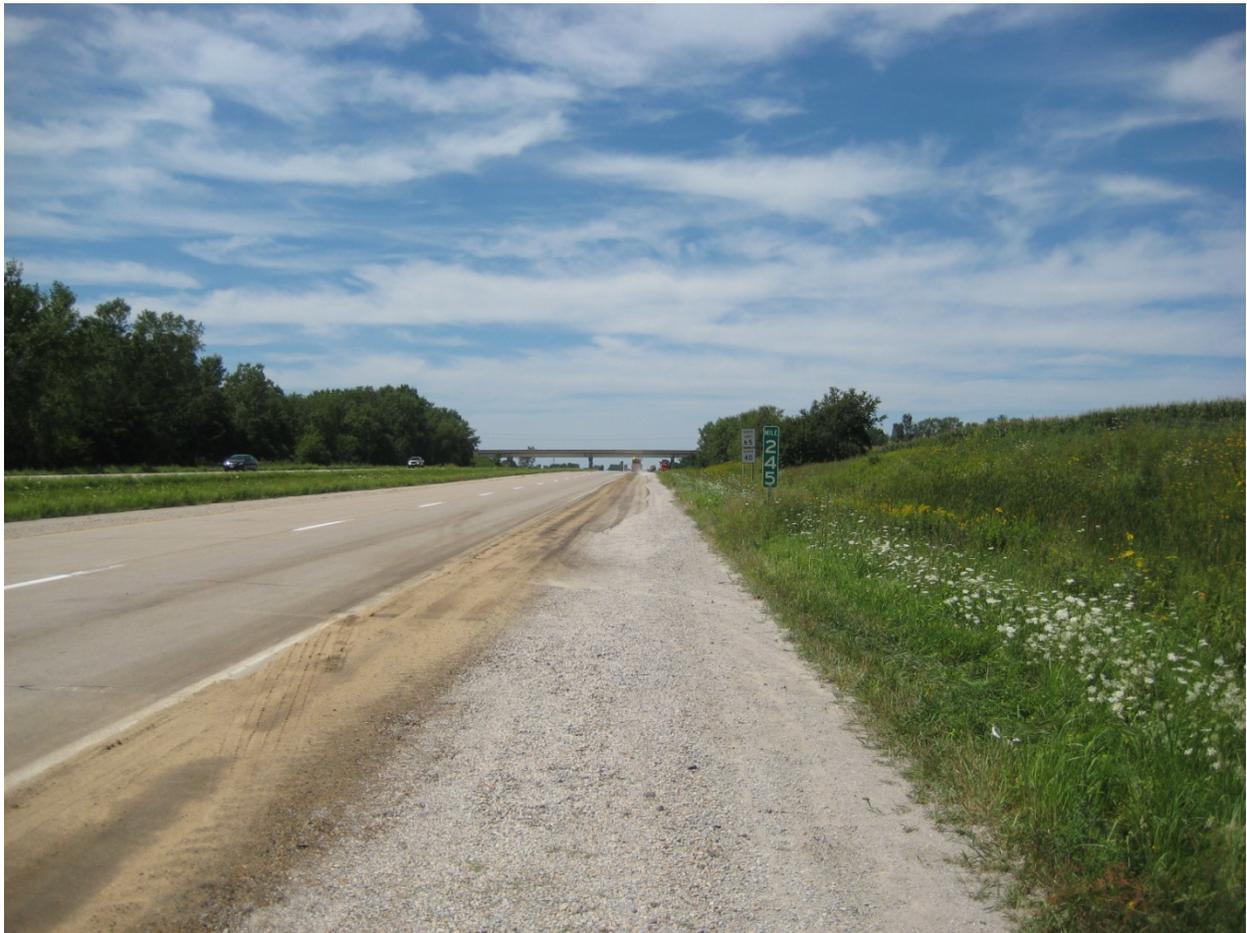
Figure 84. Stabilized shoulder surface of Sections II to IV (a) August 18, 2009

The original shoulder surface of Test Section IV was struck off to a constant cross slope with a motor grader, resulting in a pavement drop-off depth of 1.2 in. (3.0 cm) and a cross slope of 3% toward the ditch. Water and DUSTLOCK were then topically applied to the shoulder surface. Six passes of sand from the dump truck spinner were applied to the shoulder surface. The finished surface of the section is shown in Figure 84.

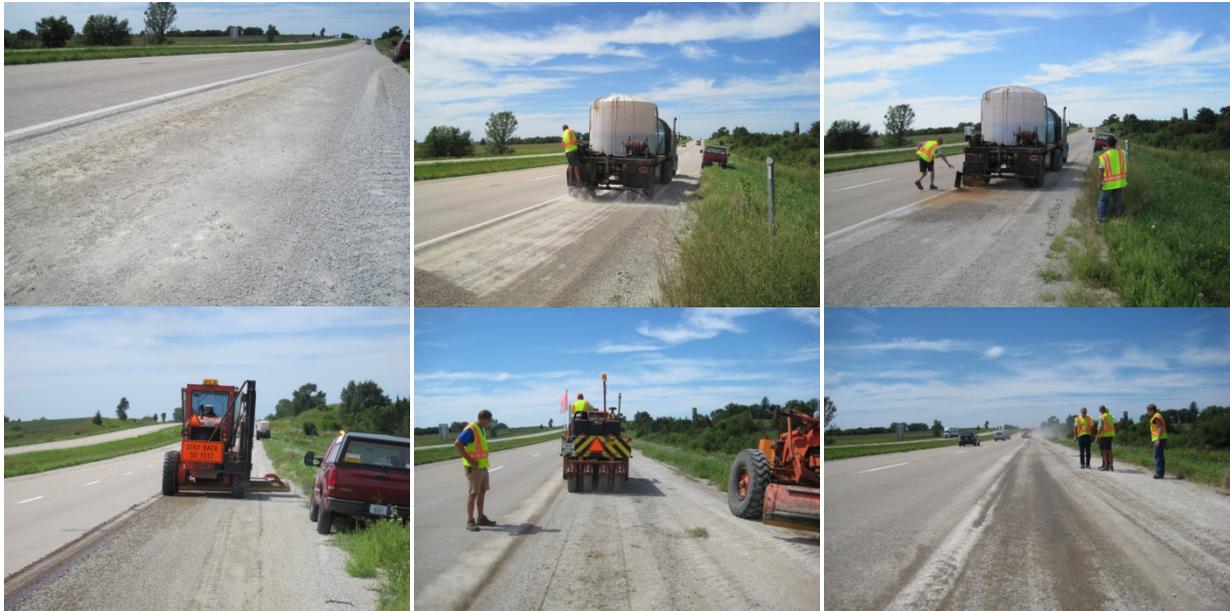
Figure 85. Construction process of Section V August 18, 2009

Redistribution of aggregate materials using the road grader reduced construction time and eliminated the use of sand. However, when the aggregate was cast back on top of the DUSTLOCK, the DUSTLOCK was rolled out of its original position. When the material was struck back away from the pavement, some of the mixture was unintentionally cast toward the ditch (See Figure 86). Nevertheless, this test section was constructed in a short period of time. The construction duration was only 34 minutes, starting at 1:15 p.m. and ending at 1:49 p.m..

Test Section V was located at the bottom of a sag from milepost 244.45 to 244.35. This area was considered to be problematic to the maintenance crews. Aggregate shoulder for this section was struck off to a 3% cross slope by the motor grader. The struck surface was sprayed with water and then DUSTLOCK. To eliminate the use of sand, the struck-off aggregate materials were cast back by the motor grader to cover the DUSTLOCK. The test section was then compacted by six passes of the pneumatic roller (See Figure 60).

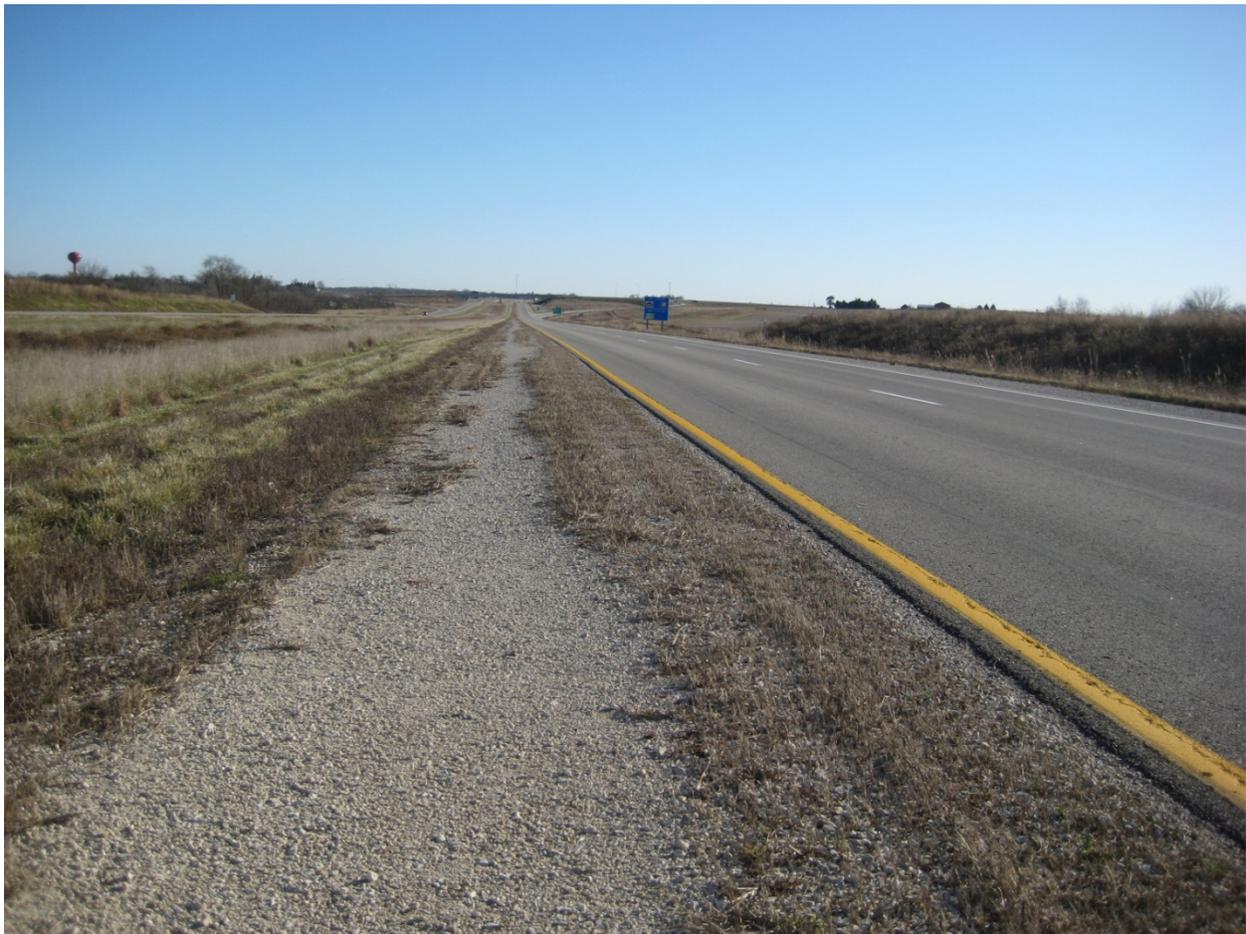
Figure 92. Test sections on November 7, 2009

The control section was 200 ft (61 m) long from mileposts 220.60 to 220.55. It was stable with no heavy rutting observed (See Figure 92). An edge rut was located within 8 in. (200 mm) of the pavement edge with an average depth of about 0.8 in. (20 mm). The elevation profiles showed that the maximum edge rut was about 1.8 in. (45 mm). The CIV values of the shoulder at various points 8 in. (200 mm) from the pavement edge ranged from 13.1 to 15.4 (See Table 31).

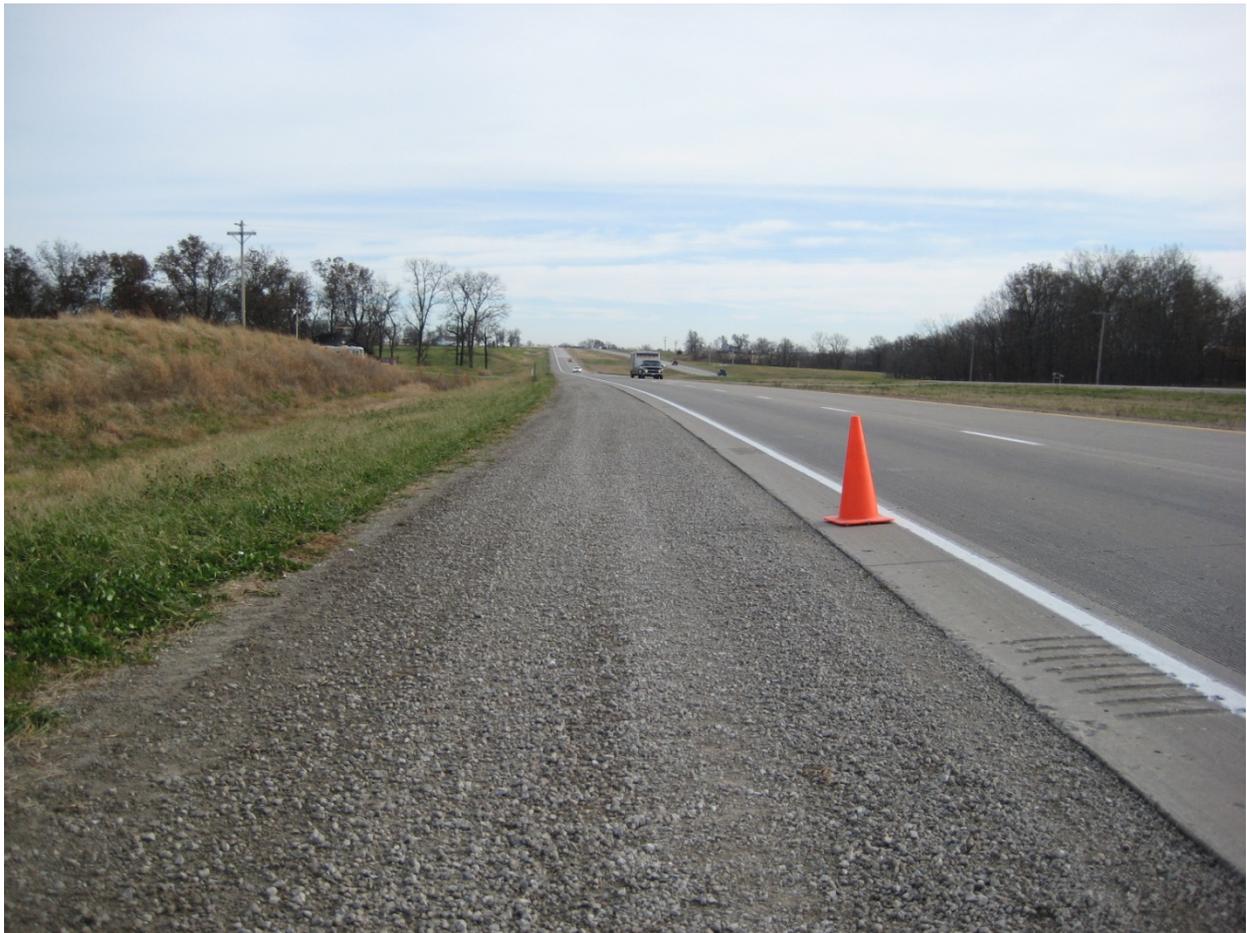
Figure 93. Test sections on November 12, 2009
