Field Testing and Evaluation of a Demonstration Timber Bridge

Final Report
February 2012

Sponsored by
Iowa Highway Research Board
(IHRB Project TR-604)
Iowa Department of Transportation
(InTrans Project 08-343)

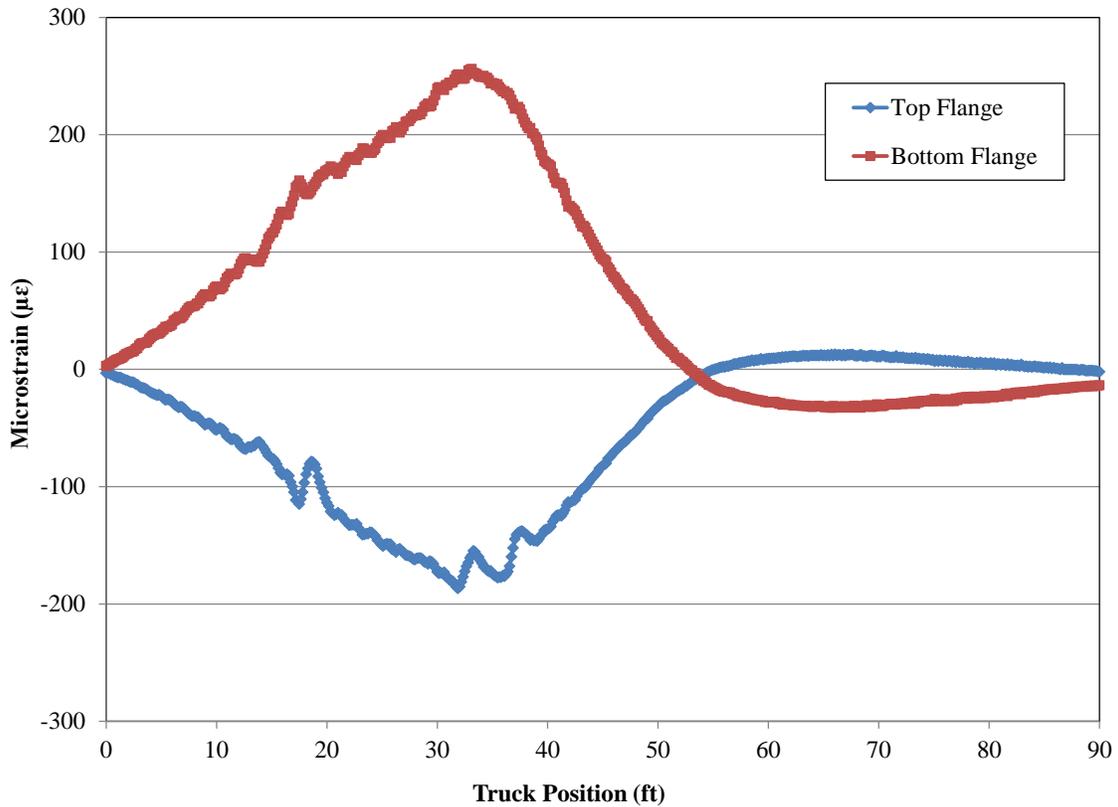
Figure 5.7. Top and bottom girder strains, Span 1, G6, 2010

A comparison of the top and bottom strain from a girder under the load truck for any given load case indicates that the transverse deck panels and the girders did not act compositely as expected; see Figure 5.7 for a typical strain plot from 2010.
