Timber Abutment Piling and Back Wall Rehabilitation and Repair

Final Report
September 2012

IOWA STATE UNIVERSITY
Institute for Transportation

Sponsored by
Iowa Highway Research Board
(IHRB Project TR-616)
Iowa Department of Transportation
(InTrans Project 10-372)

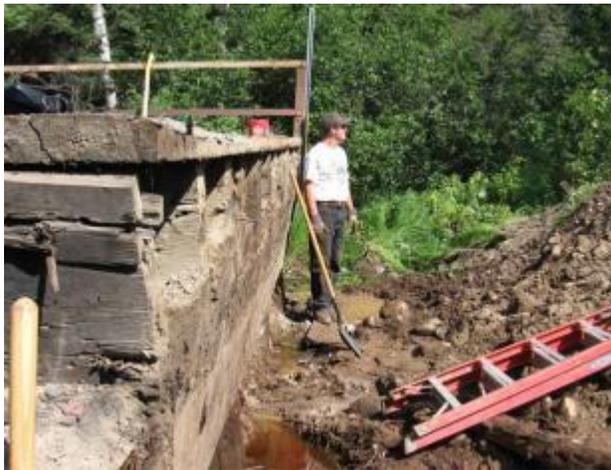
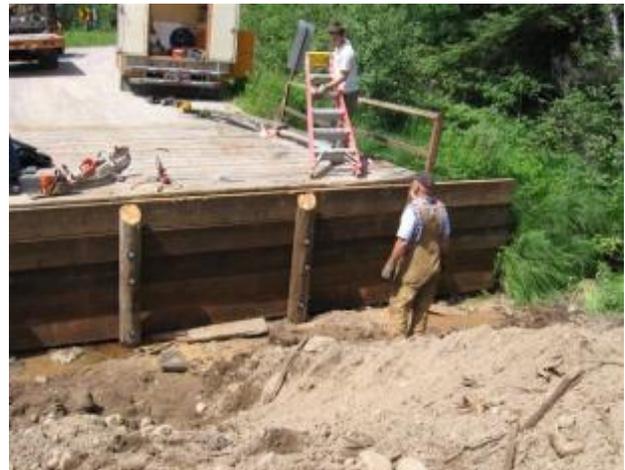
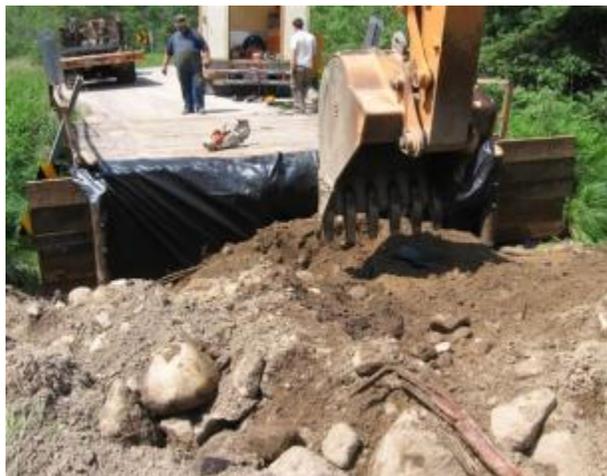
Figure 6-21 St. Louis County, Minnesota backwall repair by use of vertical pile stays

One of the backwall repair methods used by St Louis County, Minnesota is to place “pile stays” on the back side of the backwall. In order to place the pile stays, the embankment is excavated away from the existing backwall, as shown in Figure 6-21a. The deteriorated backwall planks are then replaced and vertical stays (e.g., round timbers) are bolted to the existing piles and cap beam, shown in Figure 6-21b. The wall is then covered with geotextile fabric and backfilled, seen in Figure 6-21c.

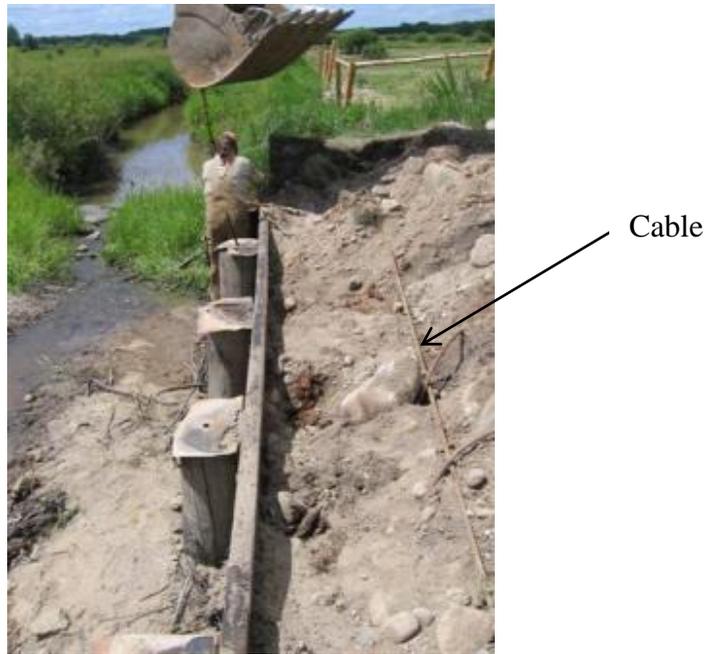
Figure 6-22 Cable tying wing walls together to prevent tip out

St Louis County has also had success preventing wing walls from tipping outward by using a cable that is run between the wing walls to tie them together. Figure 6-22 shows the cable running between the installation of the cable at an existing bridge.

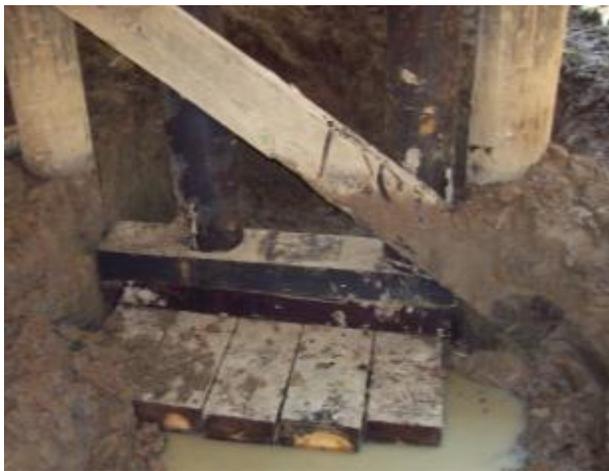
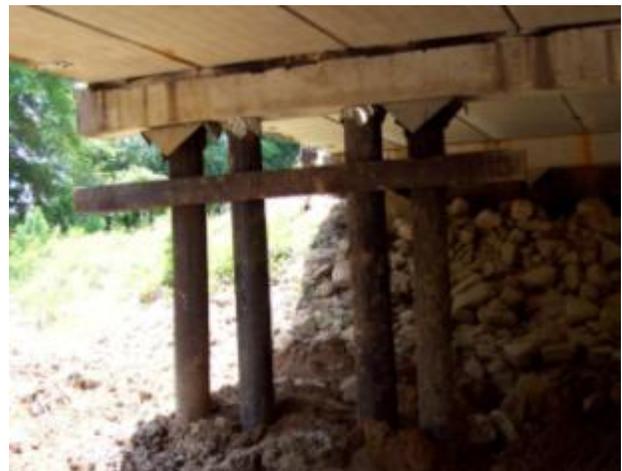
Figure 6-23 New piles placed on mudsill next to rotted existing columns and braced

The Parish of Caddo in Louisiana has had success with placing new piles on mudsills. The repair technique, shown in Figure 6-23, requires the soil around the existing pile to be removed a suitable distance to expose a firm sound bearing soil layer.

A network of thick planking (approximately 6 in. thick) are placed, as shown in Figure 6-23a, to provide a foundation for the new piles. If settlement has occurred, a jack is used to push the

bridge back up to finished grade. New treated timber piles are placed between the top of the mudsill and bottom of the cap beam. Bracing is then attached to the new piles and existing piles to provide stability. Lastly, the bases of the piles were backfilled up to existing grade. The Parish of Caddo has been performing the mudsill repairs for several years; however, improvements were made to the design approximately four years ago that have helped the performance of the repair. The two biggest improvements consisted of digging deeper to allow the mudsill to rest on a firm layer of soil and provide a larger network of planking and thusly a larger foundation below the piles. The new technique has been used on 10 to 15 bridges all showing very little settlement. The Parish of Caddo estimates the repair provides an additional 10 to 15 years of service life to the repaired substructure.

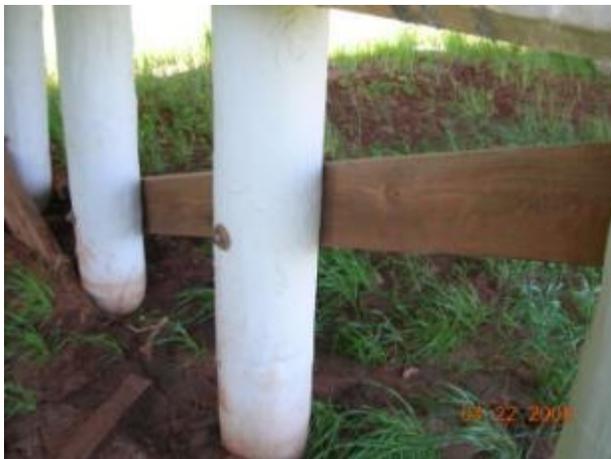
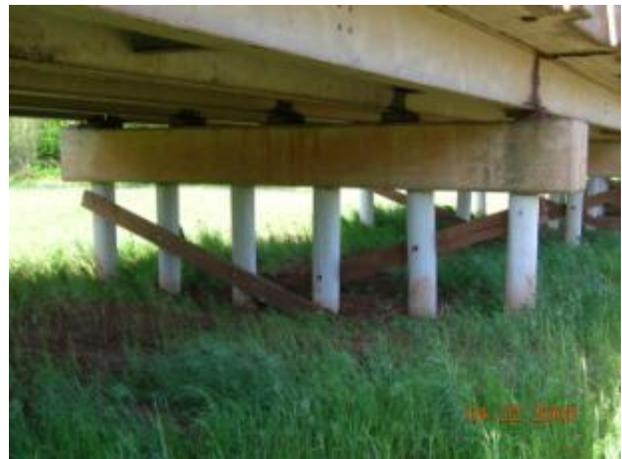
Figure 6-30 Completed Oklahoma DOT injected and FRP repaired timber piles

The Oklahoma Department of Transportation (2010) has had timber pile repair success with FRP wraps; however, they have only used the repair technique on pile bents and not on abutment piles. The technique was developed by personnel at the Oklahoma DOT and was studied by Emerson (2004) as described previously in this report. The piles are excavated below the ground line to expose a minimum of 2 ft of sound piling. Then, 3 inch-diameter holes are drilled through the outer shell of the hollow or damaged section to clean the interior of the pile. The holes are spaced to allow for cleaning and future placement of fill material in the pile. After both the surface and interior portion of the pile are cleaned, the timber is allowed to drain and dry; the timber is then remedially treated with borate fungicide, which is placed in drilled and then plugged holes above and below the damaged section. The voids in the timber pile are then filled with aggregate to lessen the amount of epoxy required and the heat from the epoxy exothermic. Two wraps of FRP material are then placed around the pile and set with fabric impregnation resin. After the resin has set, the injection port holes are drilled and spaced so that travel of epoxy between ports is assured. After the epoxy resin mortar has cured, the ports are removed. Lastly, an ultra-violet resistant coating is applied to the pile. Two views of FRP repaired piles at an Oklahoma bridge are shown in Figure 6-30.

The Oklahoma DOT has used the FRP epoxy injection techniques since 1999. To date approximately 120 piles on 12 bridges have been successfully repaired. The repair technique when used on a need by need basis is estimated to cost \$2,000 to \$3,000 depending on the length and condition of the pile. The Oklahoma DOT estimates the repair extends the service life of the pile 10 to 15 years.

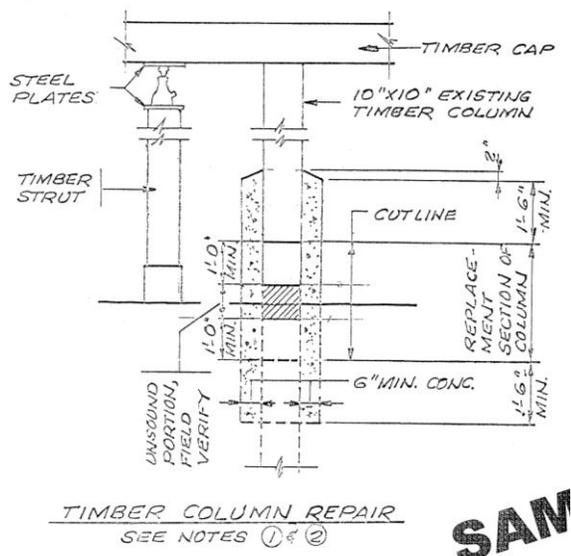
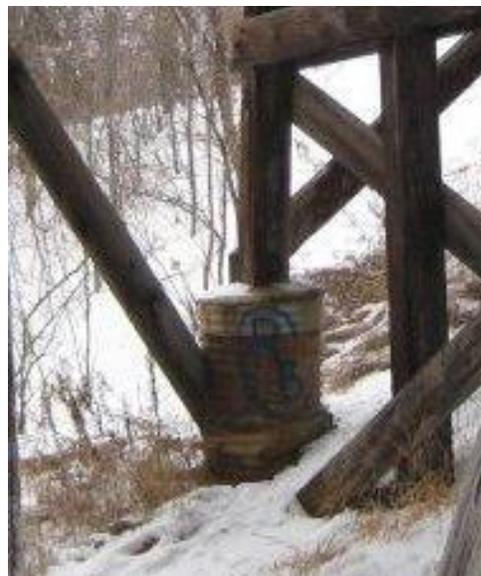
Figure 6-31 Minnesota DOT posting and concrete encasement repair for piles

The Minnesota Department of Transportation has used a combination of posting and concrete encasing to repair deteriorated piling. Shown in Figure 6-31 are example plans for repairing a timber piling and a photo of an existing repair. The repair is completed by excavating 2.5 ft below the unsound portion of the pile or to the base of the pile. Then the cap is jacked up to remove load from the pile. The deteriorated portion of the pile is cut off 1 ft above and below the deteriorated section. A new column section that is 1/4 in. longer than the removed section is placed in the same location as the section removed; after which the temporary jack is removed. The concrete jacket and reinforcing steel is placed; after which concrete is placed with 6 in. of minimum cover around the pile.

The Minnesota DOT has installed two concrete encasements and explained that the repair is generally only worthwhile when only one bad pile is found on the bridge. In most cases, there are multiple bad piles in a bridge, which, for the Minnesota DOT, results in replacement of the bridge being a more feasible option. The first concrete encasement repair done by the Minnesota DOT was completed in 1993. According to Minnesota DOT personnel, the 1993 repair, although on dry ground, is in as good of condition as the day it was installed providing an extended service life thus far of 17 years.

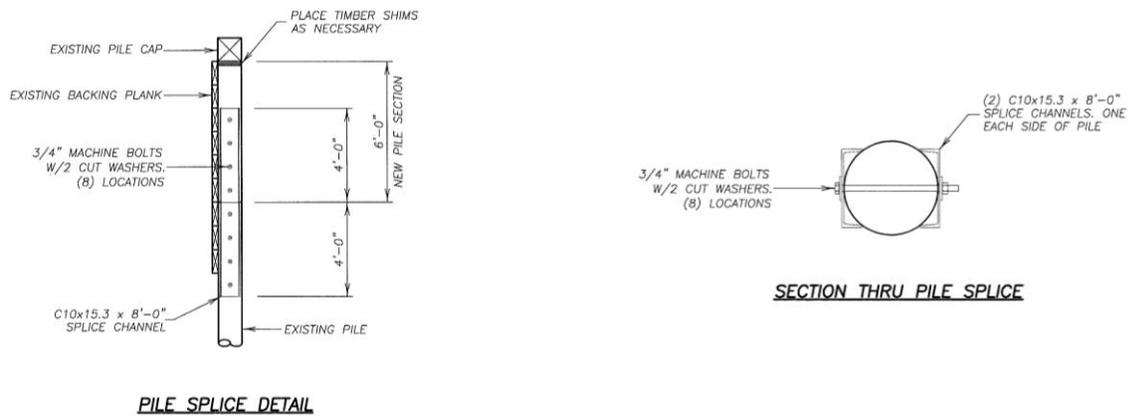
Figure 6-32 Minnesota DOT channel pile splice for piles next to backwall

The Minnesota DOT also provided information on repair for pilings next to a backwall or brace members. Since the complete circumference of the piling is not exposed, concrete encasement cannot be completed. Therefore, a combination of posting and splicing with channels is used. A similar process as described above is completed except a new section of pile is placed from the cut below the deteriorated location up to the cap beam. The new pile section is sandwiched between two splice channels as shown in Figure 6-32. The channels extend 4 ft above and below the joint between the new and old pile; through bolts are used to clamp the channels to the pile.

The channel pile splice repair is a relatively new detail for the Minnesota DOT that was designed by a local consultant. The repair is suited for rotted or damaged pile and can be placed next to a backwall or brace member. To-date the repair technique has not been used, but Minnesota DOT personnel feel that it will last at least as long as the remaining service life of the bridge.

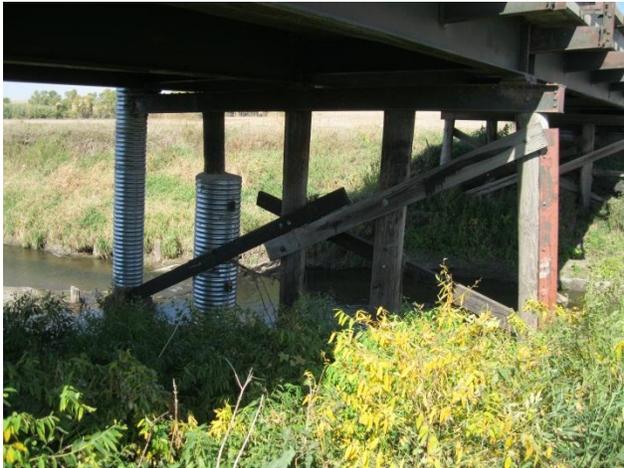
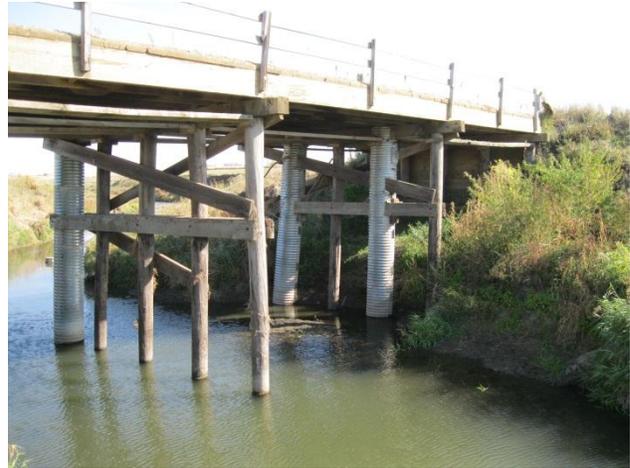
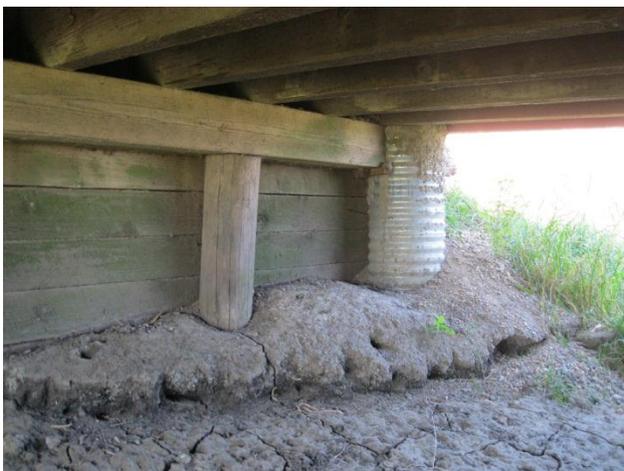
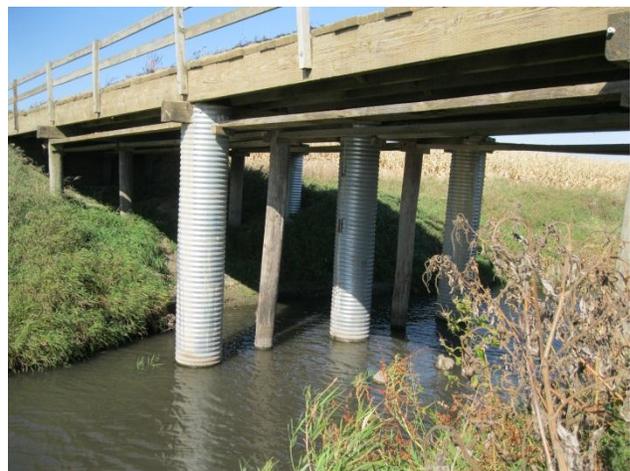
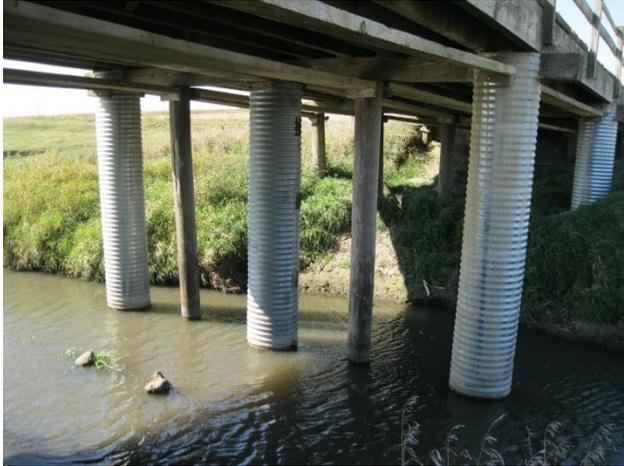
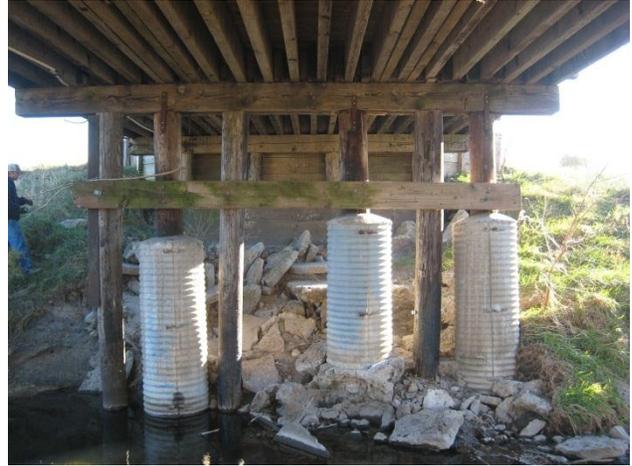
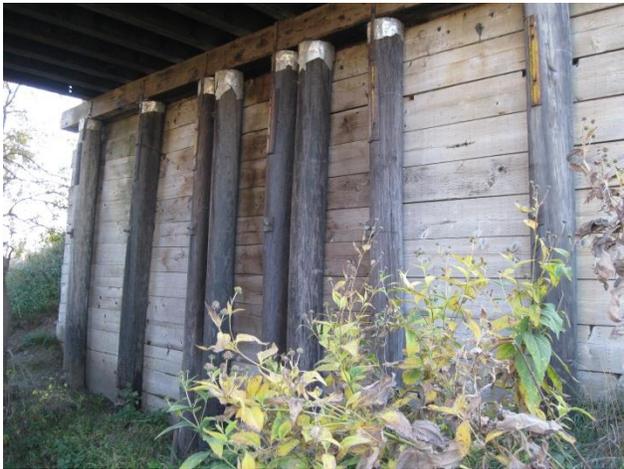
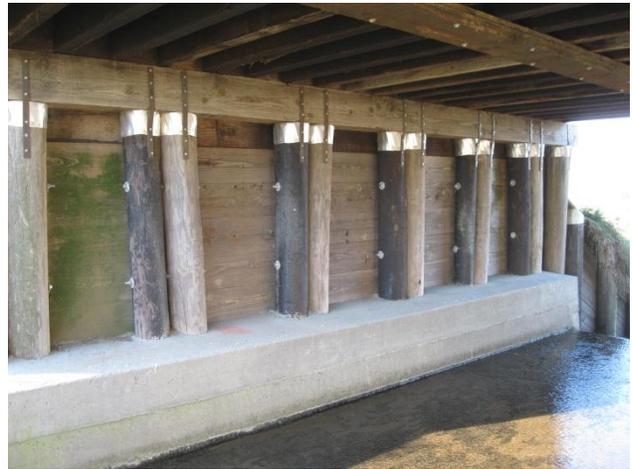
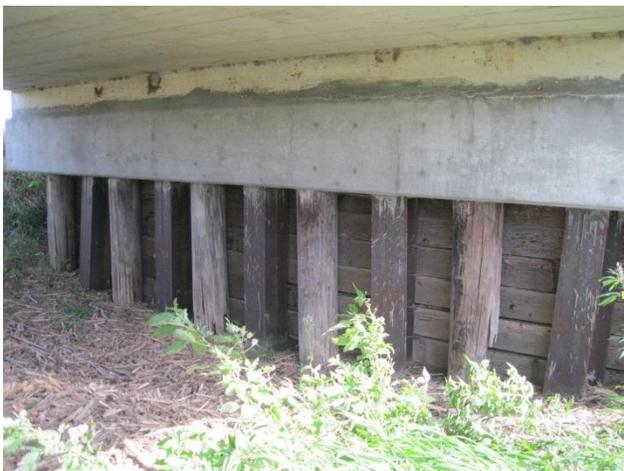
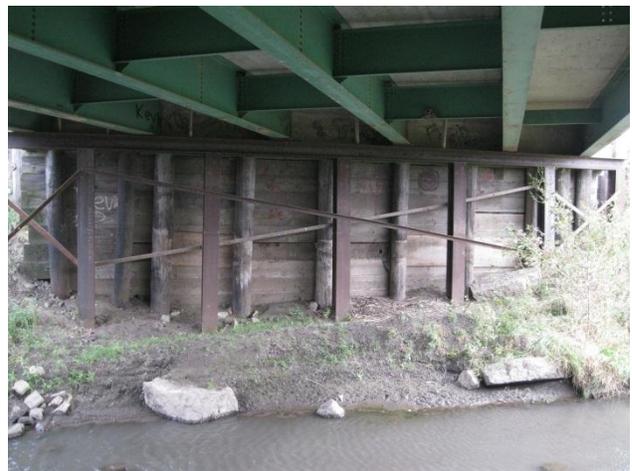
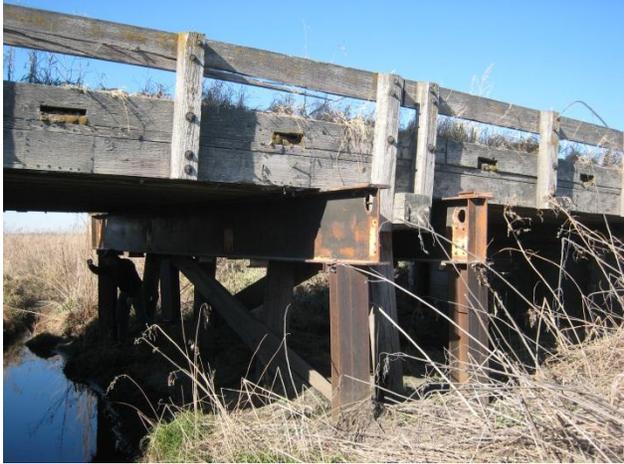
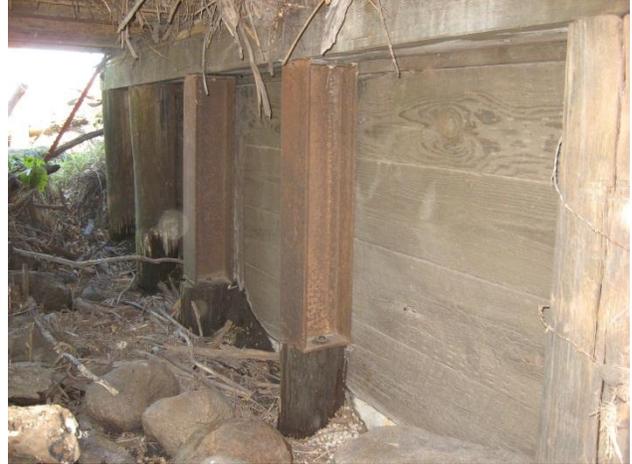
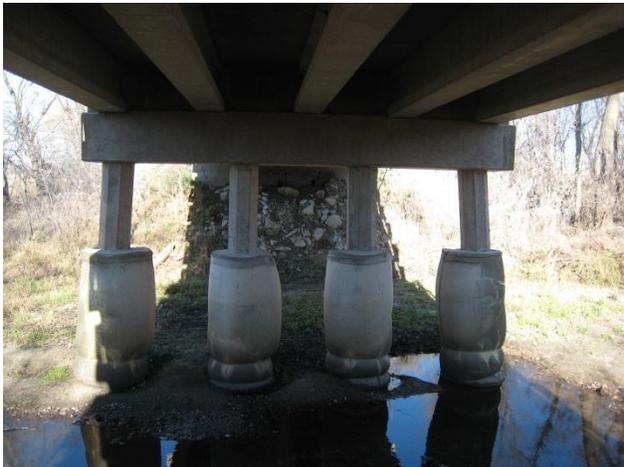
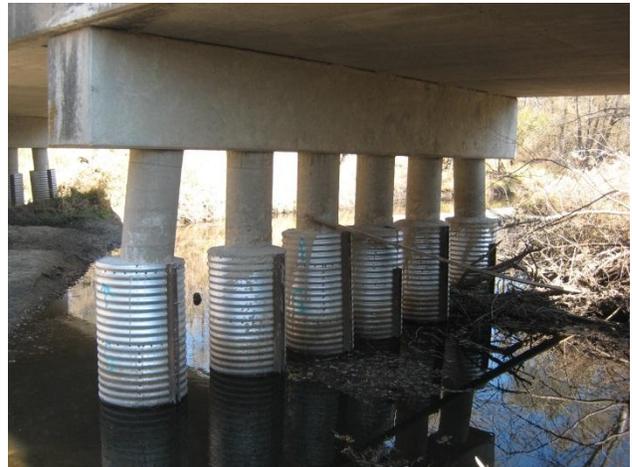
Figure 7-1 Example of timber piles and abutment repairs in Iowa

Upon review and synthesis of the survey data, five counties in Iowa were selected for field reconnaissance of bridges with timber pile and/or abutment repairs from which several could be selected for live load testing. Within these counties, the methods of repair were both varied and similar, allowing for a broad scope of testing and the ability to compare the performance of like repairs. Figure 7-1 shows several of the repair methods encountered and are described in the following. Images a) - f) show variations of casts created from corrugated metal pipe and concrete infill. Images g) - i) show the addition of supplemental piles; those in image i) are steel rather than timber. Additionally, new concrete sills and pile caps were constructed for those bridges in images h) and i), respectively. Images j) and k) show the addition of an all-steel pier that could effectively replace the timber bents in the event of failure. Images l), m), and n) show steel posting, dough-boy casts, and another variation of corrugated metal pipe casts, respectively.

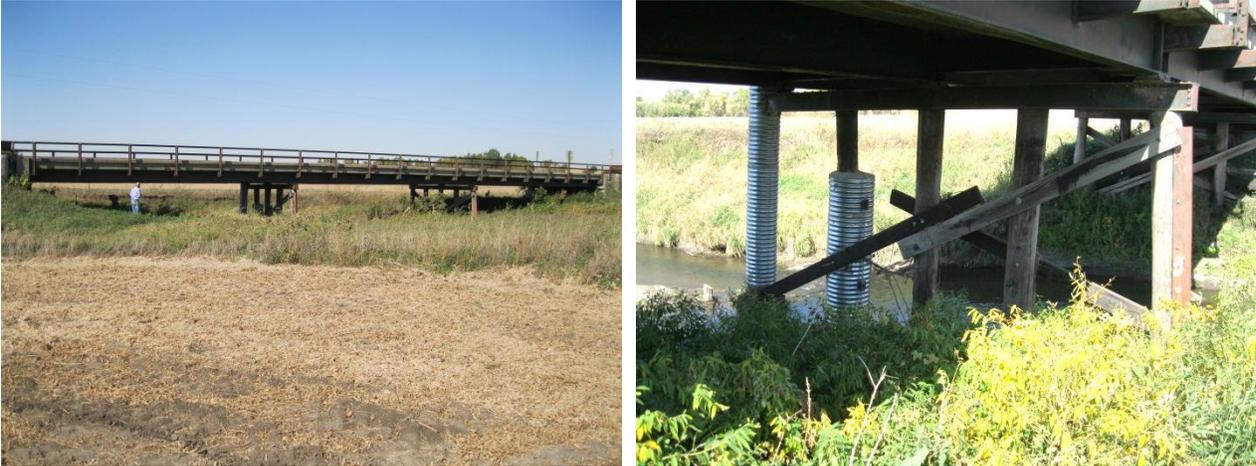
Figure 7-2 Bridge 1 side view and instrumented pier

Bridge 1 is a 126 ft long bridge with three equal spans. The continuous span superstructure consists of three steel girders and a concrete deck, while the substructure consists of timber piles, five at each abutment and pier. The only timber pile repairs were located at the southernmost pier; two of the five piles were repaired using the concrete encasement method. The

instrumented pier is shown in Figure 7-2. One of the repaired piles was completely encased, while the other was only partly encased (Figure 7-3).

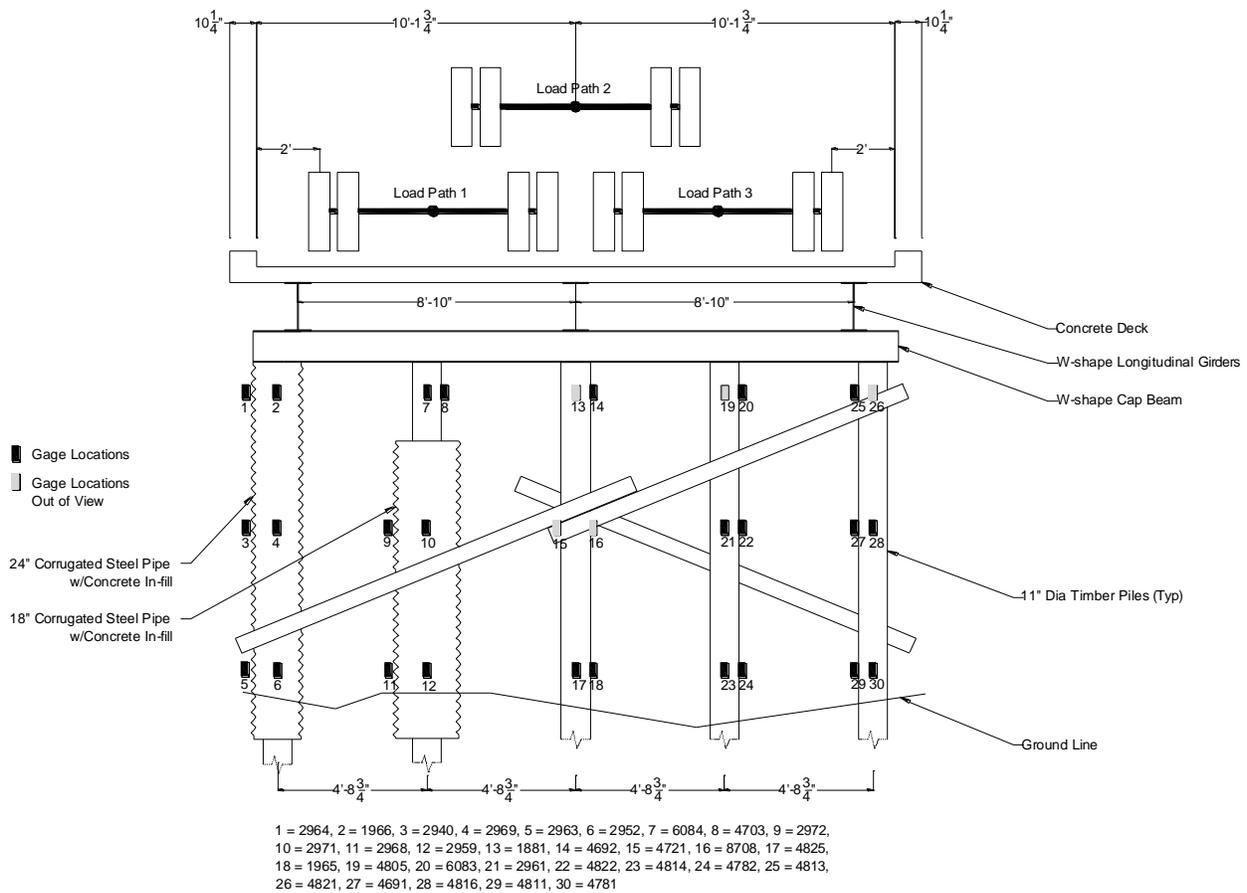
Figure 7-4 Schematic of Bridge 1 instrumented piles and load paths

One can assume by visual inspection that the concrete encasement stiffens inadequate piles, yet the need exists to quantify the actual force transferred to the encasement. Each of the five piles within the pier were instrumented with multiple strain gages placed to enable quantification of the force carried by the concrete encasement and, when accessible, the timber piles. It is evident by the strain plots (Figure 7-5) that the concrete encasement did carry part of the total load imposed on the repaired piles. As one might expect, the strain values measured on the encasement were considerably less than those measured on the timber piles alone. This can be attributed to the substantial difference in total cross-sectional area between the timber pile and concrete, along with the greater modulus of elasticity of the concrete. It is assumed that the concrete encasement does not carry the entirety of the load imposed on the pile. This phenomenon would most likely happen only in circumstances where the entire cross-section of the timber has been lost; this method of repair would not have been appropriate if that were the case. The bridge geometry is mirrored on the centerline of the bridge. Likewise, the load paths of the test vehicle were mirrored on the bridge centerline. Subsequently, when comparing the strain values measured in the fully encapsulated pile to the timber pile on the opposite side of the pier, the percentage of total load introduced to the concrete encasement can be derived. After calculating the force induced into the piles given the strains and cross-sectional properties, it was

determined that the concrete encasements carried between 50 and 70 percent of the total load imposed on the respective piles. That is not to say the repaired piles were only capable of carrying 30 to 50 percent of the total load. Rather, it more likely reflects the stiffness of the concrete encasement with respect to the timber and its inherent tendency to carry a greater portion of the load.

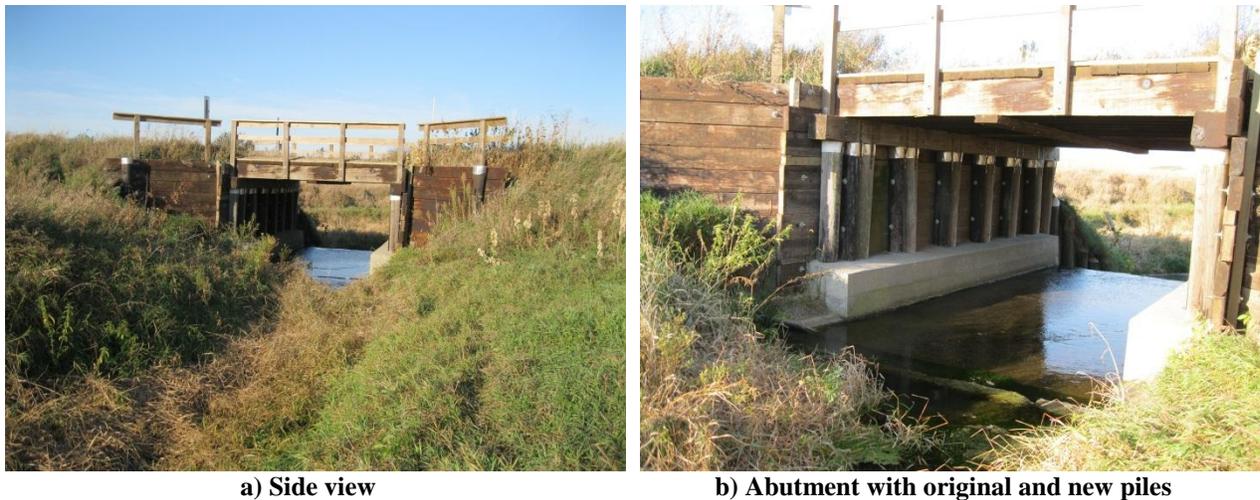
Figure 7-6 Bridge 2 side view and added piles

Bridge 2 is a single span 16 ft long Greenwood flume bridge. The superstructure consists of timber decking and 21 timber stringers bearing on a timber pile cap, while the substructure at each abutment consists of eight original timber piles and six added timber piles. Additionally, the base of all piles at the waterline was encapsulated in concrete. Bridge 2 can be seen in Figure 7-6 and the instrumented abutment piles and backwall can be seen in Figure 7-7.

The added piles were essentially the same size as the existing piles and were placed directly adjacent to them. The bearing conditions appeared to be consistent between all existing and new piles. Presented in Figure 7-8, are the strains in adjacent new and old piles when the first, second, and third axles of the load truck pass over the pile cap, respectively. By visual inspection, one can see the strains in the new and old piles are very nearly the same. Assuming that adjacent piles receive equal load, this gives evidence that the load is approximately split between the two piles, thus reducing the load capacity required by any one pile to half.

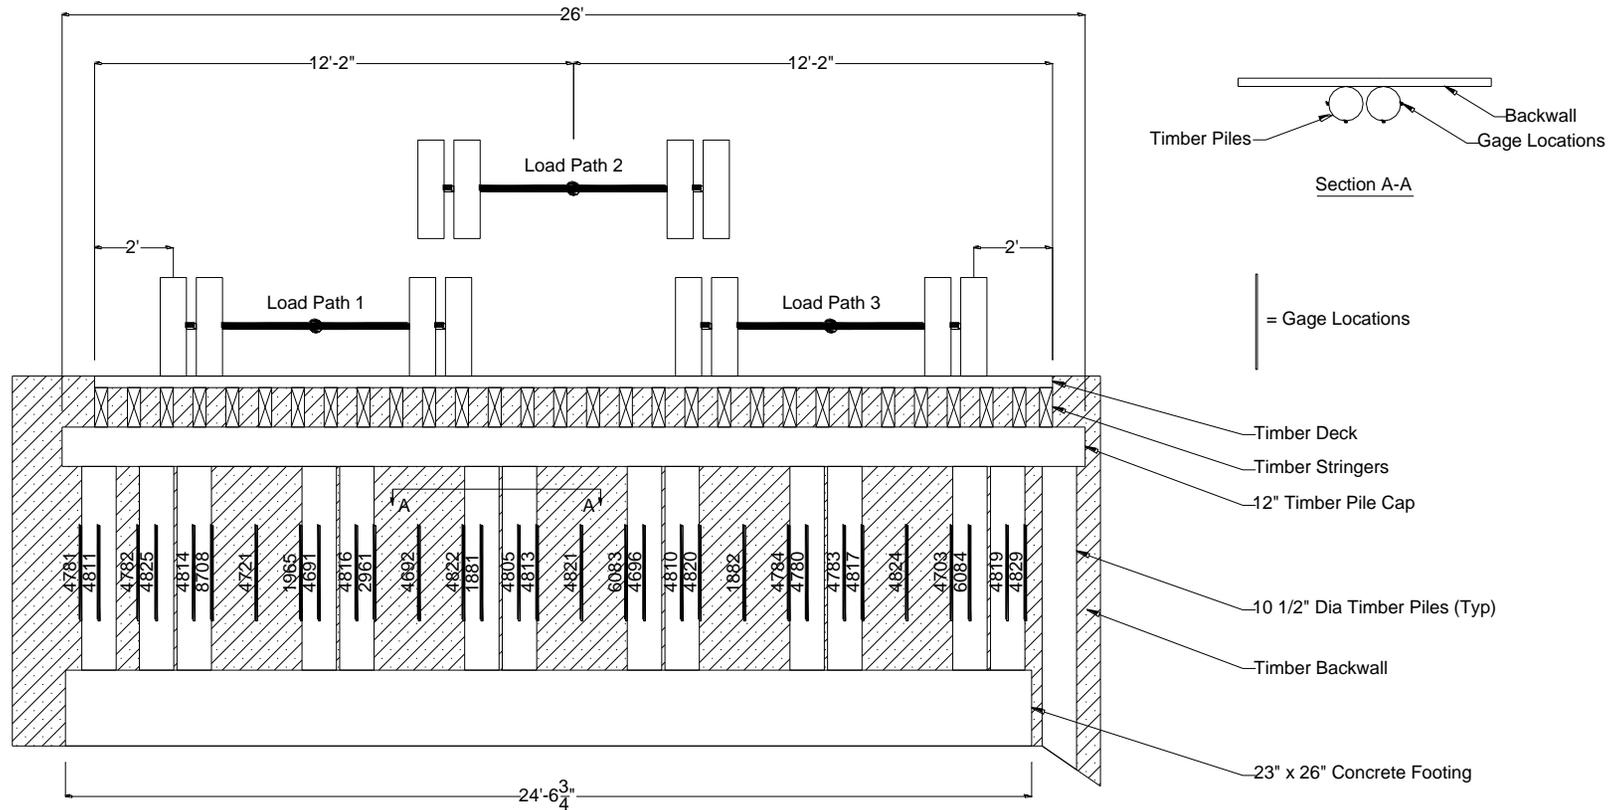
Figure 7-7 Schematic of Bridge 2 instrumented piles and load path positions

The condition of the original piles was unknown prior to the addition of new piles and concrete footing. Nonetheless, the remaining visible portion of the original piles is in good condition. With that said, the strain data also gives evidence to the good condition of the visible portion and the effects of the concrete encasement at the base of all piles. With near equal strain values, the pile stiffness and, therefore, condition must be nearly equal. Additionally, the formed concrete footing that encapsulates the bases of each pile provides a solid base for which the load can be transferred from the piling.

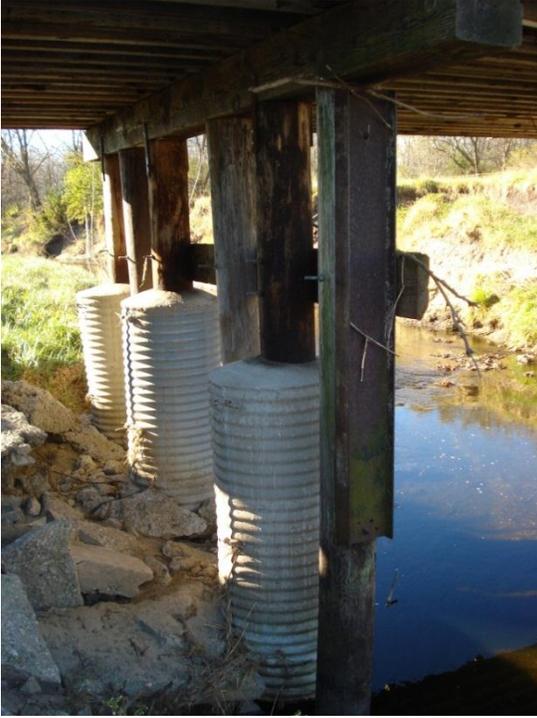
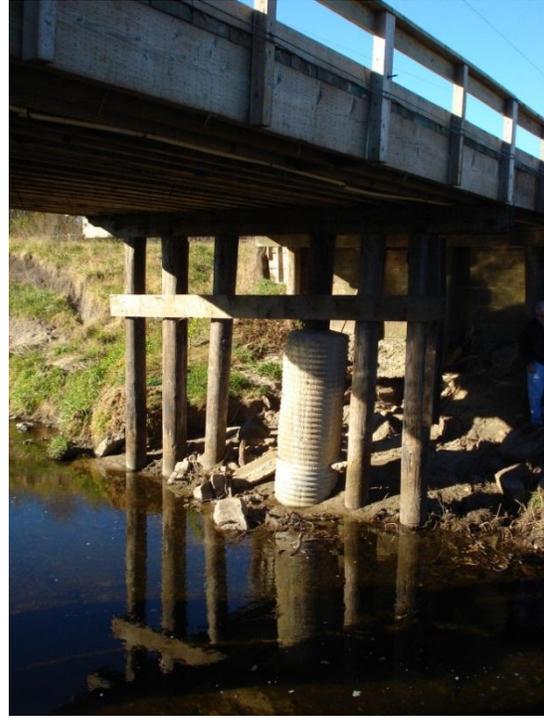
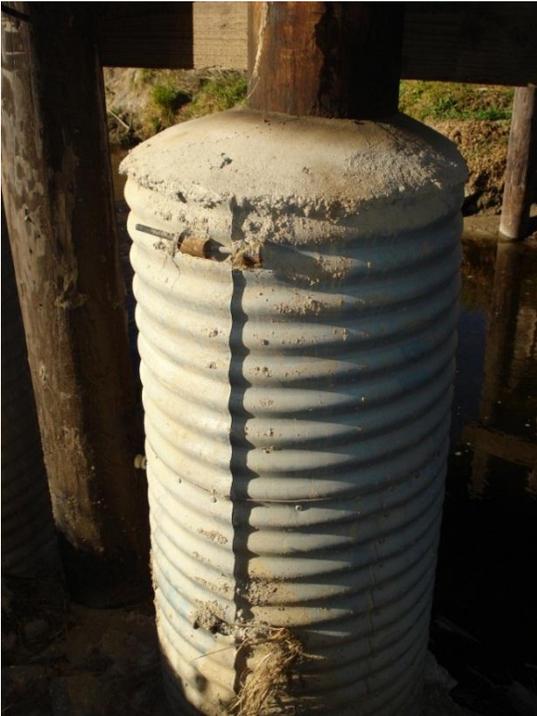
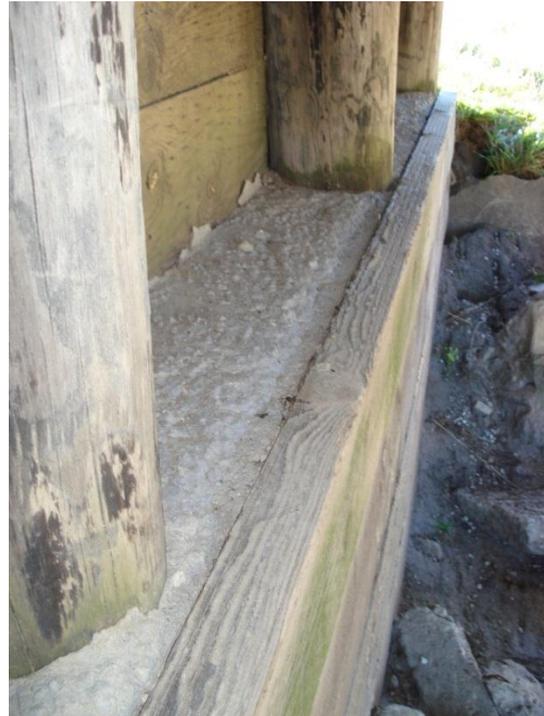
Figure 7-10 Bridge 3 repairs and reinforcement

At the piers, the measured strains revealed that part of the applied load was distributed to the formed cast portion around the existing pile. The strain values measured on the cast portion were generally smaller than those measured on the timber-only portion, which should be expected given the difference in total cross-sectional area and combination of materials used at the casted portion. Moreover, where compression and tension strains were measured in the timber-only portions of the pile (top), the strain values in the strengthened portion followed. The total load applied to the piles was calculated assuming the piles were primarily in axial compression. It was also assumed the strains measured at the strengthened portion were uniform throughout each respective cross section. Table 7-1 presents a comparison of the total load calculated in each pile to the calculated load distributed to each component (concrete and timber) within the strengthened portion. Moreover, Figure 7-12 presents the comparison in graphical form. The observable differences in total load between the top of the pile and strengthened portion can be attributed to such unknown attributes as the modulus of elasticity of each material, slight variances in cross-sectional area, or bending behavior. Nonetheless, it is evident that a significant portion of the load is distributed to the concrete within the strengthened portion of the pile.

At pier 2, the only repaired pile carried very little load in all load cases. It is possible the bearing condition between the pile cap and pile has separated enough to inhibit immediate load transfer. It may also be possible that the non-viewable portions of the pile below the ground line have deteriorated to a condition that prevents load transfer to the ground. Given the apparent load transfer within the casted portions of the piles in pier 1, it can be assumed the cast effectively strengthens and restores stiffness to the pile when the pile is in otherwise good condition beyond the casted portions.

with the concrete infill as well. By visual observation, it is clear the timber planking and concrete infill system shortens the effective length of the pile in the transverse direction, protects the bottom half of the piles from damage due to debris flow, and provides support to the existing backwall.

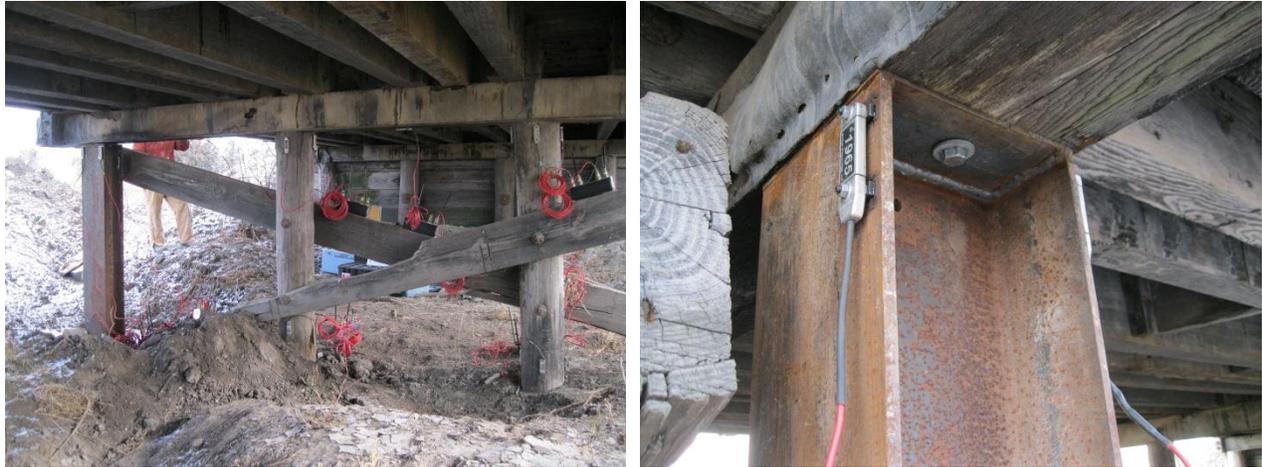
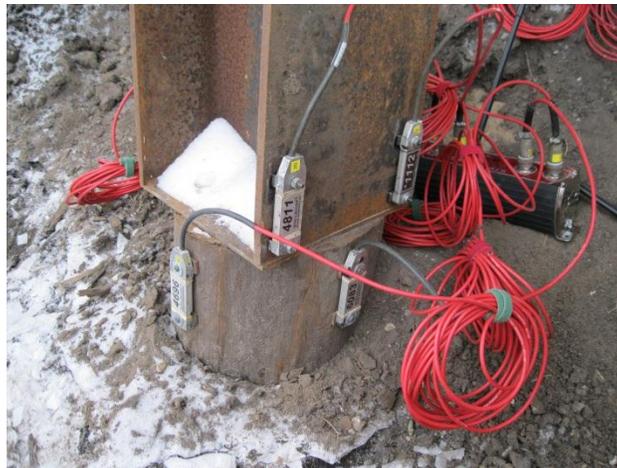
Figure 7-13 Bridge 4 posting repair

Bridge 4 (total length of 58 ft) has three spans of equal length. The superstructure consists of 13 timber girders and a timber deck, while the substructure consists of timber pile caps and timber piles, five at each abutment and four at each pier. The only timber pile repair was located at the easternmost pier; one of the four piles was repaired by removing the timber pile from between the ground and the pile cap and replacing it with a steel H-pile; the pier and repair are shown in Figure 7-13.

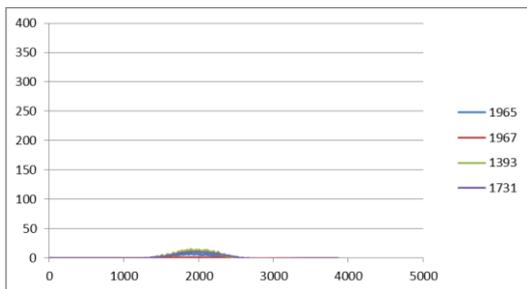
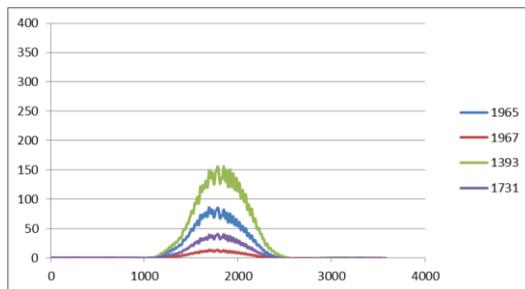
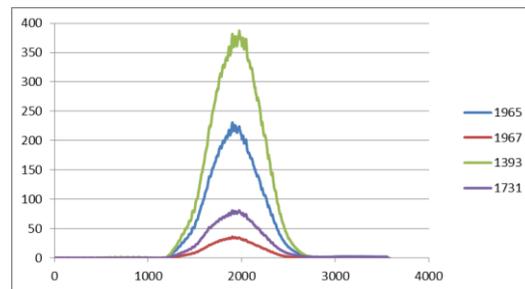
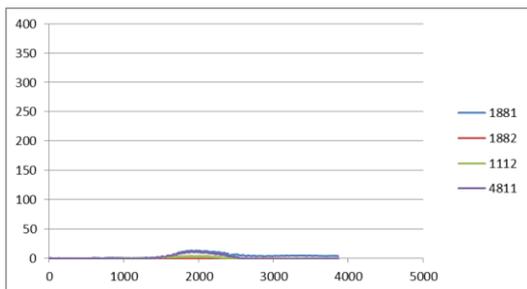
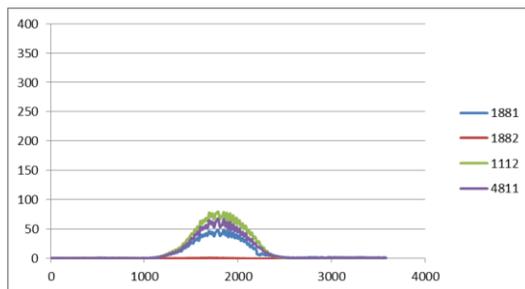
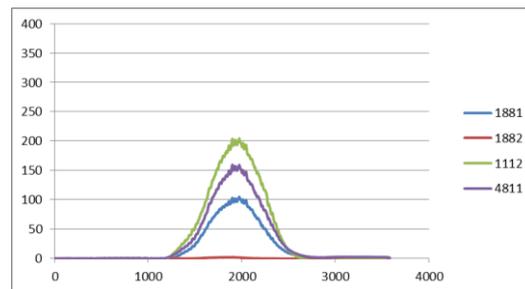
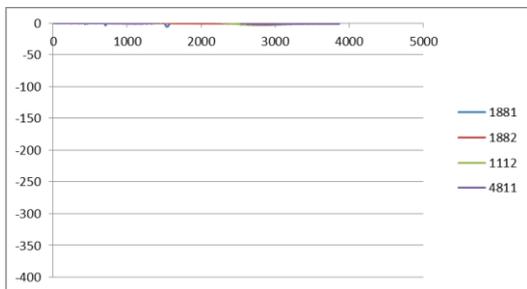
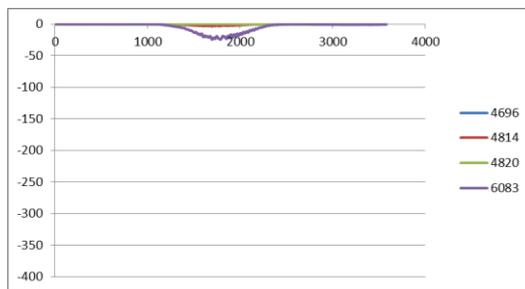
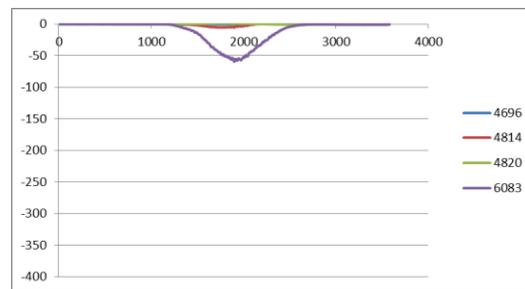
Figure 7-15 Bridge 4 posted pile strain results

The strain results obtained from the test on Bridge 4 were typical of those anticipated by the researchers based on the fairly simple overall structure (simple spans and vertical timber piles with diagonal cross-bracing). However, the results obtained from the steel pile, presented in Figure 7-15, were unusual especially given that the only connections to the pile were at the pile cap and at the cut end of the original timber pile, i.e., no diagonal bracing. The researchers anticipated significant compression loading in the steel pile and, at a minimum, compression loading on one side of the pile if bending occurred. Given the position of load path 3 with respect to the position of the steel pile, it would appear very unlikely the pile would be in tension. However, this was the case. Moreover, the strain results in the original timber pile to which the steel pile was connected indicated compression loading. The researchers questioned the validity of the results because of this unusual and seemingly illogical phenomenon; thus, the researchers decided to retest the pile in question. After retesting the pile, the results from the original test were verified to be correct. Without a much greater amount of instrumentation and significant investigation, this puzzling occurrence may be left unsolved.

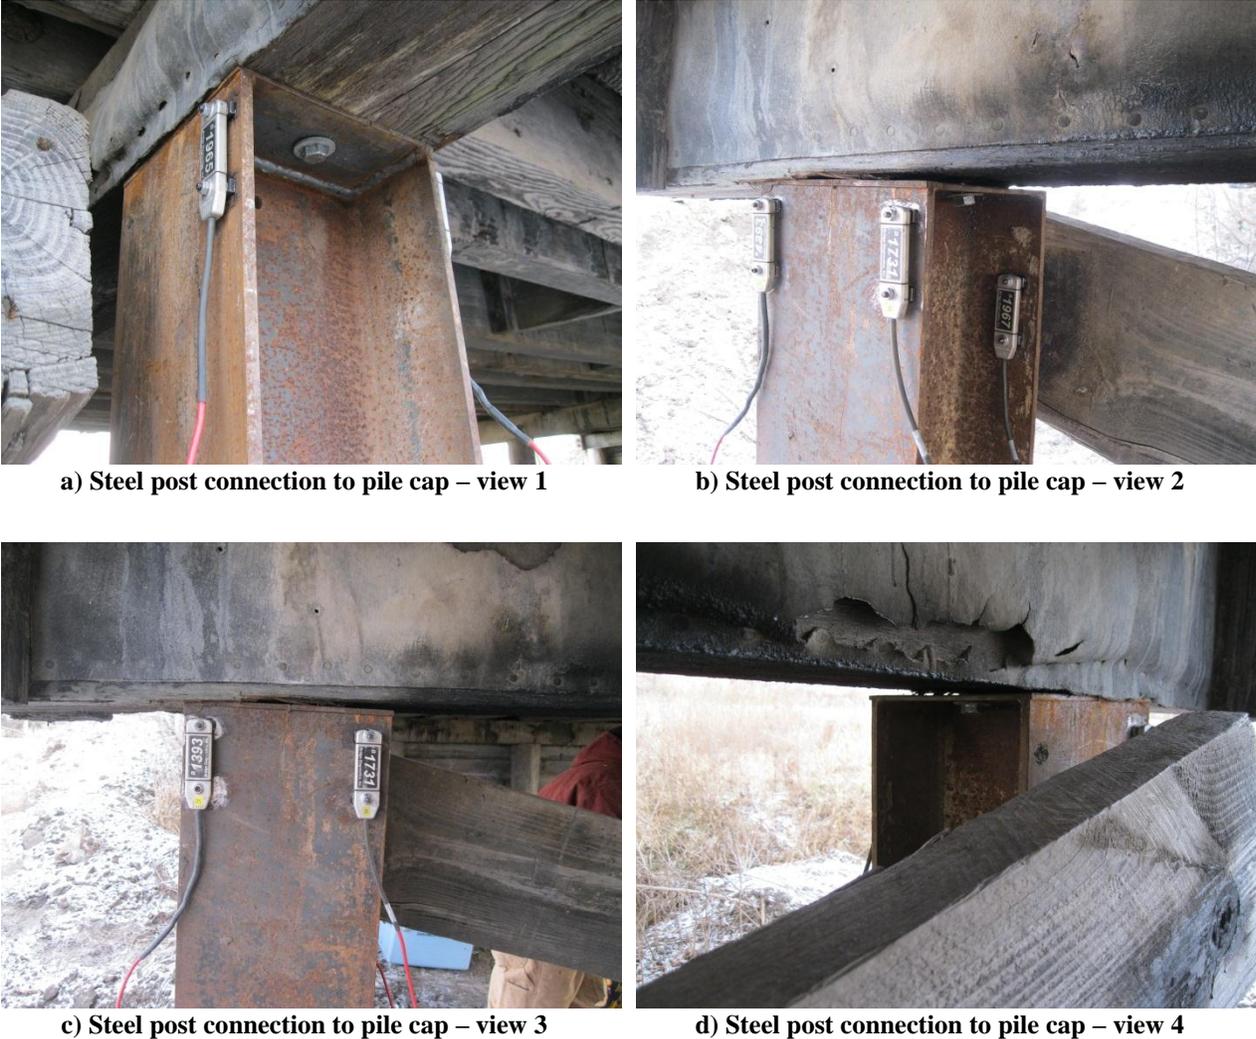
Figure 7-16 Bridge 4 steel pile to pile cap connection

This incident may be attributable, at least in part, to the connections of the steel pile to the original pile and pile cap shown in Figure 7-16. The pile cap did not achieve full bearing on the post. Rather, the pile cap achieved bearing only on one edge of the post. Additionally, lag screws were used to connect each component. It is possible that when a load was introduced to this connection, the localized load path induced tension into the pile. Regardless of the unusual results, and possibly despite little structural assistance of the repaired pile, the bridge has been able to carry vehicular loads.

It is often difficult to achieve full bearing when retrofitting or repairing bridge piles in the field. As such, additional laboratory testing of a method to enable full bearing was completed and is presented in the next chapter.

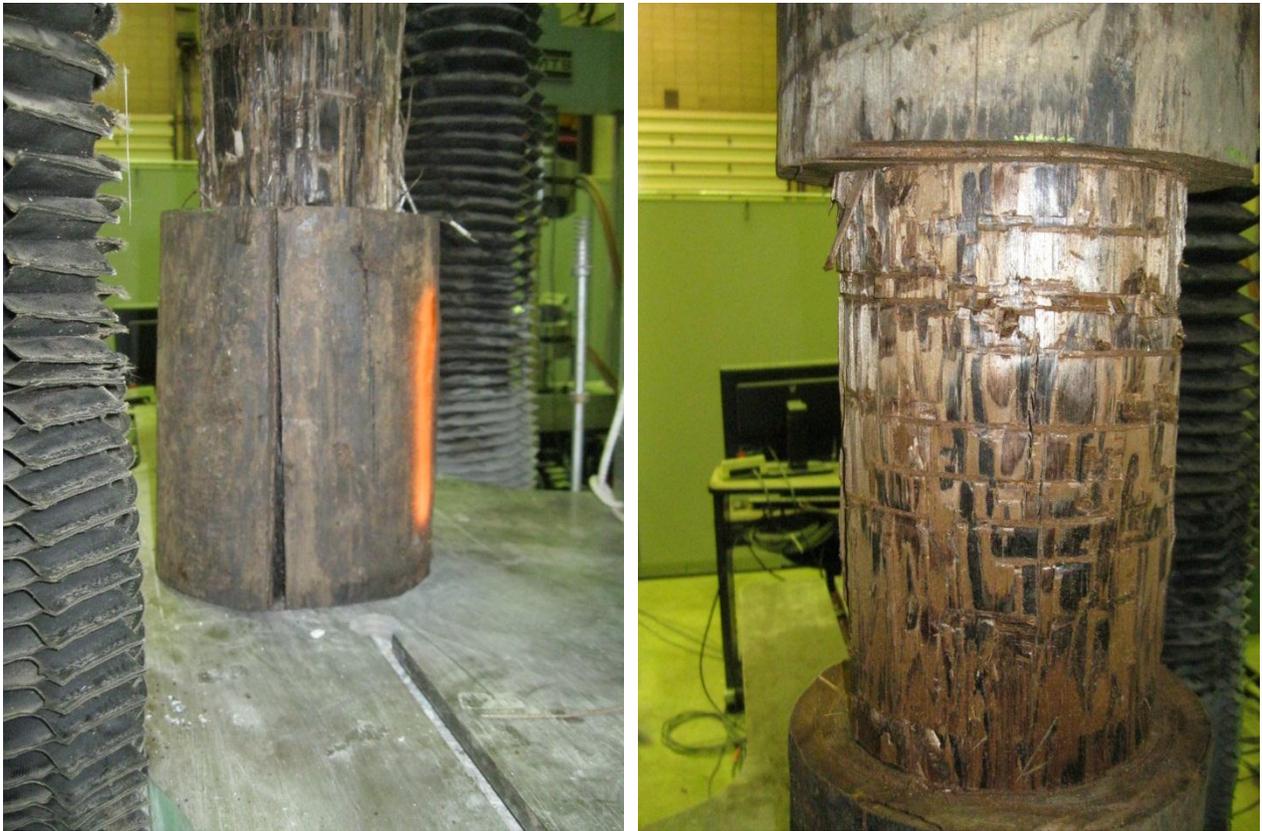
Also noteworthy was the way each of the piles eventually failed. During loading, the reduced section began to balloon in the radial direction until most exterior fibers would splinter and peel away from the specimen. If any checks were present prior to loading, the size of the checks was magnified and propagation often ensued. Representative photographs taken after completion of the load tests are shown in Figure 8-5

a) Deep check

b) Splintered outer fibers
