Timber Abutment Piling and Back Wall Rehabilitation and Repair

Final Report
September 2012

IOWA STATE UNIVERSITY
Institute for Transportation

Sponsored by
Iowa Highway Research Board
(IHRB Project TR-616)
Iowa Department of Transportation
(InTrans Project 10-372)

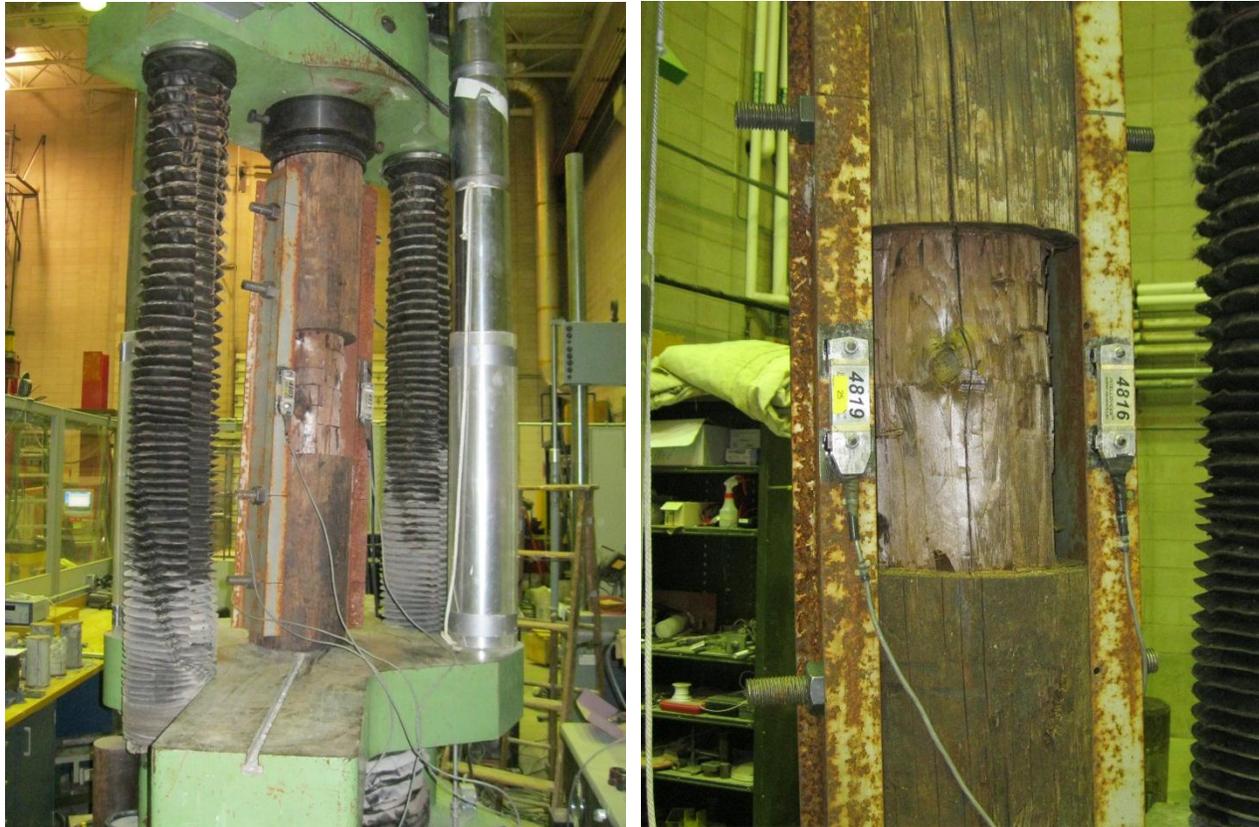
Figure 8-8 Timber pile sistered with steel sections

The researchers included this method in their laboratory investigation and testing. A pile was modified to simulate a 50 percent cross-sectional area loss over a one foot length. Table 8-2 presents the measurements of the modified pile. Two M6x4.4 ($A = 1.29 \text{ in}^2$) steel sections were used to span the section loss and were anchored by four one-inch diameter threaded steel through rods; the specimen is shown in Figure 8-8. Both steel sections were instrumented with strain gages on each flange at the midpoint of simulated decay.

a) Full specimen view

b) Strain gage placement

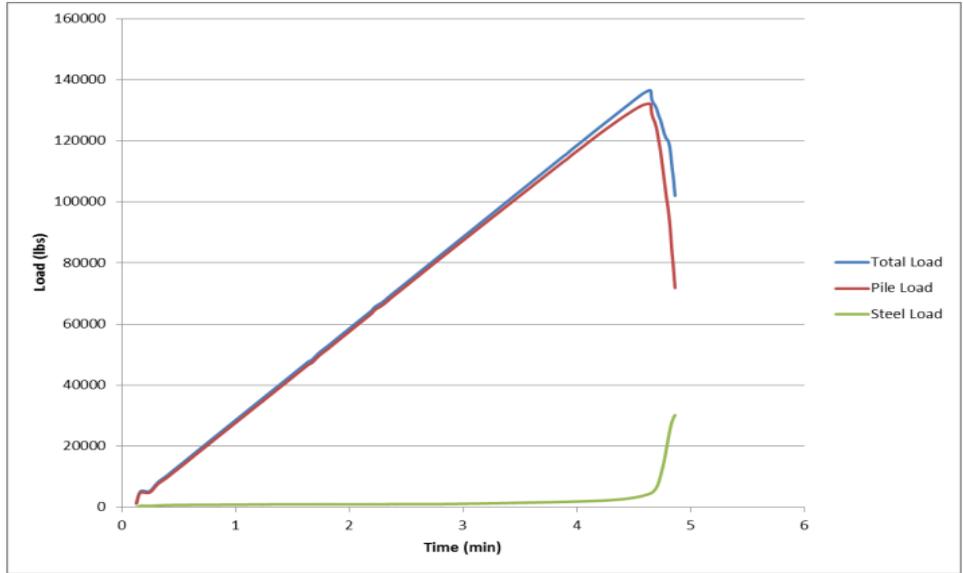
Figure 8-9 Steel sister load test results – Load

The specimen was axially loaded for purposes of comparison with the control section without the steel sisters. The total combined and individual loads observed in the timber and steel sisters are shown in Figure 8-9. It was found in this test that the steel resisted minimal load until the failure of the pile was imminent and the steel sisters became engaged – the tolerances around the anchor rods were enough that a certain amount of deformation in the pile was required before the rods would bear on the sisters. Even with the simulated 50 percent section loss, the pile performed very well before the sisters were engaged. In fact, the performance was well enough to withstand loads commonly seen by these piles due to vehicular traffic. Nonetheless, with minor changes in how the sisters are attached to the pile, it is likely that one would be able to engage the steel sections almost immediately upon loading.

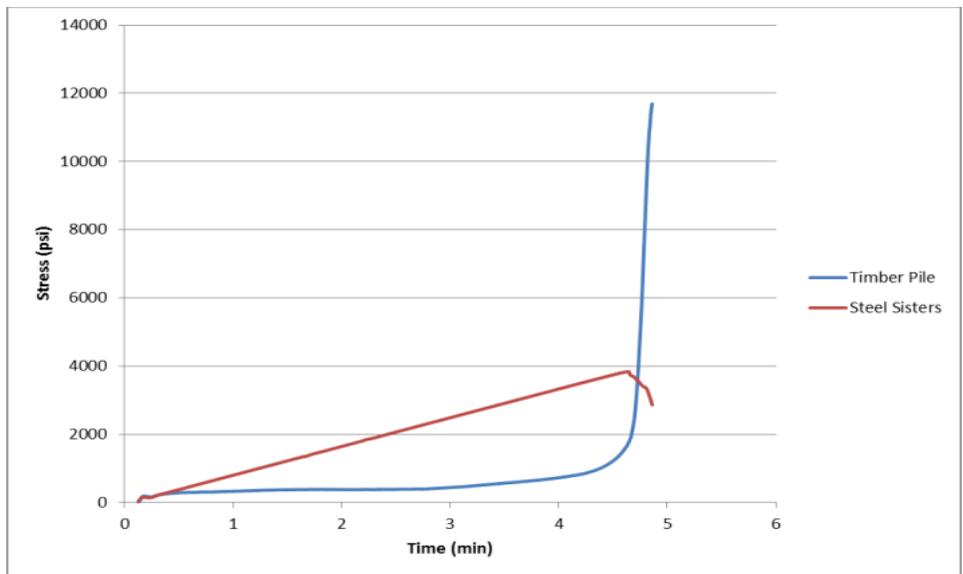
Figure 8-10 Steel sister load test results – Stress

The stress values in the timber and steel are shown in Figure 8-10. The observed maximum stress of 3,713 psi in the timber is on the same order as that observed in the control specimens, thus providing assurance that the sistered pile was a representative specimen. Additionally, upon failure of the pile, the maximum stress observed in the steel was only 11,694 psi – well below the yield stress of steel. This would lead one to believe that the overall capacity of the pile would be even greater than the capacity achieved in the load test if the steel were fully engaged earlier in the loading process. Even more, the possibility exists that if the test was not stopped the steel would have become fully engaged and the total load would have reached levels corresponding to the yield stress of the steel.

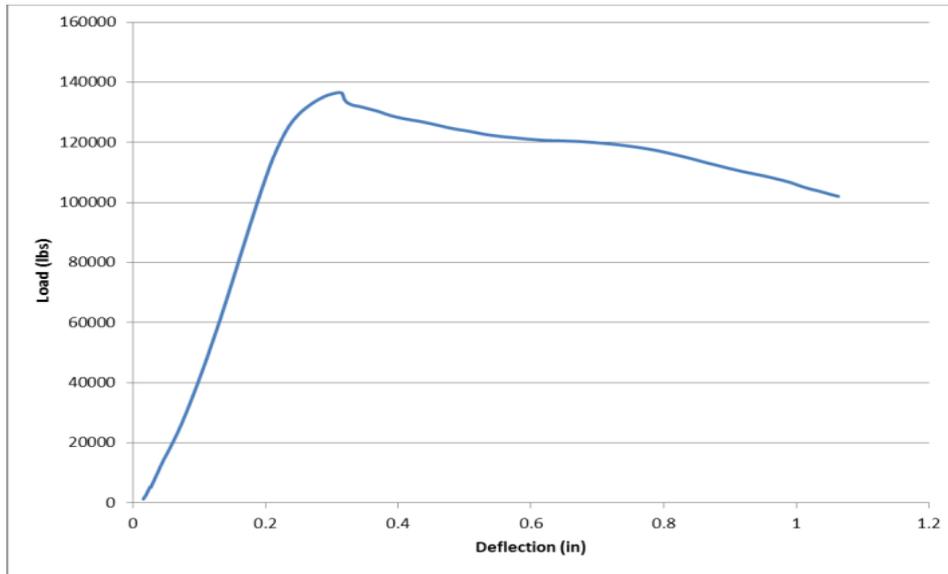
Figure 8-11 Load versus deflection of sistered specimen

Lastly, the load versus deflection curve for the sistered pile specimen is shown in Figure 8-11. Similar to the curves of the control specimens, the rate of deflection increased significantly only after reaching approximately 0.3 in of total deflection. This gives more evidence that the specimen was representative of other timber piles and the fact that the steel was not becoming fully engaged until the timber began to fail.

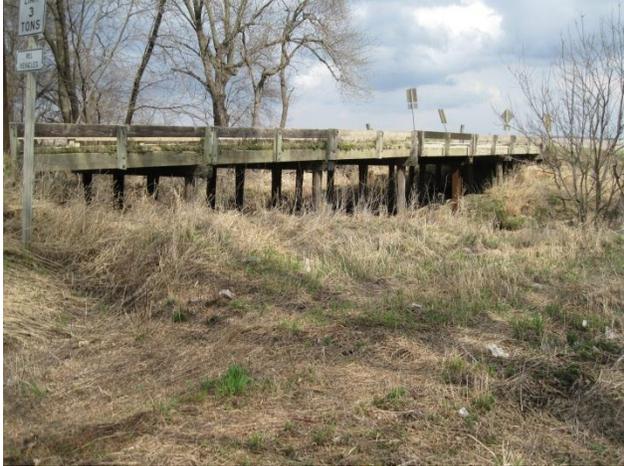
a) Bridge profile

The researchers along with the TAC were interested in pursuing a field demonstration at an existing bridge that needed pile repair and/or replacement. A bridge was selected based on the type and degree of decay seen within the piles. In total, five piers, which consisted of 20 total pier piles, were evaluated; 10 of the piles required repairs. Photographs of the bridge and common decay conditions found in the identified piles are shown in Figure 8-12. The pursued method of repair was to fill the decayed portions and other cavities within the pile with an epoxy resin, after which a fiber reinforced polymer wrap would be applied to the pile. The researchers met with a representative from a nationally known company at the bridge site to discuss the process and method of repair. Given the information provided by the representative, the researchers were confident the method could provide a satisfactory repair that would restore the desired load capacity. In the end, however, the repair could not be completed due to the prohibitive cost. Although an effective repair, it may be more suitable for a larger scale project where mobilization and labor costs do not become the greatest percentage of costs. Additionally, this repair may be one that will require independent contractors to complete. The county crews that are able to complete other repairs discussed in this report may not have the expertise or training required.
