Western Iowa Missouri River Flooding— Geo-Infrastructure Damage Assessment, Repair, and Mitigation Strategies

SEPTEMBER 2013

Final Report

Sponsored by
Federal Highway Administration
Iowa Highway Research Board
(IHRB Project TR-638)
Iowa Department of Transportation
(InTrans Project 11-419)

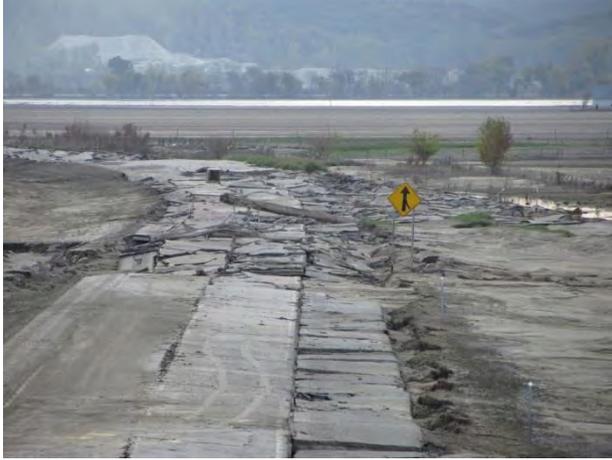
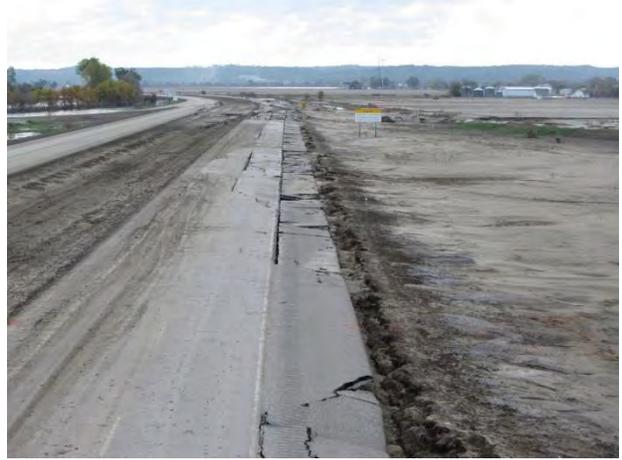
Figure 27. Pictures taken near I-29 and I-680 intersection north of Council Bluffs on 9/21/2013

Pictures showing the extent of damages on the primary roadways are provided in Figure 27. A summary of the various damages noted, the repair/emergency measures followed to fix the damages, and the reported costs on primary roadways are summarized in Table 8. The damages observed on primary roadway geo-infrastructure can be broadly categorized as follows:

Repairs generally involved clearing damaged areas by removal of debris (deposited by the flood water, broken culverts, pavements, and pipes, etc.) and re-construction (replace with new material) to achieve pre-flood conditions. In some instances, flowable mortar grouting was used to fill voids beneath pavements and bridge approaches, and geosynthetics were used in bridge backfills and for drainage ditch levee foreslope erosion protection.

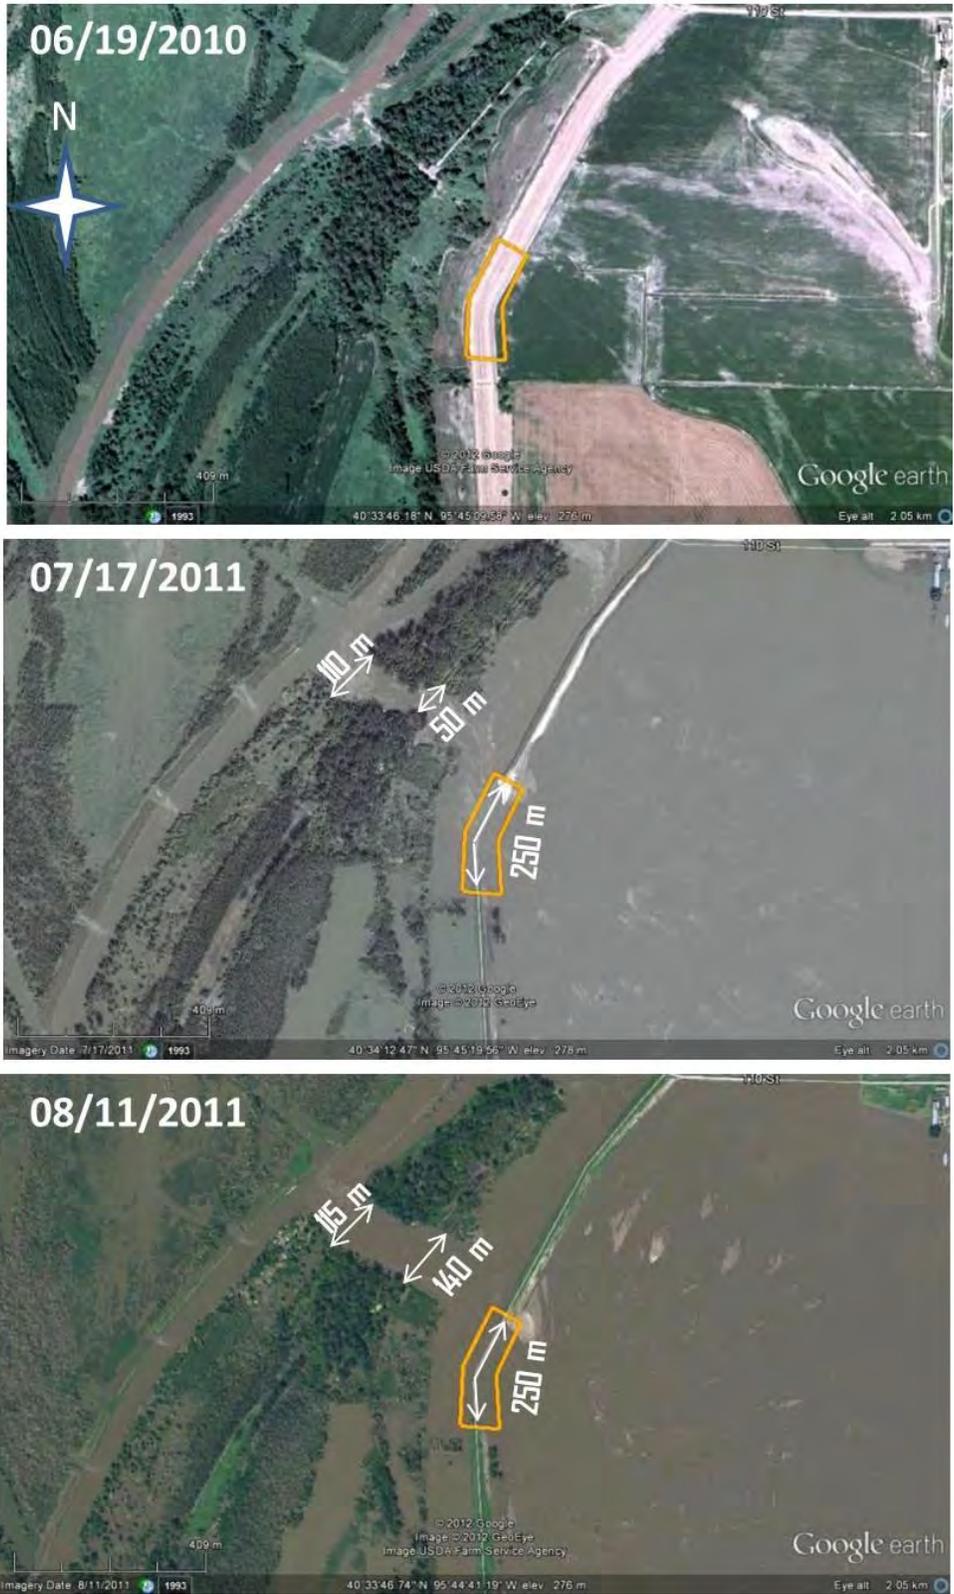
Figure 35. Levee breach in north part of Fremont County (images updated on 6/9/10 and 8/11/11)

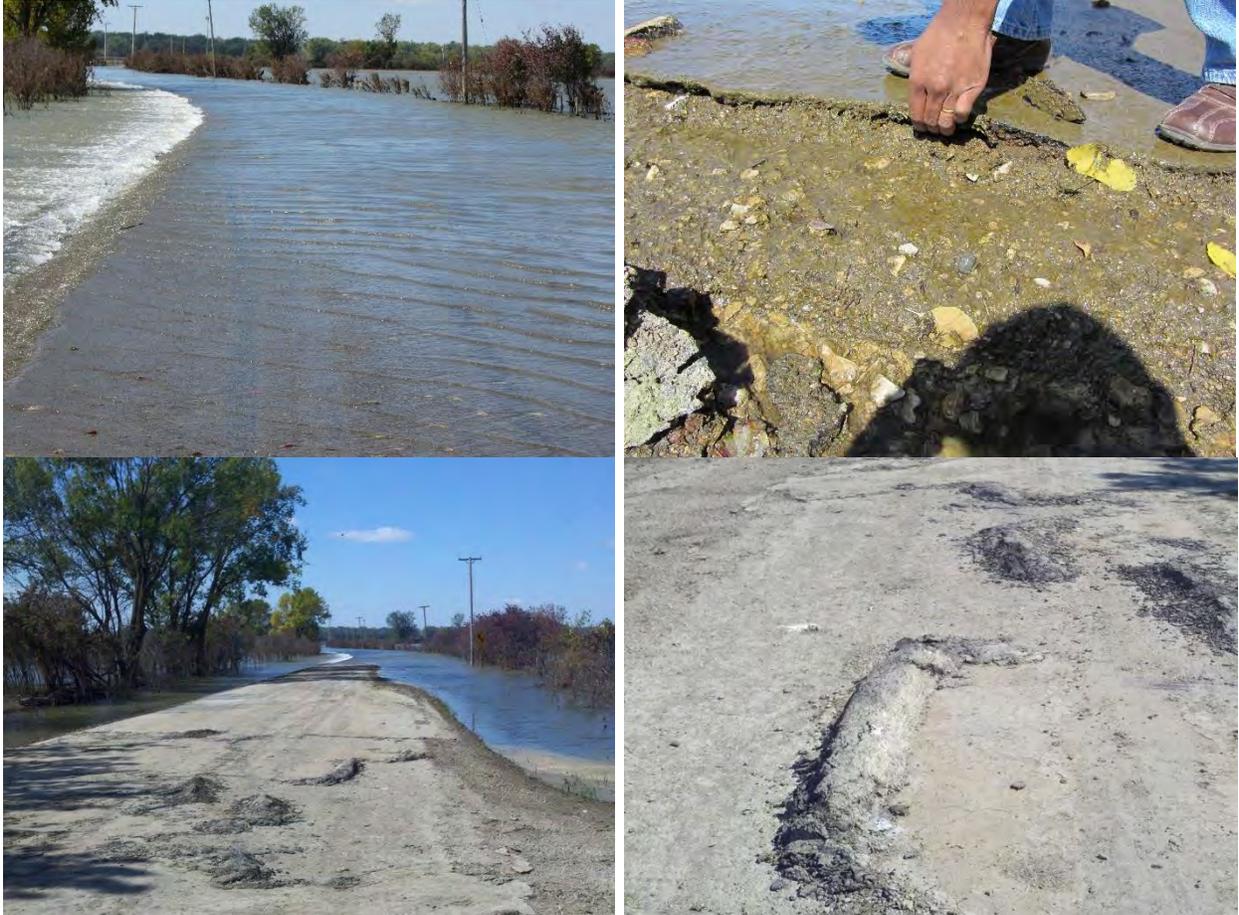
Figure 41. Eroded shoulder next to PCC pavement being reconstructed on 9/21/11 – Old Mormon Road (looking west towards I-680 and I-29 intersection), Pottawatamie County (Photos taken on 9/21/11)

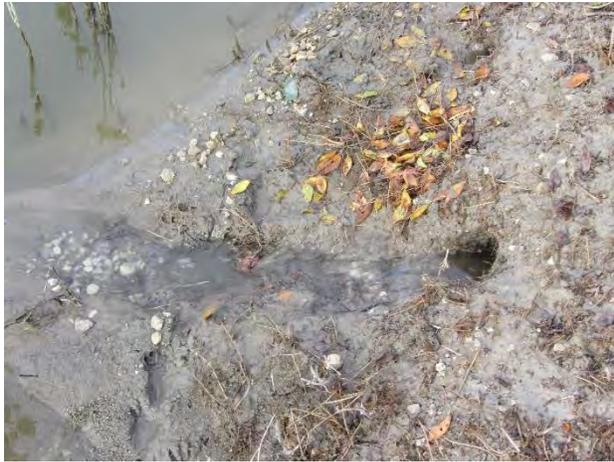
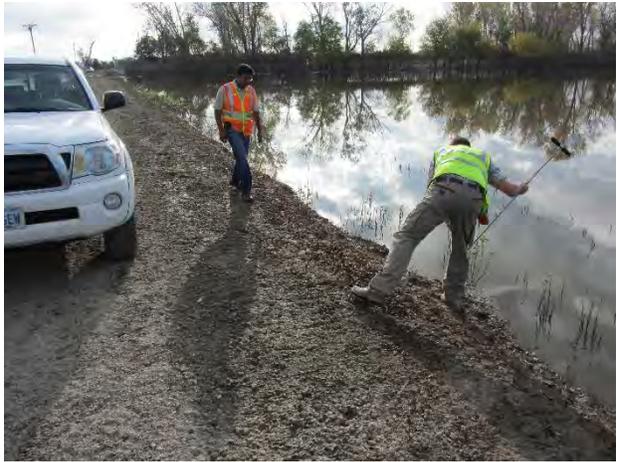
Of the areas that were surveyed during the field visits, two areas posed significant safety concerns to traffic due to damage that was not apparent at the surface (i.e., due to damage that occurred beneath the surface). One of those areas resulted in deep potholes on a gravel road due to eroded backfill around a culvert in Pottawattamie County (see Figure 46) and the other resulted in deep voids beneath roadway due to eroded backfill around a bridge abutment in Fremont County (see Figure 54). Such areas can go undetected with just visual surveys at the surface and pose a significant risk to traffic.

Figure 46. Potholes (with about 0.5 m (1.5 ft) diameter) under gravel road due to erosion of backfill material around a culvert located beneath the road – Pottawatamie County (Photos taken on 9/21/11 and 9/23/11)

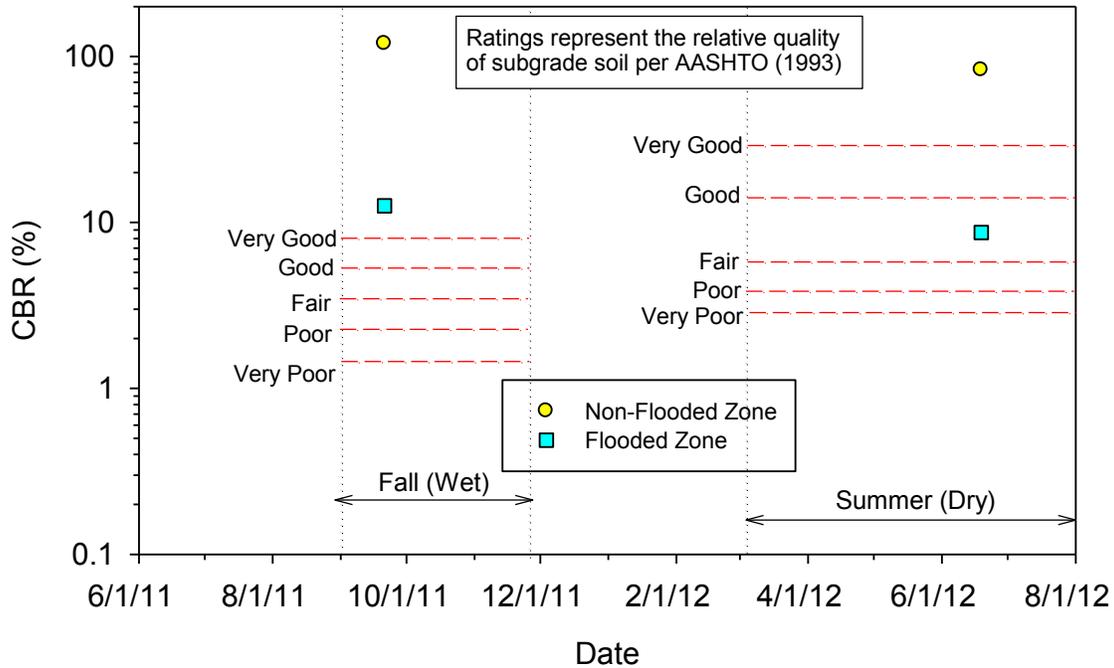
- The CBR of the base layer was about the same in both flooded and non-flooded zones (>50), but the CBR of subgrade (at depths below 650 mm) was on average about 10 times higher in the non-flooded zone than in the flooded zone (Figure 61). No significant difference was noted in the measurements obtained shortly after flooding and about 9 months after flooding.

Figure 61. Comparison of subgrade CBR values in flooded and non-flooded zones with relative quality ratings on TS1 – Pottawattamie County

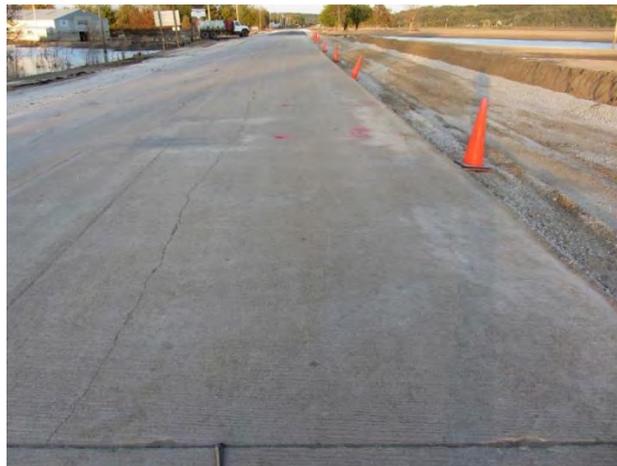
During the 2011 flood event, the test segment was fully submerged for about two months (Figure 62). Reportedly, the flood waters receded in the area on 9/1/11. The TS reportedly experienced heavy water currents as the water levels fluctuated during the flood event. The granular shoulders were completely eroded, a portion of the pavement was washed away, and subbase layer under the pavement was eroded in a portion of the TS (Figure 63). The section where the pavement was washed away was replaced with a new 230 mm (9 in.) thick PCC pavement placed directly over the subgrade. Flowable cement grout was used to fill the voids formed due to subbase layer erosion. Pictures taken two days after cement grout was placed are shown in Figure 63. The grout was very soft and did not setup even two days after placement. Field engineers indicated that there could have been water beneath pavement during grouting. Longitudinal cracks were observed on a few panels where the subbase layer was eroded (Figure 64).

Figure 64. Longitudinal cracks on PCC pavement with undermined base material on TS2 (Photo taken on 9/21/11) – Pottawattamie County

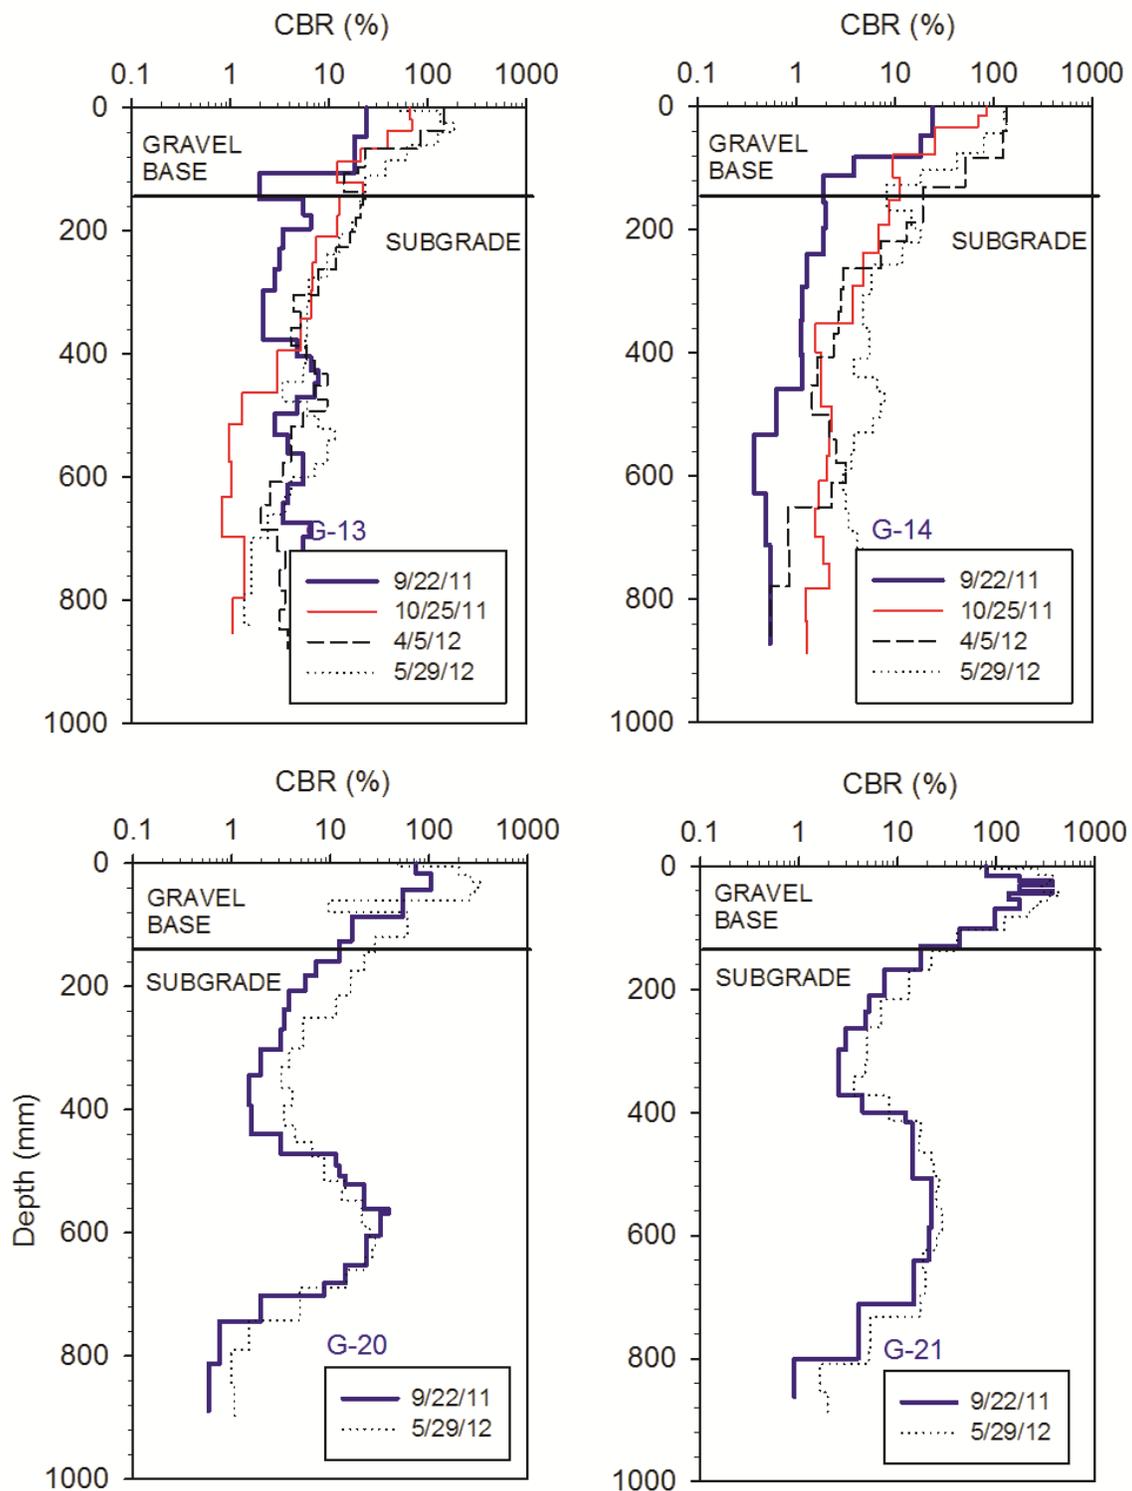
- The subgrade CBR values (averaged over the top 300 mm) in the flooded zone increased (from 1.7 to 6.4 and 4.0 to 8.5 at the two locations) from 21 to 54 days after flooding. At 21 days after flooding, subgrade CBR values in the non-flooded zone were higher (4.5 and 8.2) than the values in flooded zone (1.7 and 4.0), but they were about the same (10 to 12) at 8 months after flooding.

- The DCP and FWD test results on this test segment illustrate that both subgrade and the surface gravel layers gained strength with time, likely because of subgrade material drying over time.

Figure 76. DCP-CBR profiles at four test locations from four different testing times on TS3 – Pottawattamie County

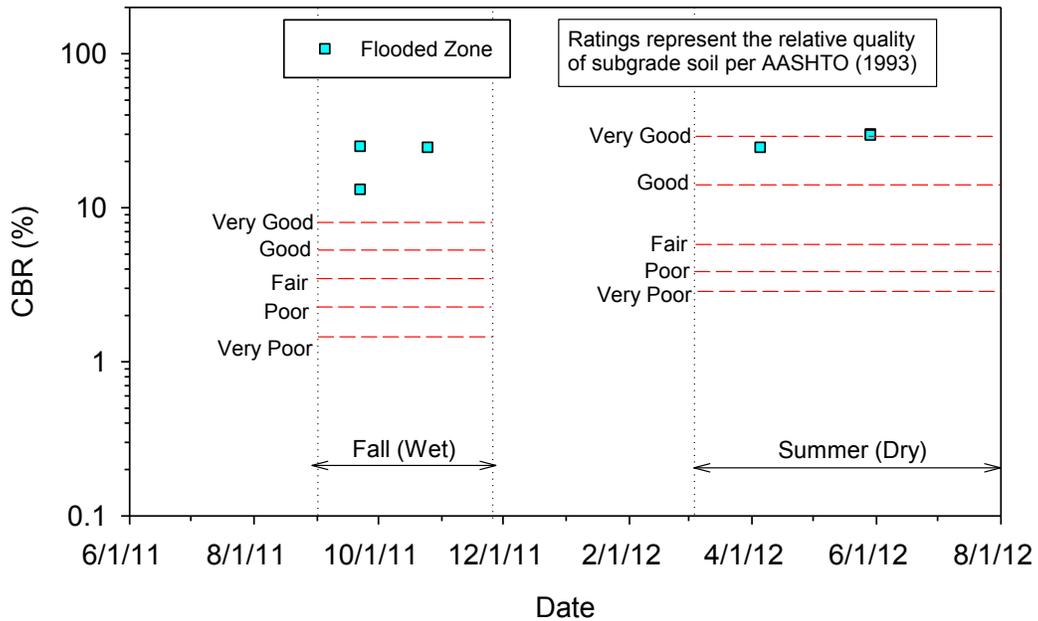
- Ground water level was located at about 0.58 m below surface under the roadway, while the water level in the ditches was close to the gravel surface during 9/23/11 testing (about 21 days after flooding). Moisture contents varied from about 12 to 18% above the water table and the material consisted of clayey to fine sand material.
- On average, the E_{SG} values in the whole TS were low and the quality is rated as “very poor” to “poor,” per AASHTO (1993). The E_{SG} values improved slightly over time (on average from about 17 to 23 MPa), likely because of subgrade material drying.
- Although limited, DCP-CBR results were in contrast with the E_{SG} values. Subgrade CBR values at two locations were > 10 on 9/23/11, which is rated as “very good,” per AASHTO (1993). Results increased over time to about 30 on 5/29/12 (Figure 96).

Figure 96. Subgrade CBR values at different testing times with relative quality ratings on TS5 – Pottawattamie County

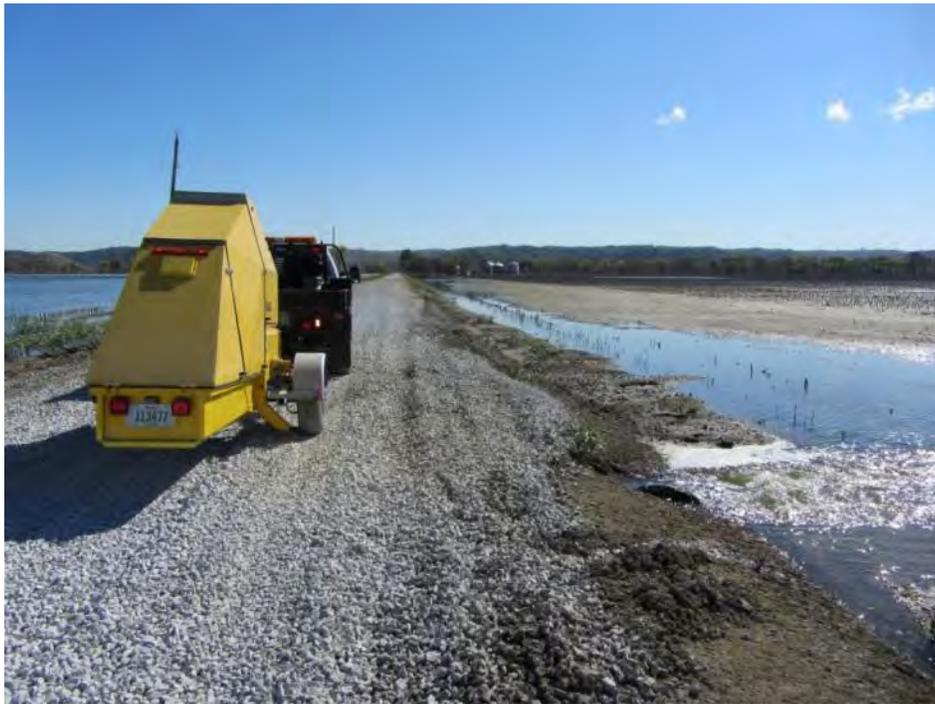
- The FWD test results showed soft conditions ($E_{SG} \leq 10$ MPa) in areas close to culverts, where the gravel was washed away and new gravel was placed, at all times of testing.

Figure 111. Newly placed gravel showing rutting near culvert (Picture taken on 9/23/2011) – Pottawattamie County

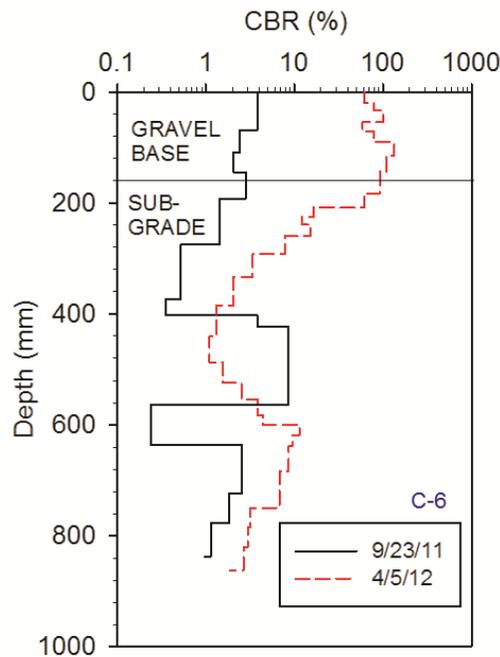
- DCP-CBR results also indicated “very poor” subgrade conditions (with $CBR < 2$ within the top 200 mm of subgrade) at 23 days after flooding, at a test location that showed the lowest E_{SG} value (9 MPa). The test area was located near a culvert, where gravel was washed away and new gravel was placed. The subgrade CBR values improved to “fair” to “good” conditions (with $CBR = 6.0$ and 8.8) at 6 and 8 months after testing (Figure 117).

Figure 115. DCP-CBR profiles from two different testing times at C-6 test location on TS6 – Pottawattamie County

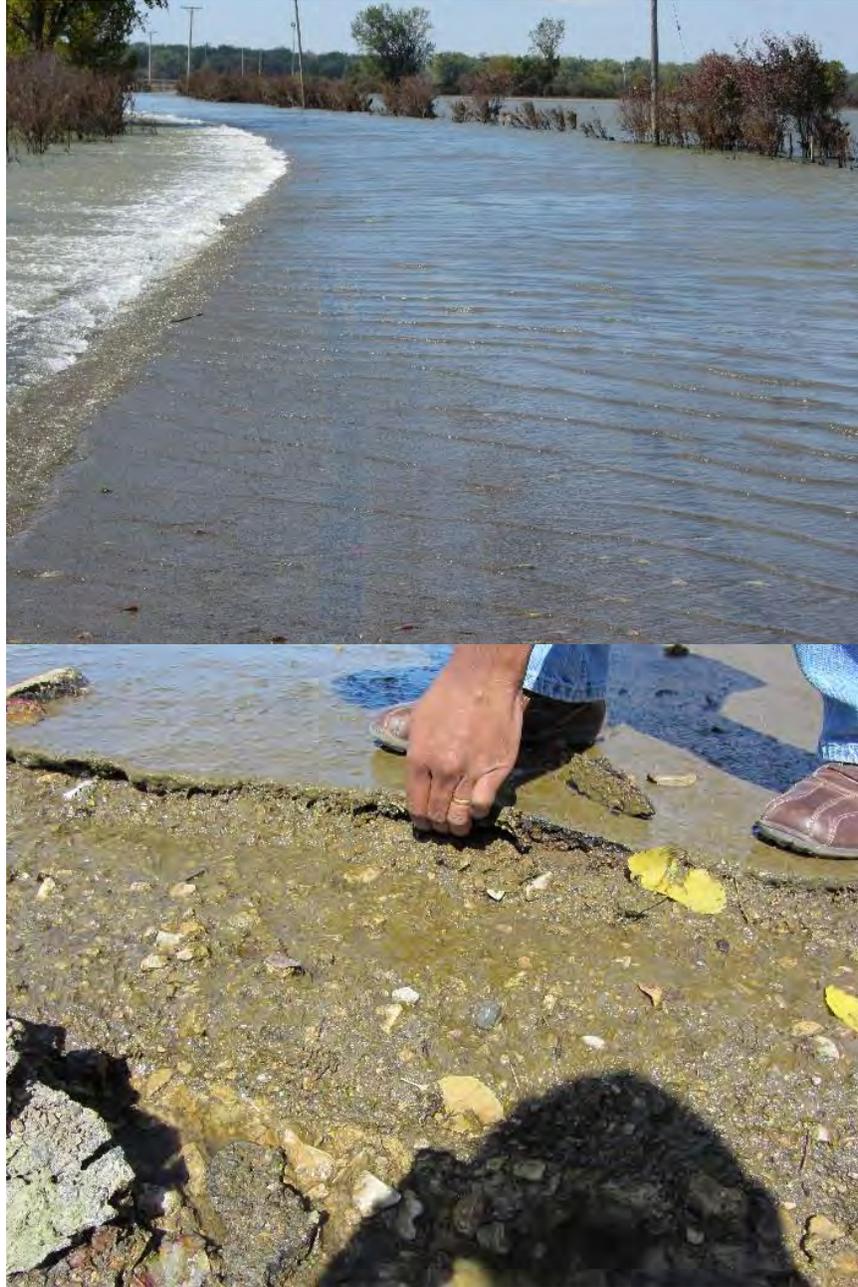
During the 2011 flood event, this TS was fully submerged under water for nearly one to three months (Figure 118 and Figure 119). The flood waters receded in a portion of this TS on 9/1/11, but in some areas flood waters overtopped the roadway till 9/31/11. During the flood event, chipseal coat was stripped off (delaminated) at a few locations and granular shoulder material was eroded at isolated locations (shown as road scour in Figure 119). Weep holes were observed around culverts along the TS. Photos taken during field testing are shown in Figure 120 and Figure 122.

Figure 120. Water overtopping Desoto Avenue on 9/21/11 and delamination of chipseal coat at the surface (Pictures taken on 9/21/11) – Pottawattamie County

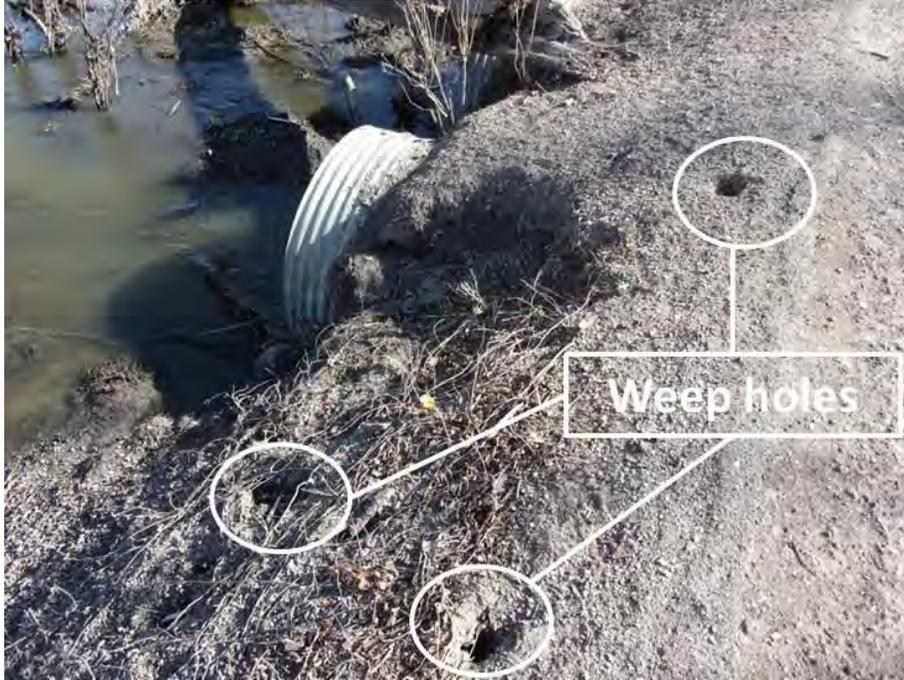
- The E_{SG} values in the whole TS were low and the quality is rated as “very poor” to “poor,” per AASHTO (1993). The E_{SG} values did not change over time (varied on average from 16 to 17 MPa).
- With the exception of granular shoulder loss at a few locations, which was replaced shortly after the flood event, no significant distresses or damages were noted on this roadway. Some weep holes were observed around culvert locations and were also found in GPR scans as discussed below.

Figure 122. Weep holes around culvert inlets on TS7 (Picture taken on 10/25/11) – Pottawattamie County

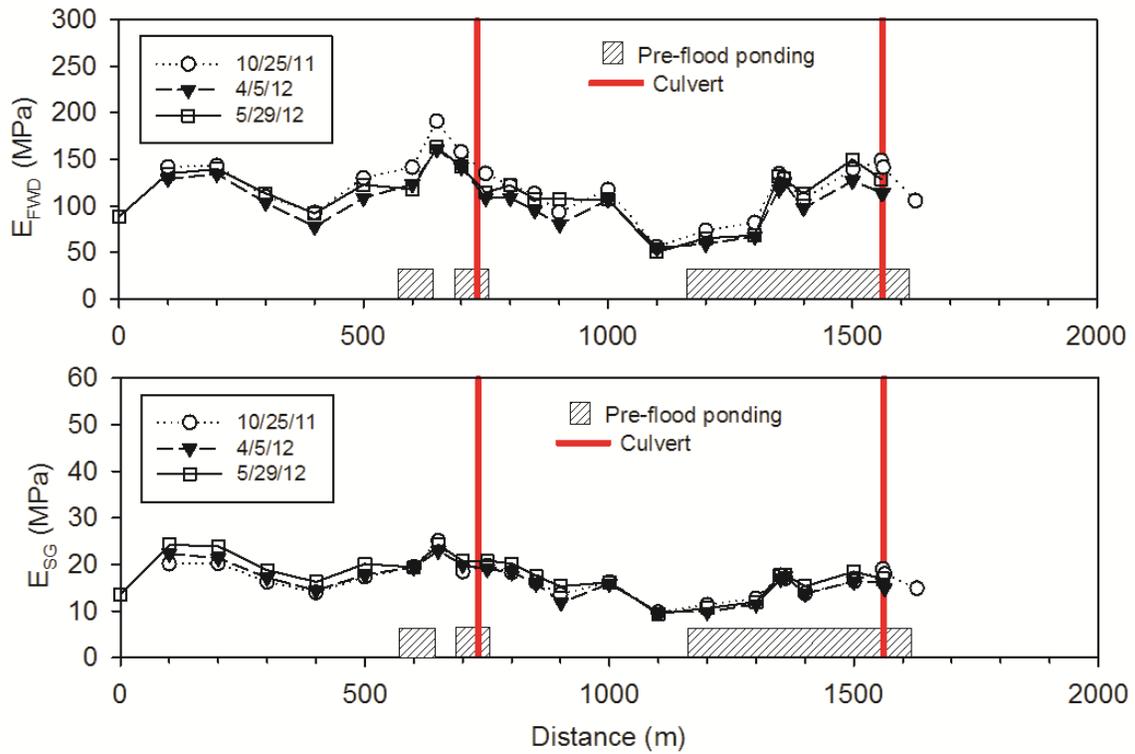
Figure 123. Surface FWD modulus and subgrade modulus at three different times after flooding on TS7 (entire TS was flooded and pre-flood ponding zones identified from aerial maps) – Pottawattamie County

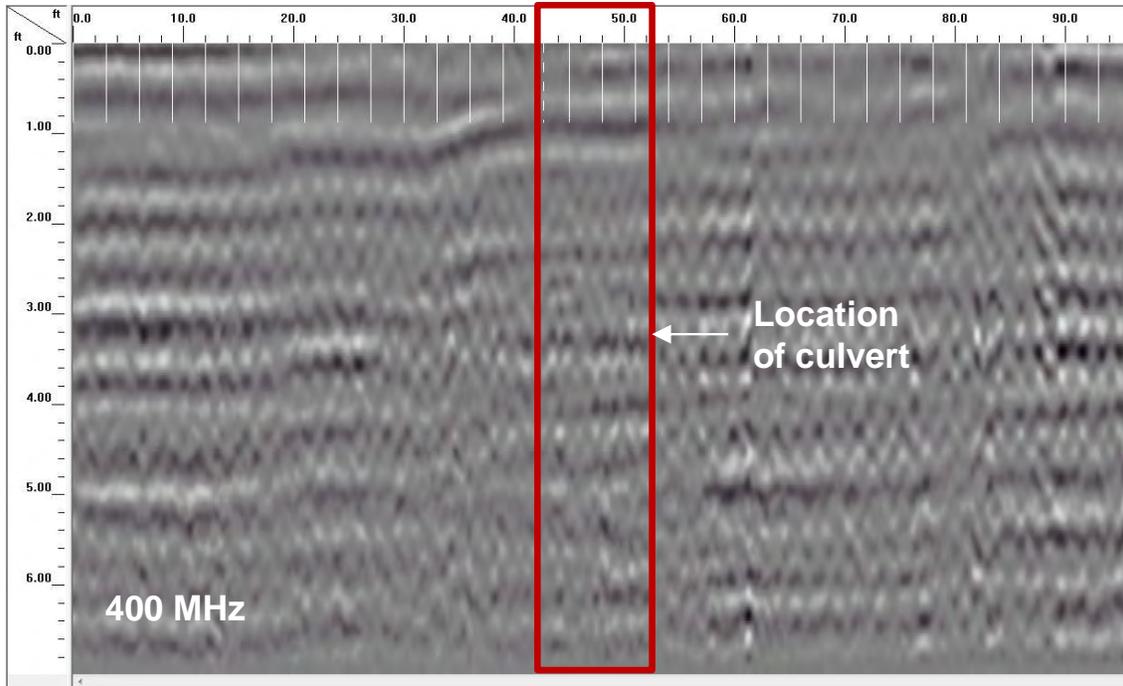
- Culvert location was not clearly identified in the scans shown in Figure 125.
- Weep holes were noted at several locations in the scans as shown in Figure 126 and Figure 127.

Figure 125. GPR scan using 400 MHz antennas on TS7 showing location of culvert (at station 724 m) – Pottawattamie County

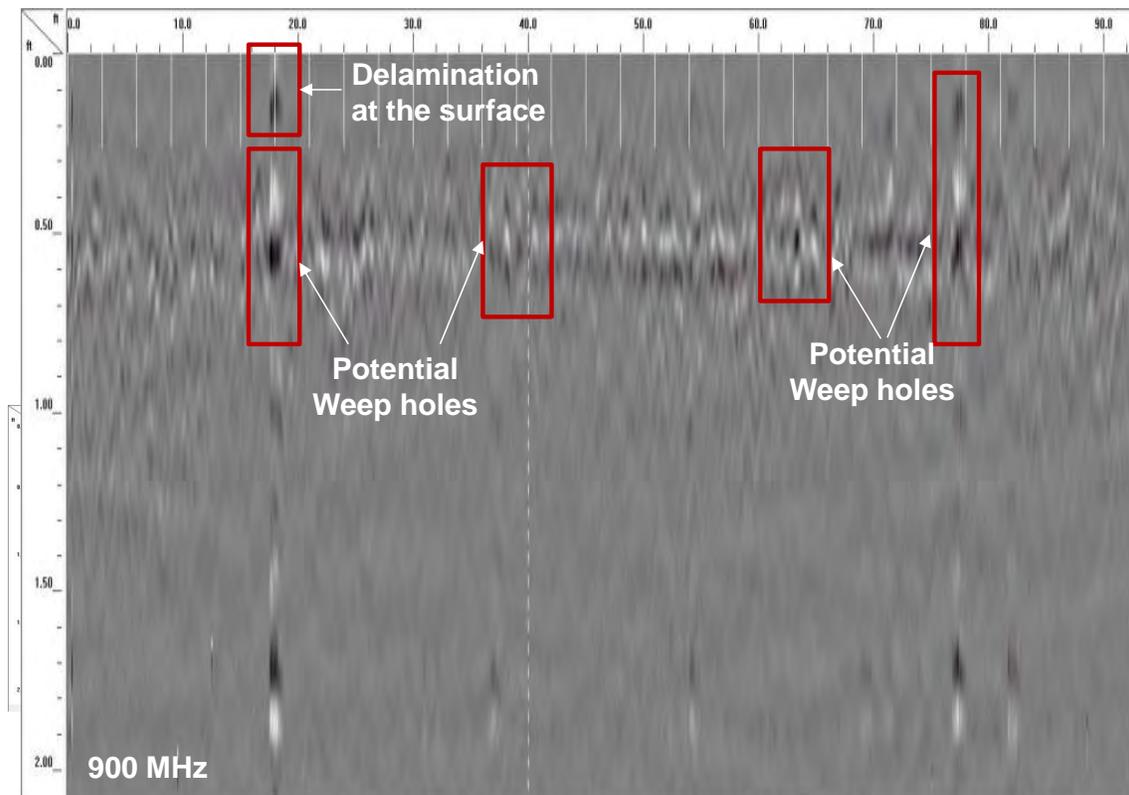
Figure 126. GPR scan using 900 MHz antenna on TS7 showing potential weep holes in the subgrade (between 720 m and 750 m stations on east bound lane) – Pottawattamie County

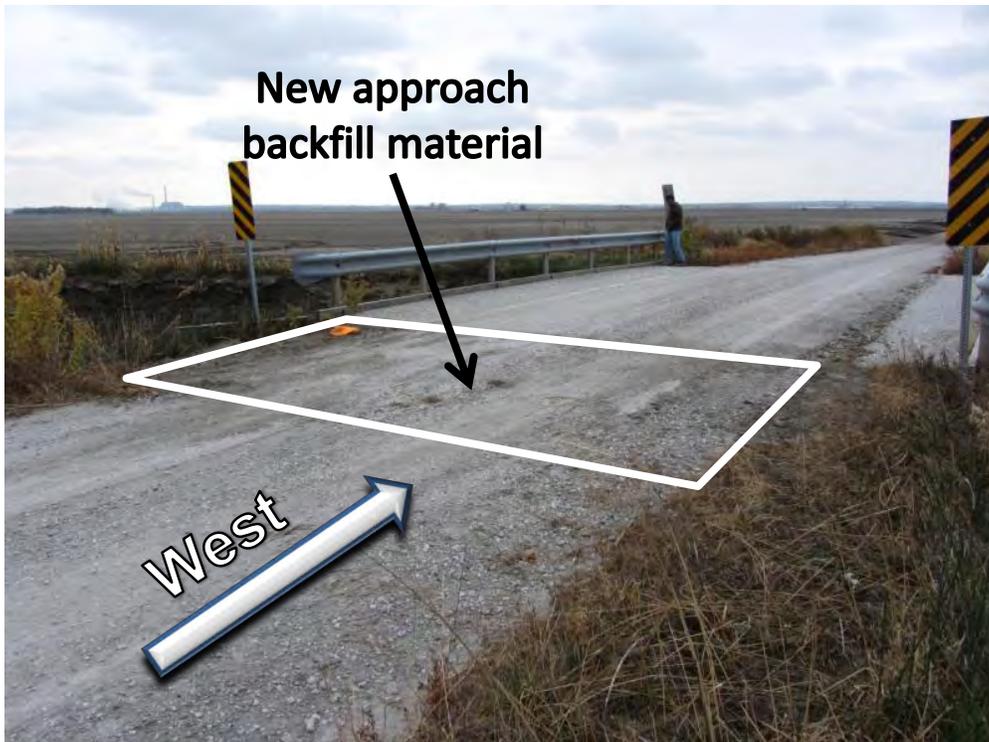
During the 2011 flood event, the TS was partially submerged for about two to three months (Figure 129). Reportedly, the flood waters receded in the area during mid-September 2011. During the flood event, backfill material behind the east bridge approach was eroded away and new fill was placed prior to testing (Figure 130). The bridge crosses a drainage ditch. The drainage ditch embankment slopes (close to the bridge abutments) were scoured during the flood event (see pictures from 10/25/11 in Figure 131 to Figure 133). Field observations during 4/4/12 indicated continued erosion of backfill materials abutment, and scoured embankments (Figure 134). The scoured embankment slopes and bridge abutments were repaired by 6/19/12 using on-site clay fill material (Figure 135).

Figure 130. New bridge approach backfill material placed along the east approach on TS1 (Picture taken on 10/26/11) – Fremont County

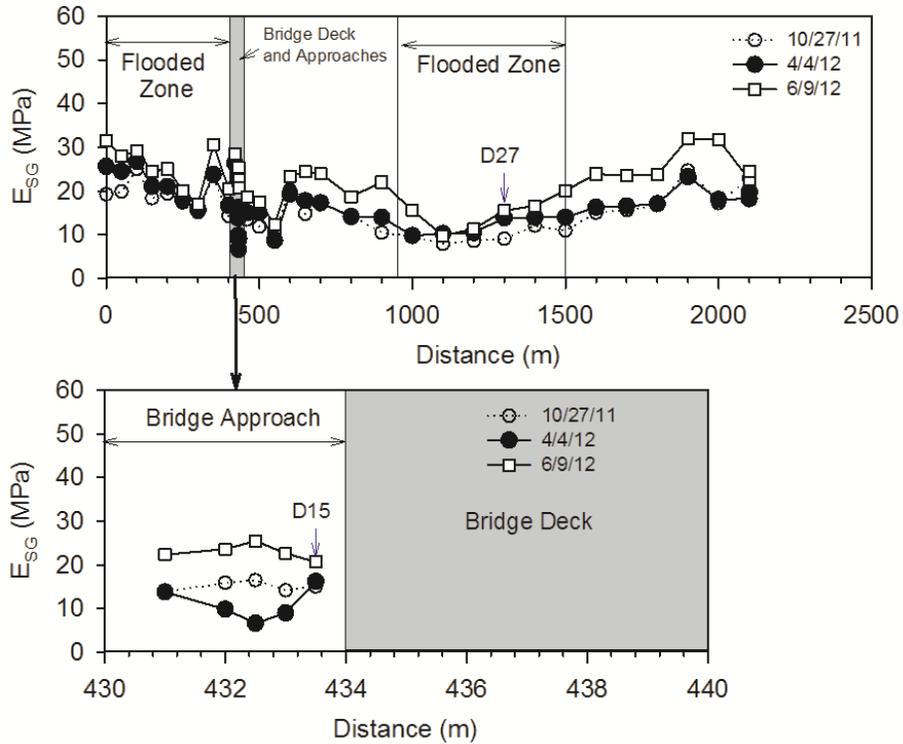
“poor,” per AASHTO (1993). Lowest values were located in the flooded zone (close to D-27 as noted on Figure 148 and Figure 149) that is located at a lower elevation (i.e., area that experienced deep waters above the roadway).

Figure 148. Surface FWD modulus at three different times after flooding on TS2 – Fremont County

Figure 149. Subgrade modulus measurements at three different times after flooding on TS2 – Fremont County

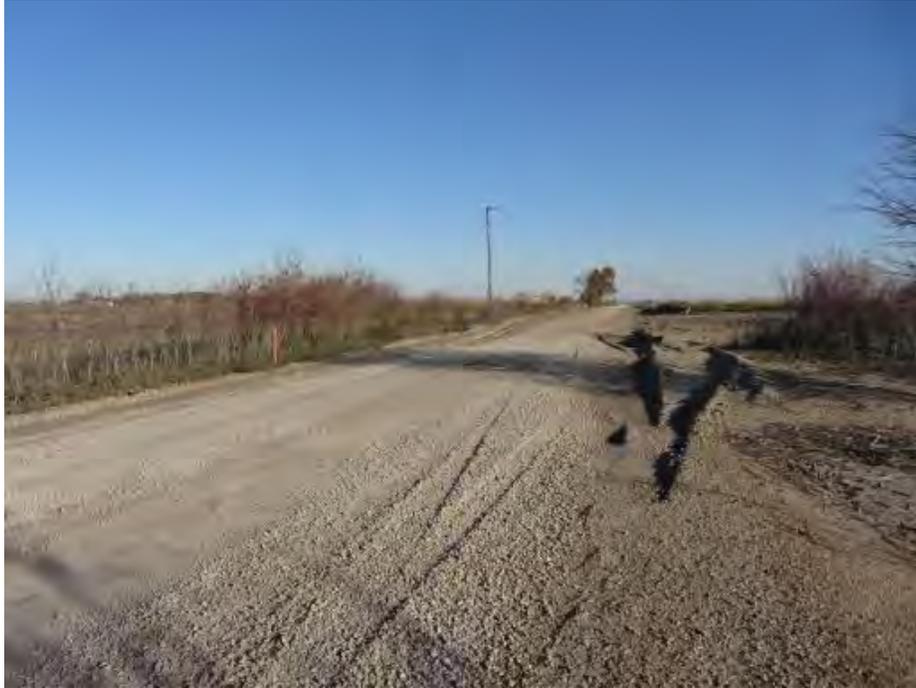
Figure 155. Newly placed gravel near a culvert at about 4700 m station on TS2 (Picture taken 10/27/11)

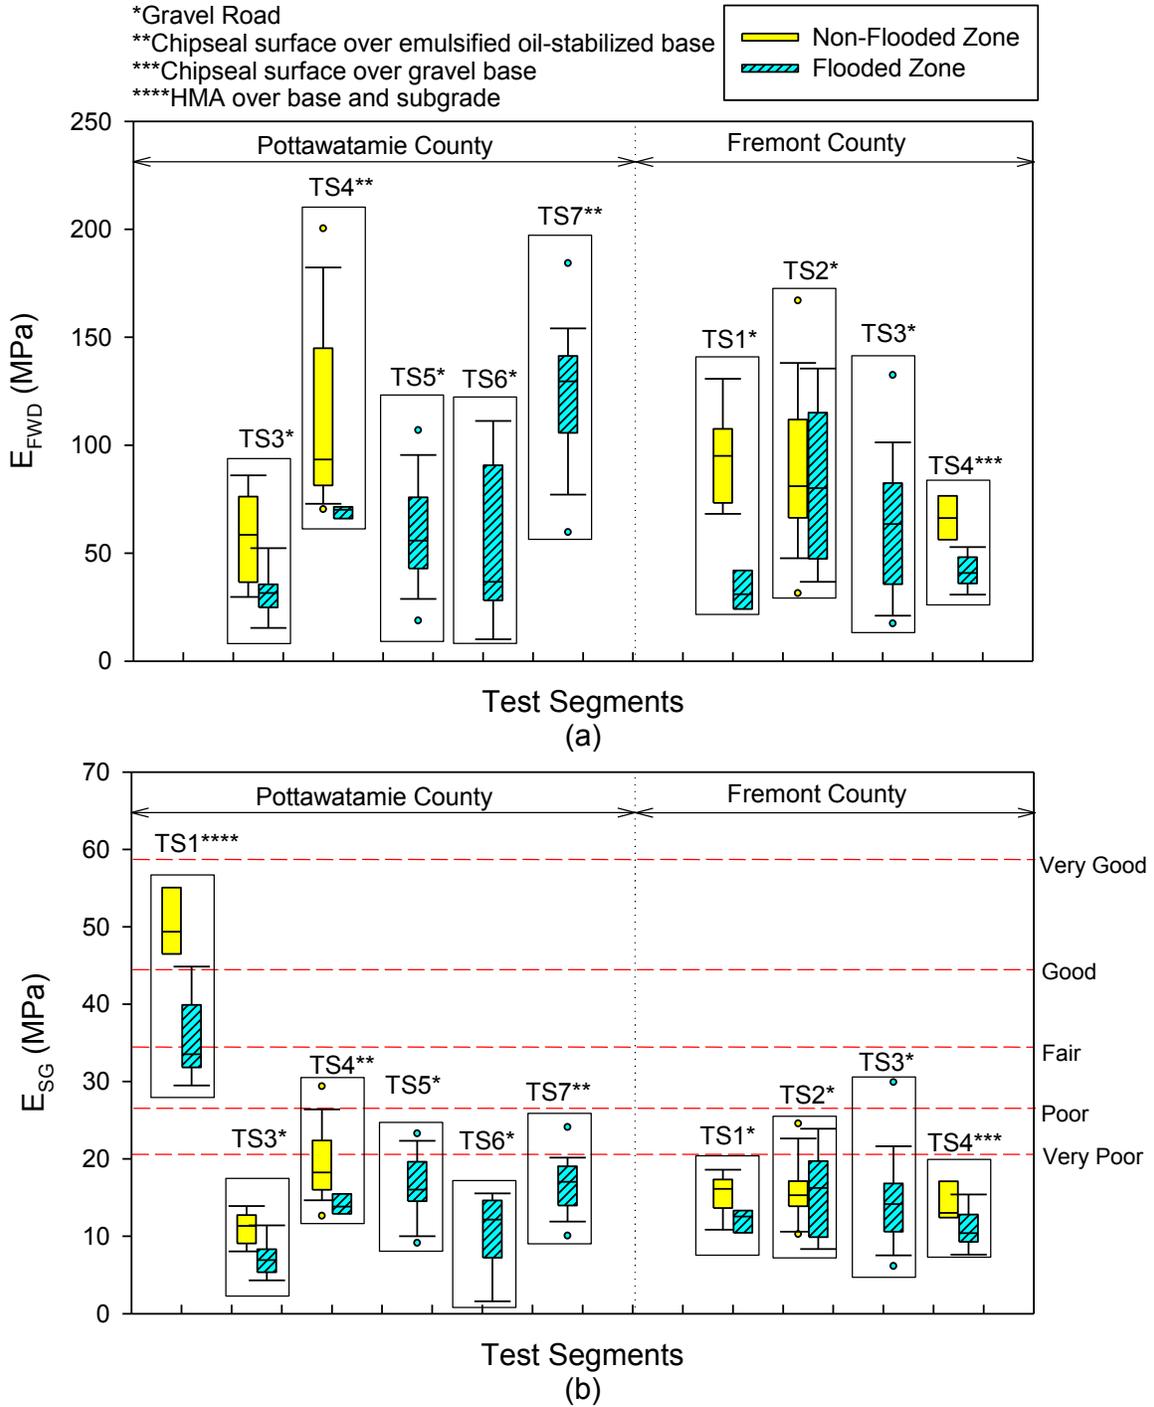
Figure 167. Box plots of (a) E_{FWD} and (b) E_{SG} obtained shortly after flooding (about 20 to 30 days) from all test segments in flooded and non-flooded zones

The comparisons presented in Figure 167 and Figure 168 and the statistical t-test results indicate that out of the 6 test segments (where non-flooded and flooded zones sections were present within a test segment), 5 test segments had statistically significant difference between flooded and non-flooded zones. On average, the E_{FWD} and E_{SG} values in non-flooded zones were about 1.3 to 3.6 times greater than the values in non-flooded zones, in the test segments where the difference was statistically significant. Results obtained about 7 to 8 months after flooding were statistically significant in only 3 out the 6 test segments. This indicates that in those test segments, the foundation layers in the flooded zone gained strength over time, likely as drainage occurred and the degree of saturation in the subgrade layers decreased.

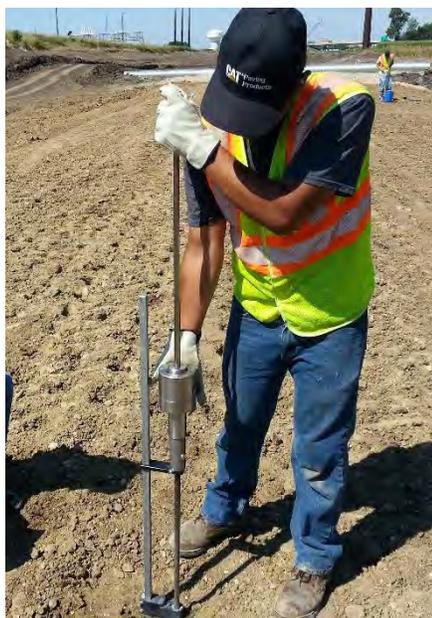
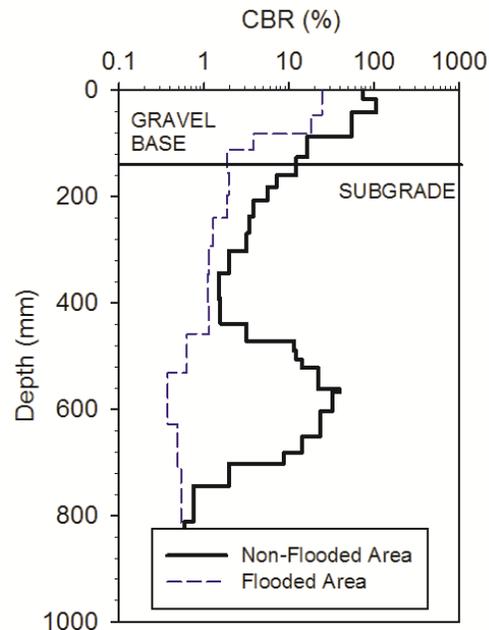
Figure D9. Dynamic cone penetrometer testing (left) and an example plot comparing DCP-CBR profiles in flooded and non-flooded areas
